## CALIFORNIA COASTAL COMMISSION

## ADDENDUM

**DATE:** October 31, 2016  
**TO:** Commissioners and Interested Parties  
**FROM:** South Central Coast District Staff  
**SUBJECT:** Agenda Items 19a, Thursday, October 14, 2016, Coastal Development Permit Amendment Application No. 4-14-0687-A1 (Santa Barbara County)

**Proposed Amendment Description:** After-the-fact authorization for installation and retention of approximately 415 ft. long, 10-20 ft. wide, and 9-12 ft. high geotextile cells filled with cobble and earth that were installed in March 2016 within the central portion of Goleta Beach County Park to protect public recreational facilities and utilities from erosion during strong El Niño storm conditions.

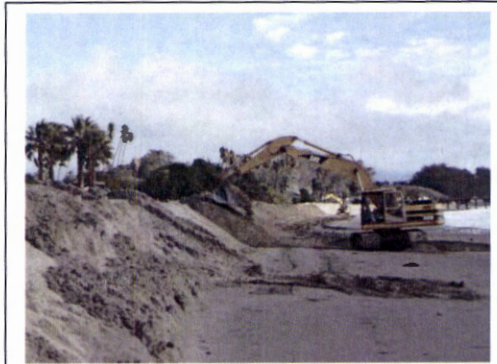
*Following completion of the sand berm in December, frequent maintenance involved use of excavators to rebuild the eroding sand berm.*

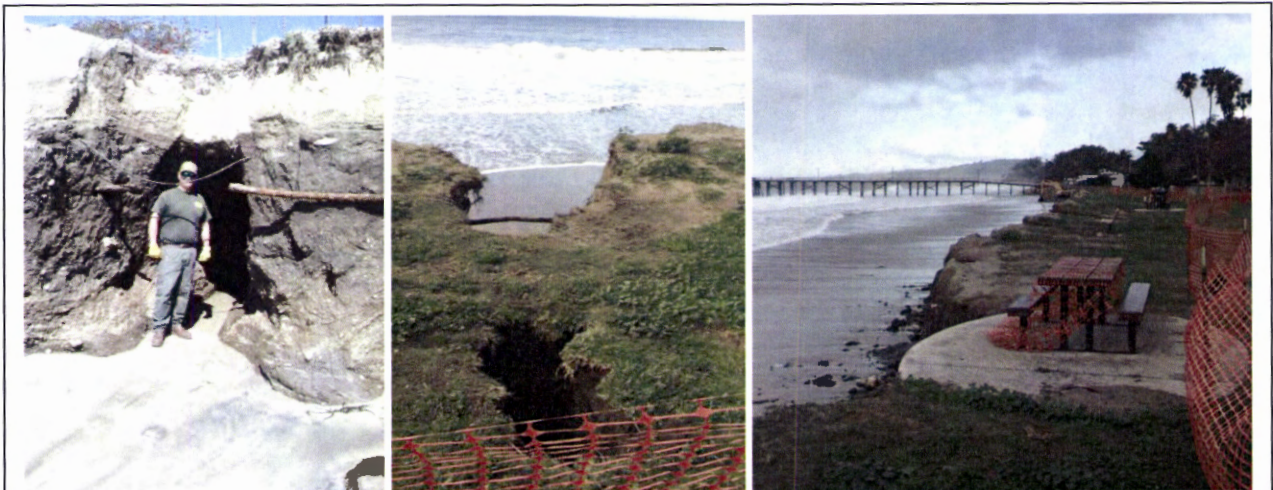
Consequently, in the early weeks of March 2016, substantial damage occurred to the park's lawn area, including sinkholes and crevasses that appeared in at least eight locations on March 6, 2015 and March 7, 2016. This erosion created substantial damage to park facilities and infrastructure and threatened health and safety of visitors and workers. As an emergency response, damaged regions of the park were fenced off to the public and the County submitted an application for an emergency permit to repair the damaged areas of the park (Figure 2).

*Sink holes that developed in March 2016 exceeded more than 10 feet in depth in some locations (left), with crevasses extended 15-20 feet deep into the lawn resulting in imminent substantial impacts to public safety at the park. The County took permitted emergency action to cordon off and fill these areas and to initiate repairs.*

On March 9, 2016, the CCC approved emergency work under CDP G-4-16-0027, including backfilling of the sinkholes with imported earth and cobbles (see Figure 2).<sup>1</sup> However, these measures proved ineffective and erosion and damage to park facilities accelerated along with release of compacted earth and cobbles into the surf zone due to high tides and strong wave action.

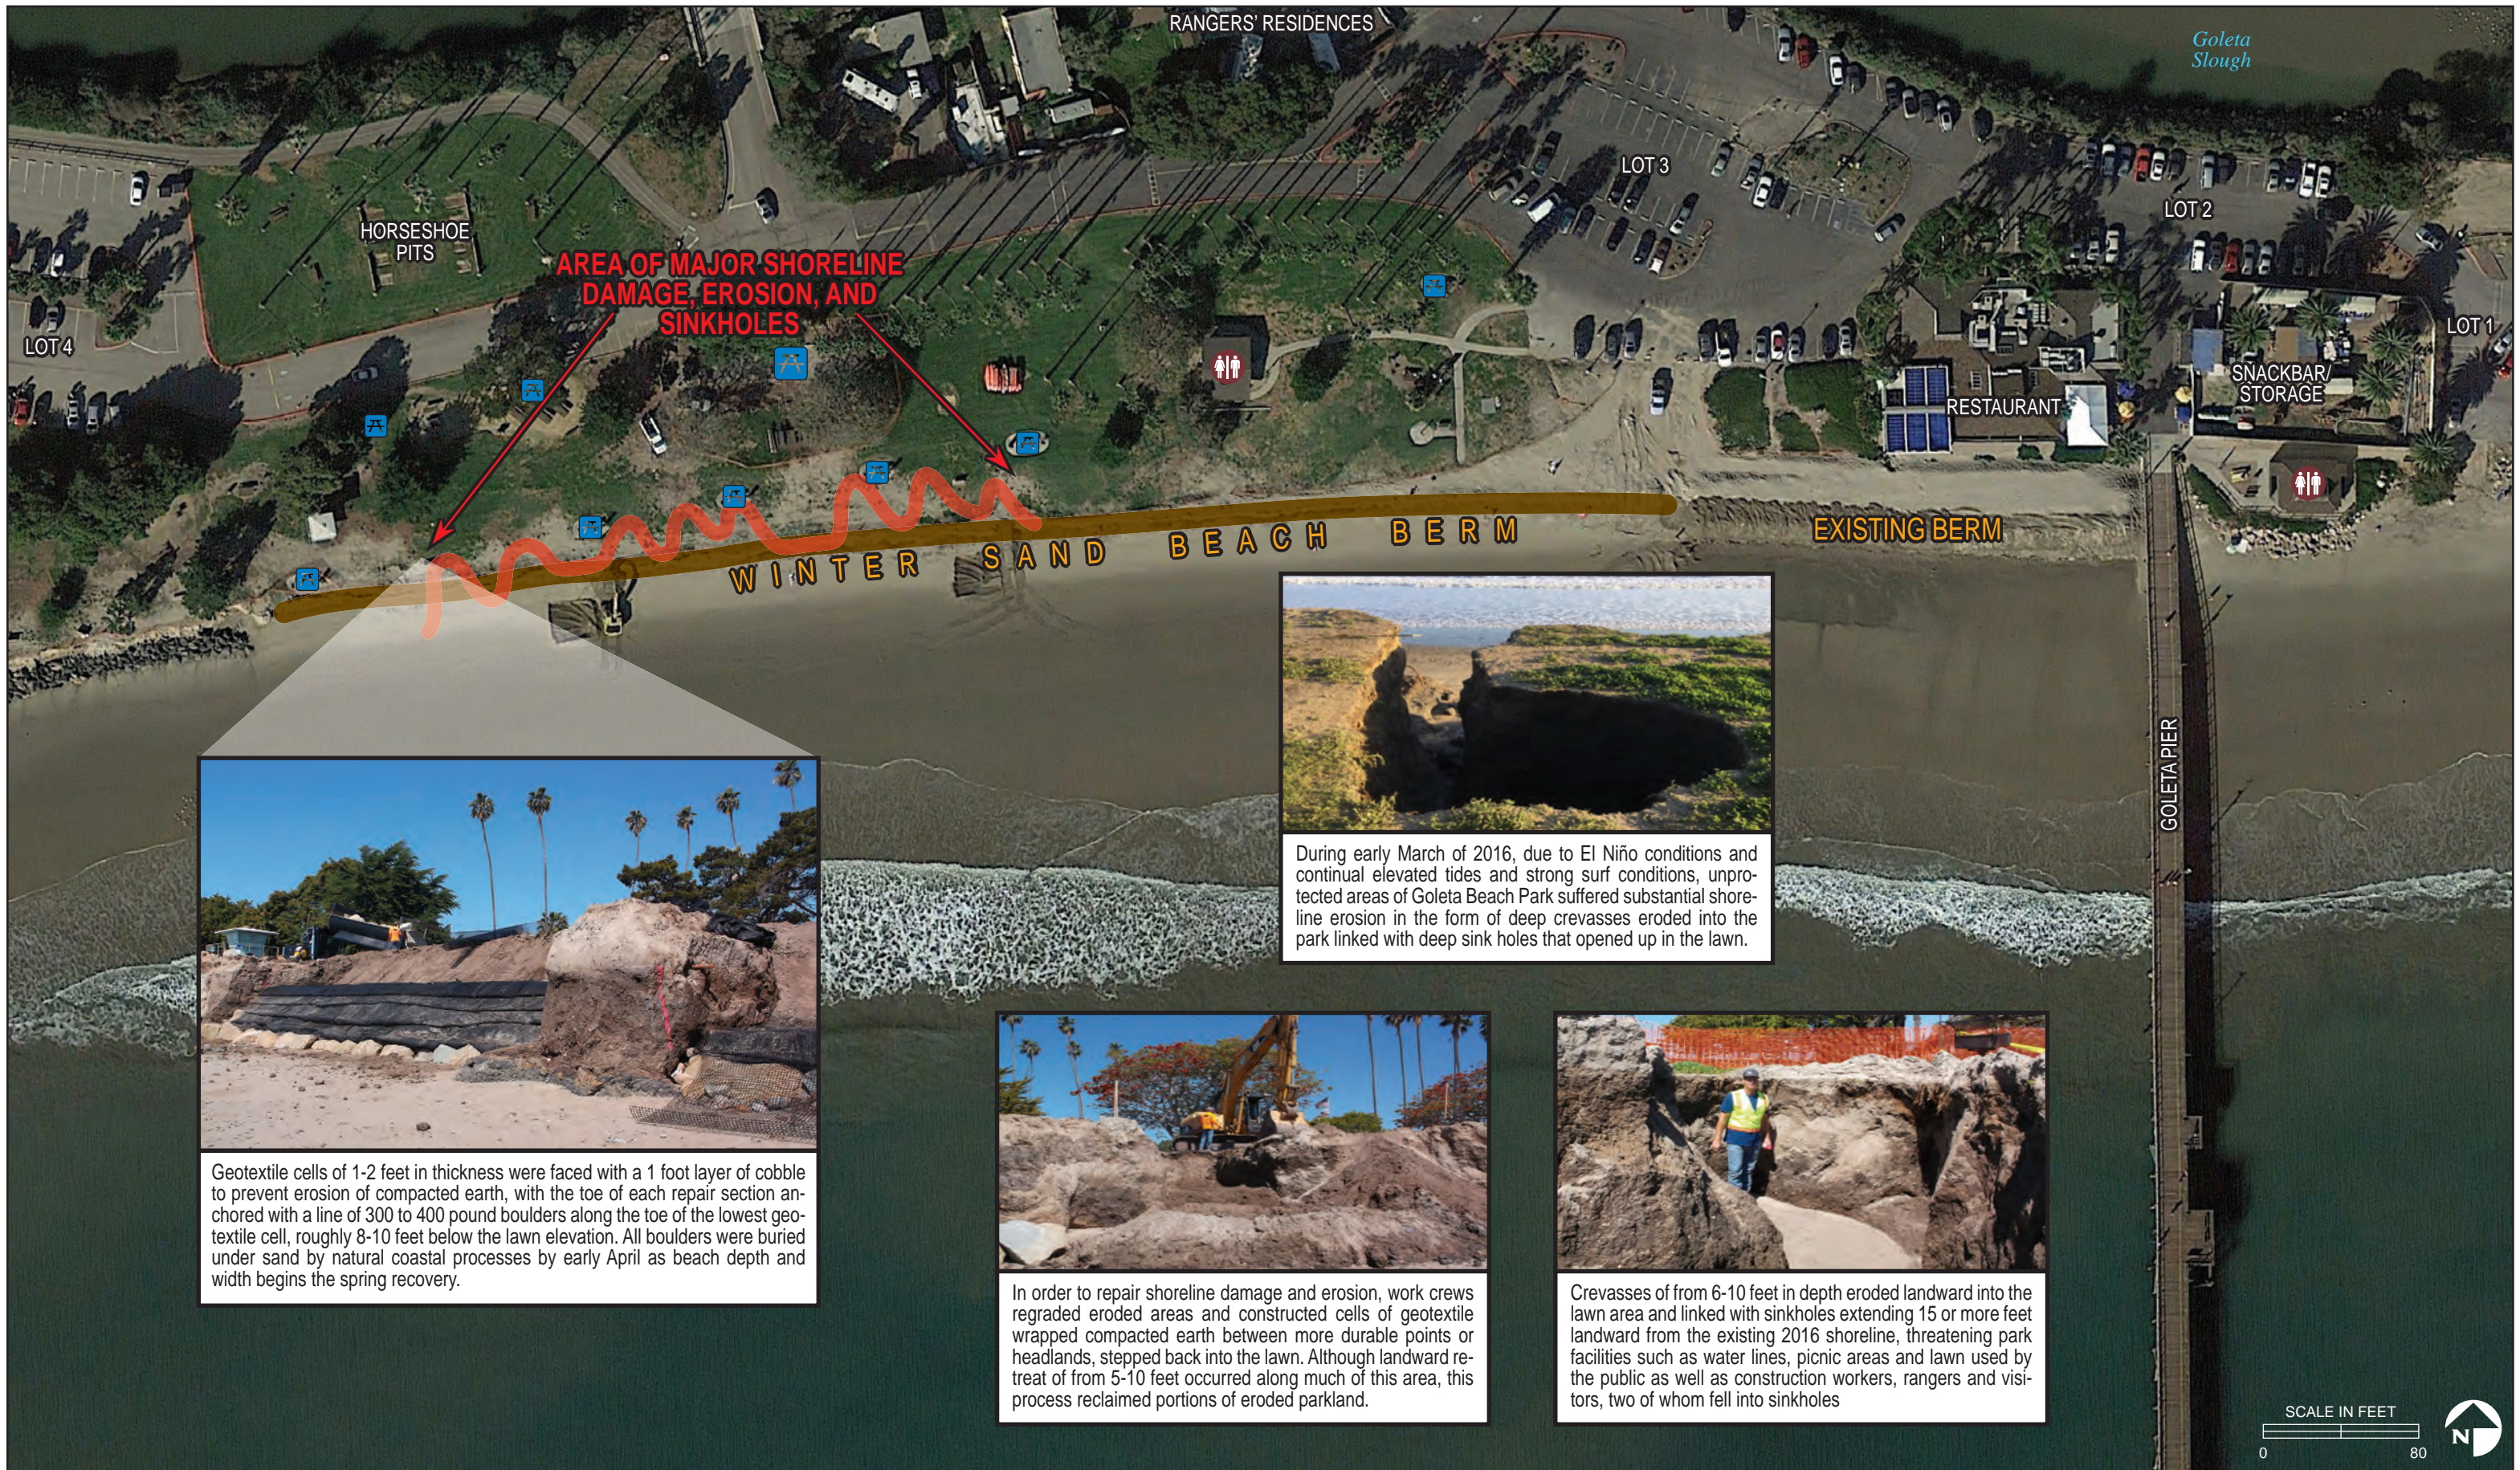
**AREA OF MAJOR SHORELINE  
DAMAGE, EROSION, AND  
SINKHOLES**

**WINTER SAND BEACH BERM**

**EXISTING BERM**

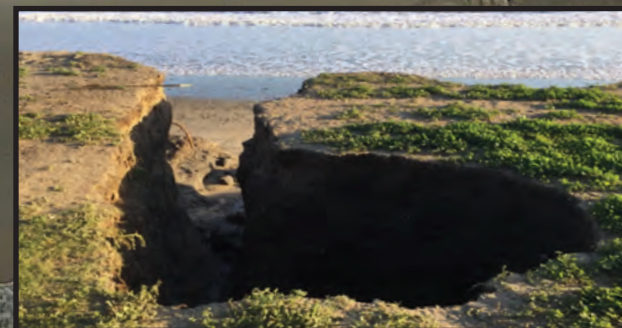
During early March of 2016, due to El Niño conditions and continual elevated tides and strong surf conditions, unprotected areas of Goleta Beach Park suffered substantial shoreline erosion in the form of deep crevasses eroded into the park linked with deep sink holes that opened up in the lawn.

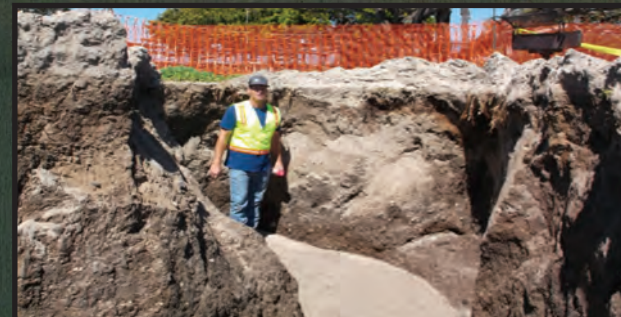
Crevasses of from 6-10 feet in depth eroded landward into the lawn area and linked with sinkholes extending 15 or more feet landward from the existing 2016 shoreline, threatening park facilities such as water lines, picnic areas and lawn used by the public as well as construction workers, rangers and visitors, two of whom fell into sinkholes

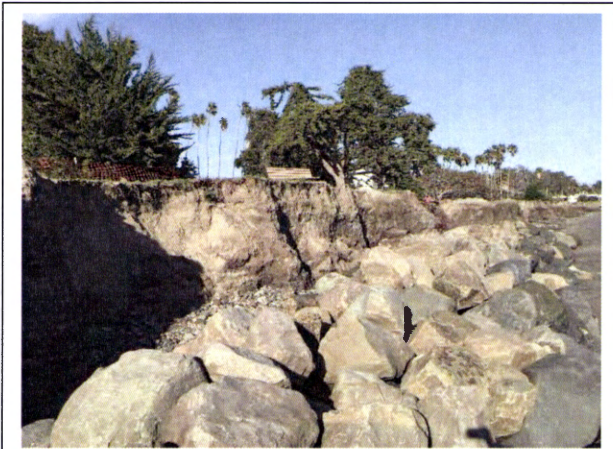
*Overtopping of the existing permitted rock revetment eroded landward park area and required importation of cobble to stabilize the eroded gap between the rock revetment and the eroded park area.*

El Niño conditions induced high tides and near continuous strong surf also led to overtopping of the existing permitted rock revetment in places with erosion damage to lawn areas along 125 to 150 feet of the eastern end of the permitted rock revetment (Figure 4). Landward erosion of the lawn varied from approximately 2 to 11 feet along this reach, with the most severe erosion at the east end of the rock revetment, potentially due to end cutting around the terminus of the revetment. To address this erosion, 6 truckloads of natural cobble (approximately 60 cubic yards) were imported and placed along the landward side of 125 to 150 feet of the rock revetment on the eastern side. The depth and width of cobble fill varied substantially as erosion was uneven. Much of

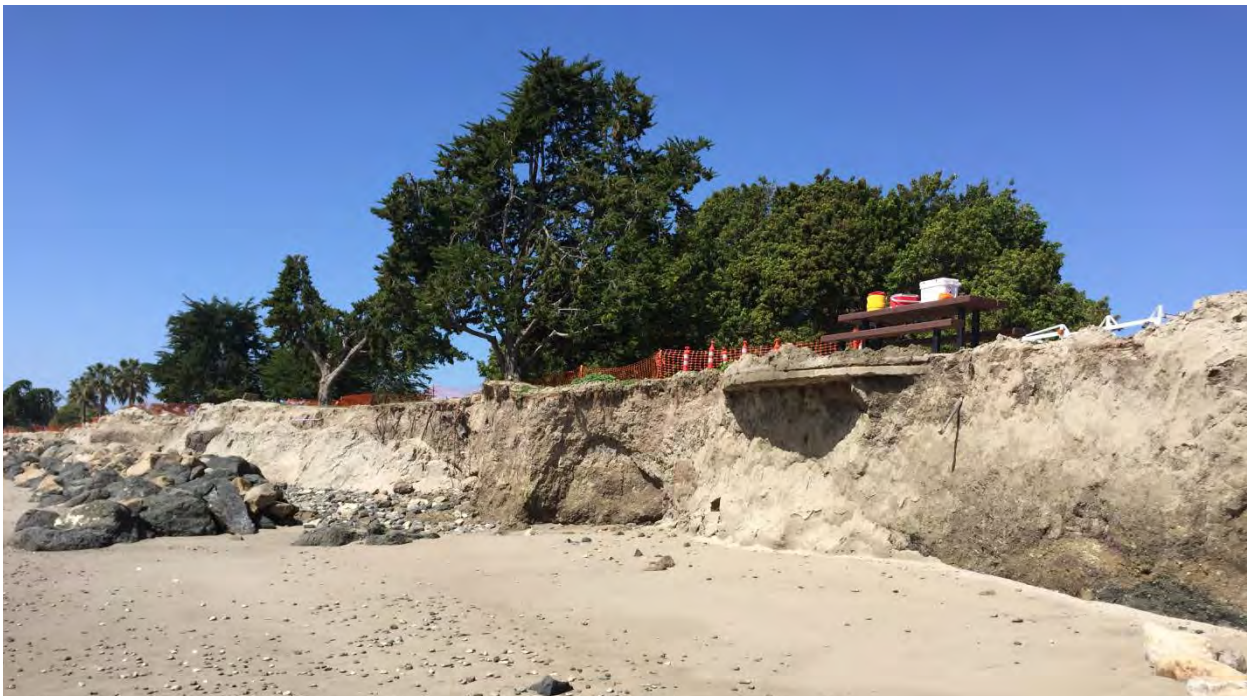
The above photograph shows a portion of Goleta Beach County Park after erosion occurred in March of 2016. On the left side of the photograph is the exposed rock revetment and on the right side of the photograph is a picnic table area that was undercut by wave caused erosion.

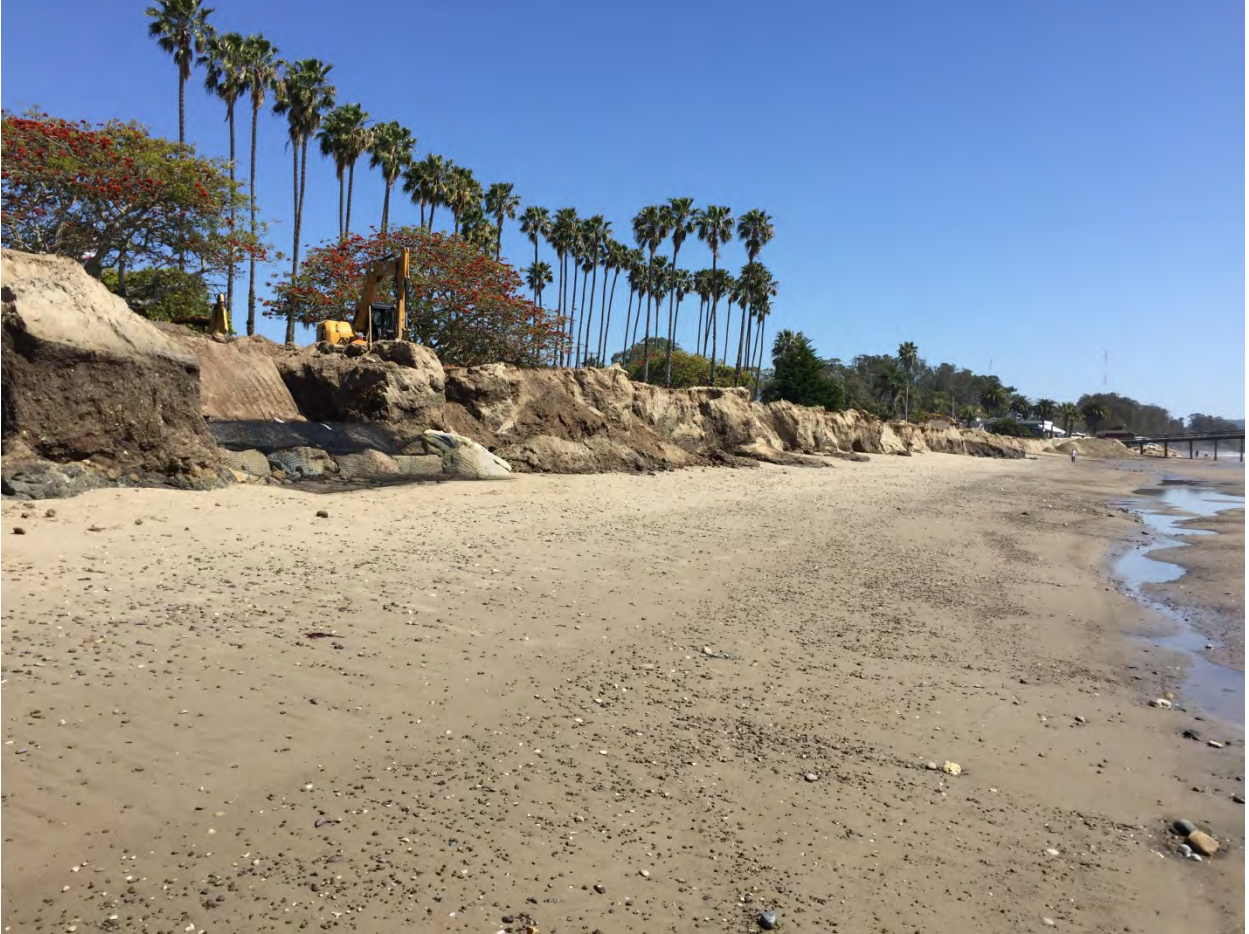
The above photograph shows the central area of Goleta Beach County Park after erosion occurred in March of 2016.
