Subject: STAFF REPORT ADDENDUM for W12a

CDP Application Number 2-17-0018 (Caltrans Marin Highway 1 Rumble Strip

and Shoulder Widening Project)

STAFF REPORT: REGULAR CALENDAR

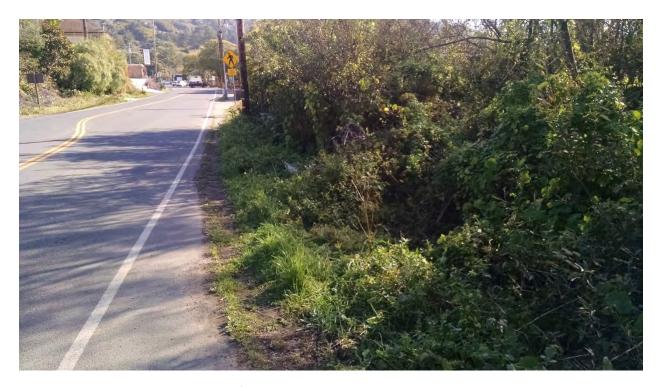
Photo 1. Overview of pullout location 1, looking east, December 1, 2015

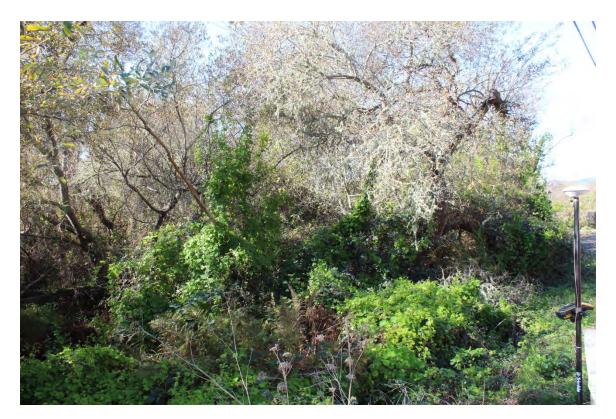
Photo 10. Riparian vegetation in pullout location 4, looking south, November 25, 2015
