**6-18-1089 (CALIFORNIA DEPARTMENT OF PARKS AND
RECREATION)**

JUNE, 2019

EXHIBITS

**Long-Term Hazards
Management Plan**

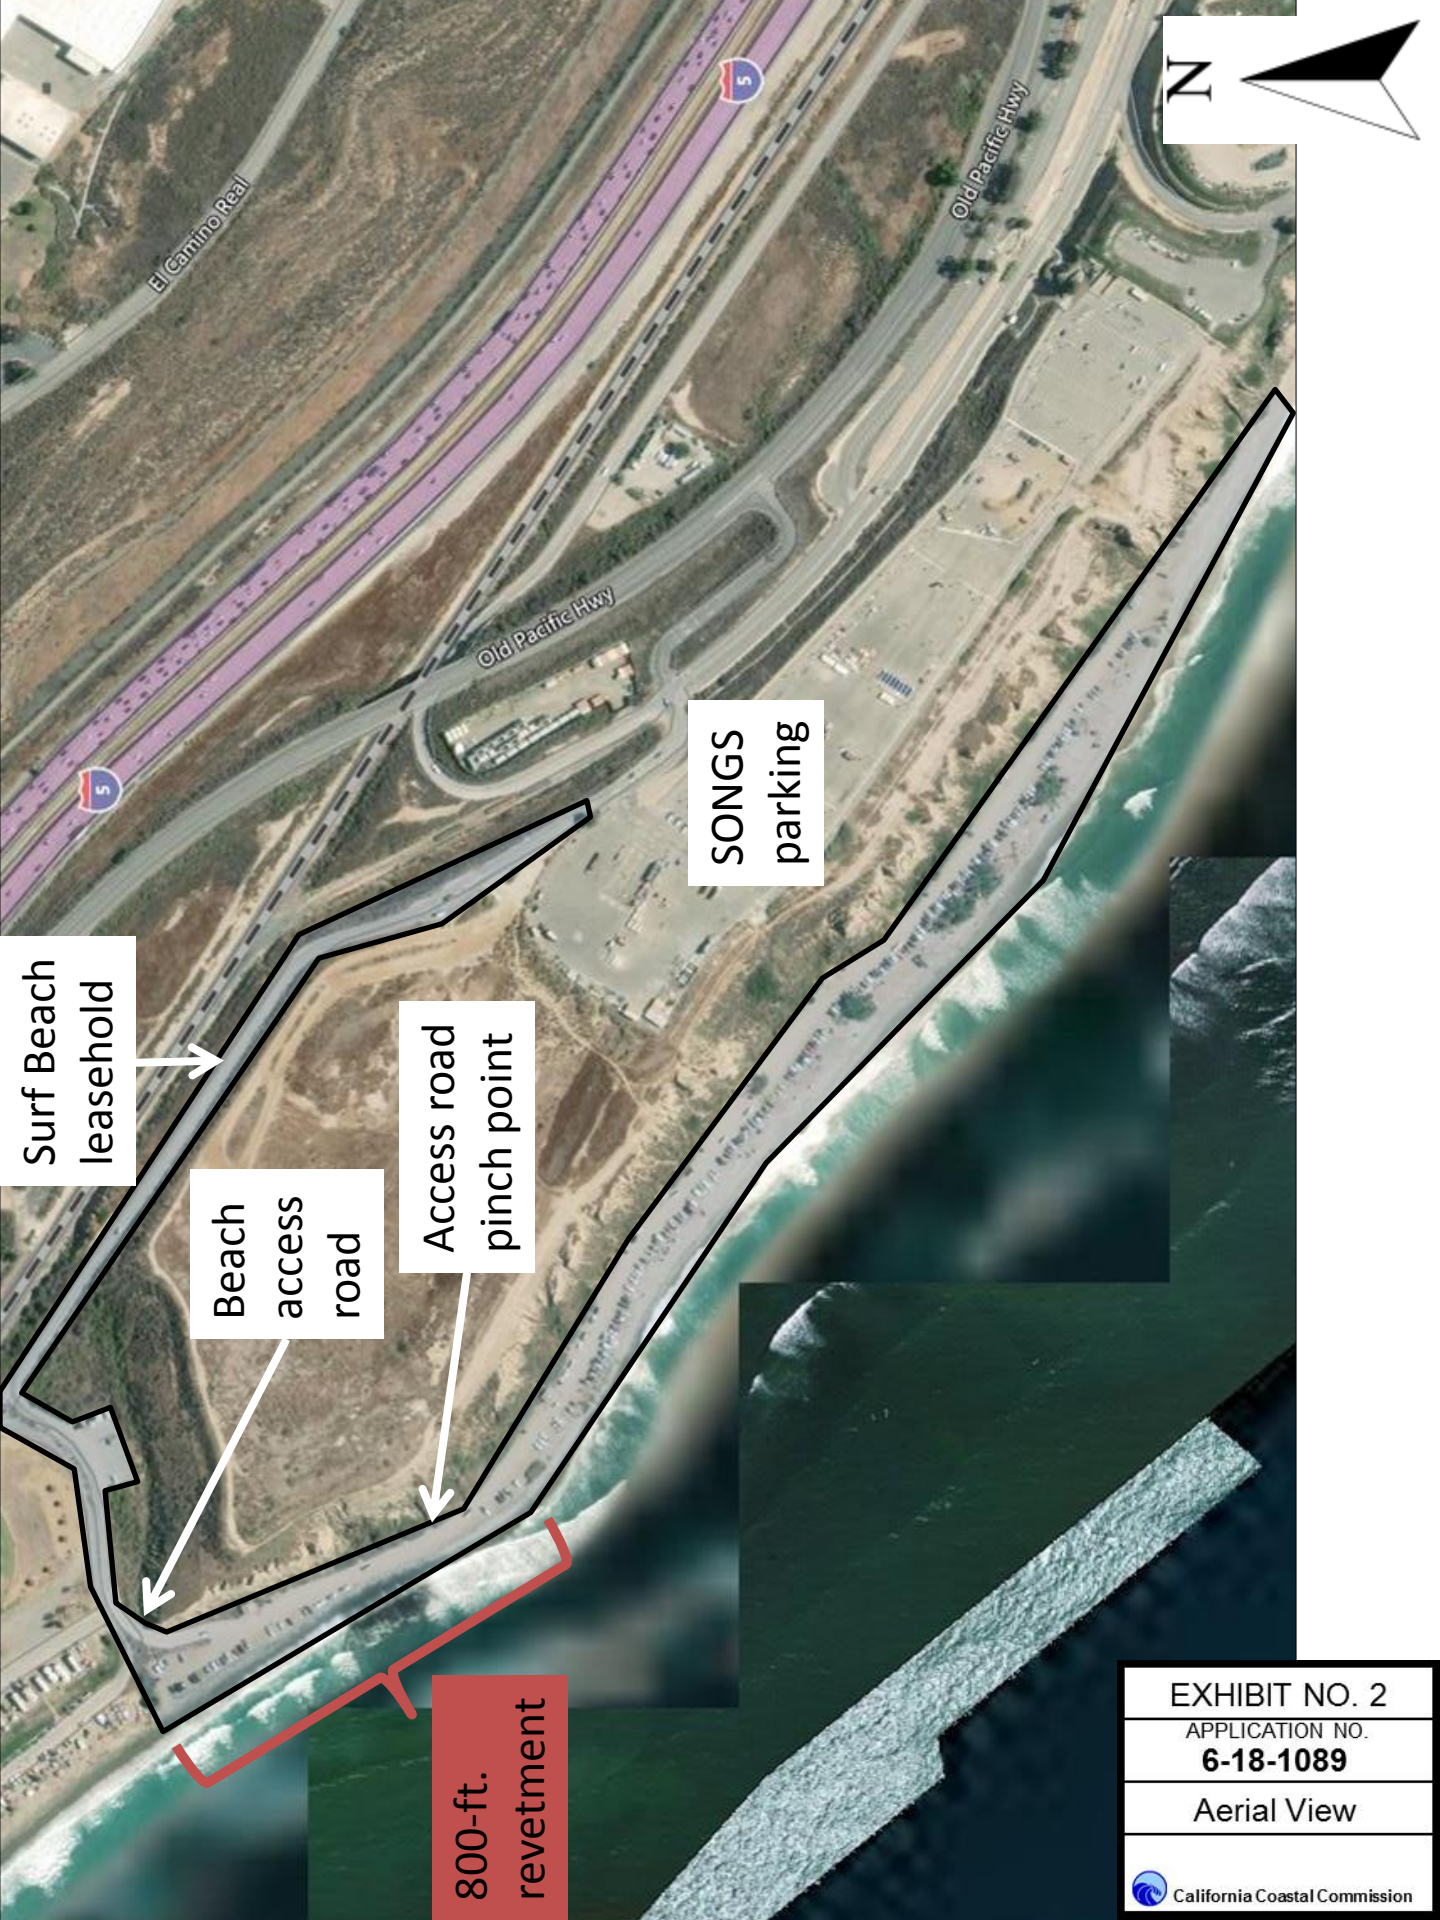
EXHIBIT NO. 2

Access road
pinch point

800-ft.
revetment

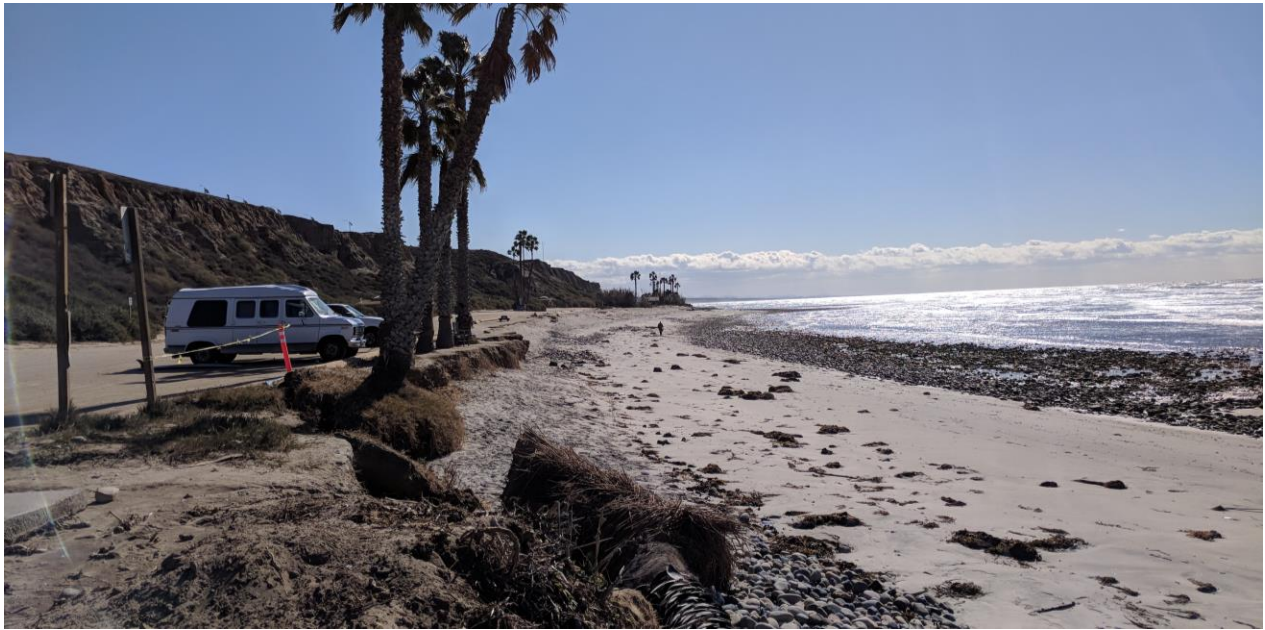
FIGURE 2.5: NARROW SANDY BEACH

The Surf Beach shoreline is comprised of a narrow sandy beach with cobble (Figure 2.5), backed by coastal bluffs (Figure 2.6). The combined width of the sandy beach and road/parking area (bluff toe to wetted edge of sand) currently varies from very narrow (~80ft) near the northern edge at “The Point” surf break to wider (~160ft) at “Old Man’s” and “Dogpatch” to the south, (as estimated from a February 2018 aerial image). The nearshore area is relatively shallow with a large amount of cobble and scattered kelp beds (Figure 2.7).

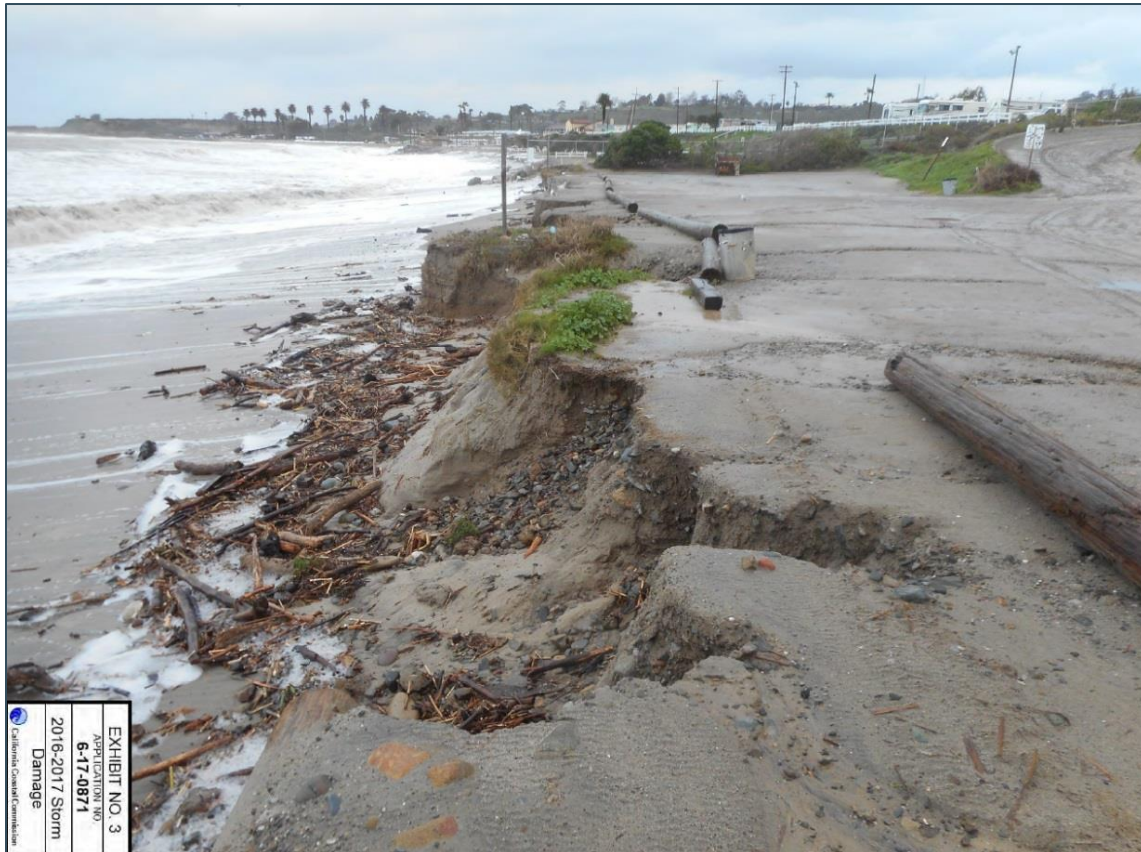
FIGURE 3.1: 2017 STORM DAMAGE, LOOKING NORTH

During the 2015-2016 El Niño storm season, the southern portion of the Surf Beach study area experienced significant beach erosion that extended landward to the roadway and parking area. This erosion continued in 2017, leaving portions of the parking areas and roadway unstable with a 10 ft vertical drop from the parking areas' eroded edge to the beach (Figure 3.1 – Figure 3.4). Installation of an emergency revetment was necessary.

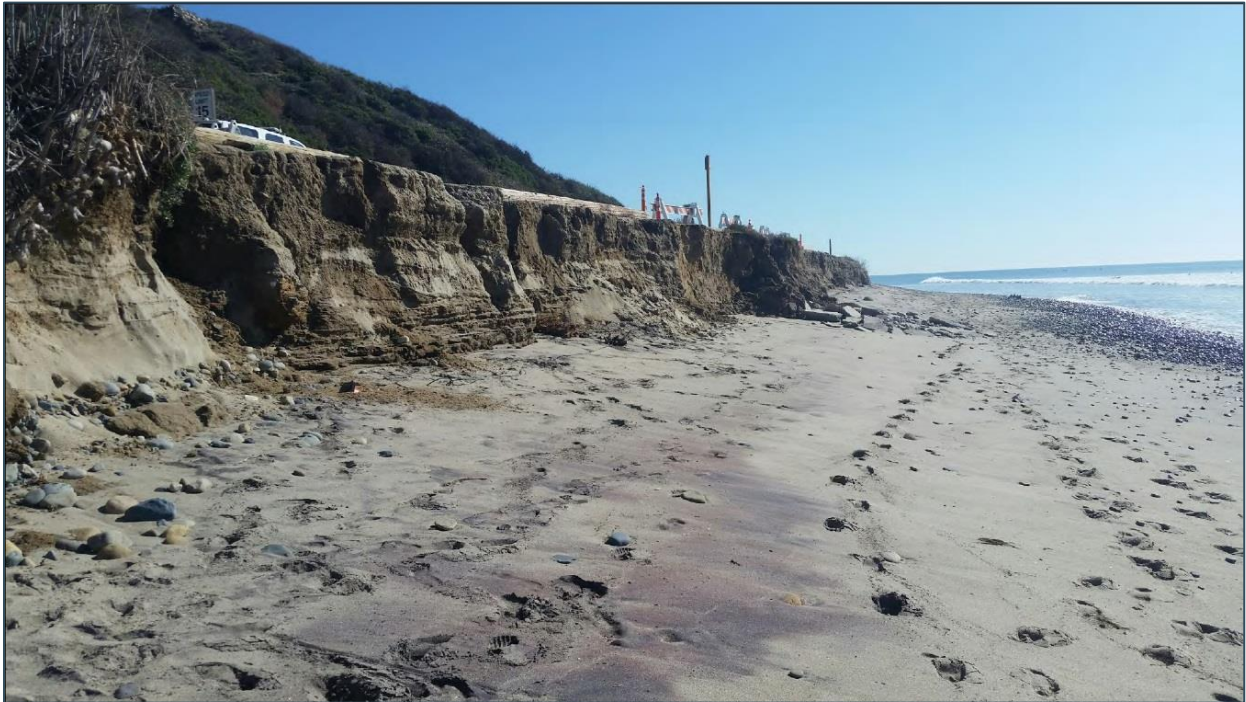
FIGURE 3.2: 2017 STORM DAMAGE, LOOKING SOUTH

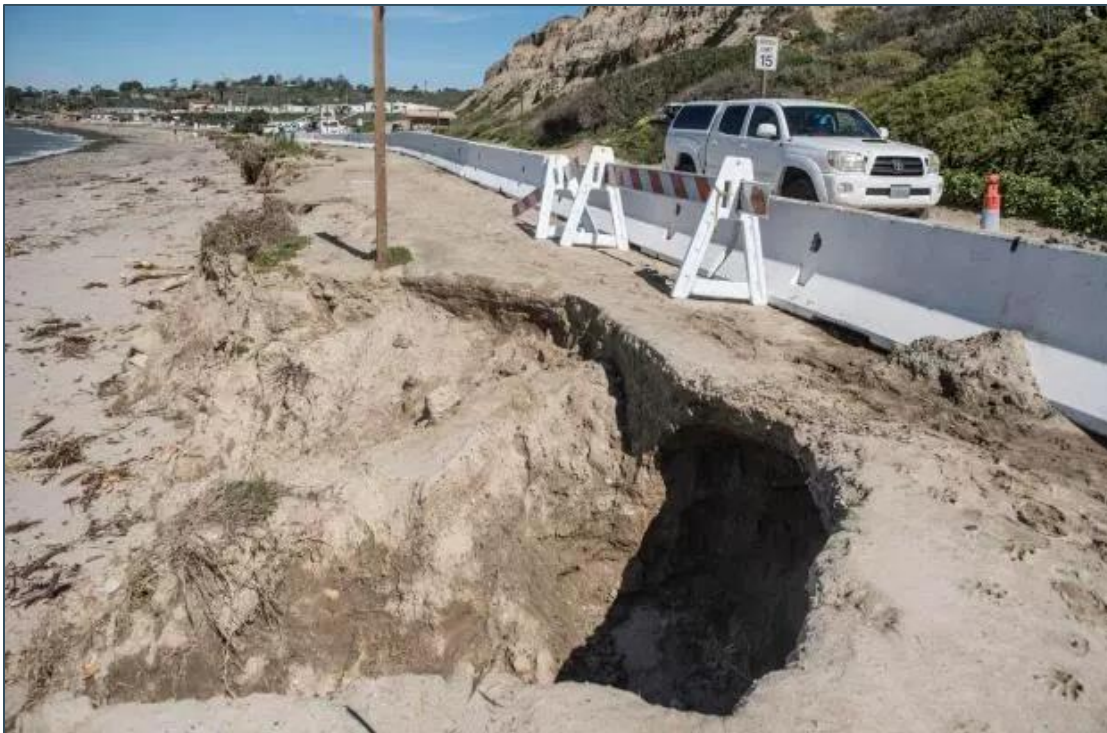
FIGURE 3.3: NARROW ACCESS WAY RESULTING FROM 2017 STORM DAMAGE (OC REGISTER, 2017)

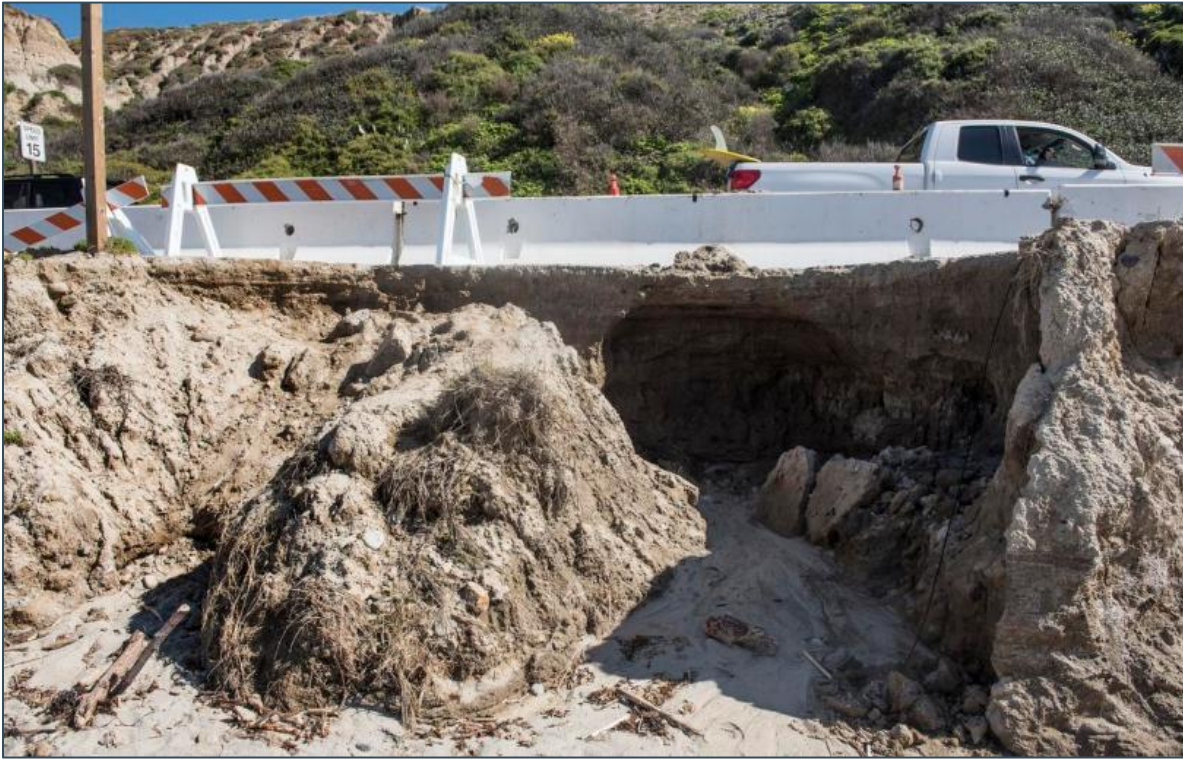
FIGURE 3.4: UNDERMINING OF ROAD/PARKING AREA FROM 2017 STORM DAMAGE (OC REGISTER, 2017)

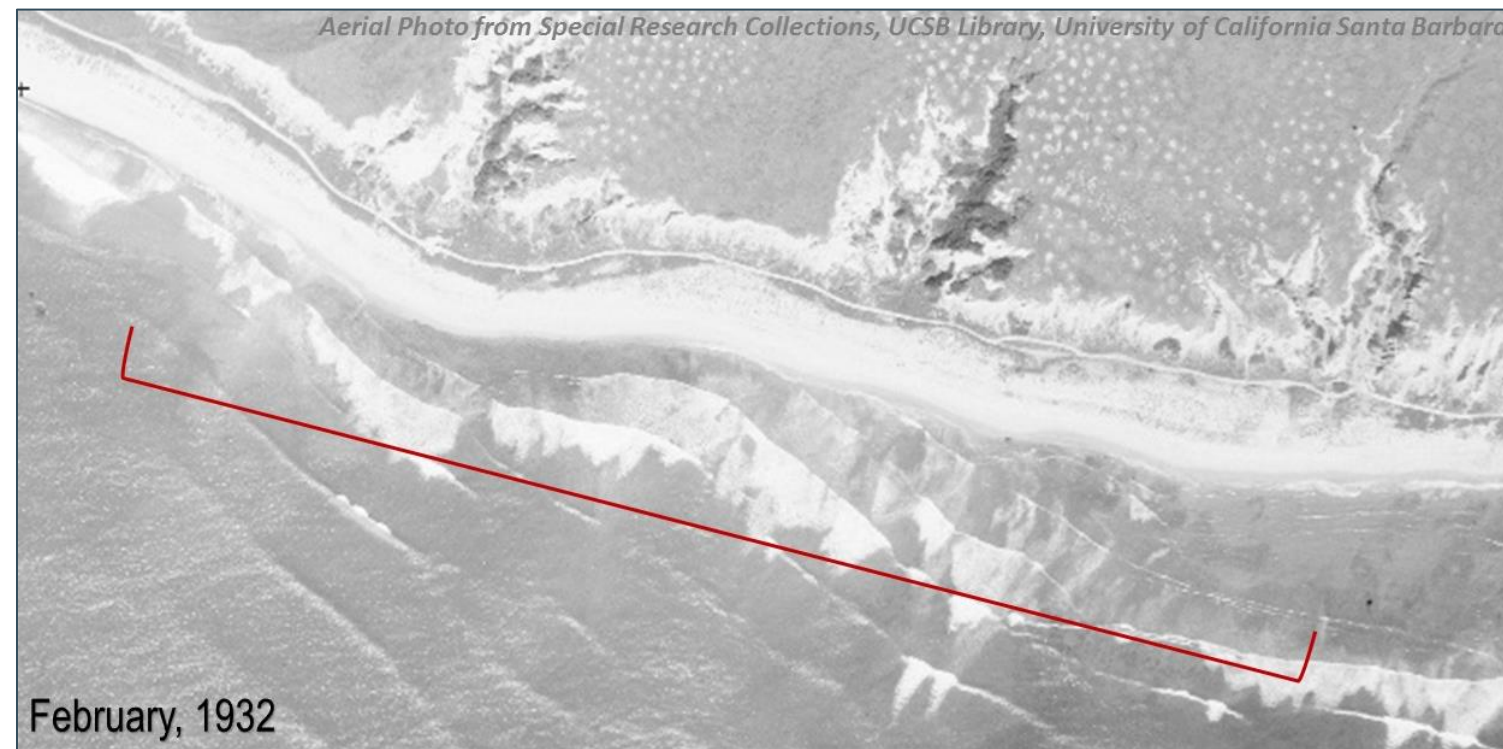
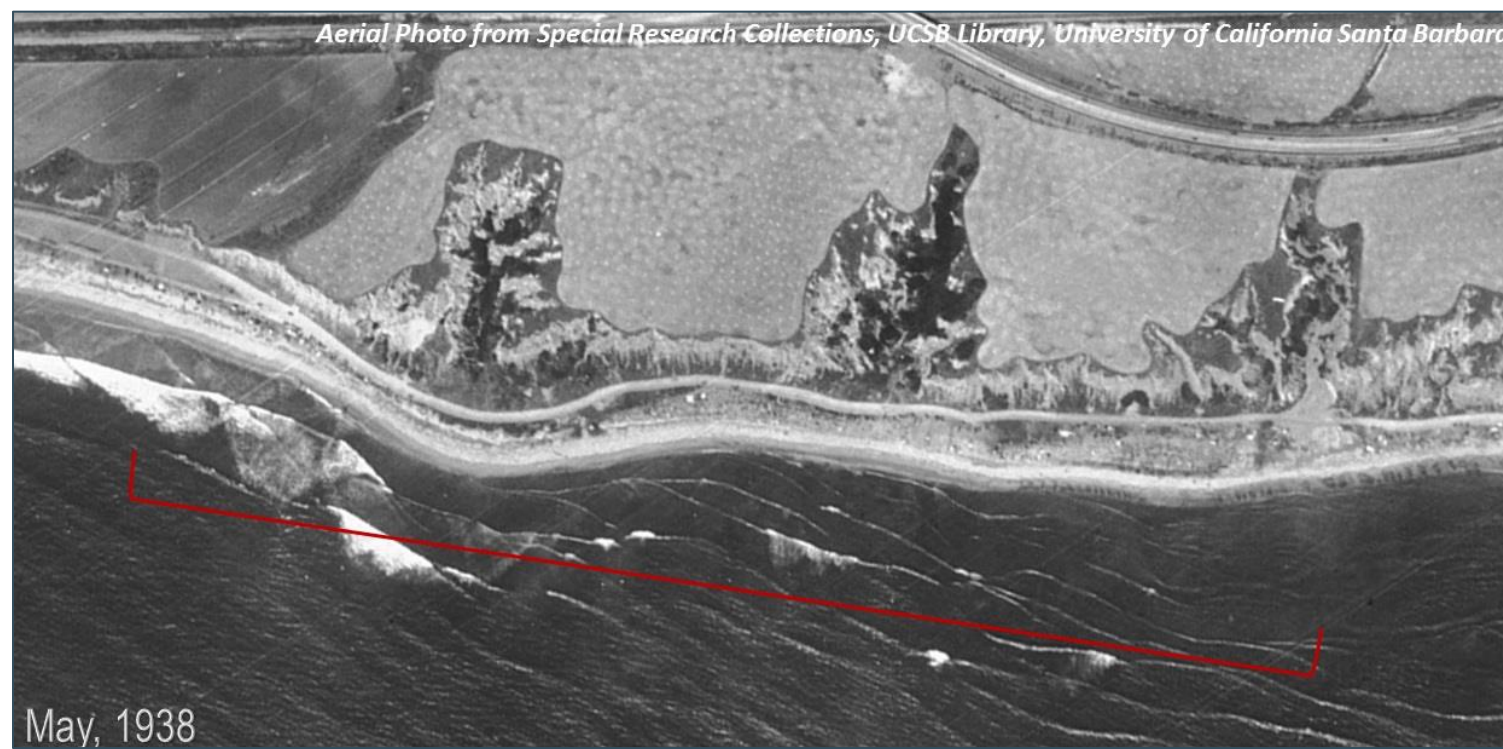
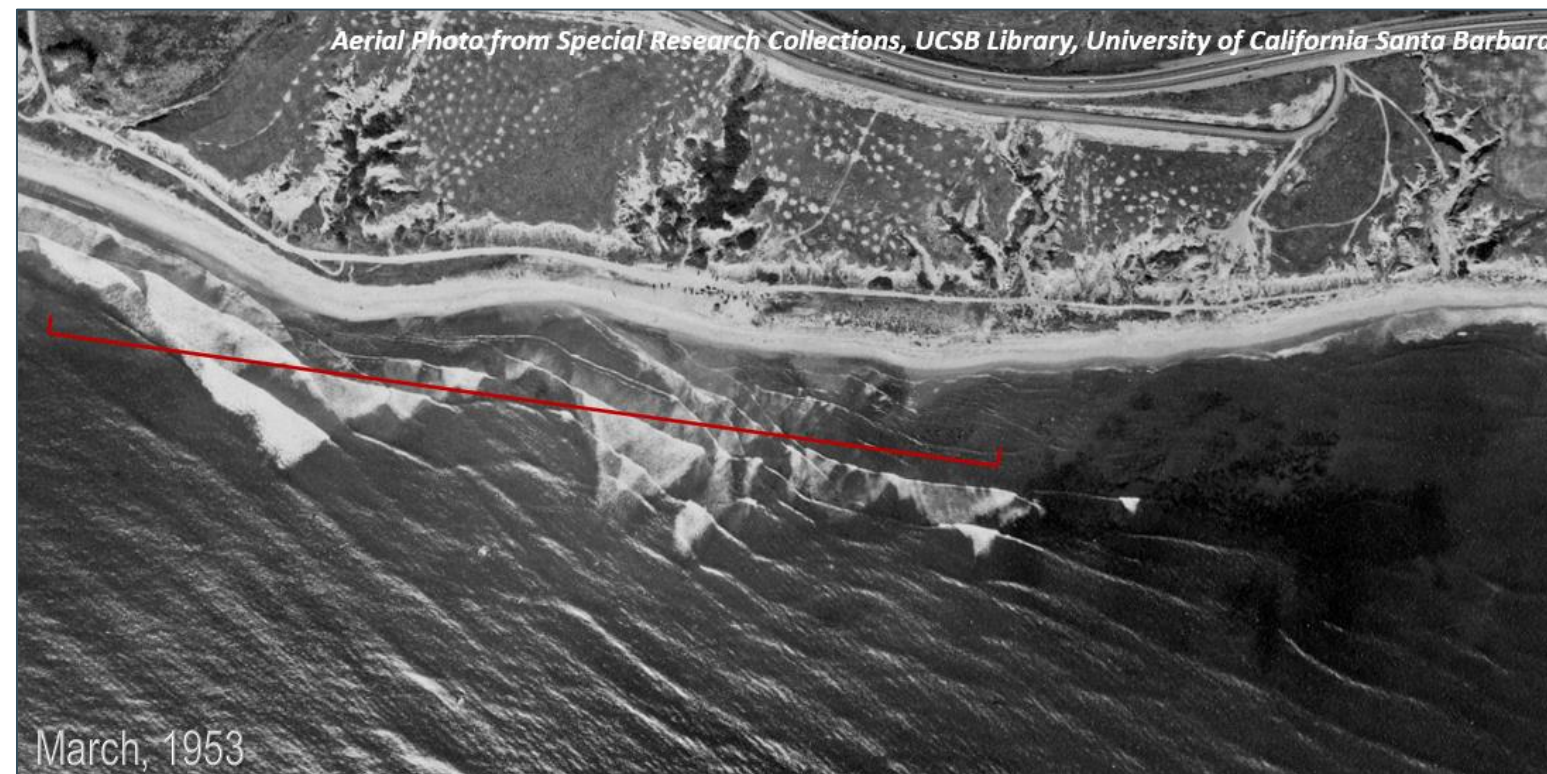
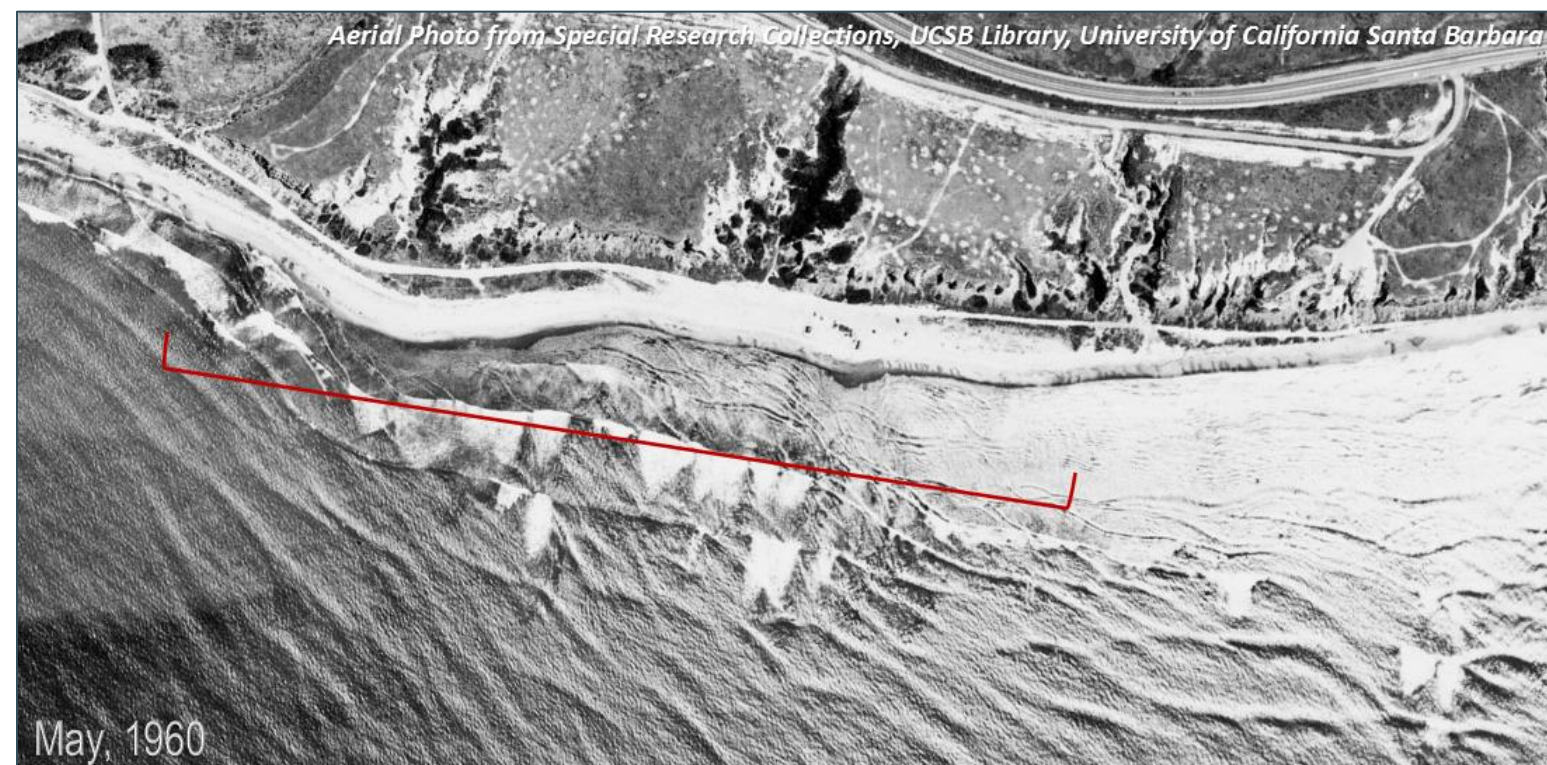
A series of natural “barrancas” (eroded canyons / gullies) were previously present along the Surf Beach bluffs, as can be seen in the 1932, 1938, 1953, and 1960 aerial imagery on the previous pages. These barrancas were filled with excavated terrace deposits during the initial years of SONGS construction; available aerial imagery indicates the fill occurred sometime between 1960 and 1965. Figure 4.7 shows the bluff in its filled state, which persists today.

FIGURE 4.1: AERIAL PHOTO FEBRUARY 1932 (UCSB LIBRARY)

FIGURE 4.2: AERIAL PHOTO MAY 1938 (UCSB LIBRARY)

FIGURE 4.3: AERIAL PHOTO MARCH 1953 (UCSB LIBRARY)

FIGURE 4.4: AERIAL PHOTO MAY 1960 (UCSB LIBRARY)

Historical shoreline conditions at Surf Beach were determined from shoreline delineations, reports, and aerial imagery (Figure 4.1 to Figure 4.4). A full catalogue of available historical aerial imagery is provided in Appendix D.

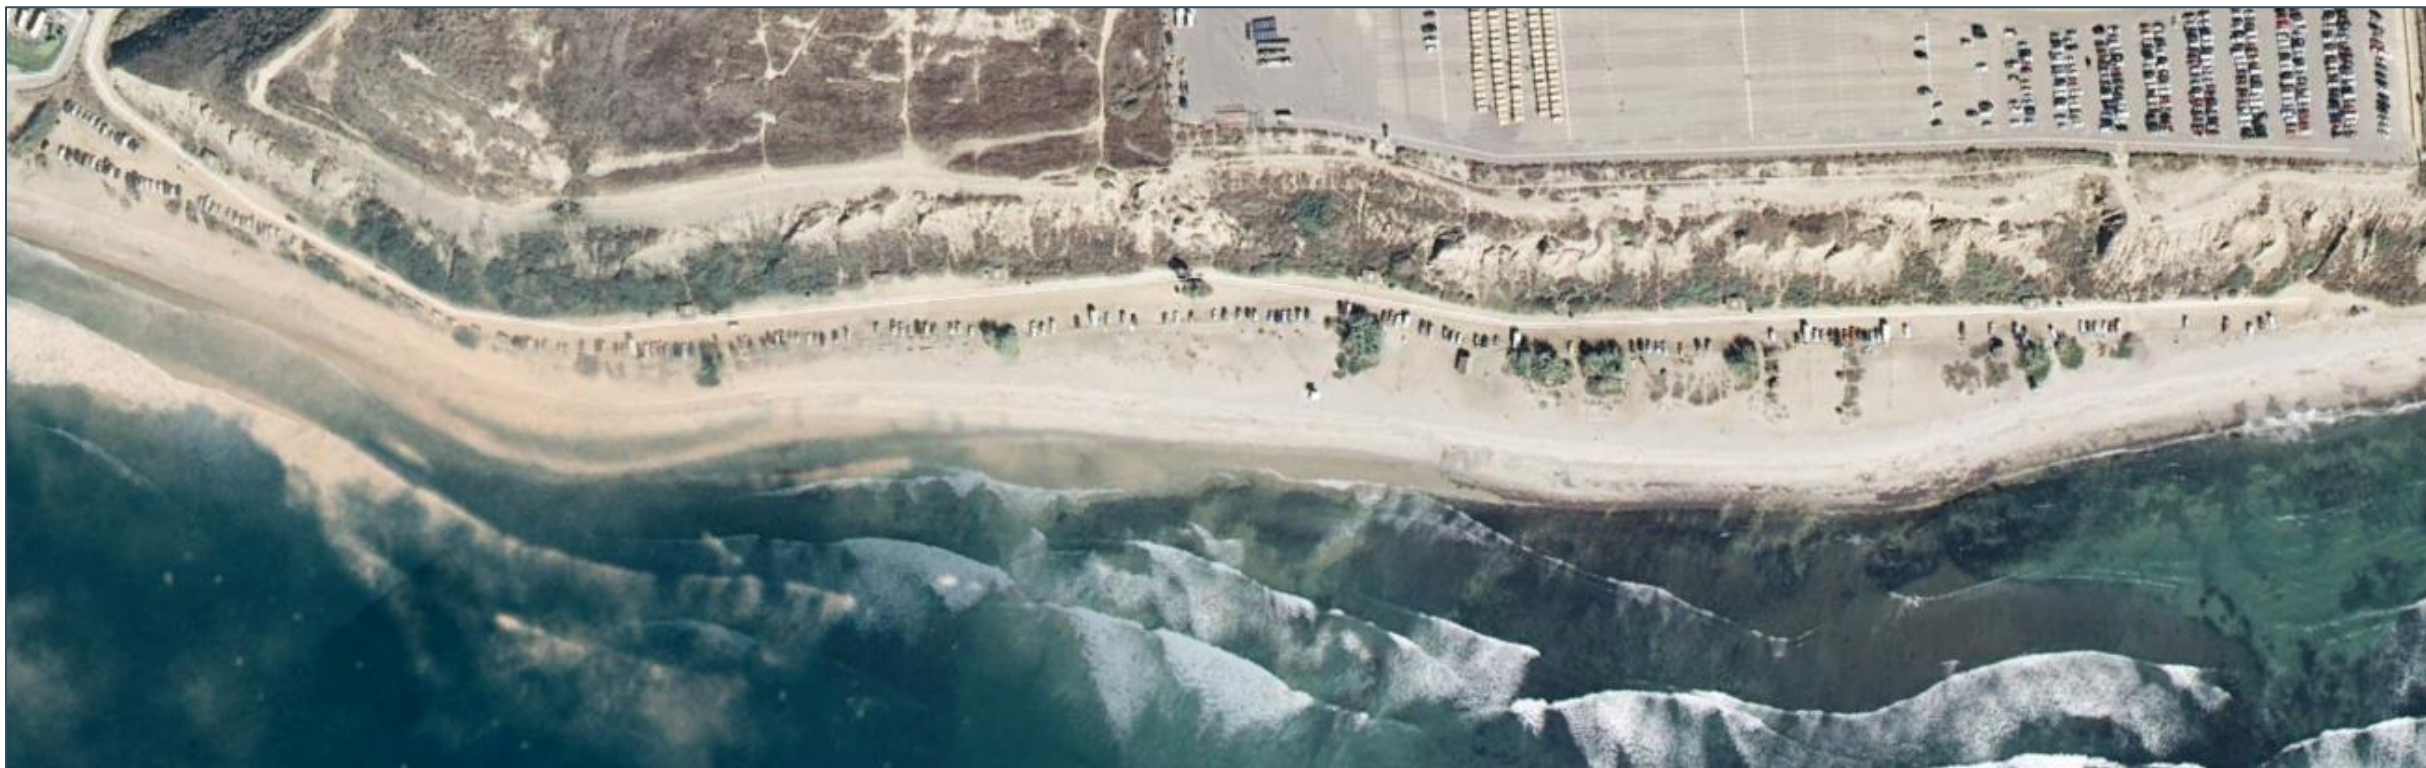
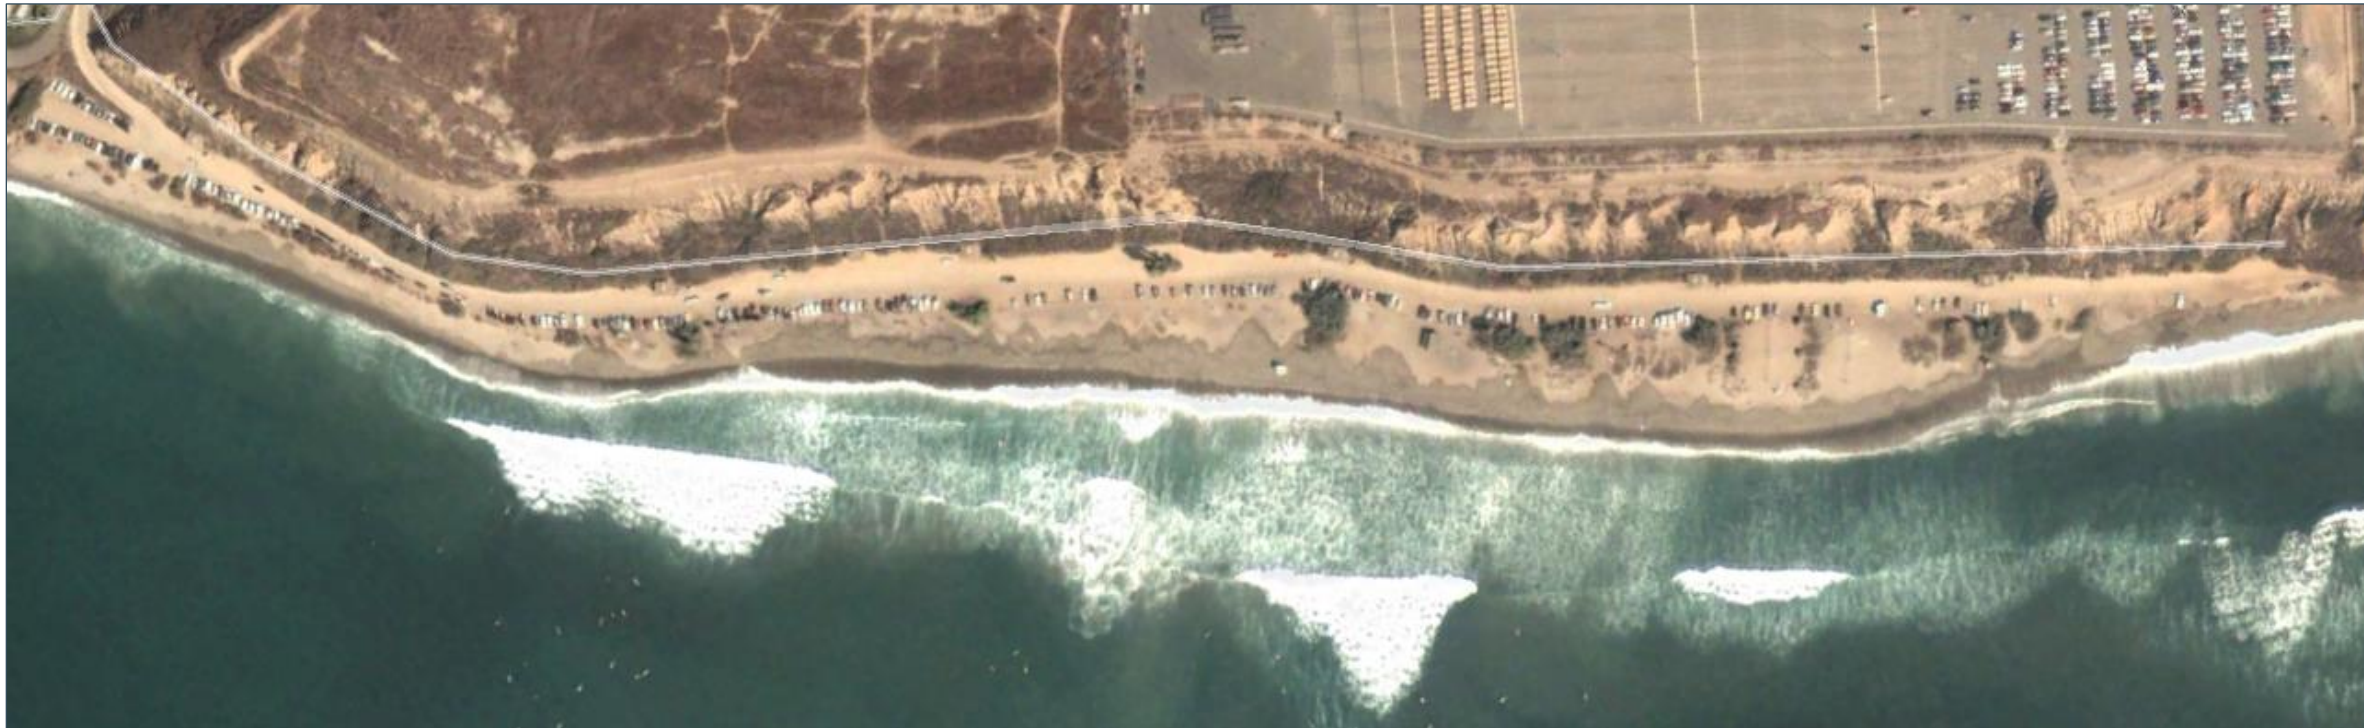
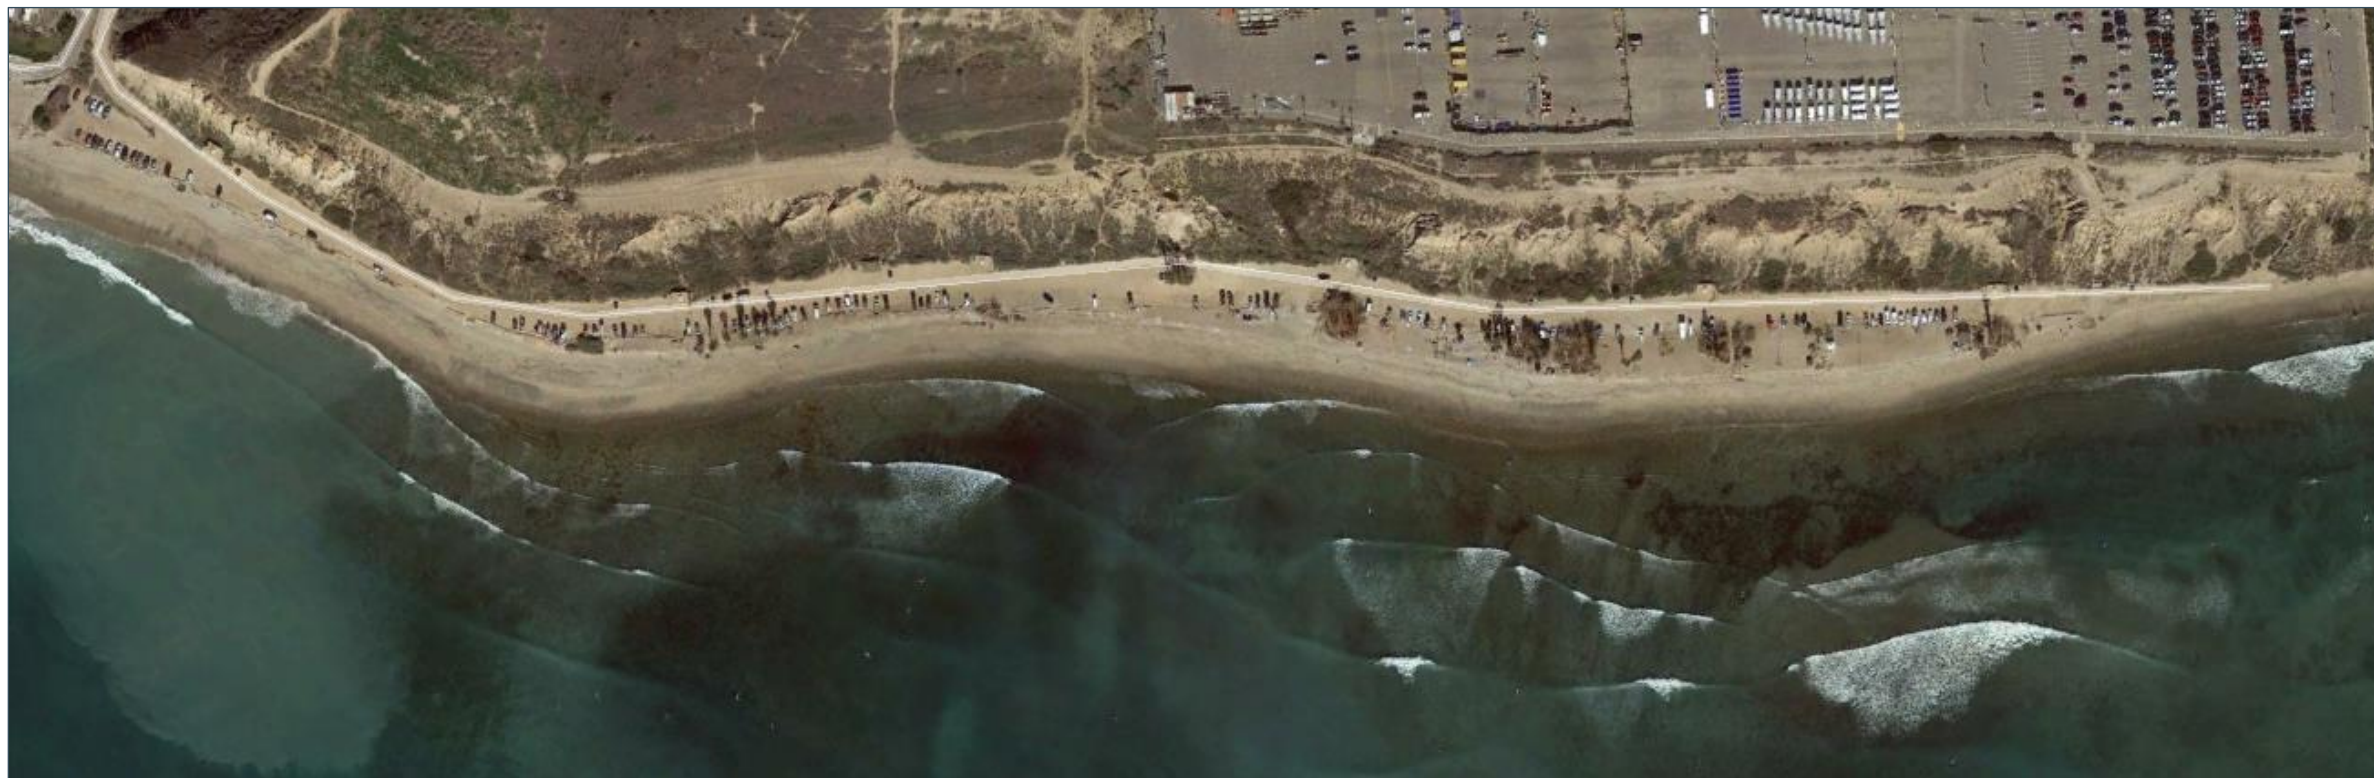
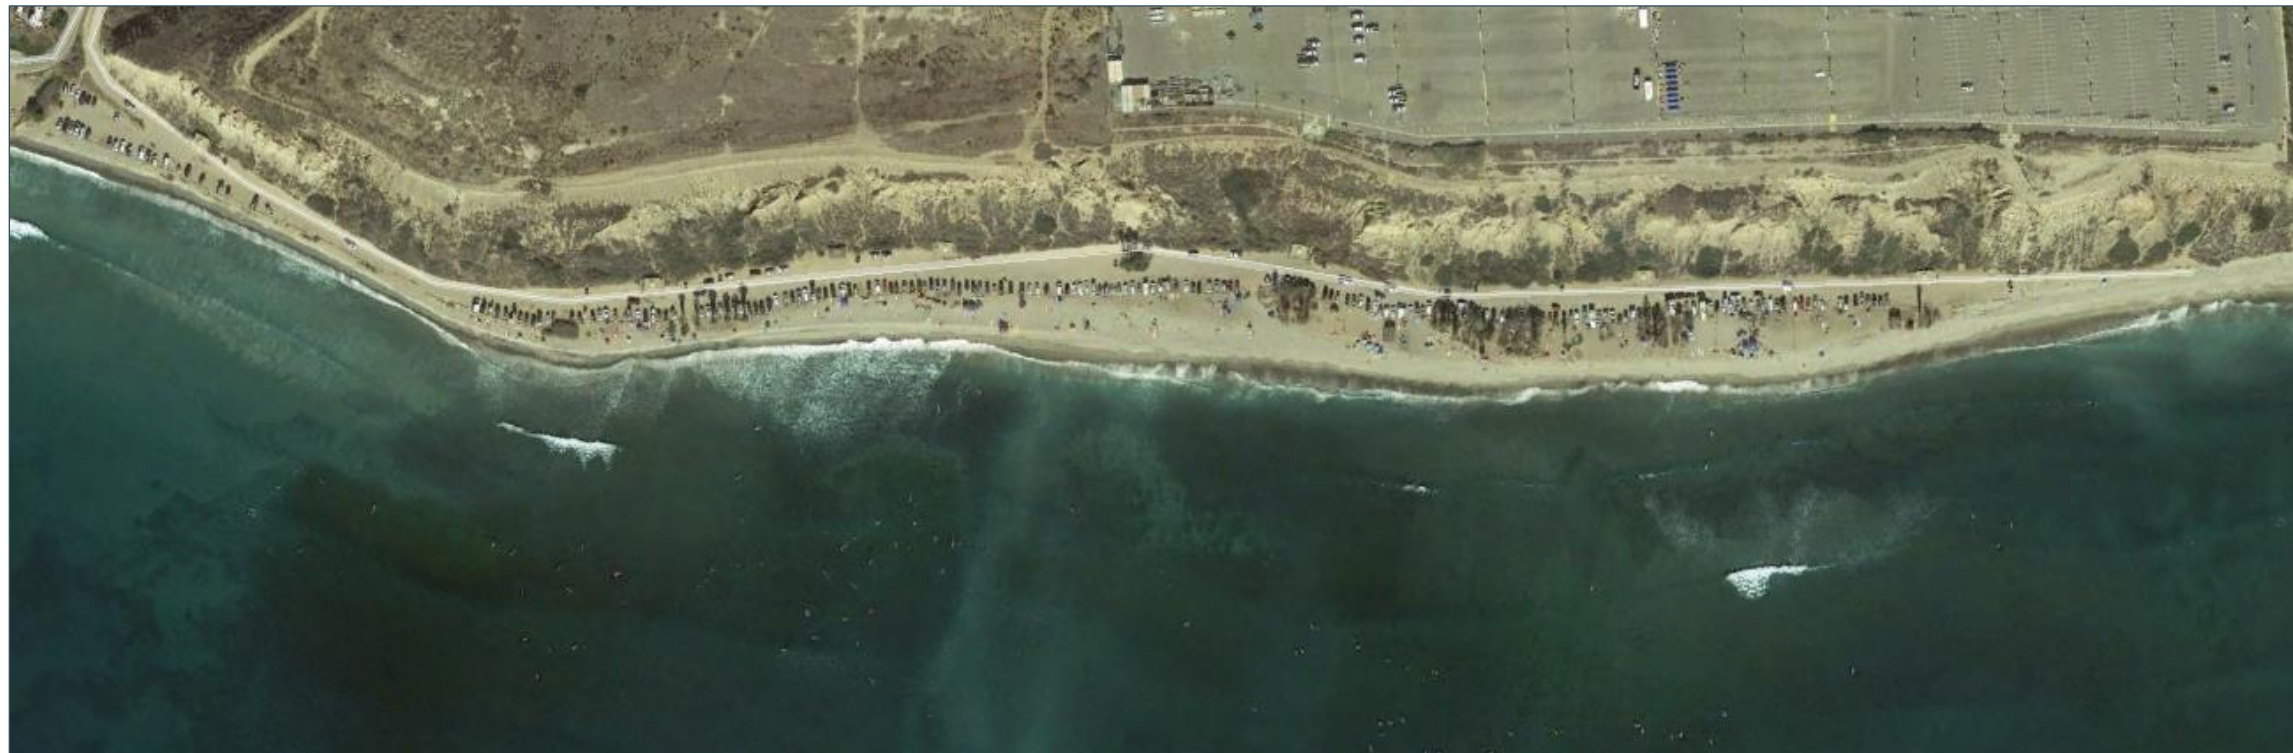
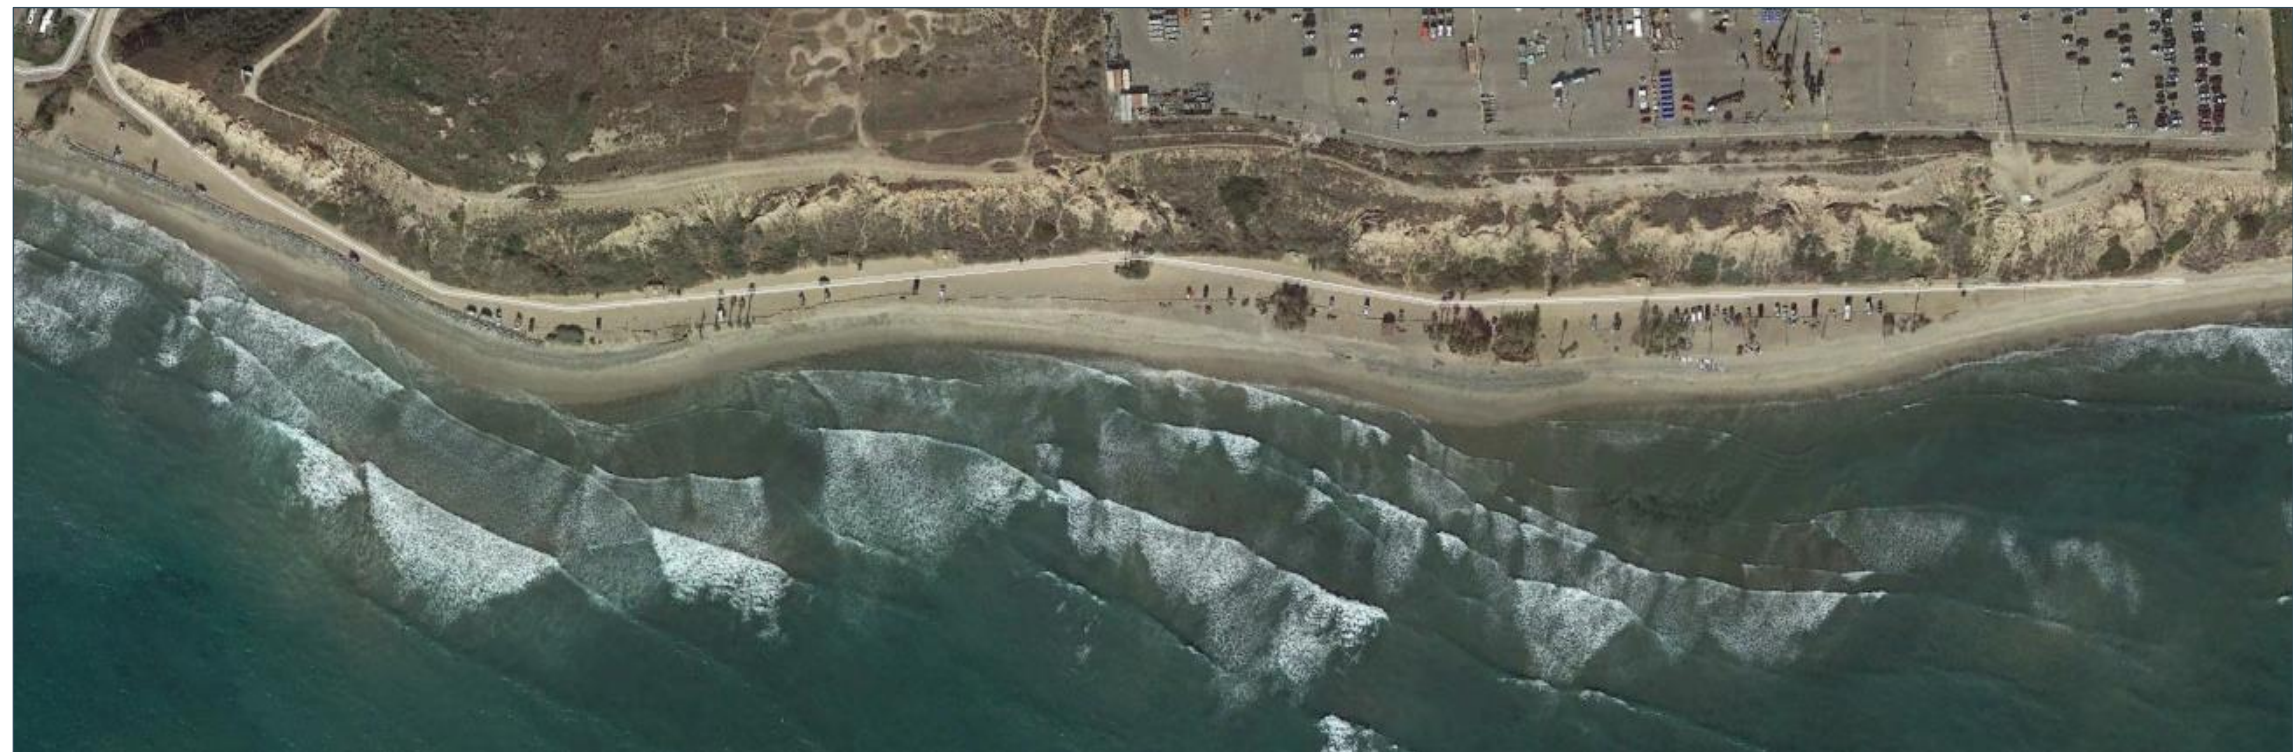
FIGURE 4.11: AERIAL IMAGE MARCH 2003 (GOOGLE)

FIGURE 4.12: AERIAL IMAGE NOVEMBER 2003 (GOOGLE)

FIGURE 4.13: AERIAL IMAGE FEBRUARY 2016 (GOOGLE)

FIGURE 4.14: AERIAL IMAGE OCTOBER 2016 (GOOGLE)

FIGURE 4.15: AERIAL IMAGE FEBRUARY 2018 (GOOGLE)

Aerial photographs (Figure 4.10 - Figure 4.15) show fluctuations in the Surf Beach shoreline from 1994 to 2018, based on both timeframe and season. The photos indicate that beach widths over the past 24 years exhibit similar variability to beach widths over the period from 1932 to 1960. Moderate beach widths in 1932, 1953, and 1960 are similar to those in May 1994, March 2003, and February 2016, while the narrow beach width in 1938 is similar to those in November 2003 and October 2016. The most recent aerial image from February 2018 shows the beach has partially recovered from its eroded condition of October 2016.

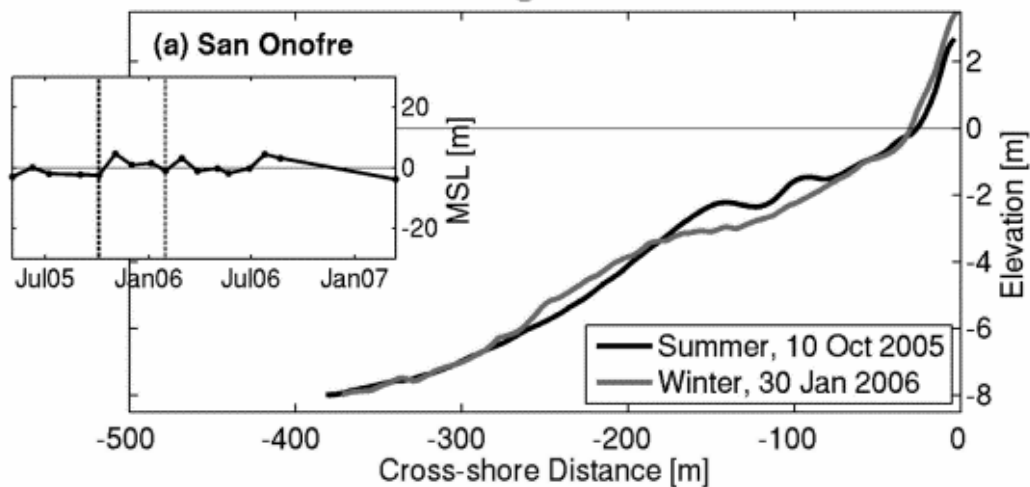
FIGURE 5.2: SEASONAL BEACH PROFILES COMPARISON (YATES, 2009)
