**6-18-1089 (CALIFORNIA DEPARTMENT OF PARKS AND
RECREATION)**

JUNE, 2019

EXHIBITS

**Long-Term Hazards
Management Plan**

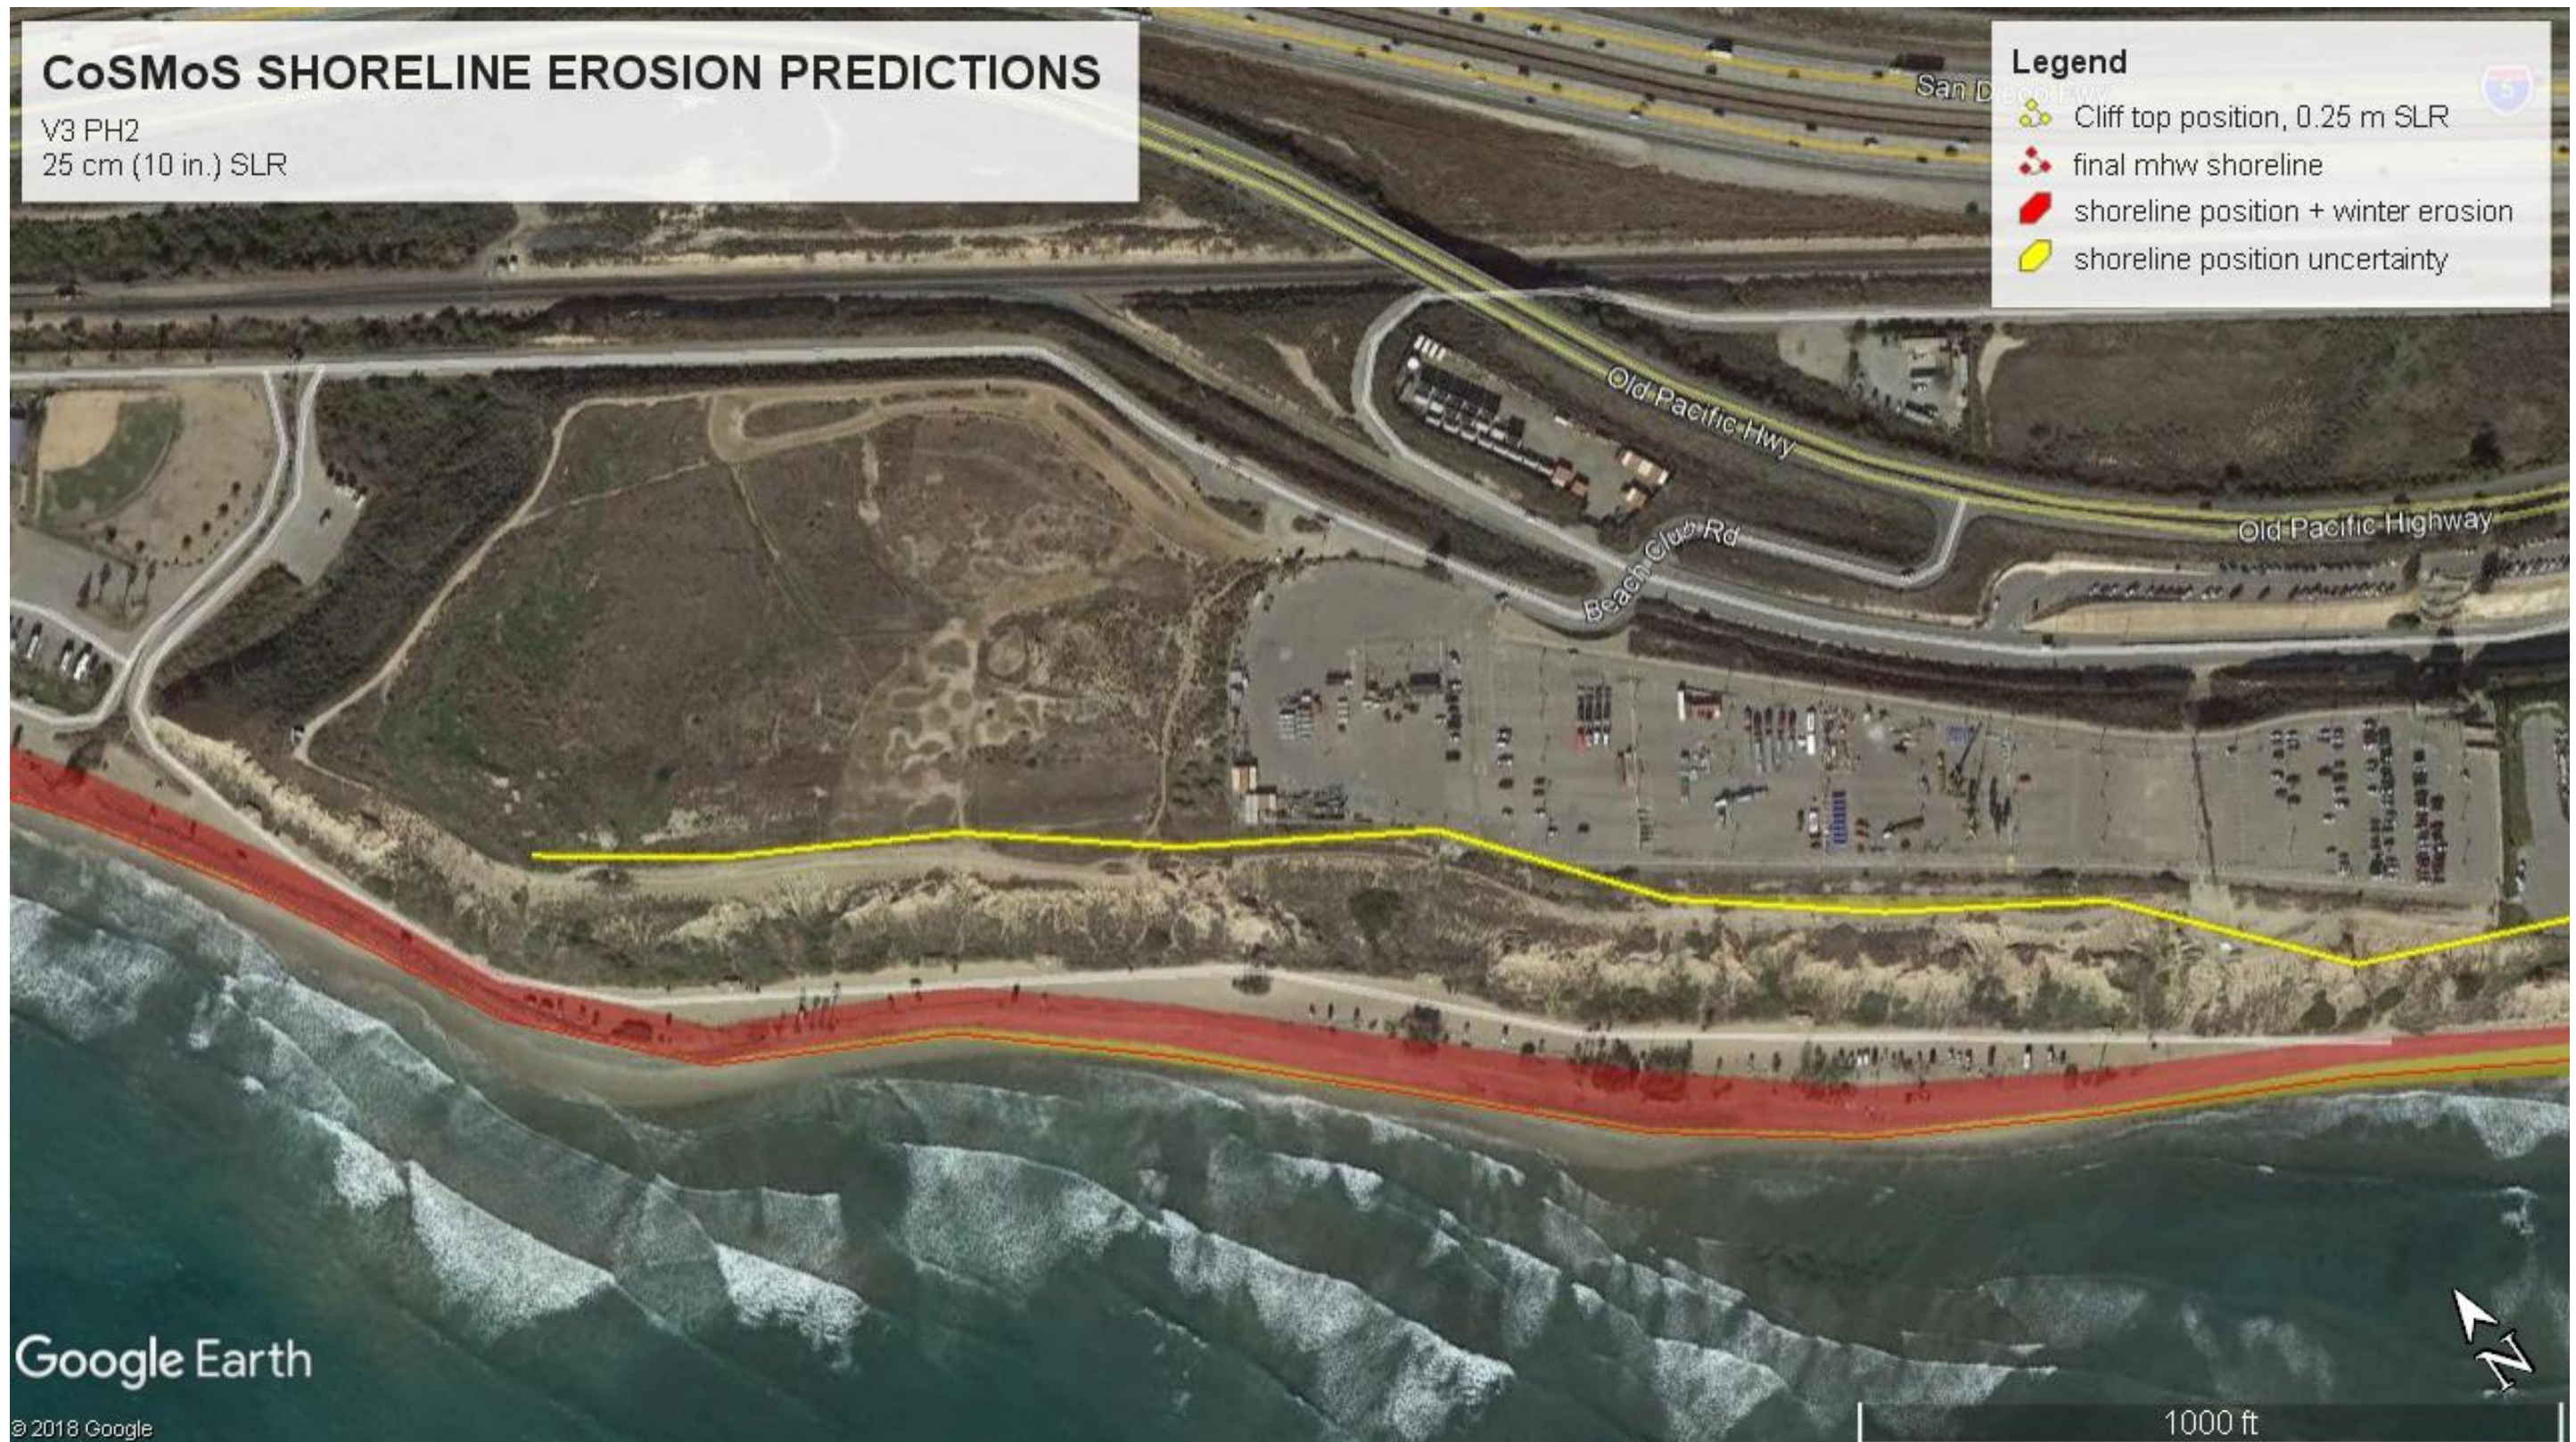
FIGURE 5.4: CoSMoS SHORELINE EROSION PREDICTIONS – 0.8 FT (10 IN. / 25 CM) SLR

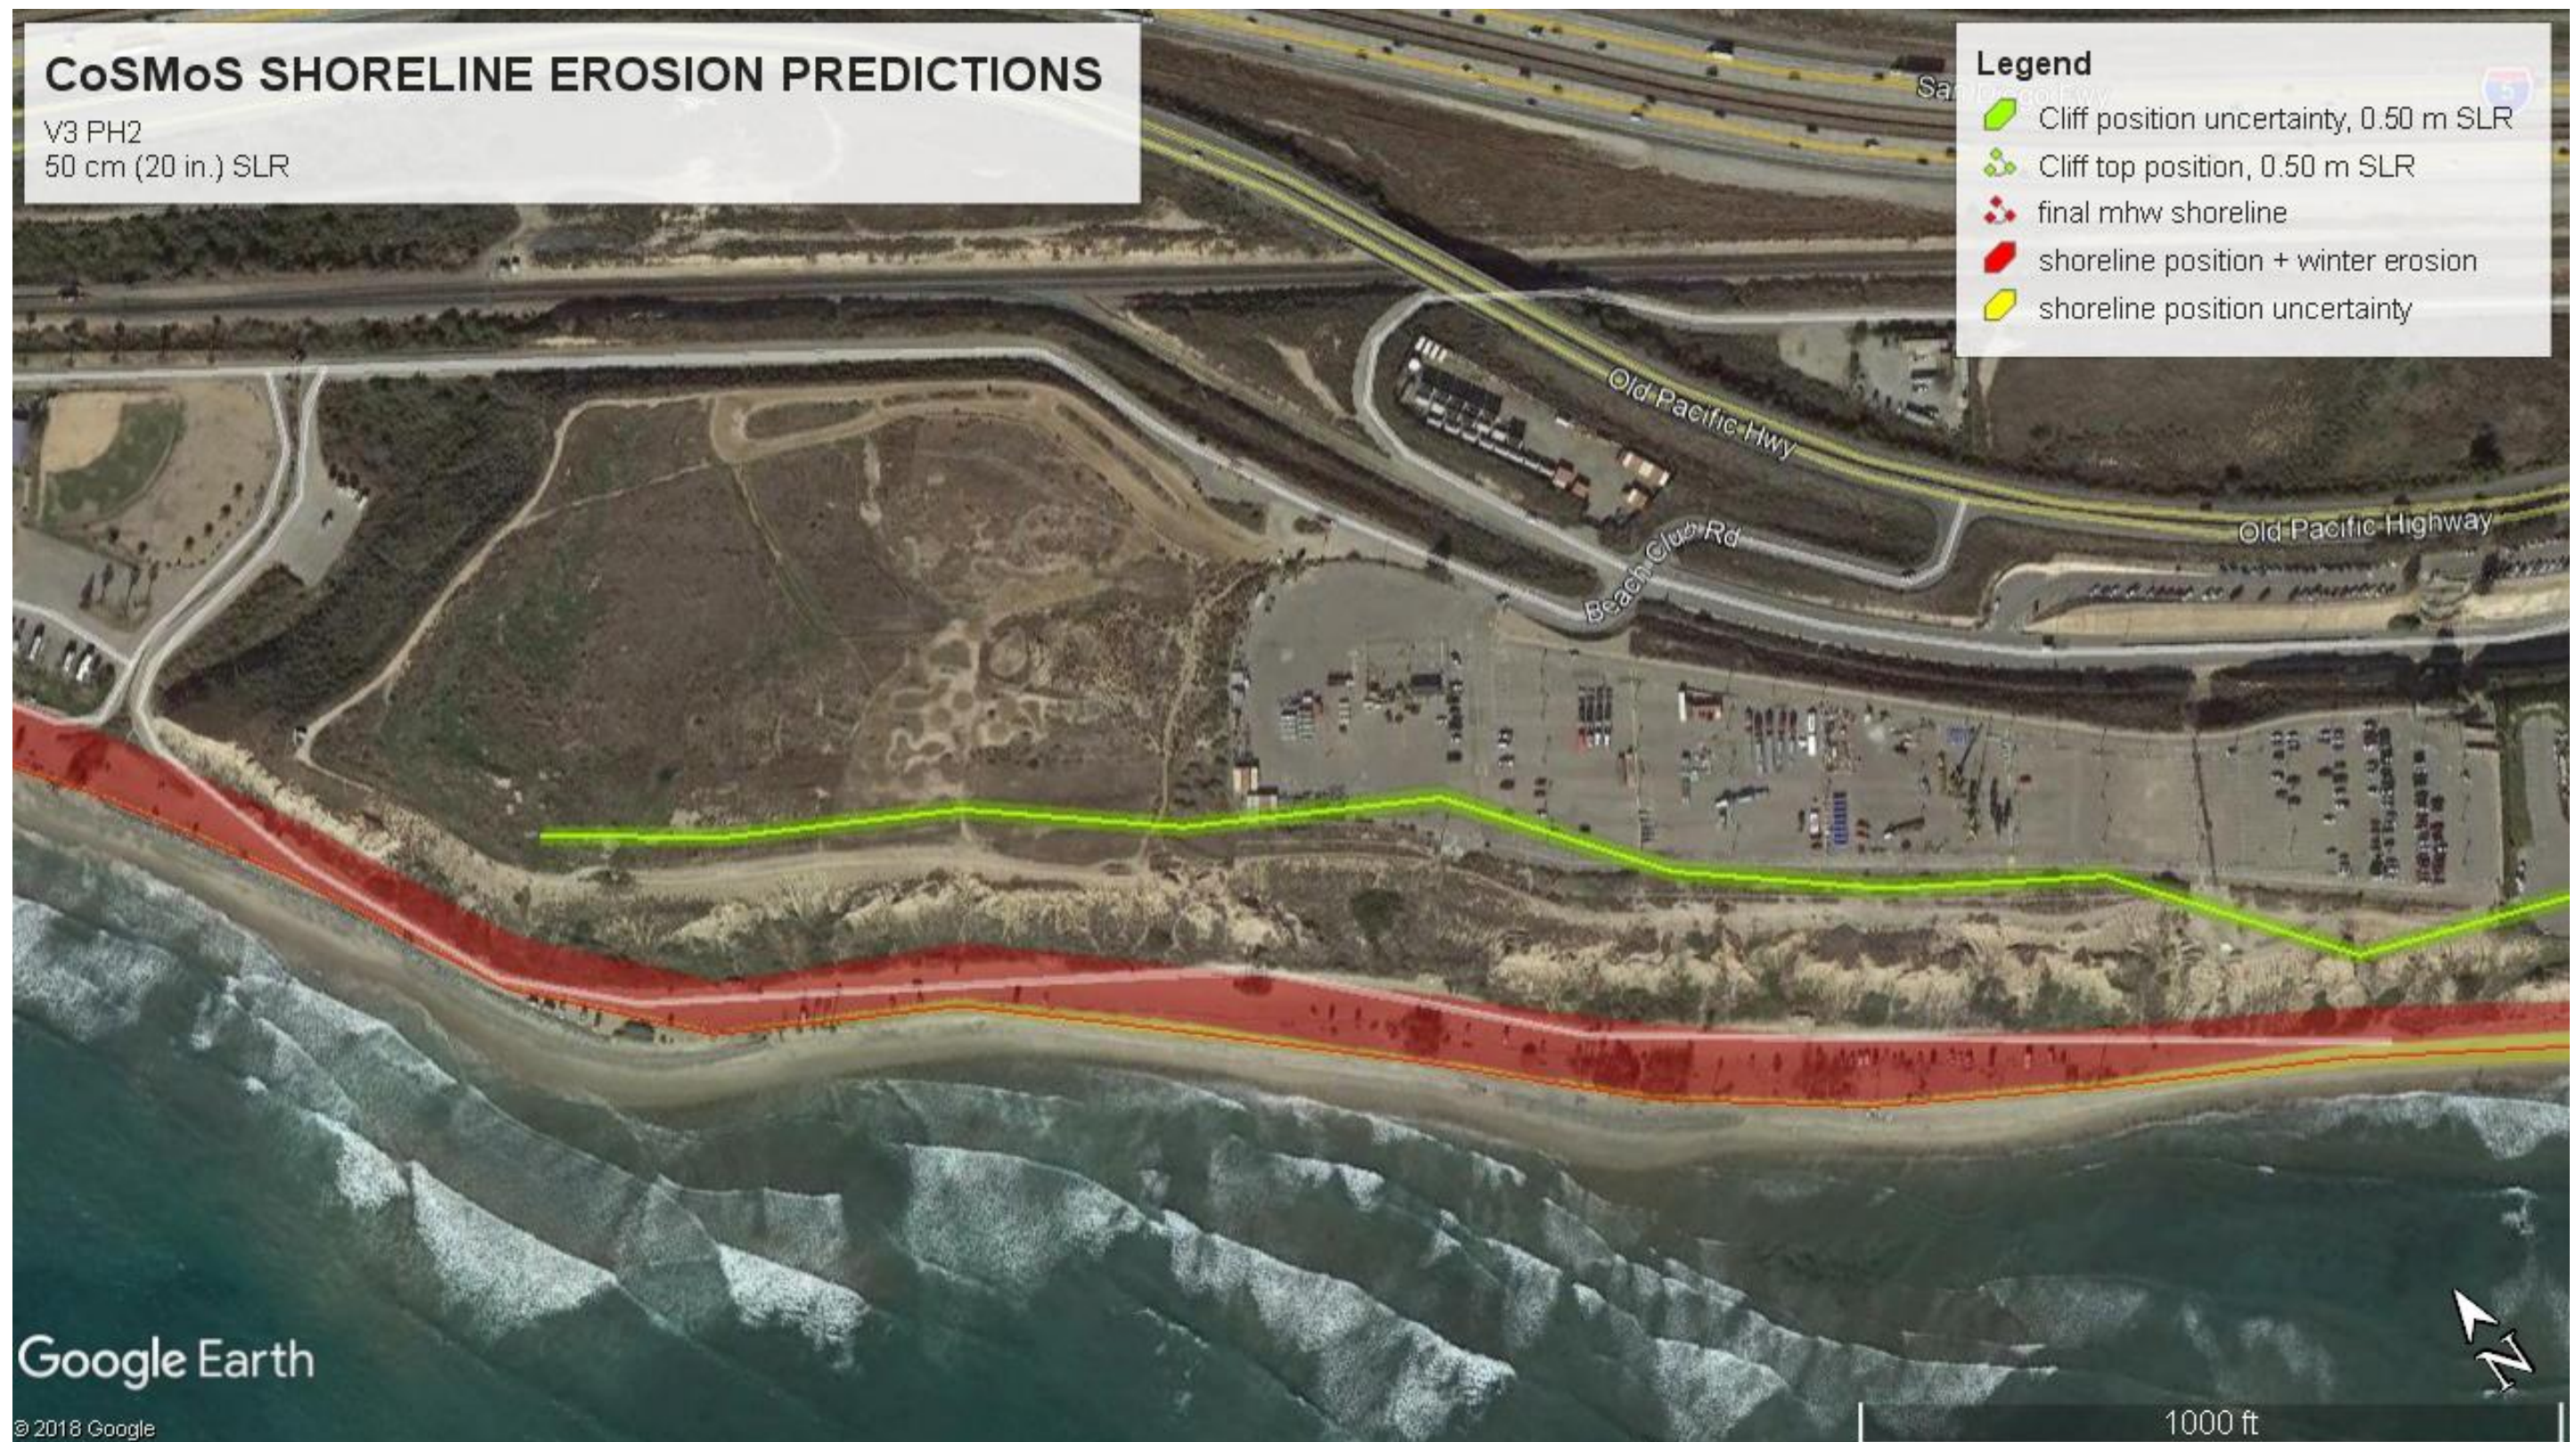
FIGURE 5.5: CoSMoS SHORELINE EROSION PREDICTIONS – 1.6 FT (20 IN. / 50 CM) SLR

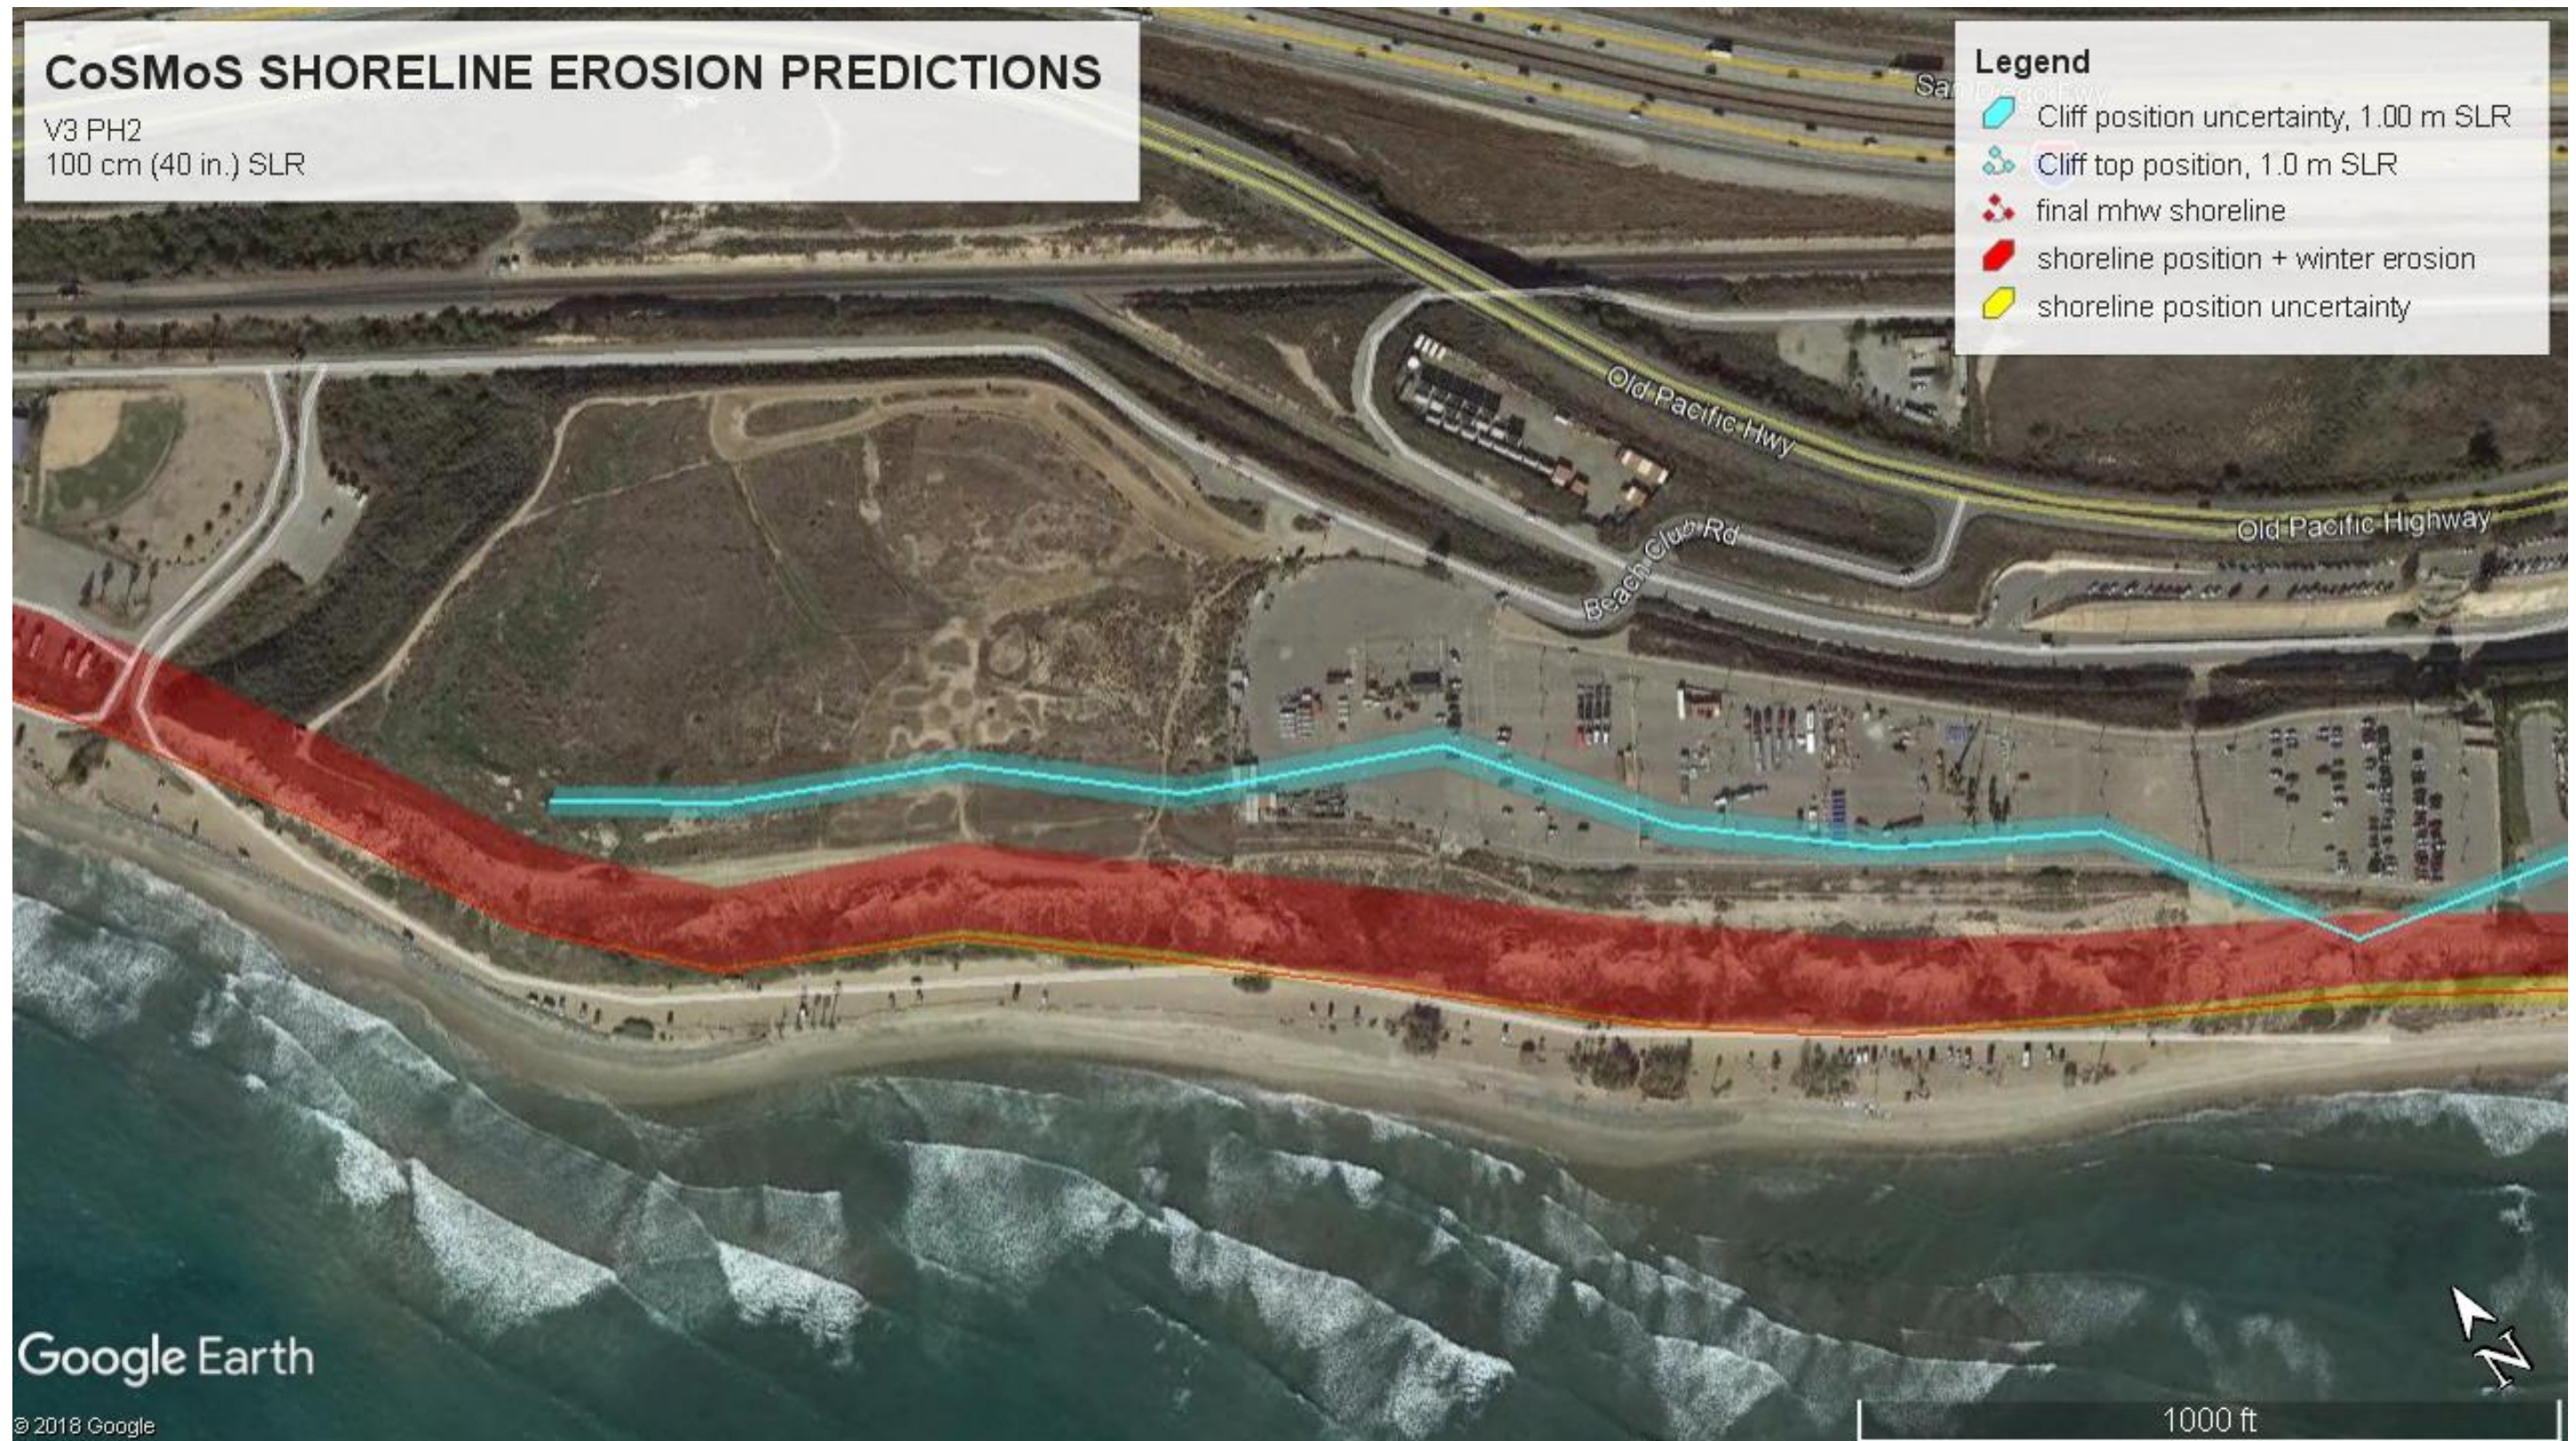
FIGURE 5.6: CoSMoS SHORELINE EROSION PREDICTIONS – 3.3 FT (40 IN. / 100 CM) SLR

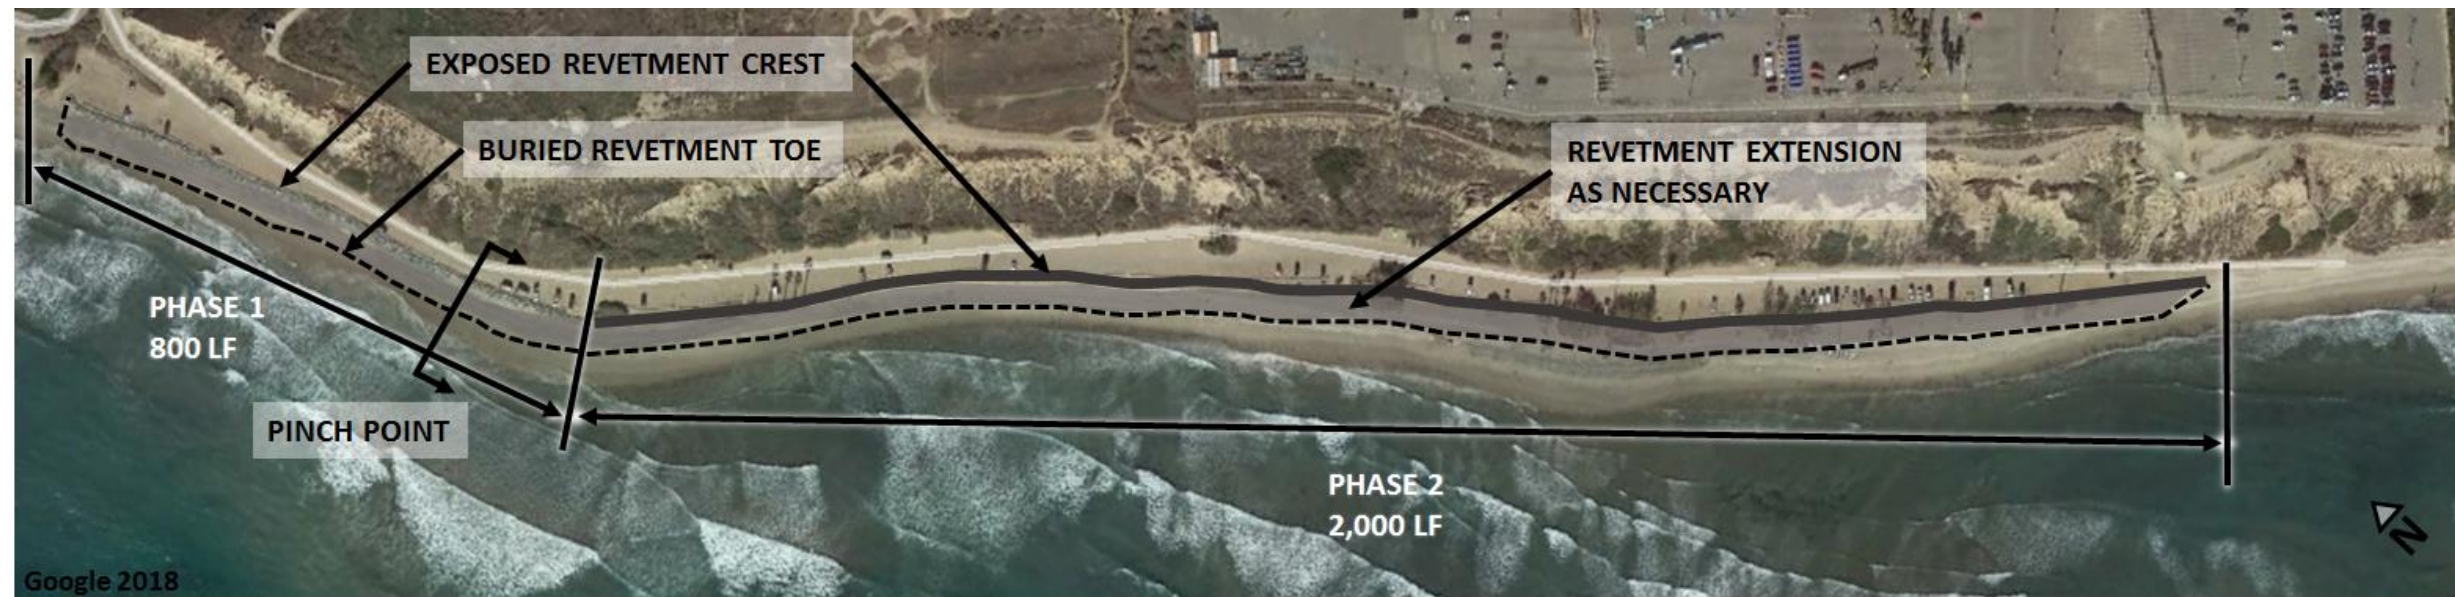
FIGURE 8.1: ALTERNATIVE 1: ROCK REVETMENT CONCEPTUAL DESIGN

The revetment would be located as far landward as possible, along the edge of the parking area so as to minimize loss of sandy beach footprint and impoundment of sand behind (landward of) the revetment. Sand excavated during construction would be placed back on top of the revetment.

If there is a decision to construct additional segments along the shoreline, the entire remaining 2,000 linear feet of Surf Beach shoreline would require a total of approximately 36,000 tons of armor and underlayer rock, based on a conceptual level of design.

A conceptual design of this alternative is provided in Figure 8.1.

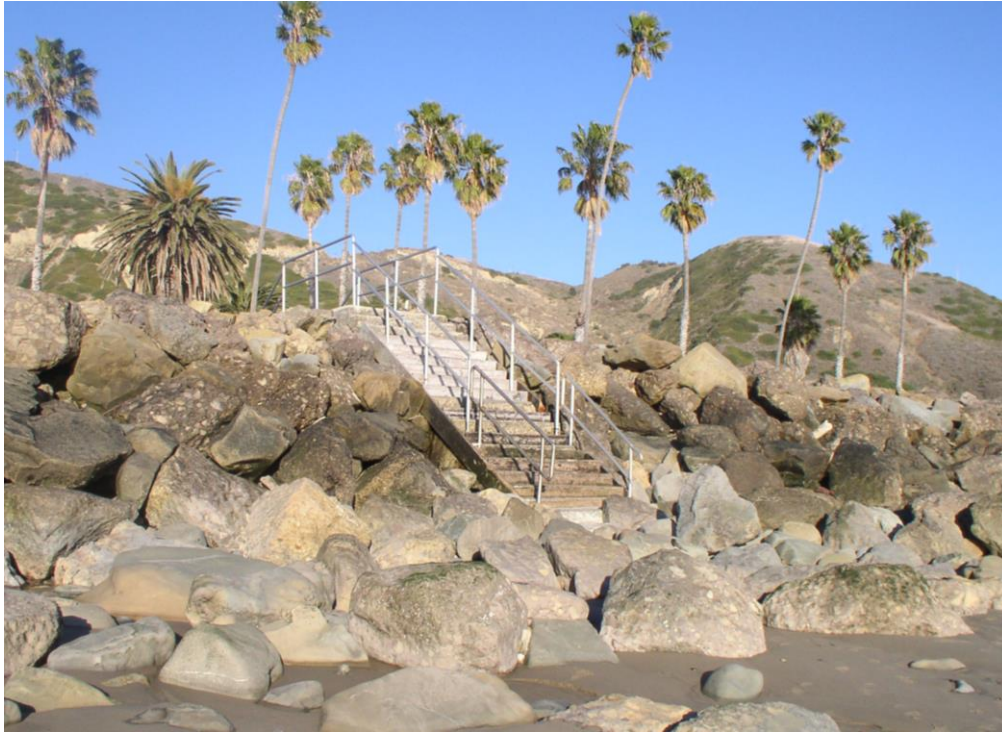
FIGURE 8.2: EXAMPLE REVETMENT STAIRS – AT HOBSON COUNTY PARK IN VENTURA

In order to enable public access over the rock revetment, concrete stairways could be constructed from the parking lot edge, over the revetment crest and down the revetment's seaward face to/from the beach and water. (See photo, Figure 8.2, for an example public stairway at a beachfront County park in Ventura,).

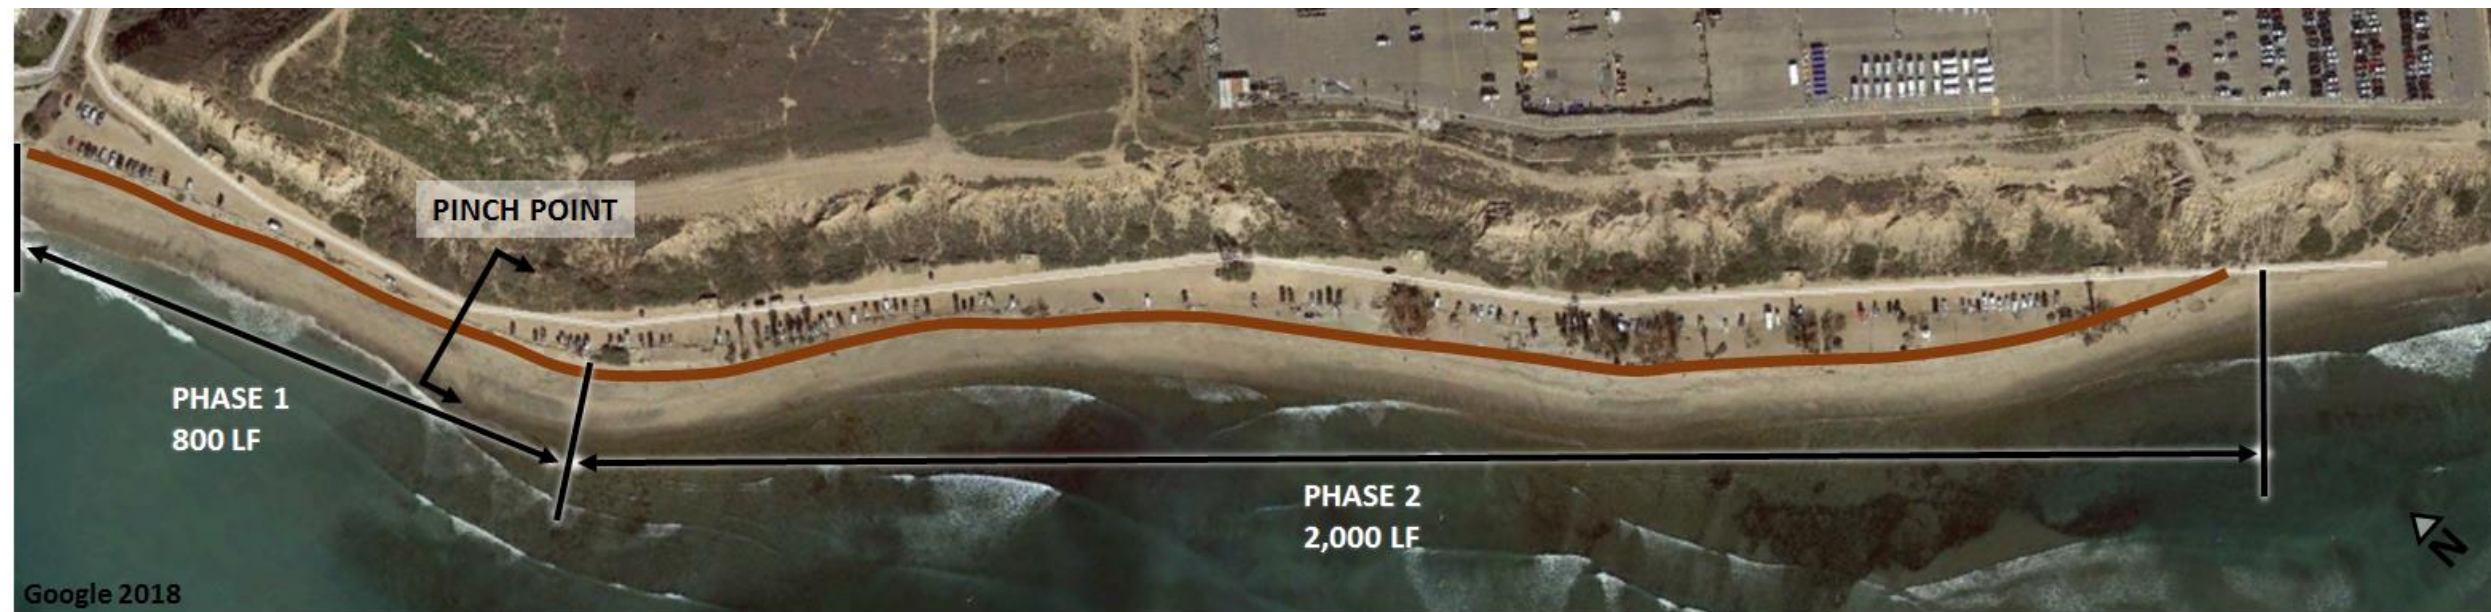
FIGURE 8.3: ALTERNATIVE 2: NARROW FOOTPRINT ARMORING CONCEPTUAL DESIGN

A conceptual design of this alternative is provided in Figure 8.3.

Potential design concepts are to use cast-in-place concrete or steel sheet pile and a beach/bluff-like architectural fascia using sculpted shotcrete. Further geotechnical investigation of the substrate and engineering are required to develop a design which is stable under scour and wave loading conditions.

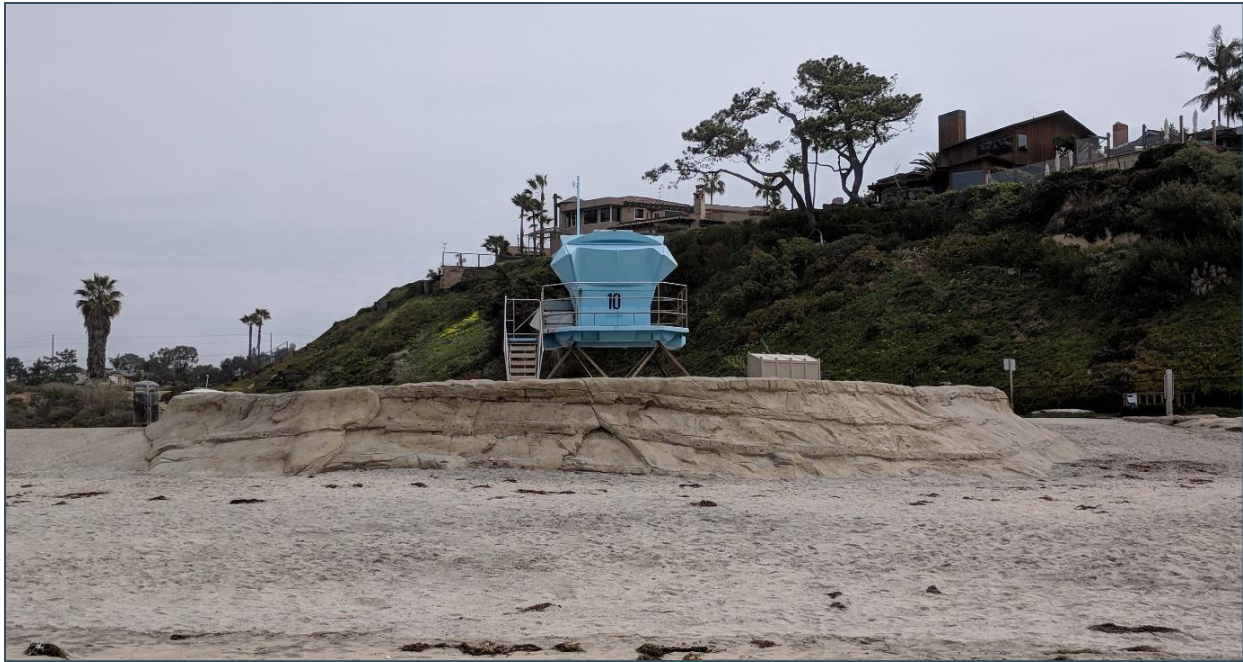
FIGURE 8.4: SCULPTED SEAWALL AT CARDIFF STATE BEACH (EXAMPLE OF NARROW FOOTPRINT ARMORING)

A similar wall was installed in front of a lifeguard tower on the south end of Cardiff State Beach (Figure 8.4).

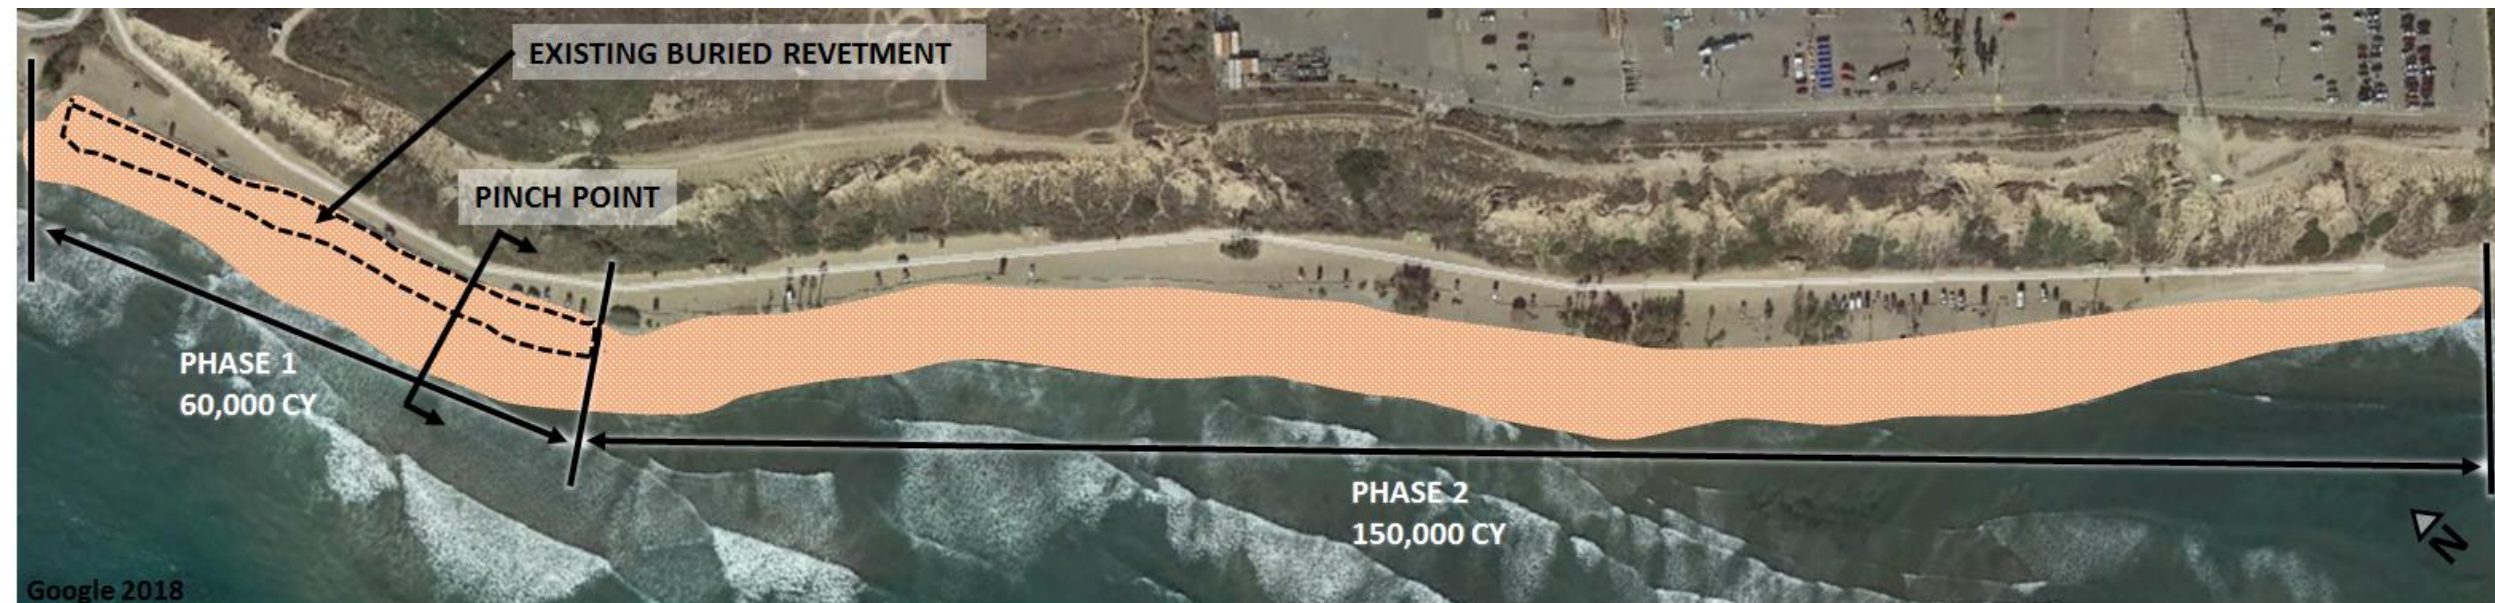
FIGURE 8.5: ALTERNATIVE 3: BEACH NOURISHMENT CONCEPTUAL DESIGN

This alternative consists of placement of imported sand to restore a wider sandy beach and provide protection to State Parks' facilities. The 800 LF emergency rock revetment would remain in place. During the first phase of nourishment, approximately 60,000 CY of sand would be placed to bury the existing emergency revetment and increase the beach berm width to approximately 50 ft. Based on a conceptual level of design, an additional 150,000 CY of beach nourishment would be necessary to increase the beach width along the remaining shoreline without revetment protection. It is expected that the beach will erode during large storm events, the revetment will become exposed and limit further erosion, and thus periodic re-nourishment will be required over time. However, the revetment will serve as a last-line-of-defense protection and limit erosion and damage to the road and parking lot.

A conceptual design of this alternative is provided in Figure 8.5.

** beach profile used in runup analysis based on profile shown in Figure 8.5.

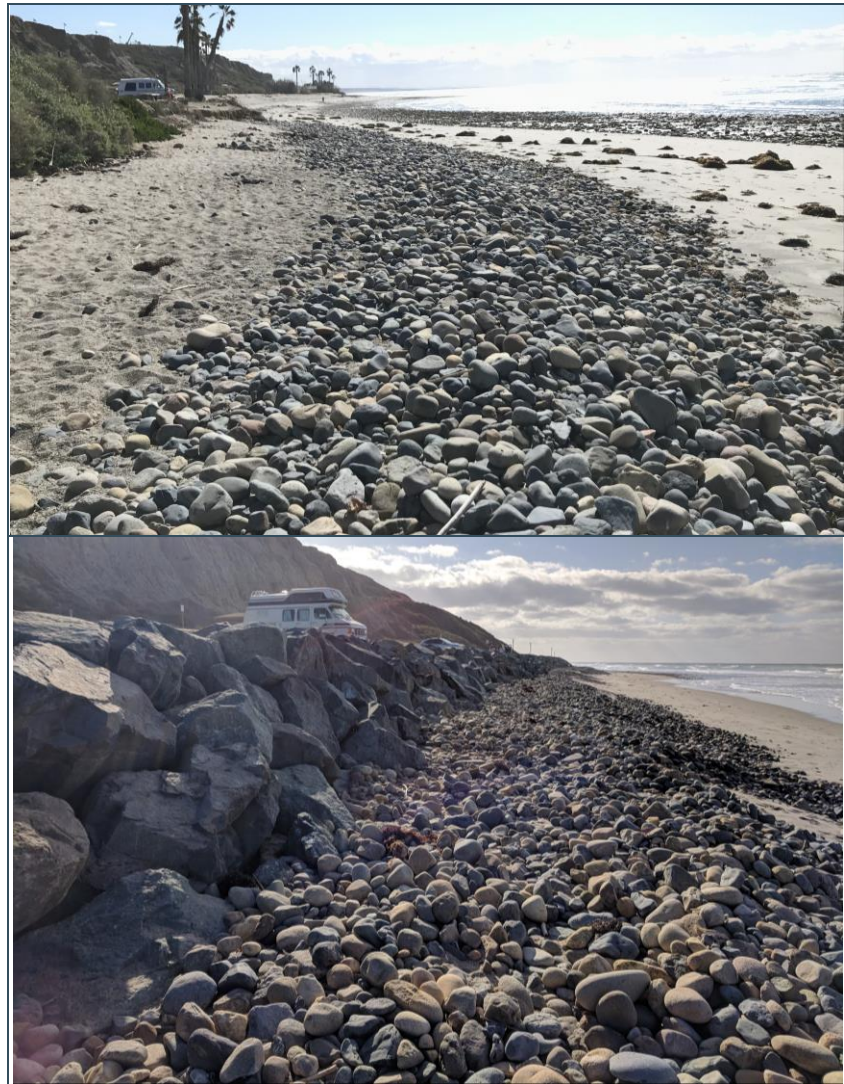
FIGURE 8.7: EXPOSED NATURALLY-OCCURRING COBBLE ALONG SURF BEACH

Cobble berms (a type of “living shoreline”) have been previously constructed in Oregon (Cape Lookout State Park) and in California (Surfers Point in Ventura and Imperial Beach in San Diego). Another is planned for implementation at Cardiff State Beach in 2018-2019. Naturally-occurring cobble berms also exist throughout Southern California, e.g. Del Mar, Cardiff, Batiquitos Lagoon, South Carlsbad, Emma Wood State Beach, and to some extent already along Surf Beach as can be seen in Figure 8.7.

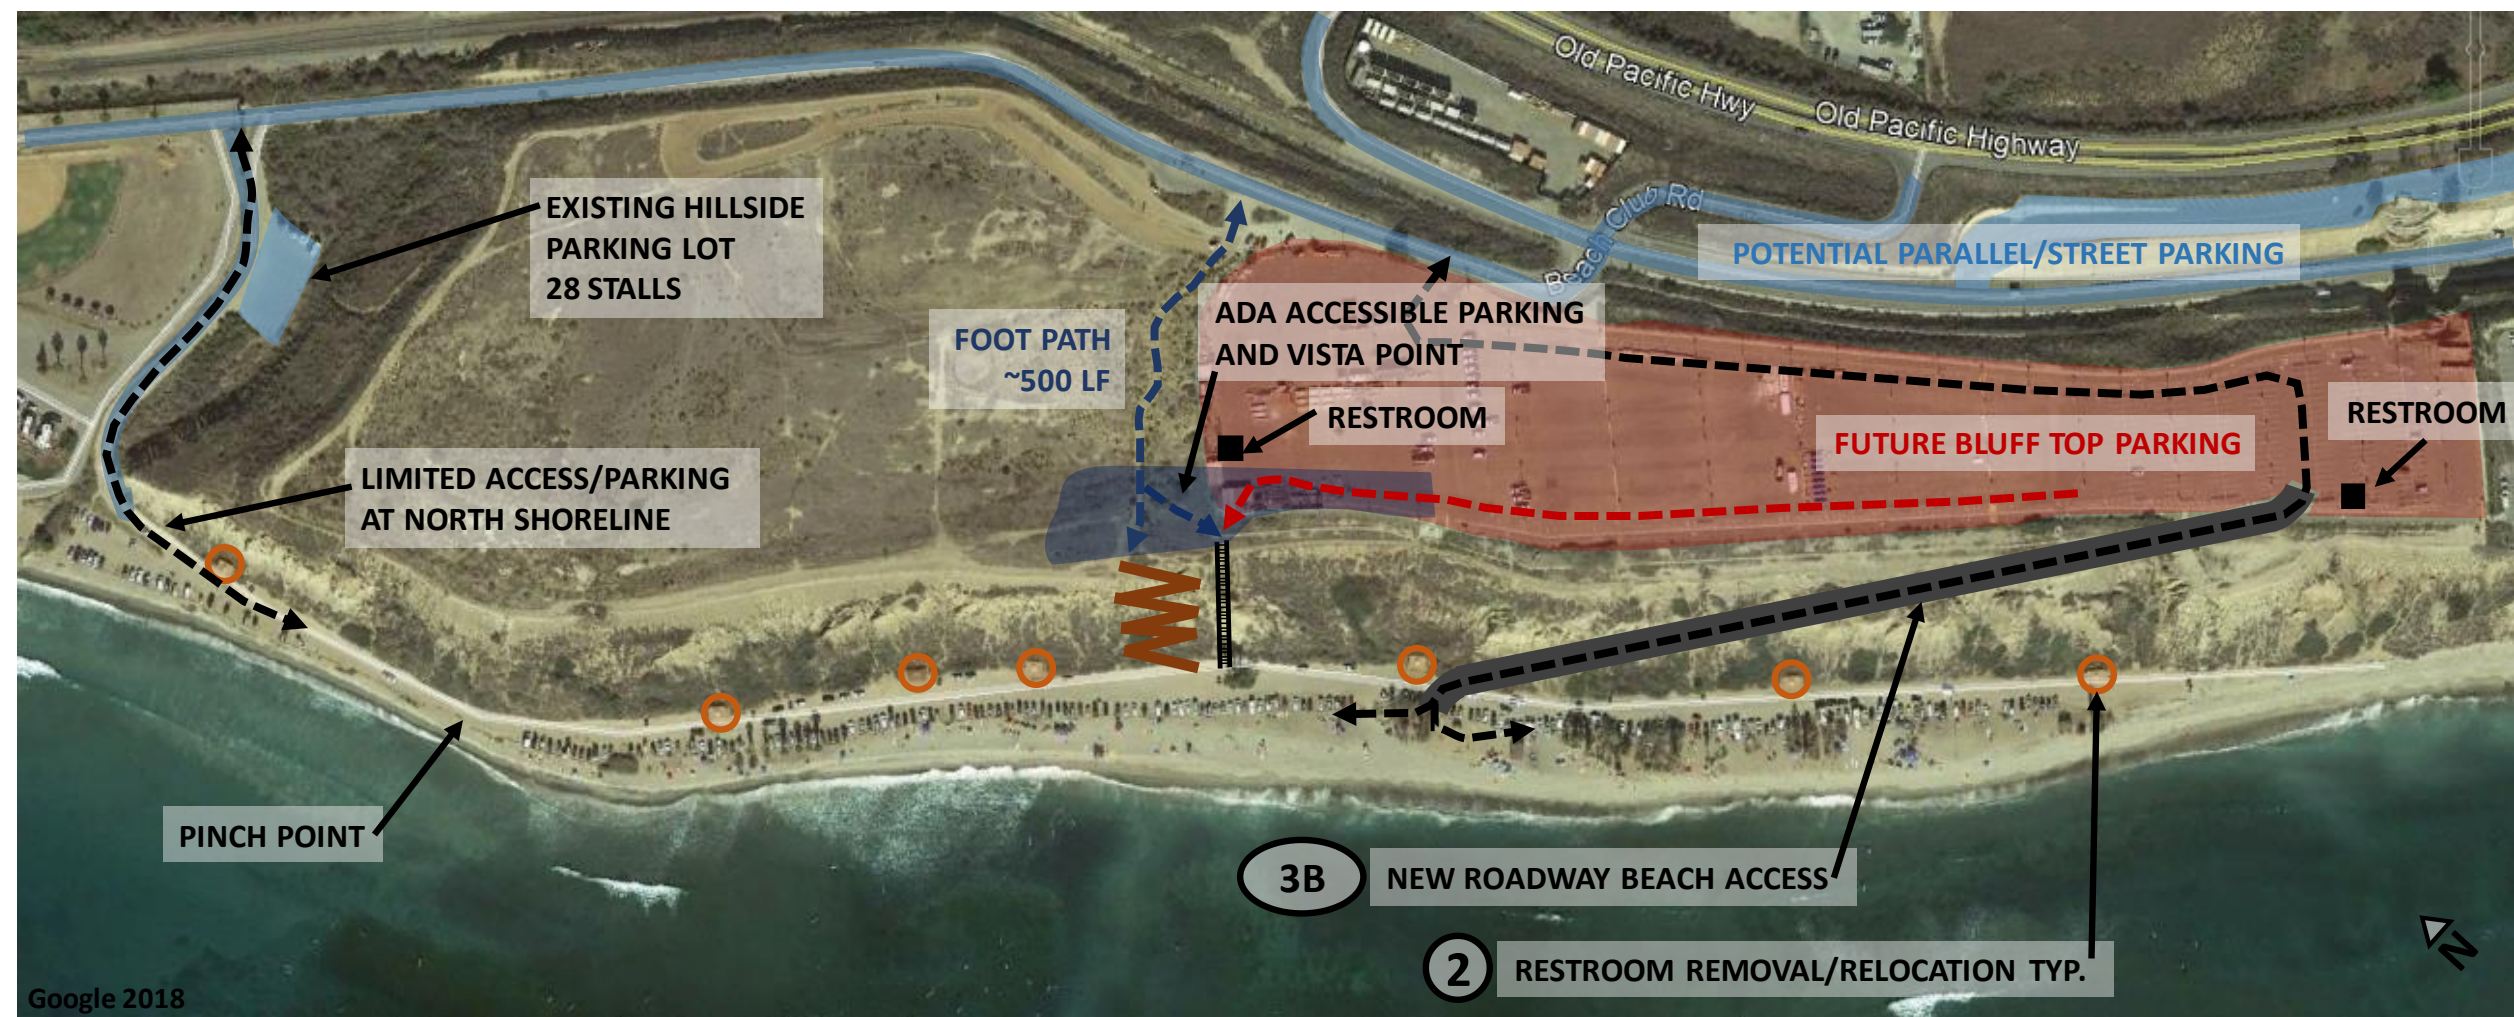
PHASE 3B (LONG-TERM OPTION): Construct a roadway to provide vehicular beach access from the bluff top near the southern end of the SONGS parking lot. Limited parking would be available on the beach for as long as feasible. As beach parking is no longer feasible, the roadway could be used for loading/unloading beach equipment and emergency access. The SONGS parking lot would be used for bluff top parking if/when the facility becomes available. Other parking options could include creating parallel/street parking spots along Beach Club Road and surrounding access roads.
