**6-18-1089 (CALIFORNIA DEPARTMENT OF PARKS AND
RECREATION)**

JUNE, 2019

EXHIBITS

**Long-Term Hazards
Management Plan**

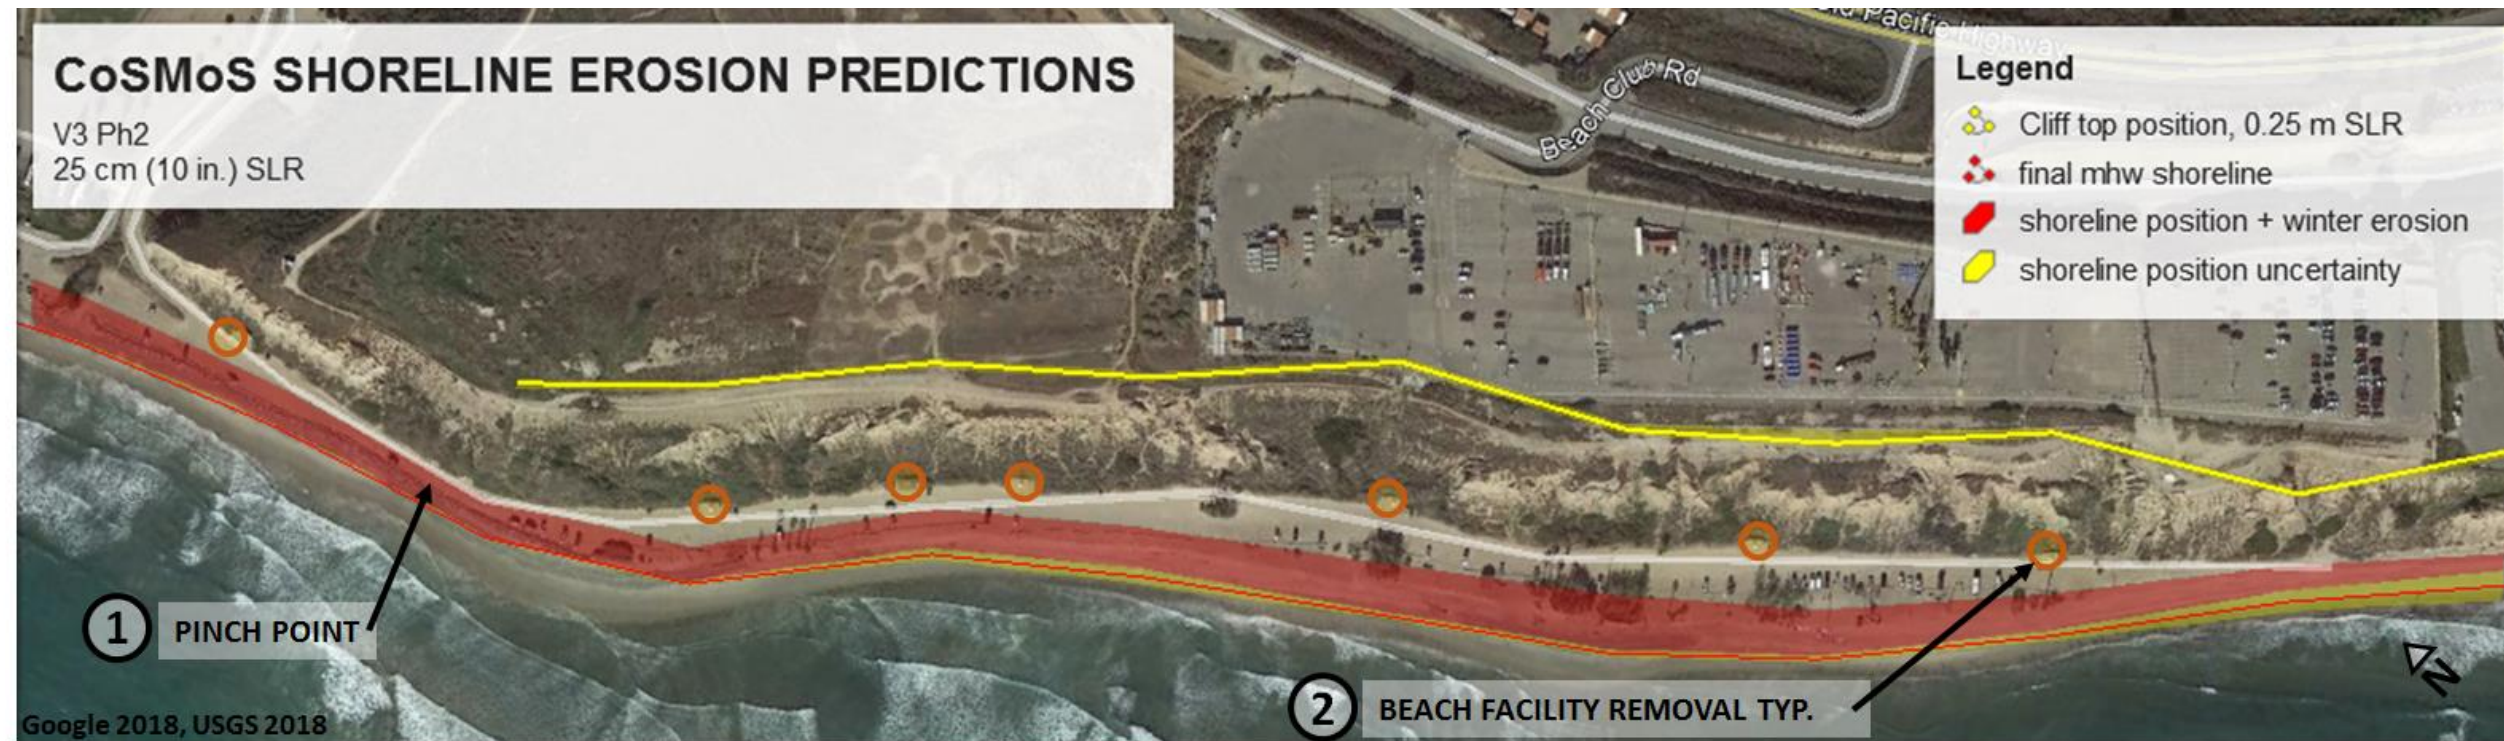
PHASE①: Emergency revetment removed; erosion impacts beach parking and access at pinch point. Some areas may only be passable seasonally, at low tide, or with an off-road vehicle during calm conditions. The existing hillside parking lot and northernmost beach parking would be the only parking option if pinch point is impassable, some vehicles could potentially park along Beach Club Road.

PHASE②: Erosion progresses and beach parking is extremely limited north of the pinch point. The pinch point is no longer passable, thus beach parking is not accessible to the south and typical facility maintenance vehicles can not access the beach facilities (restrooms). All beach facilities south of pinch point to be removed at the point in time maintenance vehicles will soon no longer be capable of servicing these facilities.

FIGURE 8.14: ALTERNATIVE 7: LIMITED ACTION WITH 0.8 FT OF SEA LEVEL RISE

Graphics of the erosion progression and time horizons of this alternative are provided in Figure 8.14 and Figure 8.15.

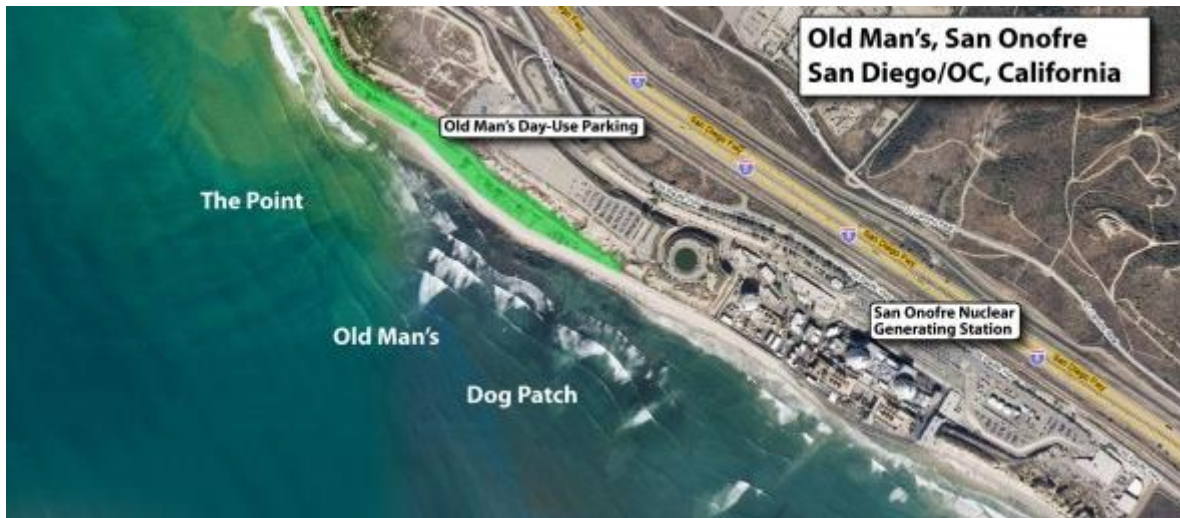
FIGURE 9.2: SURF BEACH SURF SPOTS

The location of the three surf spots along Surf Beach are shown in Figure 9.2 below.

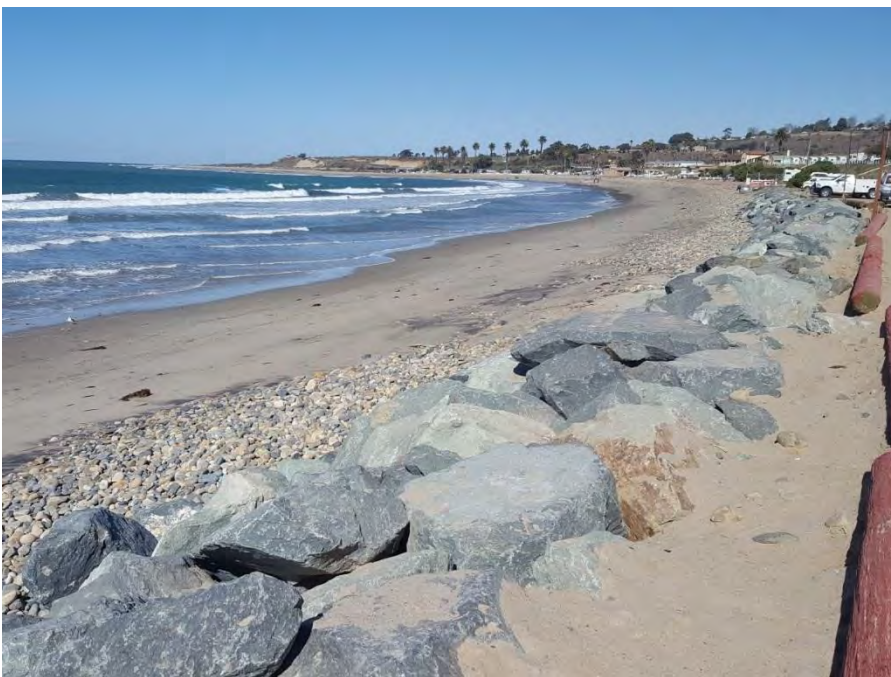
PP1. Photo taken facing northwest depicting unvegetated revetment at northern end of Project site.

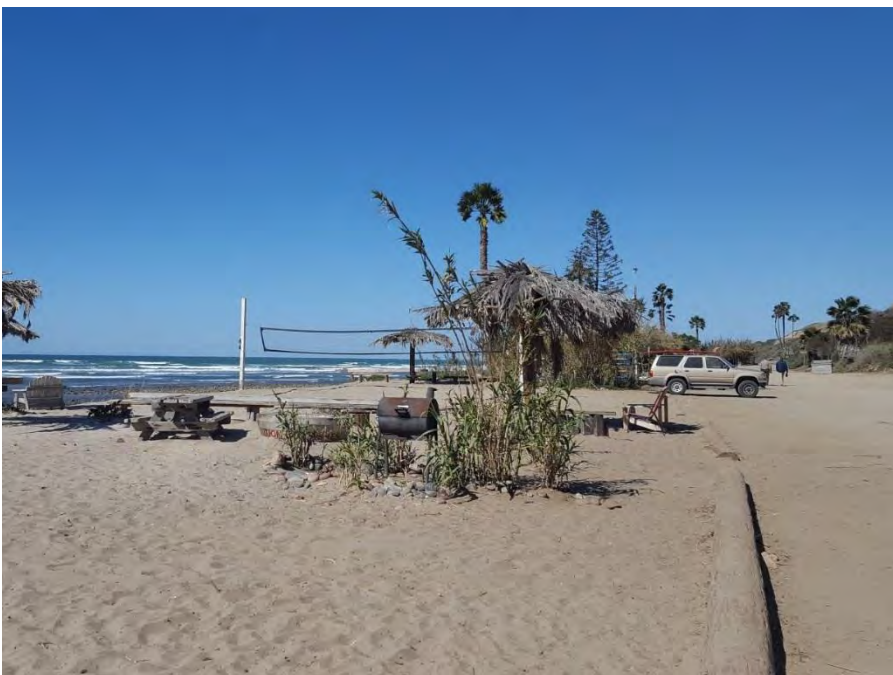
PP6. Photo taken facing northwest along the shore seaward of the parking lot. Patches of giant reed (*Arundo donax*) were observed growing throughout the Sandy Beach area.

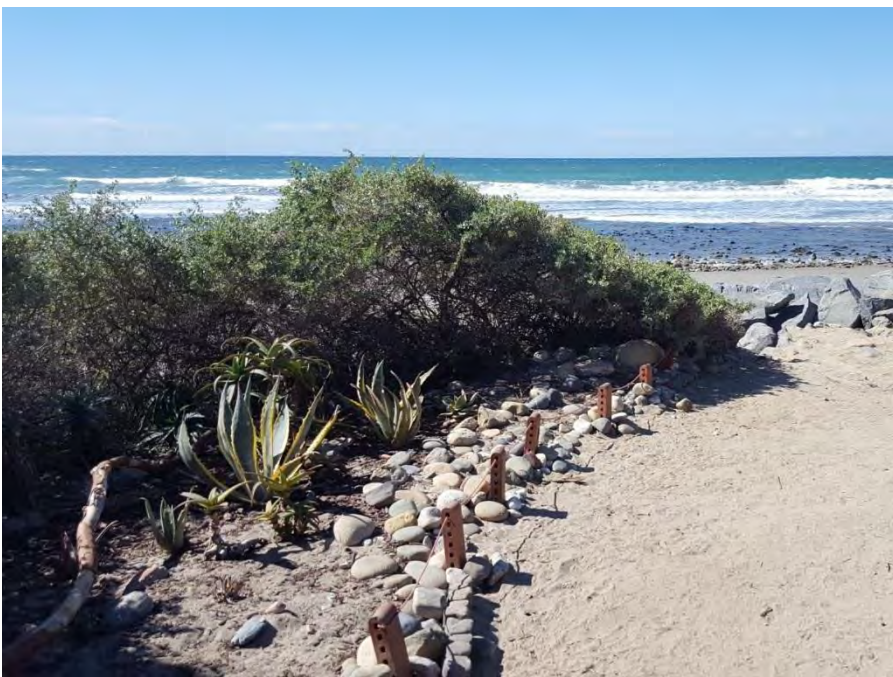
PP7. Photo taken facing west at the southern end of the revetment within the Survey Area depicting Ornamental / Mixed Native Landscaping.

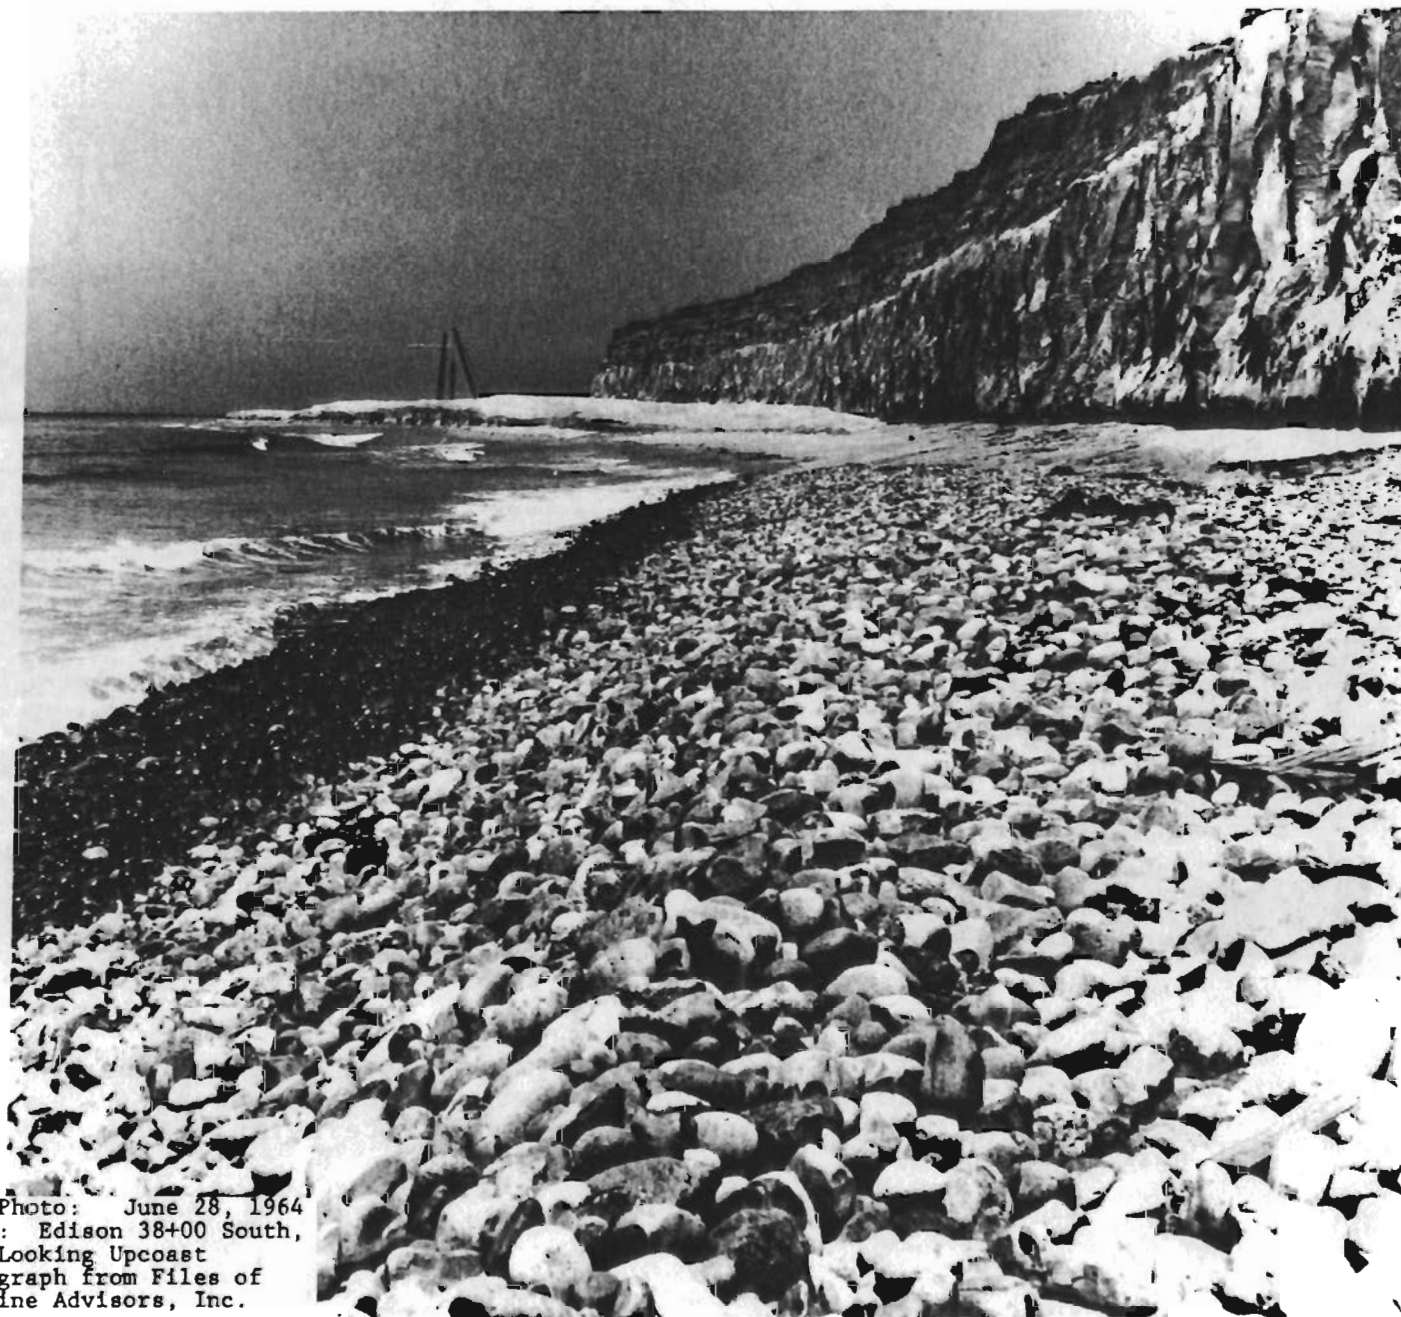
Date of Photo: June 28, 1964
Location: Edison 38+00 South,
Looking Upcoast
Photograph from Files of
Marine Advisors, Inc.

Figure 4. Photograph taken 28 June 1964 near the southern end of the SONGS property and looking north. Note construction equipment in background. Note extensive cobble field and wave cut notch in bottom of cliff face.

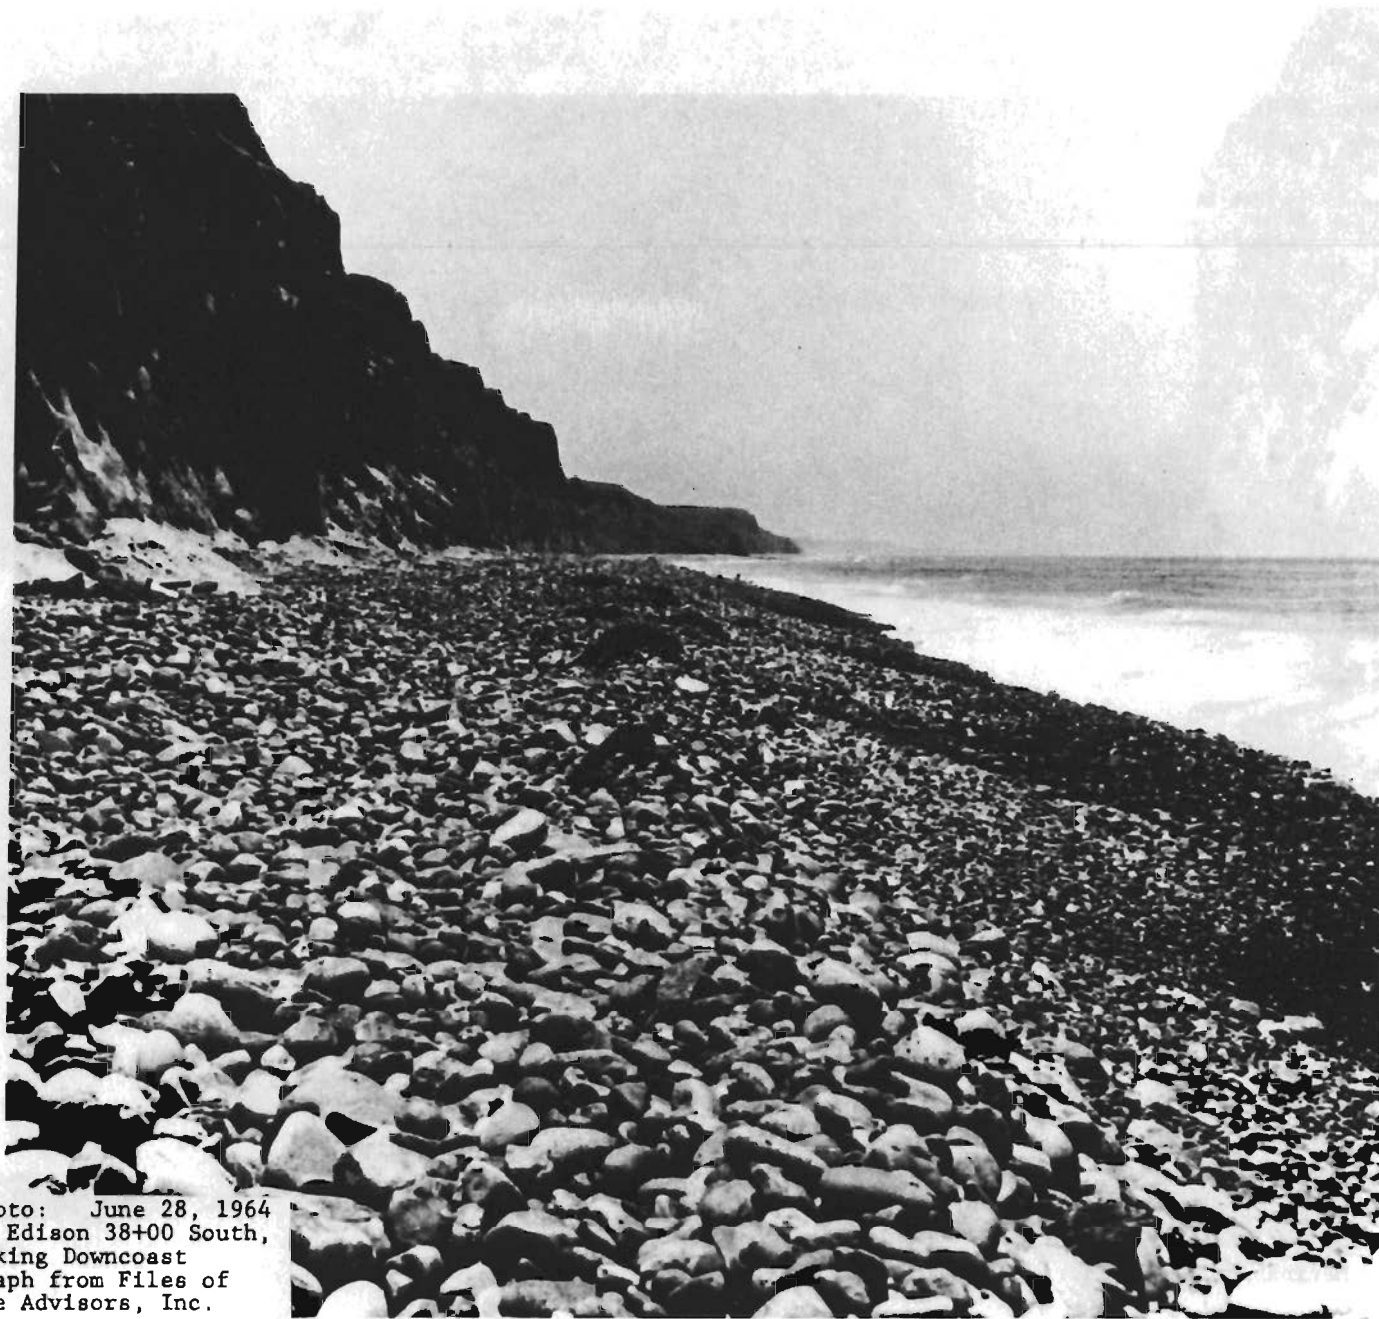
Date of Photo: June 28, 1964
Location: Edison 38+00 South,
Looking Downcoast
Photograph from Files of
Marine Advisors, Inc.

Figure 5. Photograph taken 28 June 1964 at same location as
Figure 3, but looking south.

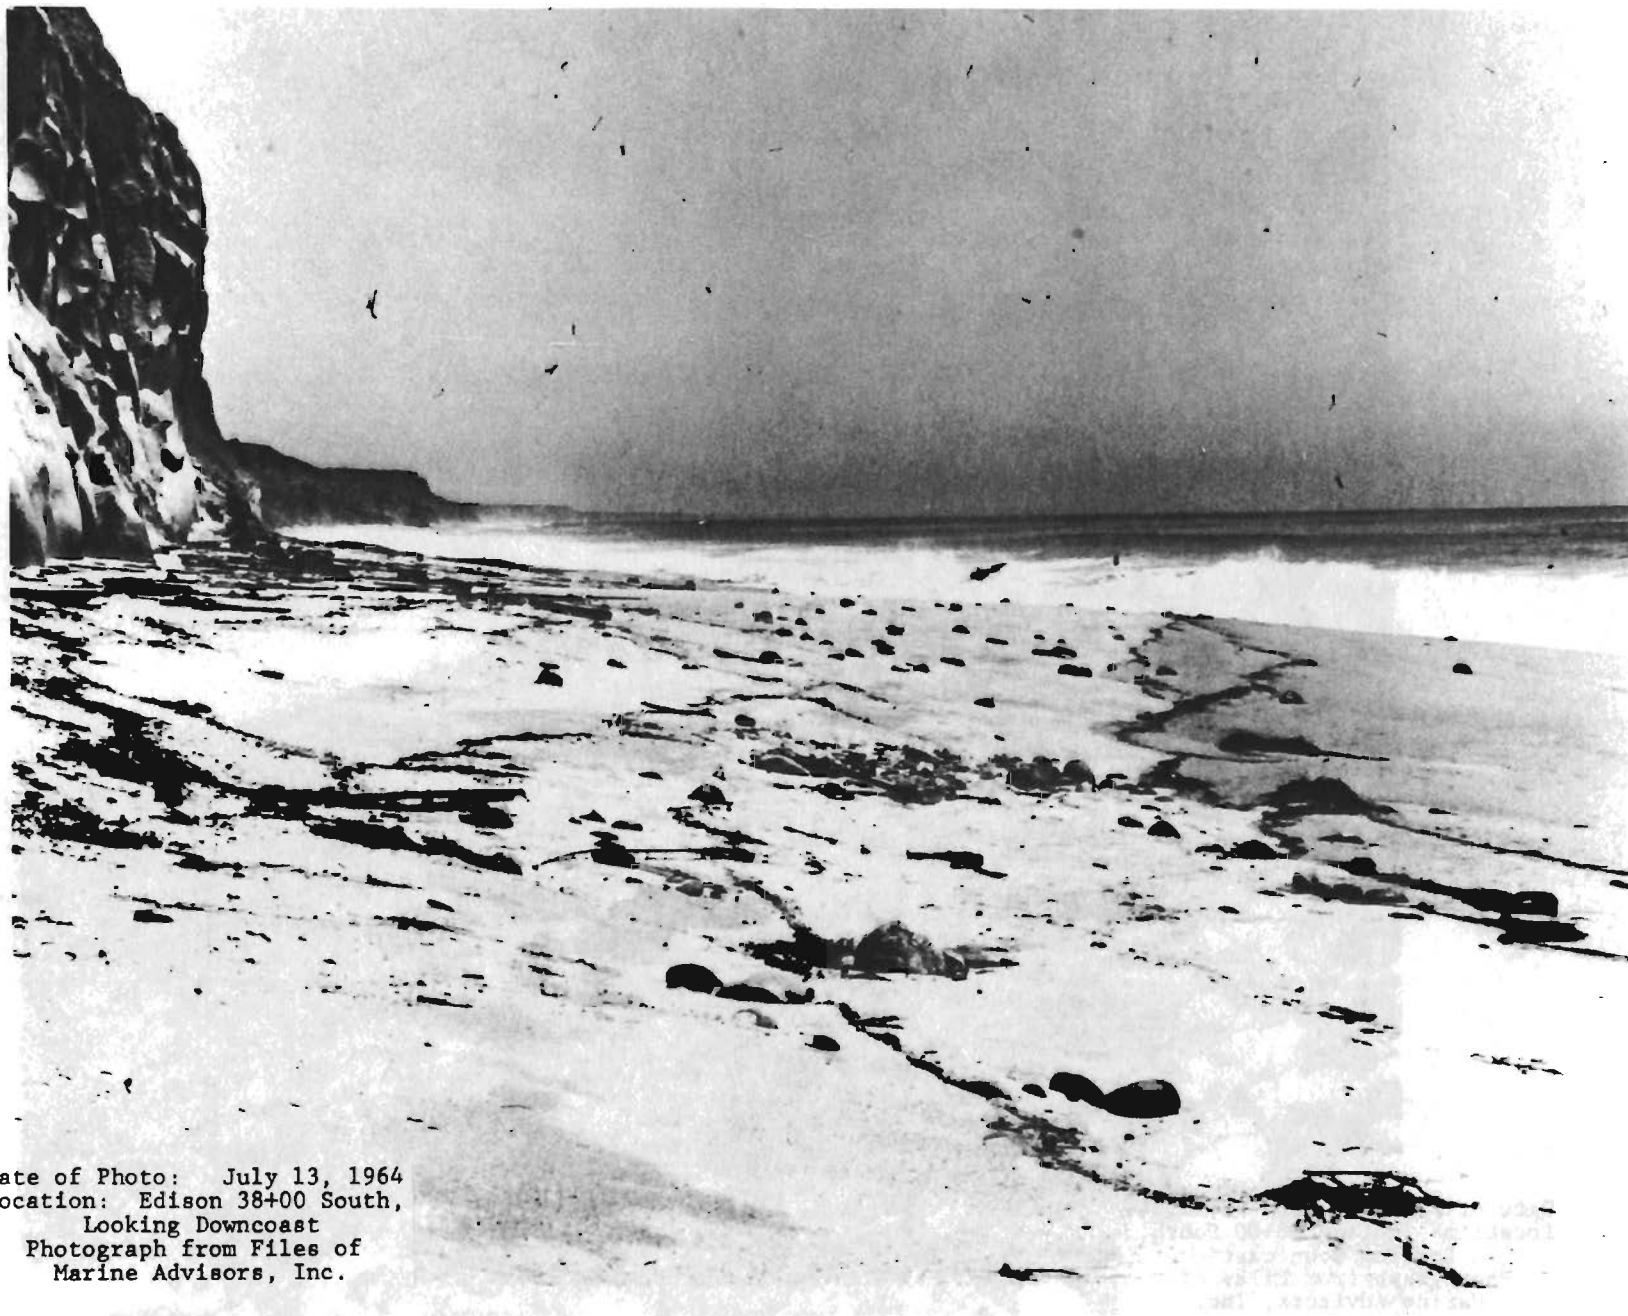
Figure 6. Photograph taken 13 July 1964 at same location as Figures 3 and 4, and looking south. Note thin veneer of sand that has covered the cobbles since 28 June 1964. Note high tide reaches base of cliff, as evidenced by kelp and debris line.

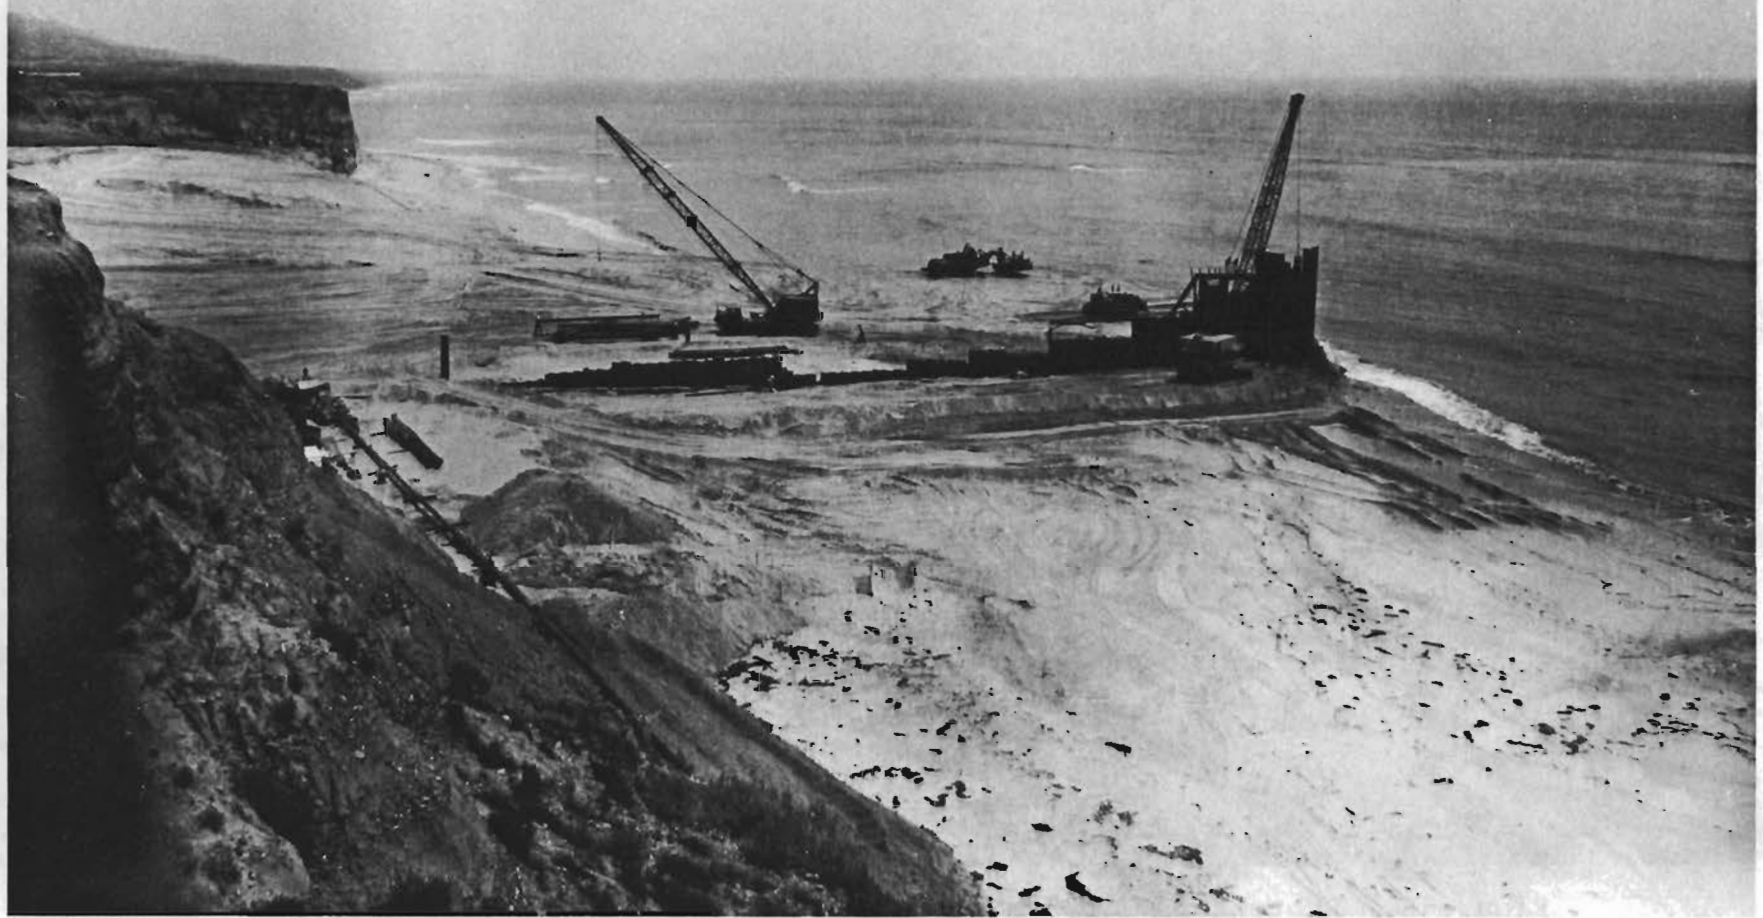
Figure 7. Photograph showing construction of north wall of Unit 1 laydown pad, taken on 4 June 1964 from Station "A".

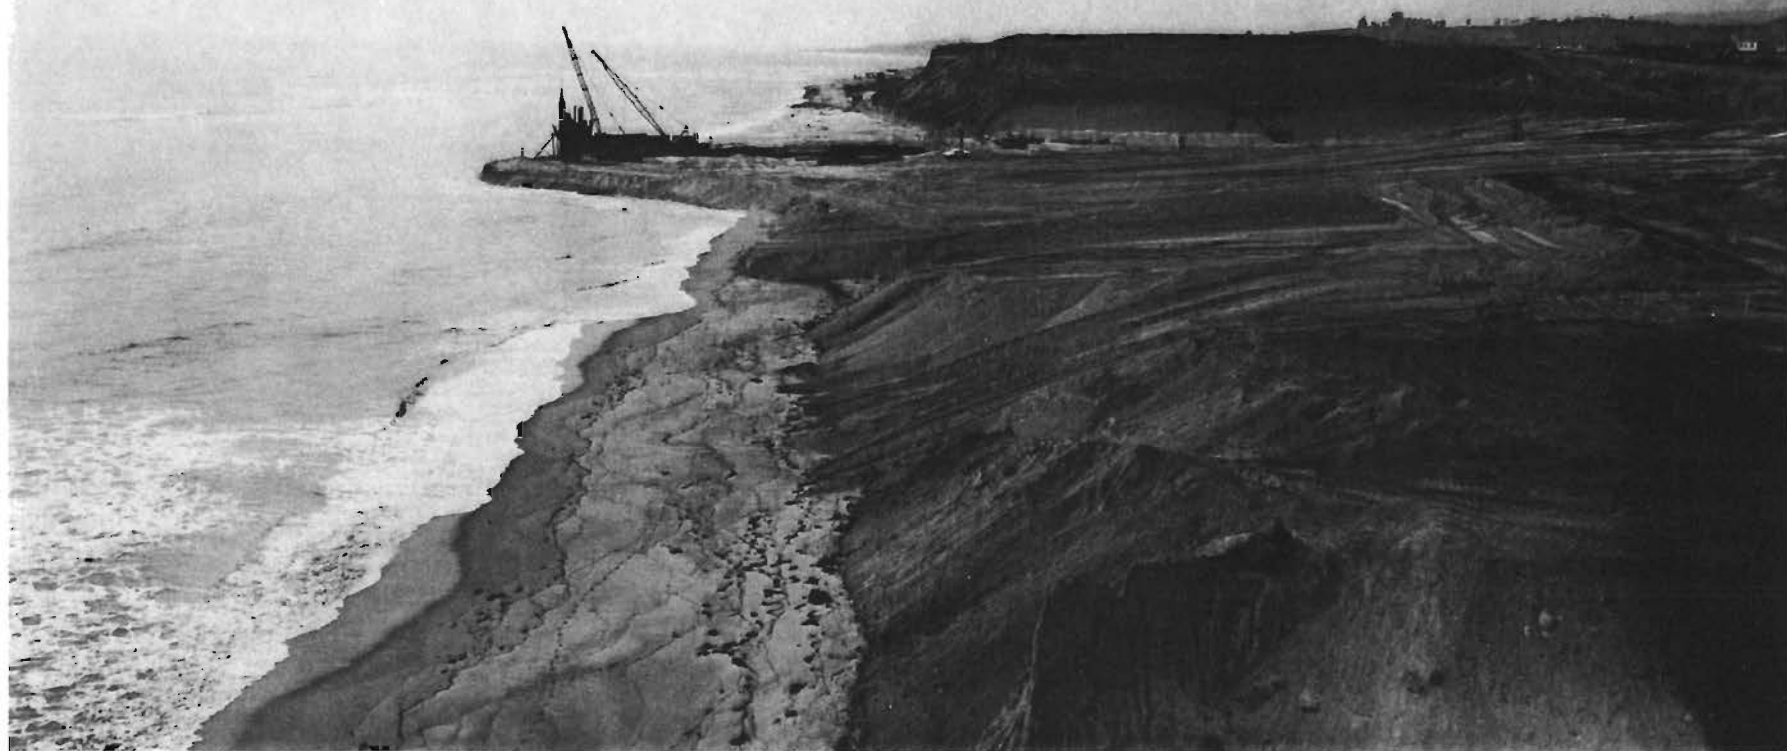
Figure 8. Photograph similar to Figure 6, but looking north from Station "B". Note the relatively narrow beach to the north of the construction activity. Also note the contact line between lower San Mateo sand formation and overlying terrace deposits in the exposed cliff cut.

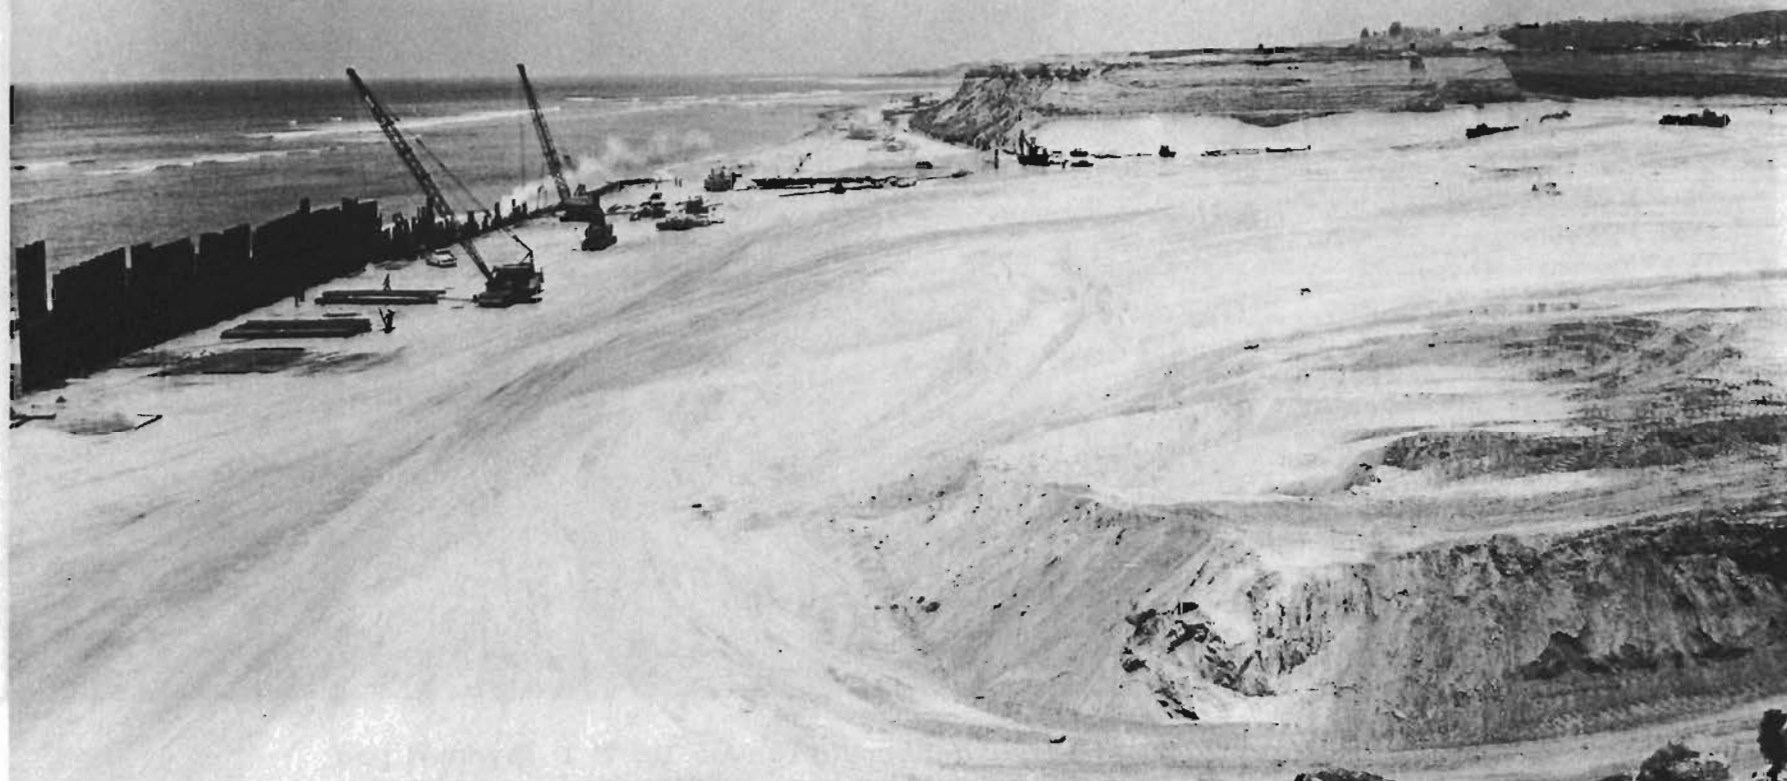
Figure 9. Photograph similar to Figure 7, but taken 17 June 1964 when west portion of laydown pad was well underway.

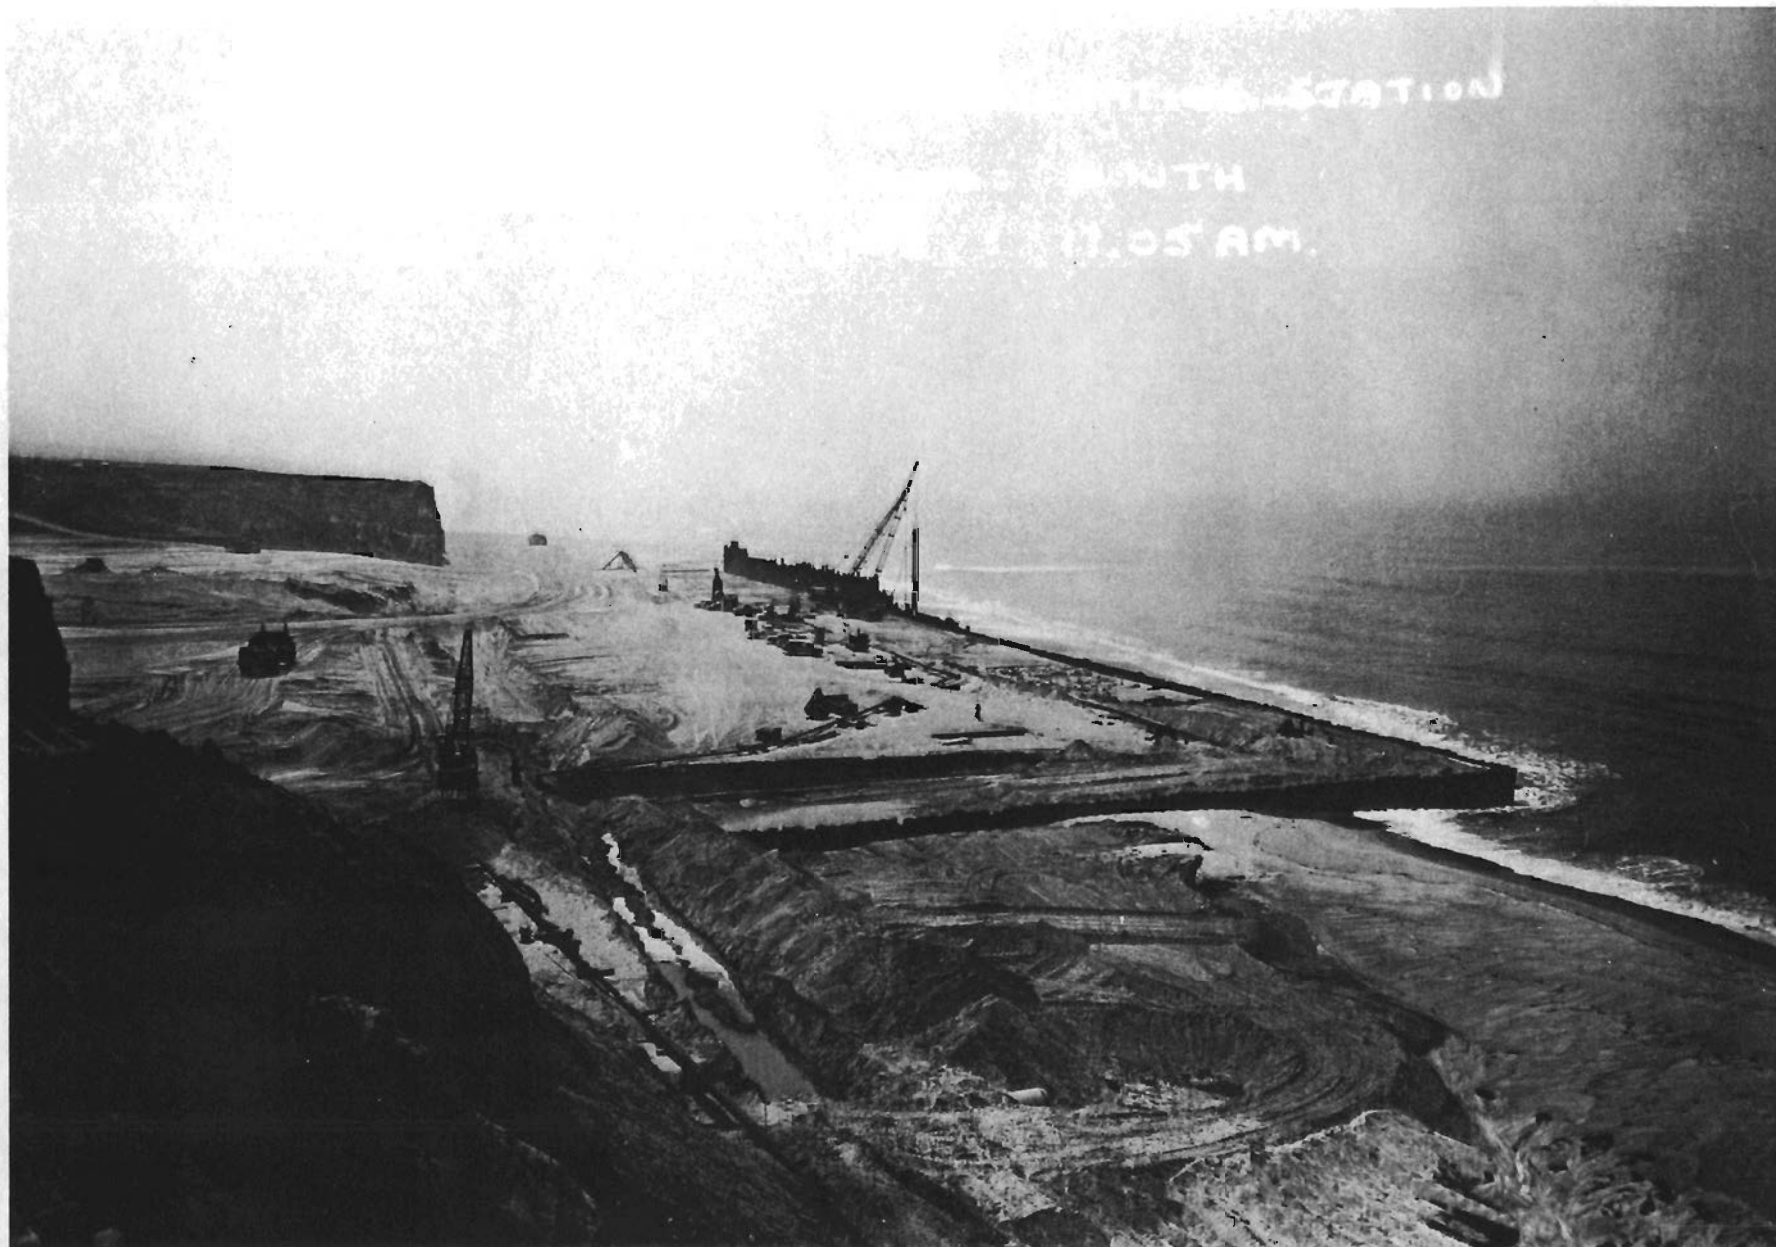
Figure 10. Photograph showing construction of Unit 1 laydown pad taken on 24 June 1964 from Station "A". Note sand spoil on north (foreground) side of sheetpile from continued excavations, in contrast to Figure 6.

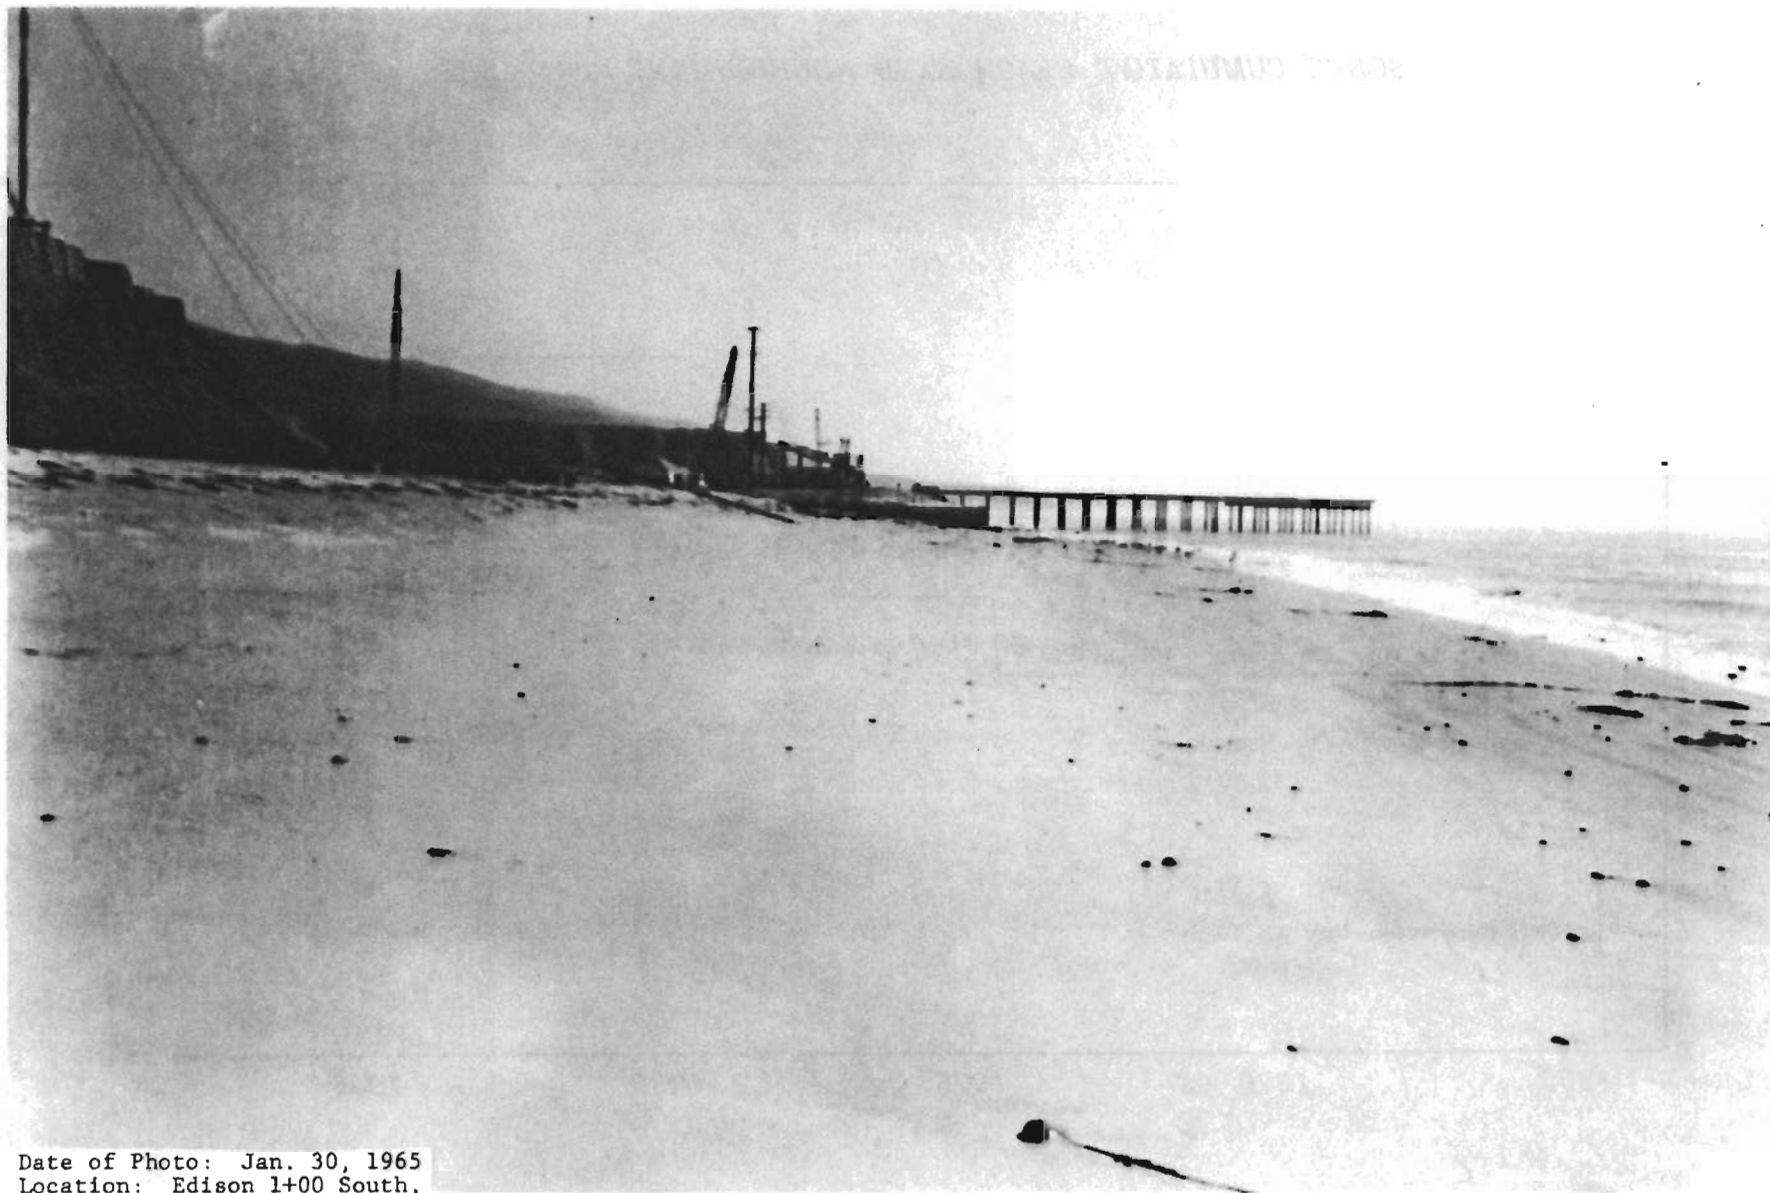
Date of Photo: Jan. 30, 1965
Location: Edison 1+00 South,
Looking Downcoast
Photograph from Files of
Marine Advisors, Inc.

Figure 11. Photograph looking south toward Unit 1 laydown pad
taken 30 January 1965. Note existence of trestle used to
dredge for and lay cooling pipes.

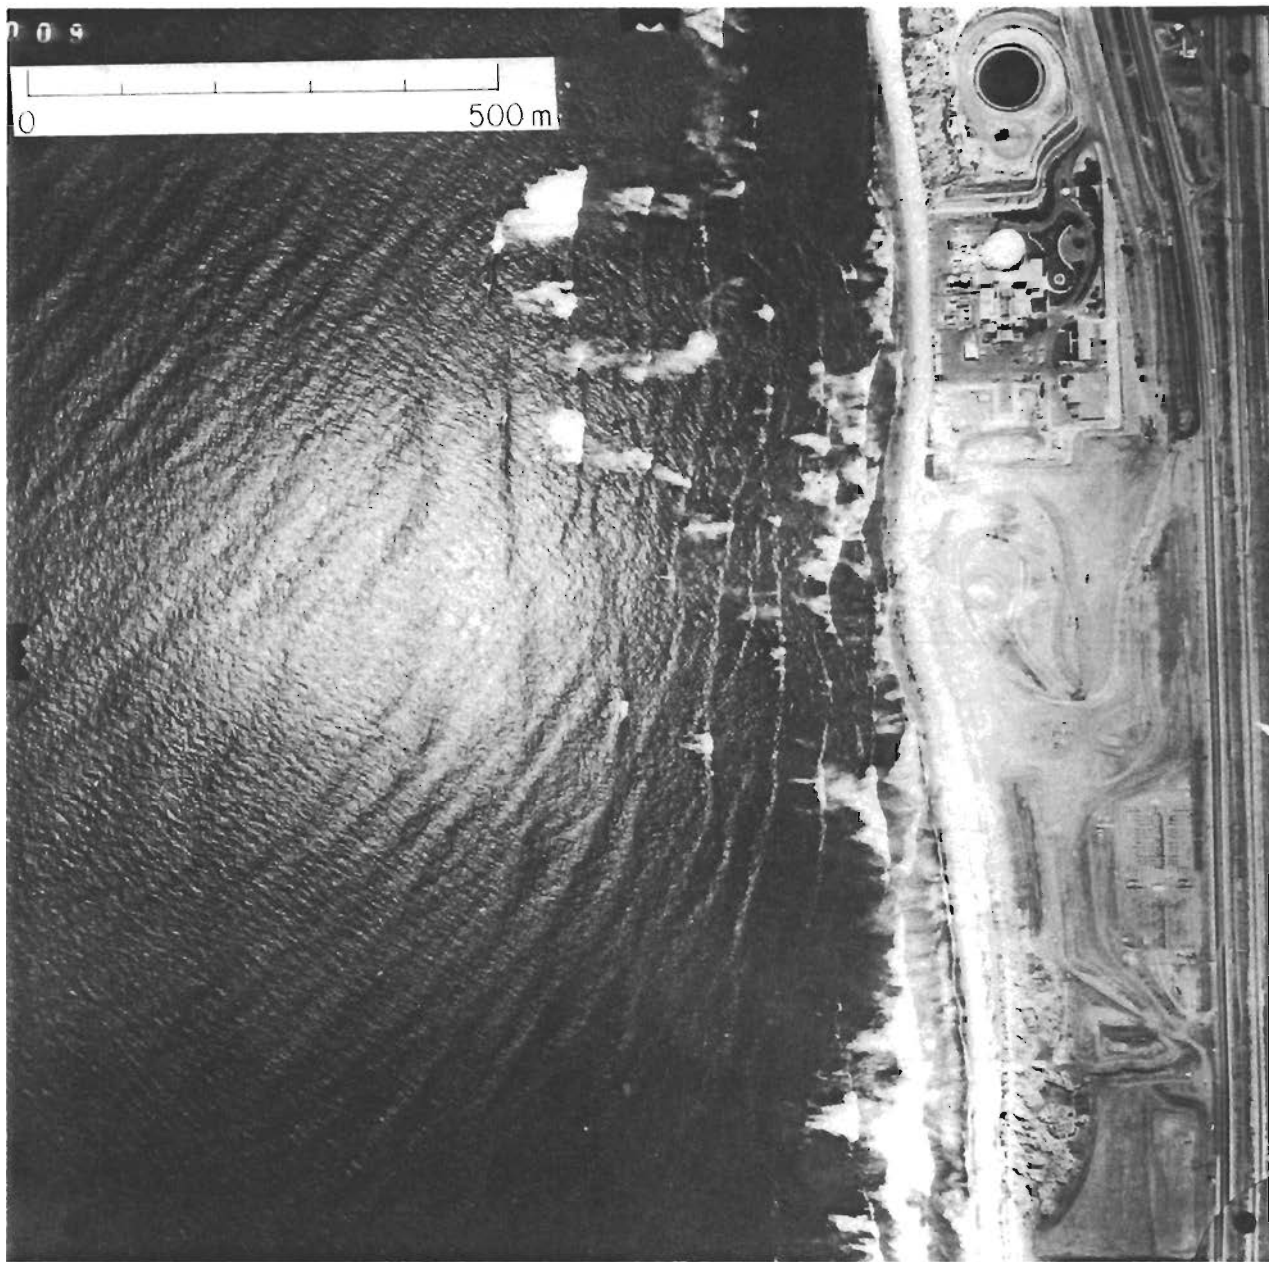
Figure 18. Aerial photograph of cliff excavation early in Units 2 and 3 construction phase, 17 May 1974.

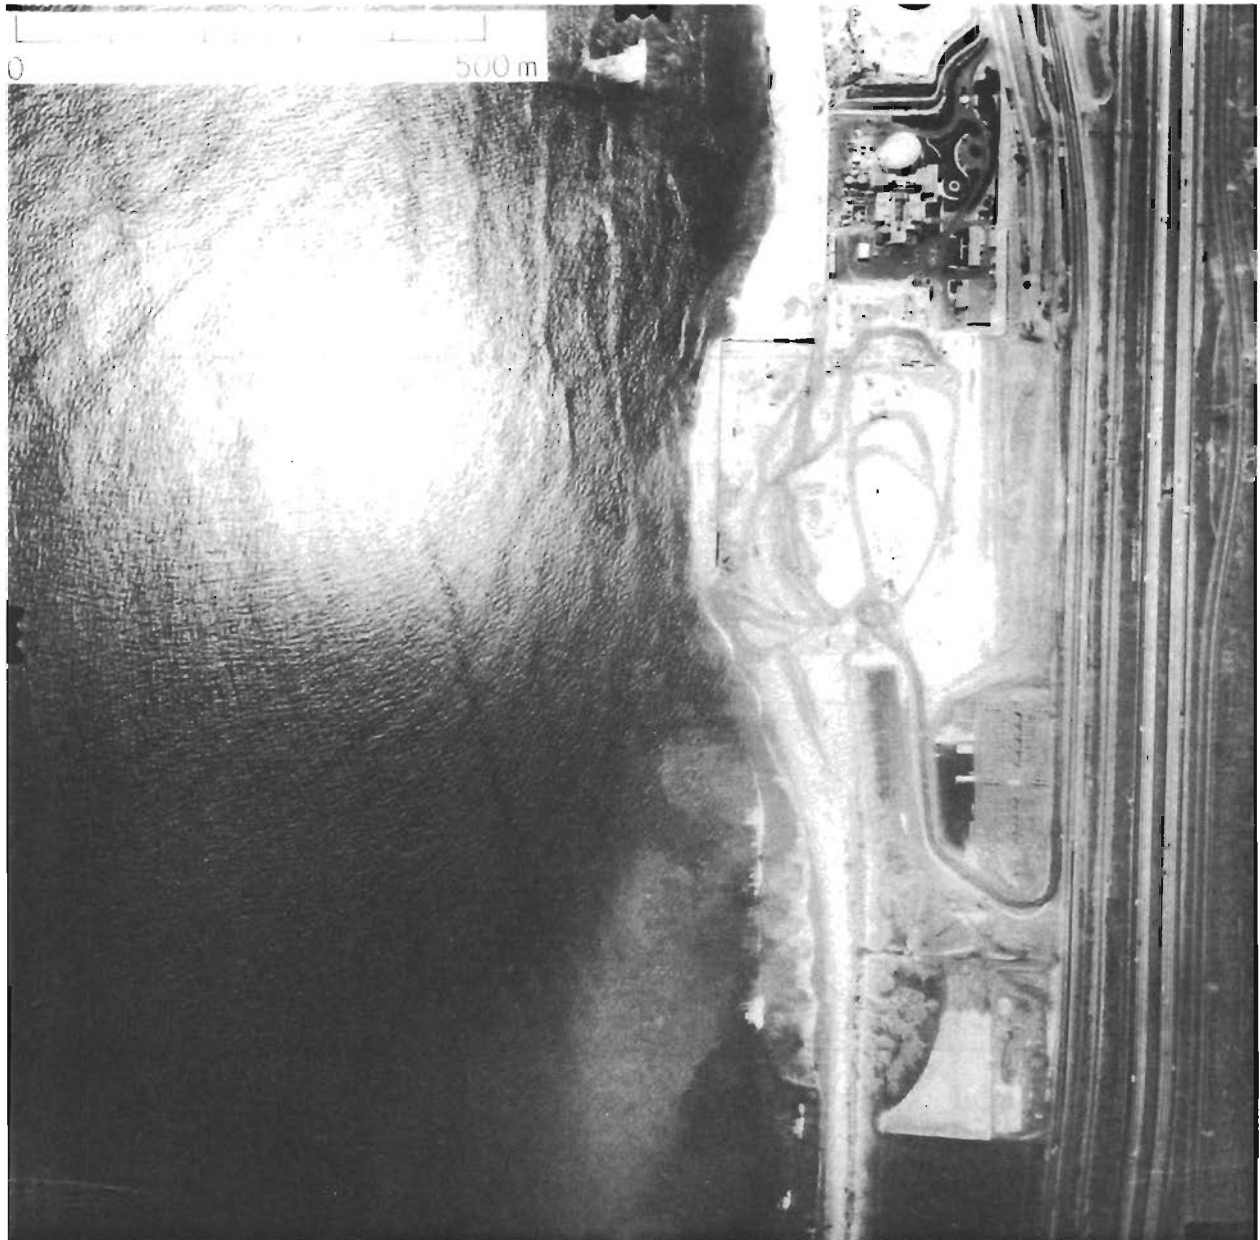
Figure 19. Aerial photograph taken 3 July 1974 and showing Units 2 and 3 laydown pad nearing completion.
