**6-18-1089 (CALIFORNIA DEPARTMENT OF PARKS AND
RECREATION)**

JUNE, 2019

EXHIBITS

**Long-Term Hazards
Management Plan**

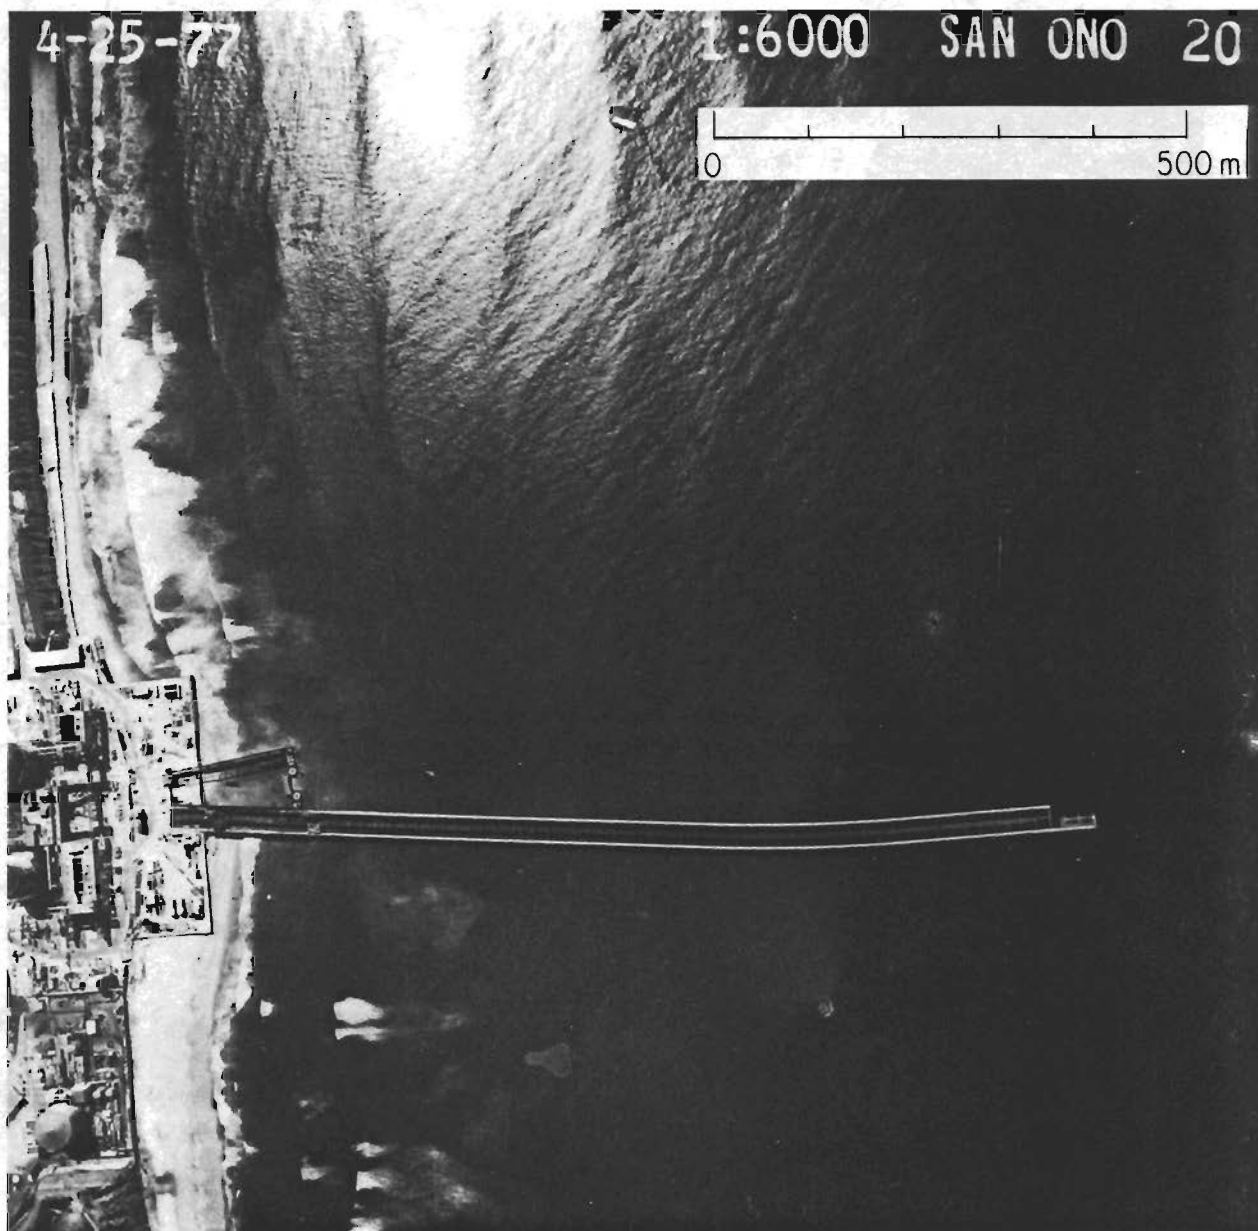
Figure 21. Aerial photograph of beach trestles used to lay Units 2 and 3 cooling pipes. Photo taken 25 April 1977. Note widened fillet beach upcoast of (below) laydown pad beginning to bypass the structure.

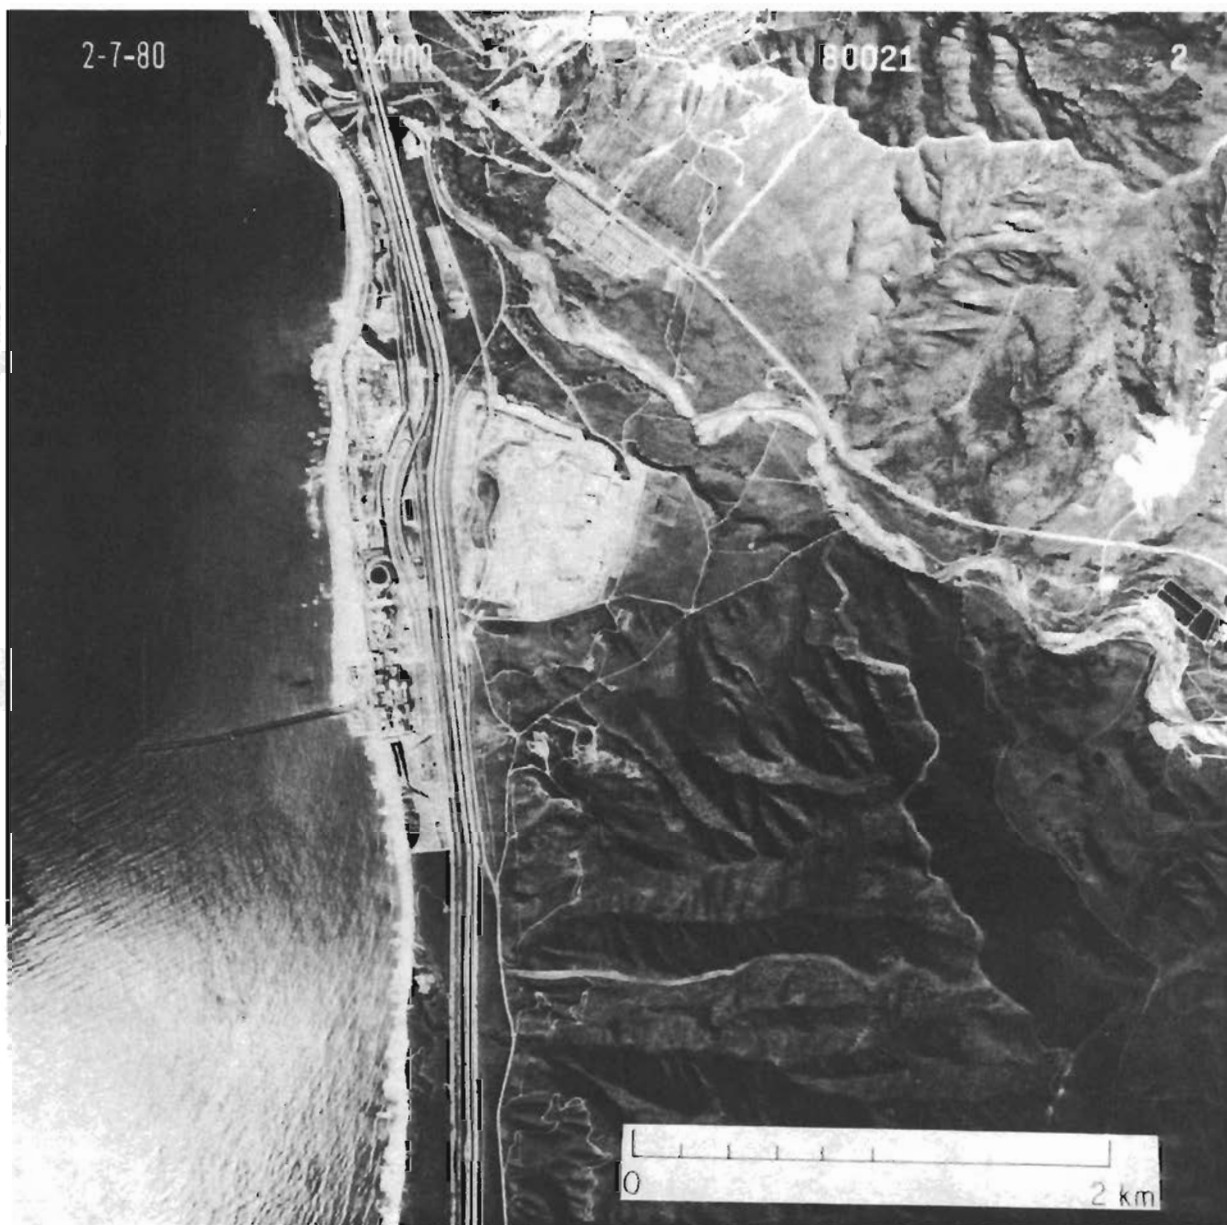
Figure 22. Aerial photograph of reach from San Onofre Creek to south of SONGS taken 7 February 1980. Note beach in front of laydown pad suggesting active sand bypassing at this time which limited upcoast beach width as well as downcoast erosion.

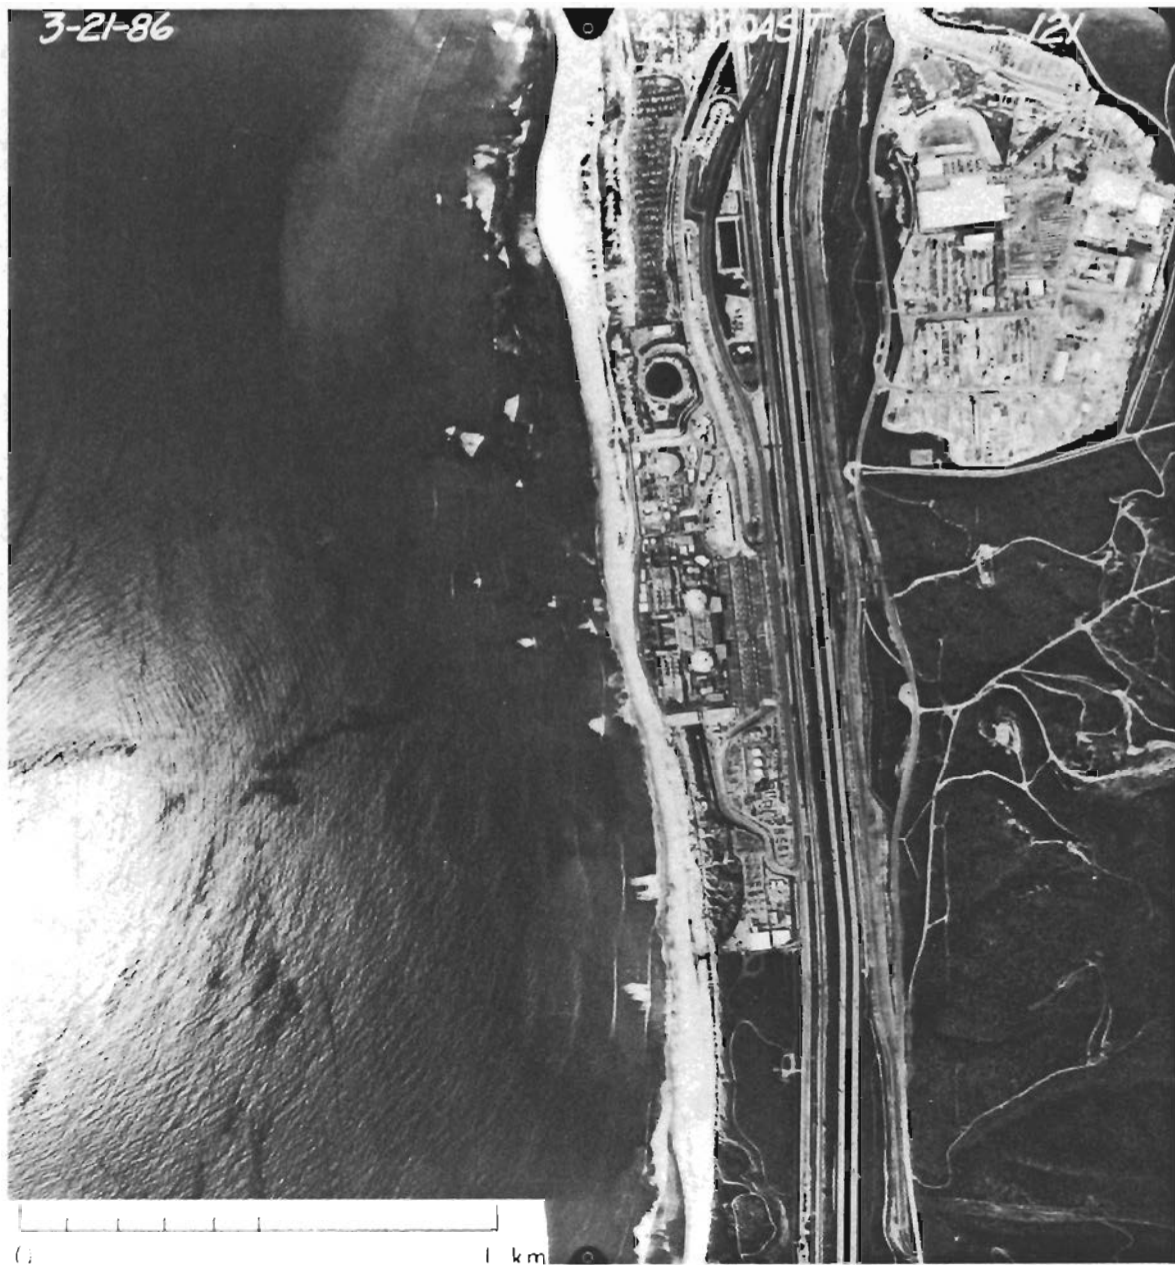
Figure 23. Aerial photograph taken 21 March 1986, about one year after removal of Units 2 and 3 laydown pad.

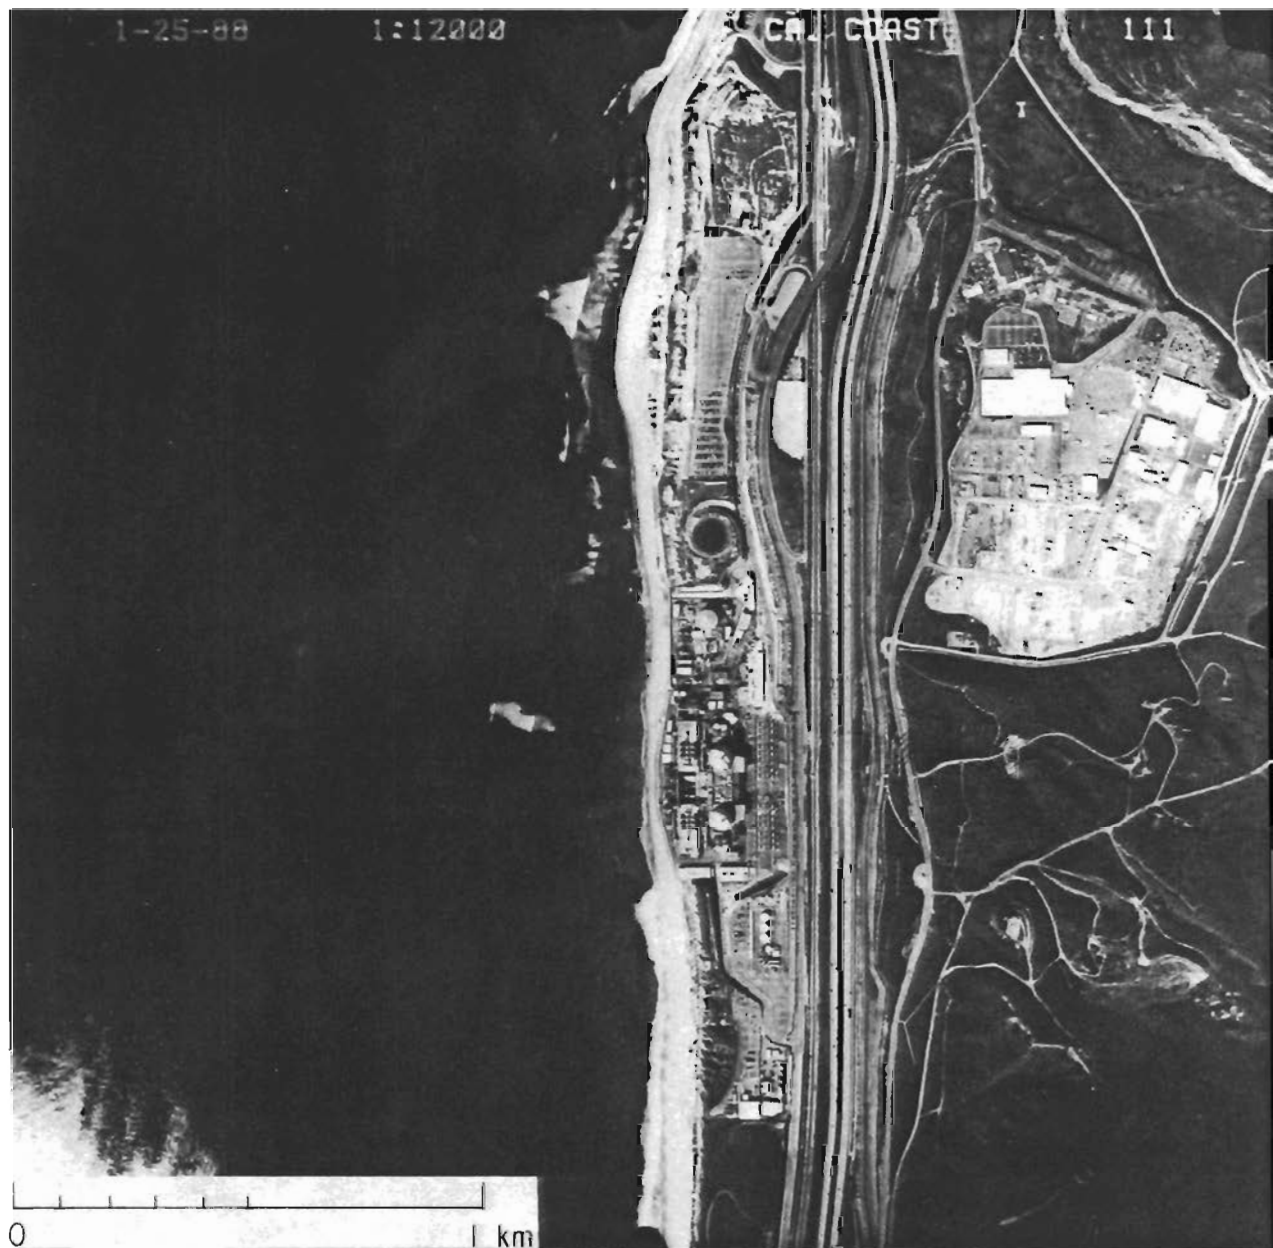
Figure 24. Aerial photograph taken 25 January 1988. Note much reduced beach width in front of Units 2 and 3 seawall. Contrast this with Figure 23.
