APPENDIX F: May 13, 2019 supplemental information from the Trinidad Rancheria regarding hazards

Trinidad Rancheria Responses to Coastal Commission Staff Report Regarding Coastal Consistency Determination CD-0001-19

Crawford & Associates, Inc. (CAInc) prepared this Geotechnical Feasibility and Preliminary Design Report for the Trinidad Rancheria Cher-Ae Heights Hotel project in Trinidad, California. This report provides our geotechnical data, geologic hazards evaluation, feasibility assessment and preliminary geotechnical recommendations for planning and preliminary design/costing. CAInc will prepare a final Geotechnical Design Report for the project based on further definition of project details, including final structure layouts, building loads, retaining walls, site grading and drainage/subdrainage elements.

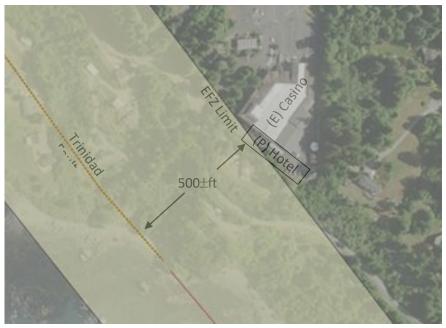
The active Trinidad Fault is mapped near the shoreline approximately 500±ft to the southwest of the proposed hotel. The California Geologic Survey (CGS) considers a fault to be active if it has shown evidence of ground displacement during the Holocene period, defined as about the last 11,000 years. The hotel lies at the eastern edge of an Alquist–Priolo Earthquake Fault Zone (EFZ) as defined by CGS.

The Earthquake Fault Zone Act requires structures for human occupancy to be set-back a minimum of 50 ft from an active fault. EFZ boundaries are commonly set at 500 feet from major active faults to accommodate imprecise fault locations and possible branches of active faults. The basis for establishing the Trinidad EFZ is a Fault Evaluation Report (FER-138, California Division of Mines and Geology, 1982); this report concludes that the fault scarp can be traced with confidence north of the site but is less distinct along the coast to the south. The relatively wide zone in this area reflects the imprecise location of the Trinidad Fault and potential for other branches of this fault to exist.

Except for the northwest corner, the proposed hotel footprint is positioned outside of the mapped EFZ. While we cannot say conclusively that an active fault is not present within this footprint, we consider the likelihood of an active fault through the site to be low and that the risk of fault rupture does not represent a "fatal flaw" to the project. Further investigation would be necessary to confirm this assessment, if required.

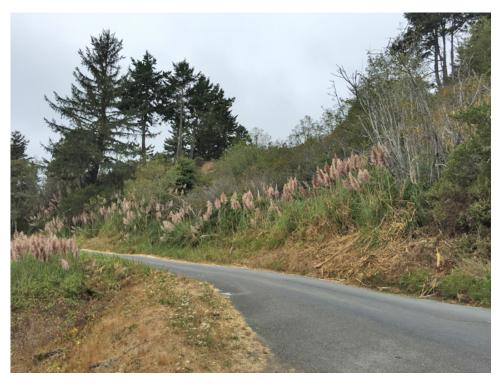
Photo 1: Looking east at head of landslide

The slopes adjacent west of the site are moderately steep with localized areas of instability. An active slide is located along at the south end of the site and extends from the top of bluff to ocean level 200+ft below. The existing casino is not affected by this feature, although the existing parking area near the mechanical building is at the head of this slide and the outer edge of the pavement has broken and dropped about 6-inches vertically. Scenic Drive crosses this slide and has experienced distress from this movement. This slope contains evidence of shallow groundwater and springs that likely contribute to the slope instability in this area.

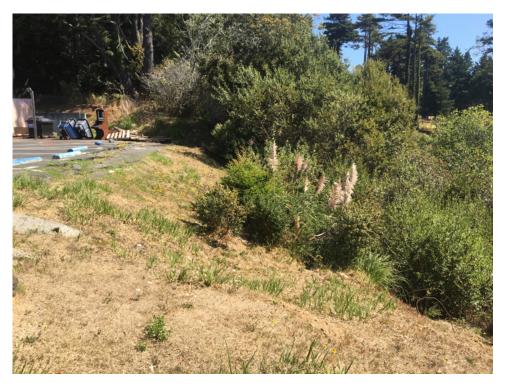
Photo 2: "Water loving plants" beneath landslide at Scenic Drive

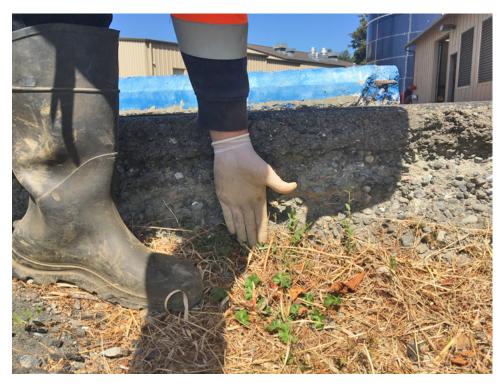
Photo 3: Vertical drop at landslide scarp

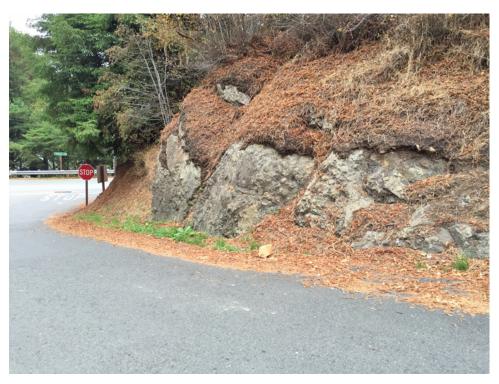
Photo 4: Exposed bedrock at Casino Entrance

Rock consistent with the Franciscan Complex is exposed near beach-level and locally in the site vicinity near the intersection of Scenic Drive and the casino exit road. This rock is observed to be variablyweathered shale and greywacke sandstone, with layering dipping typically to the northeast. Some rock is very hard while some is soft (mostly within sheared shale layers). The hard rock is generally resistant to erosion, as evidenced by the "sea stacks" left standing in the bay and along the shore.

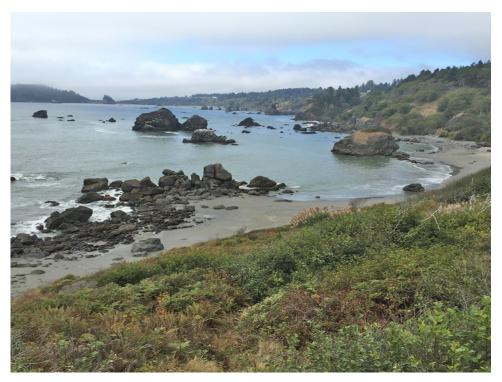
Photo 5: Sea stacks at beach west of Scenic Drive

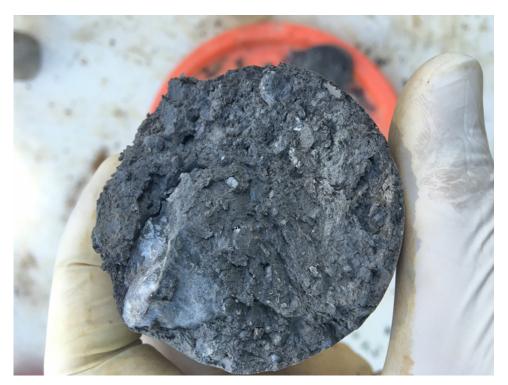
Photo 6: Weathered bedrock
