6-19-1007 (City of San Diego, Torrey Pines outfall)

October 2020

TORREY PINES GOLF COURSE
STORM DRAIN REPAIR PROJECT
STORM DRAIN PLAN AND PROFILE,
FINAL GRADING

RE: Natural Resource Impact Analysis, Torrey Pines Golf Course, San Diego, CA

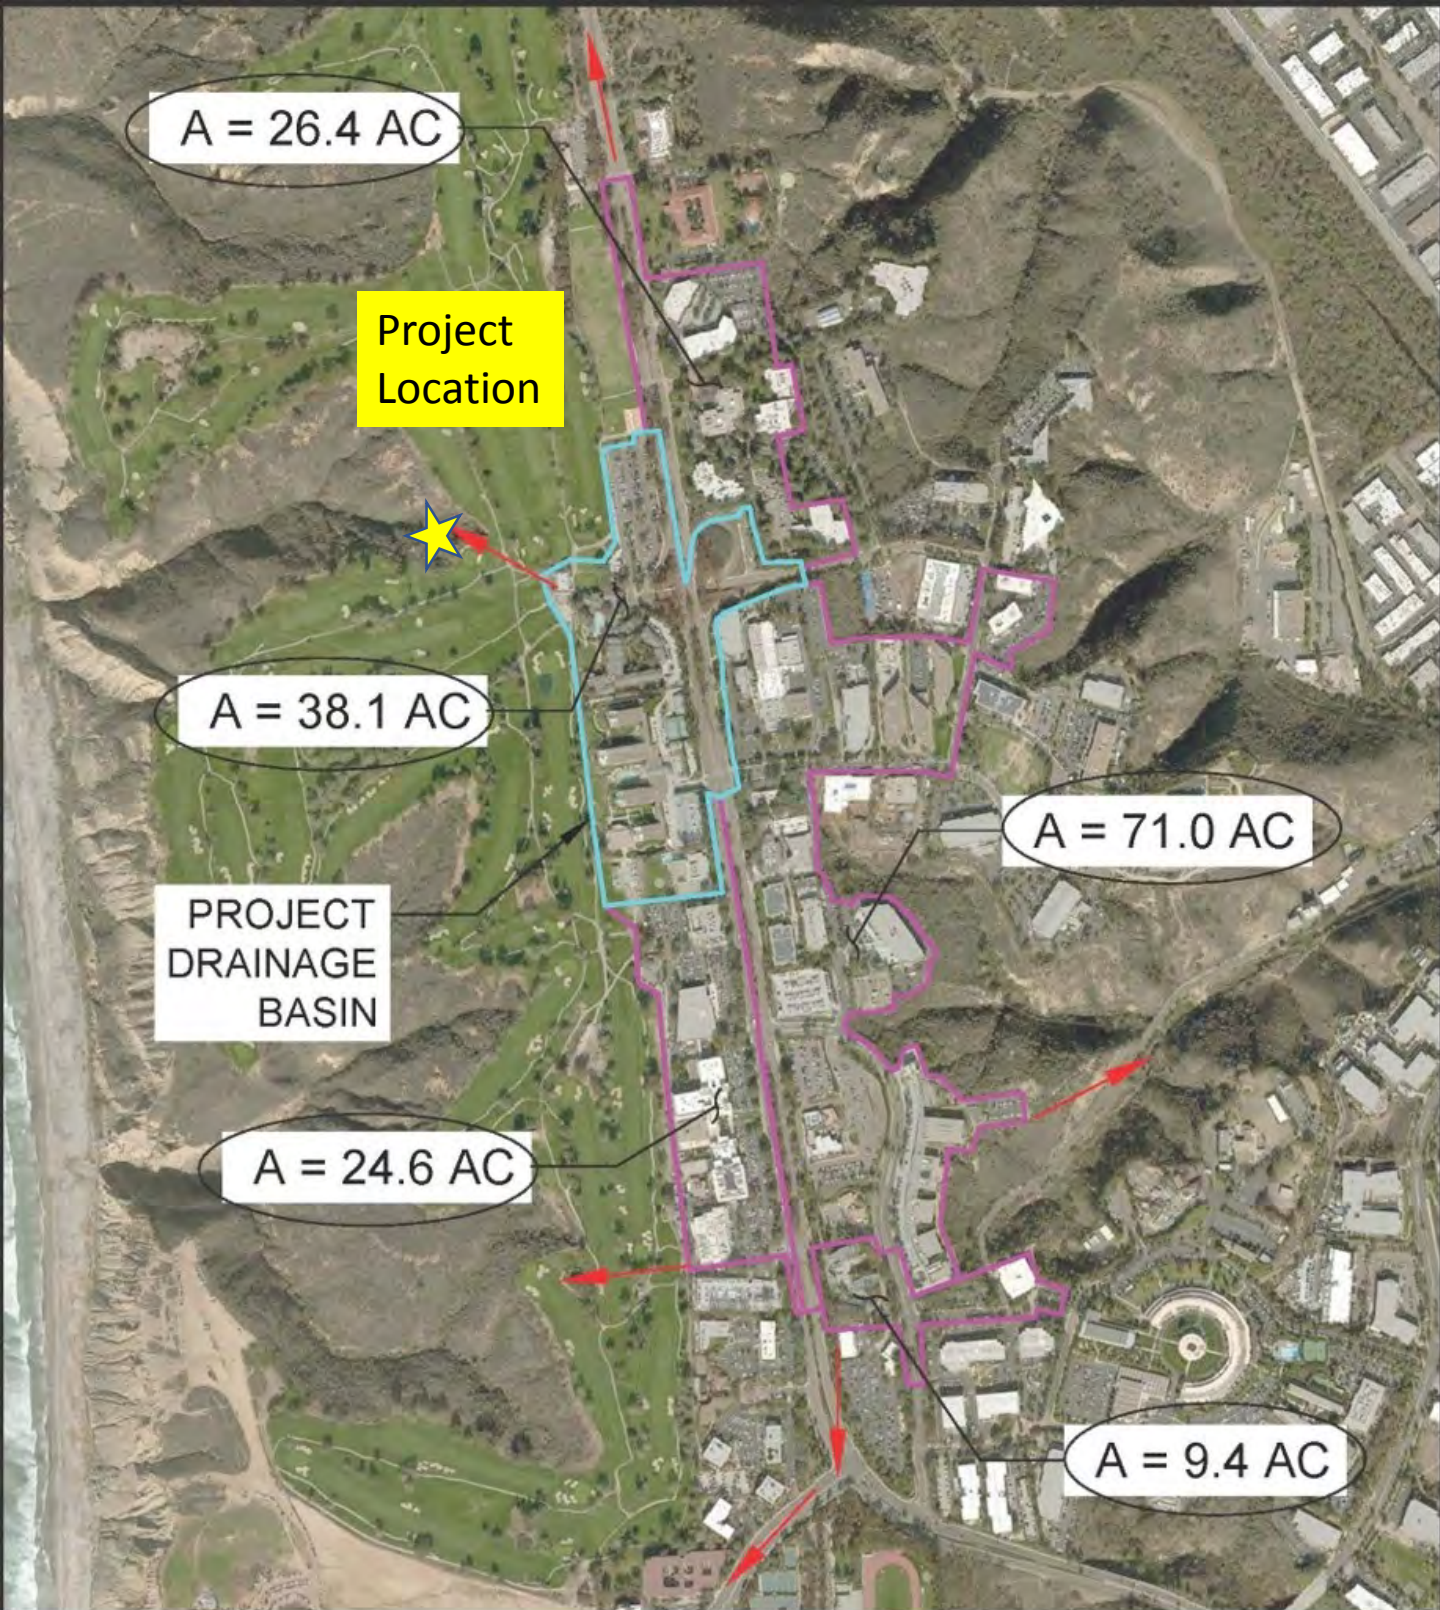
Drainage Basin
Boundaries

OUTLET DIRECTION FOR DRAINAGE BASIN

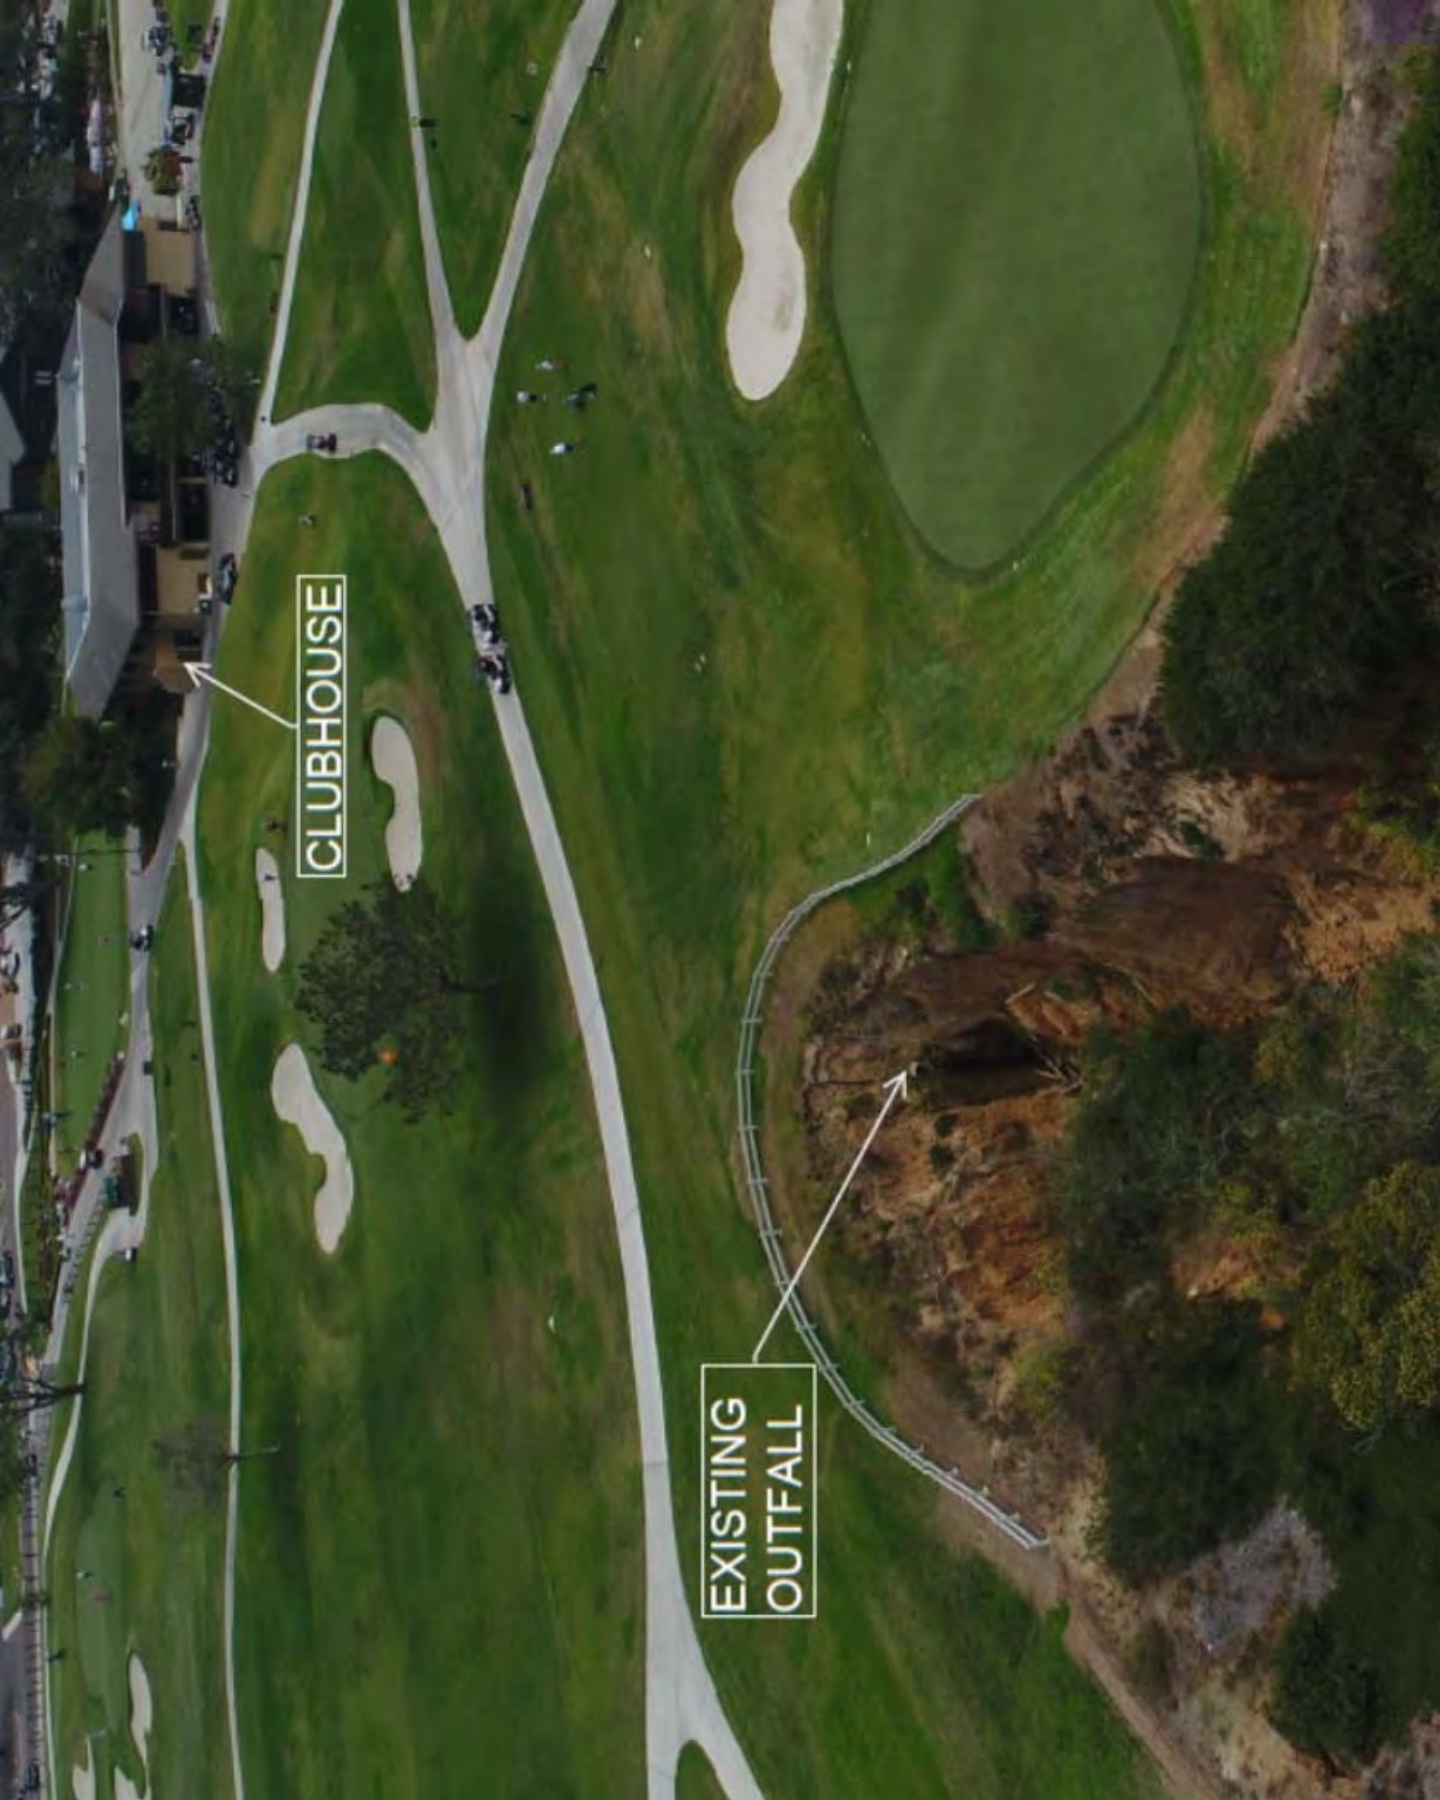
CLUBHOUSE

EXISTING
OUTFALL

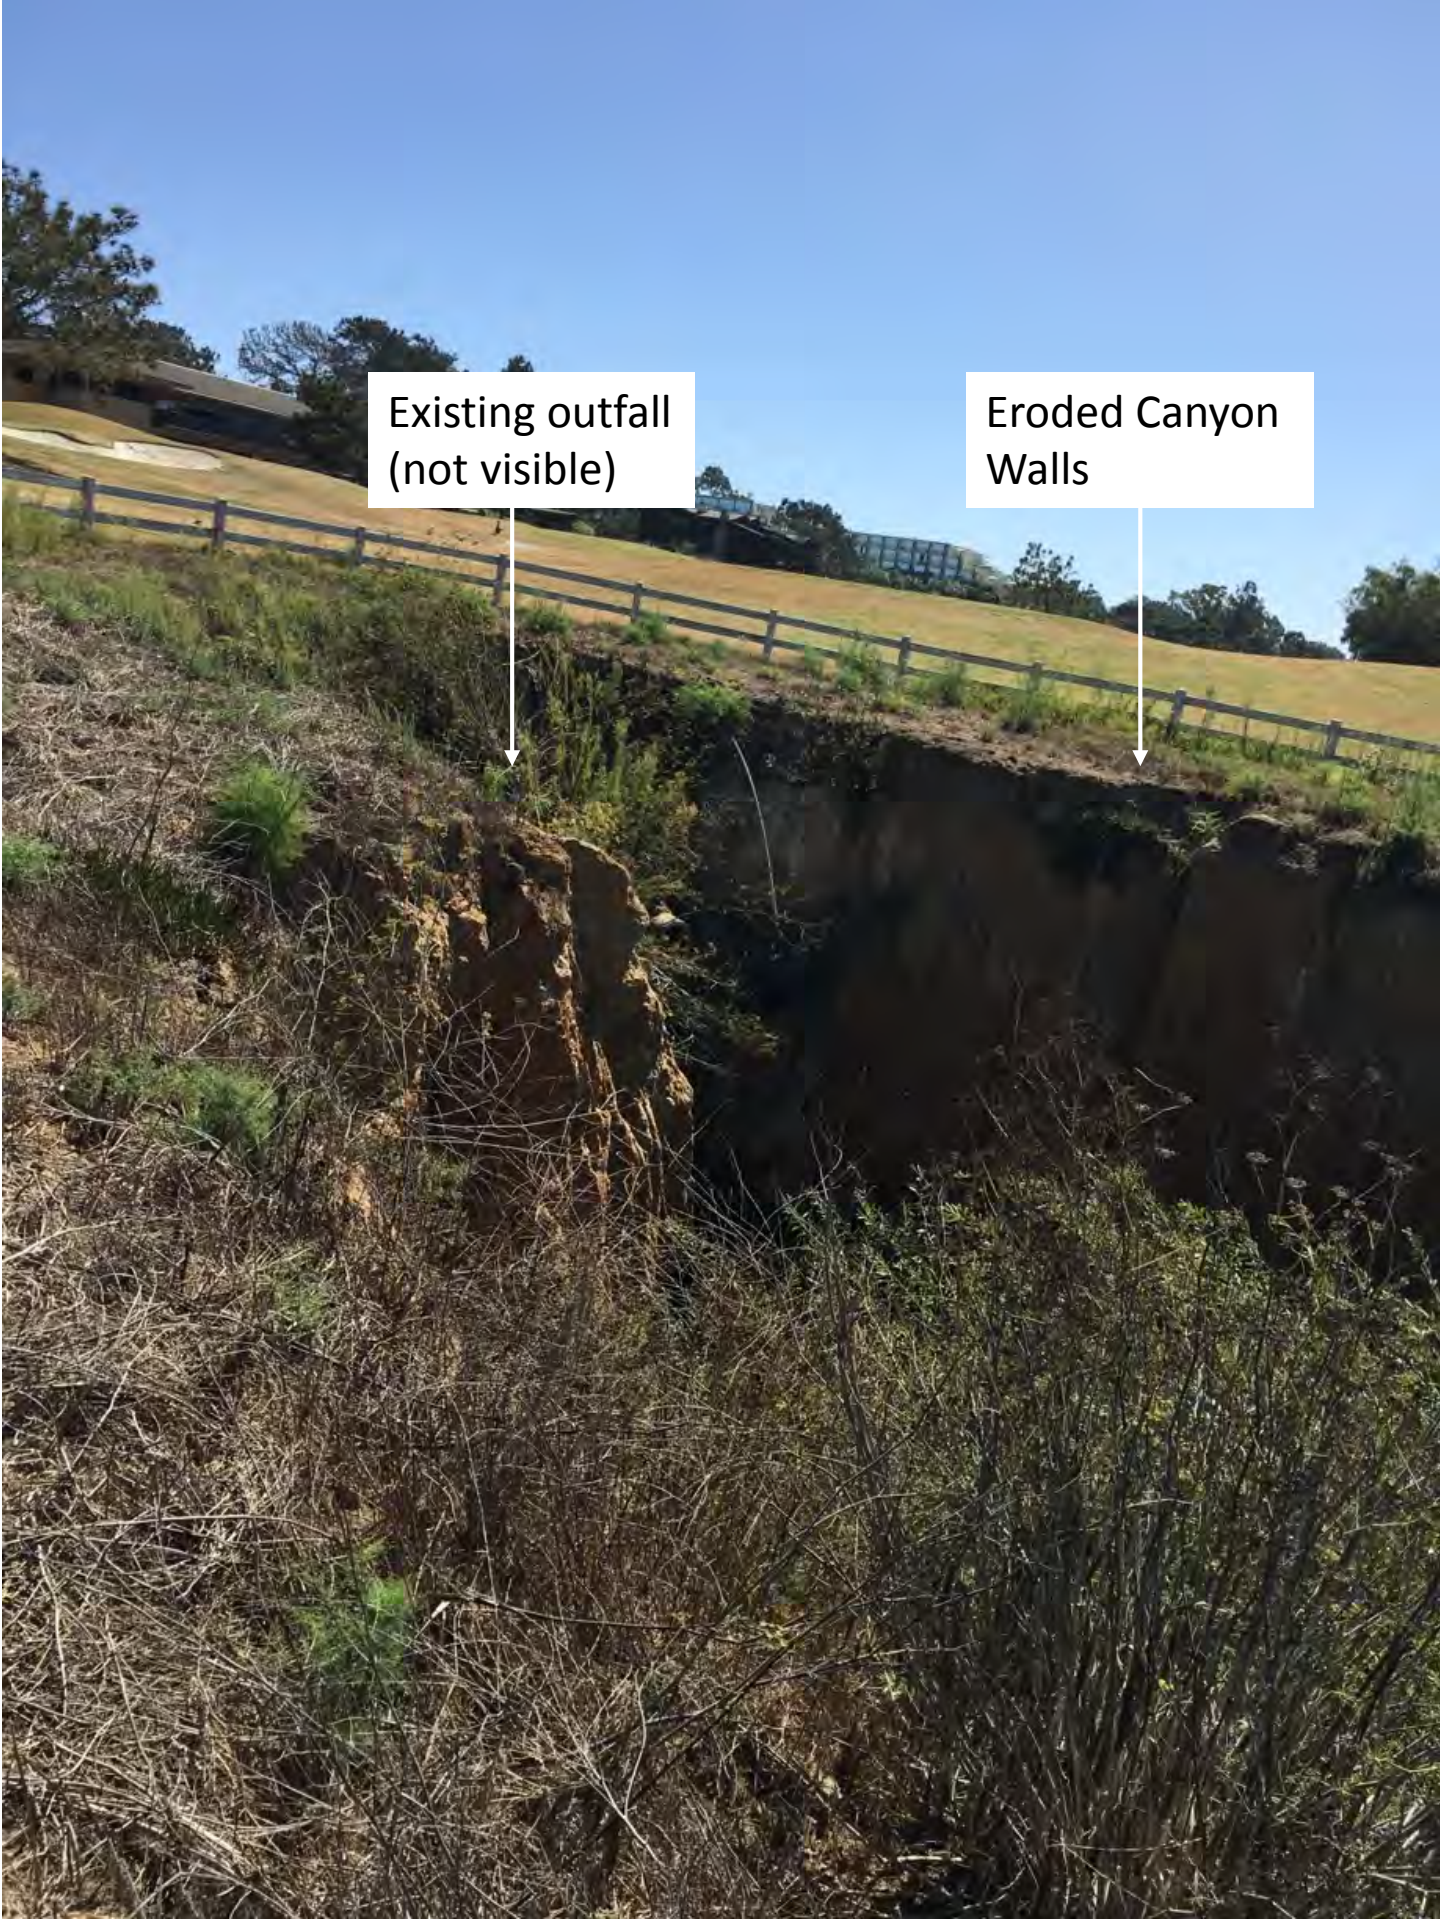
Existing outfall
(not visible)

Eroded Canyon
Walls

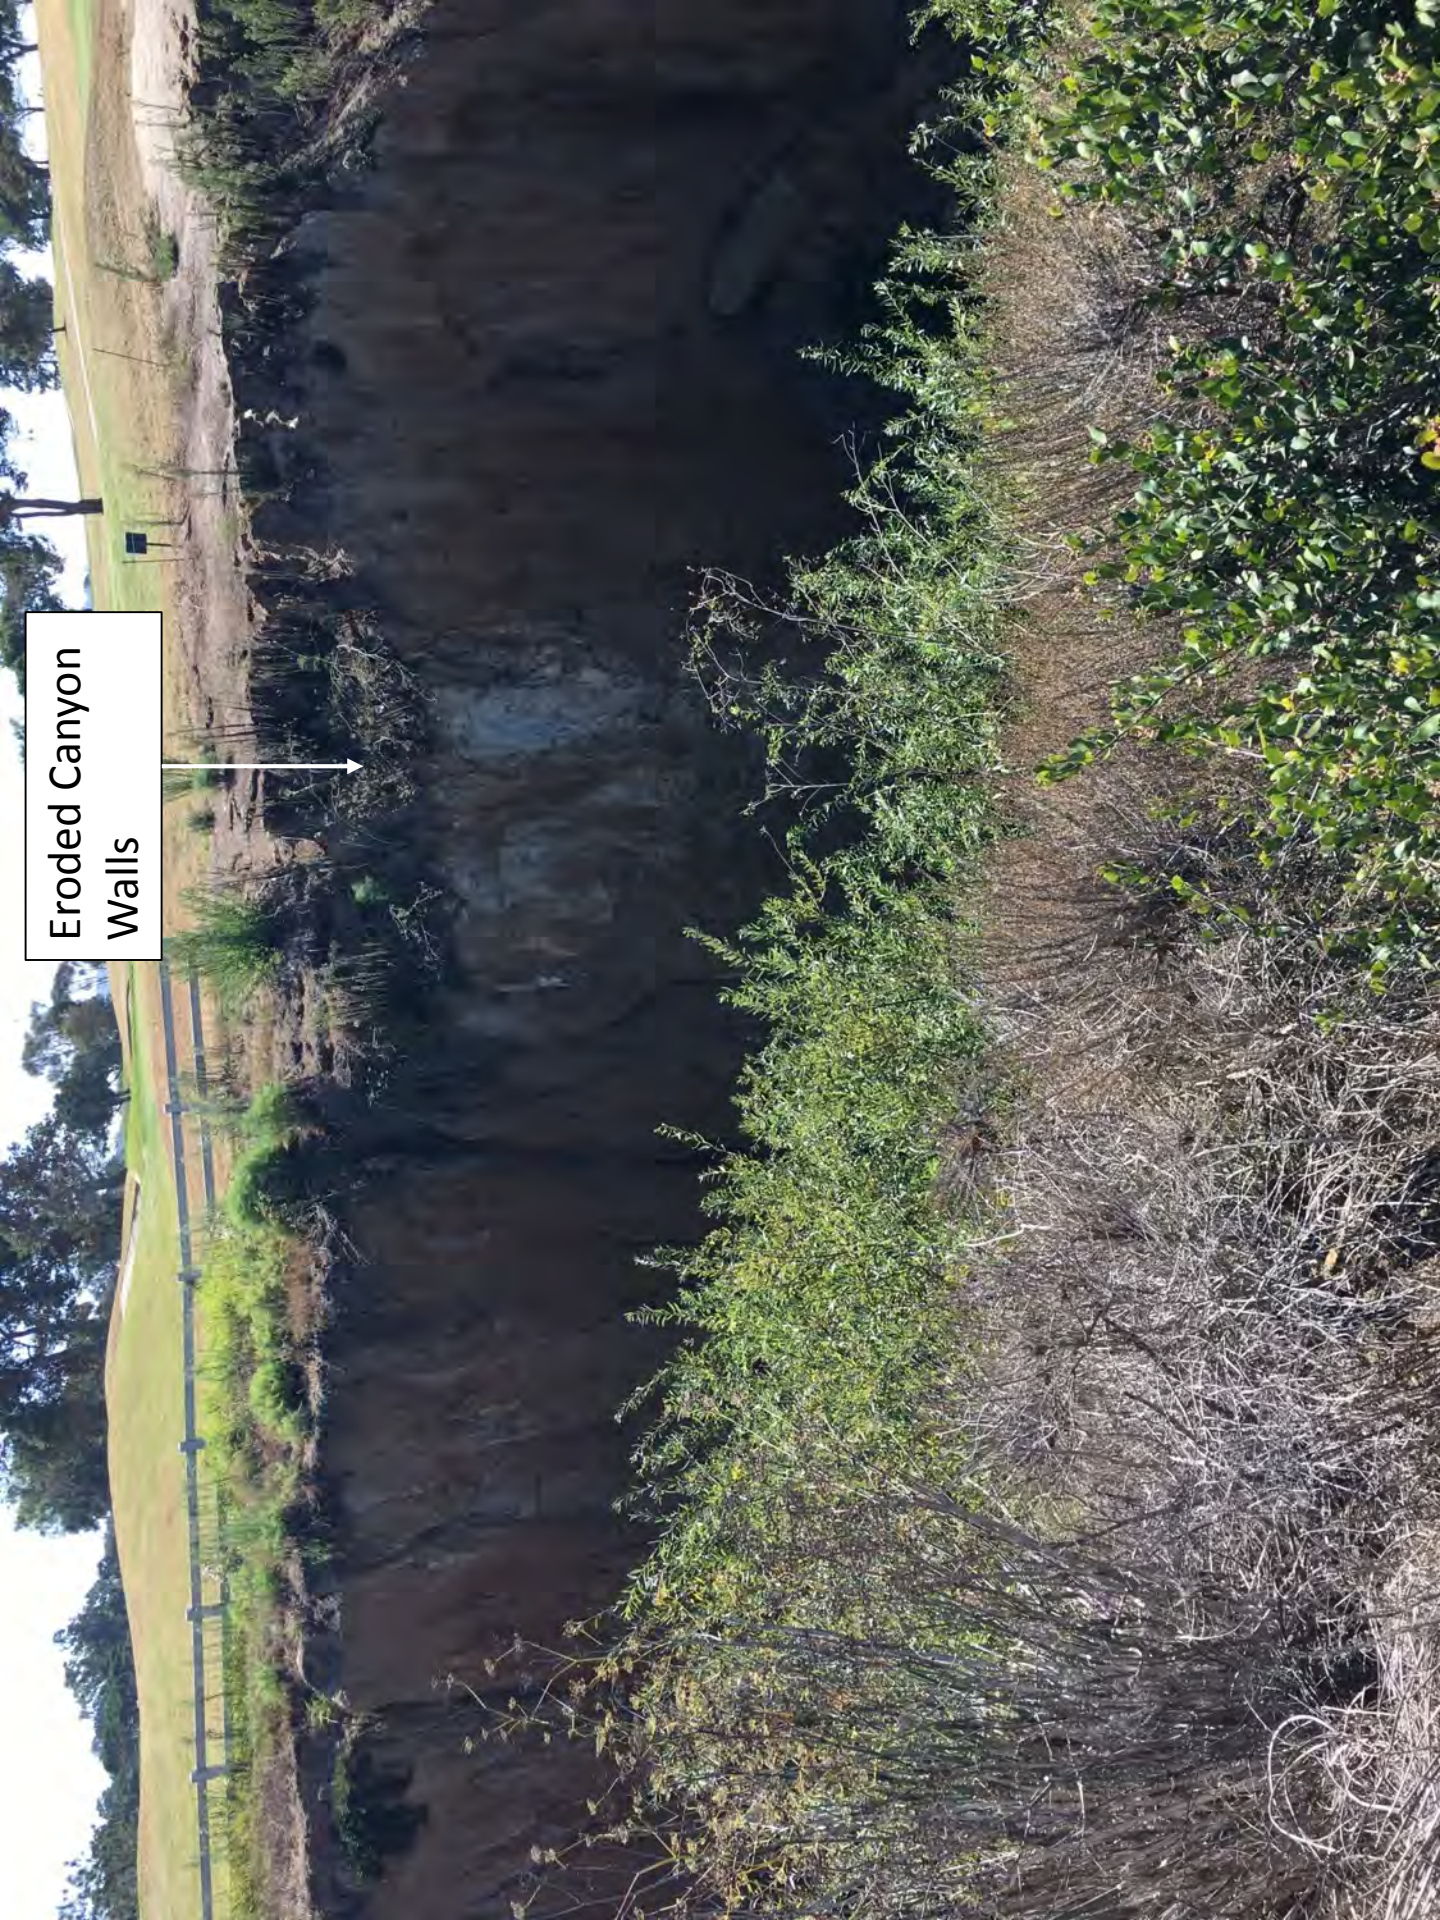
Looking west down
canyon from north rim

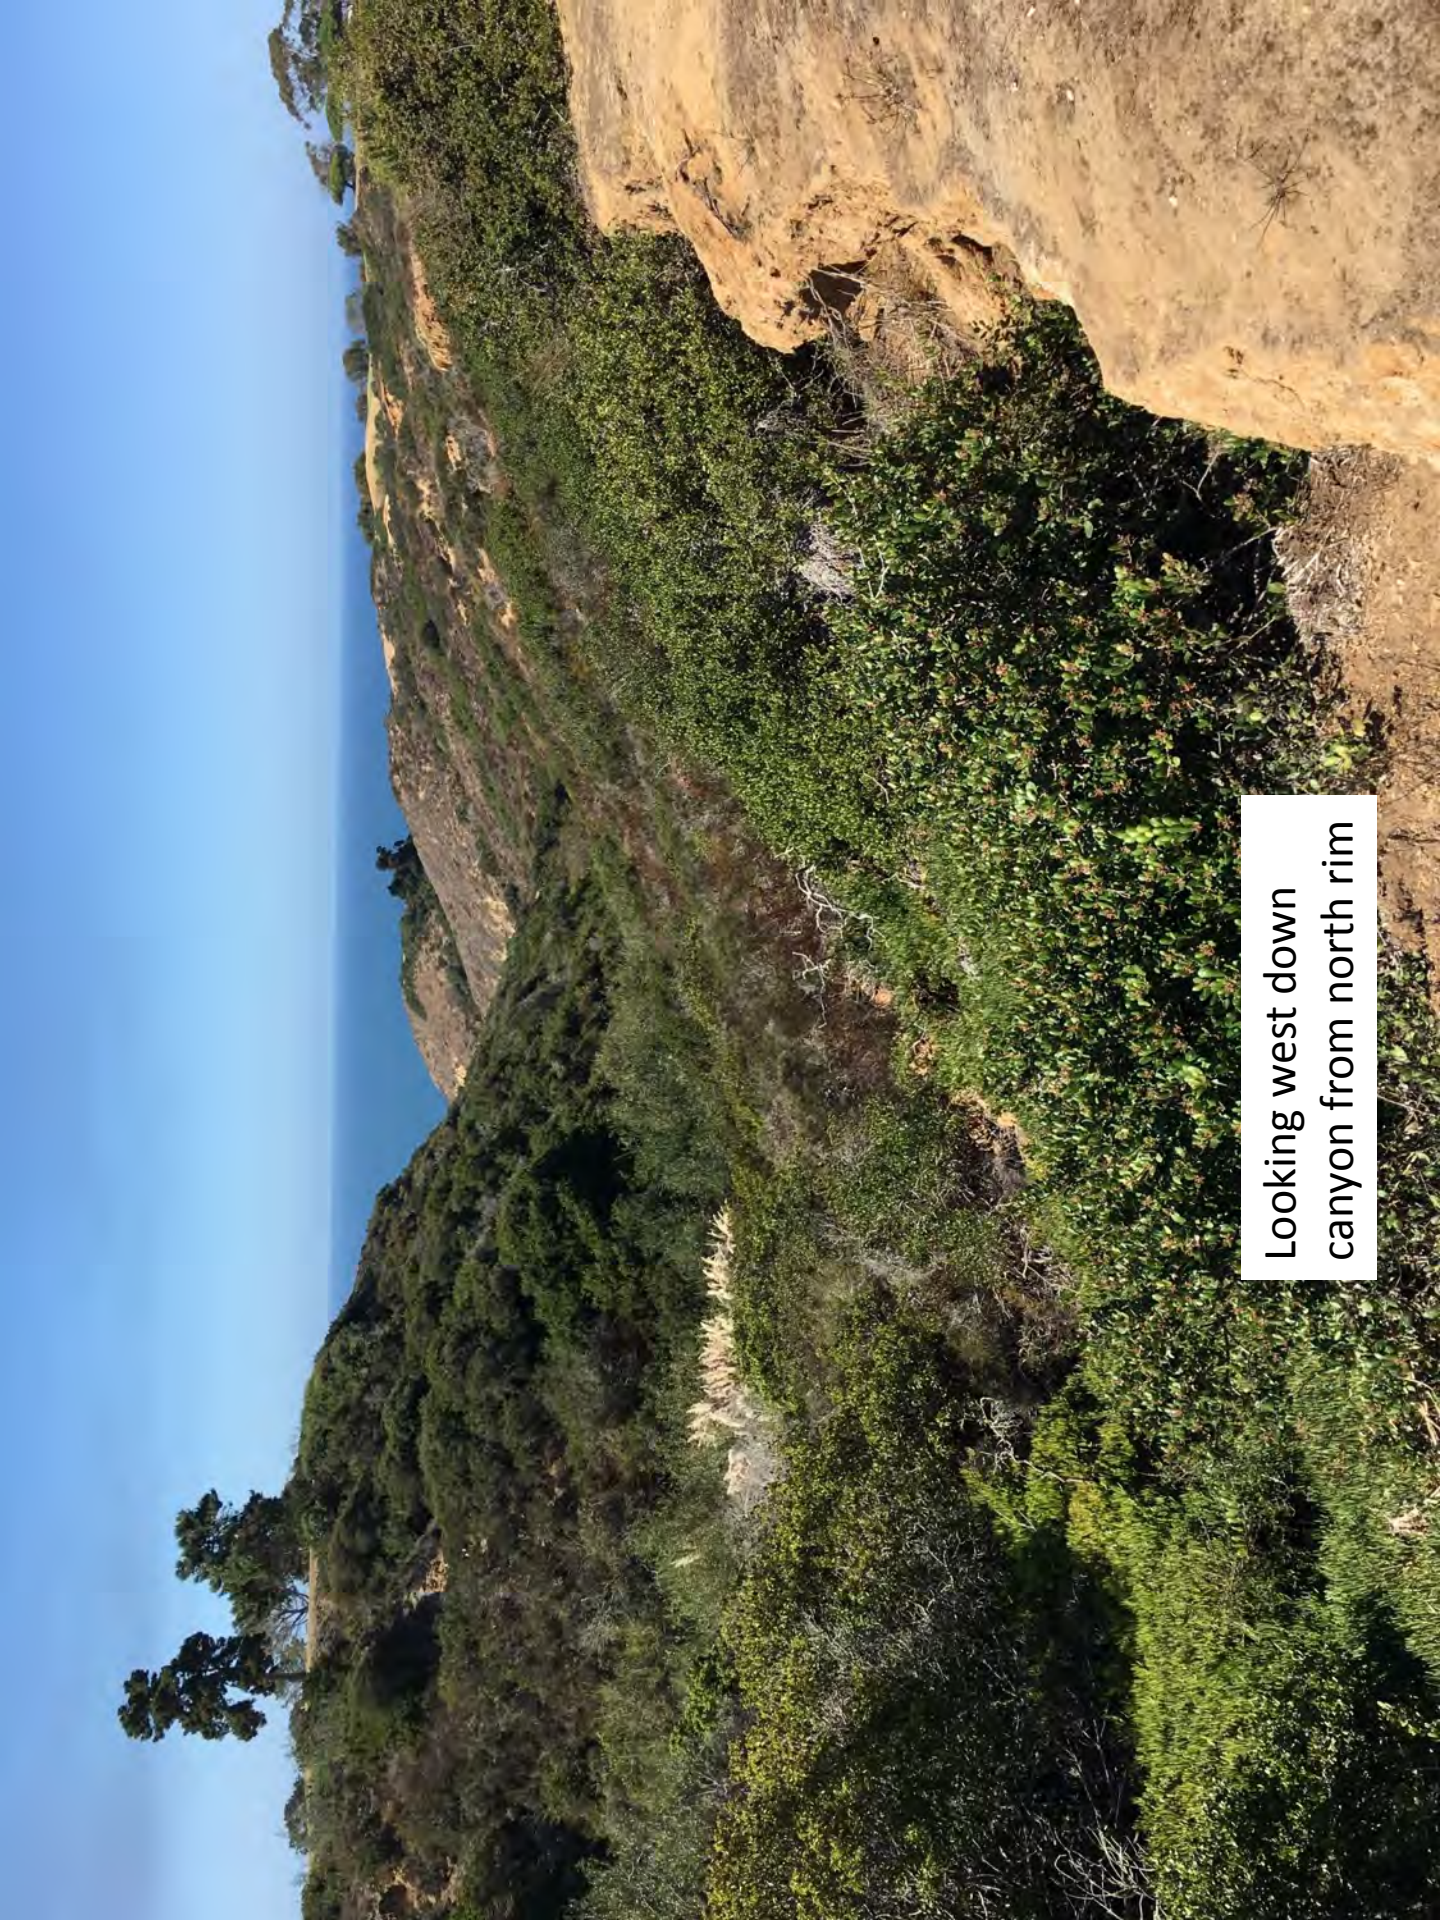
Eroded Canyon
Walls

Existing outfall's discharge
during 0.25" storm

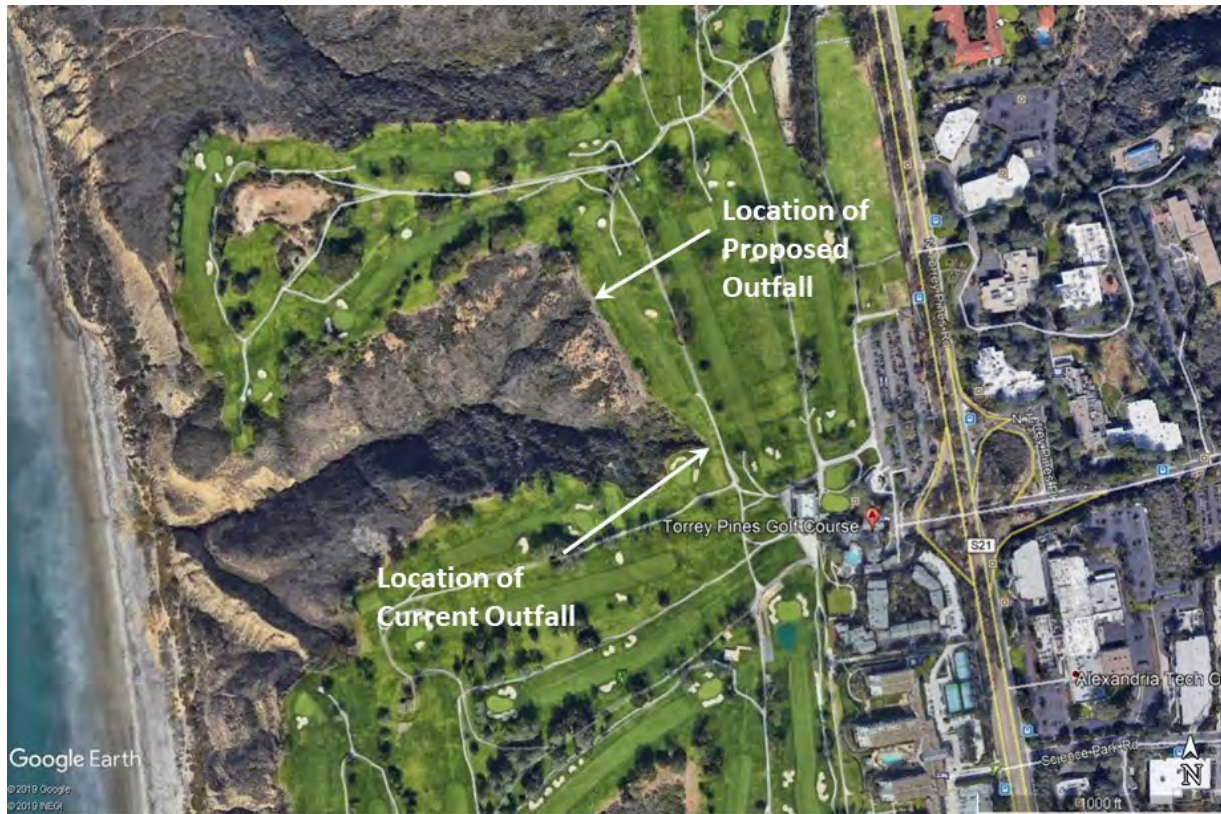
Figure 2: Location of current and proposed outfalls and drainage pathway

The proposed project consists of the portion of the drainage system that approaches the outfall, which drains into a steep coastal canyon and ultimately the ocean, at the western margin of the Torrey Pines Golf Course, **Figures 1 and 2**. The current system consists of an 18 inch underground pipe that daylight at the canyon, with storm water exiting into a steep ravine. A system clean-out associated with the terminal pipe is present for removing debris that accumulates with the storm water. This system was installed prior to passage of the Coastal Act, and therefore, has not previously undergone coastal review. The changes proposed would increase the system drainage capacity by installing a 42 inch reinforced concrete pipe and by removing from use the existing 18 inch pipe, but allowing it to remain in place. In addition, a new drainage clean-out would be installed, and the new pipe extended to a location north of the existing outfall. Grading would occur along the top of the canyon slope, and an energy dissipater would be installed in this location to reduce the erosive capacity of the storm water as it enters the canyon. At its current location, erosion is evident below the outfall, and several invasive plants have established following prior disturbance, **Figures 3a and b**.

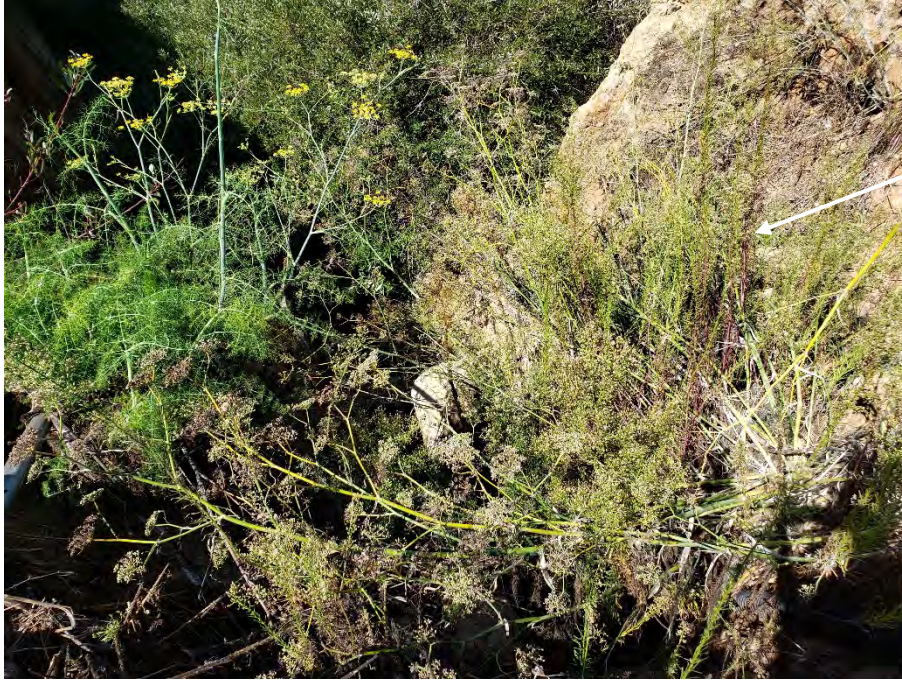
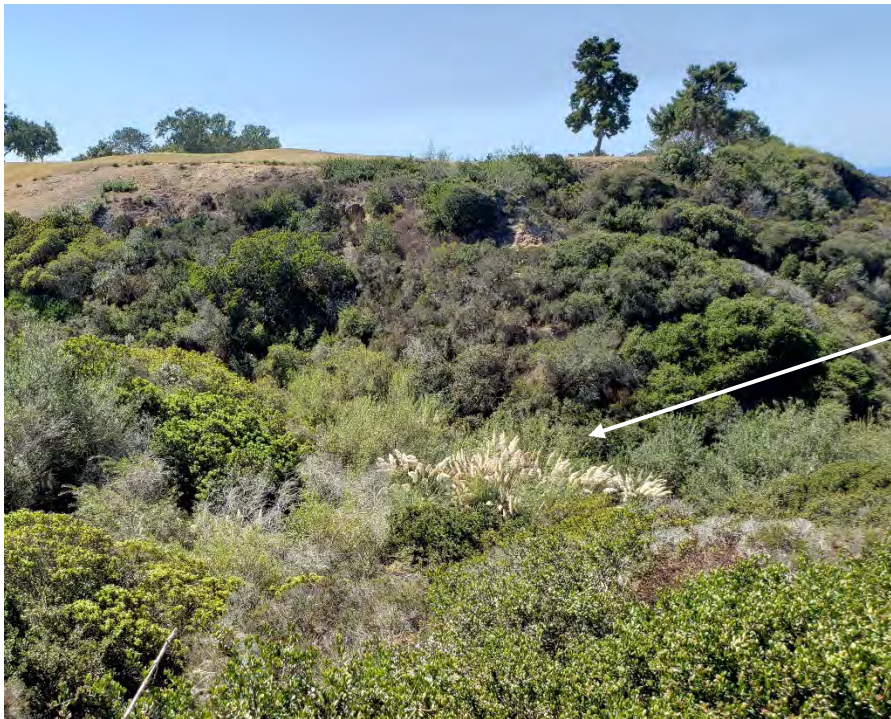
Sweet Fennel,
Foeniculum vulgare,
(highly invasive)

Pampas grass
Cortadairia selloana,
(highly invasive)

Figure 3: Examples of non-native, invasive plants that have colonized canyon areas where erosion has occurred due to storm water disturbance.

Despite the loss of the southern maritime chaparral habitat at the new outfall location, I see relocation of the outfall as the superior alternative to maintaining, or potentially repairing the current outfall. The reasons are threefold. First, the positioning of the current outfall has facilitated the introduction of invasive species into the canyon, as noted above, and is evident in **Figures 3a and 3b**. The species pictured there are invasive fennel, *Foeniculum vulgare* and pampas grass, *Cortaderia selloana*. Also present in the canyon below the outfall were ice plant, *Carpobrotus edulis*, and tree tobacco, *Nicotiana glauca*, among others. Of these four species, three are listed by the California Invasive Plant Council, as being highly invasive. Tree tobacco is listed as moderately invasive⁵, but remains a substantial problem species in San Diego County. The presence of these species in the canyon means they are available to spread further, and displace native habitat when opportunities open-up. Second, erosion at the outfall location has progressed laterally over time as vegetation loss or erosion of the rock face along the bluff top pulls adjacent vegetation with it, or causes the loss of the underlying substrate, leading to a cascading effect of vegetation loss and bluff failure. This phenomenon has almost certainly occurred at the current location, and has grown quite extensively over time, as is evident in **Figures 4a and 4b**. Third, the high energy impact of the water stream during high storm flow events has created a situation of geologic instability where larger bluff catastrophic failure is highly likely in the future. Under the current configuration, continuing erosion at the base of the gully would be expected to maintain the steep escarpment that has developed over time, increasing the susceptibility to block fall failures. Continuance of this situation is likely to prevent the “lay back” of the slope to a more stable inclination that would otherwise be expected to occur. The collapse of the old headwall, the existence of the erosion depression at the bottom of the gully, the very steep scarp, and observable landward erosion at the head of the gully are all strong evidence supporting the instability of the current configuration⁶.

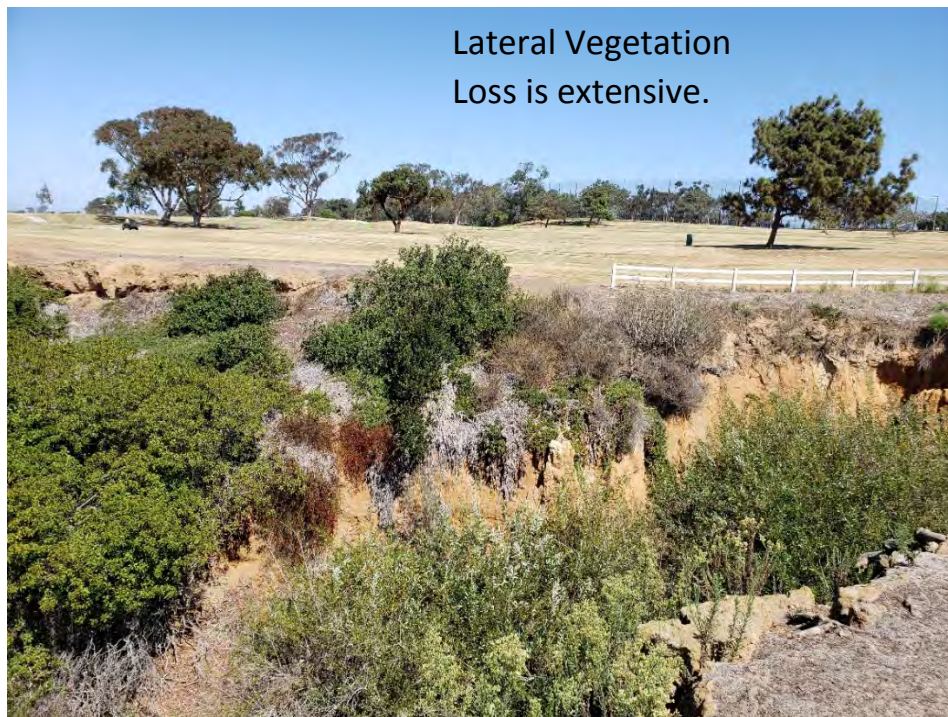
Figure 4: Examples of creeping habitat loss in the vicinity of the original outflow (a) on both sides of the outfall (b) Extending to the northwest. In the lower photo, outflow pipe is just to the right of the photo edge.

I conclude that impacts will exceed 0.09 acres due to relocation of the outfall. In the current outfall configuration, the outfall has created southern willow scrub wetland habitat through concentrating drainage into a stream that exists through the outfall pipe. Once the drainage is relocated, the water supply that supports the southern willow scrub community will be reduced, thereby impacting this habitat, as water is one of the fundamental drivers of plant community composition⁴. Some water will continue to reach the area because the location of the outfall is a natural

Considering the past and future impacts discussed above, invasive species colonization and lateral erosion have both occurred over the time period that the current outfall has been in place, as has the steepening of the canyon slope that creates the conditions for catastrophic slope failure. Yet, these past impacts, although quite real and substantial are not accounted for in the context of the current project. Also not accounted for are potential future impacts that would result from catastrophic failure of the slope. In the event of a large block failure, ESHA habitat loss is likely to occur on a larger scale than the habitat removal that is proposed for reseating the outfall to the north. Thus, in considering impacts that have already occurred because the current outfall is undersized and the streamflow during high storm events is highly erosive, relocation appears to be the less impactful alternative. Further, the increased risk of catastrophic, or block failure, due to progressive erosion at the base of the gully, makes further impacts to sensitive habitat highly likely in the future.
