A-6-CII-20-0056 (Cline)

Re: Appeal No. A-6-CII-20-0056 (Cline), Thursday, November 5, 2020, Agenda Item Th15a

Project No. 2983-01
January 9, 2020
Revised: February 7, 2020

RESPONSE TO COASTAL COMMISSION REVIEW COMMENTS
5215 SHORE DRIVE
CARLSBAD, CALIFORNIA

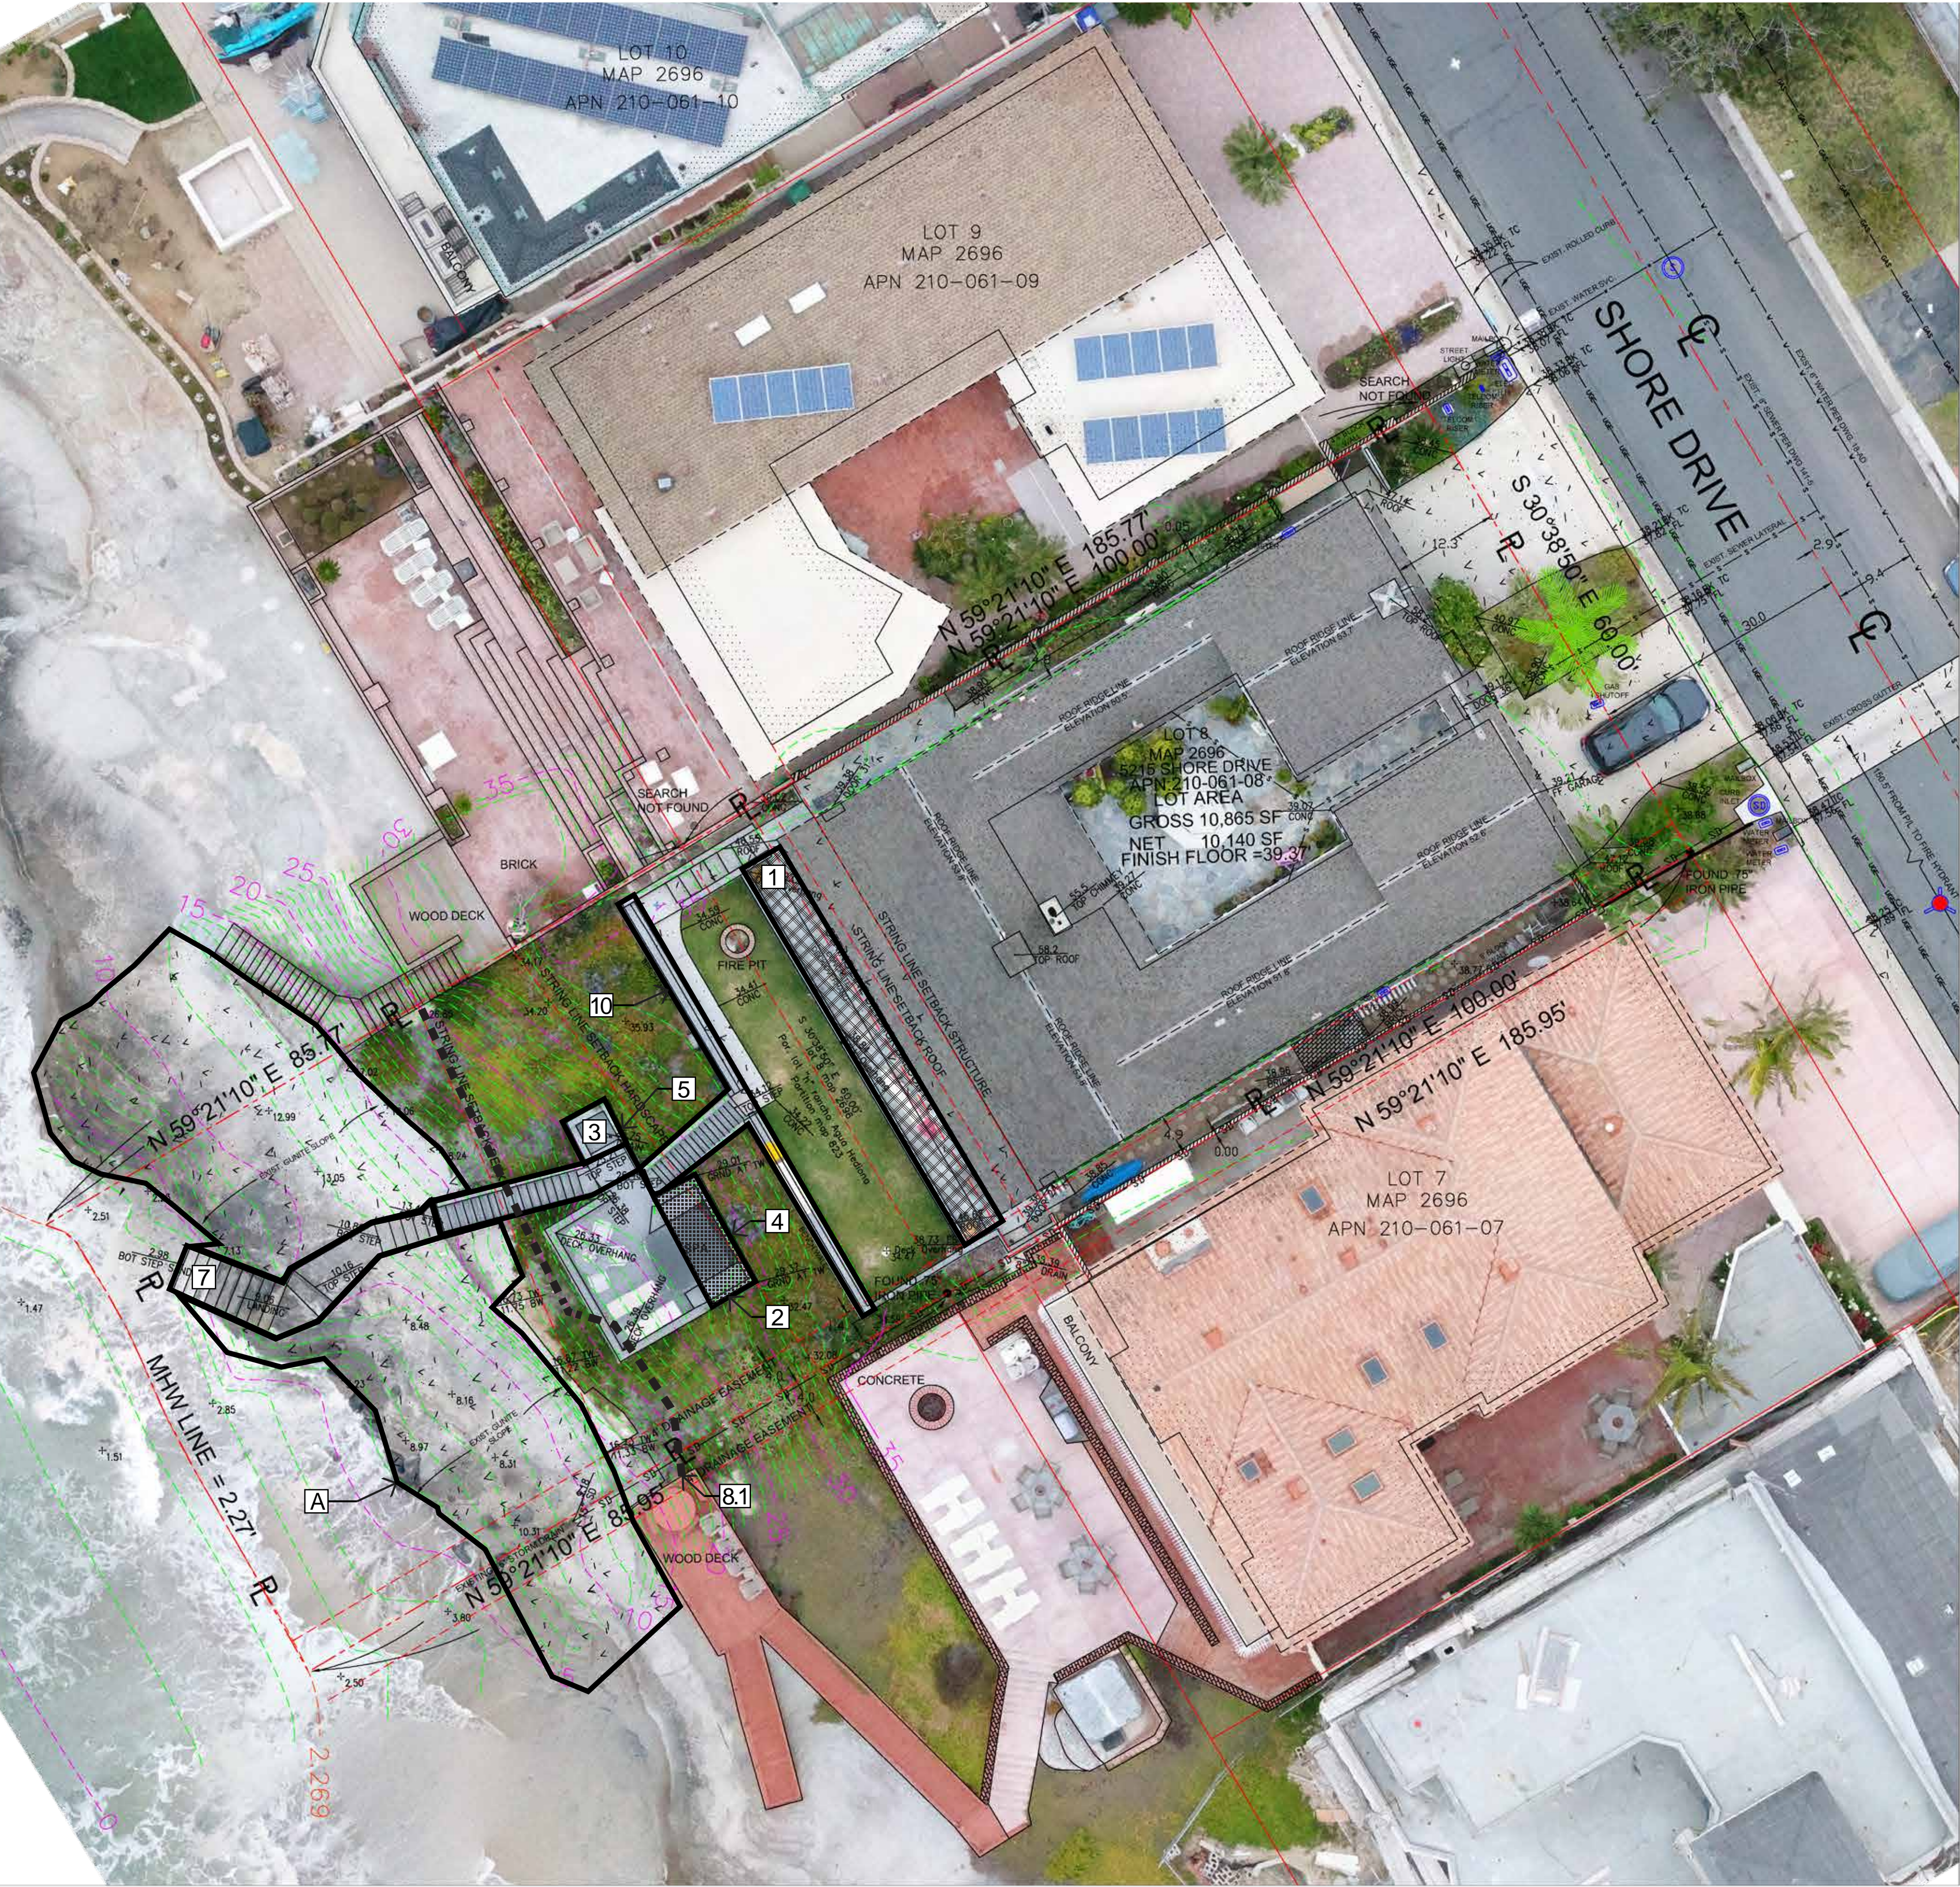
EXHIBIT

- 1) CANTILEVERED/EXPANDED PORTION OF THE PATIO LOCATED DIRECTLY ADJACENT TO THE WEST WALL OF THE HOME.
- 2) RECENT UNPERMITTED ELEVATED WOOD DECK EXTENSION TO BE REMOVED AND BLUFF RESTORED TO NATURAL CONDITION TO REMAIN.
- 3) RECENT UNPERMITTED SHOWER AREA AND ASSOCIATED PLUMBING TO BE REMOVED AND BLUFF RESTORED TO NATURAL CONDITION.
- 4) RECENT UNPERMITTED RETAINING WALL LOCATED MID-BLUFF TO BE REMOVED AND BLUFF RESTORED TO NATURAL CONDITION.
- 5) RECENT UNPERMITTED RETAINING WALL LOCATED MID-BLUFF THAT STABILIZES THE EXPANDED SHOWER AREA TO BE REMOVED AND BLUFF RESTORED TO NATURAL CONDITION.
- 7) SAFE HARBOR STAIR ACCESS FROM BEACH TO LOWER STABLE BENCH AREA.
- 8.1) LINE OF SHOTCRETE SHORELINE PROTECTION ON BLUFF FACE.
- 10) ARCHITECTURAL STONE CLADDING ON PERMITTED RETAINING WALL.
- A) RIP RAP.

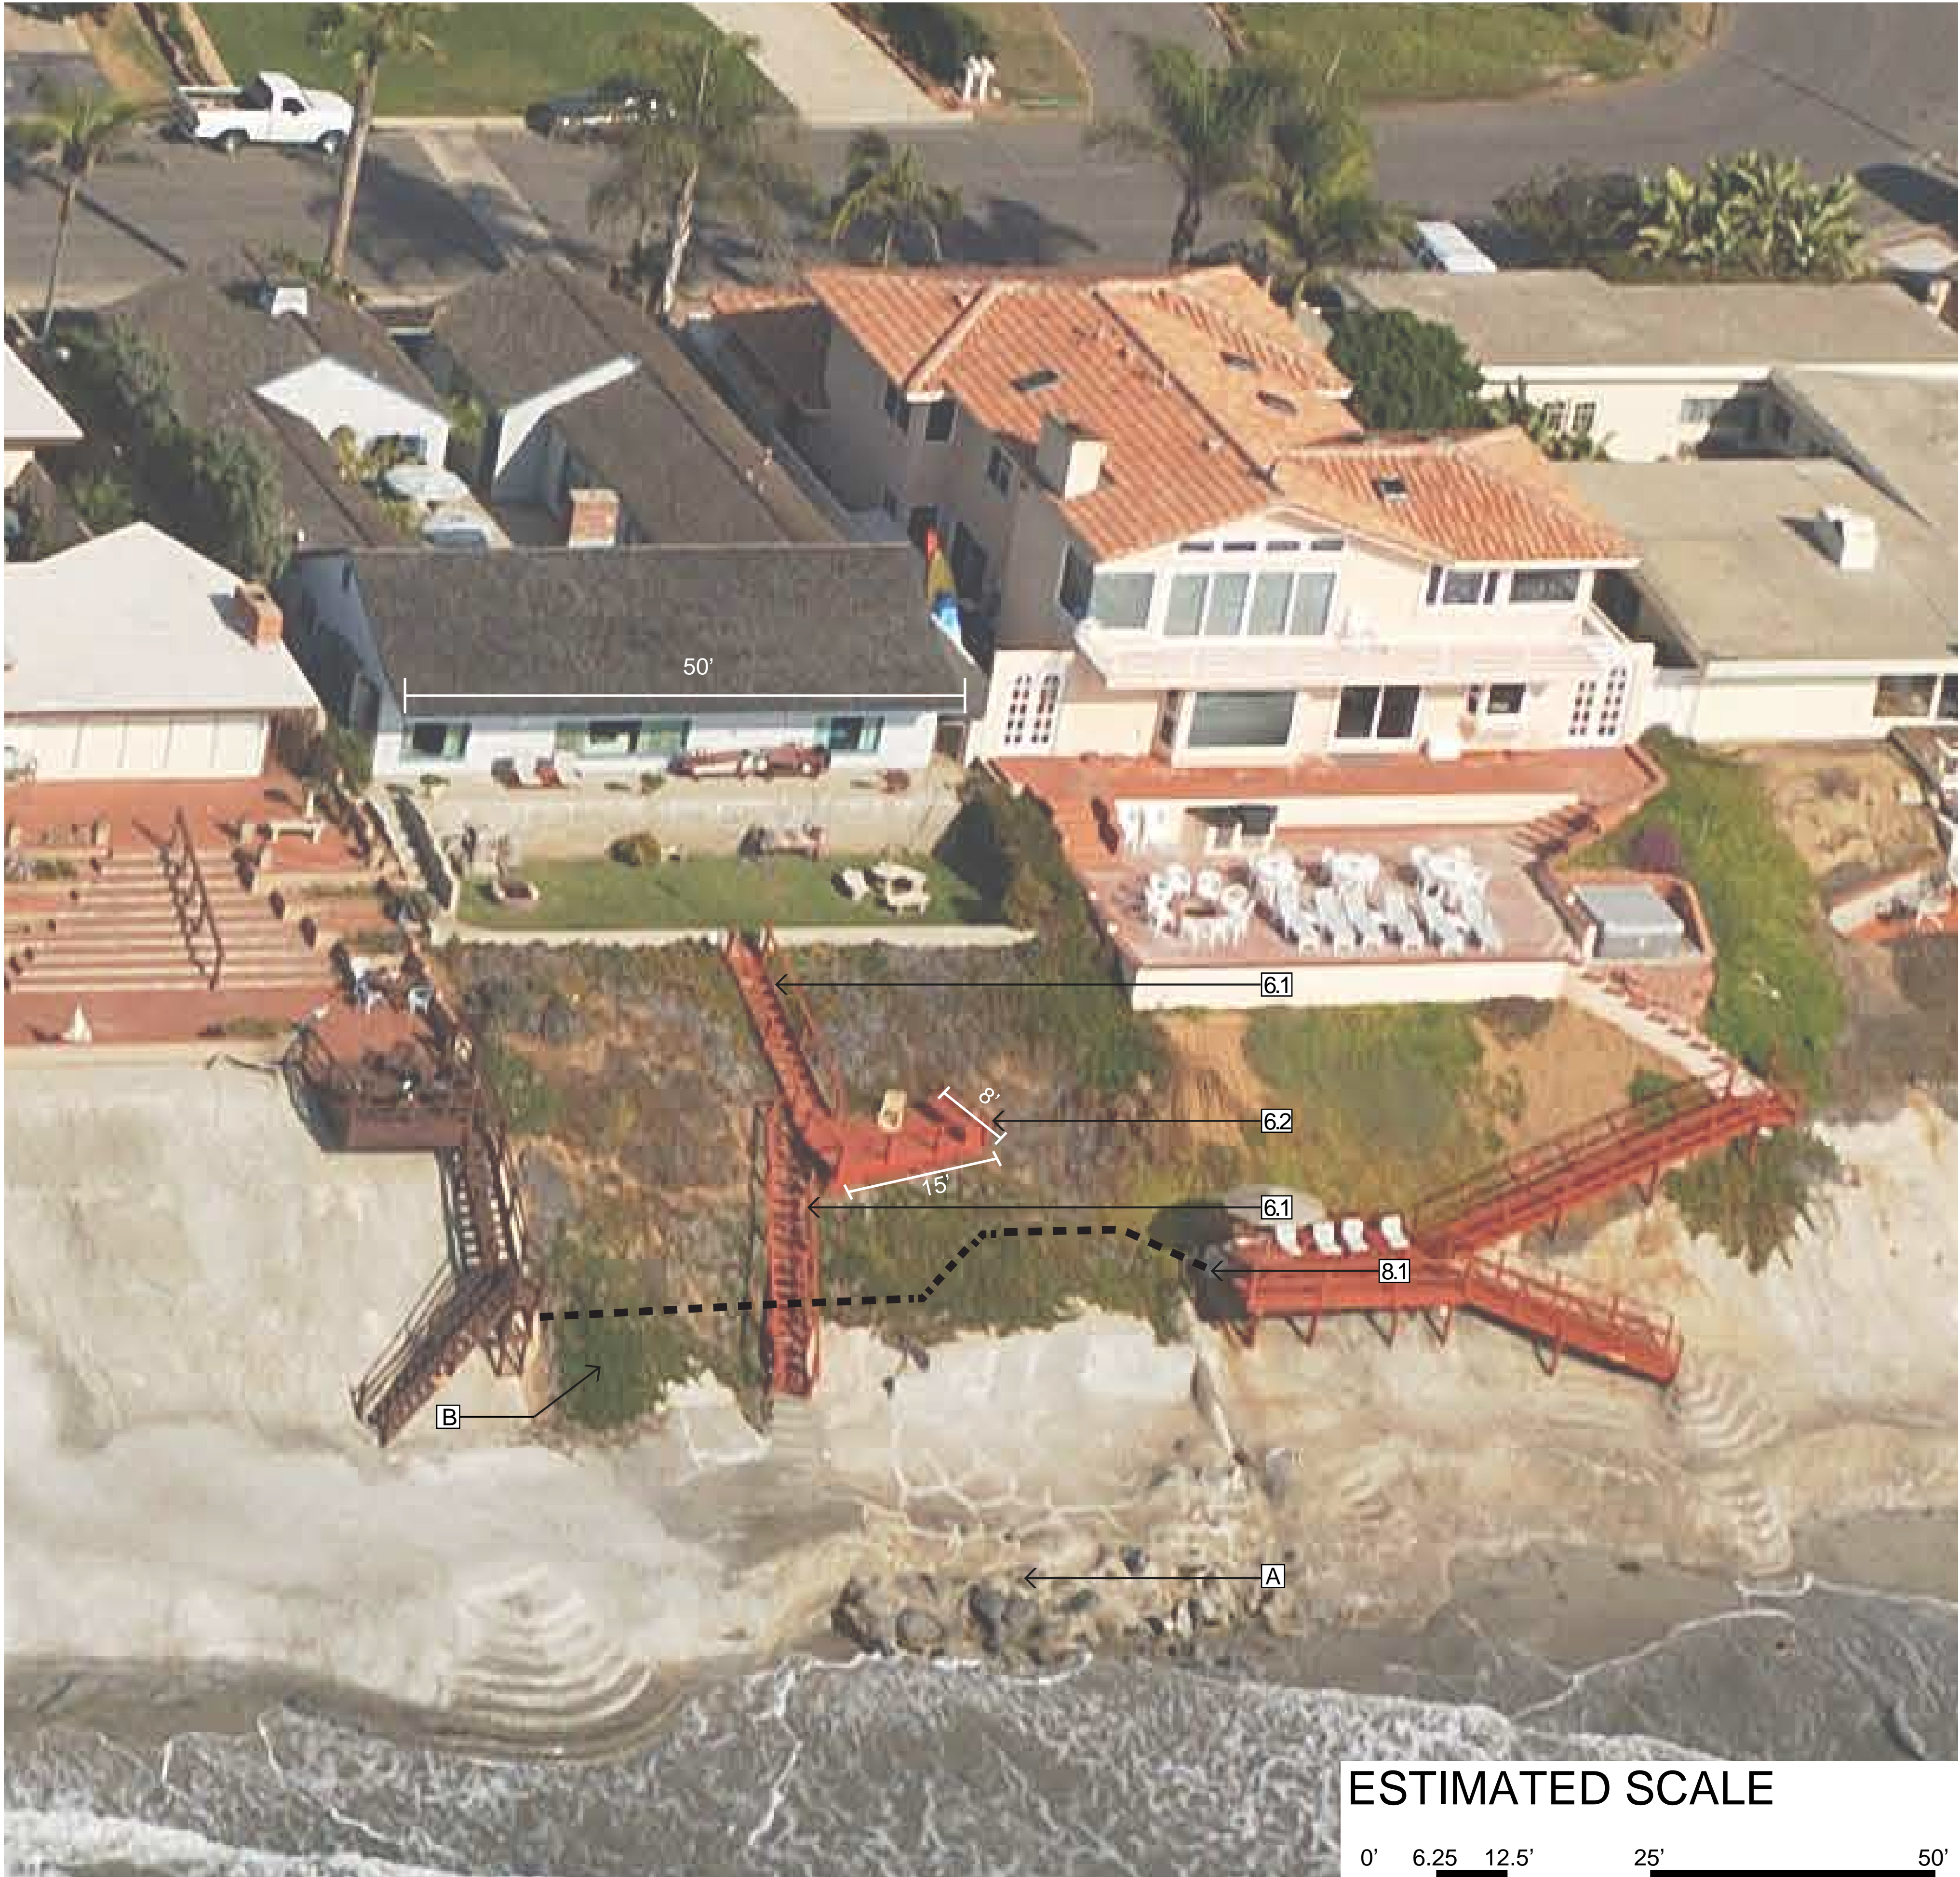
EXHIBIT

2) RECENT UNPERMITTED ELEVATED WOOD DECK EXTENSION TO BE REMOVED AND BLUFF RESTORED TO NATURAL CONDITION.

3) RECENT UNPERMITTED SHOWER AREA AND ASSOCIATED PLUMBING TO BE REMOVED AND BLUFF RESTORED TO NATURAL CONDITION.

4) RECENT UNPERMITTED RETAINING WALL LOCATED MID-BLUFF TO BE REMOVED AND BLUFF RESTORED TO NATURAL CONDITION.

5) RECENT UNPERMITTED RETAINING WALL LOCATED MID-BLUFF THAT STABILIZES THE EXPANDED SHOWER AREA TO BE REMOVED AND BLUFF RESTORED TO NATURAL CONDITION.

6.1) LOCATION OF WOOD CONSTRUCTED STAIR PRE-COASTAL ACT. REFER TO 1972 IMAGE. REQUESTING AN AFTER-THE-FACT PERMIT FOR THE REPAIR OF THE STAIRS AND LANDING.

B) CONTINUED OVERGROWTH OF PLANT MATERIAL CONCEALING LIMITS OF SHOTCRETE SHORELINE PROTECTION.

C) STABLE LOWER BENCH AREA- REQUESTING AN AFTER-THE-FACT PERMIT FOR STABLE LOWER BENCH AREA AND ADDITIONAL LAYERS OF SHOTCRETE SHORELINE PROTECTION ON THE BLUFF FACE.

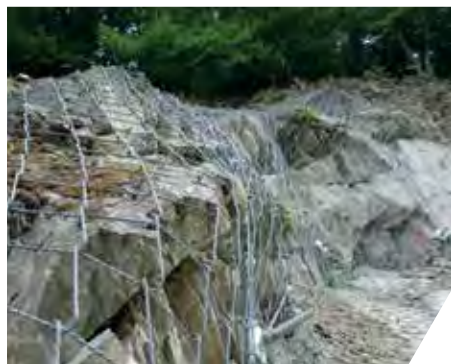
Above: SPIDER® on rock slopes

The spiral rope made of three twisted, high-tensile steel wires is characterized by its high puncturing resistance. At the same time it is unobtrusive and can be tightly secured around protruding rock boulders.

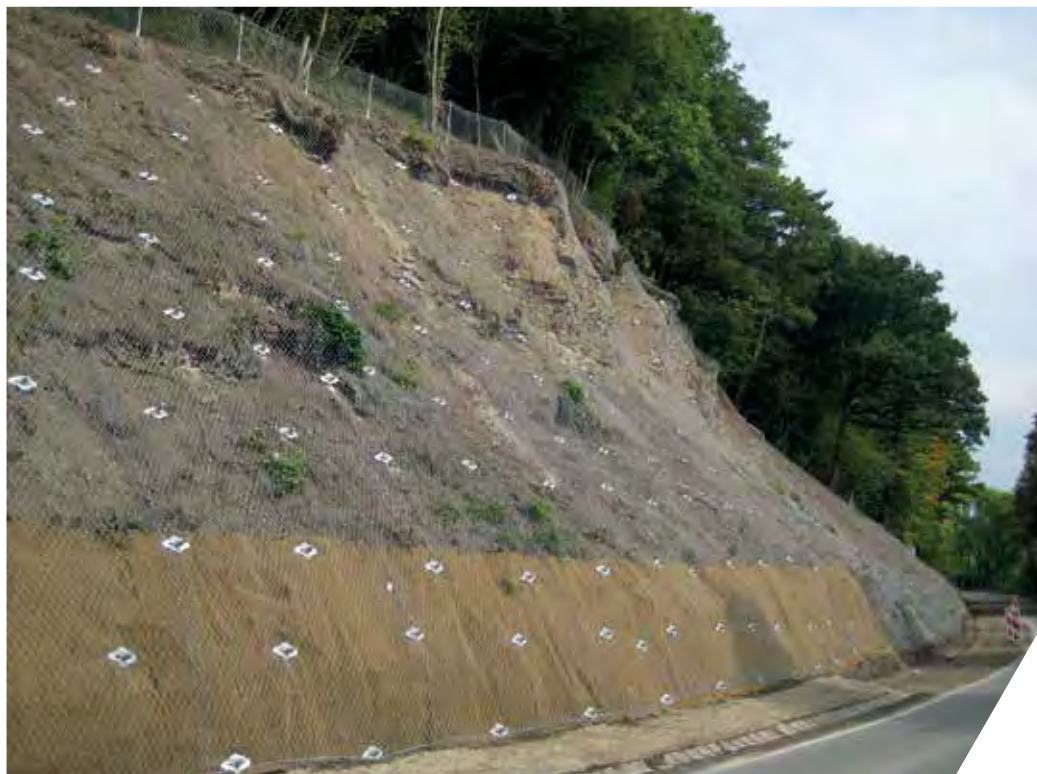
Right: TECCO® SYSTEM³ in soil

The mesh surface is easily seamed together without the need to overlap panels which results in efficient use of mesh material without any waste.

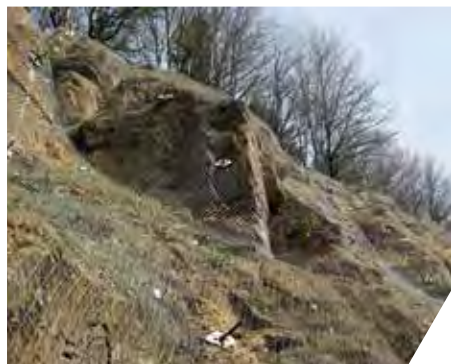
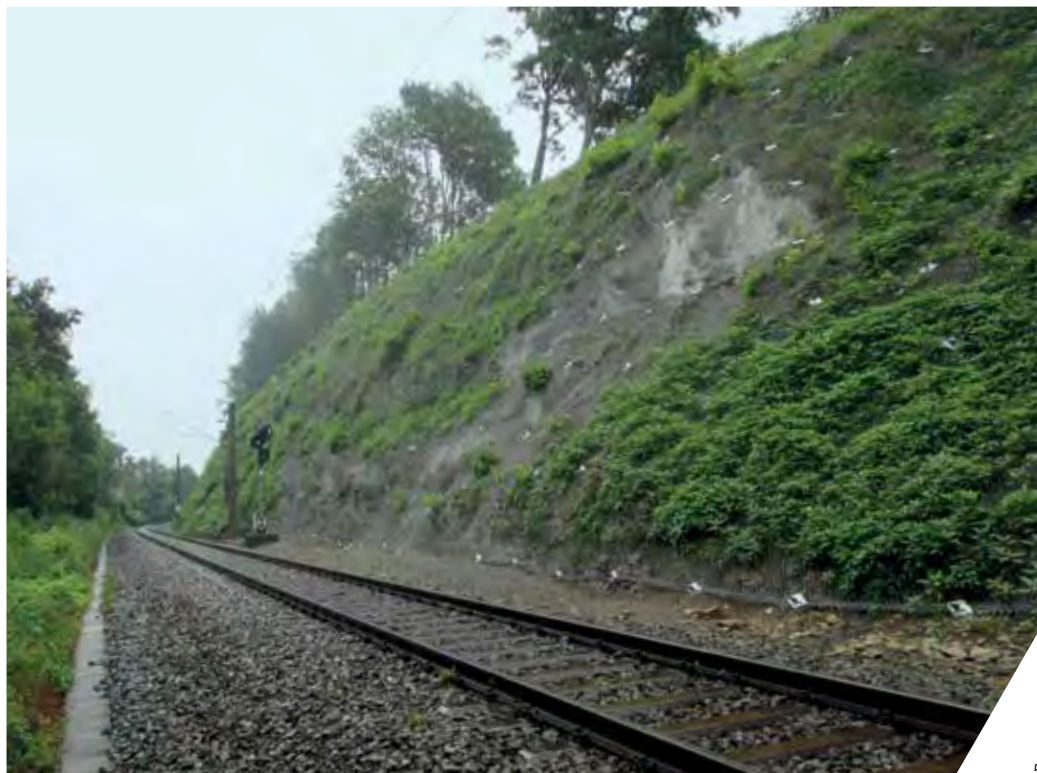
Above and right: TECCO® SYSTEM³ installed on rock slopes

Pretensioning the mesh helps it adapt closely to the topography and prevents unwanted material accumulations. The soil nail grid is dimensioned based on the geotechnical parameters.
