Appendix B: CA Coastal Commission
staff report, CDP 9-15-0228 Special
Condition 7

LA192017-R-001 REV. 1

**INDEPENDENT THIRD-PARTY REVIEW OF SONGS' INSPECTION AND
MAINTENANCE PROGRAM FOR THE HOLTEC ON-SITE INDEPENDENT SPENT
FUEL STORAGE INSTALLATION**

JUNE 12, 2020

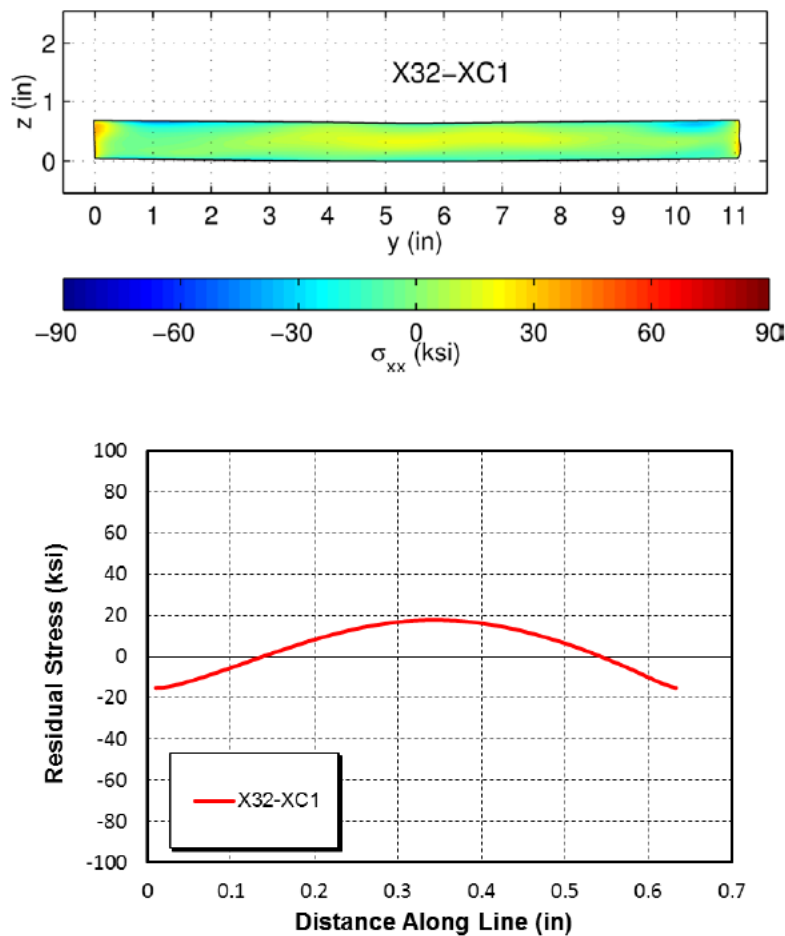
In summary, LPI reviewed the design and fabrication documentation provided for the SONGS MPC-37s, and LPI's inquiries on this subject were addressed. Based on the information provided, LPI concludes that the welding and fabrication methods employed on the MPCs at SONGS significantly reduce the susceptibility to SCC by simultaneously minimizing tensile stresses and increasing compressive residual stress.

Figure 4-1 Through Thickness Residual Stress Results after Peening [23]

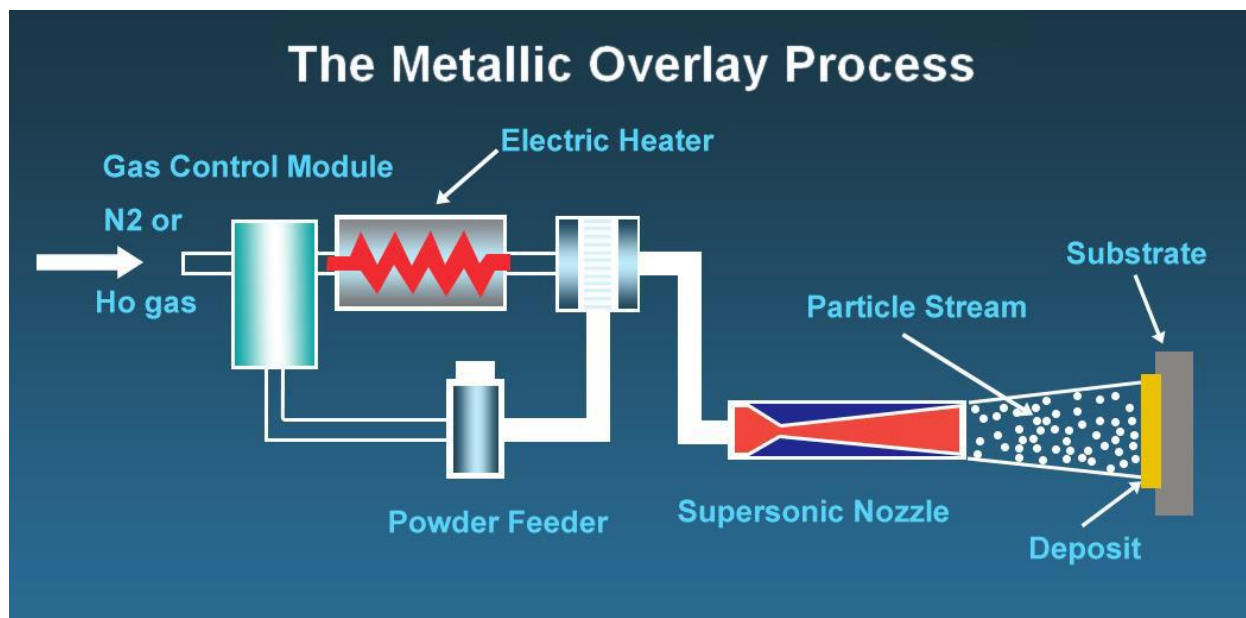
The metallic overlay process involves the application of a nickel coating to the damaged surface of an MPC. The metallic overlay process combines the capabilities of a robotic visual assessment with a high-energy solid-state coating and powder consolidation process involving an electrically heated high-pressure carrier gas (nitrogen or helium) to accelerate metallic powder through a supersonic nozzle above a critical velocity for particle adhesion (see Figure 6-2) [1, 25]. SCE and its partners developed and have demonstrated the capability to remotely apply a metallic overlay to mitigate a potential flaw in a canister. Remote inspection and canister mitigation procedures have been developed and approved by SCE [1].

Figure 6-2 Metallic Overlay Process for Repairing MPCs at SONGS [1]

LPI requested clarification on the potential for any adverse effects that result from the metallic overlay methodology, and how the overlay may affect the desired fabrication stresses of the MPC. SCE stated that laboratory tests do not show any adverse effects resulting from application of the metallic overlay process. Instead, the metallic overlay process induces a compressive stress on the base material, which improves the resistance to SCC initiation.

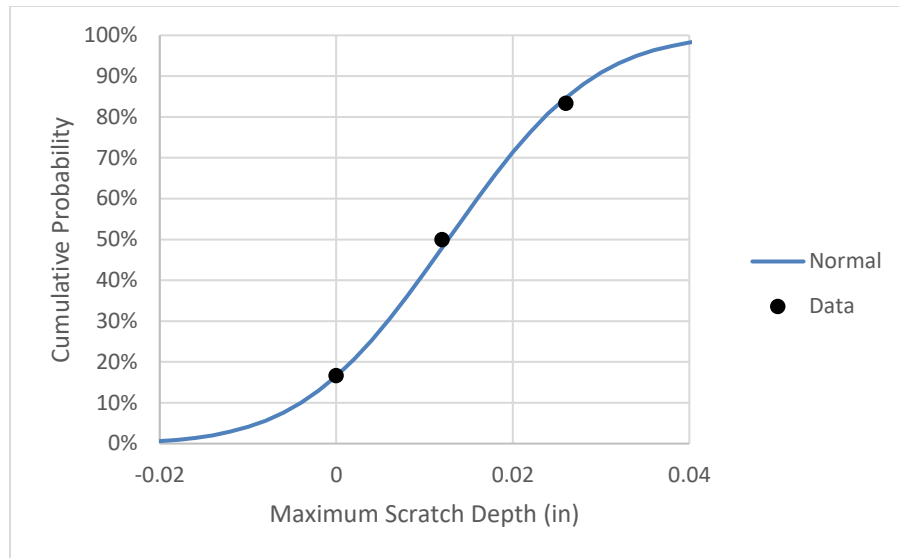
LPI is of the opinion that the Normal distribution is not appropriate to model the maximum scratch depth per canister. In [29], the Normal distribution is based on the initial three measurements of 0.000, 0.012, and 0.026 in., with a corresponding mean and standard deviation (calculated by LPI) of 0.0127 in. and 0.013 in., respectively. In contrast, the Canister Inspection Plan [29] mistakenly reports the mean and standard deviation as 0.013 in. and 0.0125 in., respectively. This was clarified by SCE (as outlined in Attachment G) by conservatively replacing the reported 0.000 in. value with a 0.001 in. value to derive the mean and standard deviation values of 0.013 in. and 0.0125 in., respectively. An LPI plot of the data and fit are shown Figure 7-1.

Figure 7-1 Normal Distribution, Three Wear Depth Measurements

For the initial three data points shown in Figure 7-1, it is evident that approximately 16.5 percent of the distribution extends into a region of negative or impossible values. If the mean and standard deviation for all 8 measurements had been used, approximately 7 percent of the distribution would still fall below zero. Both sets of data fail the typical “95% range check” [43] for considering the Normal distribution, whereby 95 percent of the fitted distribution needs to make physical sense. Although the primary region of concern is the upper tail of the distribution, specifically at 0.0625 in., having a significant amount of probability assigned to physically impossible negative values deprives the larger maximum scratch depths of probability, thereby underestimating the true risk to the canisters.

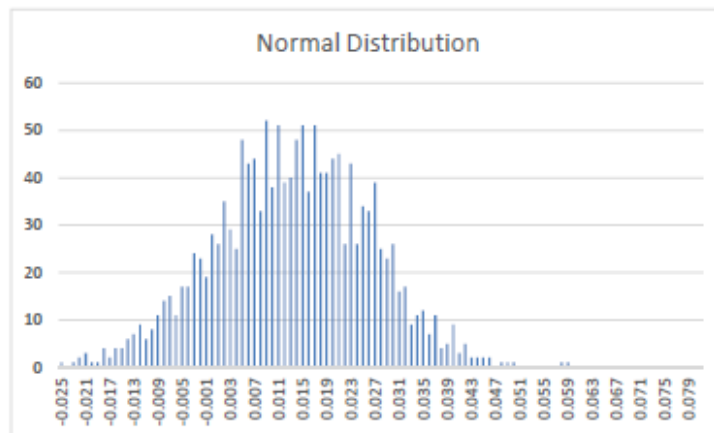
Figure 4-1.

One concern with selecting a normal distribution for modeling the deepest scratch random variable is that measured scratch depth is always a positive number and the left tail of the normal distribution will include some negative numbers making the probabilities associated with a standard normal distribution non-conservative. To determine whether use of a standard normal distribution is acceptable considering the effect of the negative left tail values, a simulation was run using 1500 trials to produce a modified normal distribution that forces all scratch depth measurements to be positive numbers. In the simulation, every time a negative value for scratch depth occurs, the simulation selected another normally distributed random number to replace the negative value until a positive value appeared. The results of simulations for the standard normal distribution and the modified normal distribution for the mean scratch depth (13 mils) and standard deviation (12.5 mils) associated with the three measured canisters are compared below.

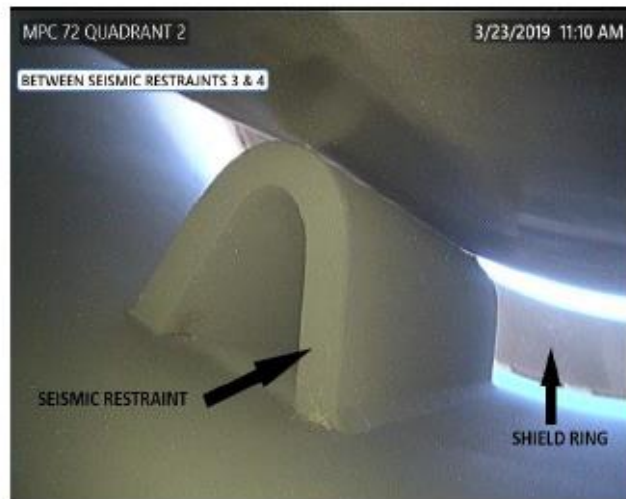
The shield ring is a circumferential ring near the top of the vault that is located above an inserted MPC, which functions to reduce radiation 'streaming' as the MPC is inserted and the shield lid installed. Interactions between the shield ring and the MPC resulted in scratches of up to 30" long, widths of <0.5" to 8" and very little depth (<0.013") because the similar diameters resulted in a broad contact area. Interactions with the shield ring were found in 7 of the 8 MPCs inspected.

The seismic restraints are 304 stainless steel curved restraints (radius 2") that are part of the VVM interior to restrict MPC movement in the event of a seismic event during storage. Two sets of seismic restraints (one set near the bottom of the installed MPC, and one set near the top) are part of the VVM design. Interactions between the seismic restraints and the MPC resulted in scratches of up to most of the length of the canister, widths of up to 0.25", and depth of up to 0.026". Interactions with the seismic restraints were identified in 4 of the 8 MPCs inspected. The upper seismic restraint and shield ring are shown in Figure 1 below.

Figure 1. Robotic system photo taken from below the seismic restraint, looking up.

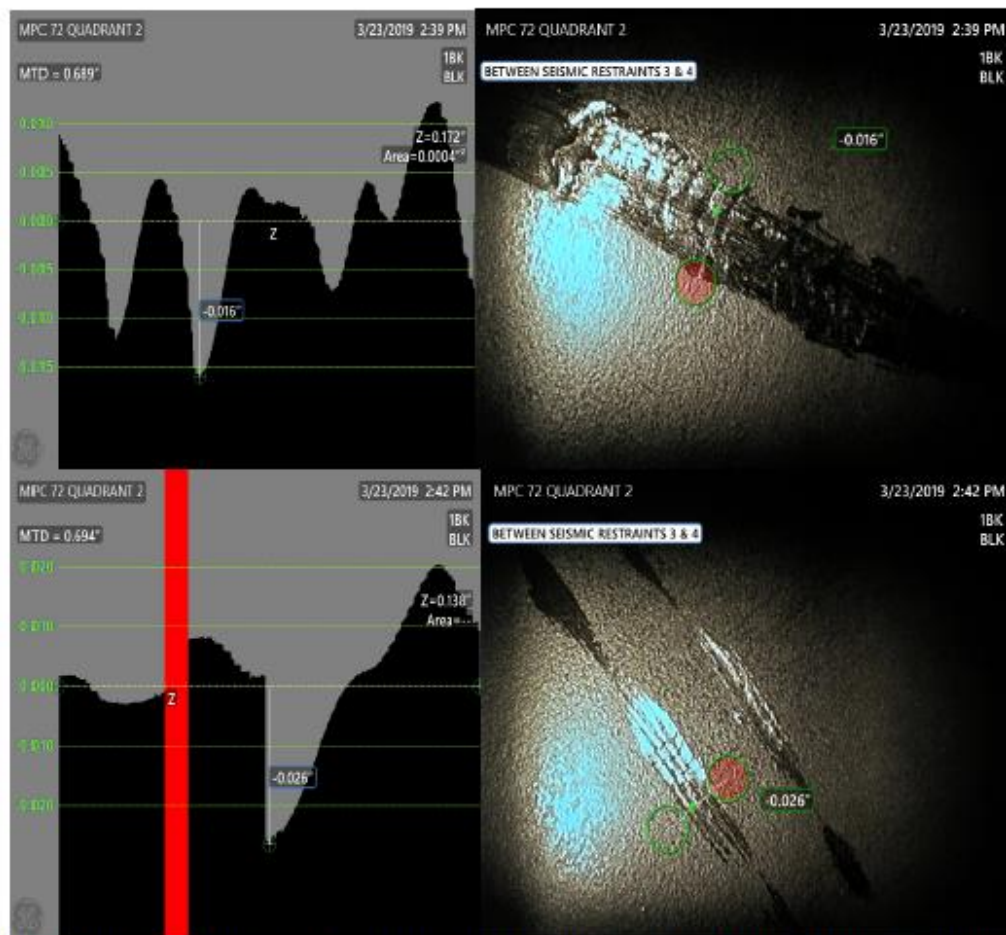
The deeper measurements were only observed in localized areas of galling. Galling occurs when two austenitic stainless steel surfaces wear, and is a different phenomenon than the scratching modeled by the FEA. Galling is self-arresting because the material is not removed, just rearranged.

Figure 2 – Canister #72 Detailed Pictures and Profilometry

(The red segment of the bottom left profilometry graph above represents 'noise' in the data that was not used for evaluation.)

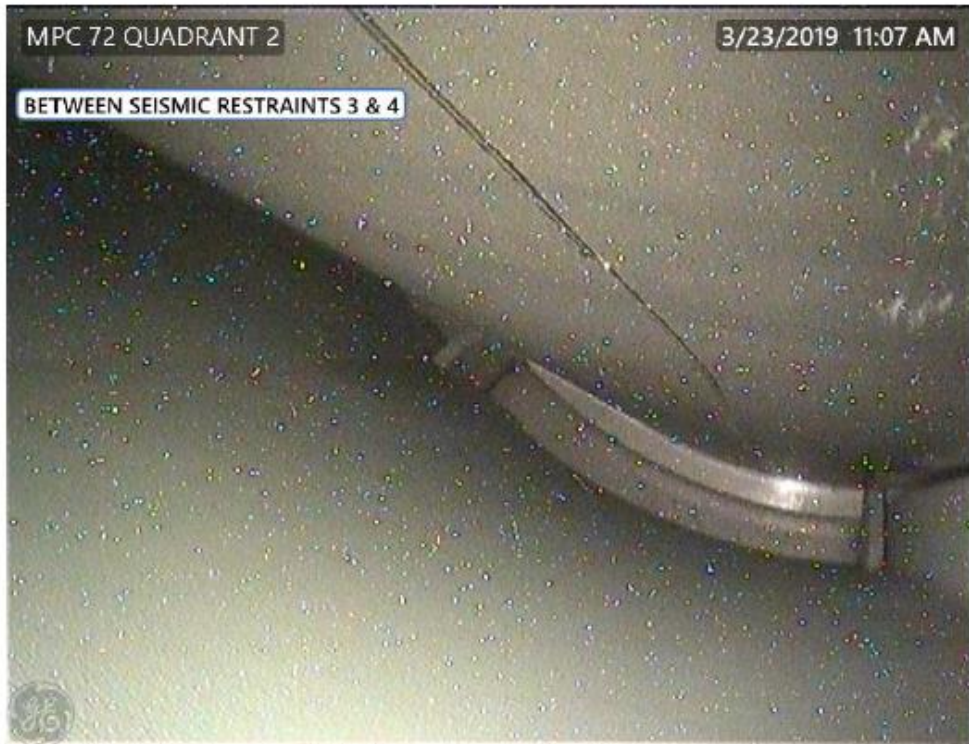
Figure 3. Photo showing a view of MPC 72 seismic restraint scratches.

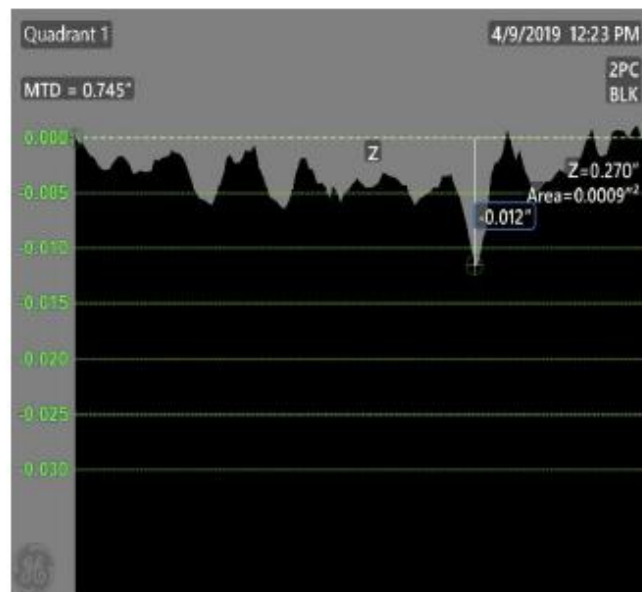
Figure 5 – Canister #94 Profilometry

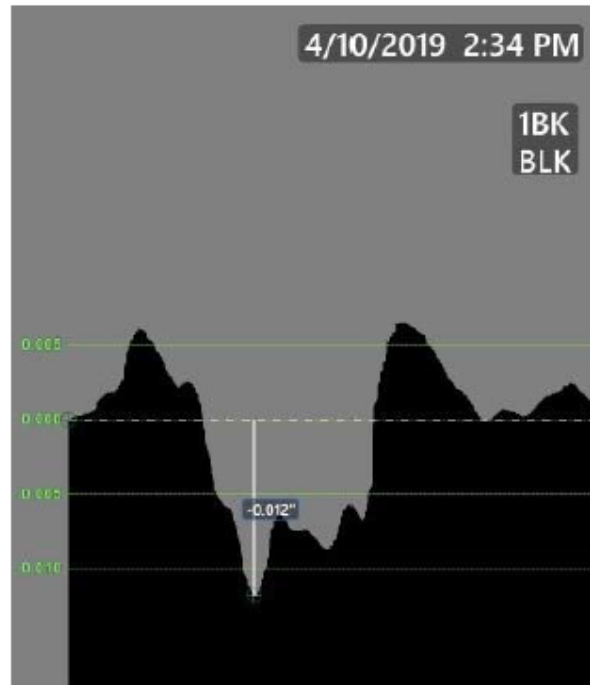
Figure 6 – Canister #55 Profilometry

Note: This scratch is the most common shape for a seismic restraint scratch. The depth of 0.012" is larger than other scratches of similar profile.
