CALIFORNIA COASTAL COMMISSION

5-19-1036 (Blue Lagoon Community Association) JULY 8, 2020

REPAIR PLANS SLOPE STABILIZATION FOR BLUE LAGOON COMMUNITY ASSOCIATION LAGUNA BEACH, CALIFORNIA

PROJECT NAME:
SLOPE STABILIZATION
BLUE LAGOON
COMMUNITY ASSOCIATION

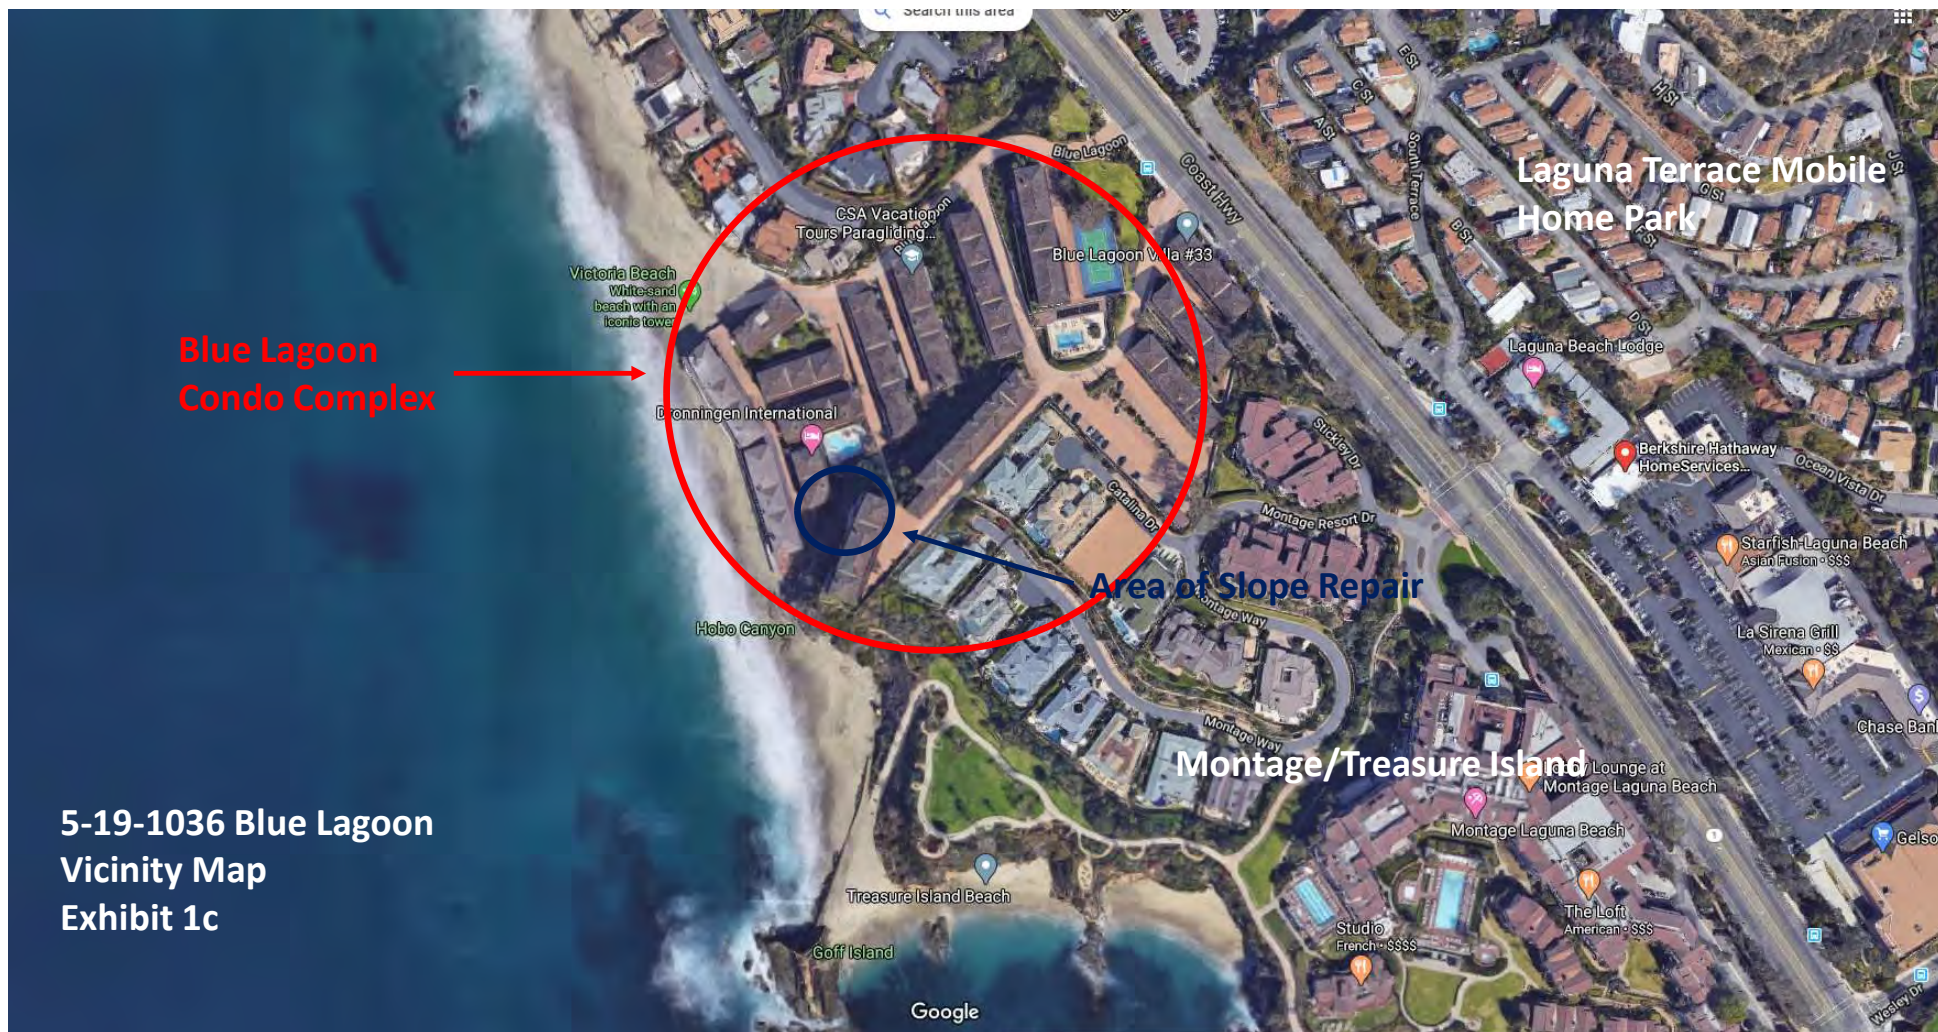
**5-19-1036 Blue Lagoon
Vicinity Map
Exhibit 1c**

**Blue Lagoon
Condo Complex**

Area of Slope Repair

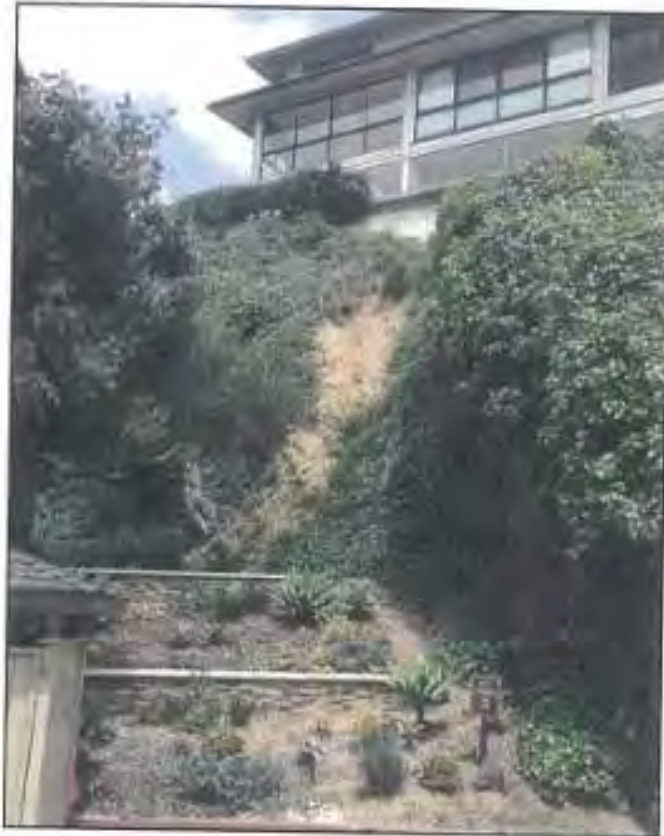
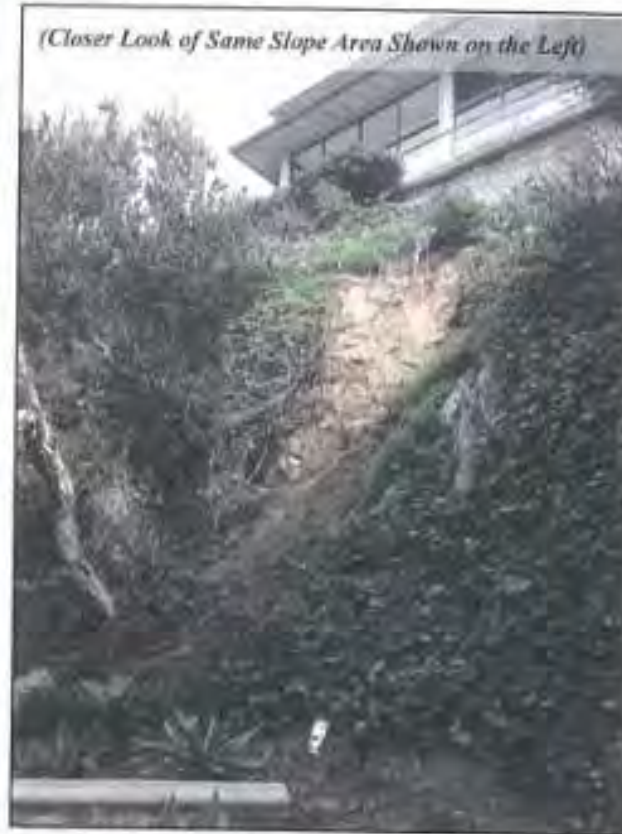
**Blue Lagoon Slope Repair
Site Photos
Exhibit 3b**

(Slope Conditions below Units 76 to 83; Source: ViaGeos 2017)
