CALIFORNIA COASTAL COMMISSION

CDP 5-18-0554 (CALIFORNIA DEPT. OF FISH &
WILDLIFE)
AUGUST 12, 2020

EXHIBITS

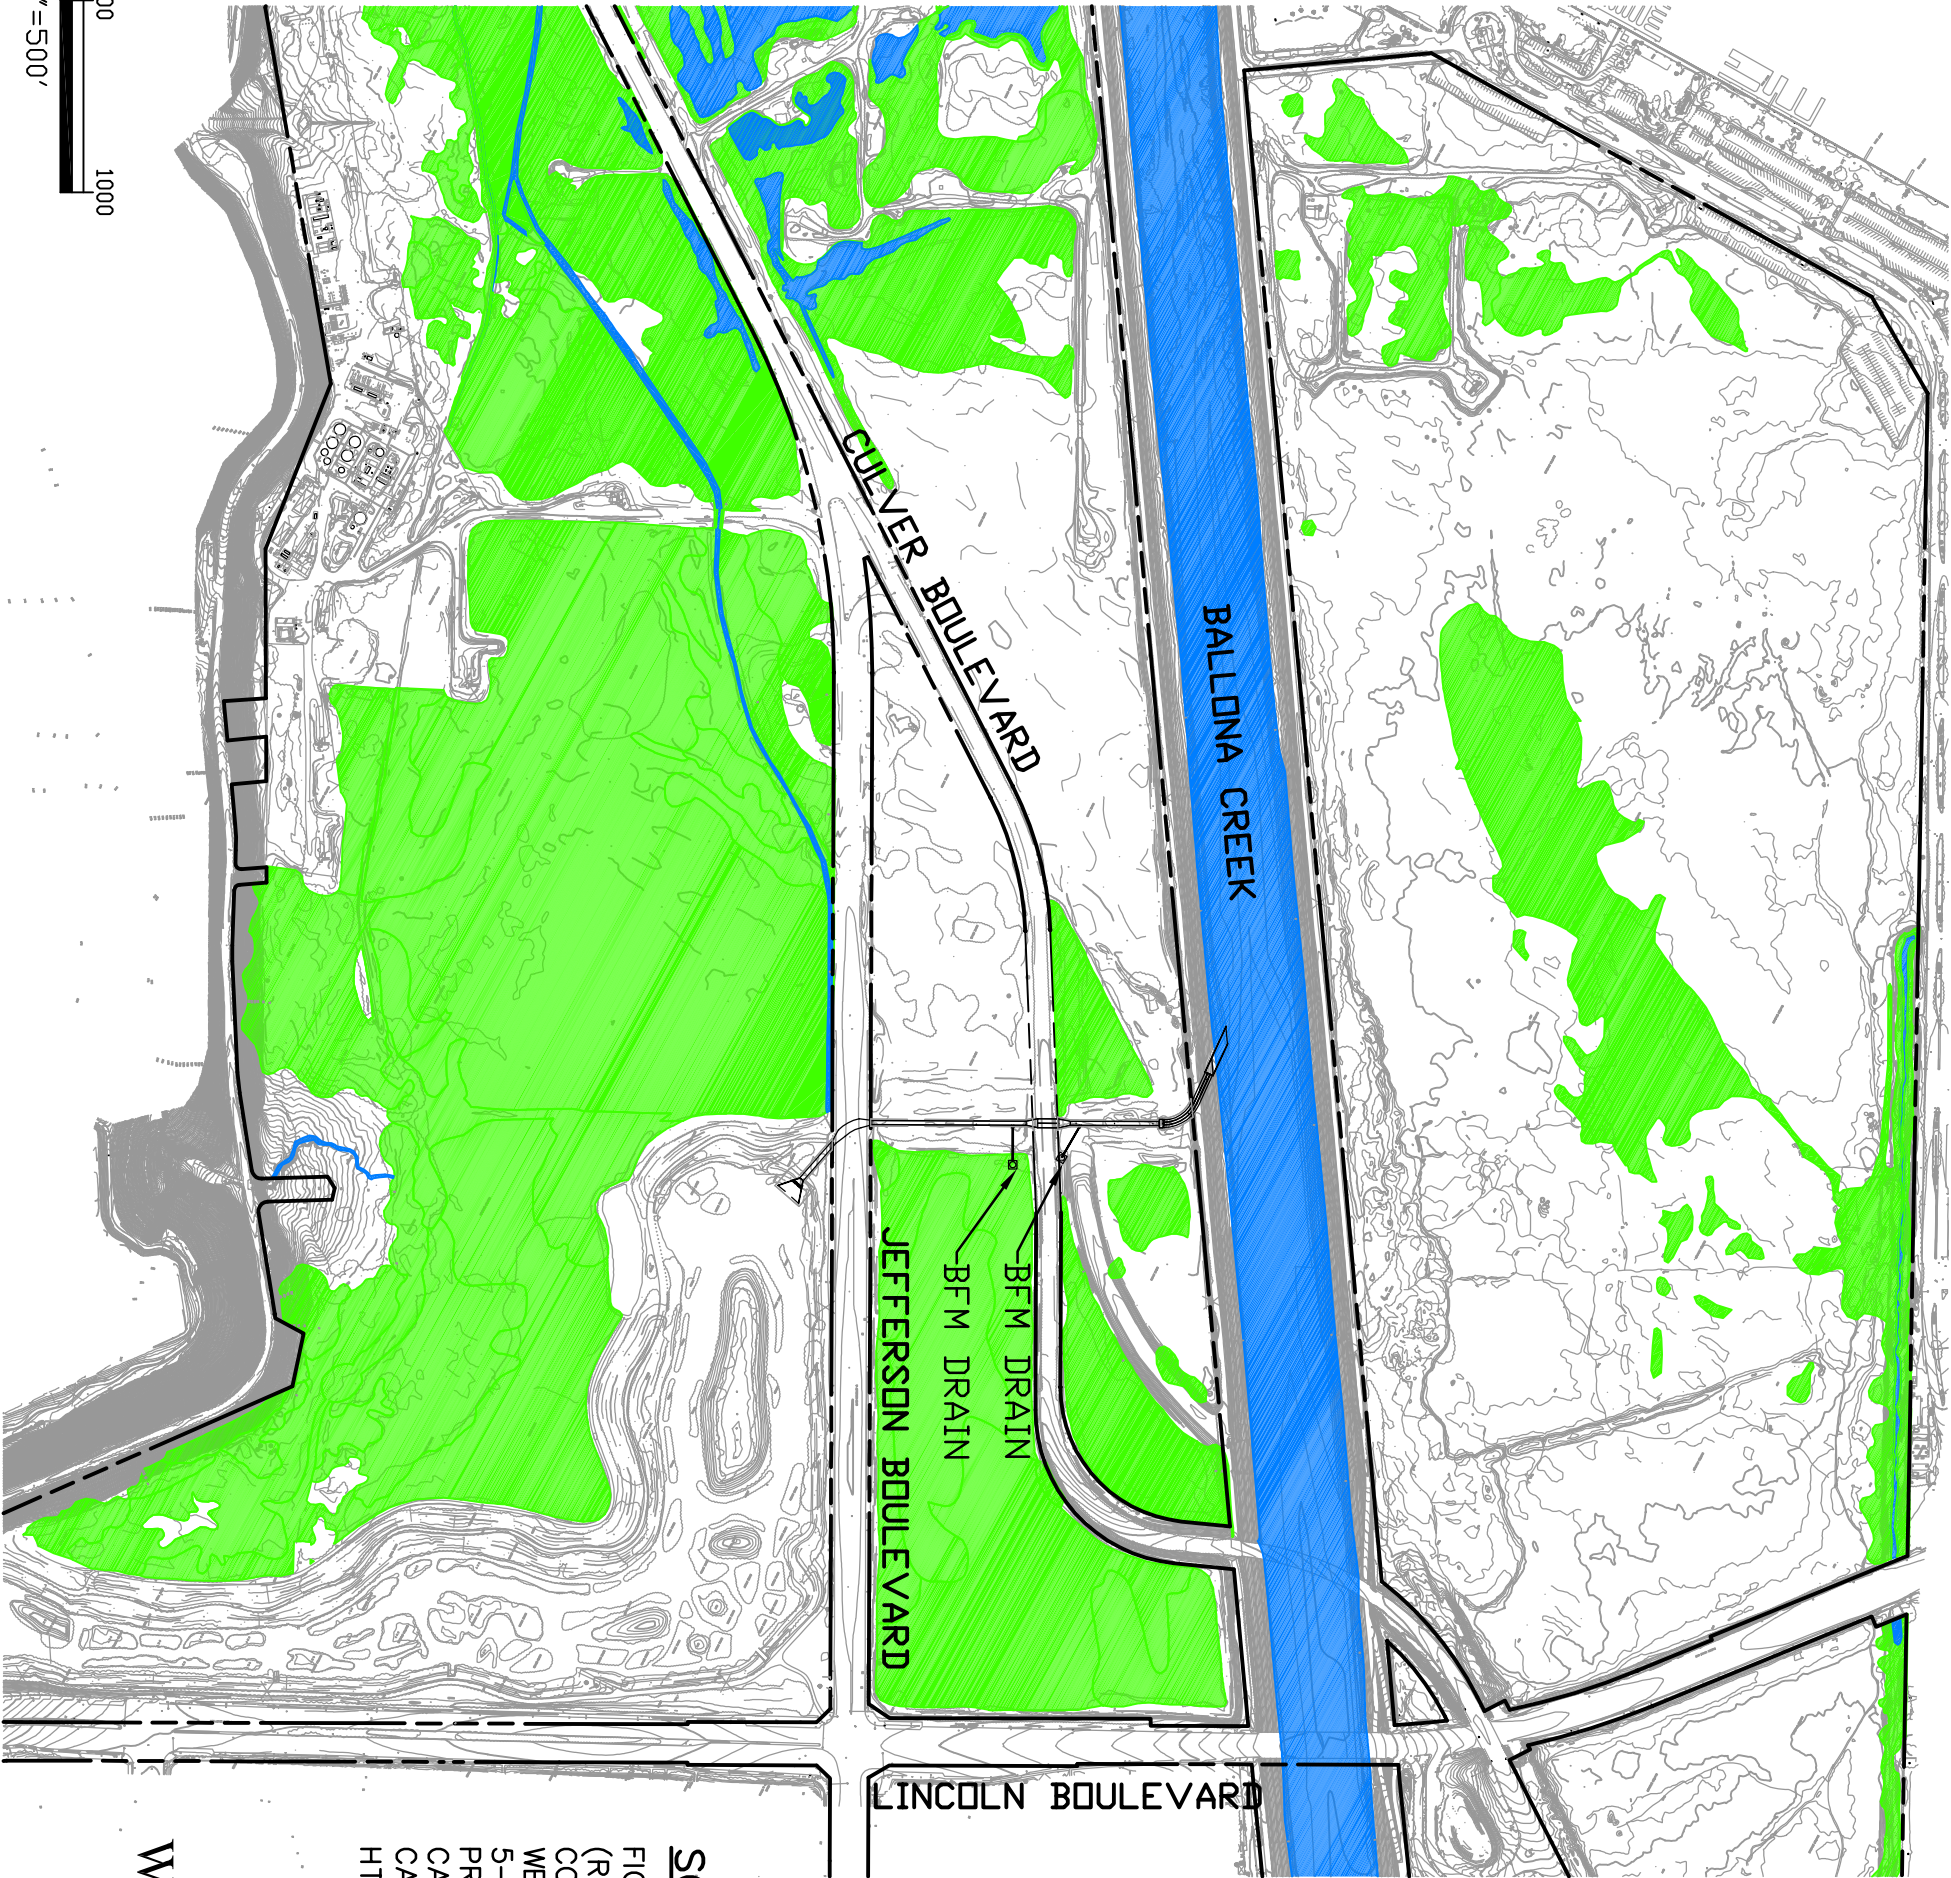
BALLONA WETLANDS RESERVE RISER ROMOVAL WETLAND DELINEATION EXHIBIT

FIGURE 9, DELINEATED WETLAND MAP OF THE RESERVE (REPLICATED FROM WRA 2011 USING CALIFORNIA COASTAL COMMISSION DELINEATION BALLONA WETLANDS ECOLOGICAL RESERVE COMPREHENSIVE 5-YEAR MONITORING REPORT, DECEMBER 2015, PREPARED BY THE BAY FOUNDATION, PREPARED FOR CALIFORNIA STATE COASTAL CONSERVANCY AND CALIFORNIA DEPARTMENT OF FISH AND WILDLIFE [HTTP://BALLONARESTORATION.ORG/BASELINE-REPORTS/](http://ballonarestoration.org/baseline-reports/)

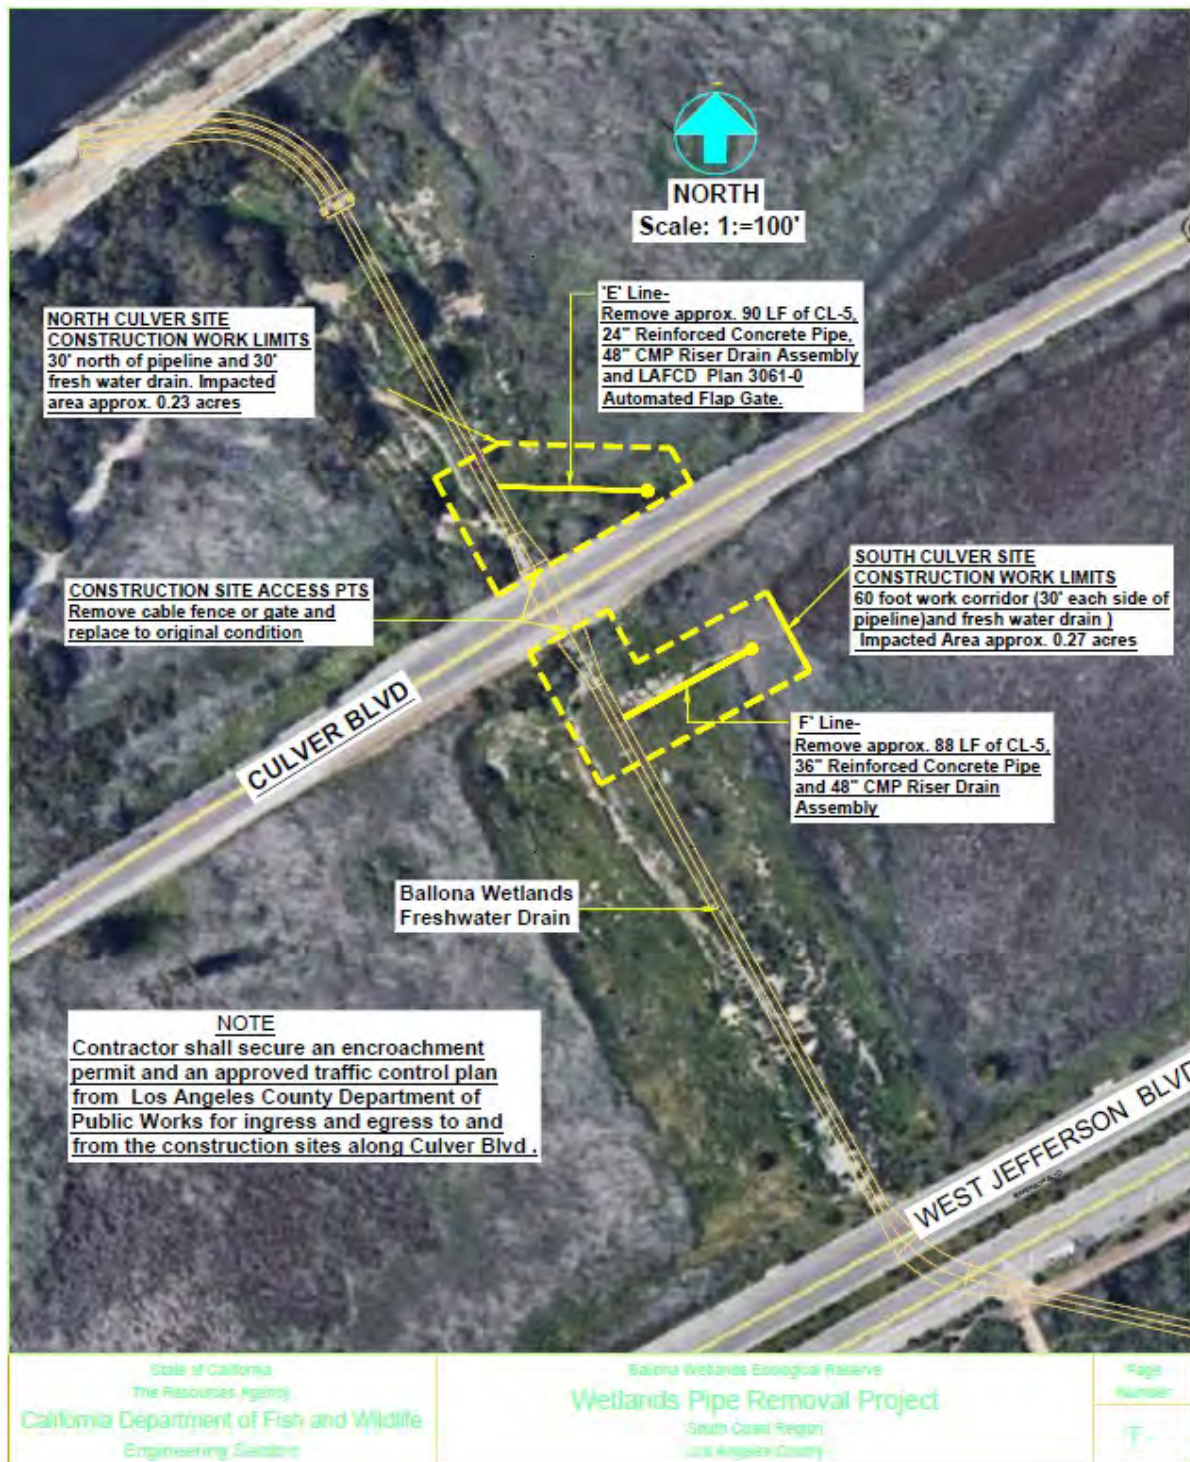
Figure 2. CDFW, Engineering Section, BWER Wetlands Pipe Removal Project exhibit (page number T -) that depicts the approximated areal extent of impact for removing the debris drain risers and pipes north and south of Culver Boulevard (that was used to calculate the mitigation acreage) and shows how the debris drain risers and pipes are connected with the freshwater marsh storm drain.

(FWM) storm drain overflow outlet pipe (Figure 1). The debris drain risers were at the end of pipes connected to the FWM storm drain overflow outlet pipe (Figure 2). The debris drain risers and pipes were not permitted. I have been asked to evaluate the history and current conditions of the natural resources within the vicinity of the unpermitted debris drains. To do this I visited the site on February 1, 2019 and have reviewed aerial photos and the documents listed above.

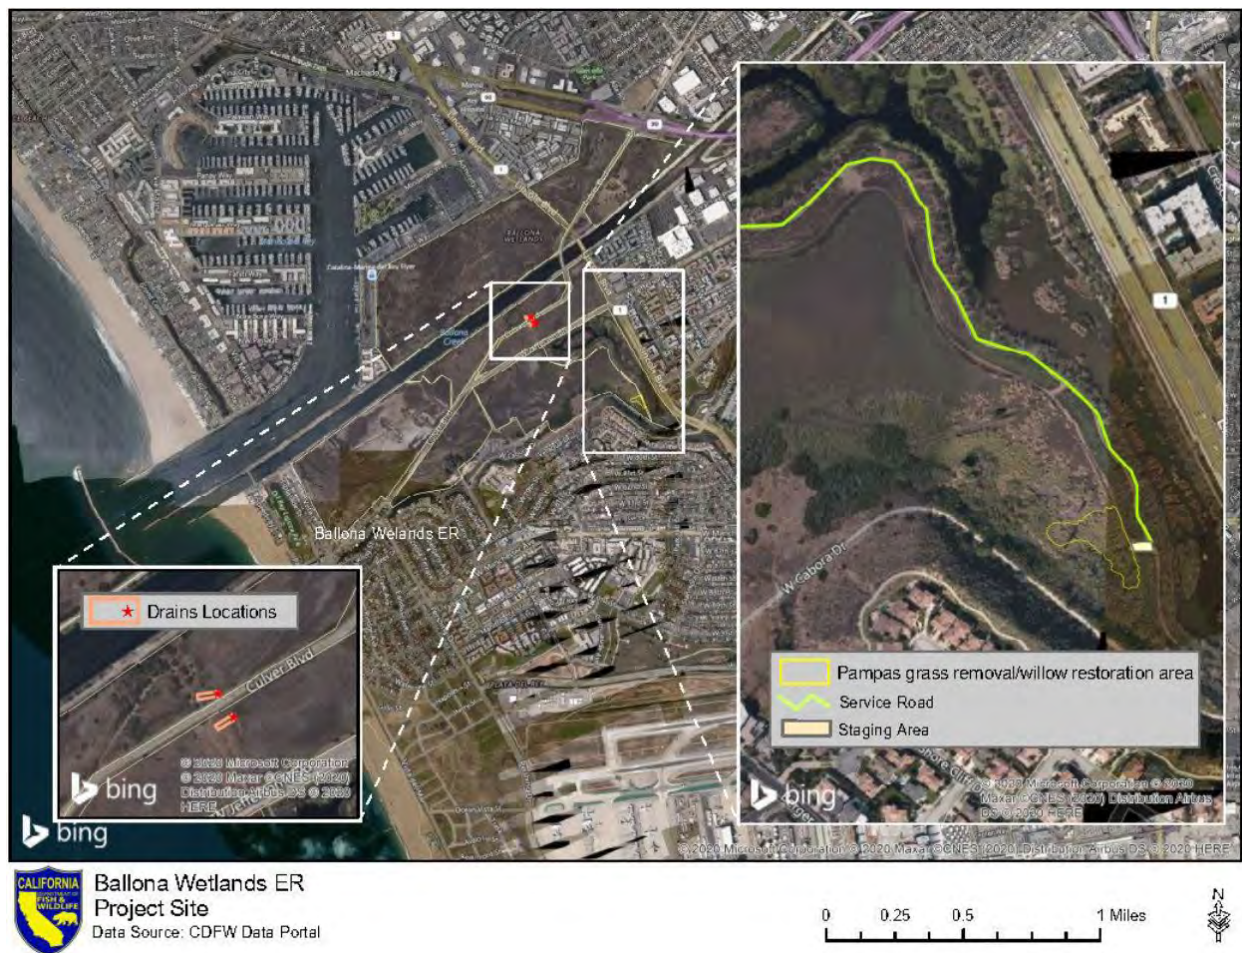
Figure 6. Figure 1, July 7, 2020 CDFW, BWER Willow Restoration Project. The left panel shows the proximal location of the drains and the pampas grass/willow mitigation area (approximately 0.35 acres apart). The right panel is a close up of the freshwater marsh and 0.6 acre pampas grass removal/willow restoration mitigation area outlined in yellow.

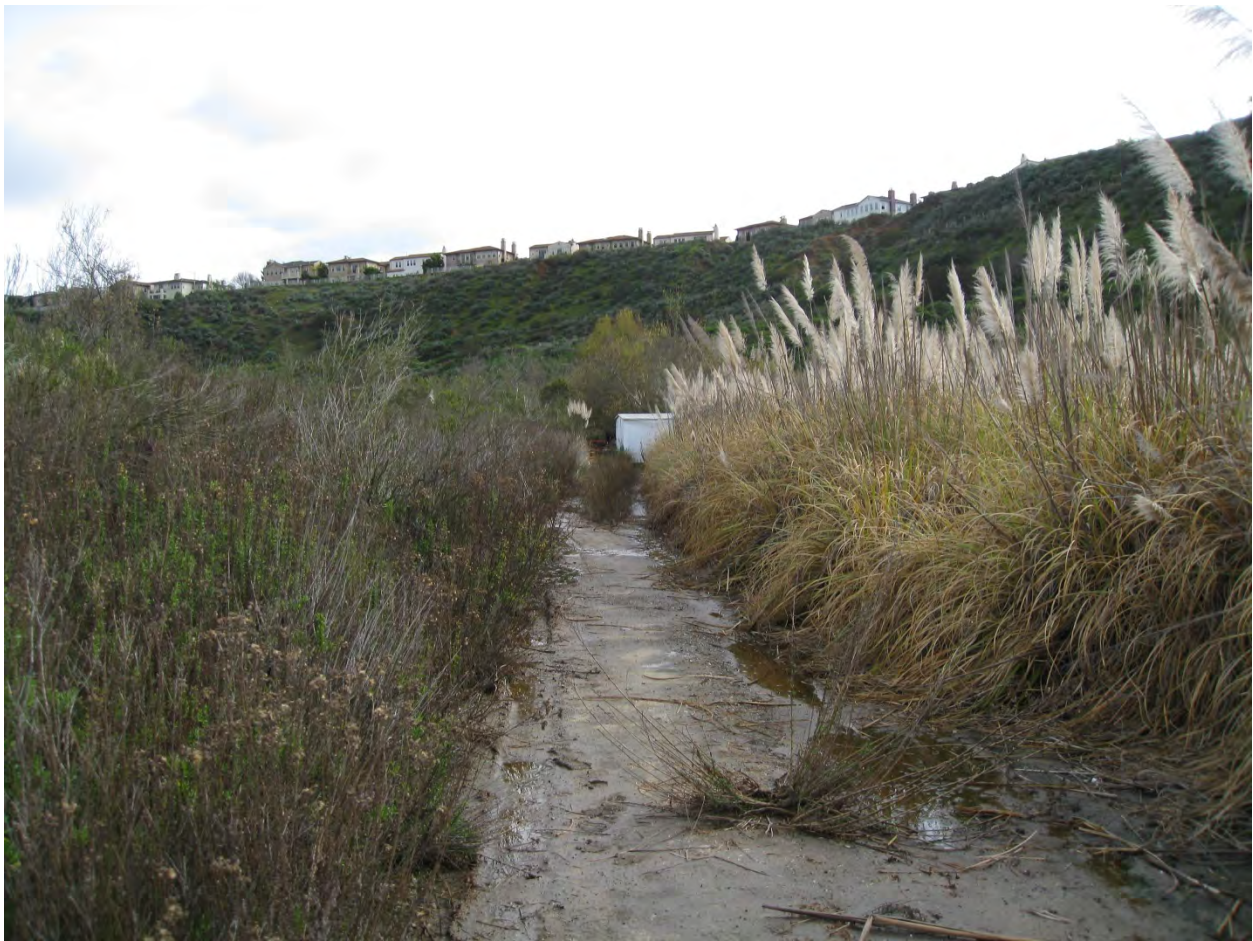
Figure 7. February 1, 2019 photograph facing east and showing the pampas grass mitigation site on the right and the freshwater marsh habitat on the left.

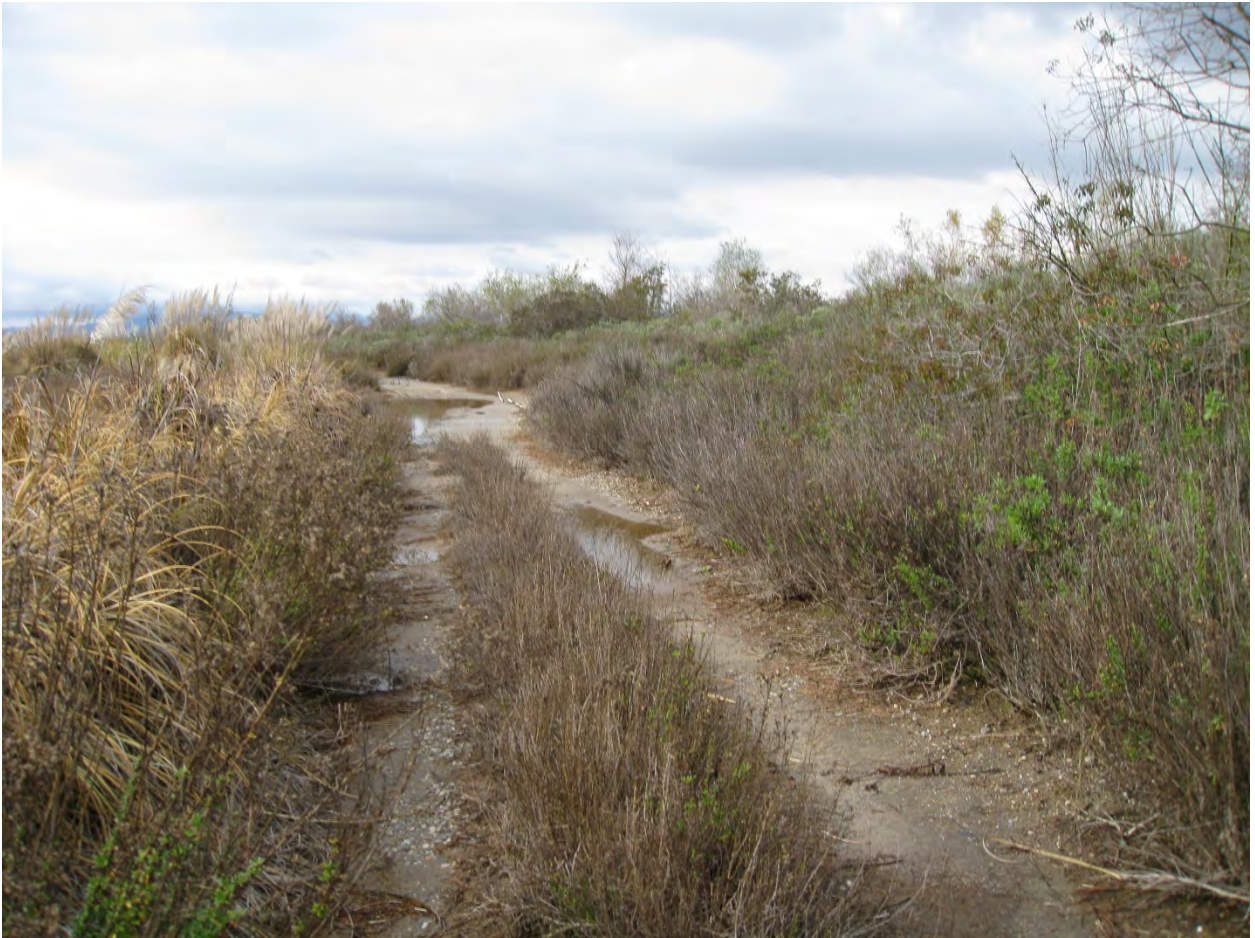
Figure 8. February 1, 2019 photograph facing north-west showing the pampas grass mitigation site on the left and the freshwater marsh habitat on the right.

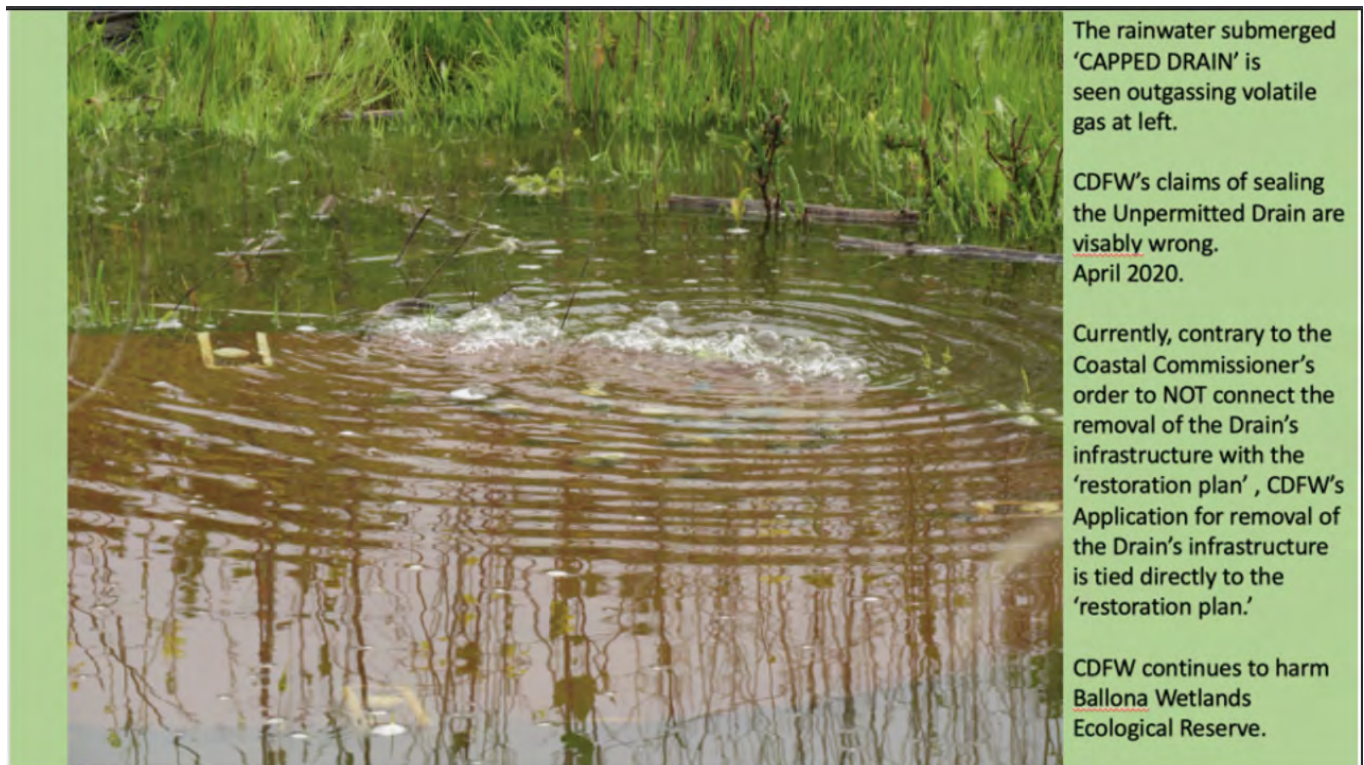
And, that with the breach of the drain, both outgassing and draining of water is taking place. The specific concern of volatile gases utilizing the Main Drain and the risers as

secondary collector zones of oilfield gas was raised by GC and dismissed by CDFW and its partner Playa Capital (and consultants) during the Coastal Commission hearings.

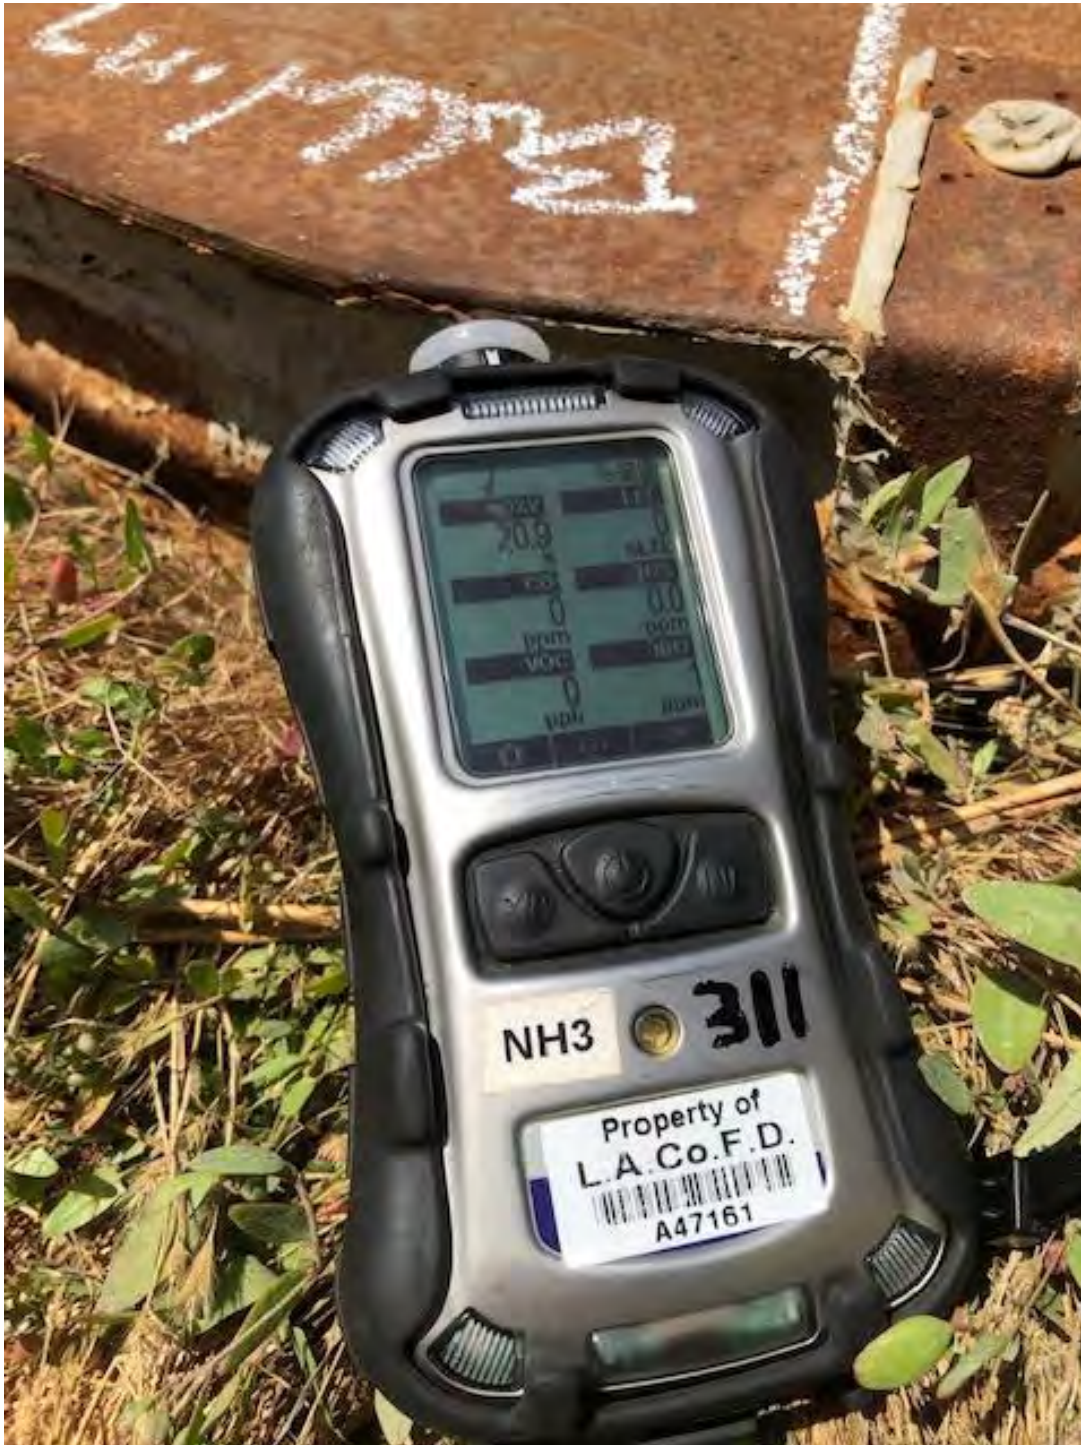
Figure 1: HazMat Meter Reading Directly in Front of South Drain Leak (all zero, except 20.9% oxygen and 1 ppm ammonia)

The results of this testing were negative with Lower Explosive Limit (LEL) 0%, Volatile Organic Compounds (VOC) 0 ppb, Hydrogen Sulfide (H₂S) 0 ppm, as read from a meter calibrated to methane. Measurements were taken directly in front of air felt flowing out of the small leak at the south drain (Figures 2) and from additional locations around the cap seal of the north drain. HazMat is preparing

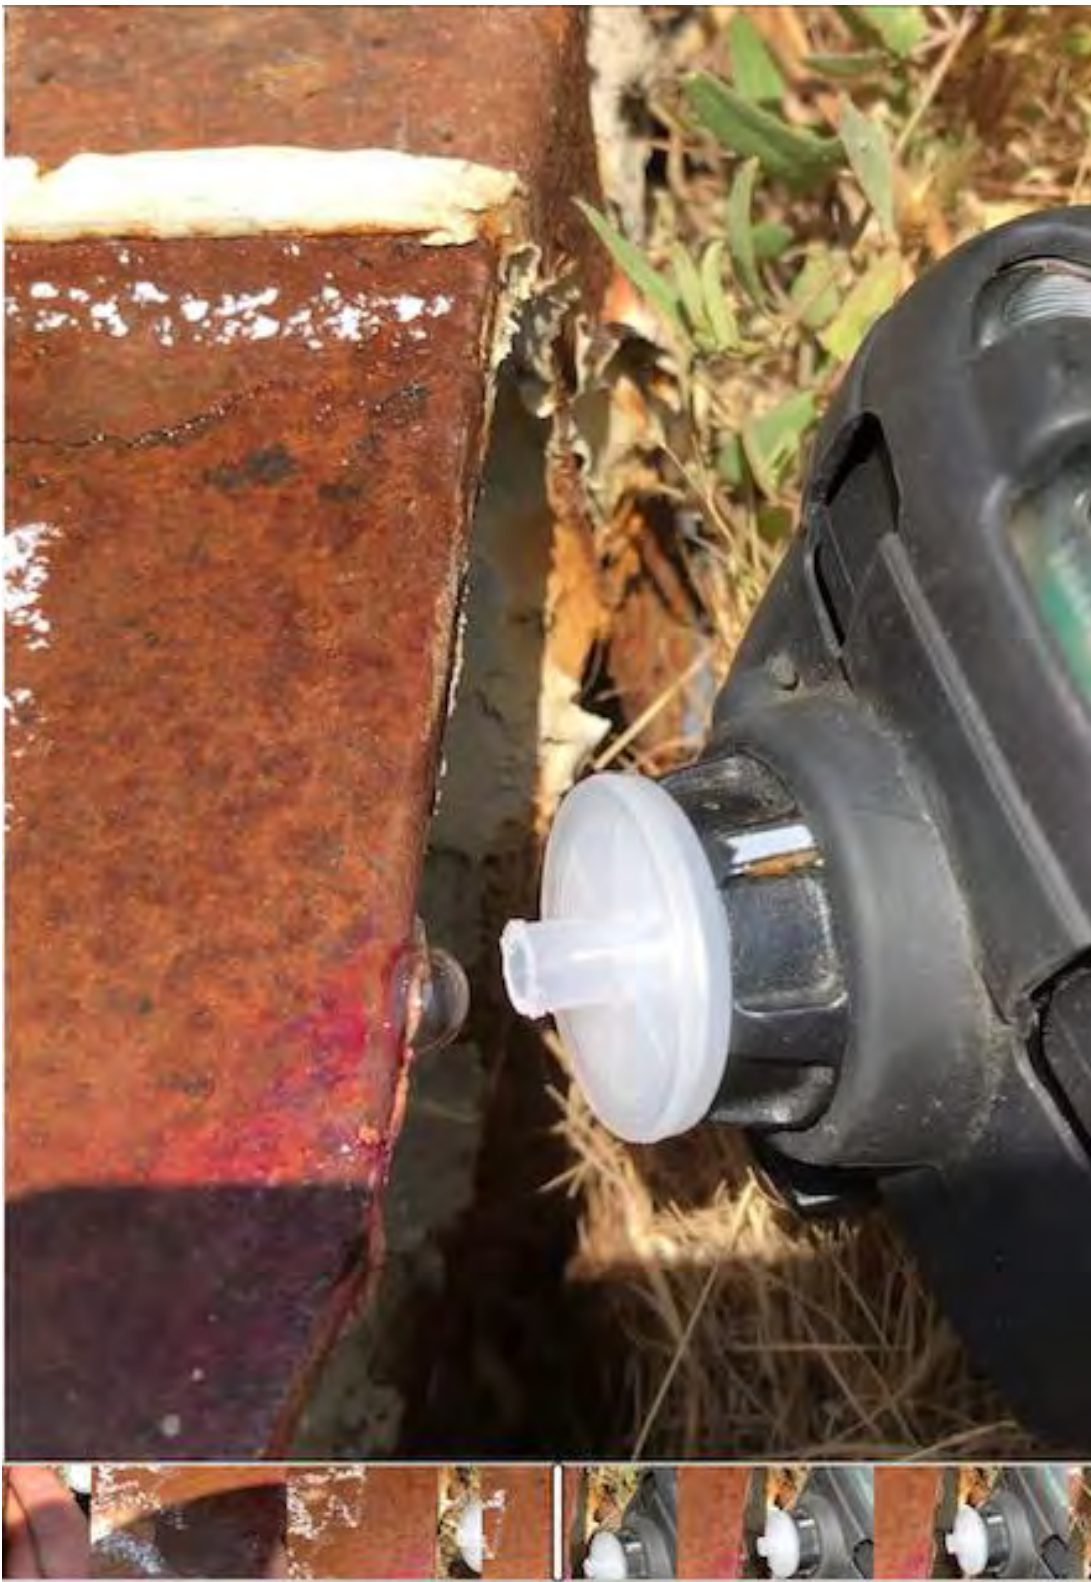
Figure 2: South Drain Reading Directly in Front of Air Leak (water poured over to expose leak)

On July 06, 2020 Department staff inspected the two risers situated along Culver Blvd. Visual observations and photos did not indicate any clear compromise of the seal. At approximately 0730 hrs., no airflow could be heard or otherwise detected from the south riser, but when inspected again at 1130 hrs. it was determined to have a small leak in a portion of the seal between the cap and the riser. When lightweight flagging tape was placed over the area where bubbling was shown on the video occurring during a flood event on April 10, 2020 at 1021 hrs., air flowing out from the seal was clearly evident (flagging was moving) and air flow could be heard when a razor blade was inserted in the gap. When airflow was rechecked at 1400 hrs. it was again undetectable through the seal at this same location.

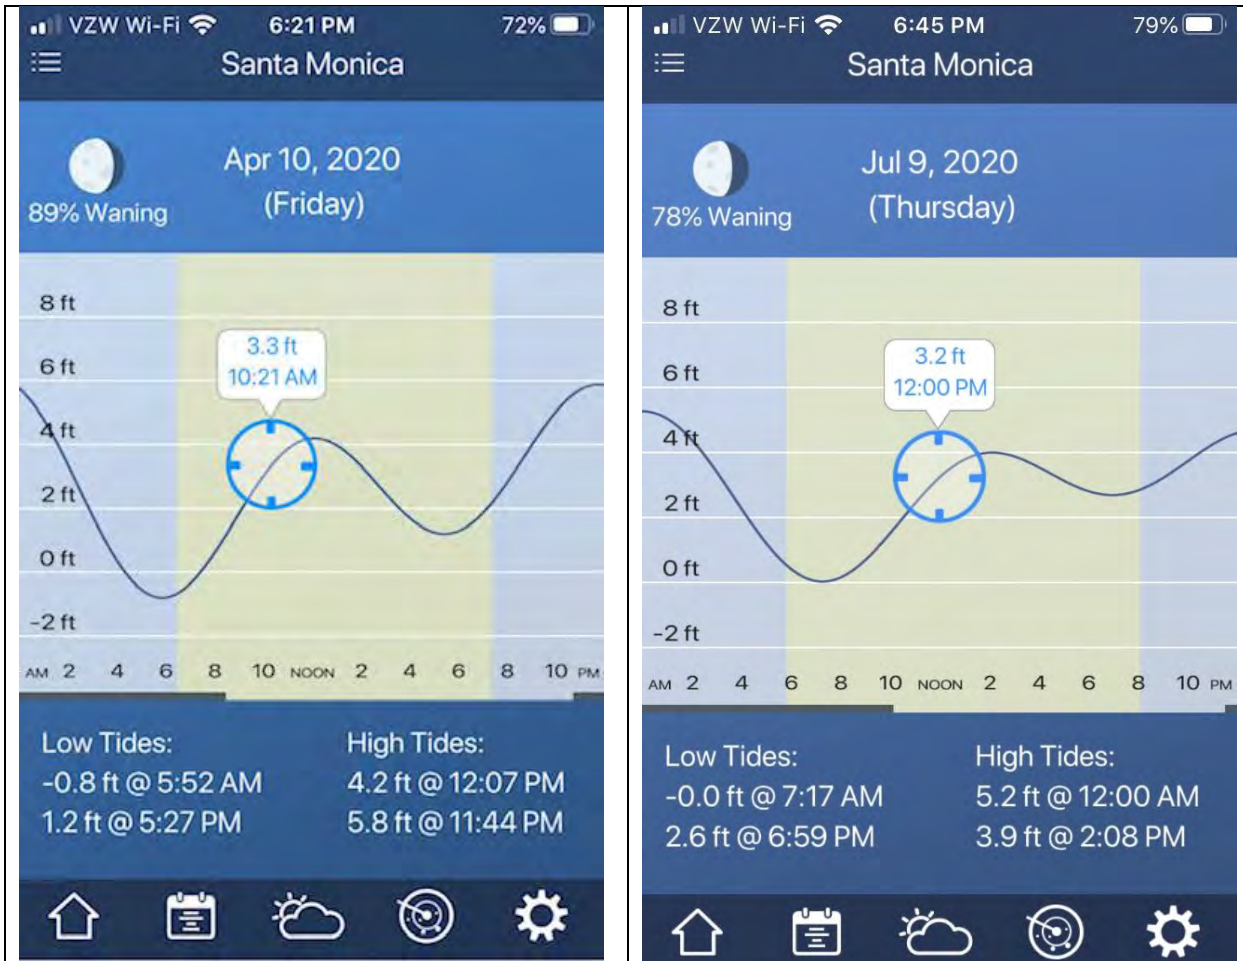
Figure 3: Tide Tables during Grassroots “detection” and HazMat Reading (both during rising tides)

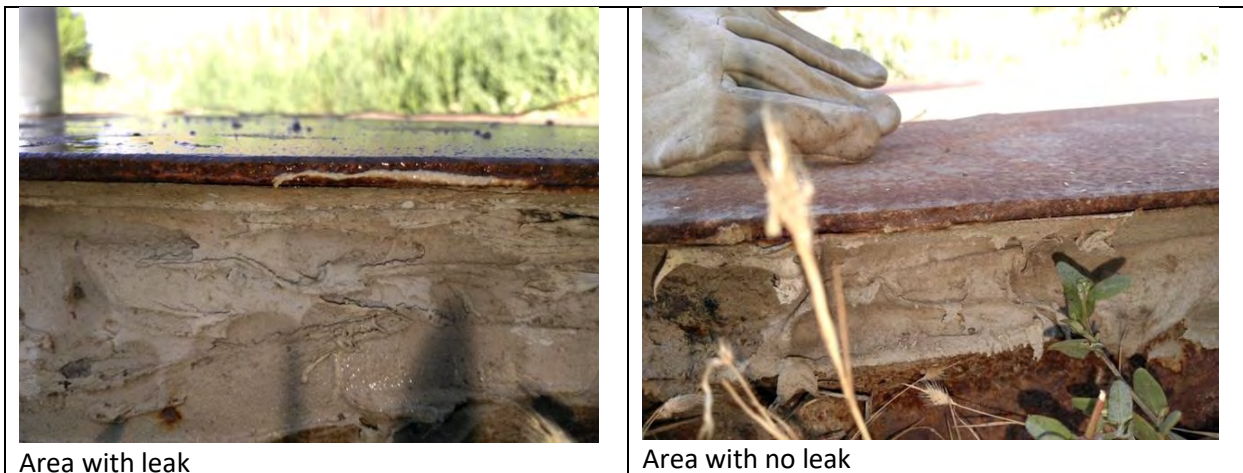
Figure 4: Pictures Meant to Show Difficulty in Finding Any Compromise in the Seal
