## **CALIFORNIA COASTAL COMMISSION**

**CDP 5-20-0706 (PLAYA REDONDO, LLC)**

**NOVEMBER 17, 2021**

### **EXHIBITS**

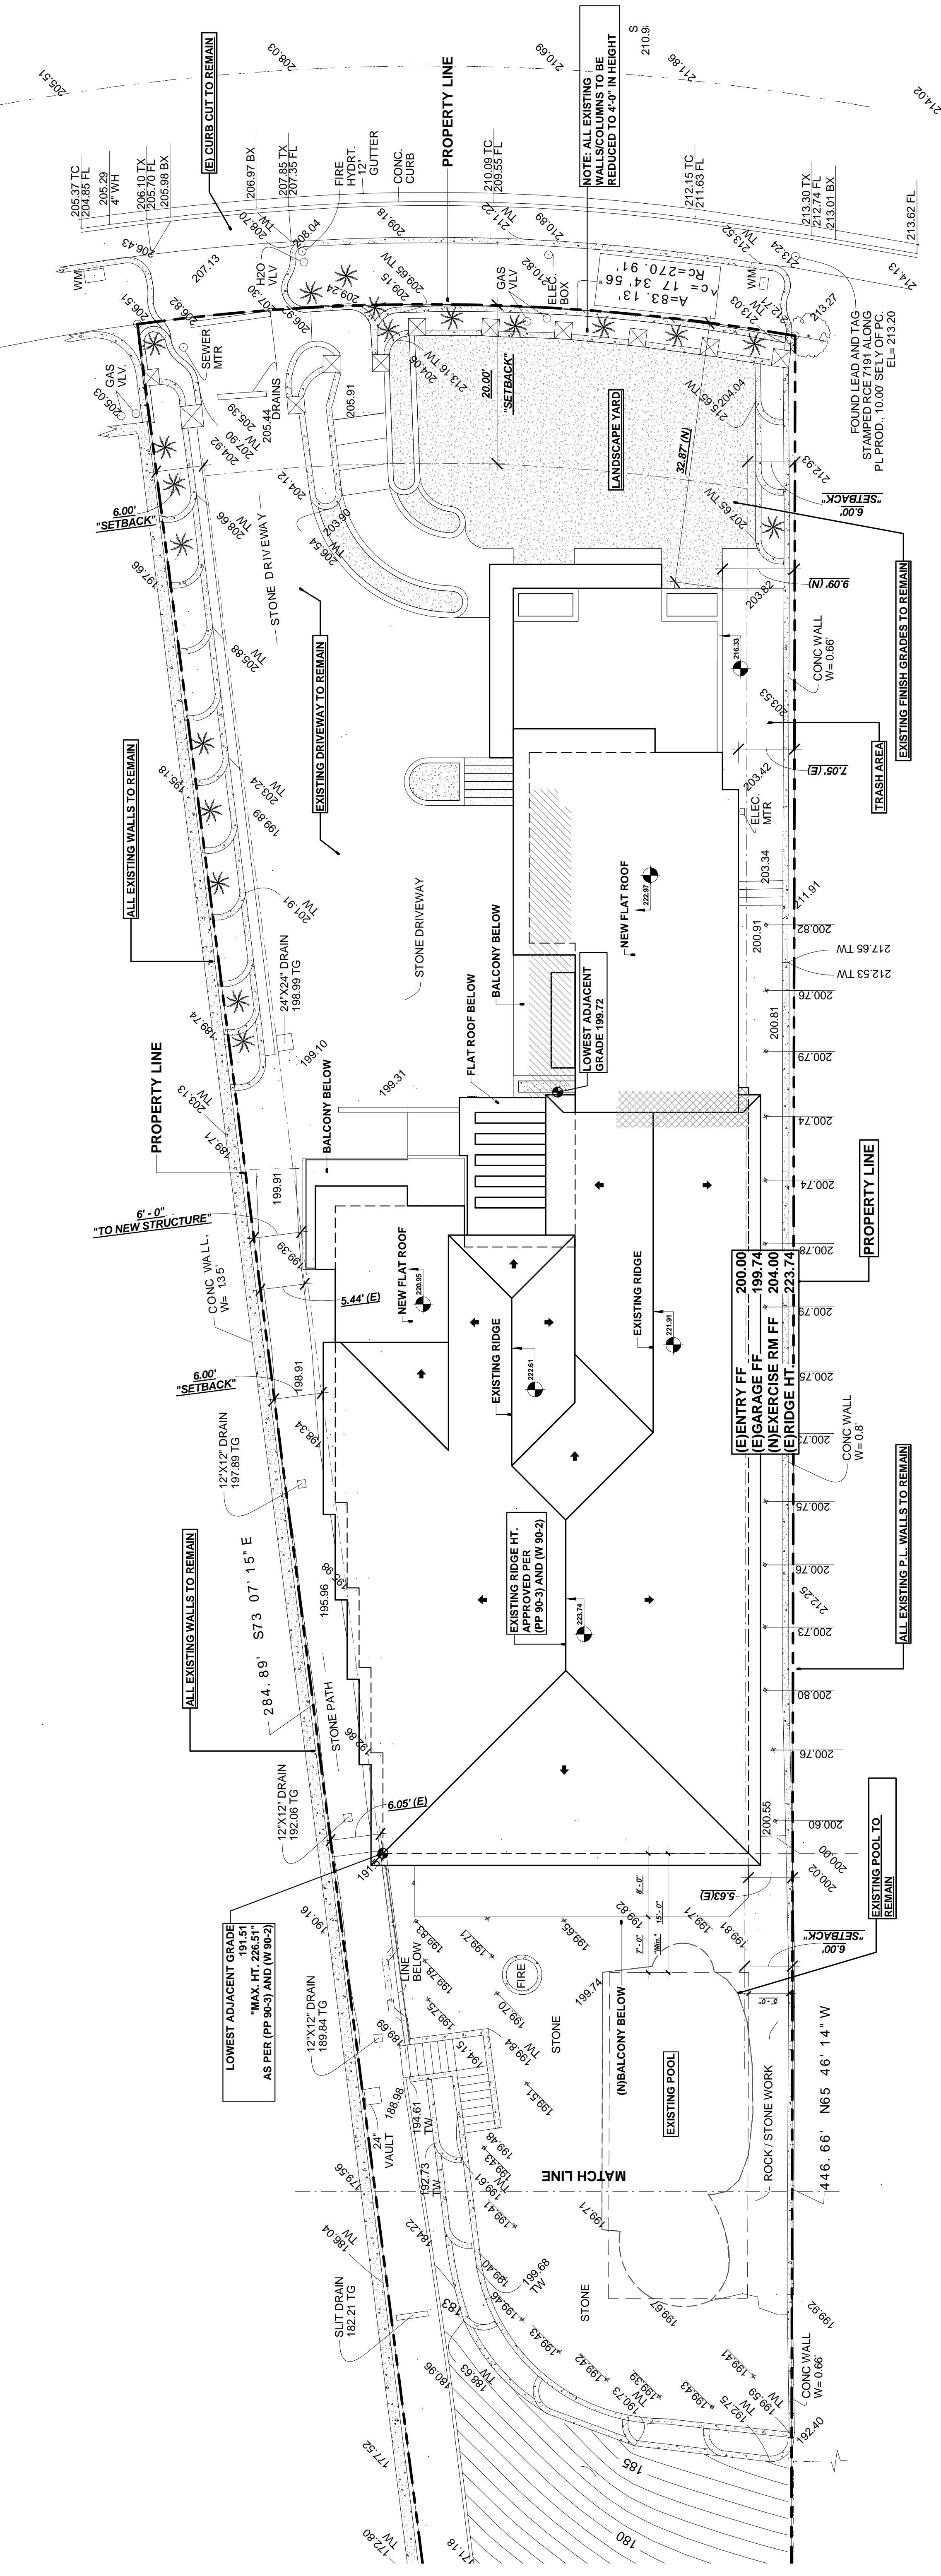
② Site 1" = 10'-0"

**SCOPE OF WORK:**  
NEW ADDITION AND REMODEL TO THE EXISTING RESIDENCE.  
RECONFIGURE EXISTING RESIDENCE PER PLAN, NEW SECOND FLOOR BALCONIES, PATCH & PAINT, NEW ARCHITECTURAL STYLE

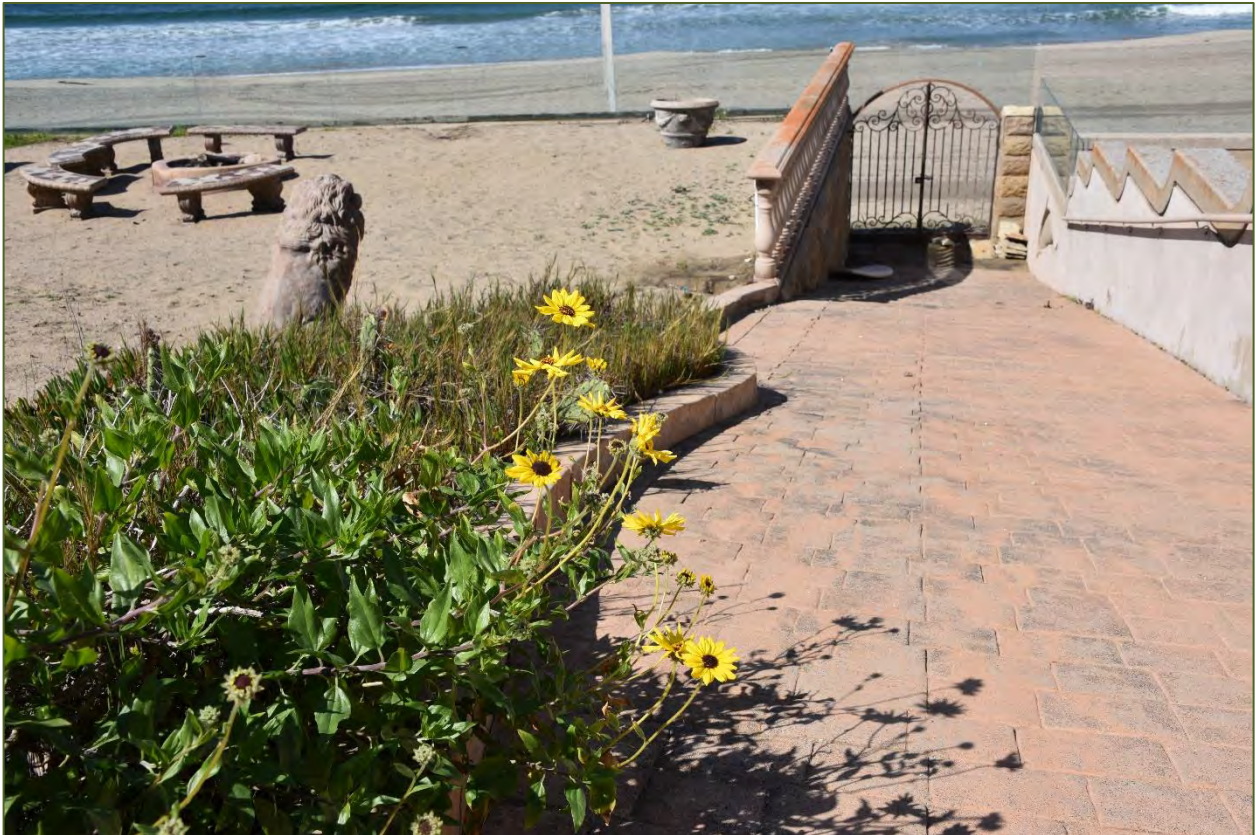
This habitat survey was conducted for the purposes of determining the type of vegetation present at 433 Paseo de la Playa, Torrance, CA 90277. Specifically, the focus is the area facing the ocean below the pool deck that drops steeply from an approximate elevation of 80 ft (25 m) to the beach sand at approximately 20 ft (6 m), covering an area of about 0.17 ac (0.07 ha).

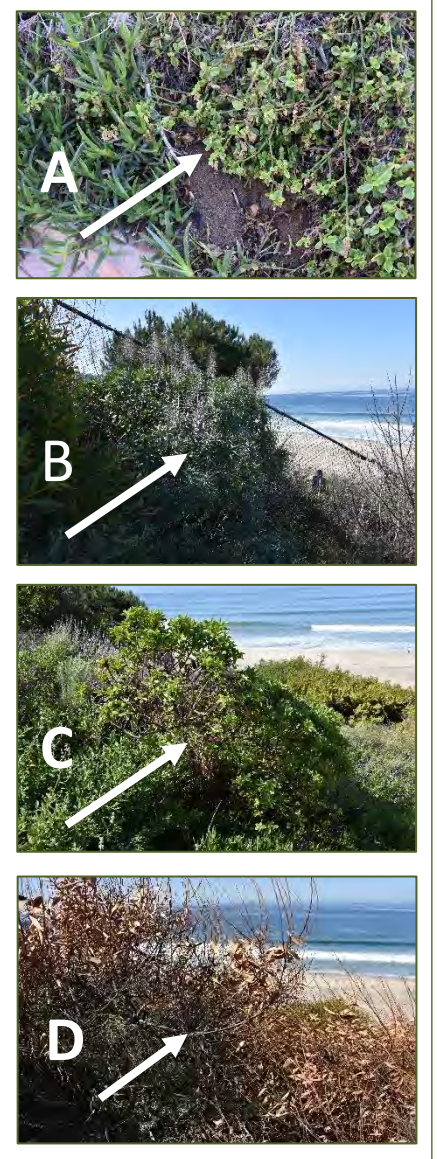
**Figure 1.** Four unidentified non-native plant species as shown in Table 1.

<i>Raphanus sativus</i>	cultivated radish	<1
Plant, Unidentified #1	See Photo A – ground cover	1
Shrub, Unidentified #4	See Photo B – ornamental shrub	1
Tree, Unidentified #2	See Photo C – small tree	1
Tree, Unidentified #5	See Photo D – dormant tree	1
<b>Total Non-native Cover</b>		<b>44</b>
Bare		5
Litter		1
<b>Total</b>		<b>101</b>

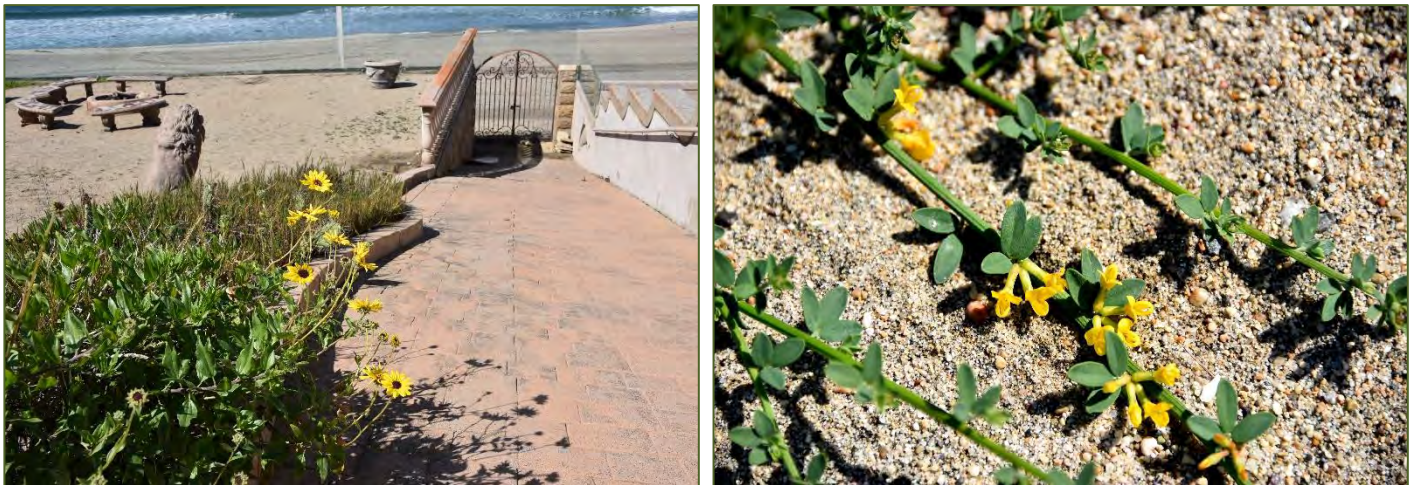
**Figure 2.** *Left:* View of beach area showing salt grass mid-photo above California bush sunflower. *Right:* Close-up of strigose lotus in the beach area

A few native species were found in the sandy beach, especially salt grass (*Distichlis spicata*), numerous suncups (*Camissoniopsis cheiranthifolia*) and a striking strigose lotus (*Acmispon strigosus*) specimen (Figure 2).

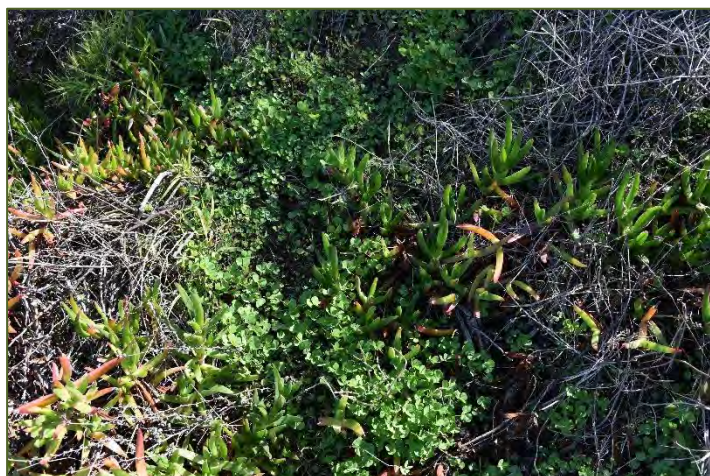
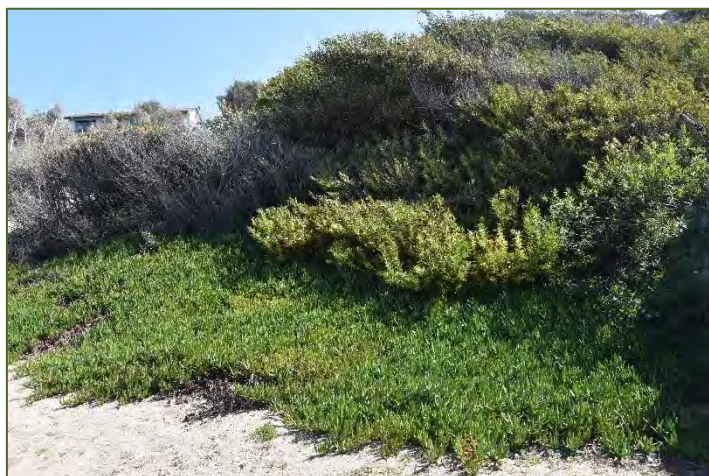
**Figure 3.** *Left:* Example of freeway iceplant invading into the sea-cliff buckwheat area. *Right:* Large mat of freeway buckwheat below the black wattle stand.

Two non-natives were dominant, and freeway iceplant (*Carpobrotus edulis*, 18% cover) and black wattle (14% cover). Freeway iceplant, a notorious invasive plant, has colonized within the shrubs along the walkway and has also formed large patches lower on the hill and sandy area (Figure 3). Black wattle has formed a huge stand near the base of the slope and appears to be moving into and over California bush sunflower plants and is poised to move into the bottom of the sea-cliff buckwheat stand (Figure 4).

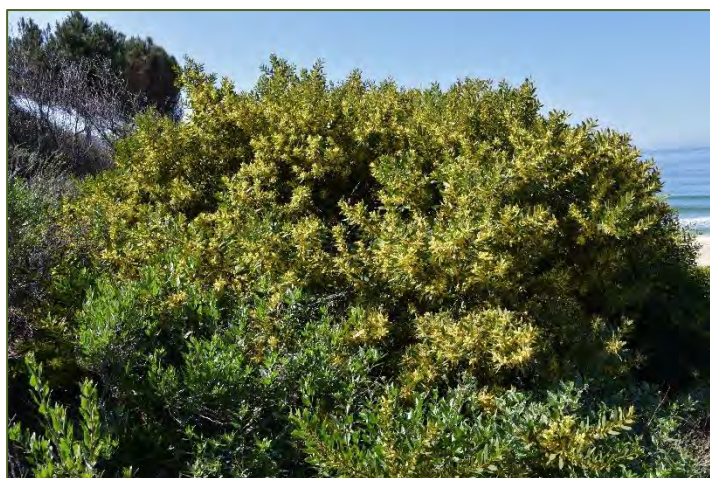
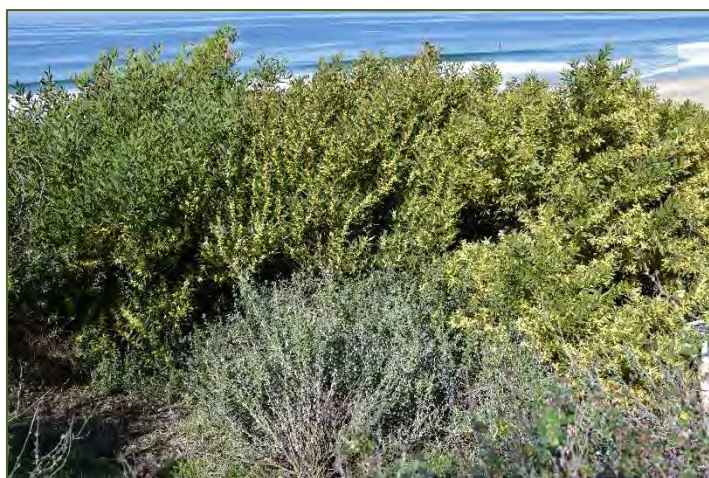
**Figure 4.** *Left:* Black wattle invading California bush sunflower. *Right:* Black wattle behind bottom of sea-cliff buckwheat stand.

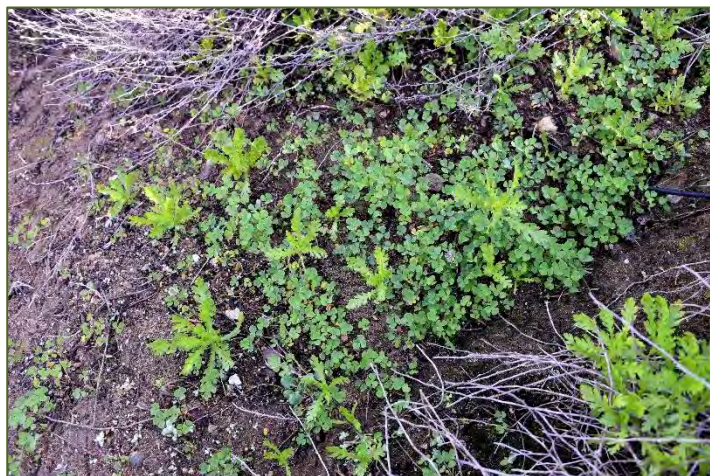
**Figure 5.** Chrysanthemum sprouts amidst other non-native forbs.

There were a number of forbs and non-native weeds present in relatively low numbers. Most concerning is carnation spurge (*Euphorbia terracina*). It is capable of rapidly expanding at the expense of native species. Another concern about carnation spurge is that its sap is an irritant, although newly emerged plants, can be easily dealt with a hoe. If allowed to form dense patches, it becomes more difficult to remove as there will be a seed bank and crews conducting the removal must wear protective clothing and eye wear. Also present was a newly emerging plant that appears to be a chrysanthemum, possibly *Chrysanthemum coronarium* (Figure 5). Chrysanthemum has the ability to form dense stands and can best removed when there are a few plants.

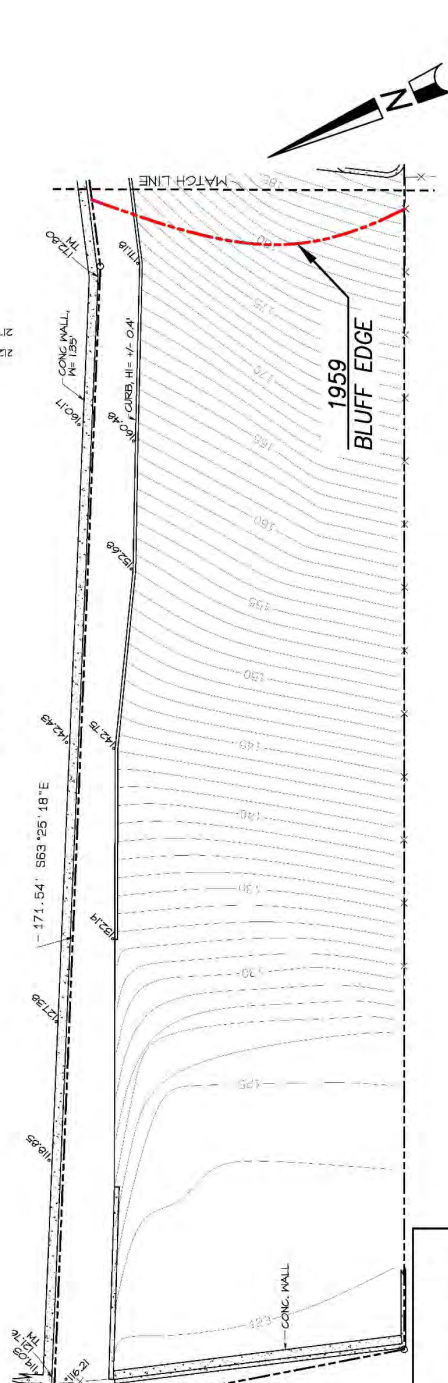
## Plate 1

Estimated bluff edge  
(GeoSoils, 2021)

Estimated bluff edge (BARA 2012)

**BLUFF EDGE  
LOCATION MAP**

— APPROXIMATE LOCATION OF FEB 2021 BLUFF EDGE AND TIE EDGE, QUERIED WHERE UNCERTAIN
-

— APPROXIMATE LOCATION OF 1972 BLUFF EDGE AND TIE EDGE, QUERIED WHERE UNCERTAIN
-

— APPROXIMATE LOCATION OF 1950 BLUFF EDGE AND TIE EDGE, QUERIED WHERE UNCERTAIN
