1-20-0216 (CITY OF POINT ARENA)

EXHIBITS

Wetland and Other Waters Delineation

Arena Cove Parking Lot Repair Project
Point Arena, California

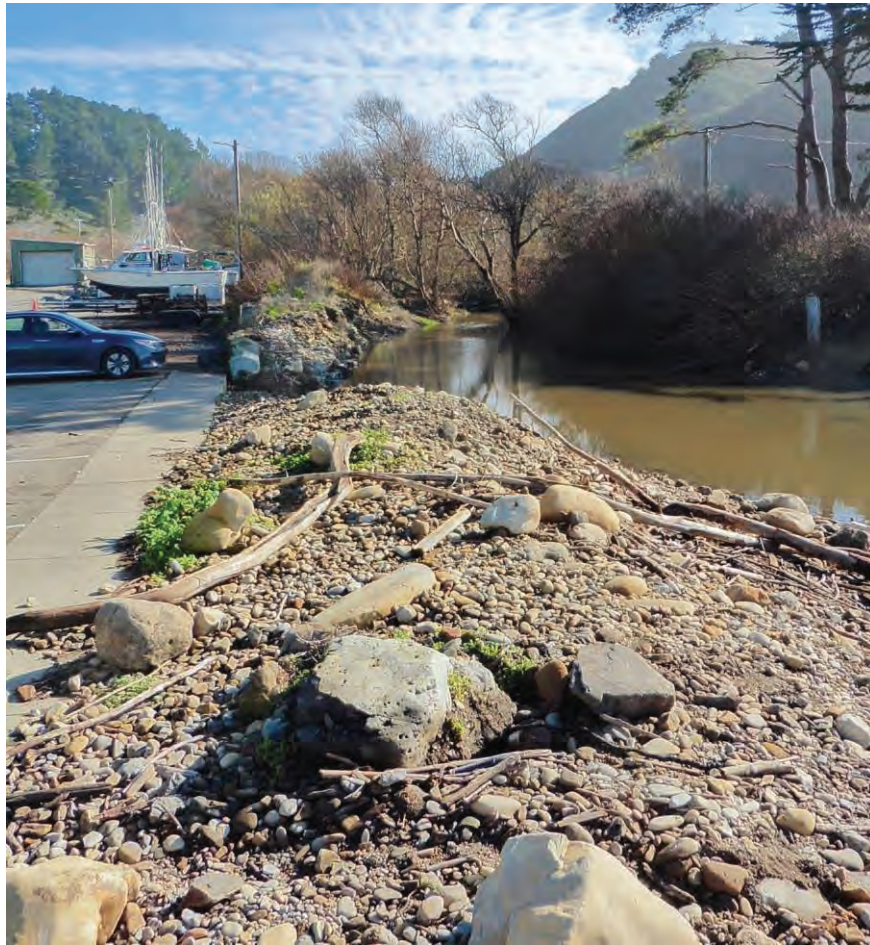
Photo 1: Project area, looking east. Note rocky cobble nature of imported fill to protect parking lot. The sea wall will be constructed along the edge of the existing parking lot. Photo taken January 22, 2020.

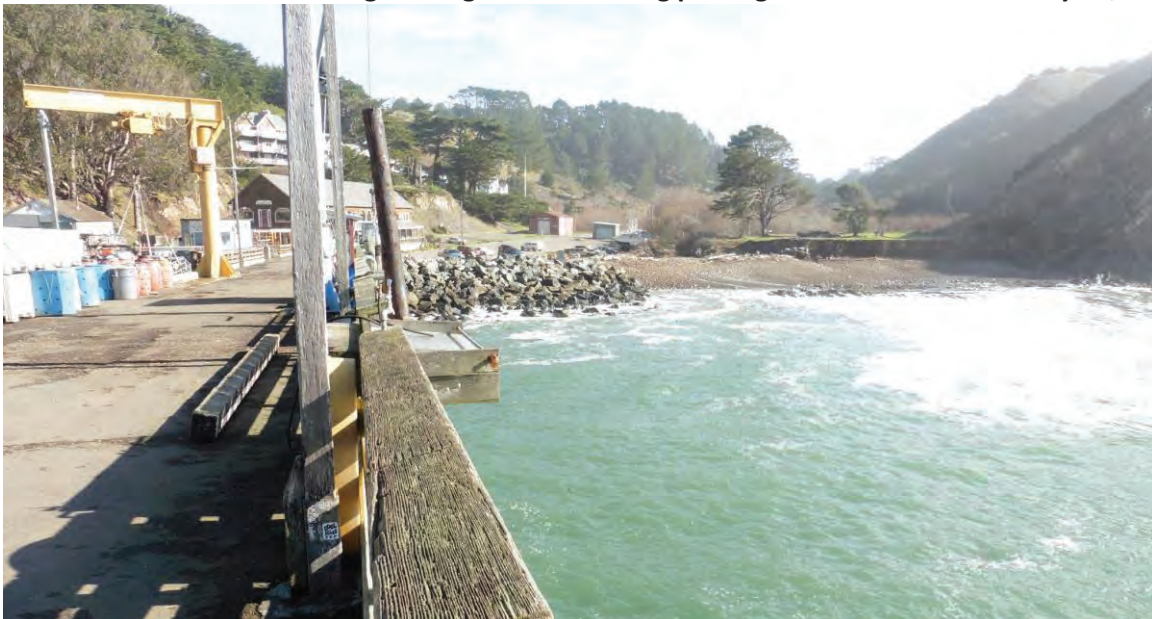
Photo 2: Looking east towards the project area from the Point Arena pier. Note proximity of parking lot and study area to the Pacific Ocean and wave action. Photo taken January 22, 2020.

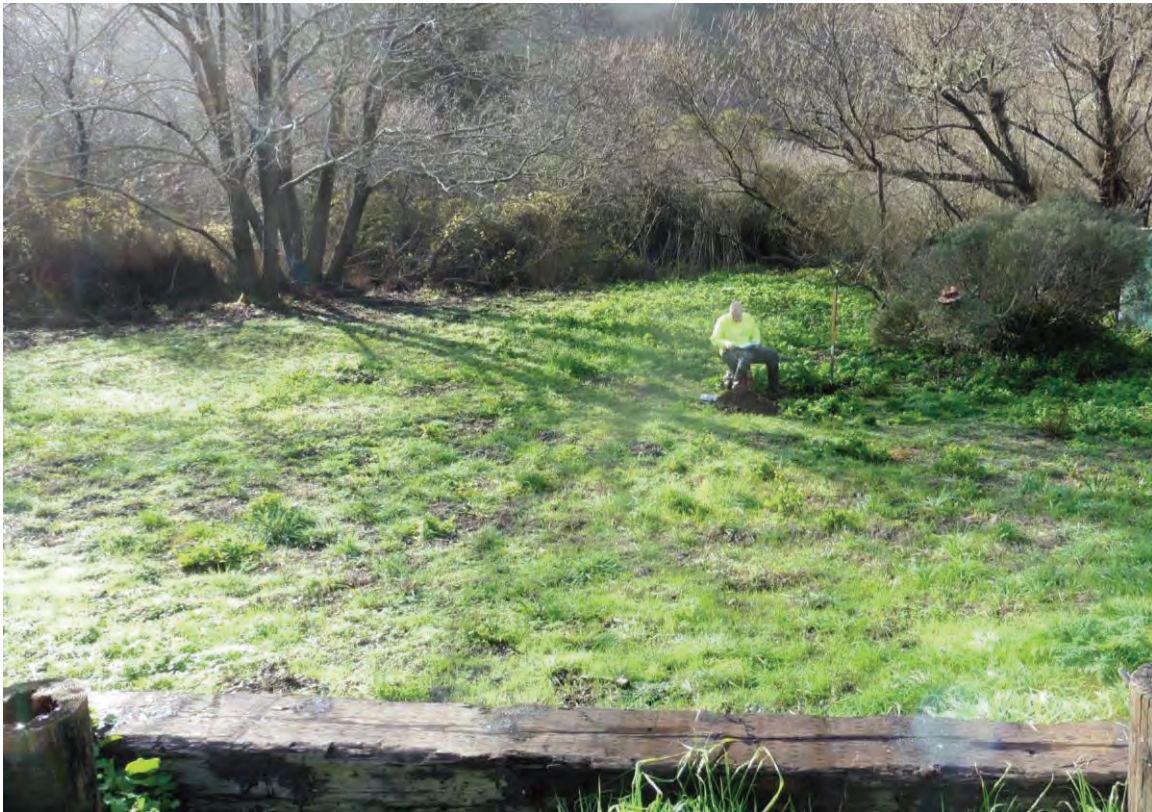
Photo 3: Small field east of the existing parking lot, looking south. Soil scientist is investigating TP1. This area is upland (see Section 8.1.3 Upland Area and Tables 2 and 3). Photo taken January 22, 2020.

The majority of the small open field immediately east of the existing parking lot had no wetland parameters present and is considered upland (see Figure 2 and Appendix 1, Photos 3, 4, and 7). TP1 was excavated within the west central portion of the small field and no wetland parameters were present (see Figure 2 and Appendix 1, Photos 3 and 4). Upland vegetation dominance throughout the majority of the area indicates that upland conditions exist until within approximately five feet of TP3. Upland conditions reflect historical disturbance and the raised topography of the small field. Dominant species within this area included wild

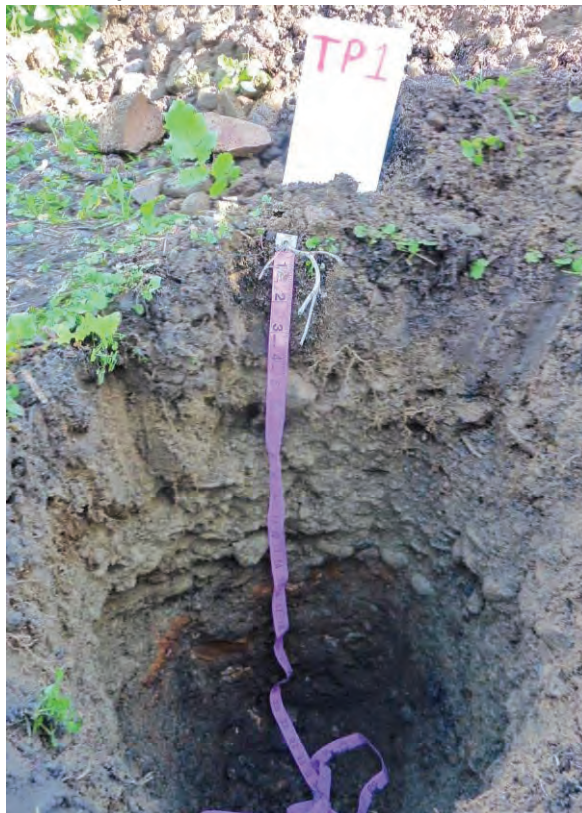
Photo 4: TP1 soil profile, showing well drained rocky upland soils. Note buried iron debris at 16 inches, indicating historical disturbance. Photo taken January 22, 2020.

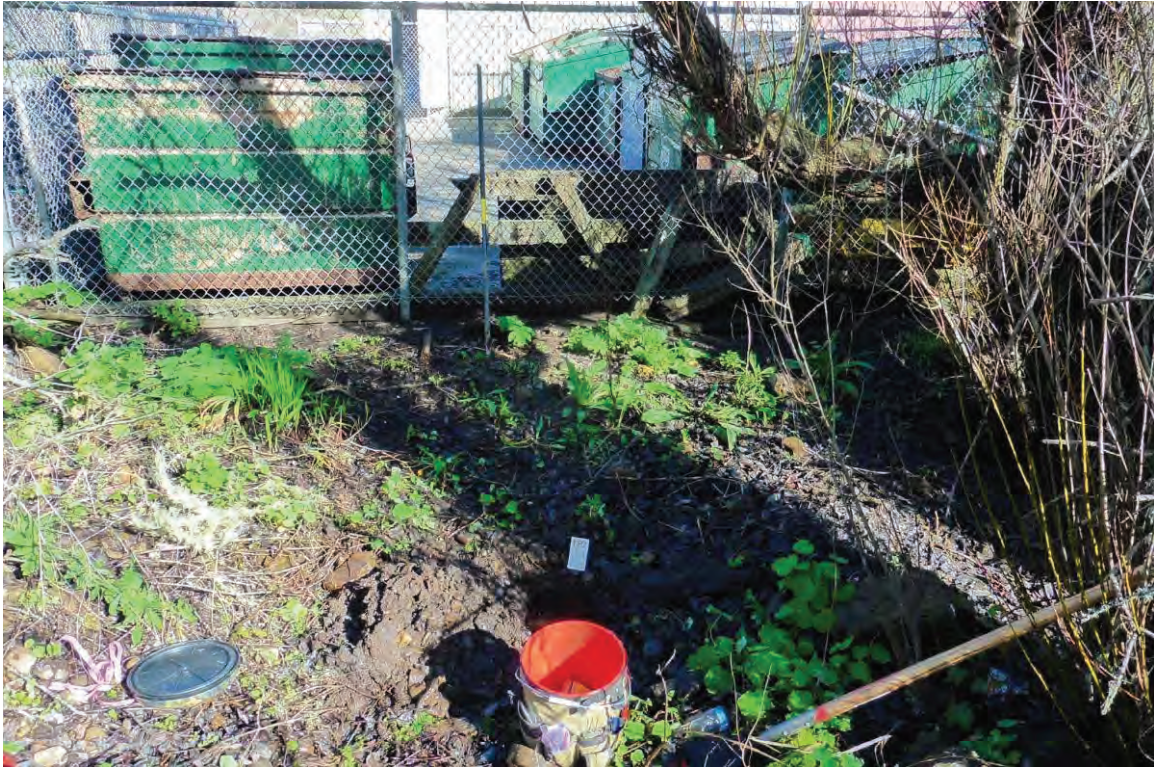
Photo 5: TP2 location, approximately 9 feet south of fence within a geomorphic depression, approximately 18 inches lower than surroundings. 2 Parameters present, photo looking north.
Photo taken January 22, 2020.

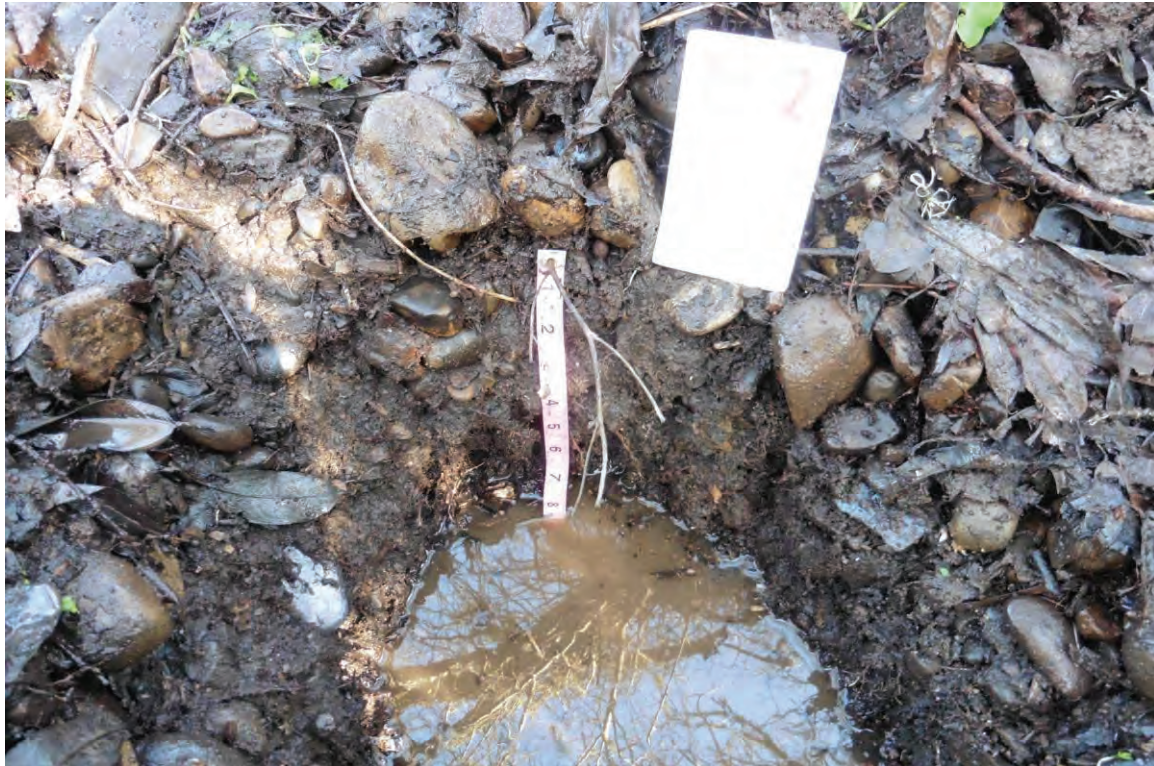
Photo 6: TP2 soil profile, showing very rocky, cobbly, disturbed soils.
Note water table stabilized at 8-inch depth after 30 minutes. Photo taken January 22, 2020.

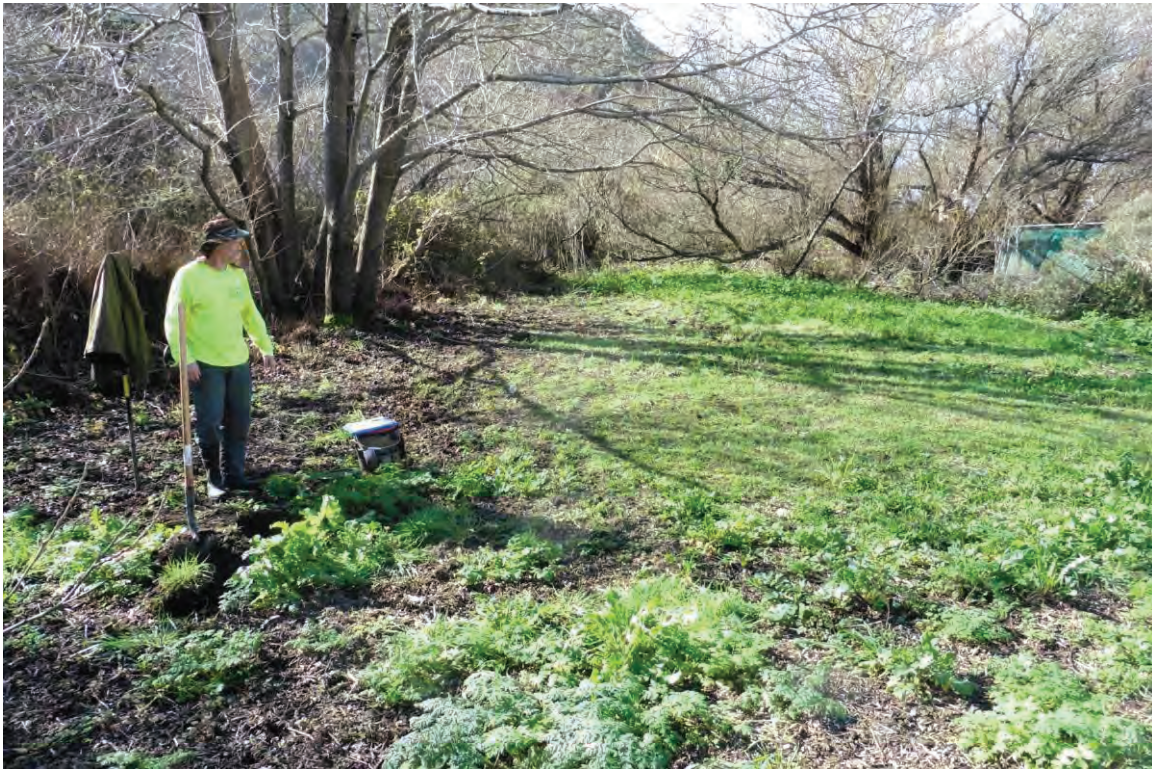
Photo 7: Small field east of the existing parking lot, looking south towards TP3. Upland transitions into two-parameter coastal wetland approximately 5 feet west of TP3, visible as the change in vegetation cover. Photo taken January 22, 2020.

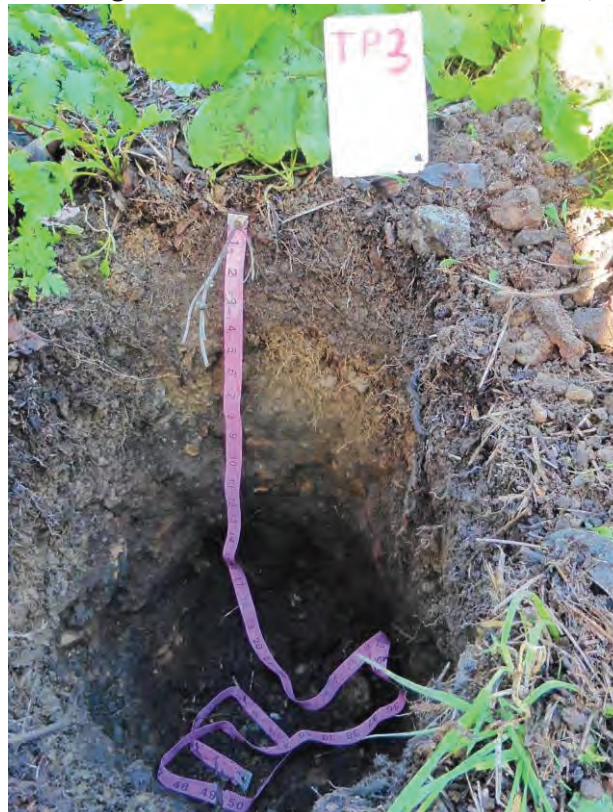
Photo 8: TP3 soil profile, showing a redox dark surface under fill. Soils are well drained, and no wetland hydrology was present. Photo taken January 22, 2020.

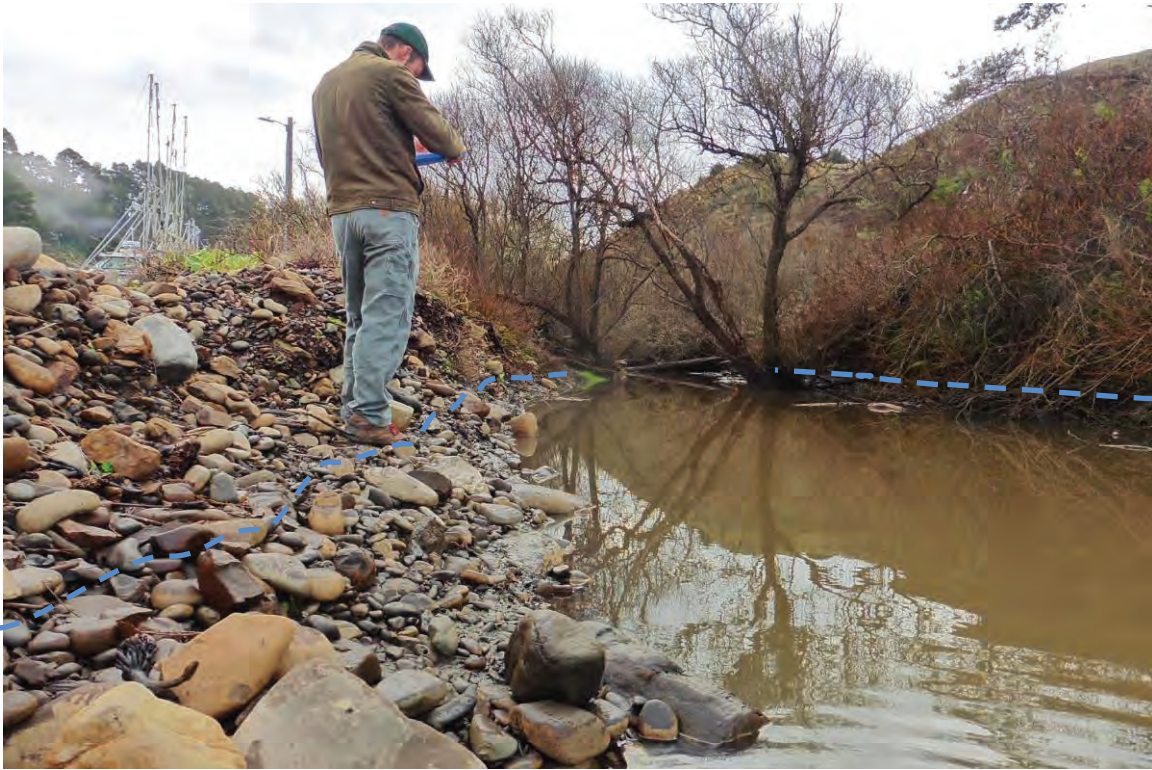
Photo 9: OHWM transect #1, looking upstream (east). OHWM is located at the feet of the wetland ecologist as delineated by the blue line and is approximately 7.5 feet from the edge of the parking lot. Photo taken January 22, 2020.

An OHWM was observed along the Arena Creek channel. Four OHWM transects were completed along Arena Creek within the vicinity of the project area, representing the largest area of jurisdictional waters within the vicinity of the project. Figure 2 shows the transect locations as well as the location of the OHWM and its proximity to the proposed project. OHWM #1 is the westernmost transect, within 150 feet of the Pacific Ocean. OHWM #1 is only 7.5 feet south of the edge of the existing parking lot and occurs on a highly-eroded, anthropogenically-created bank, constructed of cobbles piled into a berm (see Appendix 1, photos 9 and 10, and Appendix 4, OHWM sheet 1). The stream channel is 33 feet wide and OHWM #1 was approximately 12 inches above the water level at the time of the field work. OHWM #2 is 53 feet upstream (east) of OHWM #1 and is 26 feet south of the existing parking lot. OHWM #2 also occurs on an anthropogenically-created bank constructed of cobble, boulders, and gravel (see Appendix 1, photo 11, and Appendix 4, OHWM sheet 2). OHWM indicators were more evident on the natural south bank. The stream channel at OHWM #2 is 24 feet, 3 inches wide and OHWM #2 was approximately 11 inches above the water level at the time of field work. OHWM #3 is 93 feet upstream (east) of OHWM #2 and is 24.5 feet south of the existing parking lot. OHWM #3 also occurs on an anthropogenically-created bank constructed of cobble, boulders and gravel, however the channel is much wider at this location, and conditions are less disturbed than the previous OHWM transects (see Appendix 1, Photo 12, and Appendix 4, OHWM Sheet 3). The stream channel at OHWM #3 is 71 feet wide and OHWM #3 was approximately 6 inches above the water level at the time of field work, reflecting a less constricted and manipulated channel with slower moving water. OHWM #4 is 107 feet upstream (southeast) of OHWM #3 and is 120 feet south of the existing parking lot. OHWM #4 was found on natural streambanks comprised of alluvium, densely vegetated with native brambles and willows (see Appendix 4, OHWM Sheet 4). The streambank is wider at this location, and conditions are relatively undisturbed. The stream channel at OHWM #4 is approximately 40 feet wide; depth to the current water level was not measured at this location and clear photos were not taken due to dense vegetation growth.

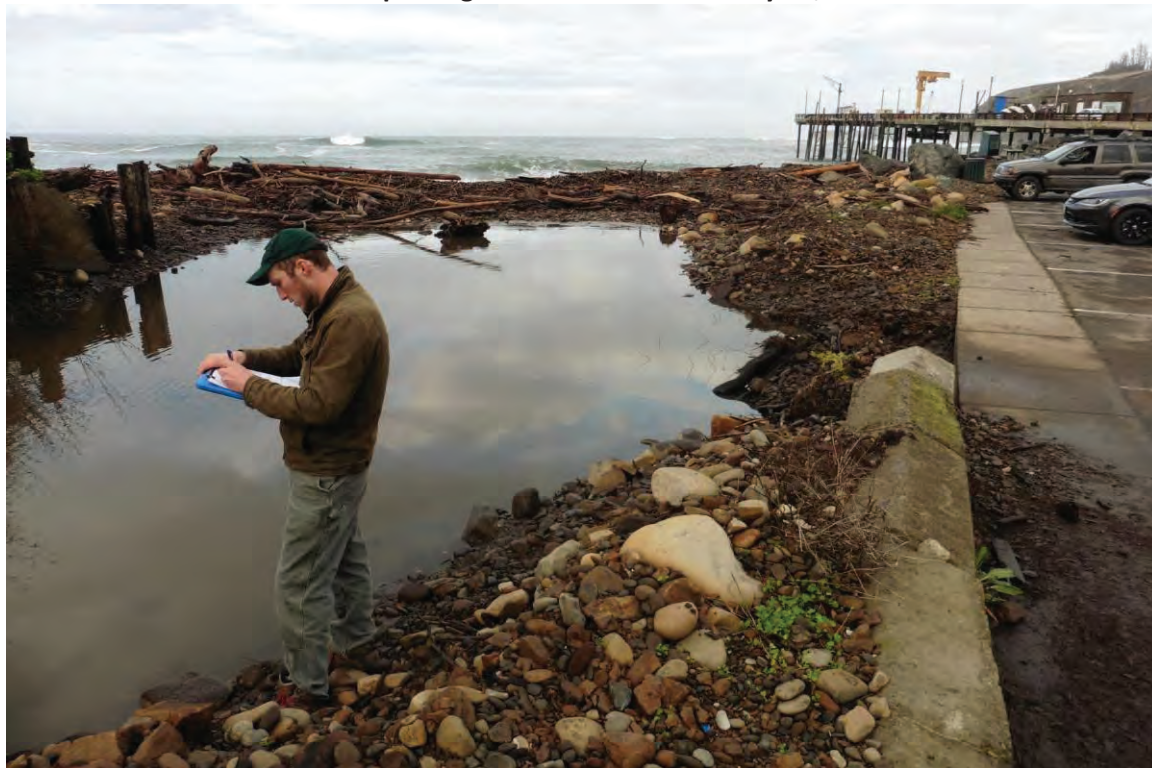
Photo 10: OHWM #1 looking west. OHWM extends to cobble and wood berm created by wave action. Photo taken January 22, 2020.

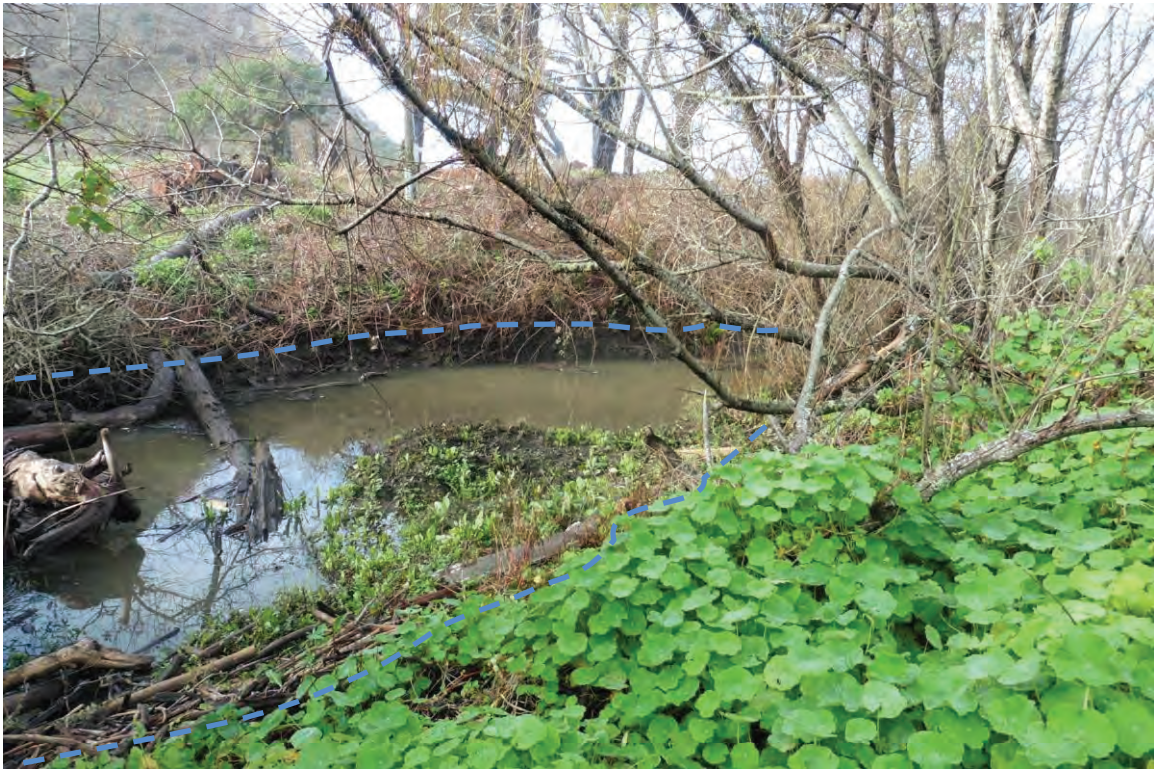
Photo 11: OHWM Transect #2 looking southwest. OHWM is delineated by the blue line and is approximately 26 ft south of the edge of the parking lot. Photo taken January 22, 2020.

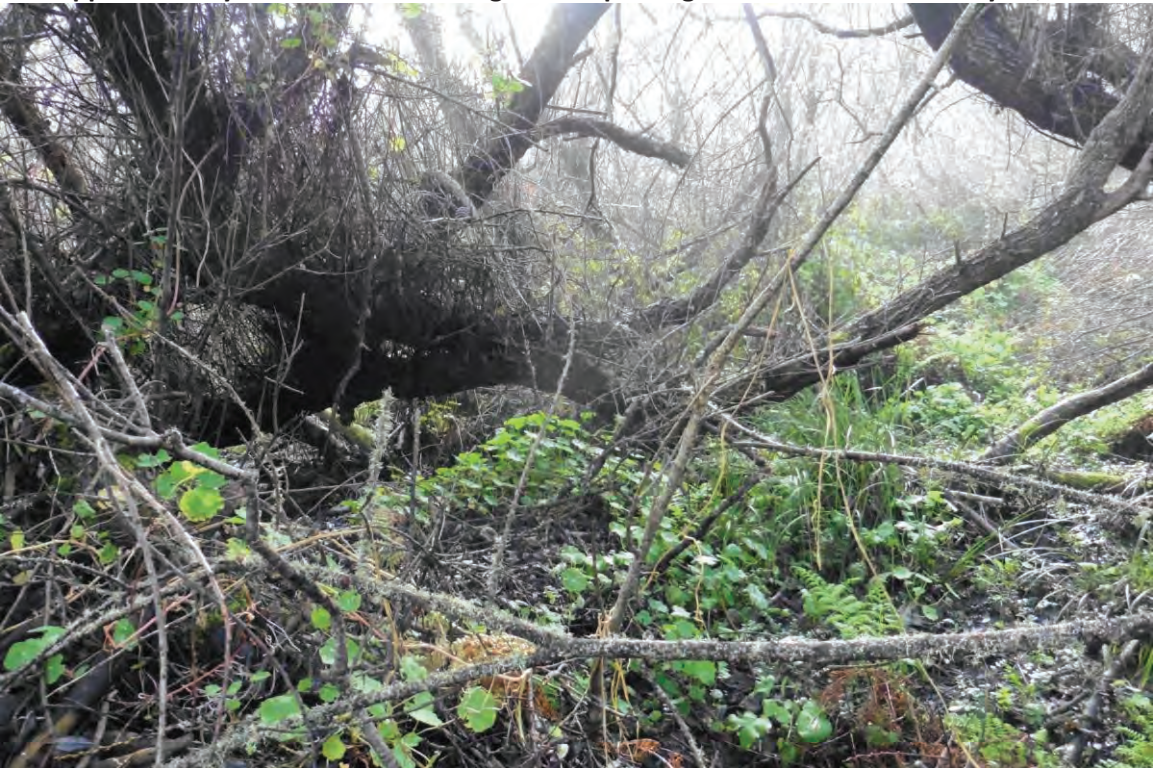
Photo 12: Conditions within the vicinity of OHWM #3, looking south. Dense vegetation made photographing the OHWM difficult and unclear. Pictured is the beginning of the two-parameter swale that connects to the OHWM and leads to TP2 (Figure 2). Photo taken January 22, 2020.

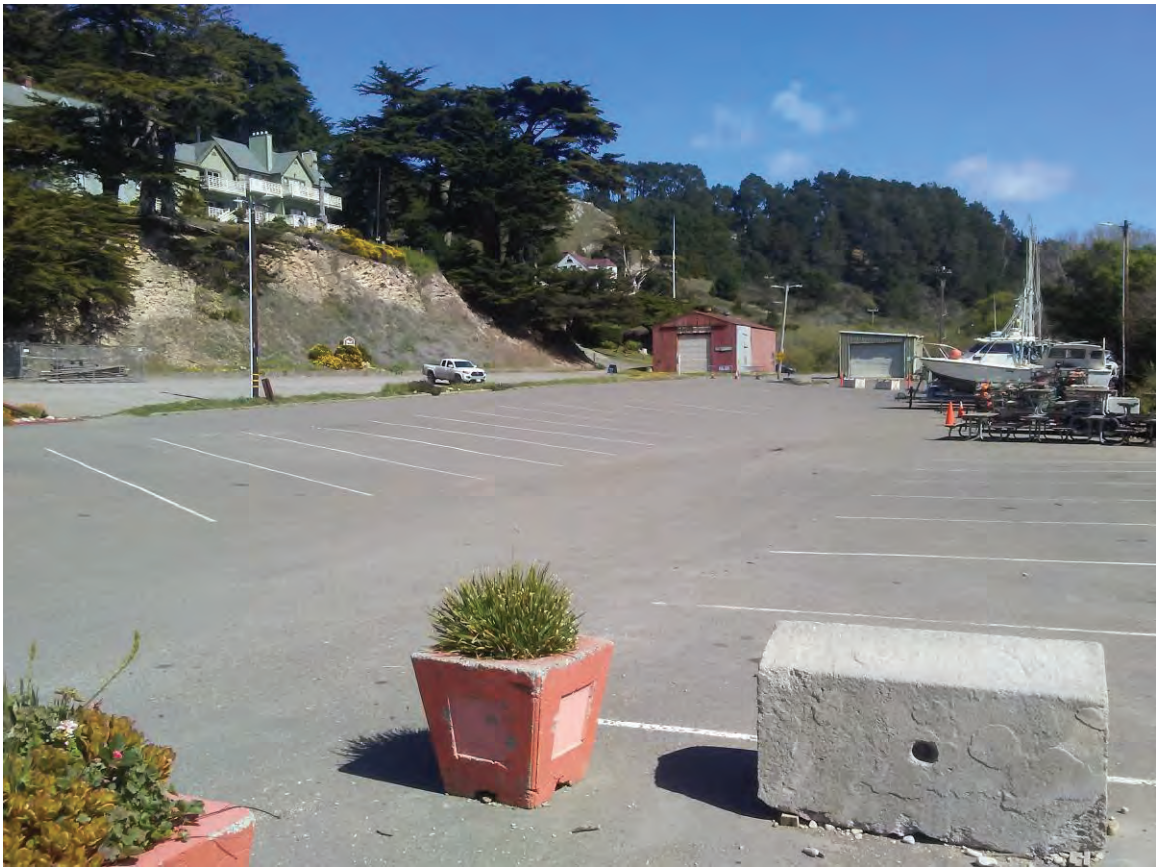
Photo 1: Looking east across the Point Arena Pier parking lot. Note existing development to be rehabilitated to better withstand storm events. Photo taken April 1, 2020.

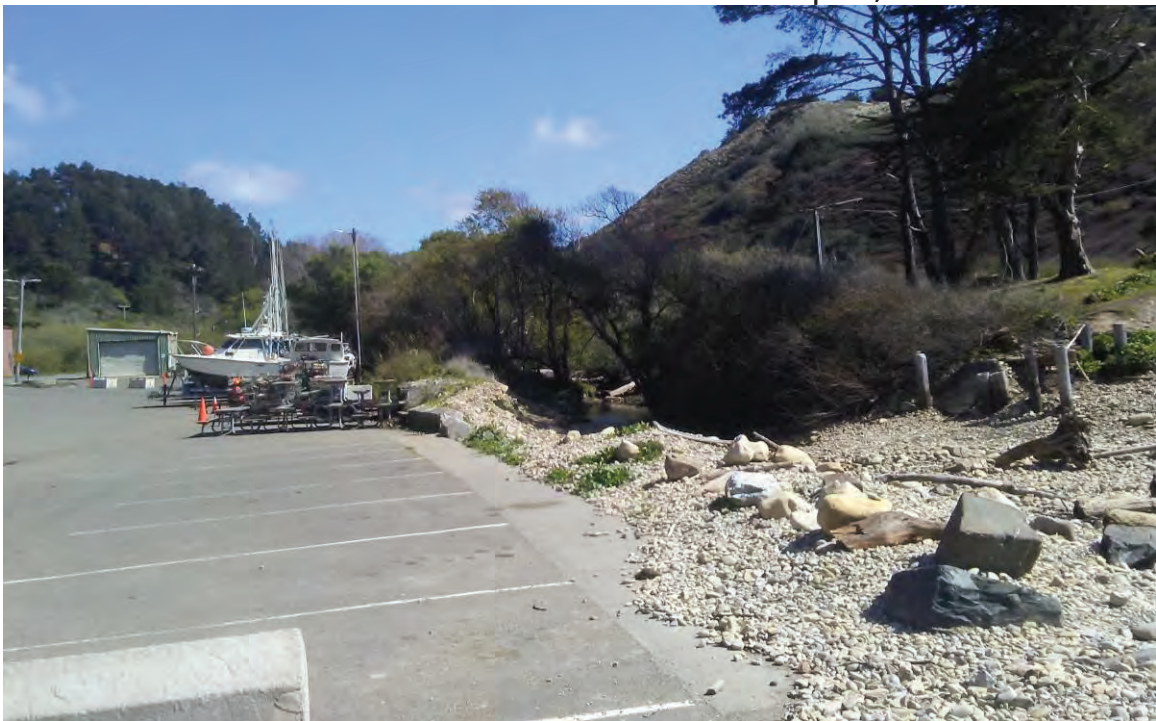
Photo 2: Looking southeast along parking lot edge adjacent to Point Arena Creek. Note that the stream edge is immediately adjacent to the parking lot. Photo taken April 1, 2020.

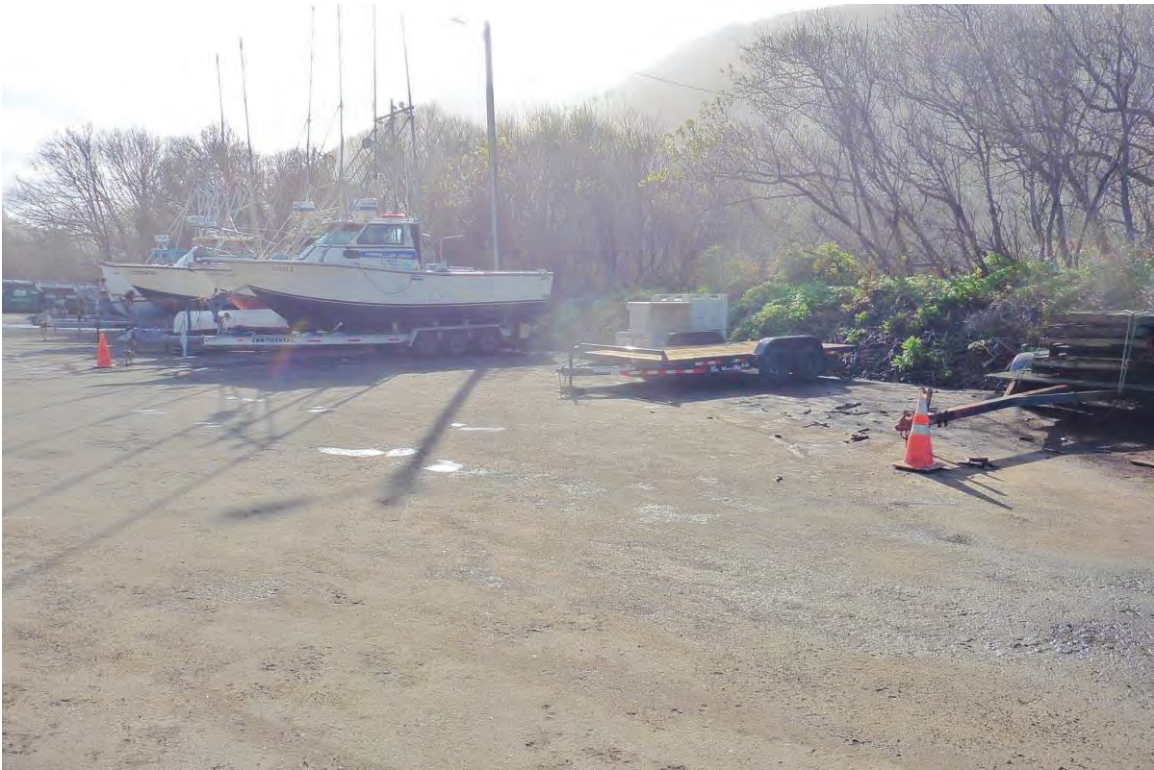
Photo 3: Looking south toward Point Arena Creek within the eastern portion of the parking lot. Note berm along edge of parking lot and riparian vegetation beyond. Photo taken January 22, 2020.

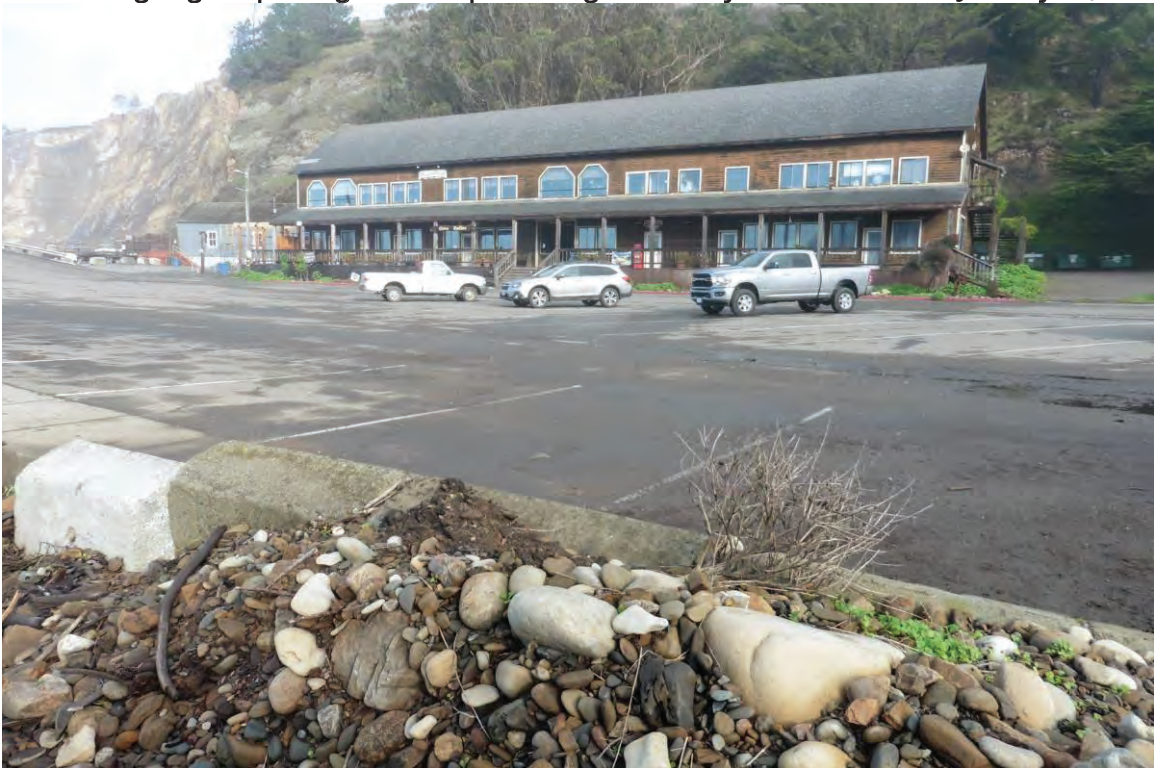
Photo 4: Looking north from Point Arena Creek across parking lot toward pier building. Note rocky berm and existing development to be rehabilitated. Photo taken January 22, 2020.

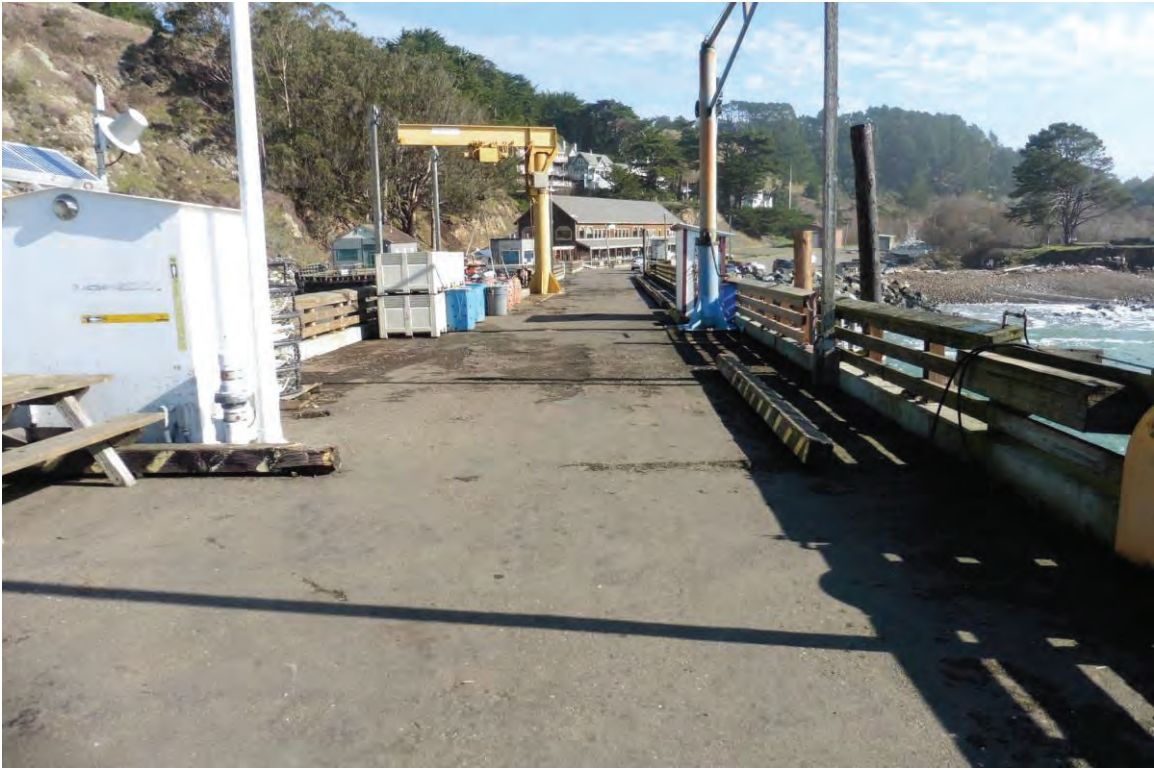
Photo 5: Looking east from the Point Arena pier toward the parking lot and study area.
Photo taken January 22, 2020.

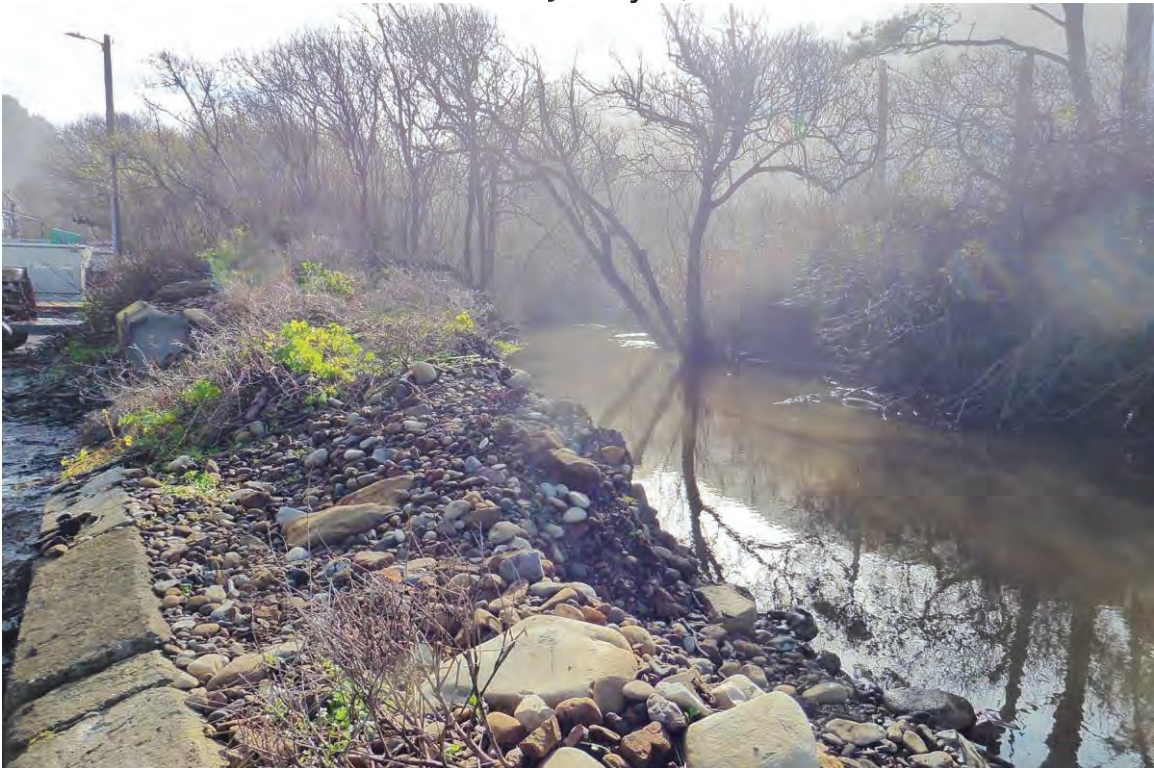
Photo 6: Looking southeast along the rocky berm separating Point Arena Creek and the parking lot.
Note Pacific willow tree canopy along the creek and dense brushy understory. Photo taken January 22, 2020.

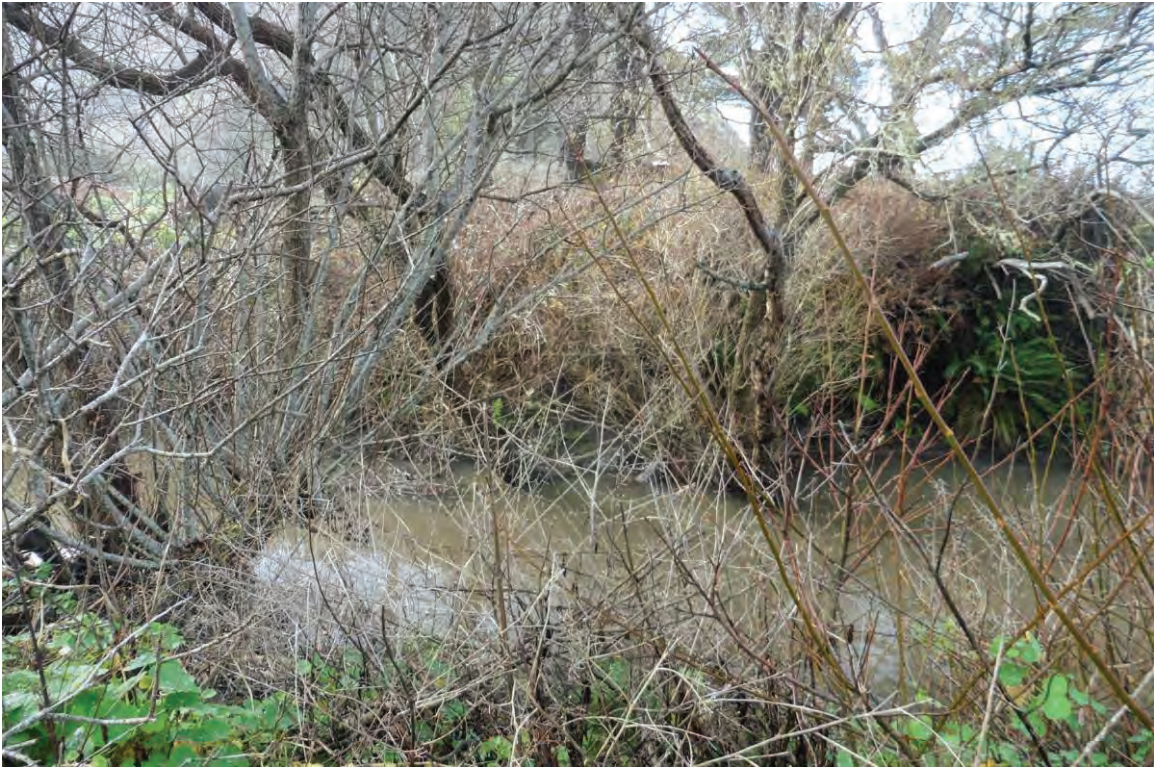
Photo 7: Looking south across Point Arena Creek from the rocky berm. Note Pacific willow tree canopy along the creek and dense brushy understory. Photo taken January 22, 2020.

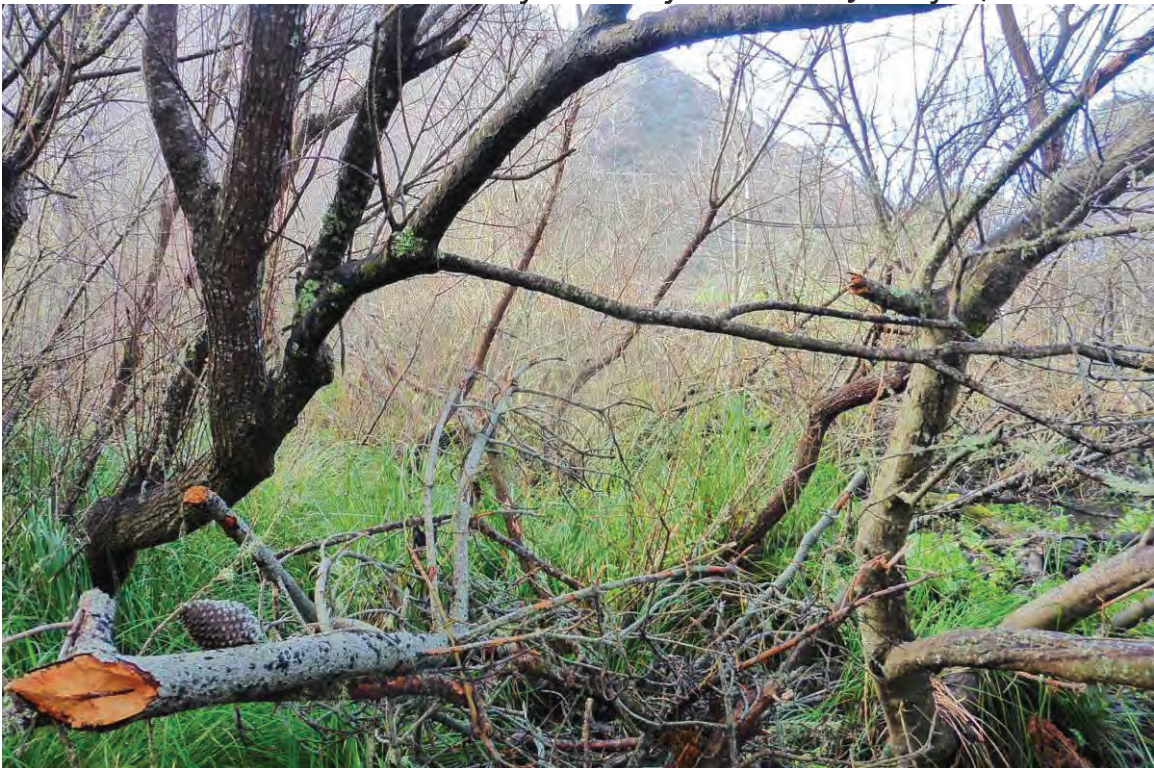
Photo 8: Looking southwest within riparian woodland along Point Arena Creek away from the parking lot. Pacific willow dominant in the canopy. Note slough sedge (*Carex obnupta*) dominance in the understory. This area is PAMB habitat, however no PAMB or burrows were present. Photo taken January 22, 2020.

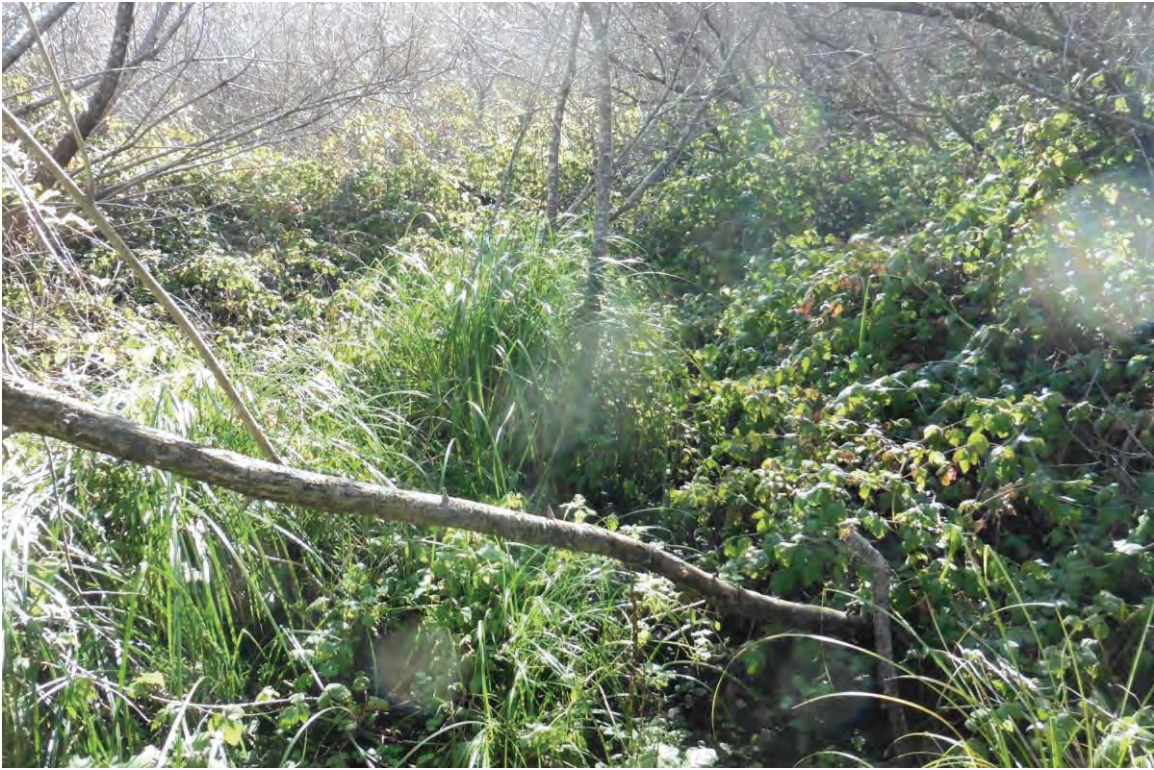
Photo 9: Looking south within riparian woodland along Point Arena Creek away from the parking lot. Coast willow dominant in the canopy. Note slough sedge and California blackberry dominance in the understory. This area is PAMB habitat, however no PAMB or burrows were present. Photo taken January 22, 2020.

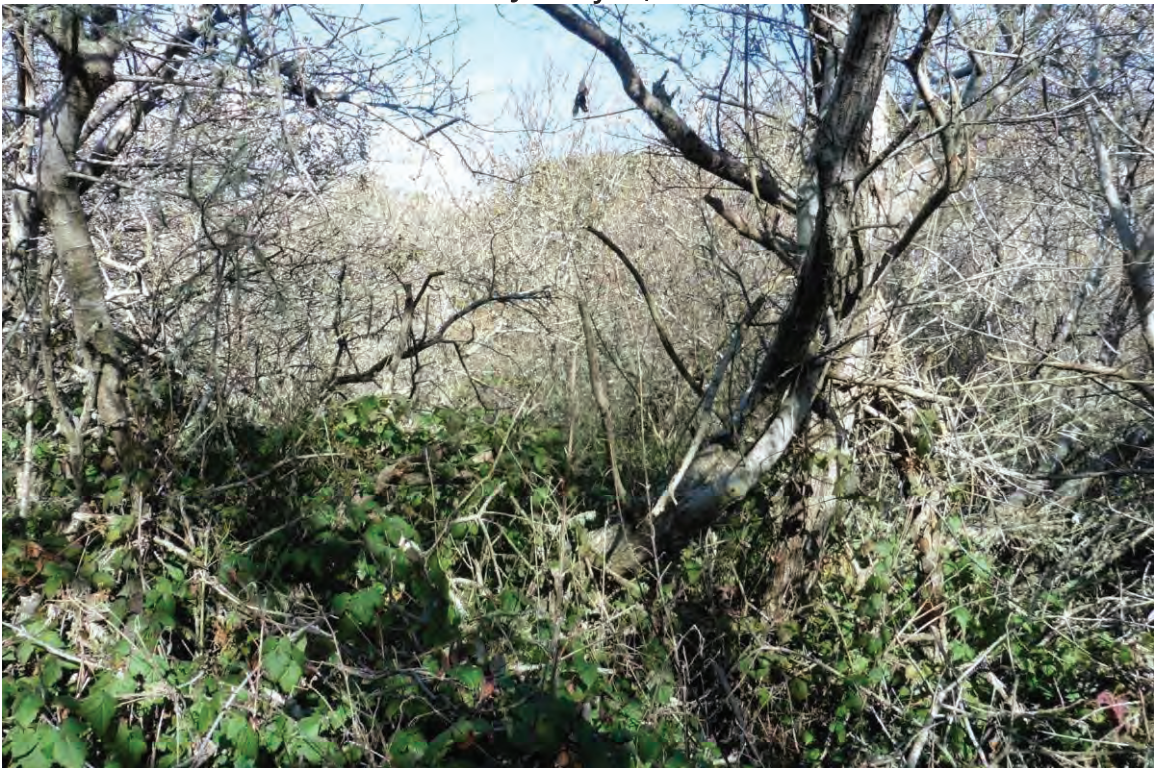
Photo 10: Looking south within riparian woodland along Point Arena Creek away from the parking lot. Pacific willow dominant in the canopy. Note California blackberry dominance in the understory. This

area is PAMB habitat, however no PAMB or burrows were present. Photo taken January 22, 2020.

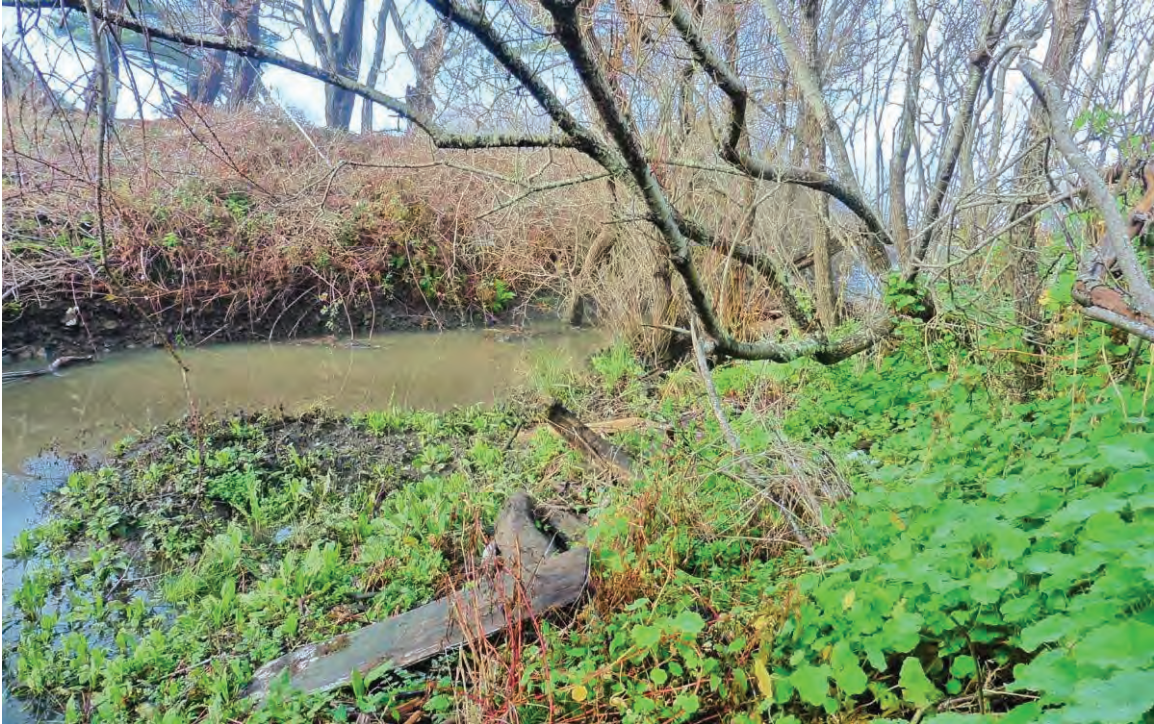
Photo 11: Looking west along Point Arena Creek immediately south of the rocky berm. Pacific willow dominant in the canopy. Note California blackberry dominance and native vegetation along south bank which is PAMB habitat, however no PAMB or burrows were present. Note garden nasturtium dominance along rocky berm. Photo taken January 22, 2020.

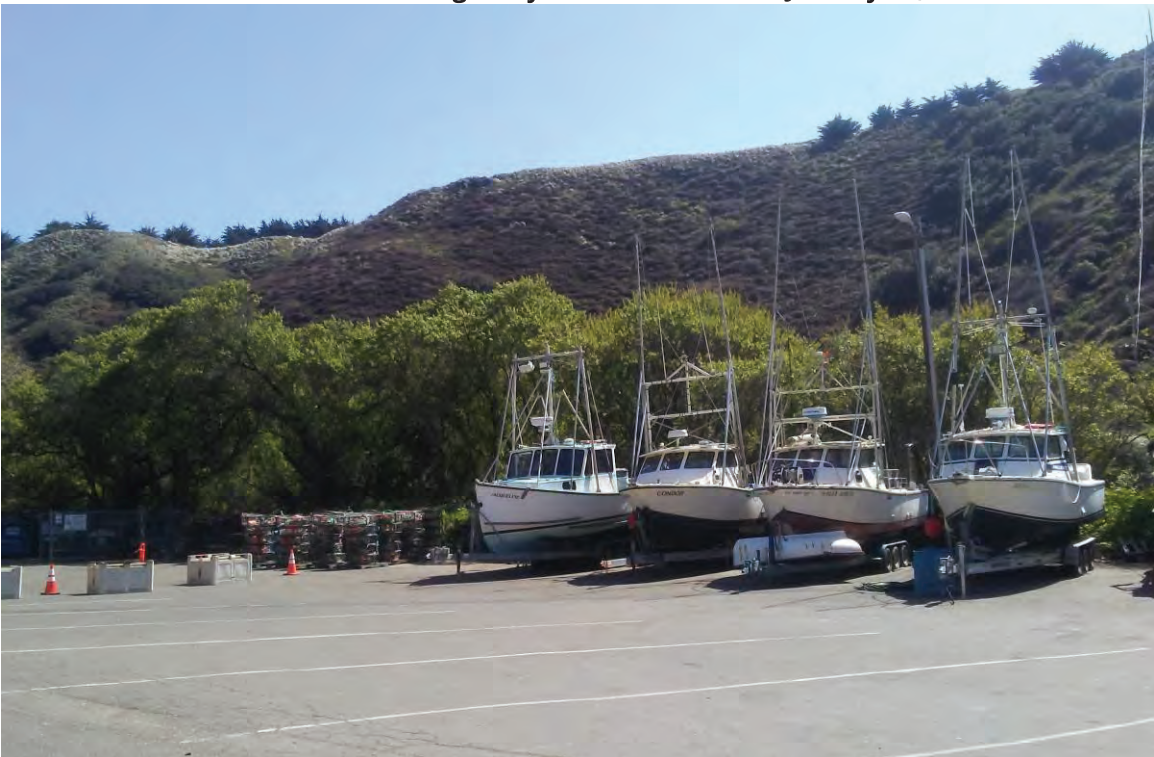
Photo 12: Looking south toward north-facing bluff slope known to have PAMB populations. This slope was not surveyed but does contain prime PAMB habitat and is presumed to be inhabited by PAMB.

Portions of the project area are located within a CNNDDB polygon depicting a known occurrence of PAMB and suitable habitat is immediately adjacent to the project area within the riparian habitat along Point Arena Creek and on the north-facing slope across Point Arena Creek (see Appendix 1, Photo 12). PAMB is known from areas with lush mesic herbaceous and woody vegetation, often on north-facing slopes or gullies where soils are well drained and friable. This typically includes riparian habitat, moist coastal scrub, and dune scrub comprised of a wide variety of brushy and herbaceous cover (USFWS, 1998). The methods described in the "Draft Guidelines for Project Related Habitat Assessments and Presence-Absence Surveys for the Point Arena Mountain Beaver" (USFWS, 2017a) were used to determine suitable habitat for PAMB within the vicinity of the project and to determine the presence or absence of the species within the observed suitable habitat. In brief, the PAMB habitat assessment included surveying for and mapping suitable habitat for PAMB within the vicinity of the project area, including indicator species. Results from this effort are recorded in the Results section of this report. Areas mapped as PAMB habitat are considered ESHA by the California Coastal Commission and are mapped as such on Figure 3.
