CALIFORNIA COASTAL COMMISSION

1-90-113-A2

(BRENNAN)

EXHIBITS

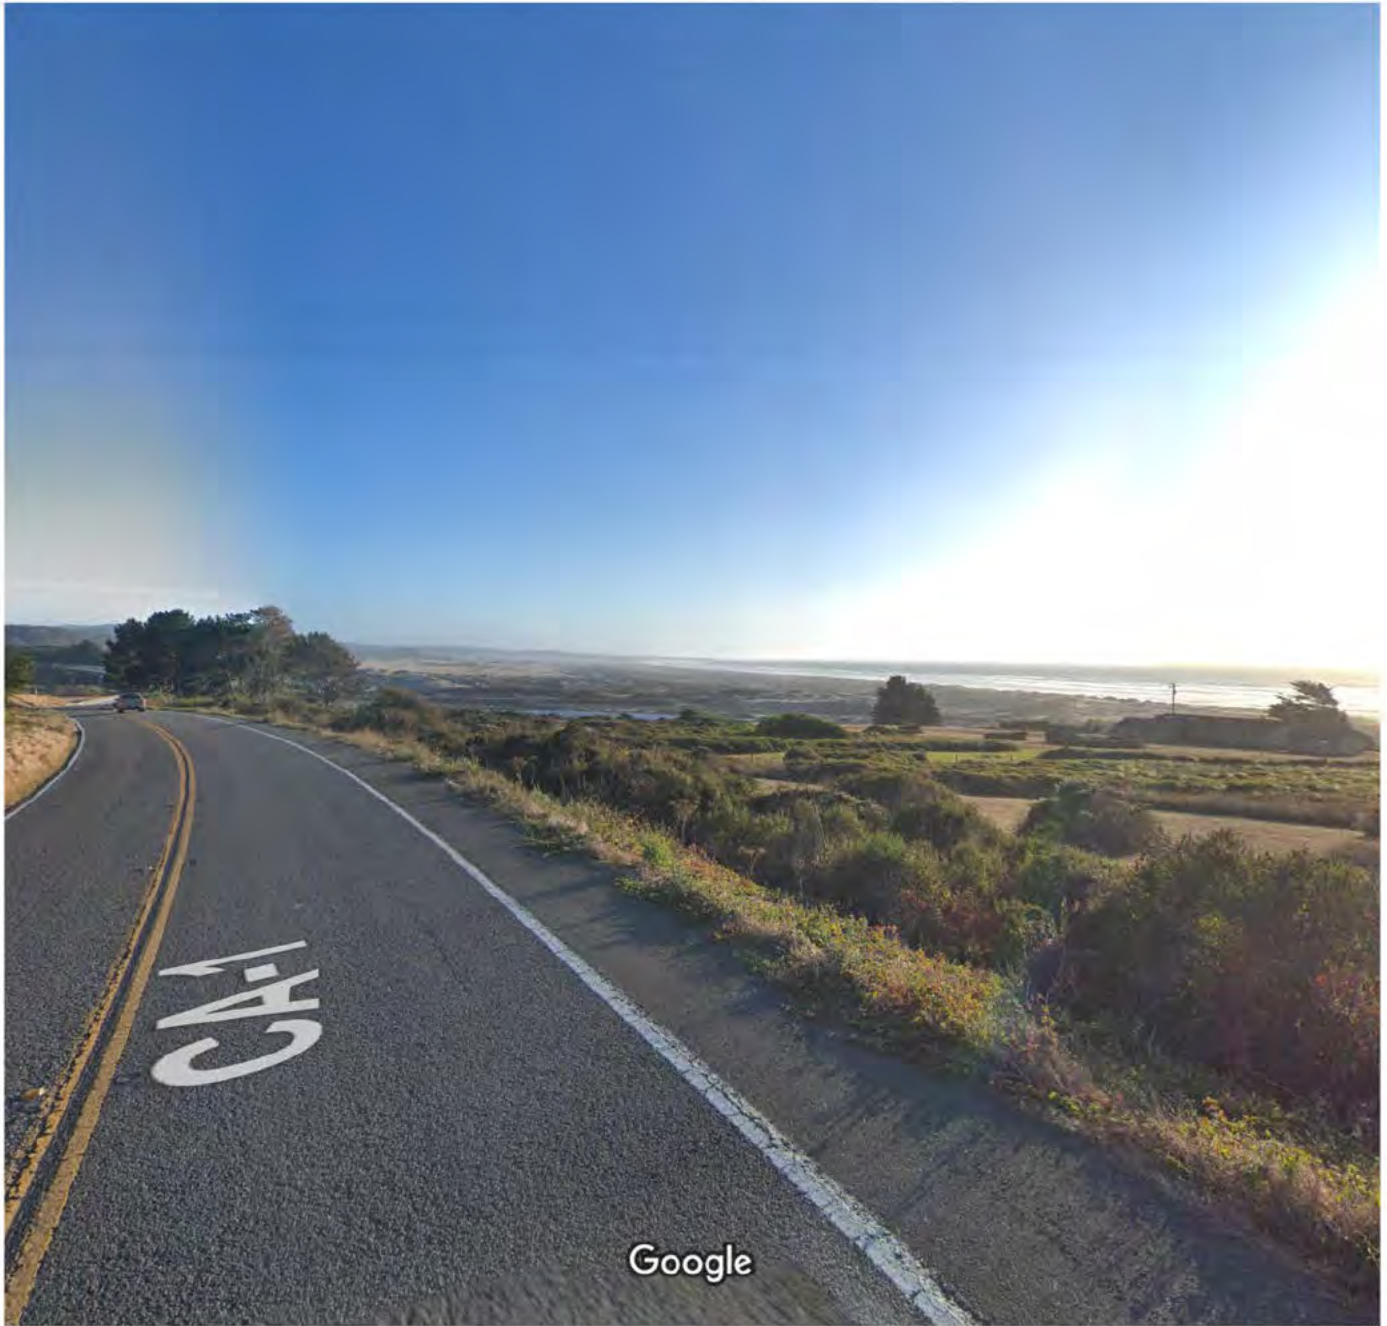
Proposed (Conceptual) Southbound Visual

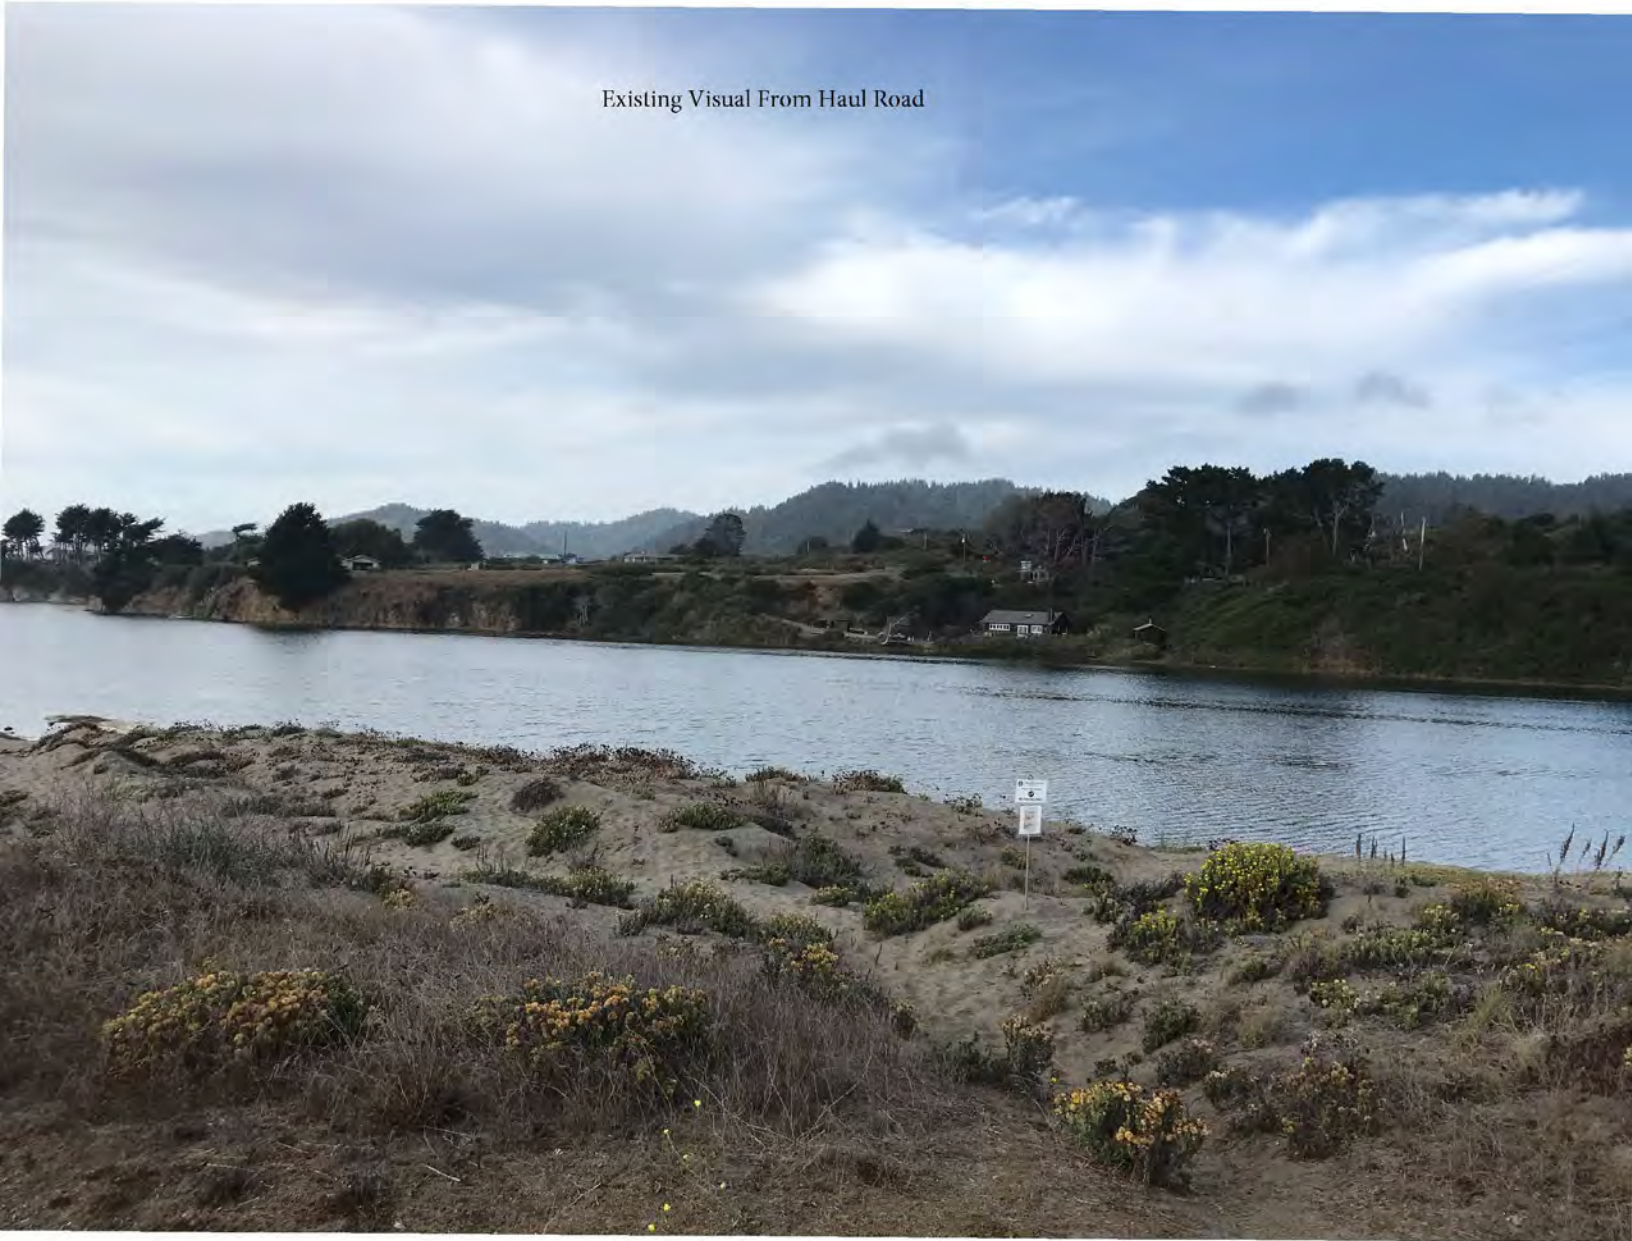
Proposed (Conceptual) Visual from Haul Road

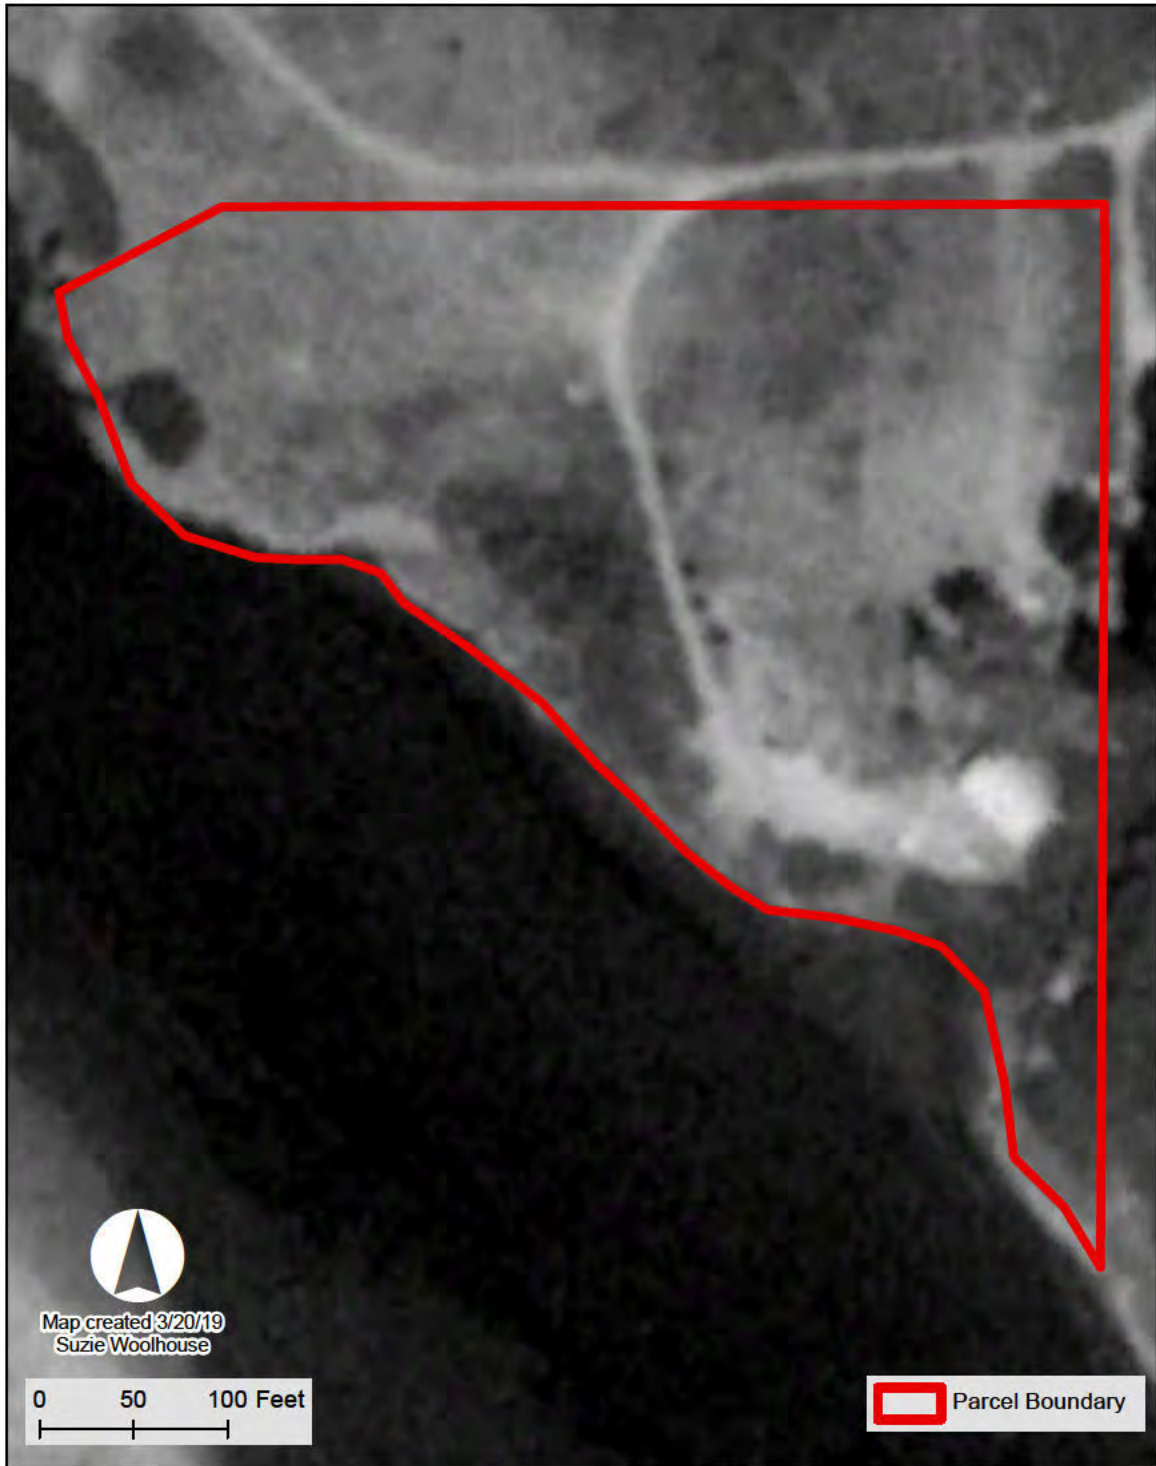
Figure 3. Map of Study Area with 1998 Aerial Photo.

1998 Google Earth Map

The Ten-Mile River watershed has a long history of ranching and logging. Historic T-sheet maps from the turn of the last century were examined but did not show any particular land use in the area of the subject parcel. 1998 Google Earth aerial imagery (**Figure 3**) shows that no major changes have occurred in the past 20 years.

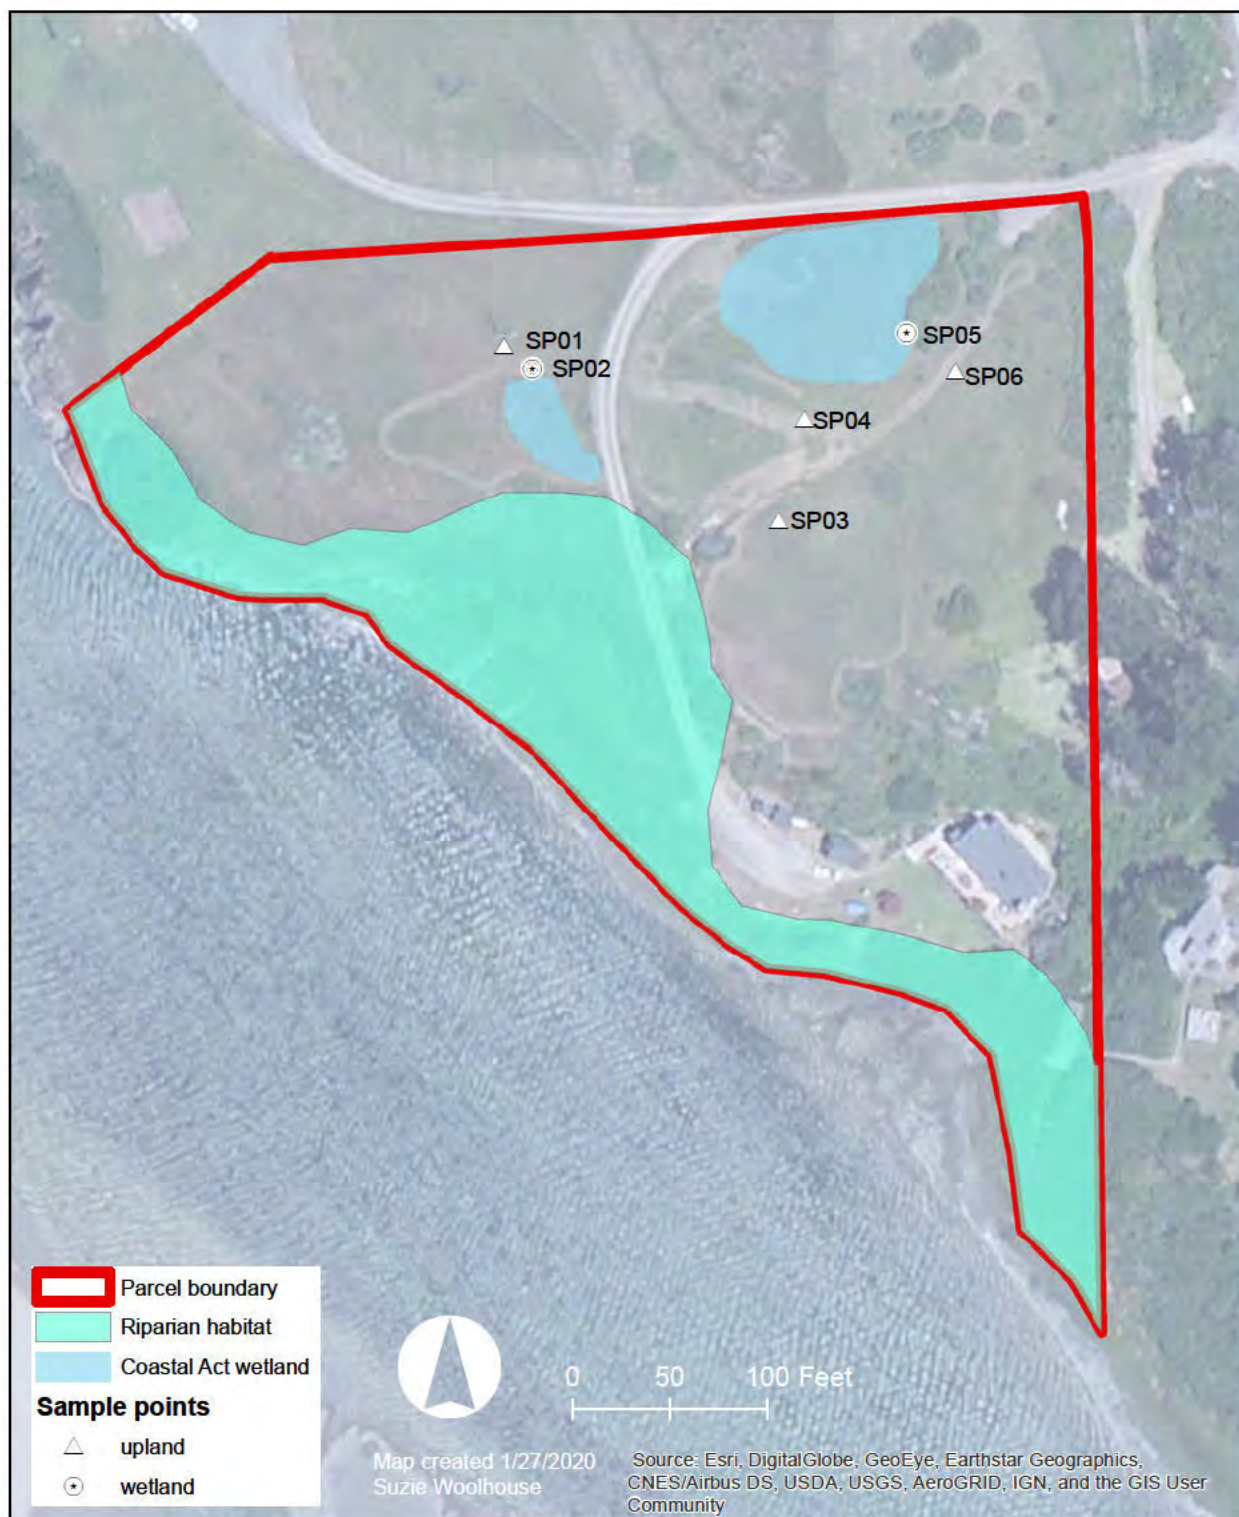
Wetland and Riparian Map

Figure 7. Wetland delineation map depicting wetlands, sample points, delineated and presumed wetlands and riparian habitat.

Wetland delineation field work began with examination of the topography and searching for surface hydrology and plant species that can grow as hydrophytes. Further analyses were performed at six sample points where wetland soils, hydrophytic vegetation, and hydrology were inspected according to the US Army Corp of Engineers (ACOE) methodology for: Western Mountains, Valleys, and Coast Region (Version 2.0). Wetland data sheets for these sample points are presented in **Appendix D**. Sampling points are marked in the field with 24-inch wooden stakes with colored flagging and labeled in Sharpie marker. Locations of sampling points are depicted on the Wetland Delineation Map in **Figure 7**. The ACOE recognizes wetlands where hydrophytic vegetation, hydric soils, and hydrology are all present. In the California Coastal Zone, wetlands are recognized if any one of the three ACOE parameters (hydrophytic vegetation, hydric soils, or hydrology) is present. Wetlands reported and mapped in this report are Coastal Act wetlands and may or may not be Army Corps wetlands; a distinction is made where important.

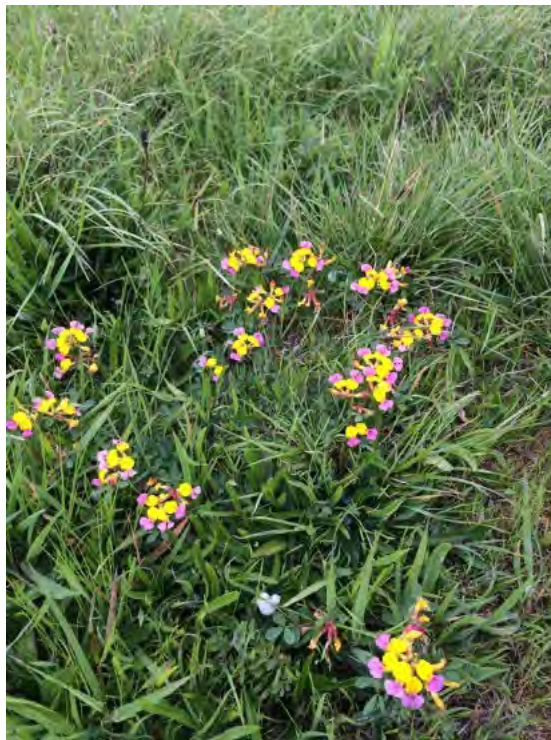
Figure 8. *Hosackia gracilis* within the study area.

Harlequin lotus (**Figure 8**) was found in a small patch on the property in the eastern section. This small plant in the pea family (Fabaceae) is believed to be the larval host plant for the Endangered Lotis Blue Butterfly (*Lycaeides idas lotis*). The patch is surrounded heavily by non-native grasses within the common velvet grass – sweet vernal grass meadow. A Lotis Blue butterfly survey was conducted and no butterflies were observed. Through consultation with USFWS, it was determined

that protection of this plant on this parcel is not necessary to avoid take of the butterfly. The harlequin lotus population was not considered ESHA for the purpose of this report.

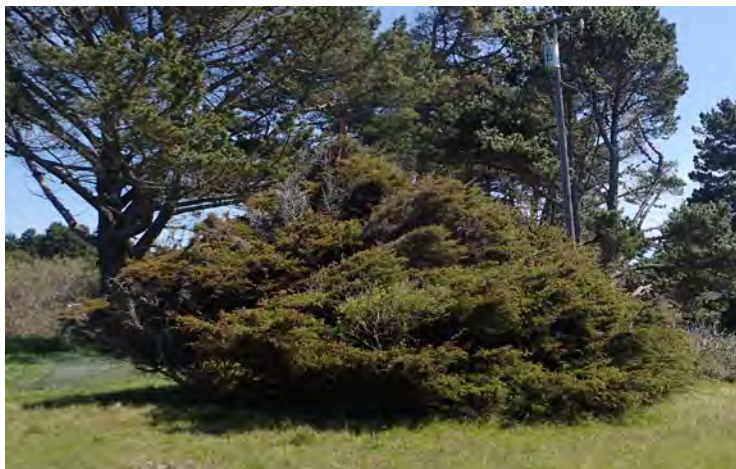
Figure 9. Presumed horticultural planting of Mendocino cypress.

A single Mendocino cypress (**Figure 9**) occurred on the eastern side of the parcel, east of the patch of Harlequin lotus. It is likely that this individual will not grow in the stunted pygmy form as it is growing in rich prairie soils. The northernmost natural population of Mendocino cypress reported on CNDDDB is on the northern side of Pudding Creek in Fort Bragg. This individual is growing approximately 7.5 miles north of its natural range. As this specimen is out of the normal range for this species, as there are no other Mendocino cypress trees around, and as this species is available for horticultural purchase locally, it is assumed that this specimen was horticulturally-planted and thus does not warrant protection. Therefore, this Mendocino cypress was not treated as an ESHA for the purpose of this report.
