CALIFORNIA COASTAL COMMISSION

A-5-LGB-19-0011 (BLUEBIRD #24, LLC) APRIL 16, 2021

GEOLOGICAL REVIEW MEMORANDUM

Re: 1585 S. Coast Highway, Laguna Beach (Bluebird #24, LLC),
Appeal No. A-5-LGB-19-0011

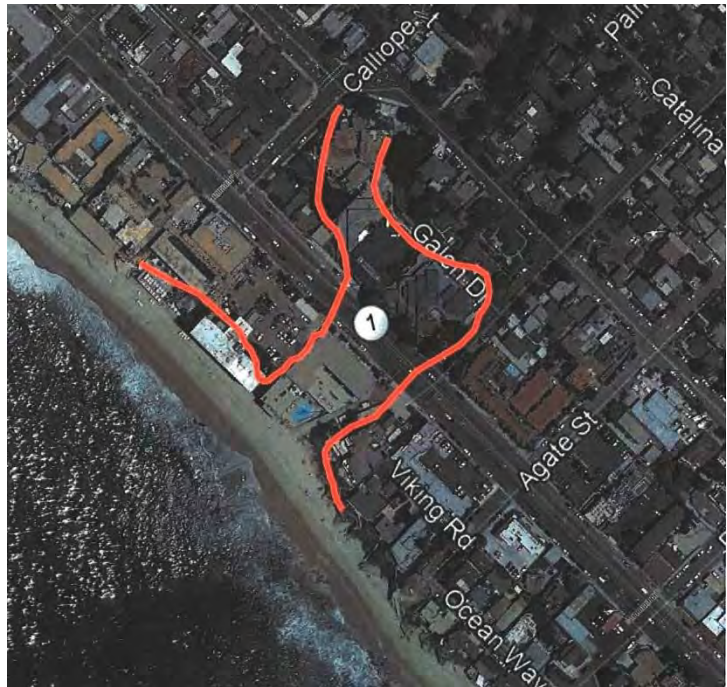
Relying primarily on a stereo pair of 1947 aerial photographs, Ref. 2 provides a delineation of the canyon edges (**Fig. 1**) that locates the northern edge between the Laguna Sands building and its northern neighbor (Surf and Sand), the southern edge just south of the present-day beach access ramp, and the entire Laguna Sands complex within the mouth of Bluebird Canyon.

Figure 1: GeoSoils' (Ref. 2) interpretation of Bluebird Canyon edges in 1947 aerial photographs

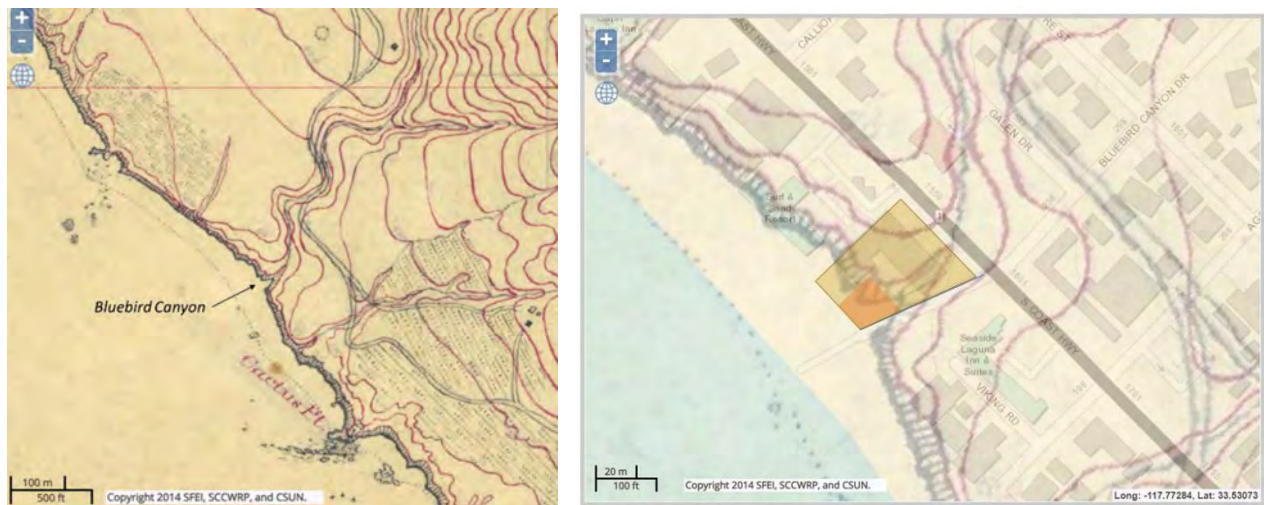
In evaluating whether the Laguna Sands site occurs on a “coastal bluff”, I have considered both the available information on the pre-development status of the site and its present-day topography. The earliest, reasonably reliable topographic map of the area is provided by the 1885 T-Sheet, which shows Bluebird Creek within a narrow, approximately 40-ft deep incised canyon that widened toward the mouth (**Fig. 2**). The general shape and path of the canyon on the T-Sheet is similar to GeoSoils’ interpretation of the 1947 aerial photographs, but with a somewhat narrower and more horn-shaped mouth.¹ More importantly, the T-Sheet map indicates that there were 60-foot high, partially seaward-facing bluffs along both the northern and southern slopes of the canyon mouth, as well as steeper, 20-foot sea cliffs at the bluff toe, likely reflecting the Topanga Formation bedrock noted in Ref. 3 (and still visible from the beach in places at the Surf and Sand property to the north) and the effects of wave action on the lower bluff. **Fig. 2** also includes an overlay of the modern street map and the approximate position of the Laguna Sands complex on the T-Sheet map. While neither the overlay nor the T-Sheet itself are likely to be perfectly accurate, it is apparent that much of the present-day building footprint corresponds to the natural bluff face, both within the canyon and on its more seaward-facing margins.

Figure 2: Views of Bluebird Canyon and Laguna Sands site from 1885 T-Sheet Map
(Source: <http://www.caltsheets.org/socal/>)

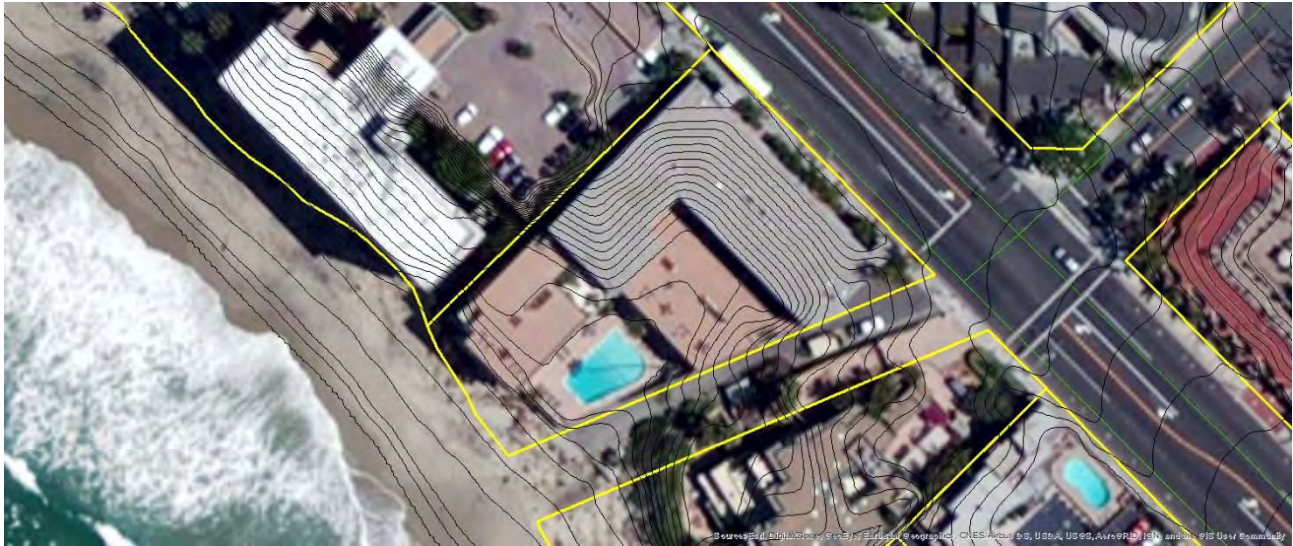
As discussed in Ref. 2, the landforms at the Laguna Sands site have since been modified, including partial filling of the canyon and culvertization of the stream. Nonetheless, the present-day topography of the site still indicates that the existing building is mostly located on the slope or face of a bluff landform meeting the LUE and Coastal Commission definitions of a “coastal bluff.” **Fig. 3** (below) shows the existing building in relation to topographic contours (and parcel boundaries) from the OCPW database. Because the property is almost completely covered by buildings, the smooth slopes indicated by the contours are not accurate – rather, they are interpolations between LiDAR measurements of the ground surface -- but the contours nonetheless show that the site still has considerable vertical relief, descending from Coast Highway, at approximately +50 ft NAVD88, to the beach at approximately +13 ft NAVD88.

Figure 3: Laguna Sands site with OCPW topographic contours

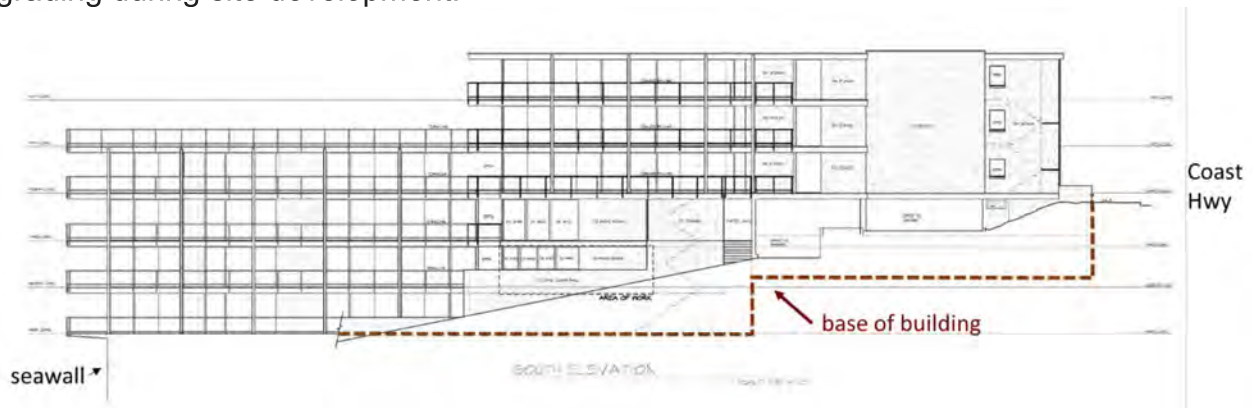
As shown in a cross section from the P+A plan set (**Fig 4**), the actual ground surface beneath the building descends from the top of slope in a series of steps, likely the result of grading during site development.

Figure 4: Laguna Sands building cross section, looking north (Modified from Ref. 1)

Although the exact nature of the historic landform modifications at the Laguna Sands site are not known, the present-day landform consists of a 35 - 40 foot high slope likely consisting remnant natural bluffs (evident in the T-Sheet and early USGS topographic maps) and imported fill. The present-day slope overlooks the beach and shoreline and were it not for the seawalls protecting the lower portions of the Laguna Sands complex, would be subject to wave attack and marine erosion (see Ref. 3). Thus, the slope on the site is an oceanfront/coastal bluff under the LUE definition, and the bulk of the Laguna Sands building is located on the bluff face.² The seaward portions of the structure may have been constructed on the beach.
