5-20-0446 (OC RE-HAB 1, LLC & GC-8, LLC)

APRIL 1, 2021

Plans and Specifications for Slope Stabilization & Surface Drainage Improvements at
Via Ballena Landslide
San Clemente, California

Via Ballena Landslide Repair, San Clemente, CA

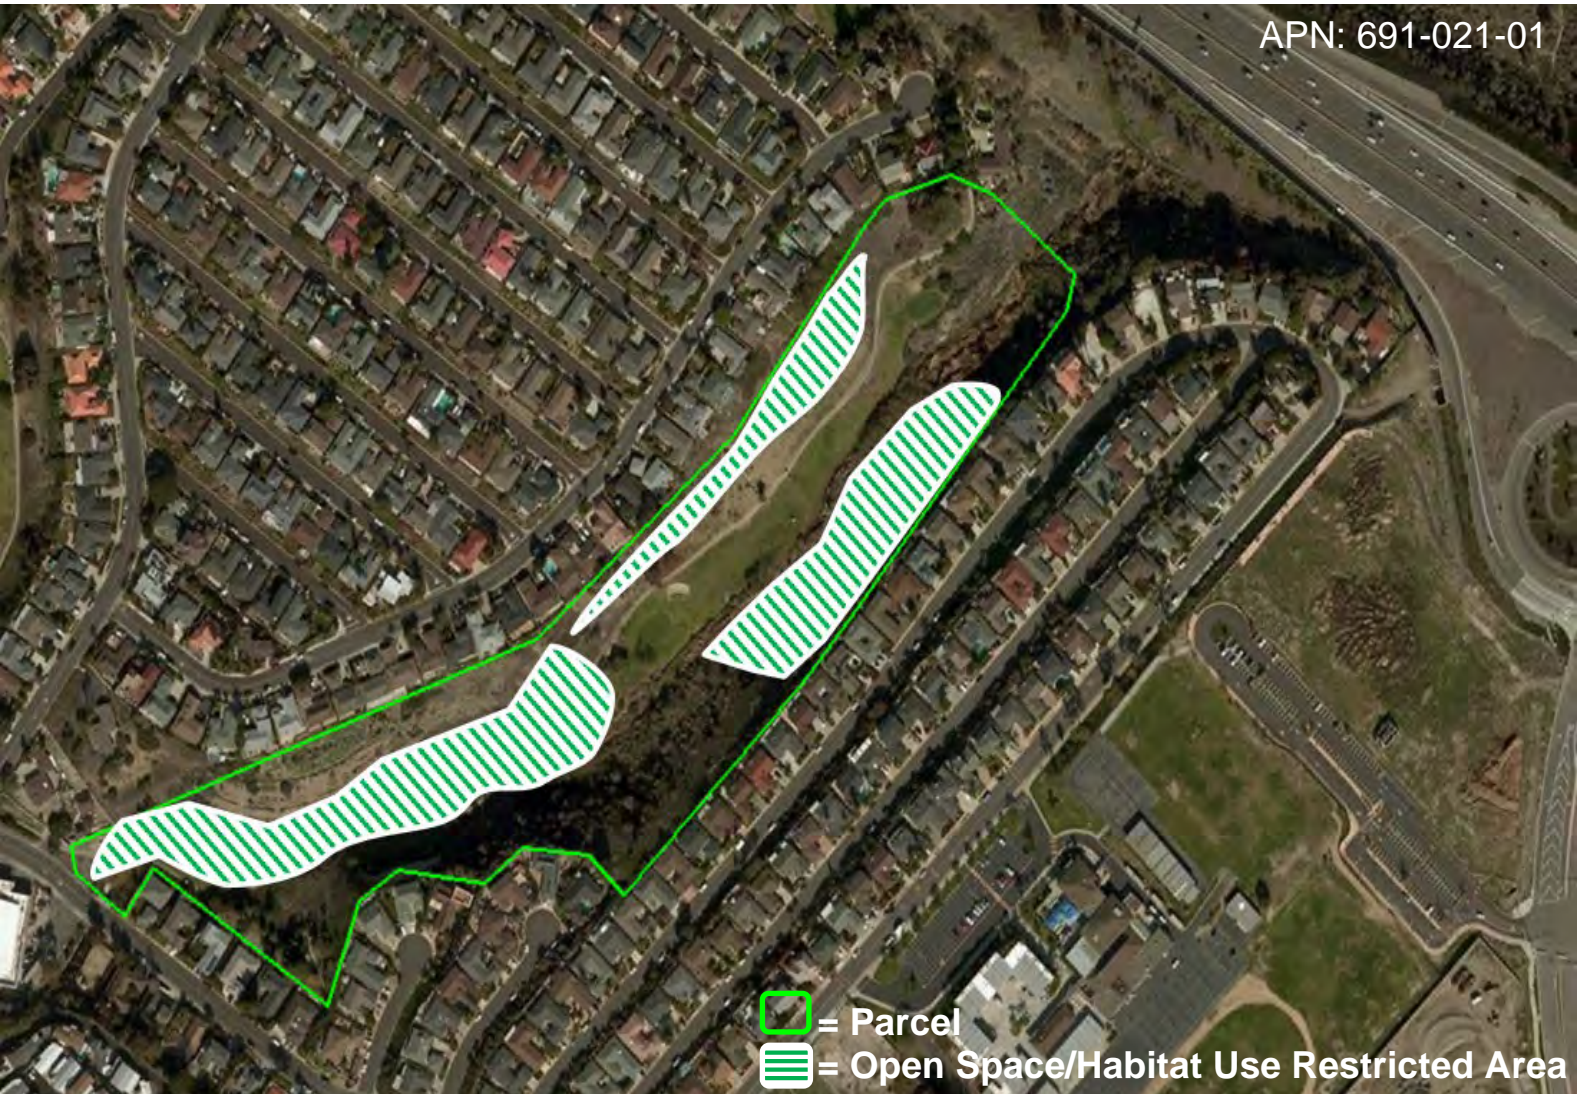
Location	APN(s)	Total Restricted Area
Project Site	691-021-01	4.62 acres
*Off-Site Mitigation Site 1	691-231-06	3.52 acres
*Off-Site Mitigation Site 2	680-041-53 680-011-63 680-011-64	3.75 acres

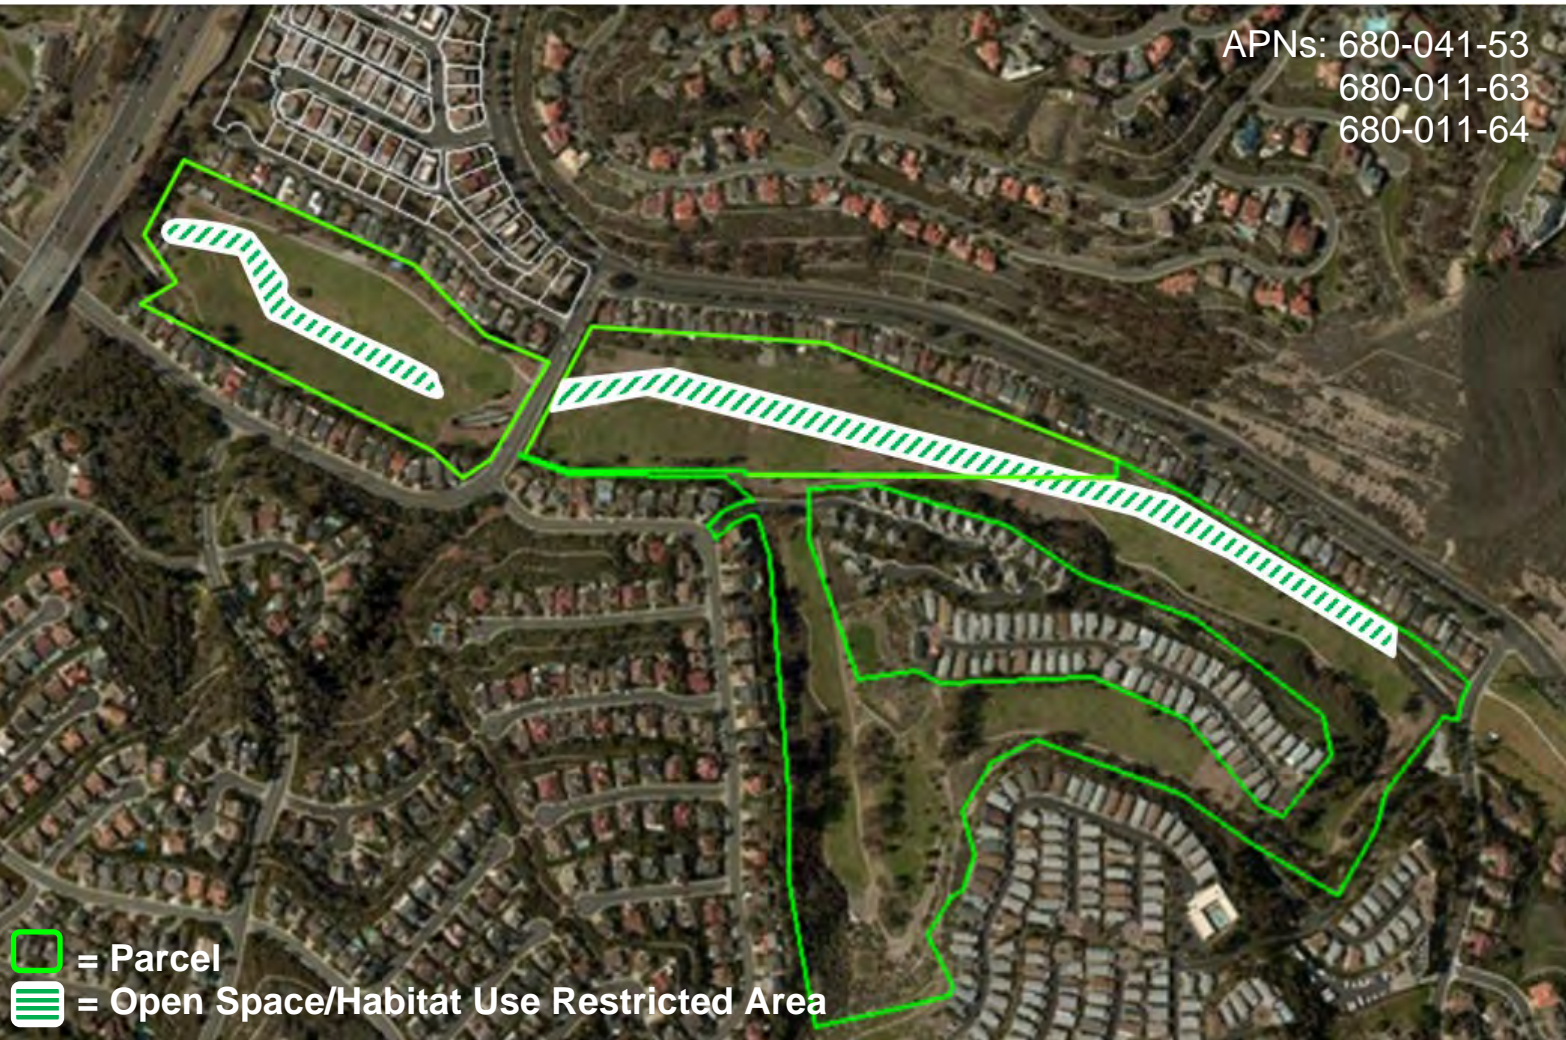
Off-Site Mitigation Site 2

APNs: 680-041-53
680-011-63
680-011-64

= Open Space/Habitat Use Restricted Area

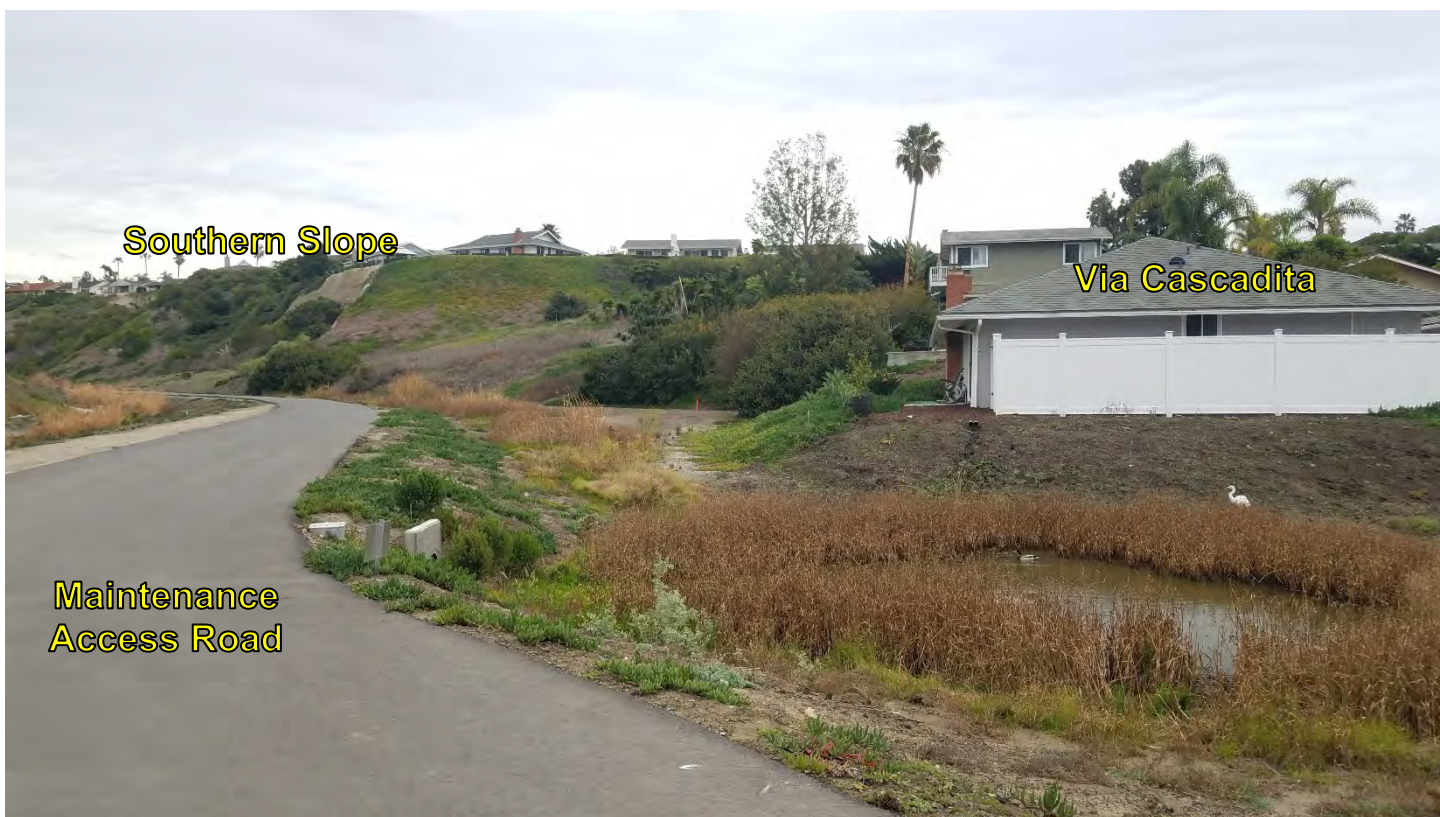
Project Site, wetlands at western entrance to Cascadita Canyon.

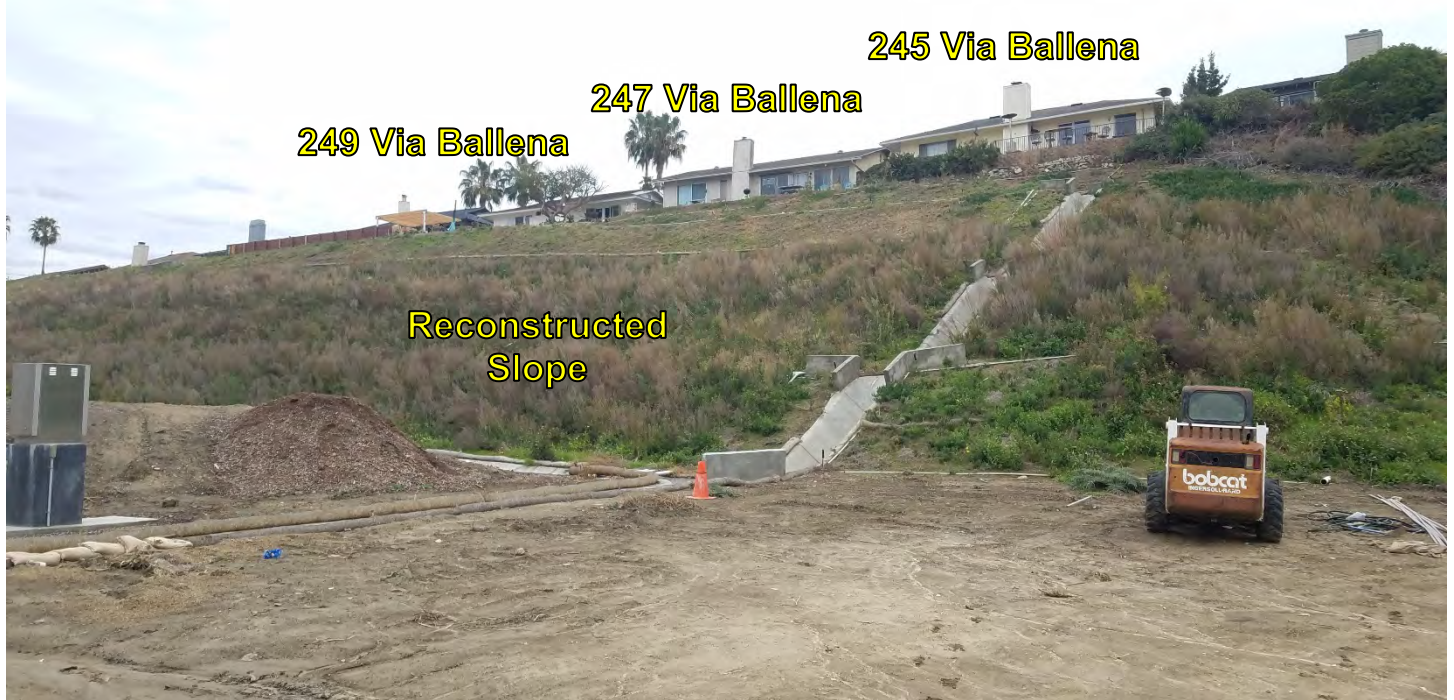
Project Site, reconstructed southern slope in Cascadita Canyon.

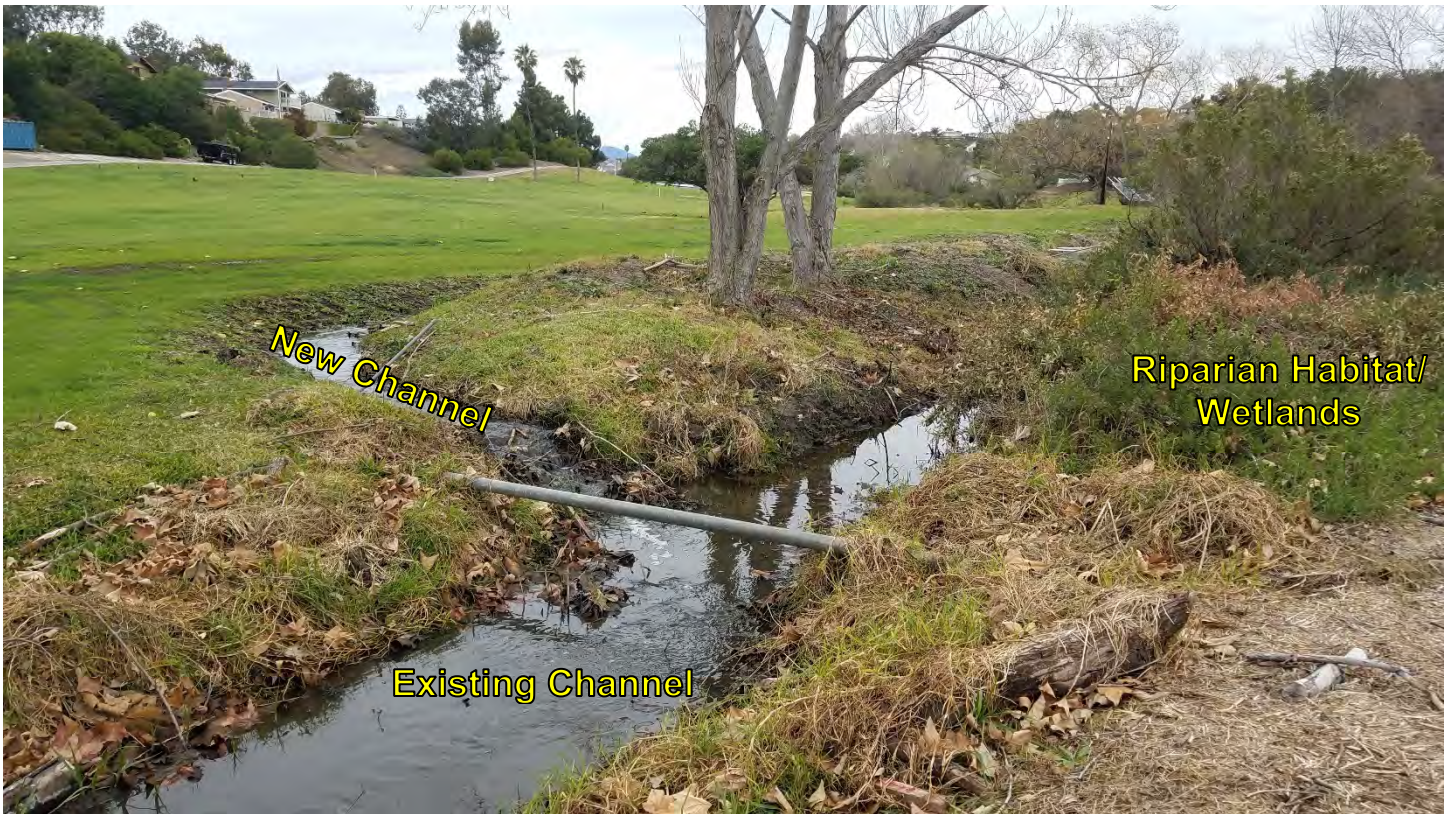
Off-Site Mitigation Site 2, new channel braided through existing channel.
