**9-20-0457 (Southern California Gas Co.)**

### **EXHIBITS**

**Subject: SoCalGas Line 80 Abandonment Project, Revegetation and Restoration Plan, Santa Barbara, Santa Barbara County, California**

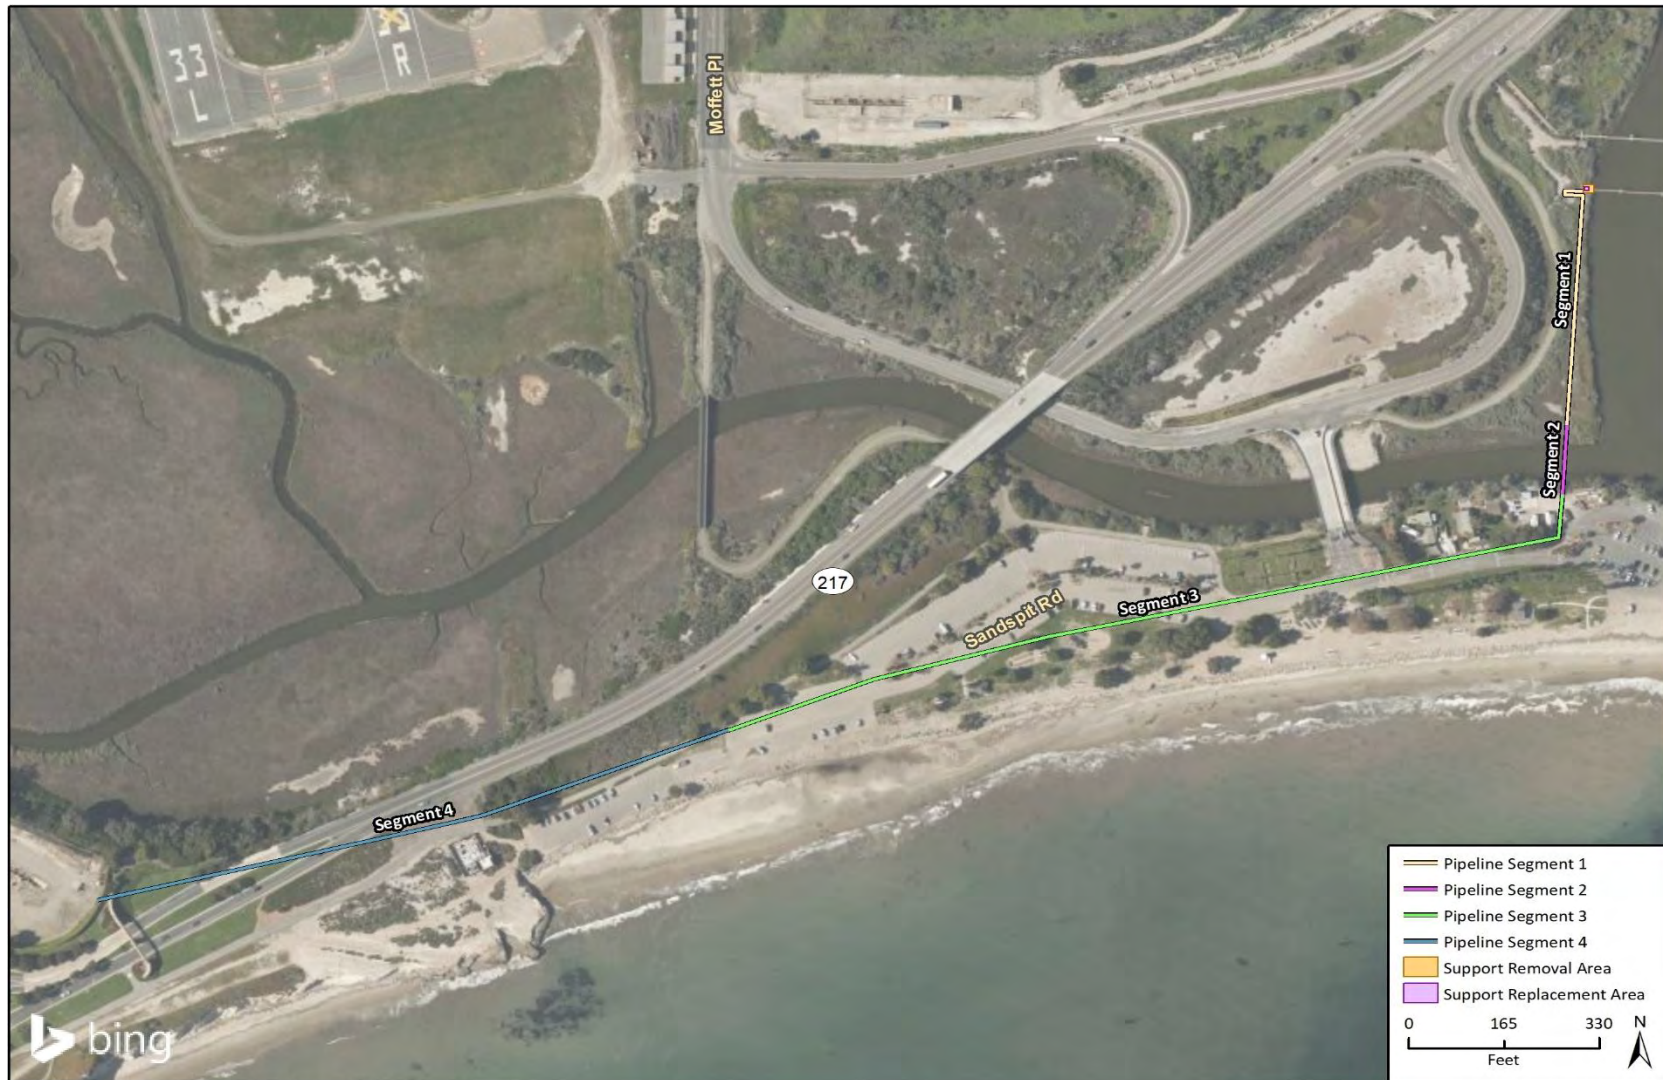
Figure 2 Project Site and Vicinity

Fig. PD-2 Project Site

The portion of Line 80 and Line 159 where the line removal and span support replacement are to occur begins adjacent to an existing bike path, east of Sandspit Road. The pipeline extends south, under Tecolotito Creek and continues west under Sandspit Road, traversing through the Goleta Beach County Park, westward, under SR 217, and terminating at an existing paved facility east of Mesa Road. The proposed portion of Line 80 to be removed or abandoned lies within the unincorporated County, with the exception of a portion of pipeline under SR 217 within the City of Santa Barbara and the terminus on UCSB. Please see Biological Resources Assessment (Rincon, 2018a) for additional location information.
