CALIFORNIA COASTAL COMMISSION

ADDENDUM

SUBJECT: **ADDENDUM TO ITEM F7a, Informational Briefing on OC Parks CDP No. 5-19-0345 (Capistrano Beach County Park) for the Commission Meeting of Friday, August 13, 2021.**

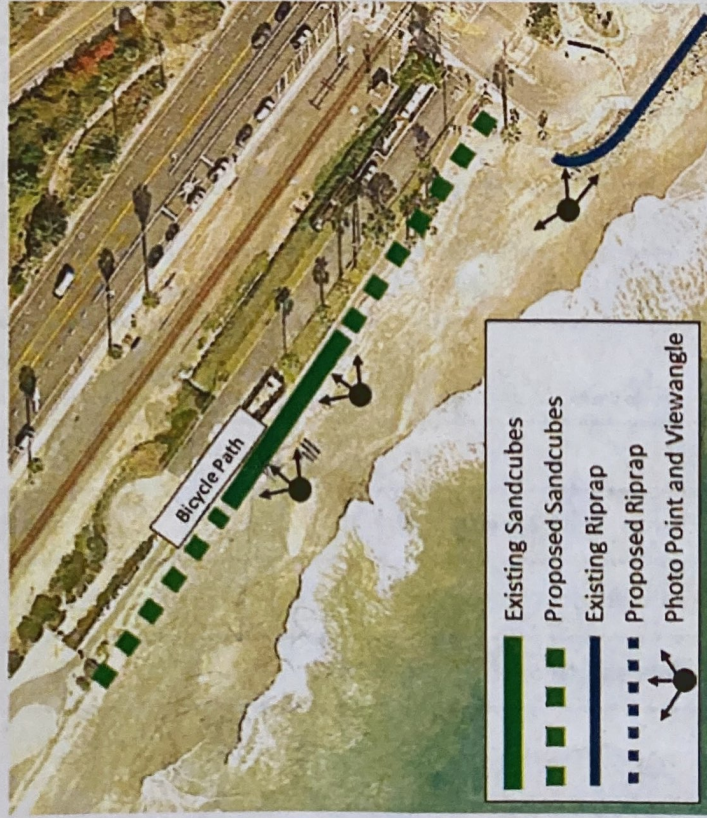
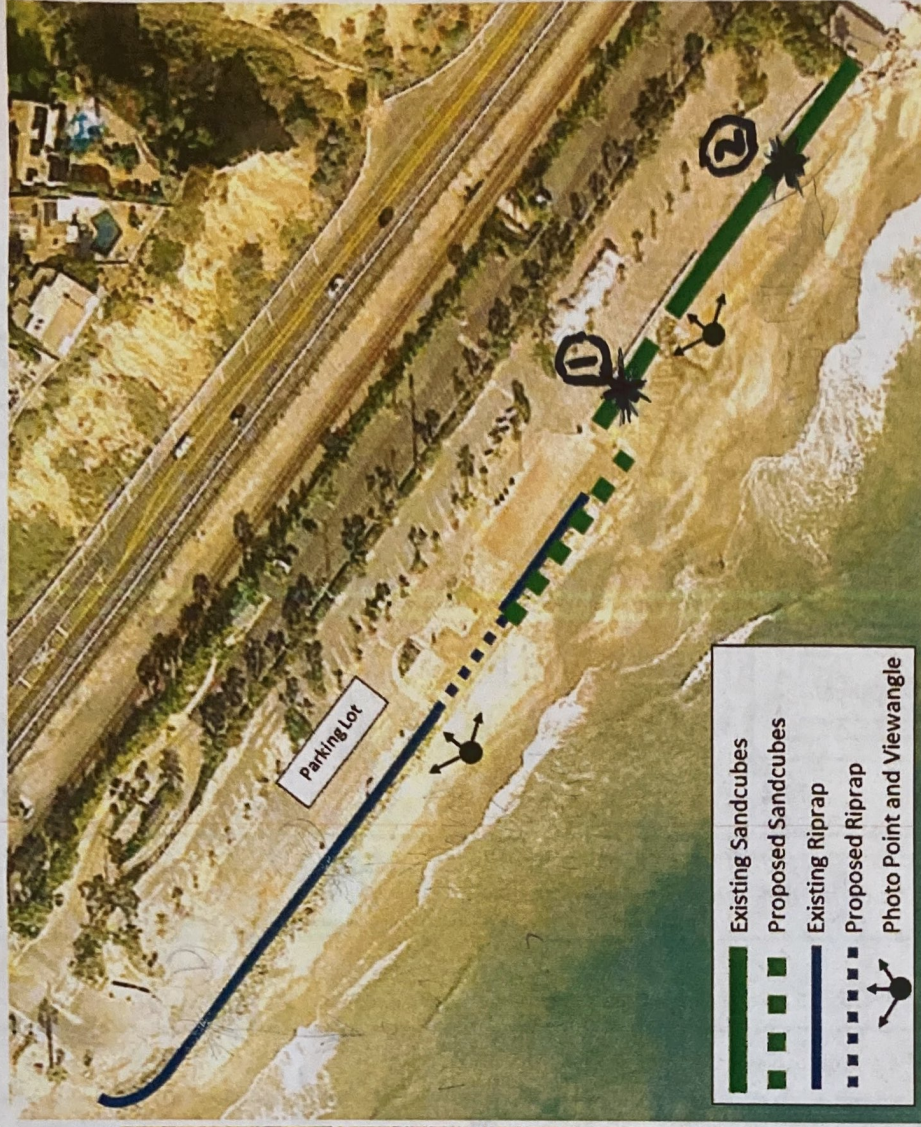
PARK MAP: Mark any notable areas from monitoring checklist and describe in narrative box below

C. Condition of South-end Sandcubes	<input checked="" type="checkbox"/> TEARS/HOLES <input checked="" type="checkbox"/> SLUMPING <input checked="" type="checkbox"/> FILL DISLODGED <input checked="" type="checkbox"/> NO LONGER HELD IN PLACE BY STRAP

E. Are Any Sandcubes Fully or Mostly Exposed (Not Covered by Sand)?	<input checked="" type="checkbox"/> YES <input type="checkbox"/> NO
	If so, how many? <input checked="" type="checkbox"/> <input checked="" type="checkbox"/>

- ① multiple torn geocubes, one with filling dislodged (see photos)
- ② numerous geocubes were torn, slumping, with missing filling; scouring evident on downcoast end of southern cubes (see photos)

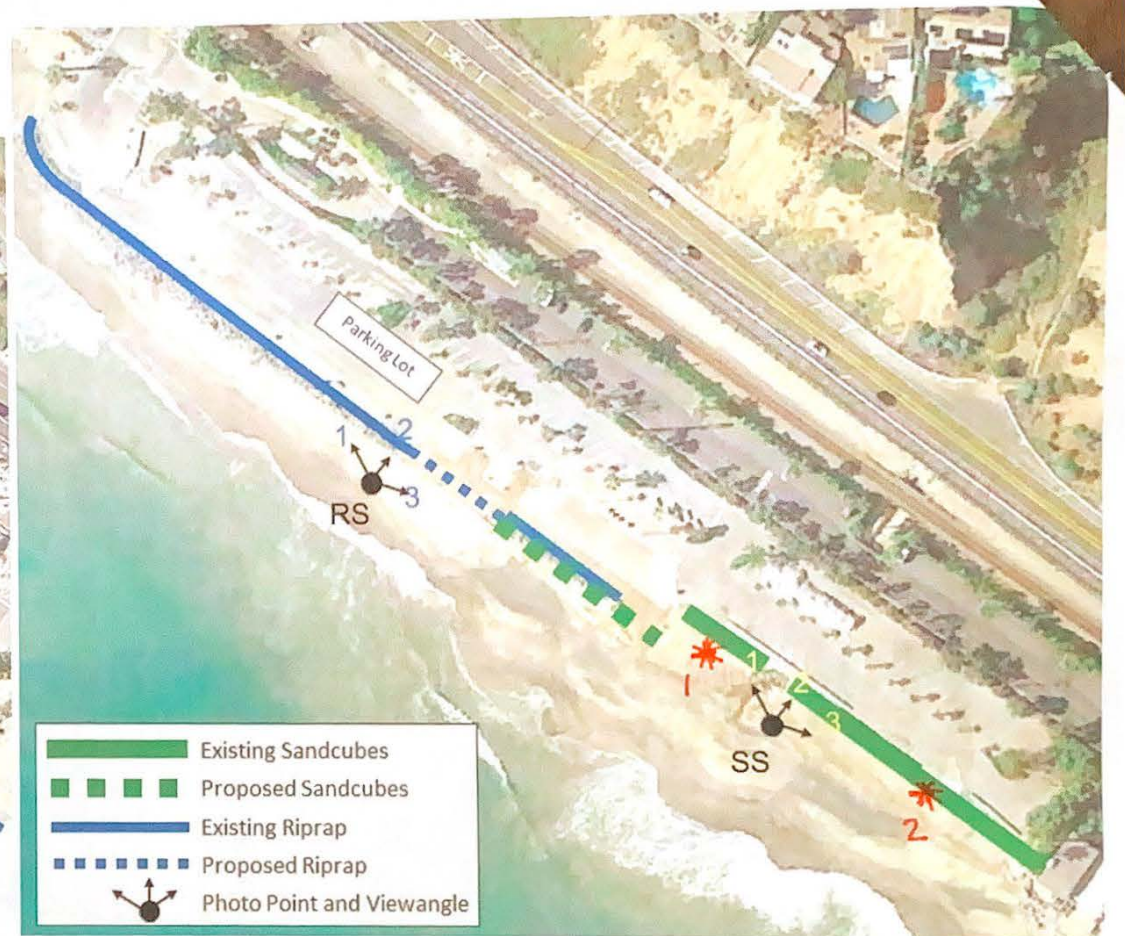
PARK MAP: Mark any notable areas from monitoring checklist and describe in narrative box below

C. Condition of South-end Sandcubes	<input checked="" type="checkbox"/> TEARS/HOLES <input checked="" type="checkbox"/> SLUMPING <input checked="" type="checkbox"/> FILL DISLODGED <input checked="" type="checkbox"/> NO LONGER HELD IN PLACE BY STRAP

E. Are Any Sandcubes Fully or Mostly Exposed (Not Covered by Sand)?	<input checked="" type="checkbox"/> YES <input type="checkbox"/> NO If so, how many? <u>X</u> <u>X</u>

- ① Similar to last week: Multiple torn sand cubes, one with filling dislodged (see photos).
- ② Similar to last week: Numerous sandcubes were torn, slumping, with missing filling; scouring evident on downcoast end of southern cubes (see photos).

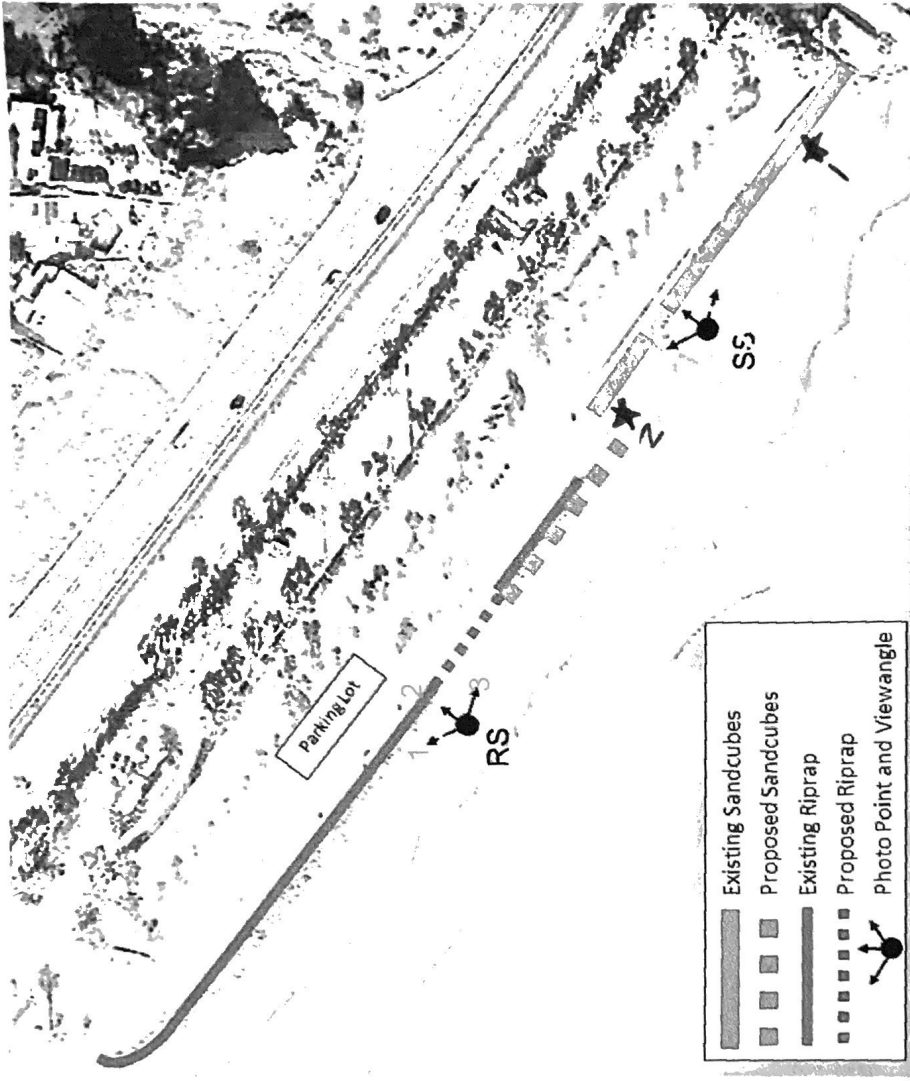
PARK MAP: Mark any notable areas from monitoring checklist and describe in narrative box below

C. Condition of South-end Sandcubes	<input checked="" type="checkbox"/> TEARS/HOLES <input checked="" type="checkbox"/> SLUMPING <input checked="" type="checkbox"/> FILL DISLODGED <input type="checkbox"/> NO LONGER HELD IN PLACE BY STRAP

- 1) Multiple tern geocubes, slumping, and fill dislodged.
- 2) Tern geocube with fill dislodged.
- 3) Exposed geocubes.
