CALTRANS INFORMATIONAL BRIEFING

File: Eureka-Arcata Highway 101
Corridor Improvement Project
HUM 101 / 79.9/86.3
01-36600 / 0100000127

SUBJECT: CDP 1-18-1078 Special Condition 1, Baseline and Annual Reports

Special Condition 1. Sea Level Rise and Flooding Impact Monitoring and Reporting

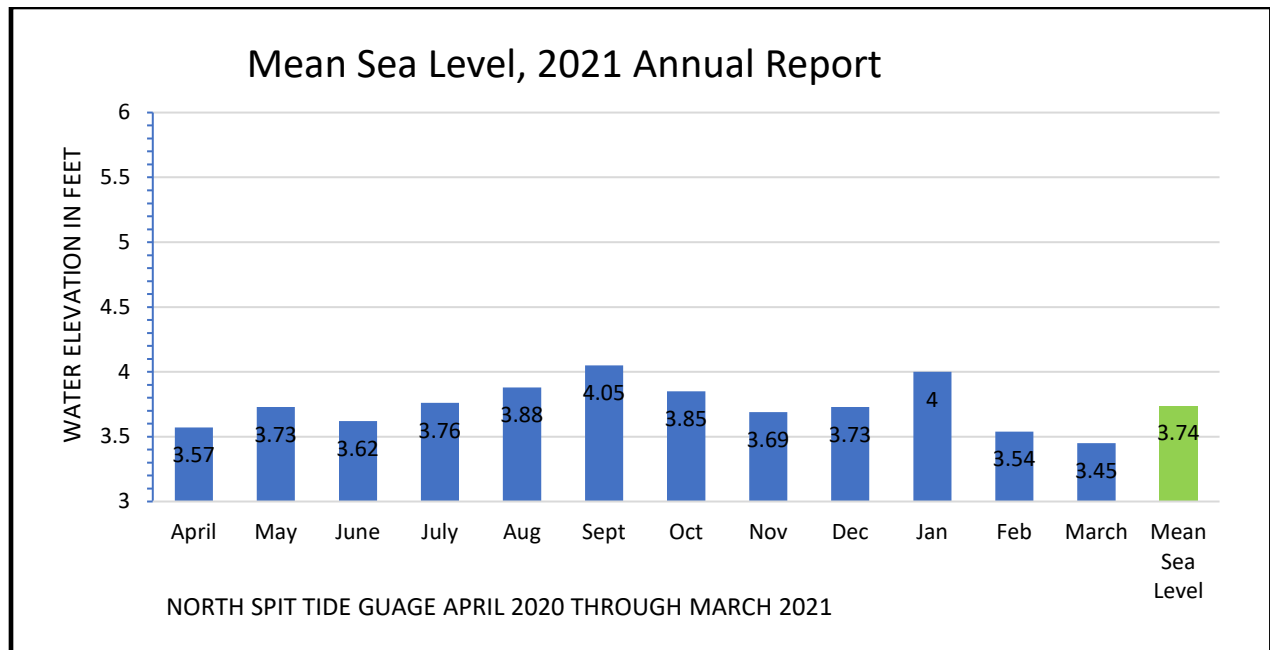
Monthly mean sea level for the reporting period ranged from 4.05 feet to 3.54 feet. Mean sea level for the 2021 Annual Report was 3.74 feet (Figure 5). In comparison, the mean sea level reported for the Baseline is 3.8 feet, 0.06 feet higher than the mean sea level for this 2021 Annual Report (Figure 6).

Figure 5. **Mean Monthly Sea Level** at the North Spit Tide Gauge for April 1, 2020, through March 31, 2021, was calculated from available monthly sea level means from the NOAA Tides and Currents webpage.

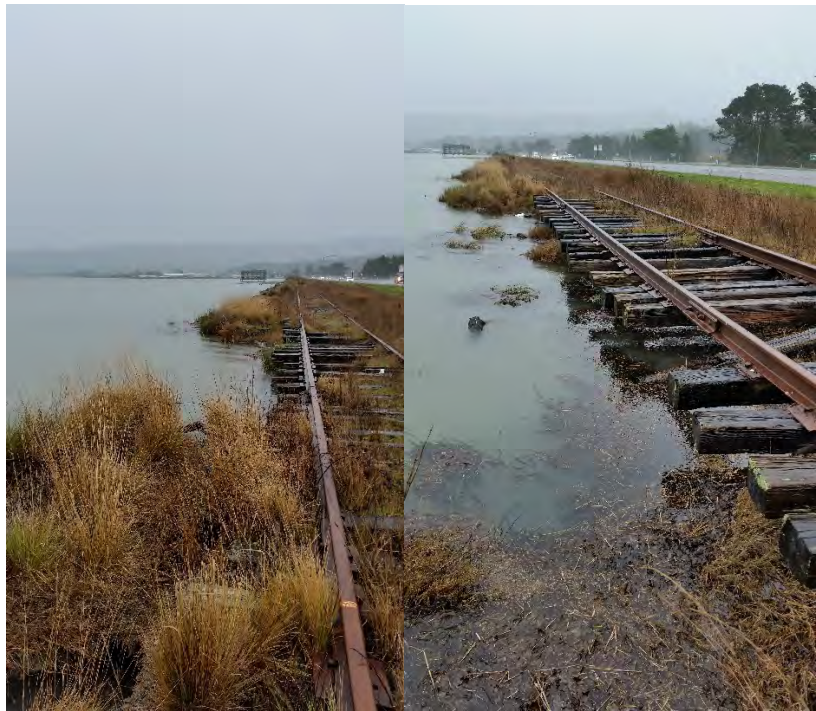
Indianola North Railroad Erosion 1/12/21

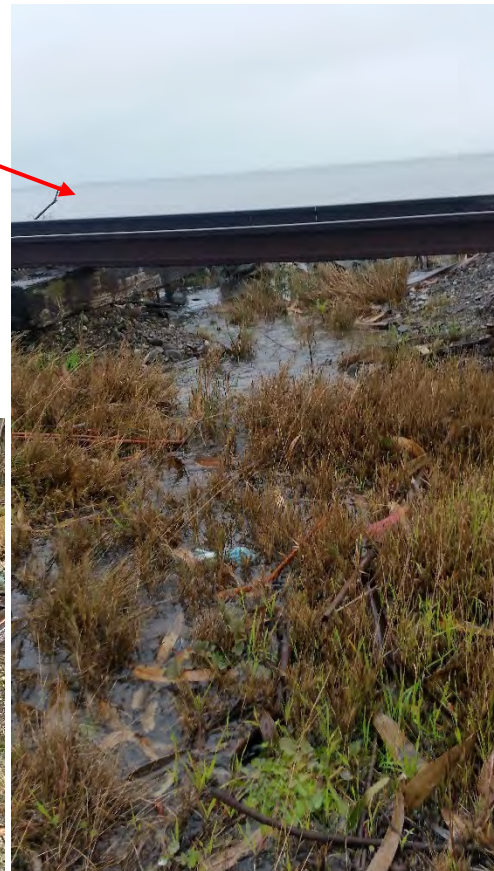
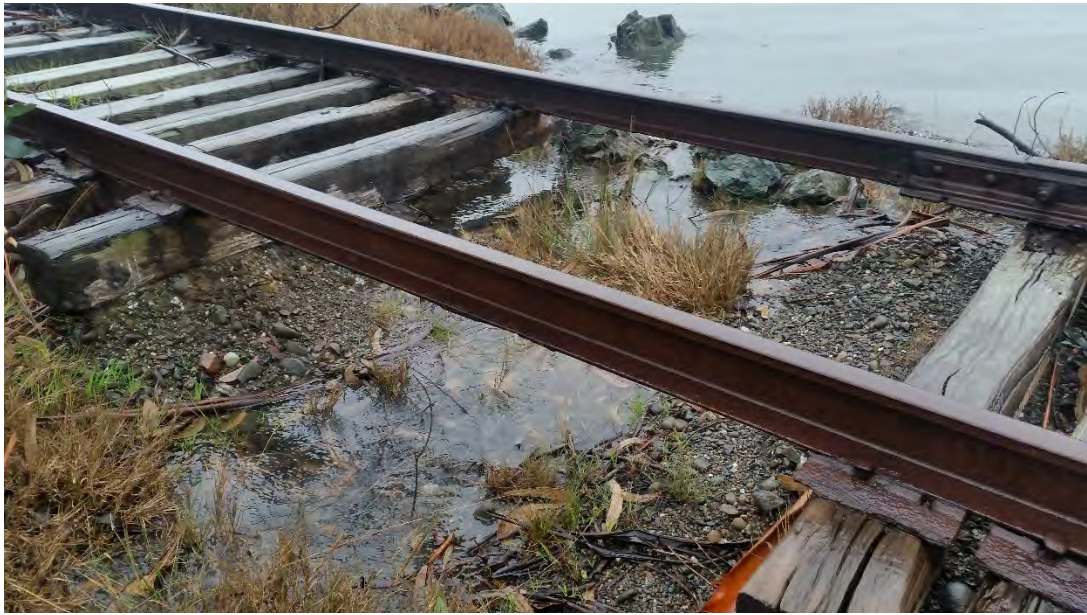
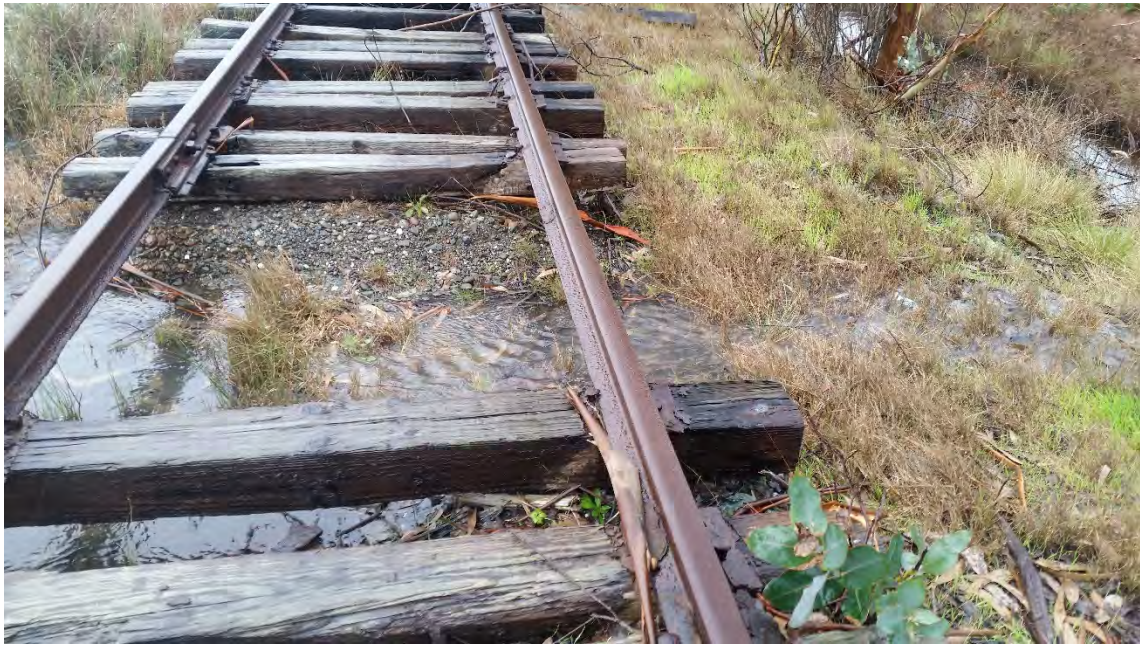
No impacts to highway infrastructure within the U.S. Highway 101 Corridor occurred during the 2022 reporting period. No temporary or ongoing flooding was observed and no weather-related incidents (such as erosion, overtopping of dikes, or tide gate failures) impacted the Corridor. Minor erosion impacted the railroad levee, which allowed bay water to flow into the roadside ditch adjacent to U.S. 101 near post mile 82.1. Photos of the localized levee erosion are on pages 42 and 43 of Appendix C.

Railroad Levee Erosion Near PM 82.1, 2022 Annual Report (1/3/22)
