A-4-STB-19-0214 (Cosmoledo Trust)

Exhibits

SUBJECT: ESHA Determination for 711 Sand Point Road, Carpinteria, CA.

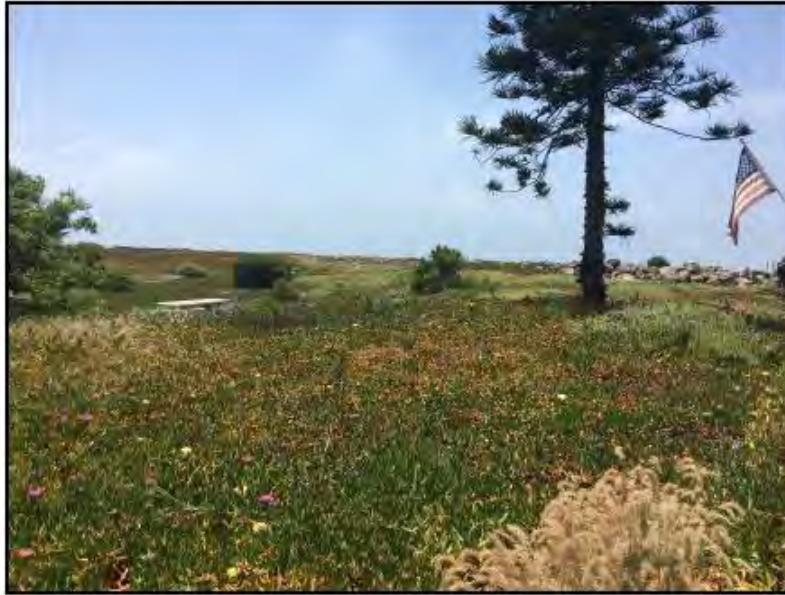
Photo 3: View of the redevelopment area along the east side of the existing residence and ice plant mats (Aspect: South). Photo taken July 10, 2018.

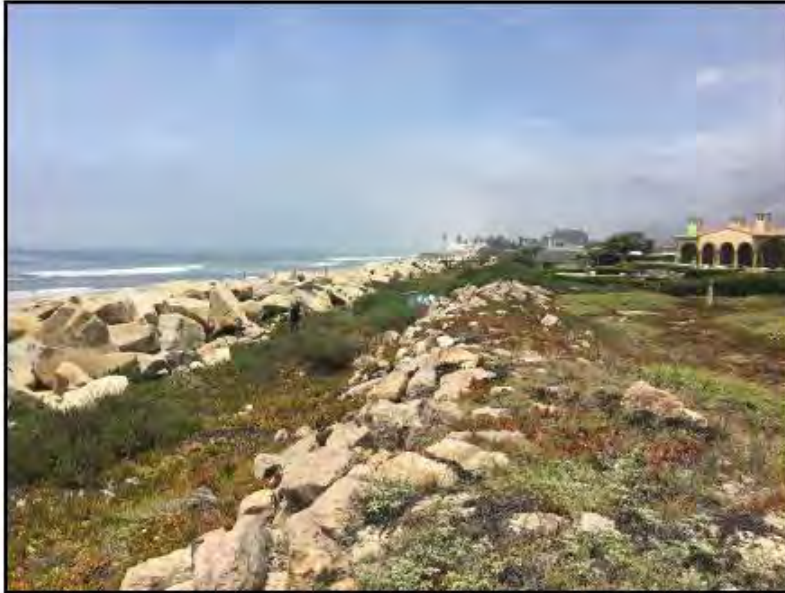
Photo 5: View of the rock revetments along the beach (Aspect: West). Photo taken July 10, 2018.

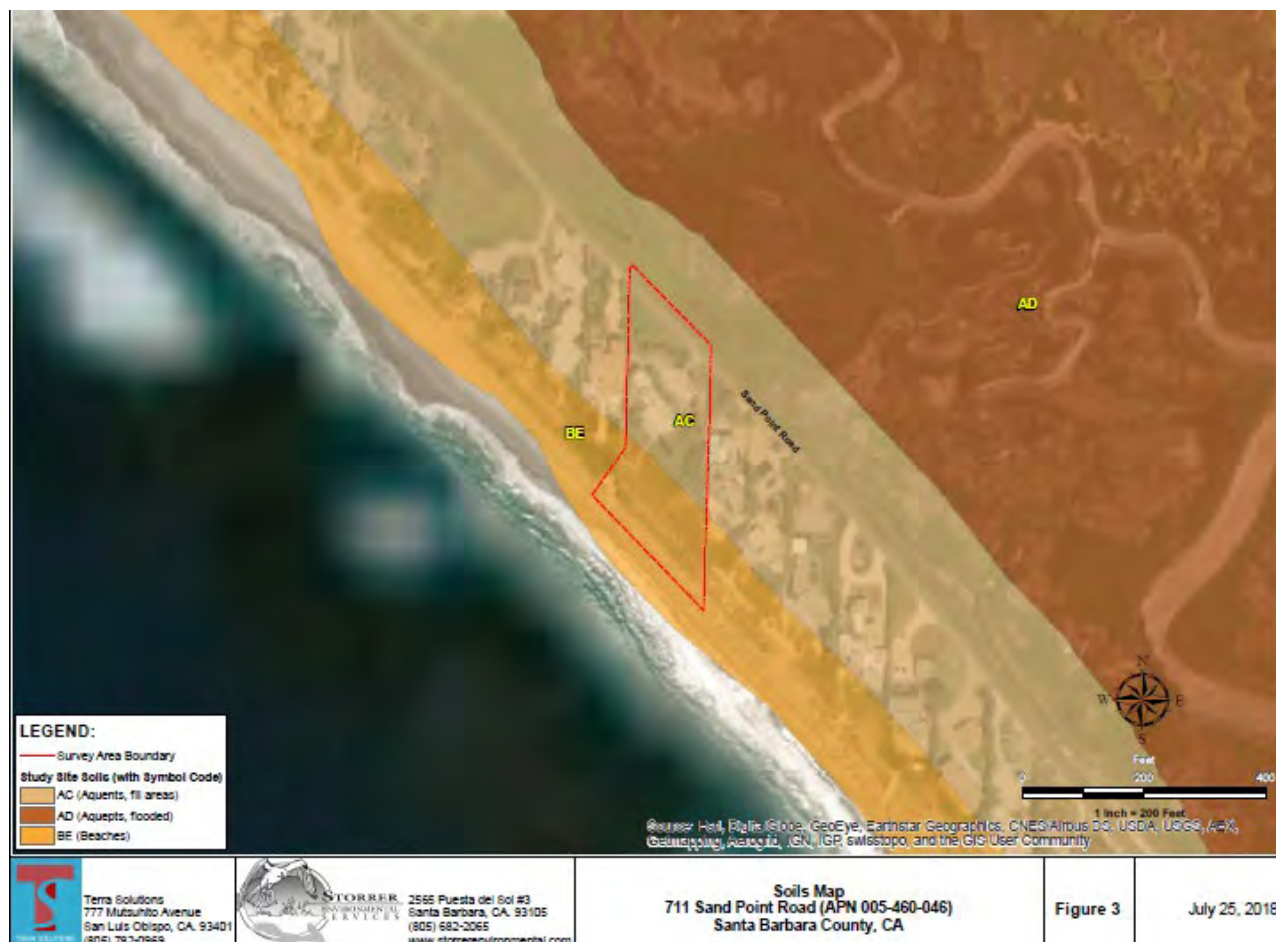
The 2018 Storrer Environmental Inc. LLC Biological Resources Assessment ("Storrer Report") reported that the soil types on the residential area of the site are almost equal halves BE or beach sand and AC or Aquent fill soil (Figure 1). The Storrer report found that the vegetation types include a small 0.024 acre patch of salt grass (*Distichlis spicata*) on a berm between Sand Point Road and Carpinteria Marsh and a 0.48-acre area of primarily sandy substrate dominated by non-native invasive iceplant mats (Figure 2). The berm was surveyed for hydric soils, hydrology, and hydrophytic vegetation. The berm did not support hydric soils, had no evidence of hydrology, and was dominated by salt grass, a species with a facultative (FAC) wetland status that means it has an equal likelihood of occurring in non-wetland and wetland areas¹. The Storrer Report determined that the salt grass berm was not a wetland and that the residential area of the subject property did not support wetland habitat.

Figure 1. Figure 3, Soils Map, of the Storrer Environmental Inc. Biological Assessment showing the area identified in yellow closest to the ocean as Beach or sandy substrate and the area just inland of this area as Aquent or fill soils.

⁹ While the soil map (Figure 1) depicts a distinct line between BE soil (sand) and AC soil (fill) I observed a gradual transition between the two soil types.

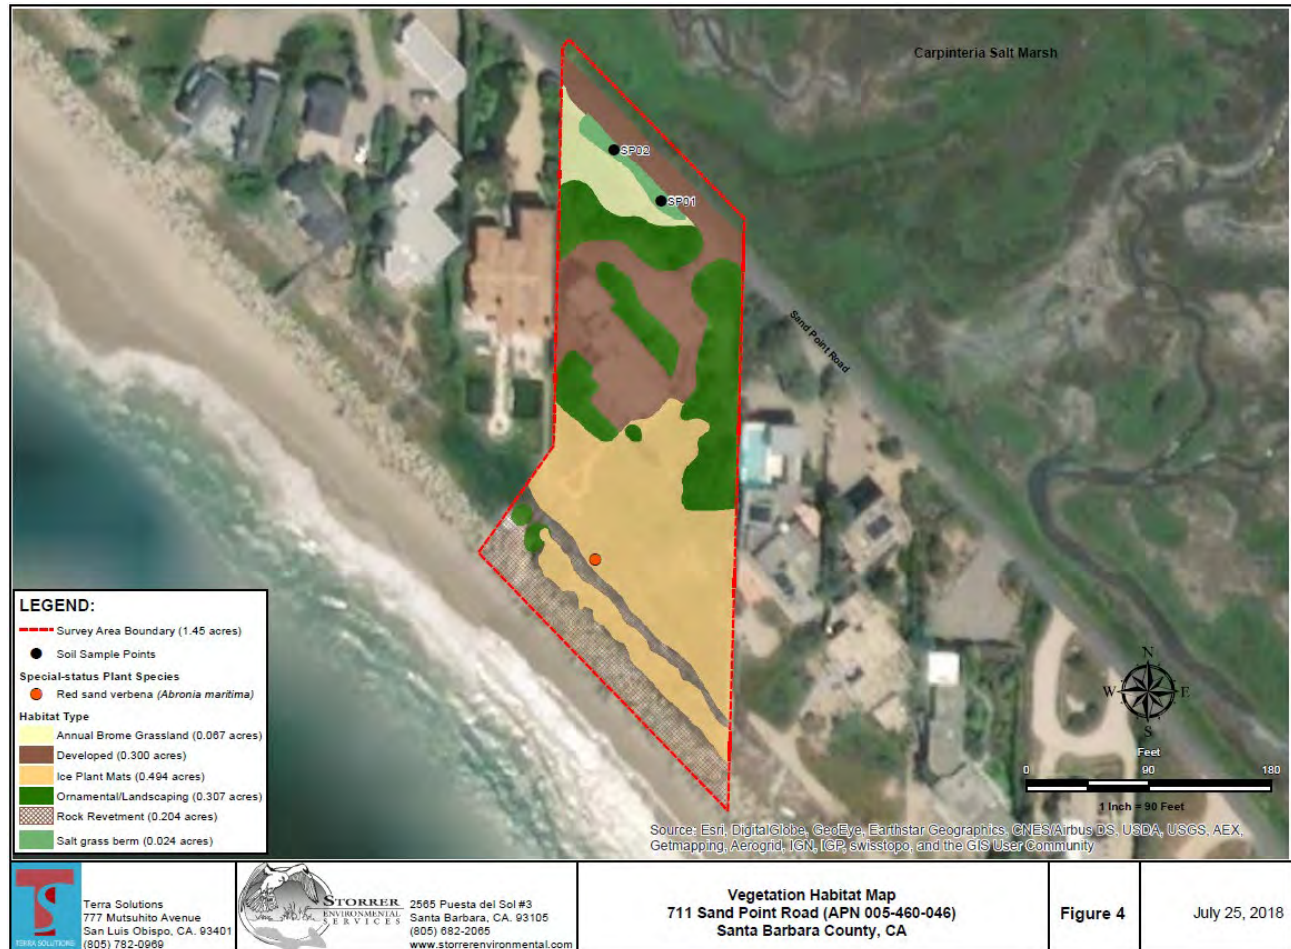
Figure 2. Figure 4 of the Storrer Environmental Inc. LLC Biological Resources Assessment showing the 0.024 acre salt grass berm in green near Carpinteria Marsh and the 0.48 iceplant mat area in tan adjacent to the ocean.

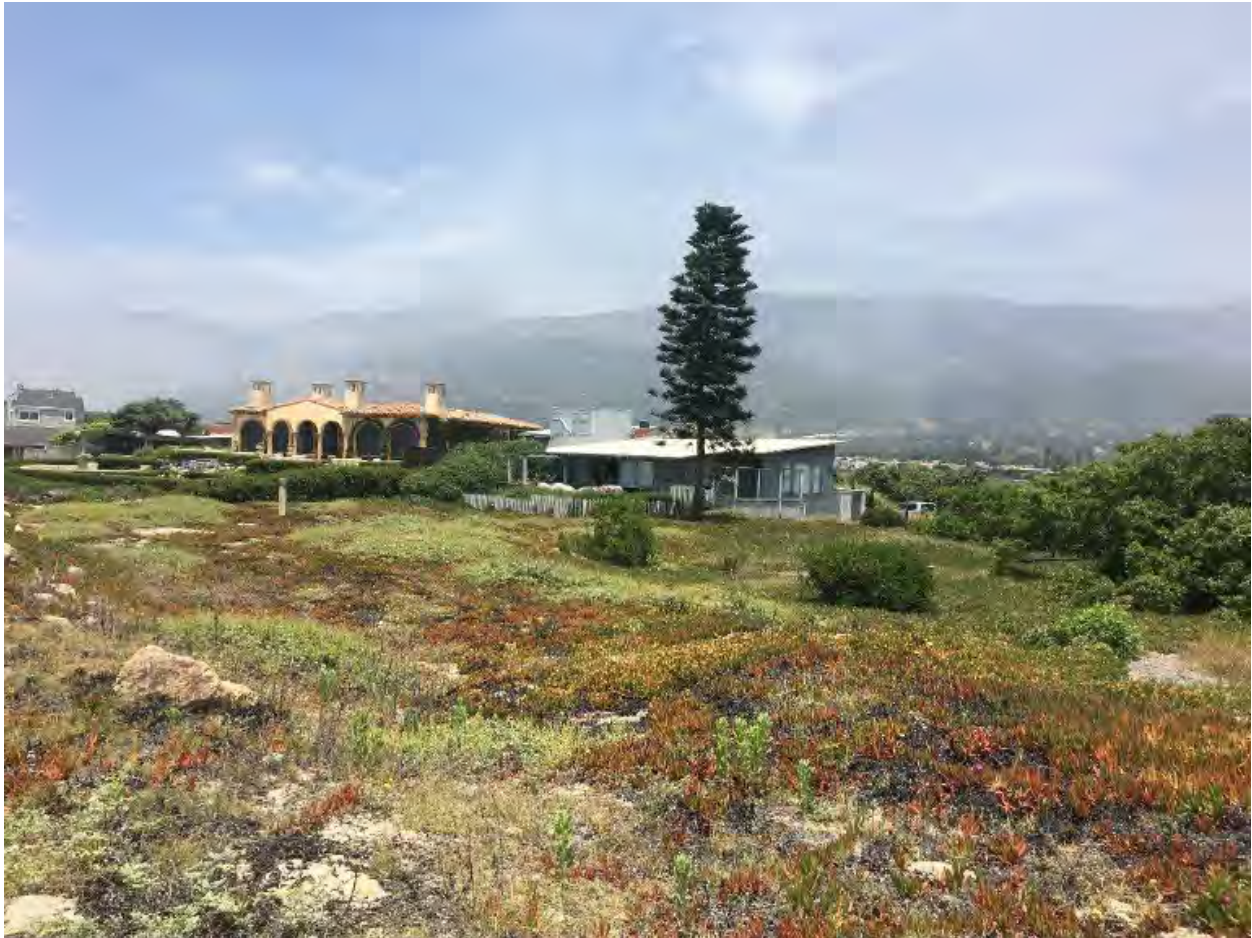
Figure 3. Cover photo of the Storrer Environmental Services LLC August 2018 report showing the large light green patches of beach bur among the iceplant mats and the hummock and hollow dune morphology.

My observations of the percent relative cover of vegetation in the area between the house and the ocean align best with the Storrer report. Iceplant mats were the dominant cover but the native beach bur and beach evening primrose were also significant components of the habitat. I concur with Storrer’s estimate of iceplant mats having approximately 60 percent relative cover and the native dune species having approximately 15 percent relative cover (see Figure 3 and Figure 7 photos from Storrer Report and June 9, 2020 site visit, respectively). The beach bur was conspicuously located on the tops of dune hummocks (Figure 7) and there was a lot of beach evening primrose immediately behind the house (Figure 8). There were also patches of bare sand interspersed throughout (Figure 9). Strangely, just six months after the June 9, 2020 site visit, photos taken and observations made by both Padre Associates Inc. and MRS Environmental Inc. depict and note far less patches of both beach bur and beach evening primrose in the iceplant mat area (Compare Figures 3, 7, 8, & 9 with Figures 4, 5, & 6).

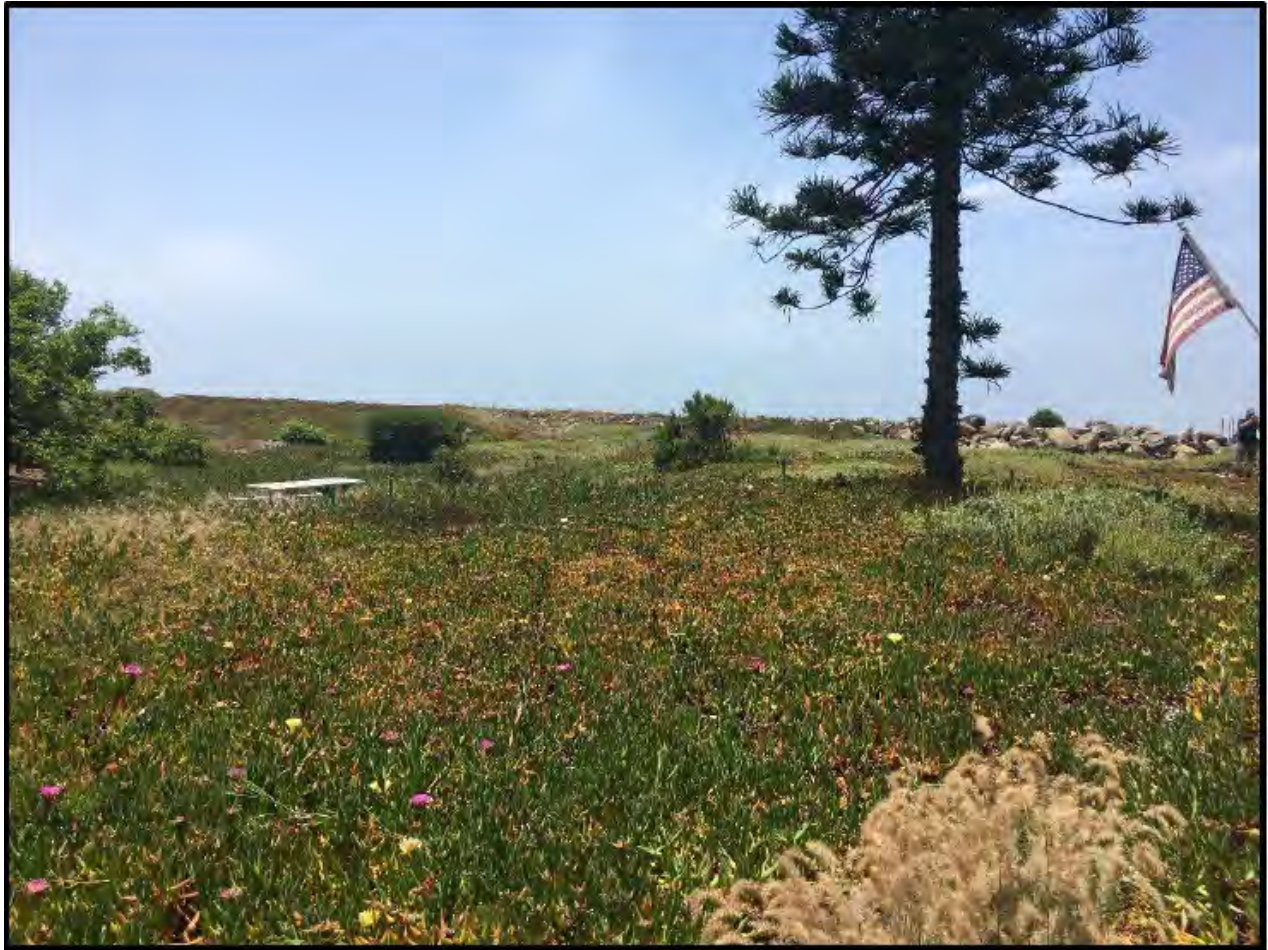
Figure 4. Photo 3 of Storrer Report taken July 10, 2018 with a view of the east side of the existing residence looking toward the Pacific Ocean with iceplant mats in foreground and beach bur patch to east of flag and more beach bur patches in the background.

increased and the cover of native dune species decreased as seen in photographs and as documented by the Padre Assessment (Figure 4, Storrer Report vs. Figure 5, Padre Assessment). While the Storrer Report estimated that the area between the house and ocean was characterized by 60 percent relative cover of iceplant mats and 15 percent relative cover of native dune plants, the Padre Assessment surveyed one area (AOI 1) and measured over 80 percent relative cover of iceplant mats and nine percent relative cover of beach evening primrose. The Padre Assessment states that “Isolated patches within the Ice plant mats were observed to support different assemblages of native and non-native plants, however, through quantitative and qualitative sampling, it was determined that ice plants remained dominant and the areas were representative of Ice plant mats”. The Padre Assessment found that the area with iceplant mats met the membership rules of *A Manual of California Vegetation, Second Edition*³ (MCV2) for Ice plant mats (*Carpobrotus edulis* or Other Ice Plants Semi-Natural Herbaceous Stands) that have a ‘High’ invasive ranking by Cal-IPC, are not a rare habitat type, and therefore the Padre Assessment concluded do not meet the definition of ESHA.

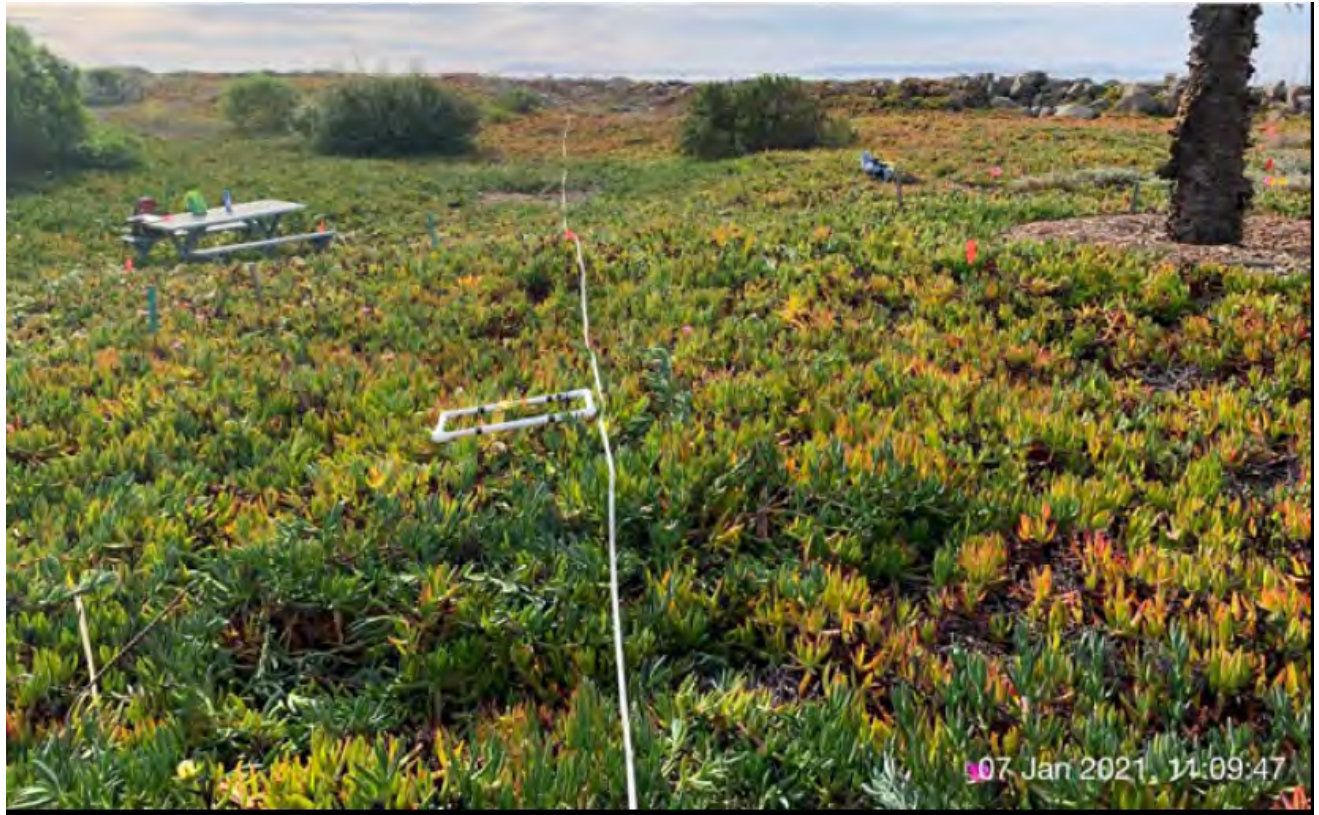
Figure 5. Photograph 8 of the Padre Assessment with a close-up view east of the existing residence looking toward the Pacific Ocean with iceplant mats and no obvious native dune species.

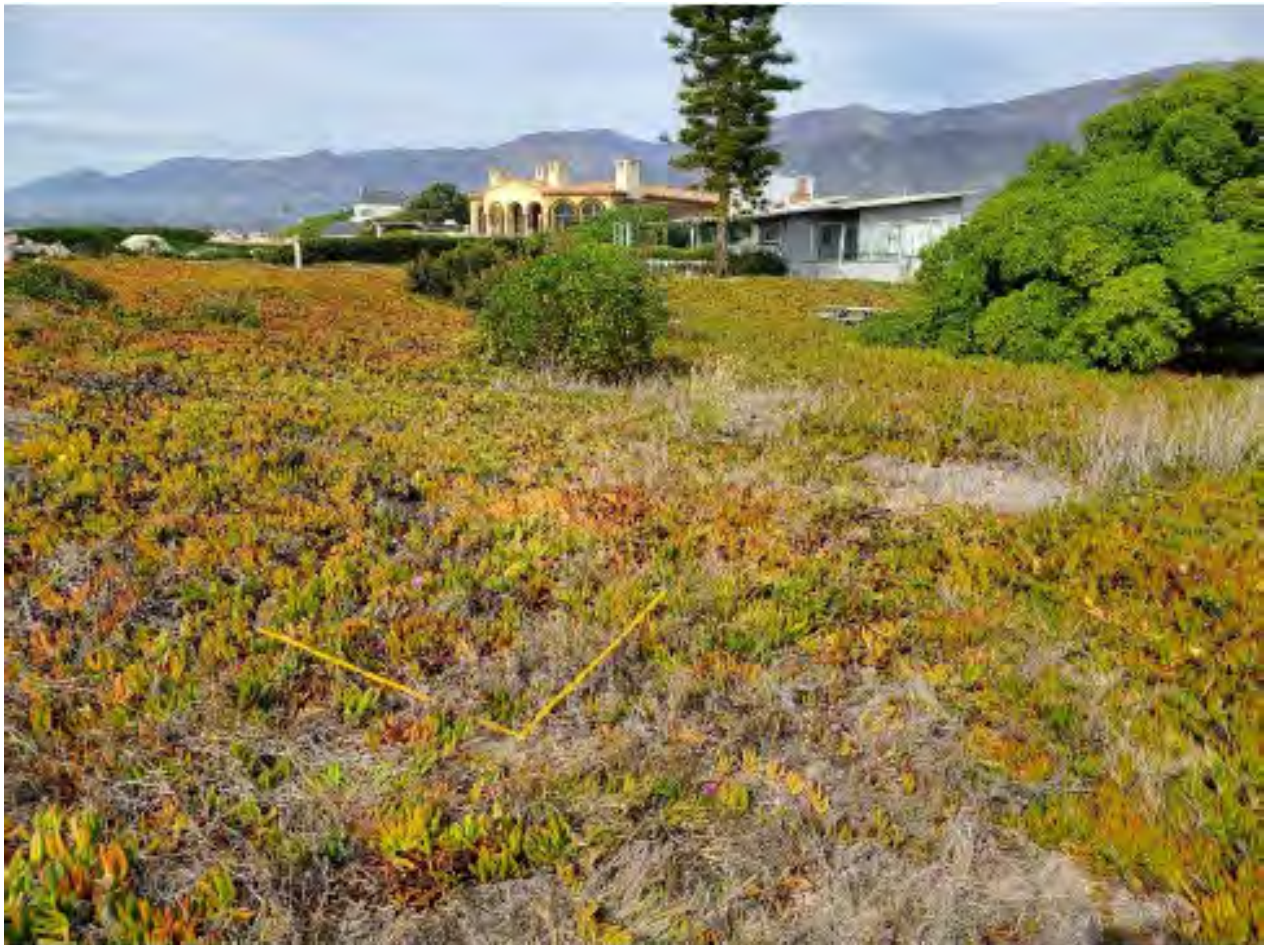
Figure 6. Photo 1 from MRS report “overlooking the iceplant mats/dunes from near the rock revetments on the south side of the property”. Photo 1 was taken from the southeast corner facing northwest. Compare this photo taken on January 12, 2021, with Figure 3, the front cover photo of the Storrer Report taken in August 2018 and Figure 7, taken on June 9, 2020, during my site visit. The beach bur, so obvious in the Storrer Report photo and my site visit photo (Figure 3 and Figure 7, respectively) is virtually absent. The June 9, 2020 site visit was just six months before the MRS photo was taken.

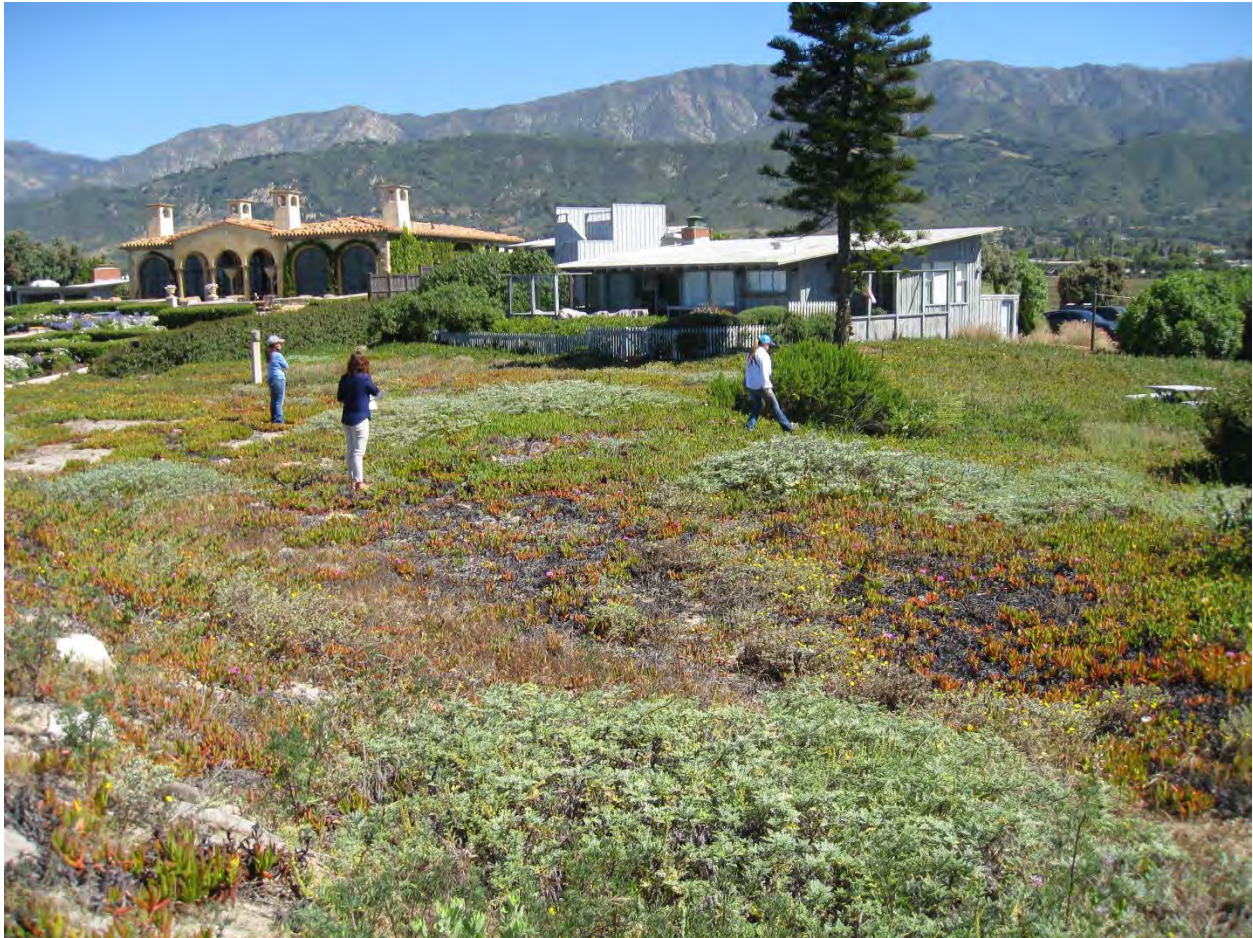
Figure 7. June 9, 2020 site visit photo taken from the revetment with southern foredune habitat between the revetment and the house. The large light green patches are beach bur and the small patches with yellow flowers are beach evening primrose. Sand is visible in the bare areas. The person with the blue ball cap is in front of a coyote bush.

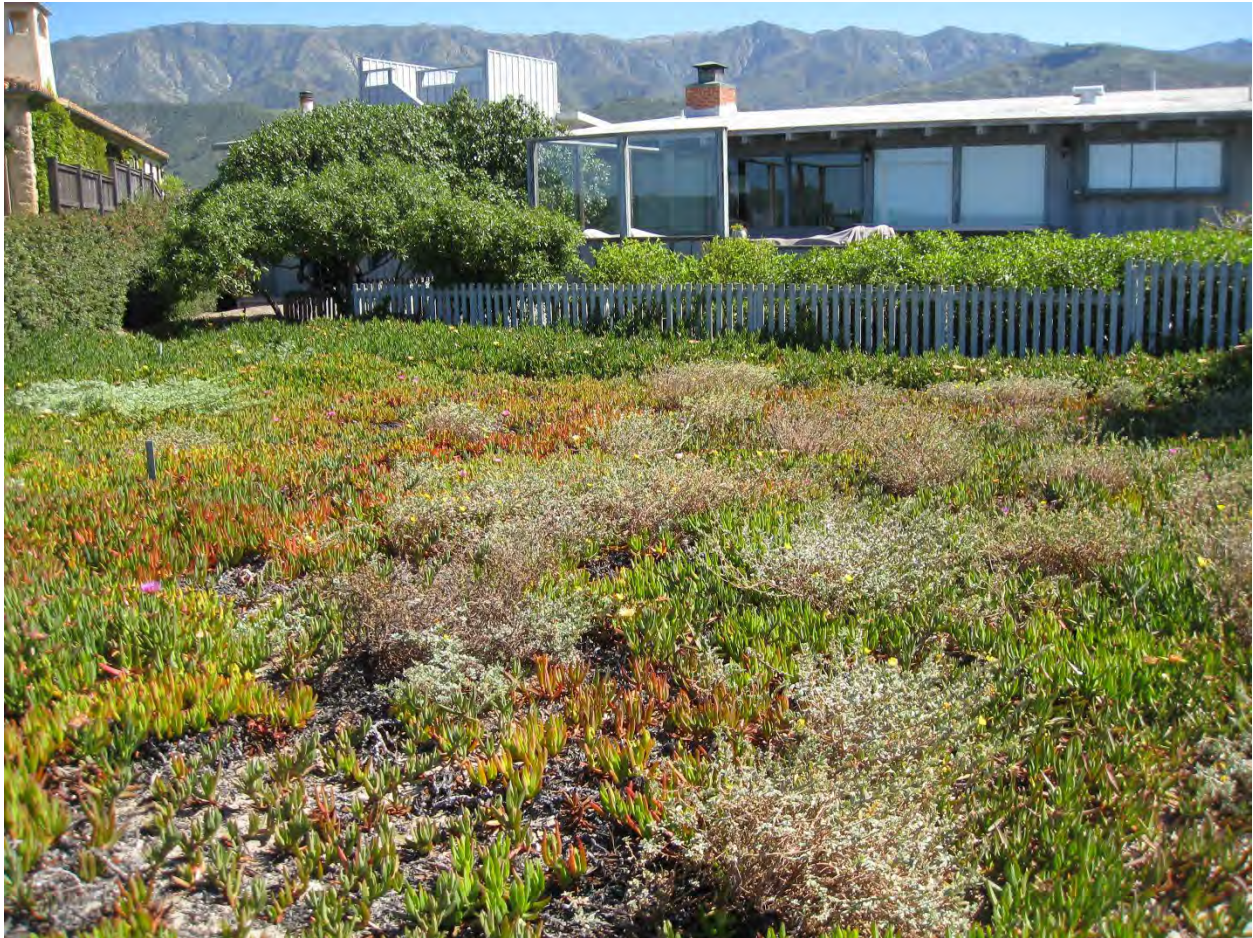
Figure 8. June 9, 2020 site visit photo showing numerous patches of beach evening primrose immediately in back of the house with a patch (light green) of beach bur in the left of the photo near the edge of the property.

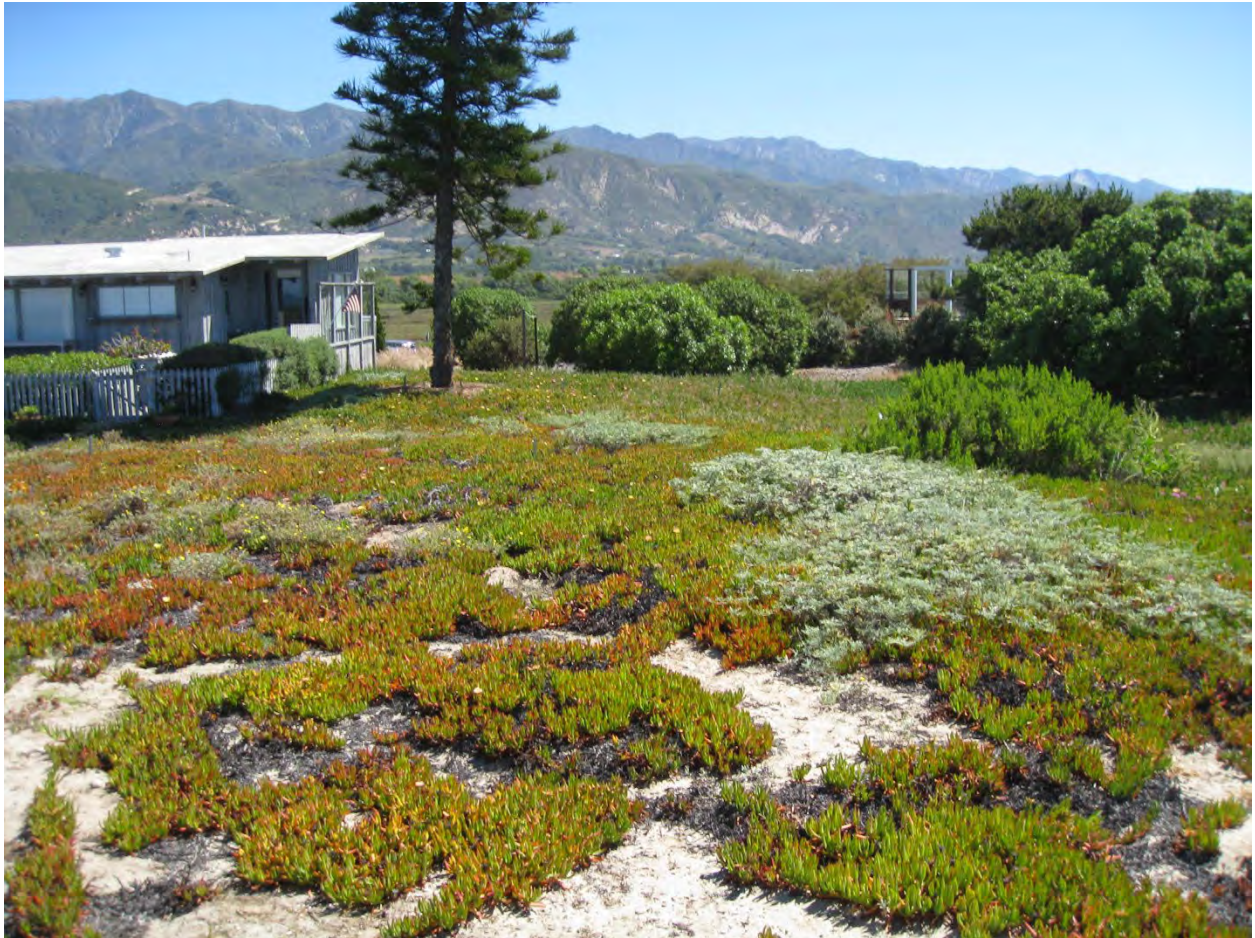
Figure 9. June 9, 2020 site visit photo – showing bare sand patches, iceplant mats and beach bur and beach evening primrose patches.

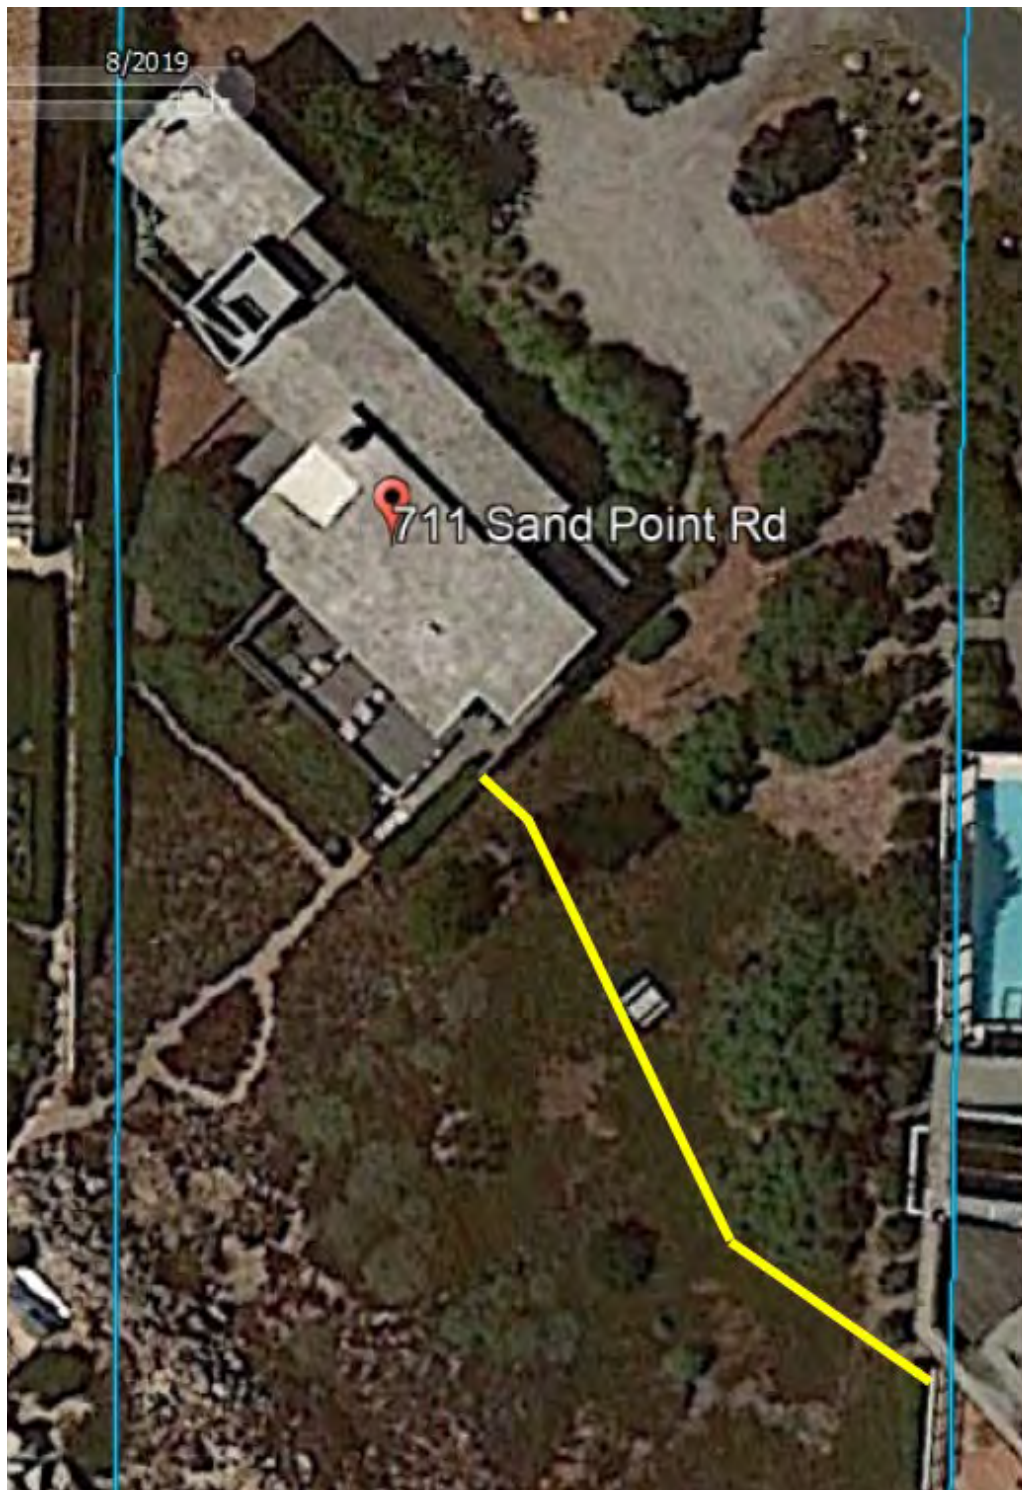
determined the boundary line for the southern foredune ESHA based on the presence of sandy substrate, dune morphology, and native dune species (Figure 10). I recommend that a minimum 25 foot buffer be established between the southern foredune ESHA and development to protect the habitat consistent with the policies of the County's LCP, provided best management practices are put in place and dune mitigation is required.

Figure 10. The yellow line is the northeastern boundary delineation on the residential portion of subject property that I have made for the extent of the southern foredune ESHA based on sandy substrate, dune morphology, and presence of native dune plants. The area seaward of the existing residence and the yellow line is the extent of the southern foredune ESHA.
