**CALIFORNIA COASTAL COMMISSION**

**9-23-0817**

**(Southern California Gas Co.)**

**Exhibit 5 -** Restoration Plan for Del Rey 4 Plug and Abandonment Project

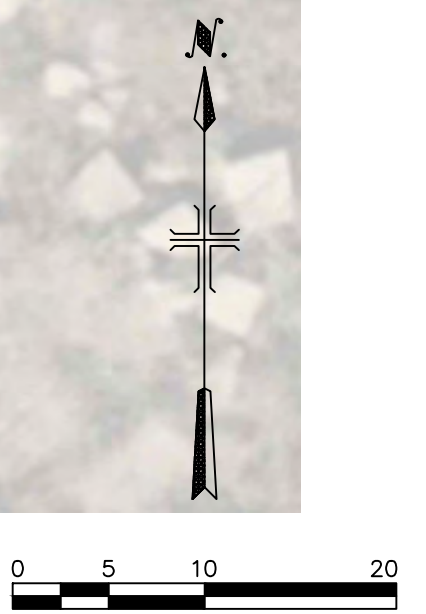
2  
 —  
 DEL REY 9 SITE PLAN — API #04-03714014  
 1" = 10'

DEL REY 9 PLUG AND  
 ABANDONMENT PROJECT: SITE PLAN  
 PLAYA DEL REY, CA

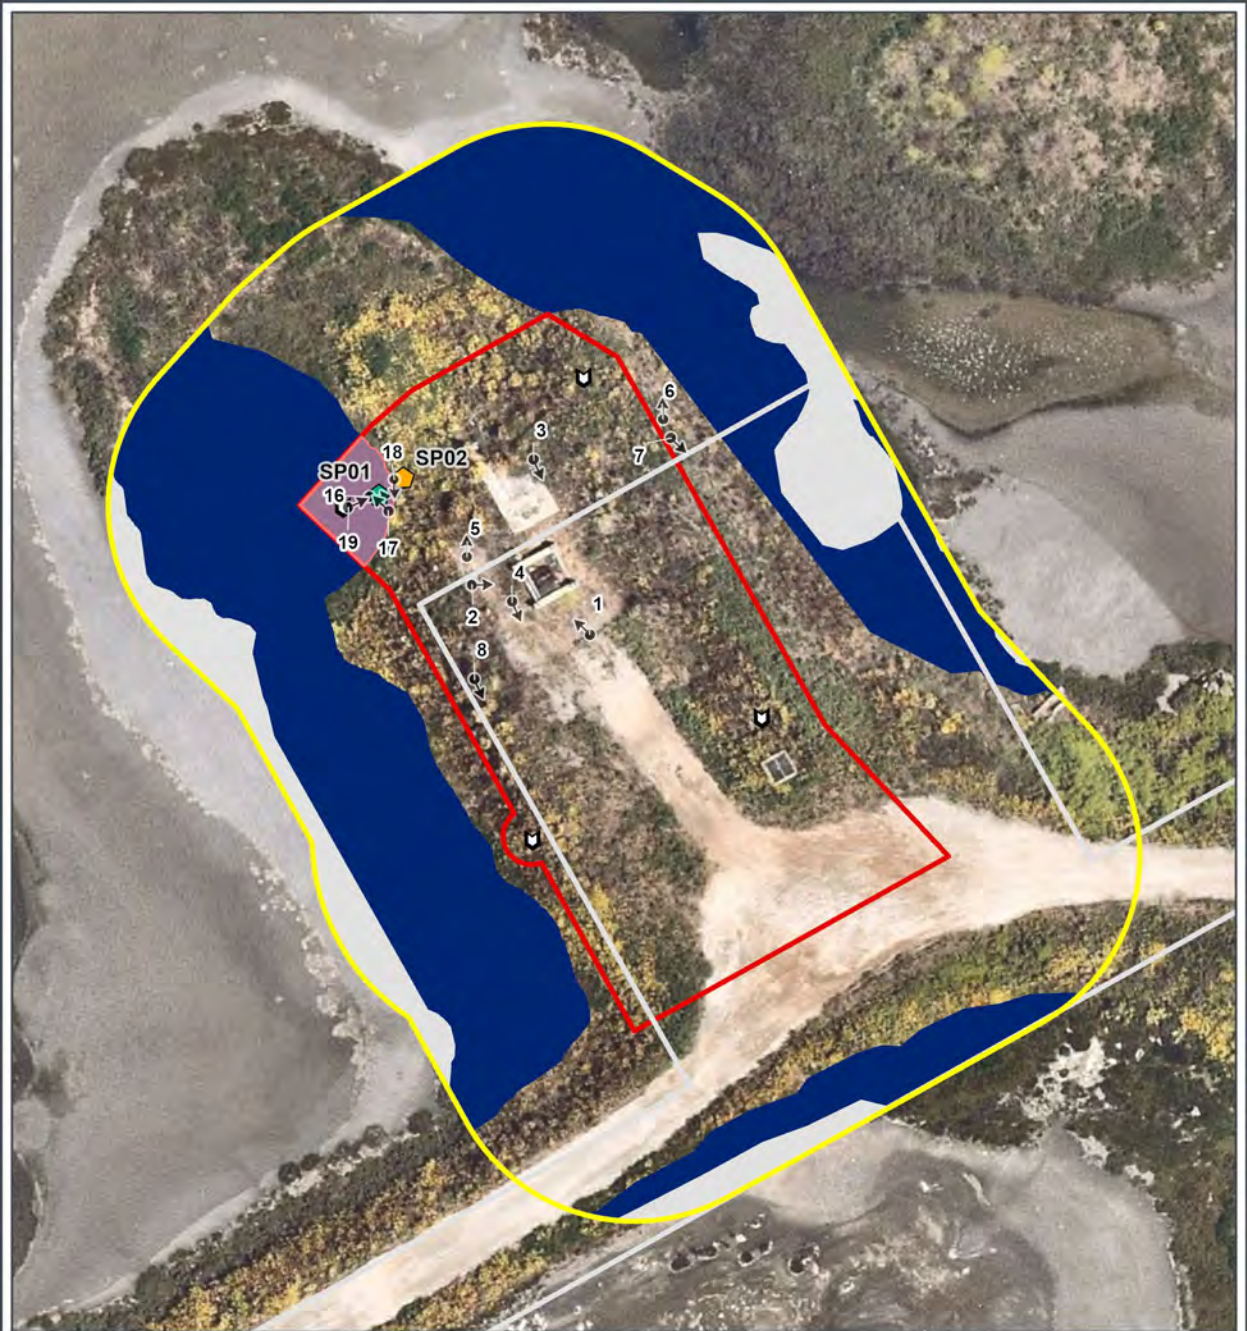
FIGURE 4A

**DR-4 Potential Jurisdiction Within Review Area and Wetland Sampling Plots.**  
 The Review Area Shows a 50-foot Buffer Around the Work Area and Temporary Impacts to Wetlands Within the Work Area

**Figure 4a. DR-4 potential jurisdiction within Review Area, and wetland sampling plots. The Review Area shows a 50-foot buffer around the Work Area and temporary impacts to wetlands within the Work Area.**

Potentially jurisdictional resources were observed outside the Work Areas of DR-4 and DR-9 (**Figure 4a and 4b; Table 3**). No CDFW streambed occurs within the project, so it is excluded from the table and impact assessment.

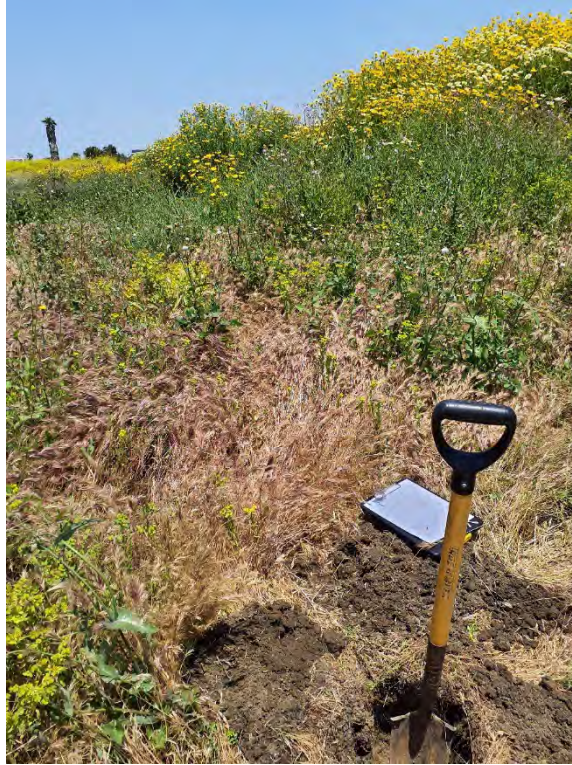
**Photo B-20: Wetland Determination Sampling Plot (SP-03) (negative) outside DR-9 Work Area. Photo facing east-northeast.**

Two wetland determination sampling plots (SP-03 and SP-04) were examined adjacent to DR-9. SP-04 was examined within a vegetated terrace immediately adjacent to the toe-of-slope that separates the terrace from the elevated compacted fill terrace. While the soils were moist throughout the associated 16-inch pedon, no water table or saturation was observed. SP-03 was examined at the base of a hillslope between the toe-of-slope of the lower elevation and the upper compacted fill terrace. No wetland hydrology indicators were observed. In addition, no hydrology indicators were observed in the elevated compacted fill terrace within the Work Area. SP-03 and SP-04 typify the transition between lower elevation and higher elevation from the existing dirt road. The transition was used to define the best Work Area. In summary, hydrology indicators were present at SP-04 outside the Work Area but not observed at SP-03 inside the Work Area.

Soils on the DR-9 elevated fill terrace are compacted and consist of sandy clay loam. The lower terraces consist of an uncompacted silty clay texture. At SP-04 hydric soils were observed within the lowest terraces abutting the toe-of-slope, consisting of redox dark surface 0 to 9 inches from the soil surface. Therefore, hydric soil indicators were present at SP-04 outside the Work Area but not at SP-03 inside the Work Area.

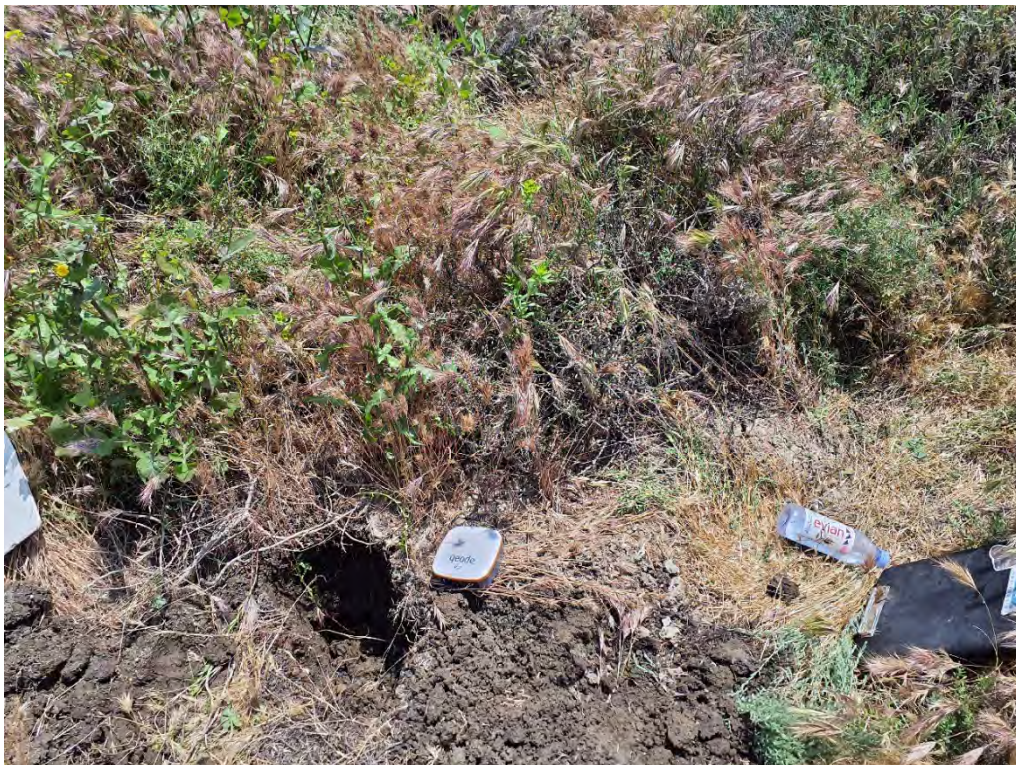
**Photo B-21: Wetland Determination Sampling Plot (SP-04) (positive) outside DR-9 Work Area. Photo facing east.**

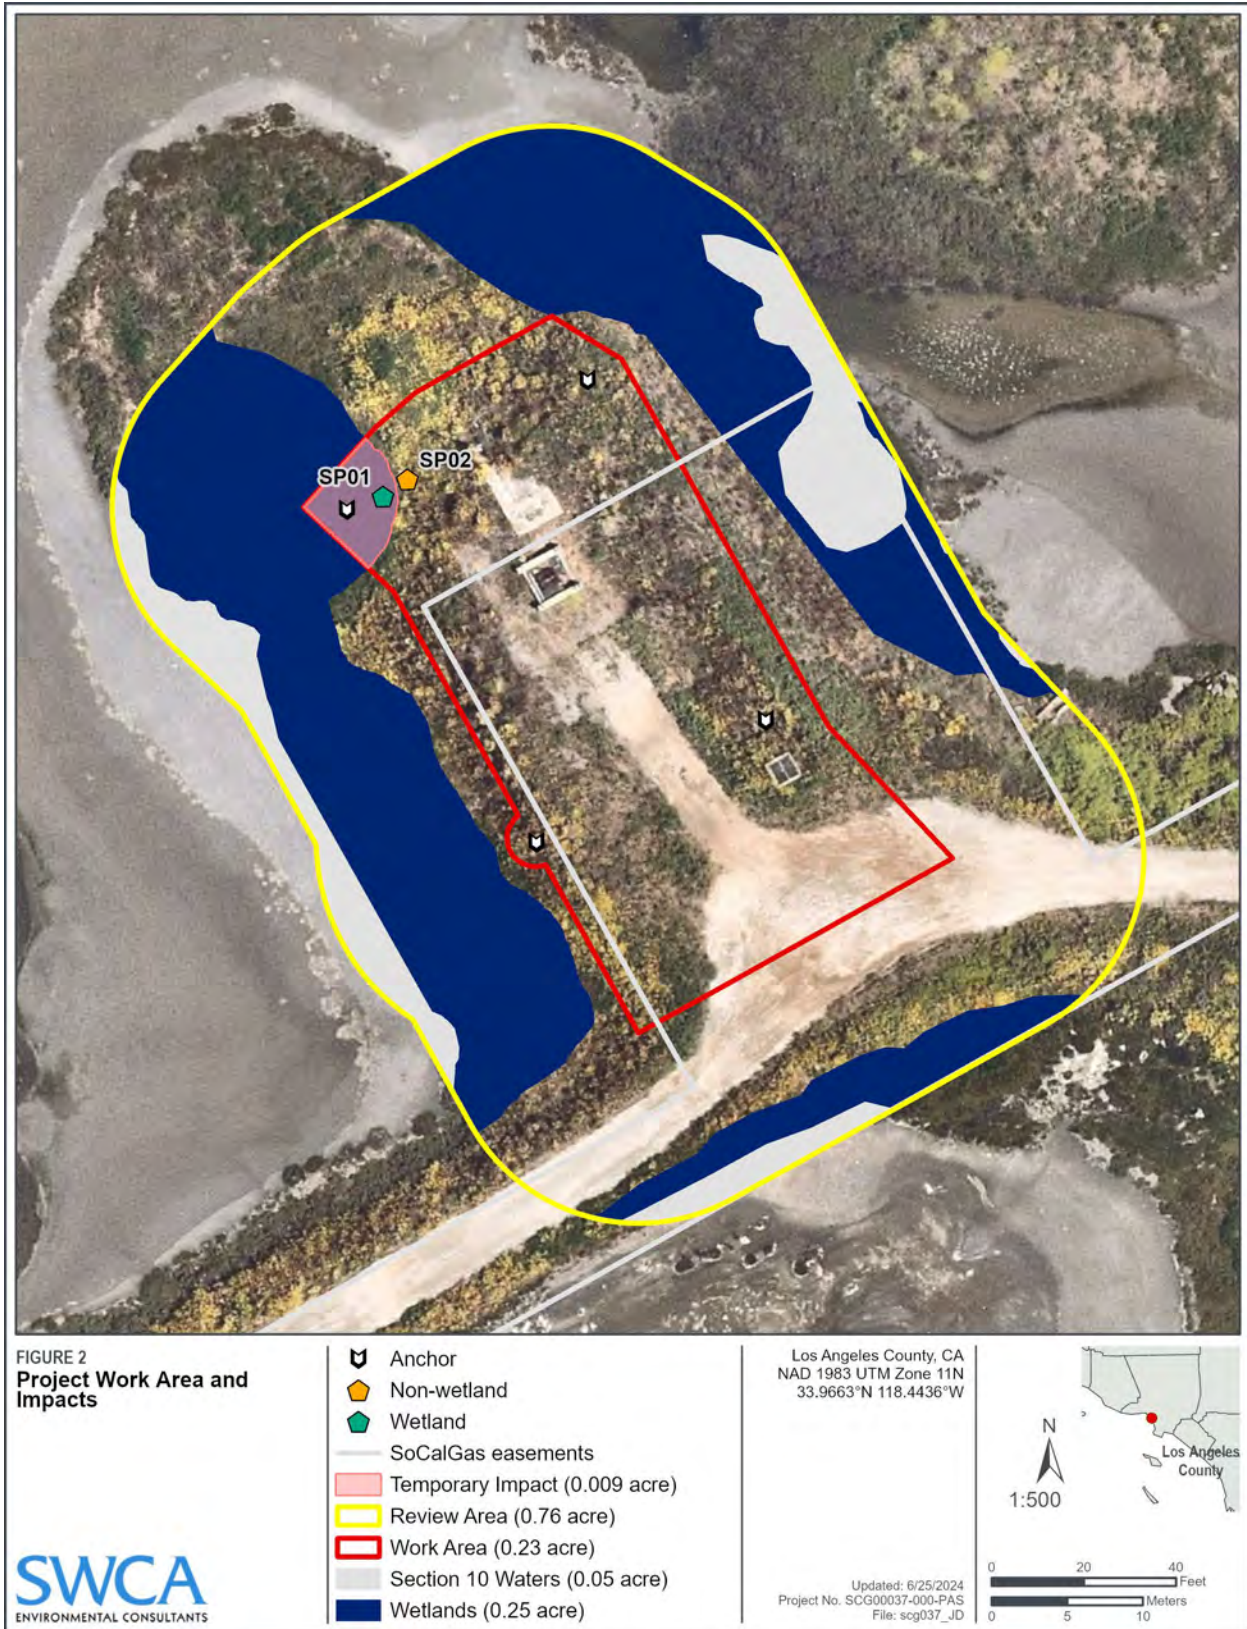
Figure 2. Project work area and impacts.

Approximately 385 square feet (0.01 acre) of temporary impacts to jurisdictional aquatic resources (wetlands) are anticipated to occur as a result of the removal of the northwest rig anchor (**Figure 2**) (SWCA, 2024). **Figure 3** shows the location of the buried rig anchor, while **Figure 4** shows what the anchor is expected to look like following its removal. This entire impact area within wetlands will be restored through planting and removal of invasive and nonnative vegetation (**Table 1**).

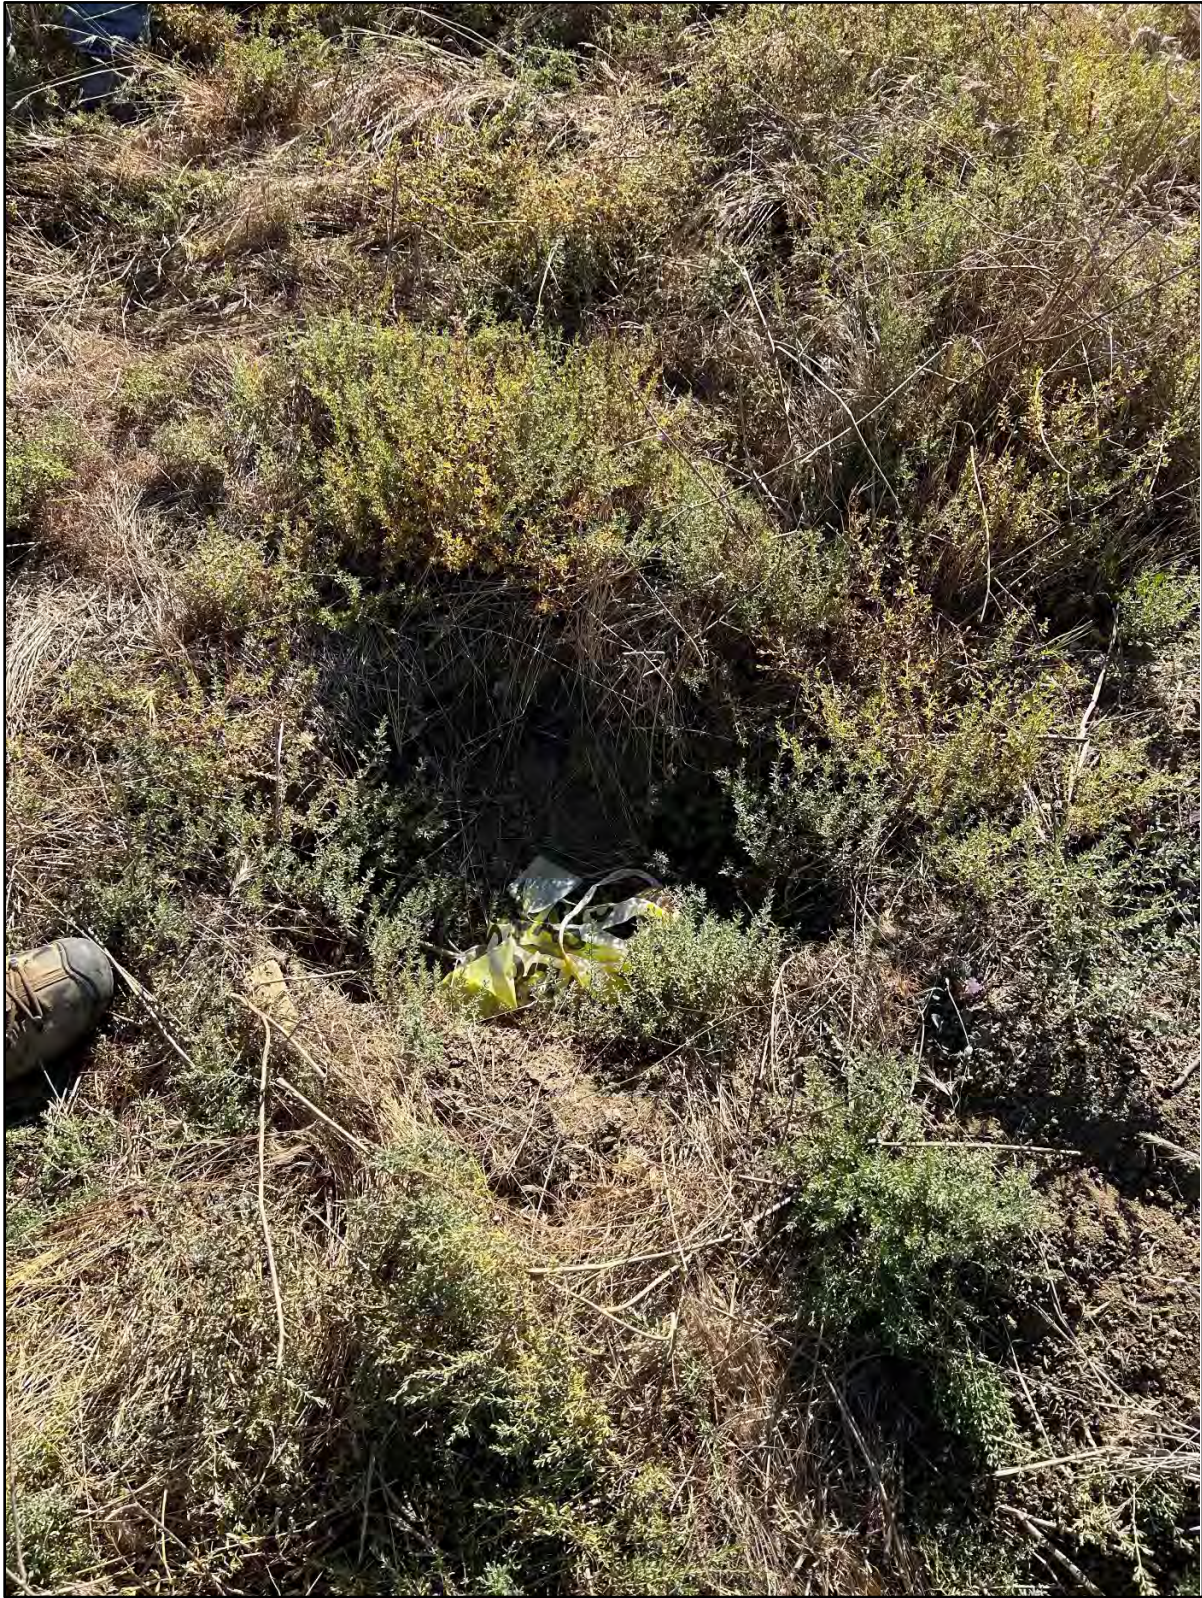
**Figure 3. Northwest rig anchor at Del Rey 4.**

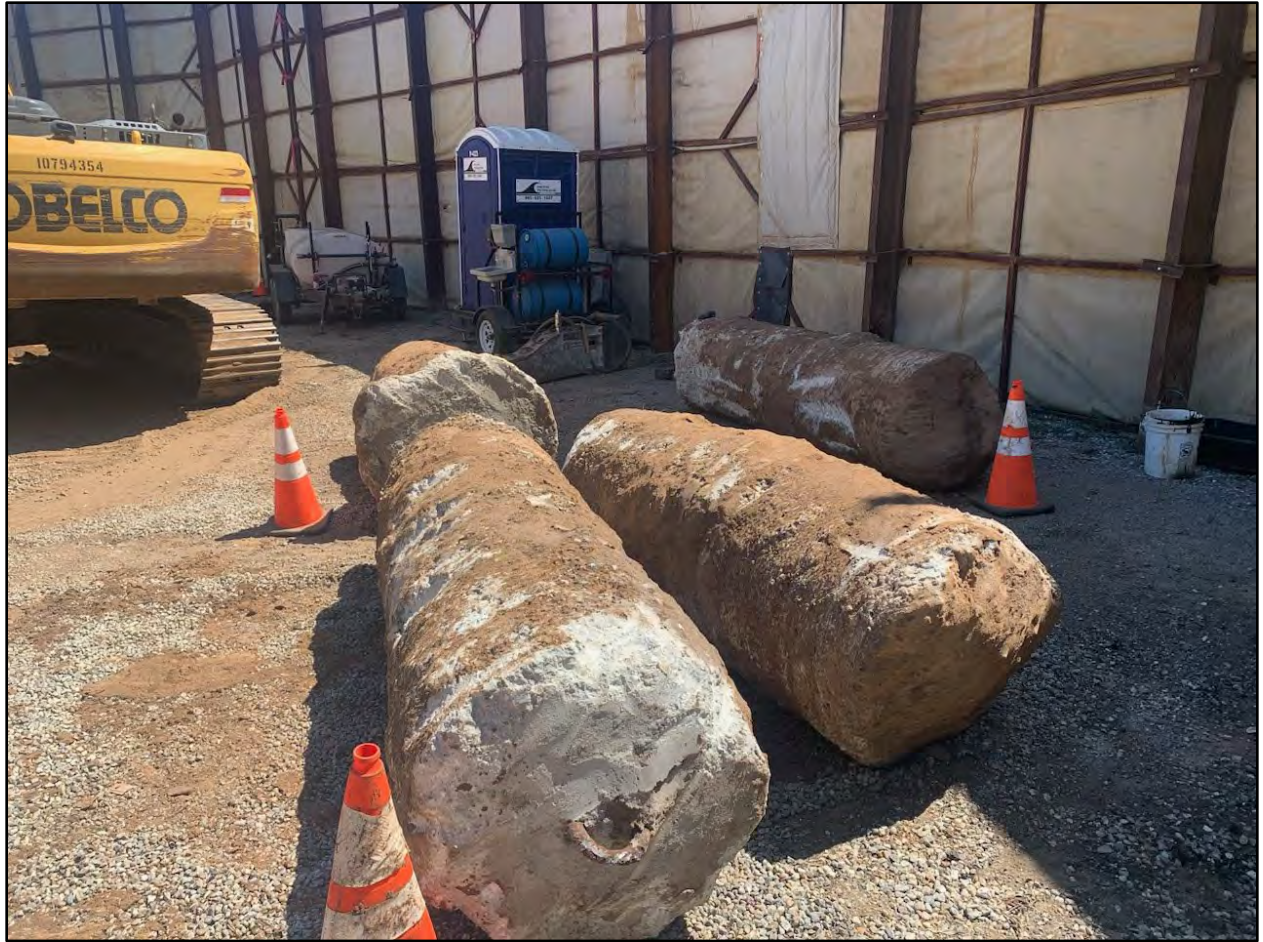
**Figure 4. Rig Anchors pulled from SoCalGas' Harper 1 well site.**

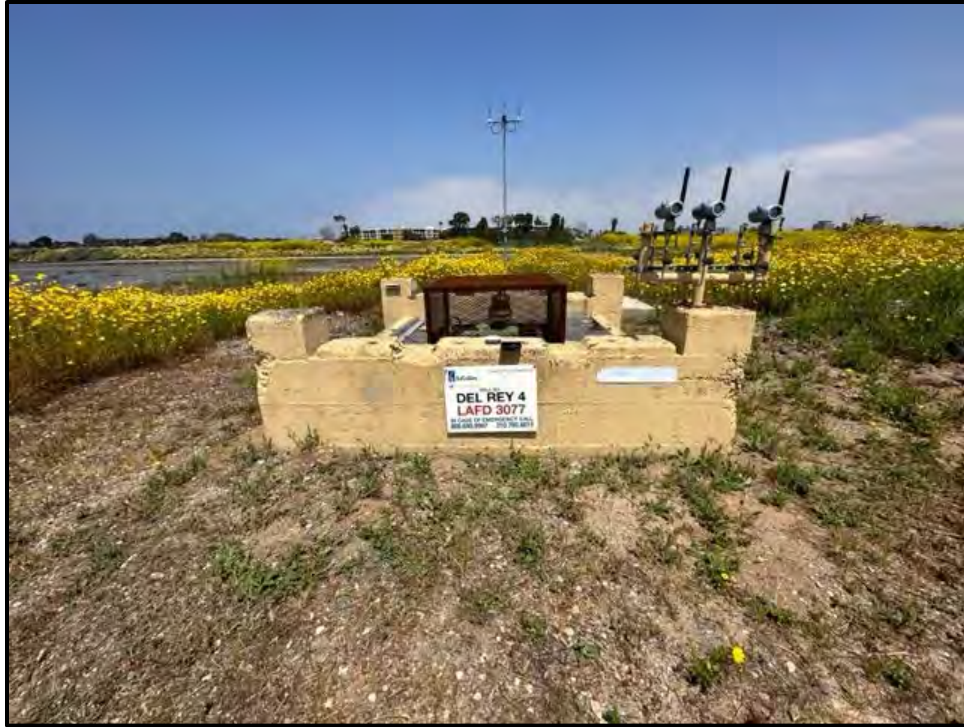
**Figure 5: View of the DR-4 well facilities, facing northwest.**

The DR-4 well is located within the Ballona Wetlands Ecological Reserve. The well is situated underground with supporting facilities on the surface. The DR-4 well pad is elevated higher than the surrounding wetlands and is generally devoid of vegetation and/or is seasonally invaded by nonnative mustards (**Figure 5**). All concrete and surface facilities would be removed as part of the well removal.
