CALIFORNIA COASTAL COMMISSION

A-2-**HMB-25-0017 (VIDOVICH SFR)**

AUGUST 13, 2025

EXHIBITS

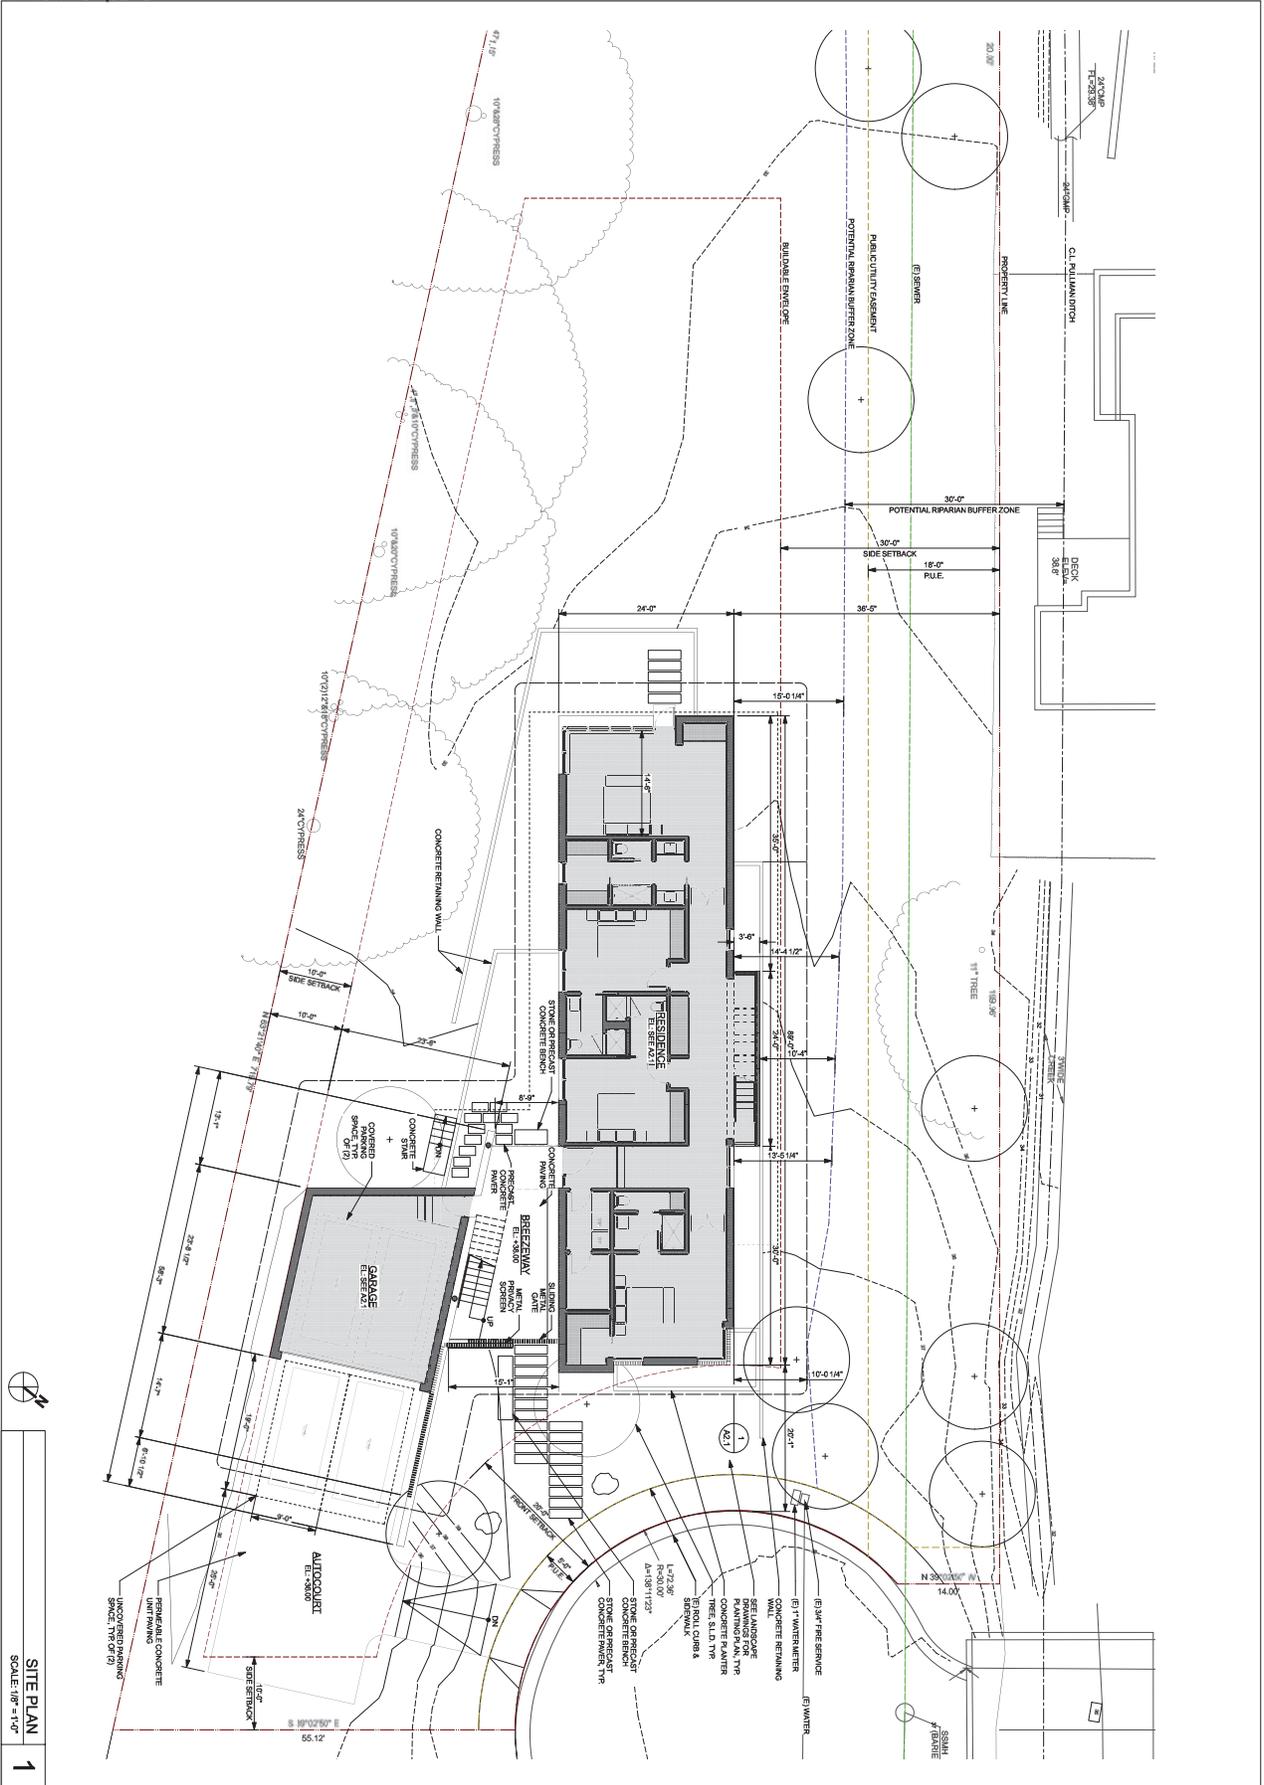
A1.1

SITE PLAN
 SCALE: 1/8" = 1'-0"
 1

DRAWING CONTENT
 SITE PLAN

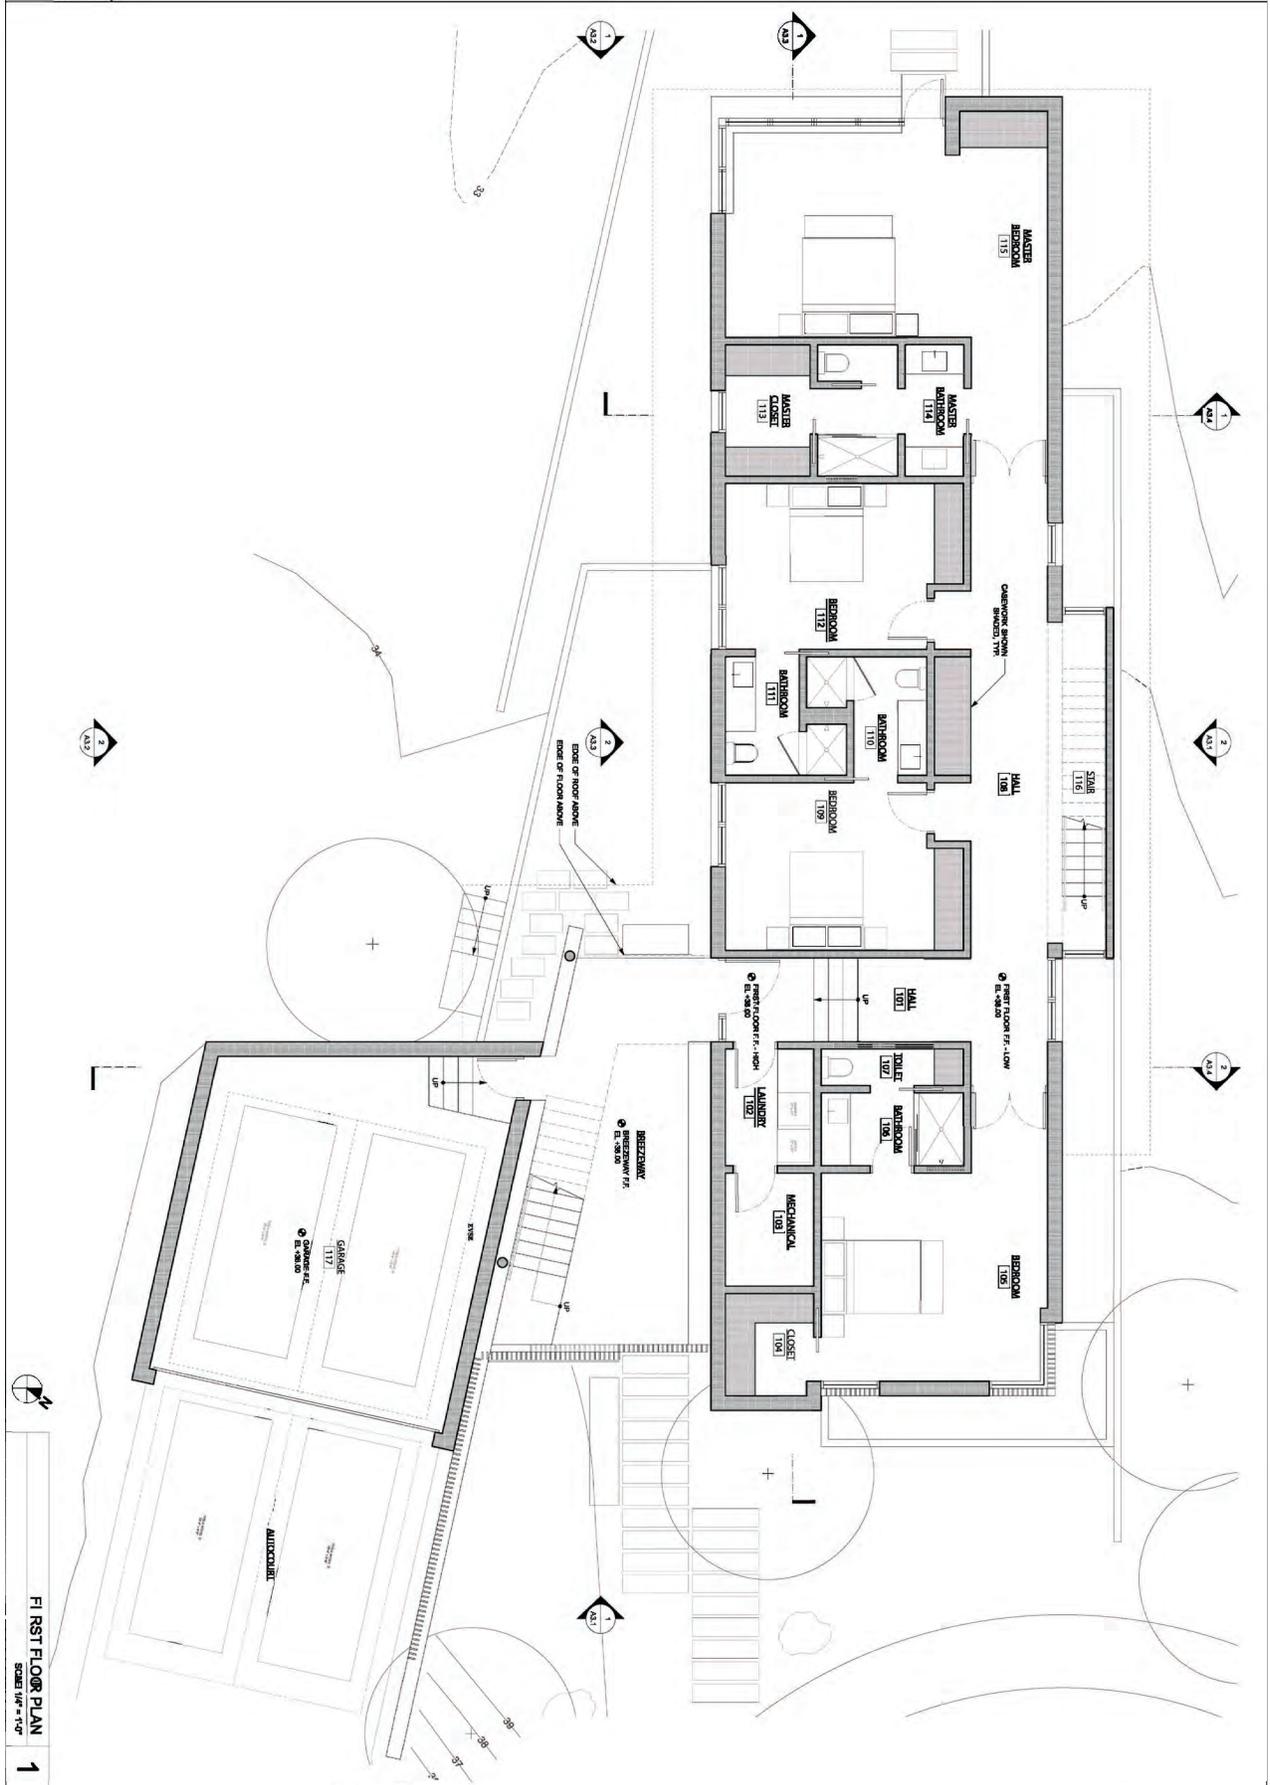
A2.1

FIRST FLOOR PLAN
 SCALE: 1/4" = 1'-0"
1

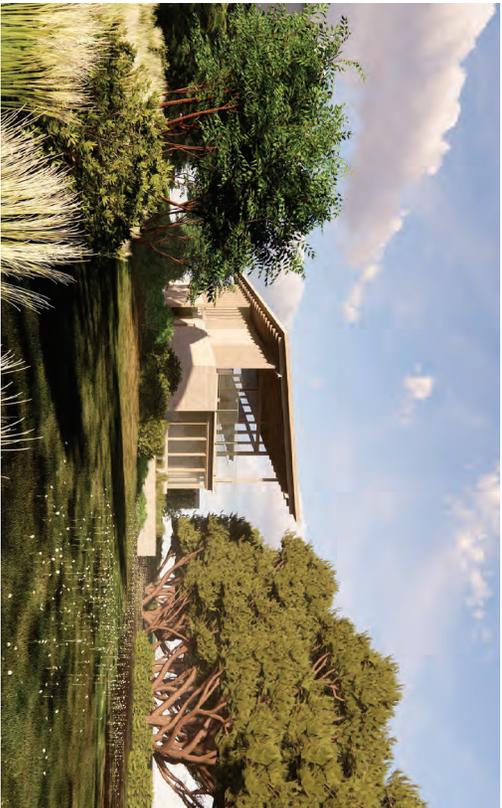
VIEW LOOKING EAST FROM ALAMEDA AVE

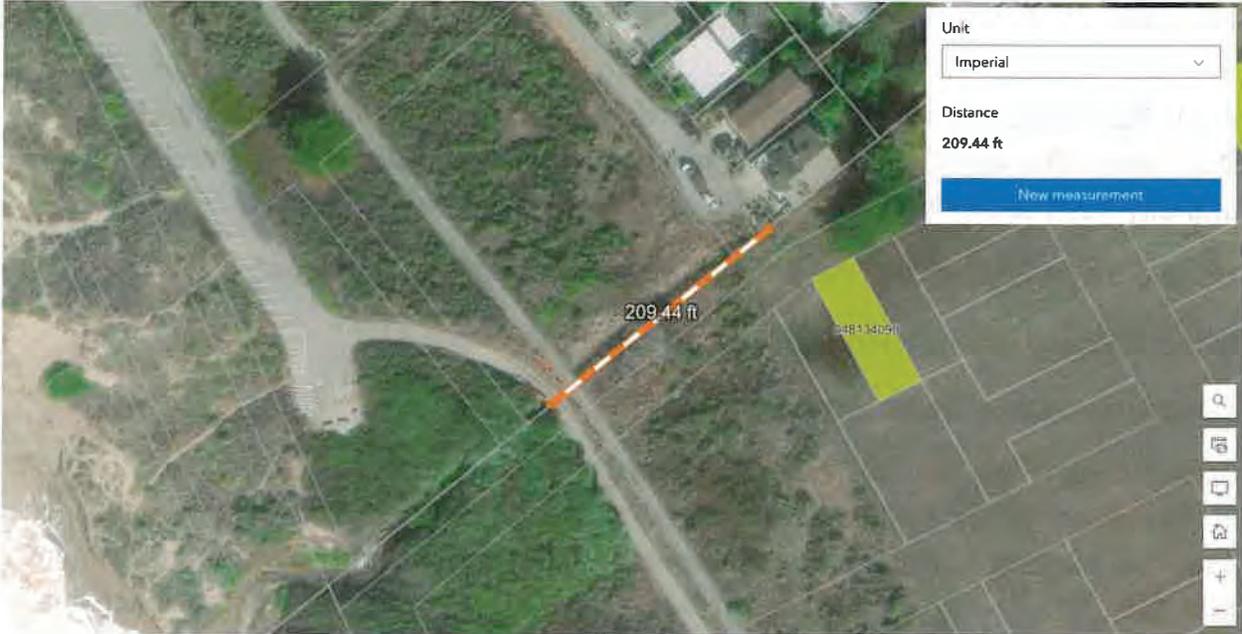
Of major concern are the Coastal Dunes immediately adjacent to 2800 Champs Elysee. They are already seriously damaged by the high velocity flow of ground water, this is the low point in the dunes beach agricultural PUD and the Stoloski Gonzales sub-division; and water that flows through and over the Pullman Ditch.

This is sheet flow across the Coastal Trail

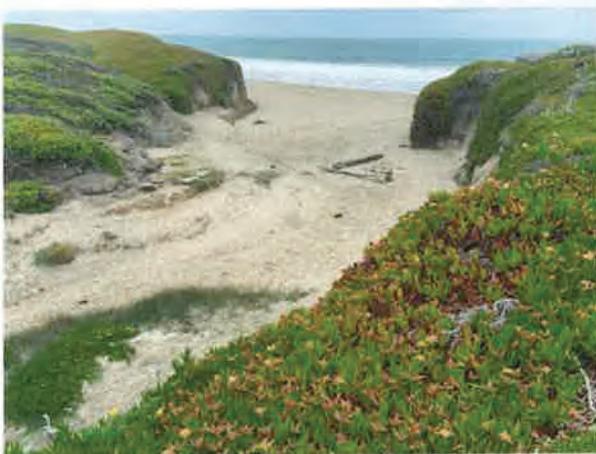
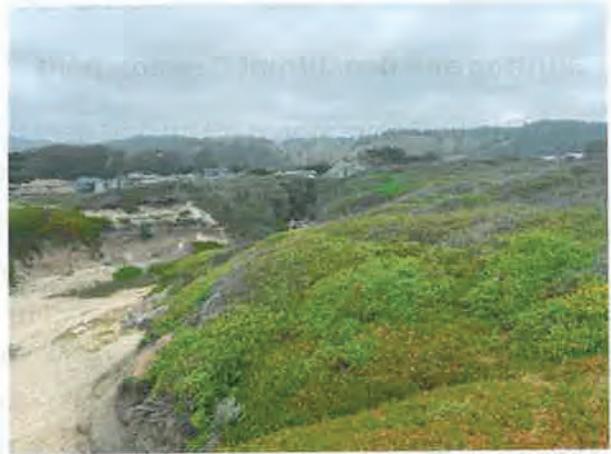
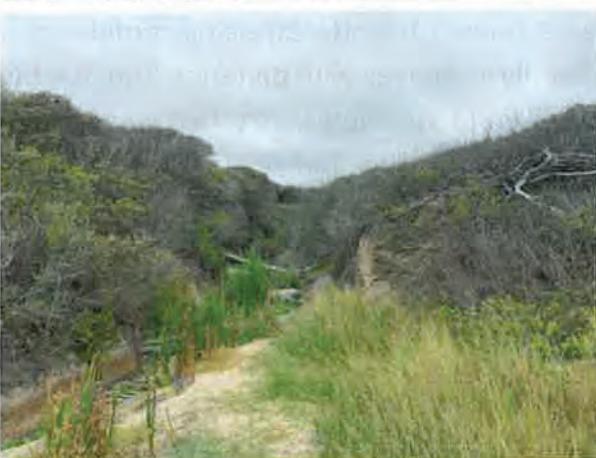
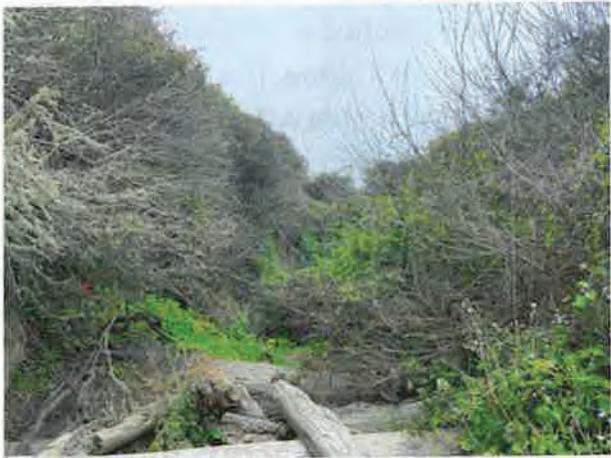
These are photos of the incision through the bluffs at the Pullman Ditch, this leads, and is in close proximity to the culvert on the Coastal Trail.

Storms are becoming more frequent, and the atmospheric rivers that feed into the Pullman ditch have carved a deep and widening chasm through the bluffs. The further addition of impervious surfaces at 2800 Champs Elysee, being the closest property at 210 feet from the bluffs will send more water into the chasm, and if the swale is disturbed it will further exacerbate this and will impact sea level rise over time. This would impact not only this property but an entire community.

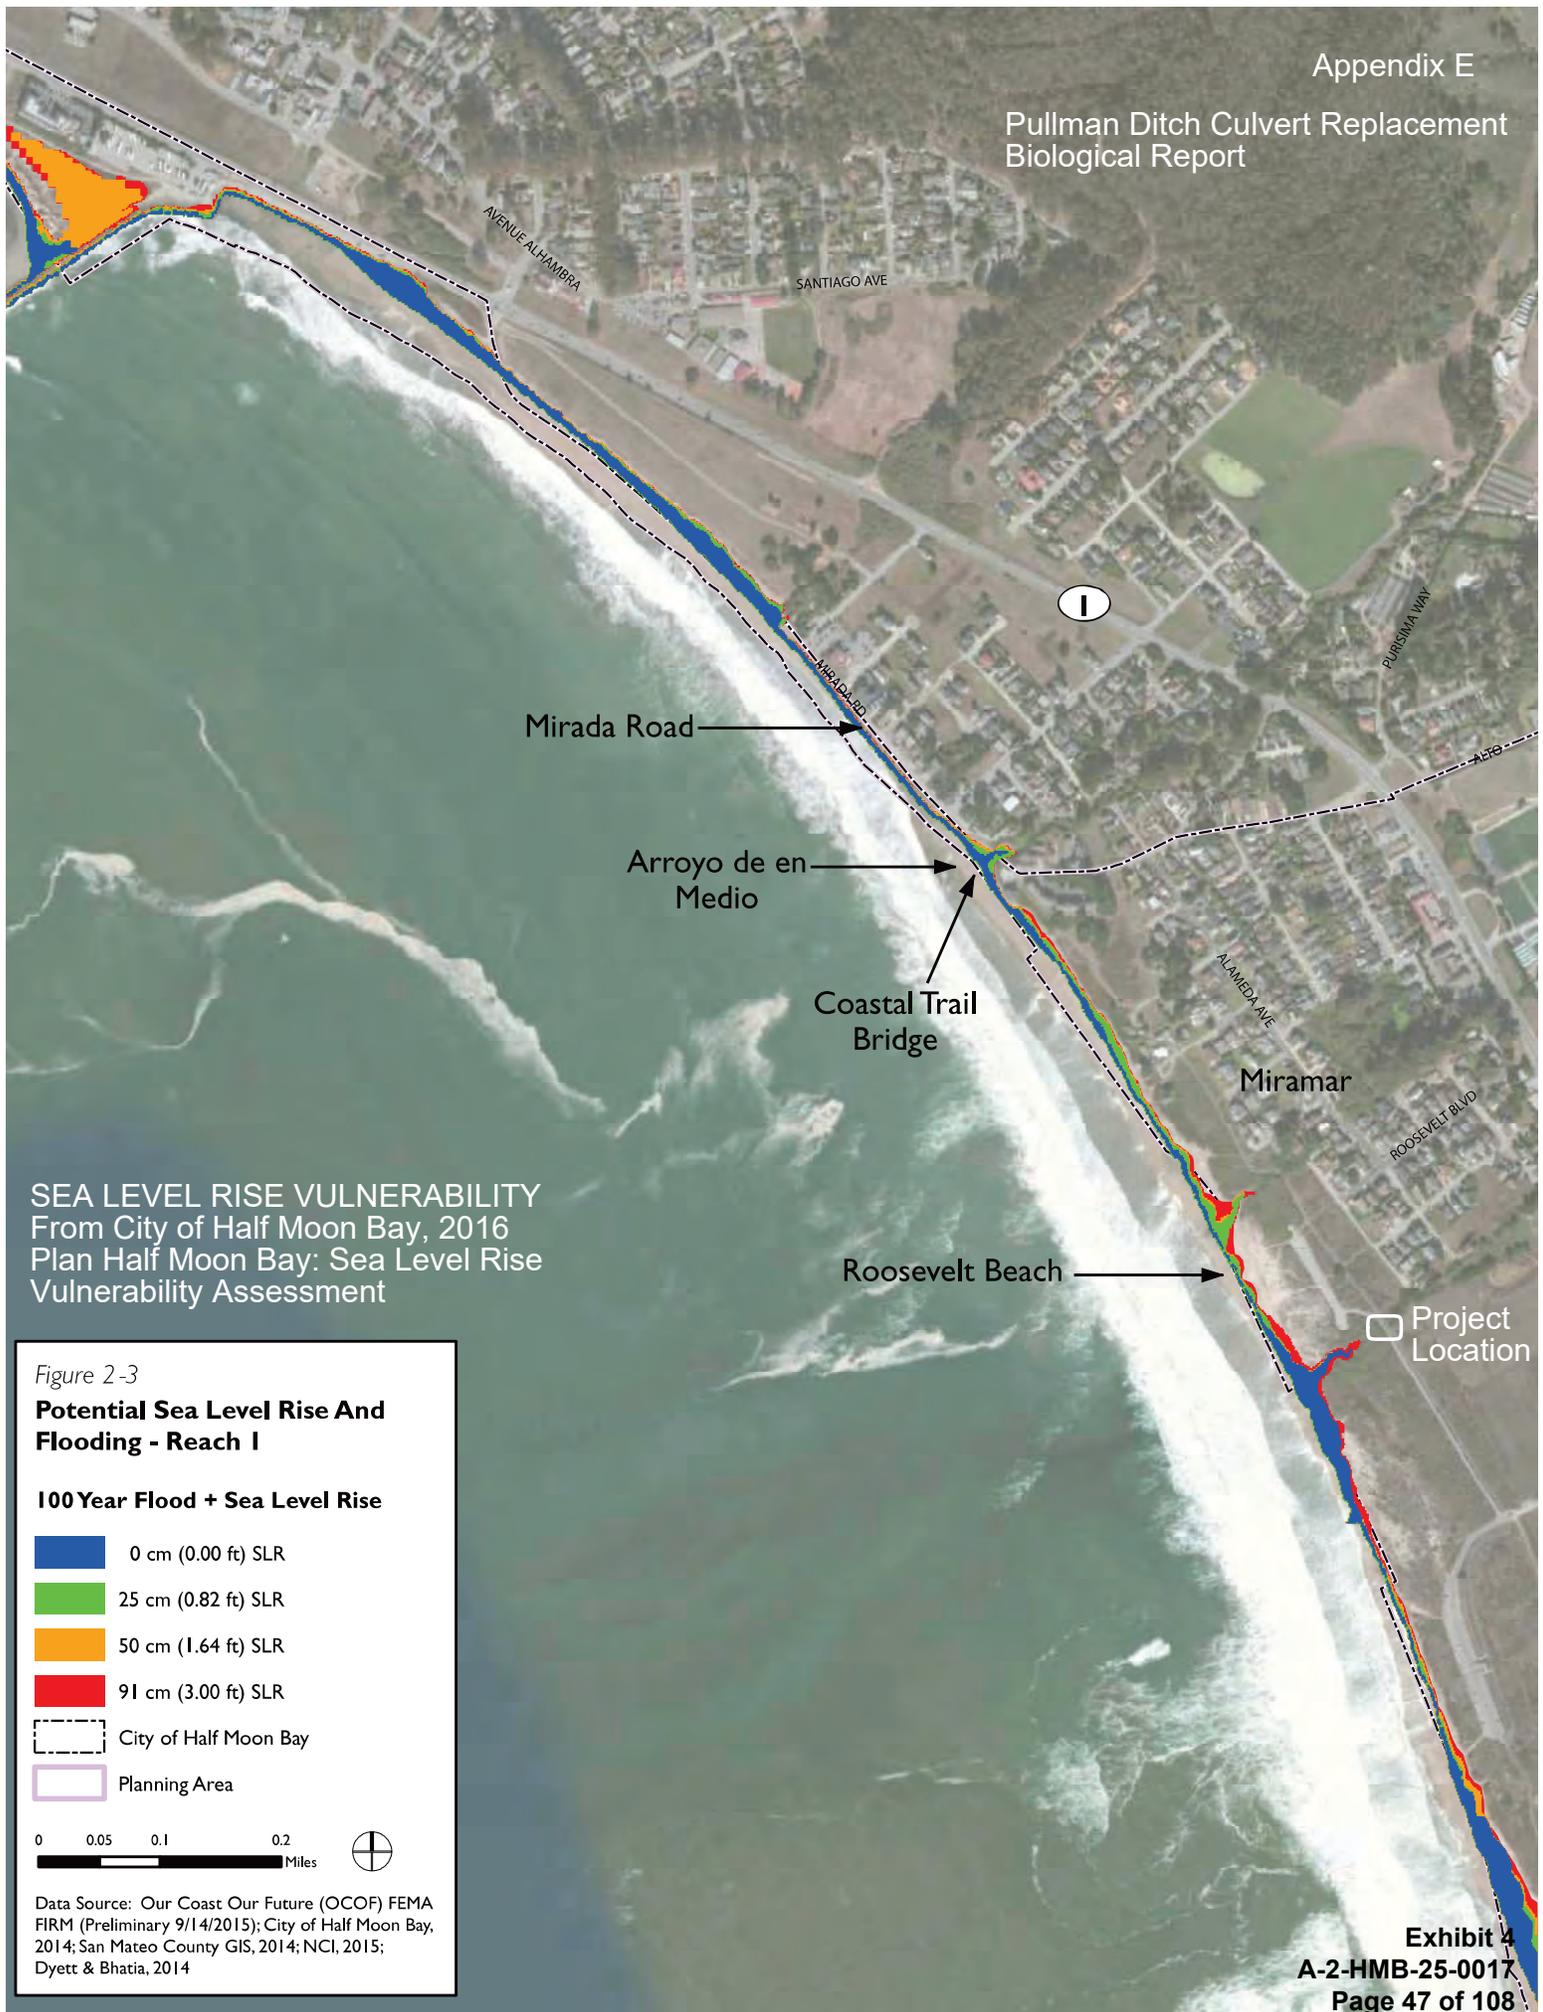
Figure 2-3

SEA LEVEL RISE VULNERABILITY
From City of Half Moon Bay, 2016
Plan Half Moon Bay: Sea Level Rise
Vulnerability Assessment

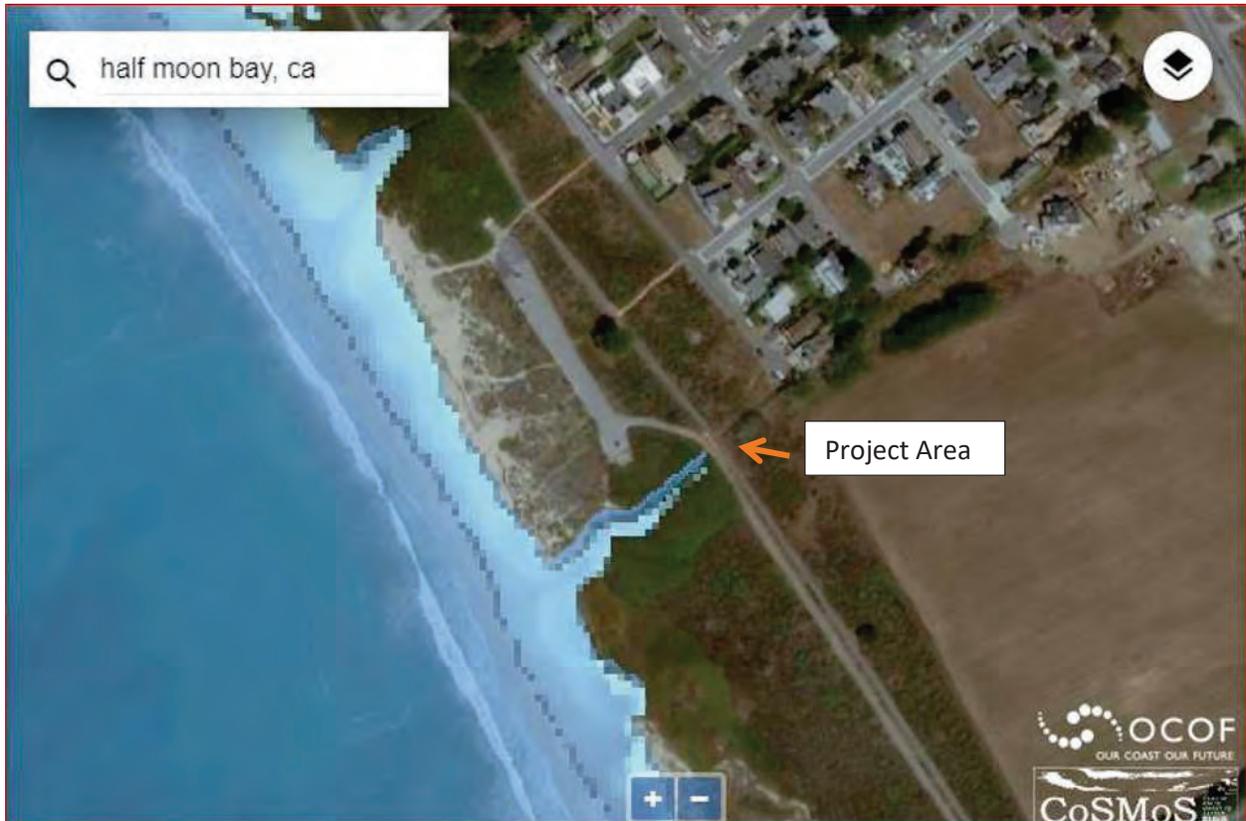
SEA LEVEL RISE PROJECTIONS: 100 CM SEA LEVEL RISE AND 100 YEAR STORM

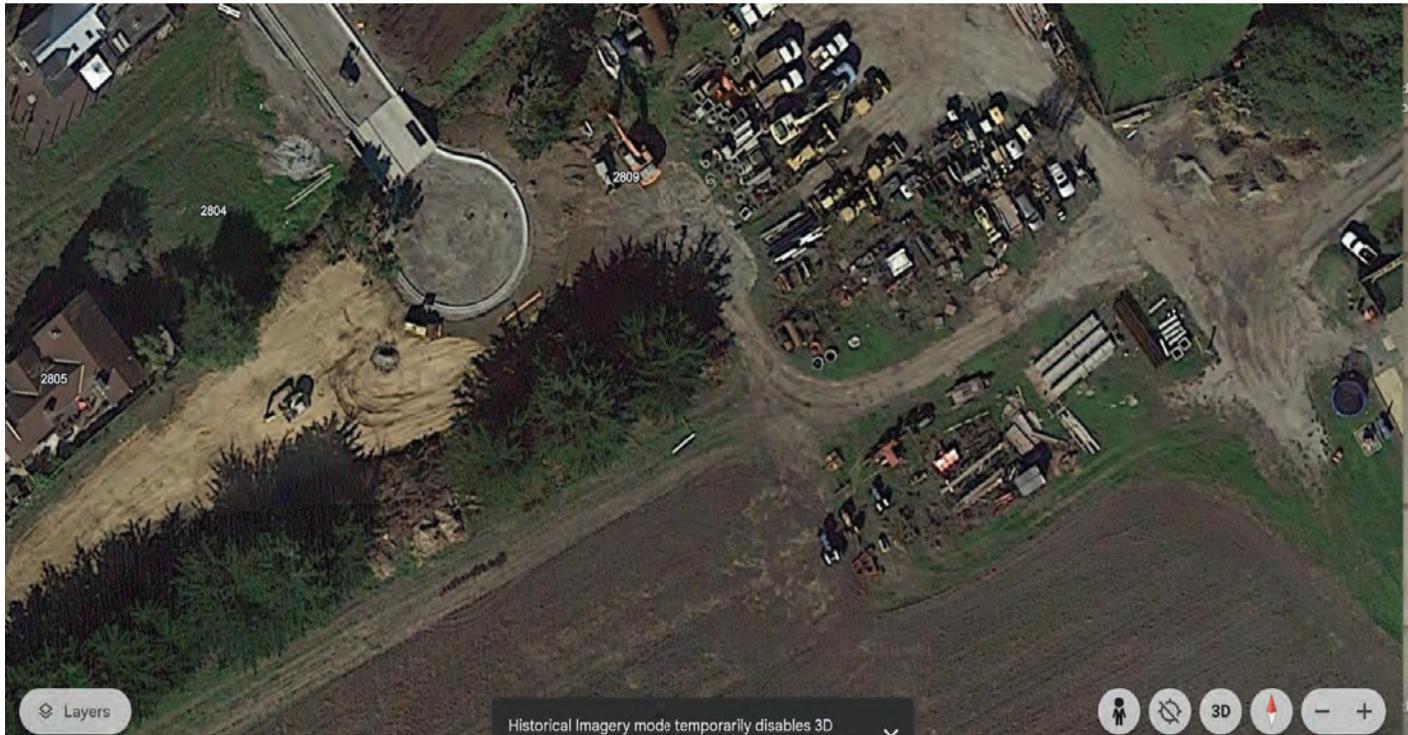
Photo 2. November 30, 2016 - Unpermitted Grading Activities on 2800 Champs Elysee

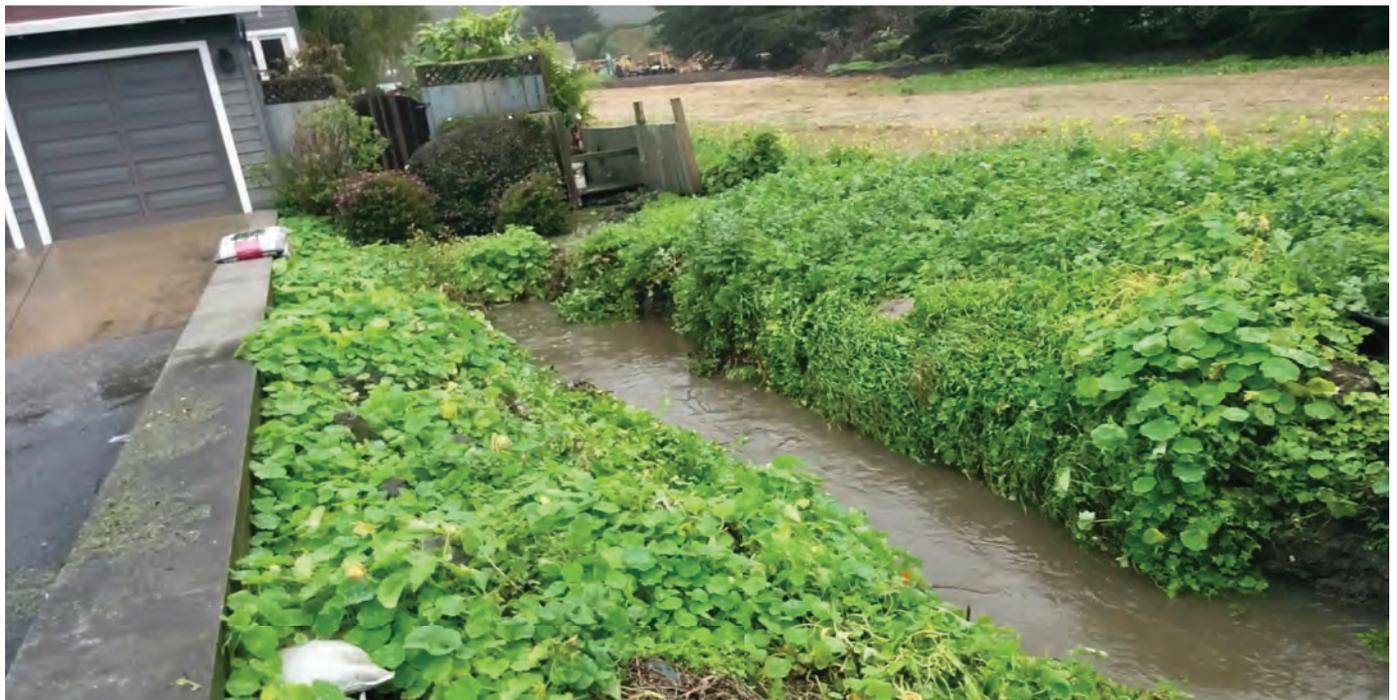
Photo 3: January 10, 2017 – Evidence of Grading 15 ft from Watercourse (Unpermitted)

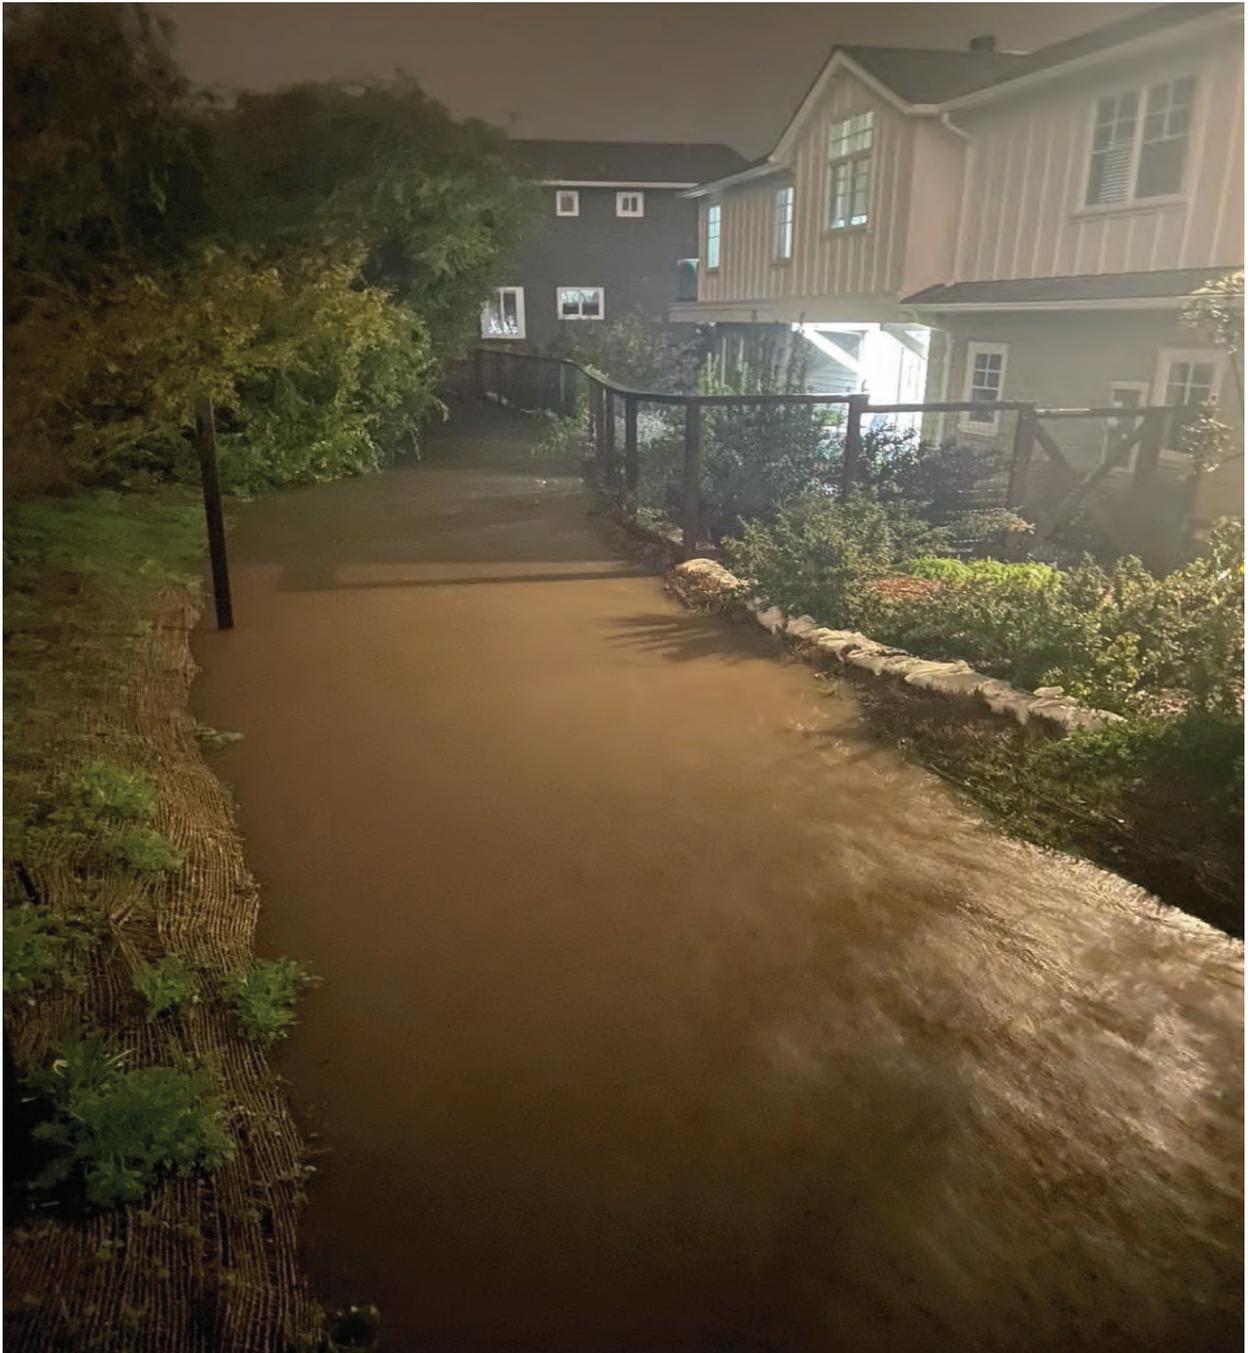
Photo 6. 2804 Flooding on Dec. 31, 2022 - (fire dept pumped first floor living space)

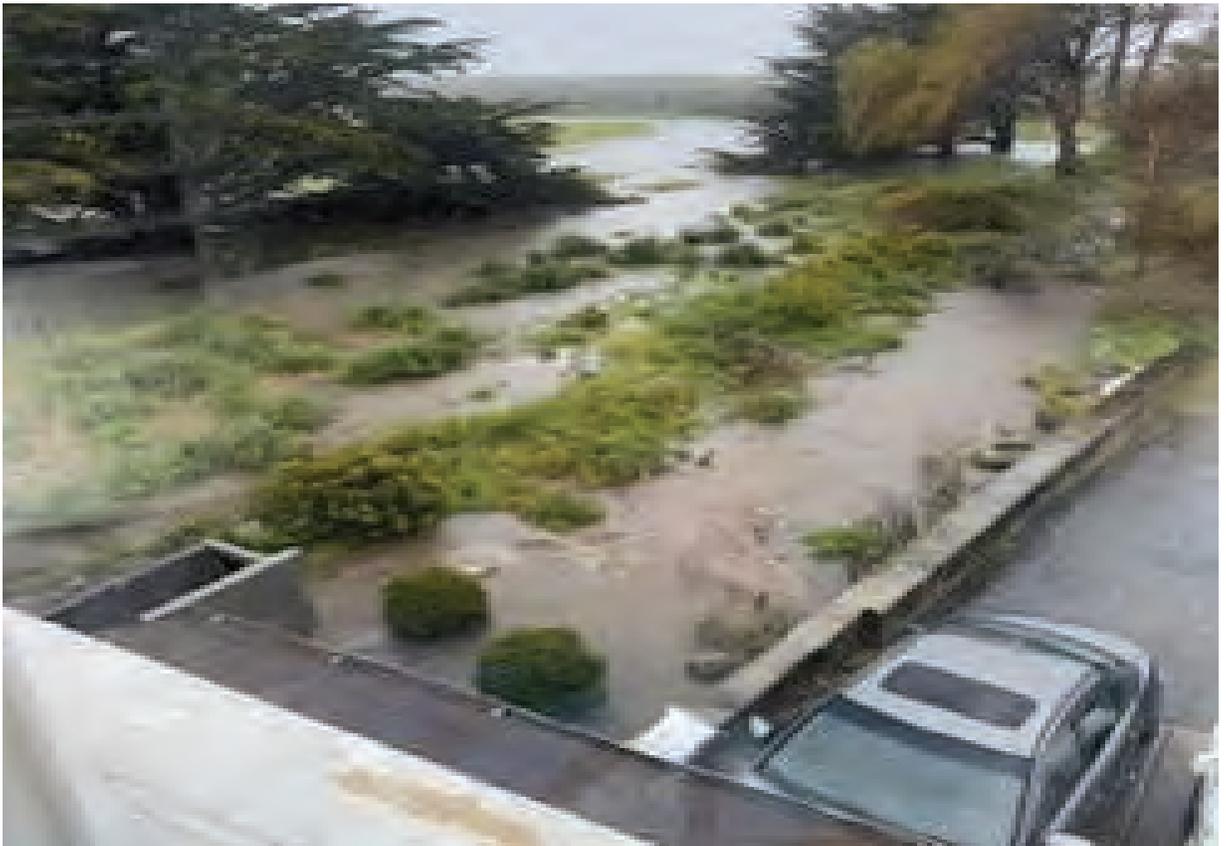
Photo 9. Flooding on 2800 Champs Elysee March 28, 2023

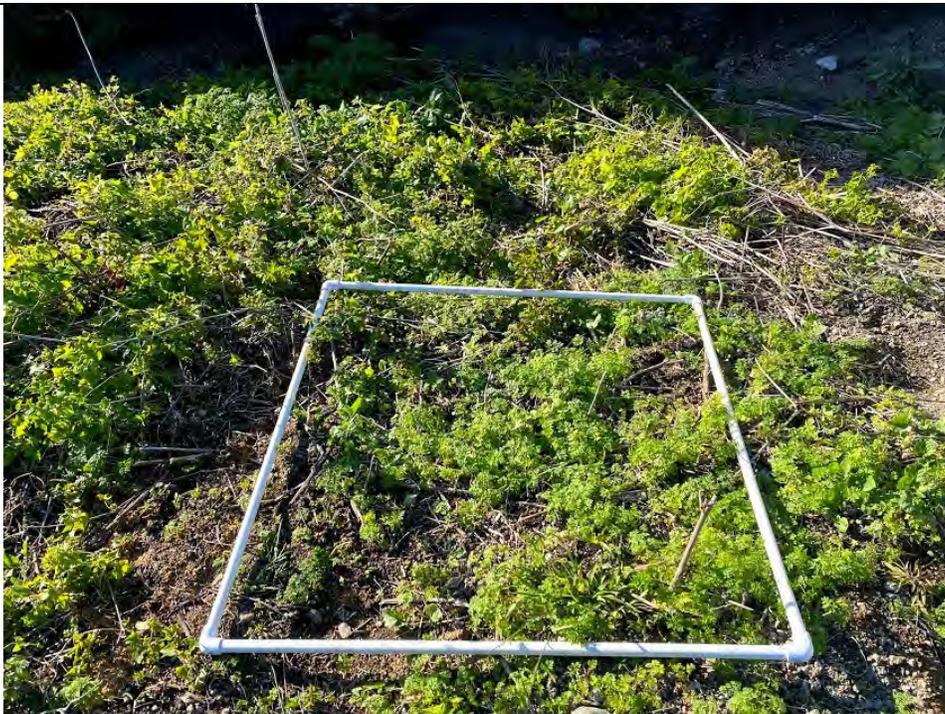
Photo 11. Sample Point 4, showing an oxidized rhizosphere. Not enough other hydrologic features were observed at this sample point, however, to make it a wetland.

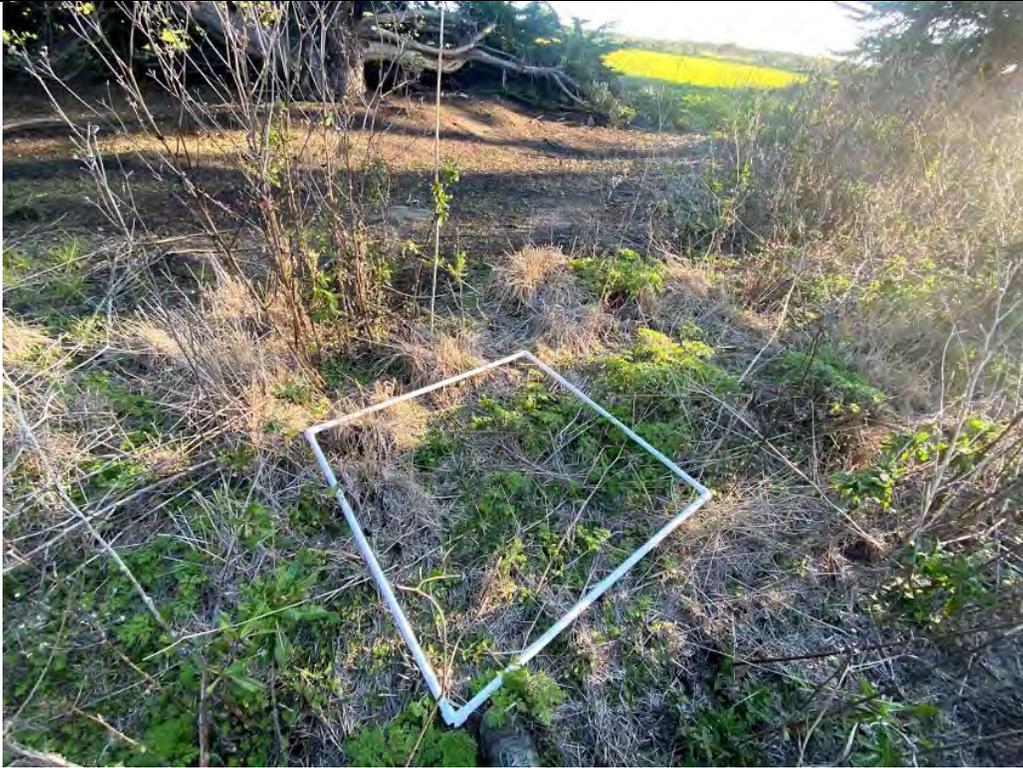
Photo 20. Sample Point 12, showing well-drained upland soils of the Denison Series, in spite of wetland vegetation.

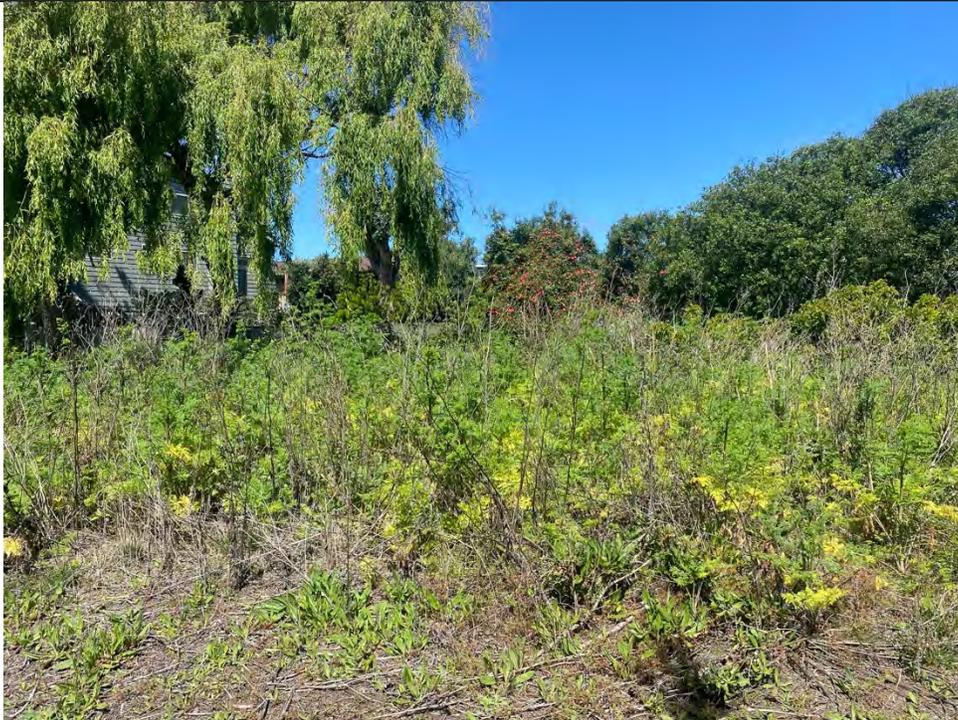
Photo 33. CCC Wetland 3 appears to follow the old banks of Pullman Creek, and is indicated by the dominance of poison hemlock running parallel to residences on the northern edge of the footprint. Most of Wetland 1 is a 1-parameter wetland, but portions also contain wetland soils.

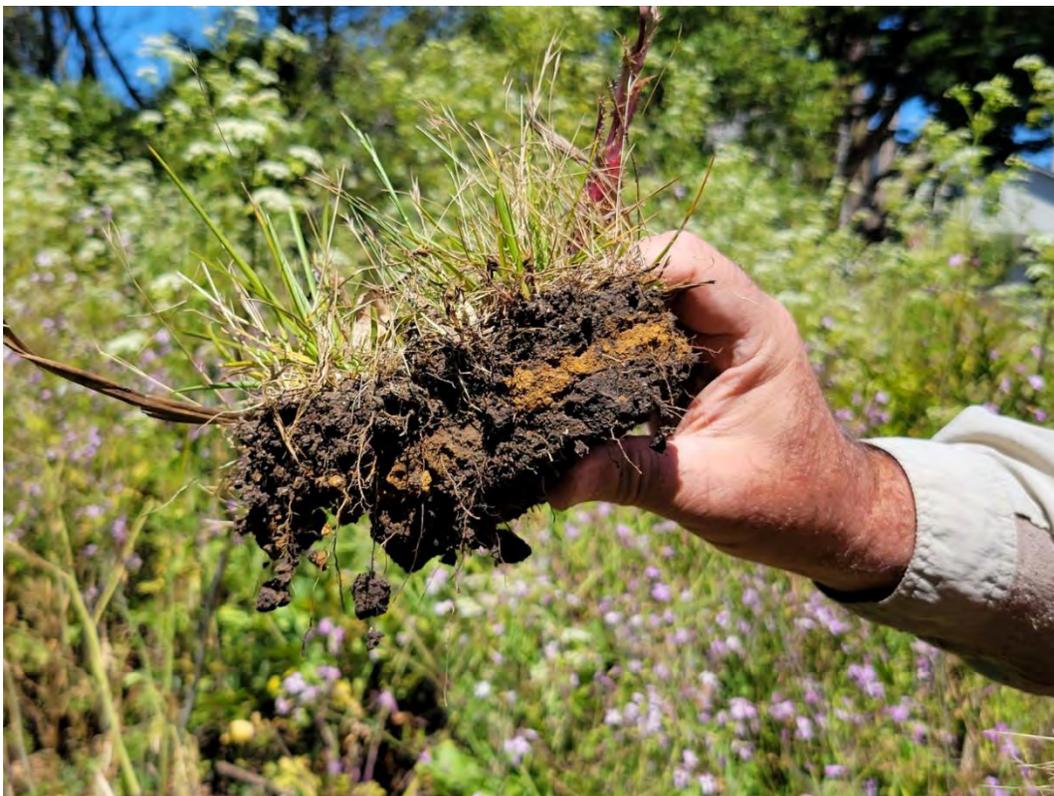
Photo 4. Sample Point 2 soil sample showing layer of fill soil. Photo date: 06/14/2022.
