## CALIFORNIA COASTAL COMMISSION

**CDP 1-24-1028**

**(Humboldt County Public Works)**

# COUNTY OF HUMBOLDT DEPARTMENT OF PUBLIC WORKS PROJECT PLANS FOR CONSTRUCTION OF STORM DAMAGE REPAIRS CENTERVILLE ROAD PM 4.62 PROJECT NO. ER-32LO(232) CONTRACT NO. 217447

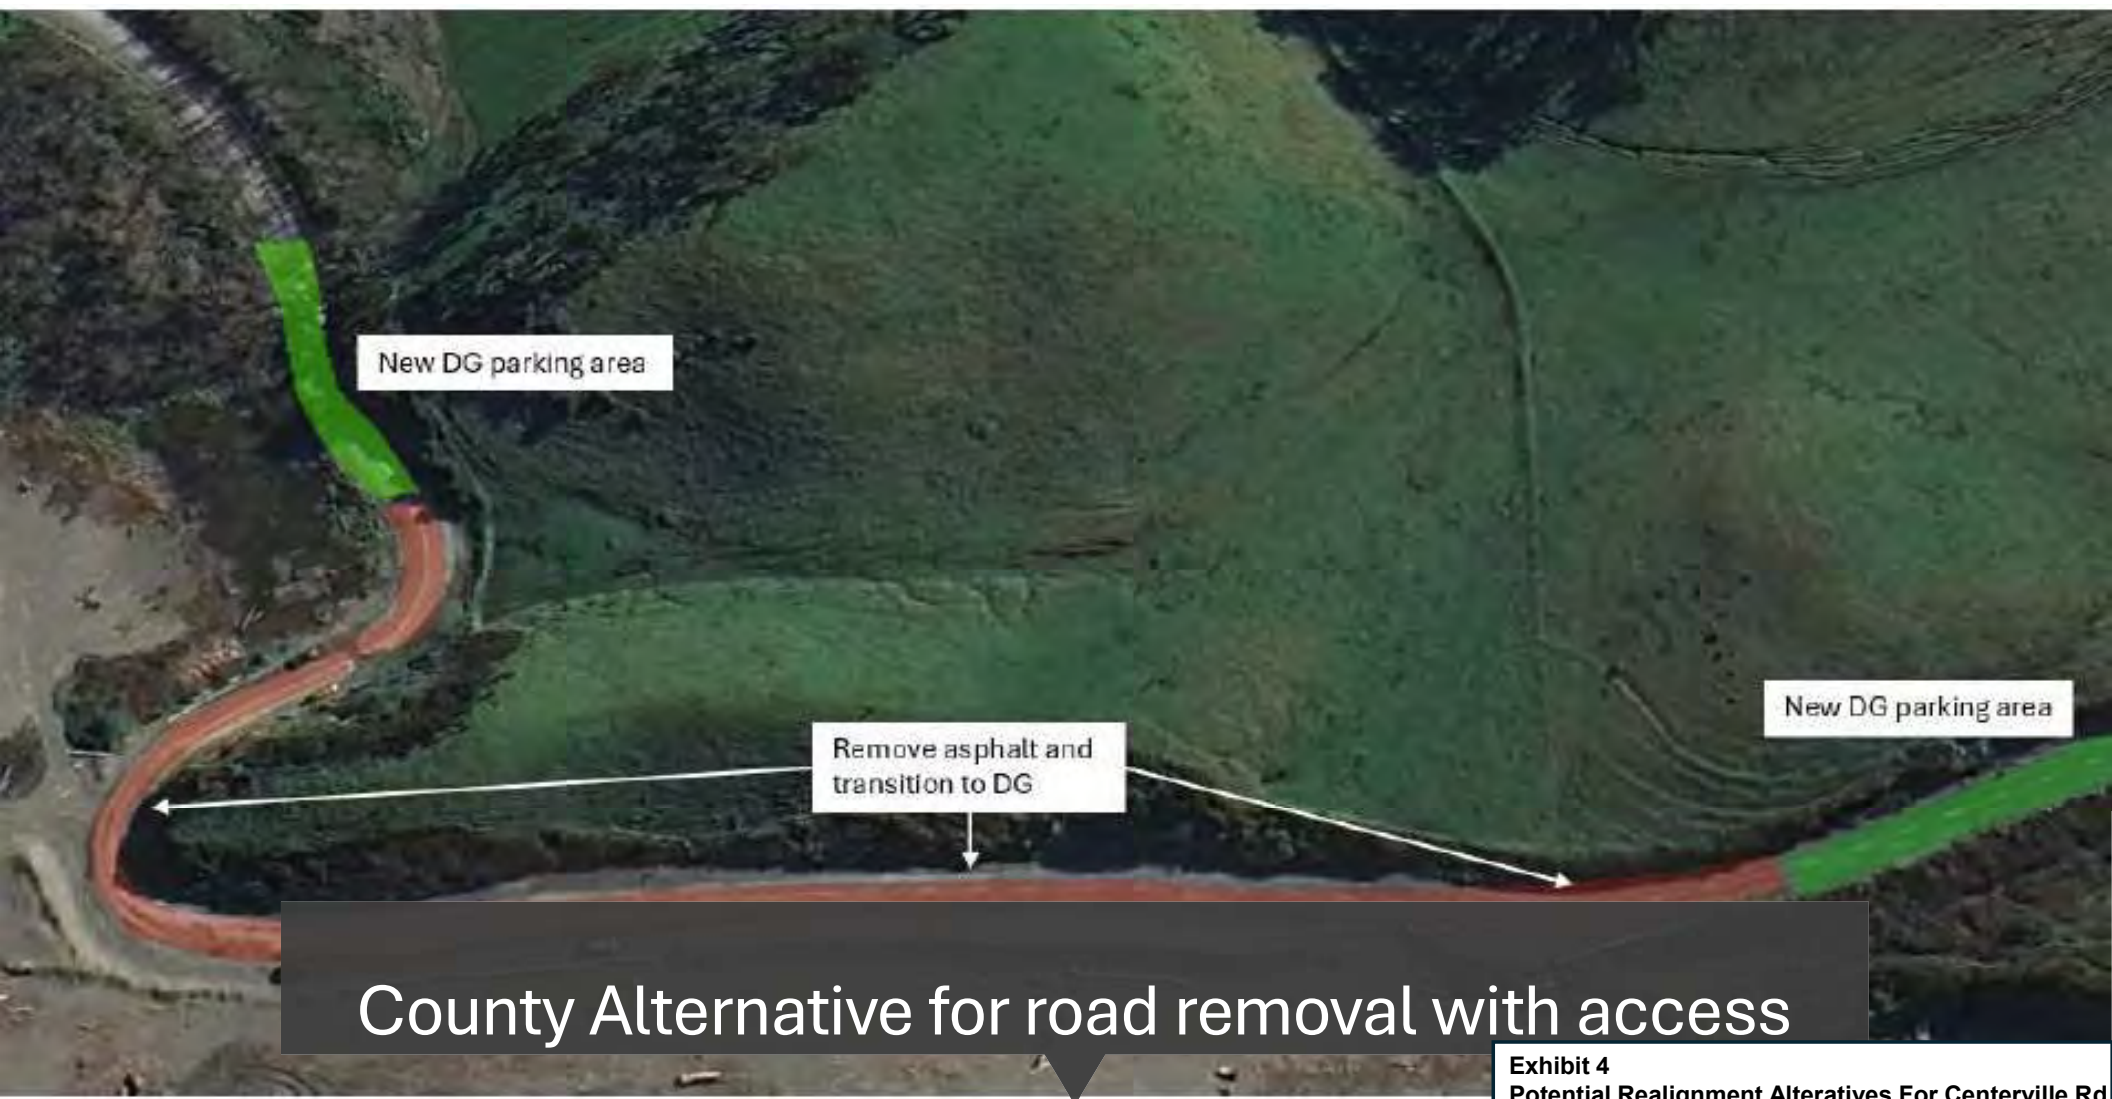
*Figure 7. Example road removal and transition to DG trail.*
