**ADDITIONAL PHASE II
ENVIRONMENTAL SITE ASSESSMENT
FOR ASSESSOR'S PARCEL NUMBERS
401-031-038, -044, -046, -055, -059, AND -060
SAMOA PENINSULA BROWNFIELD SITE
SAMOA, HUMBOLDT COUNTY, CALIFORNIA**

April 2007

Winzler & Kelly Consulting Engineers
633 Third Street
Eureka, California 95501
707-443-8326

Project No. 016670-5001-11110

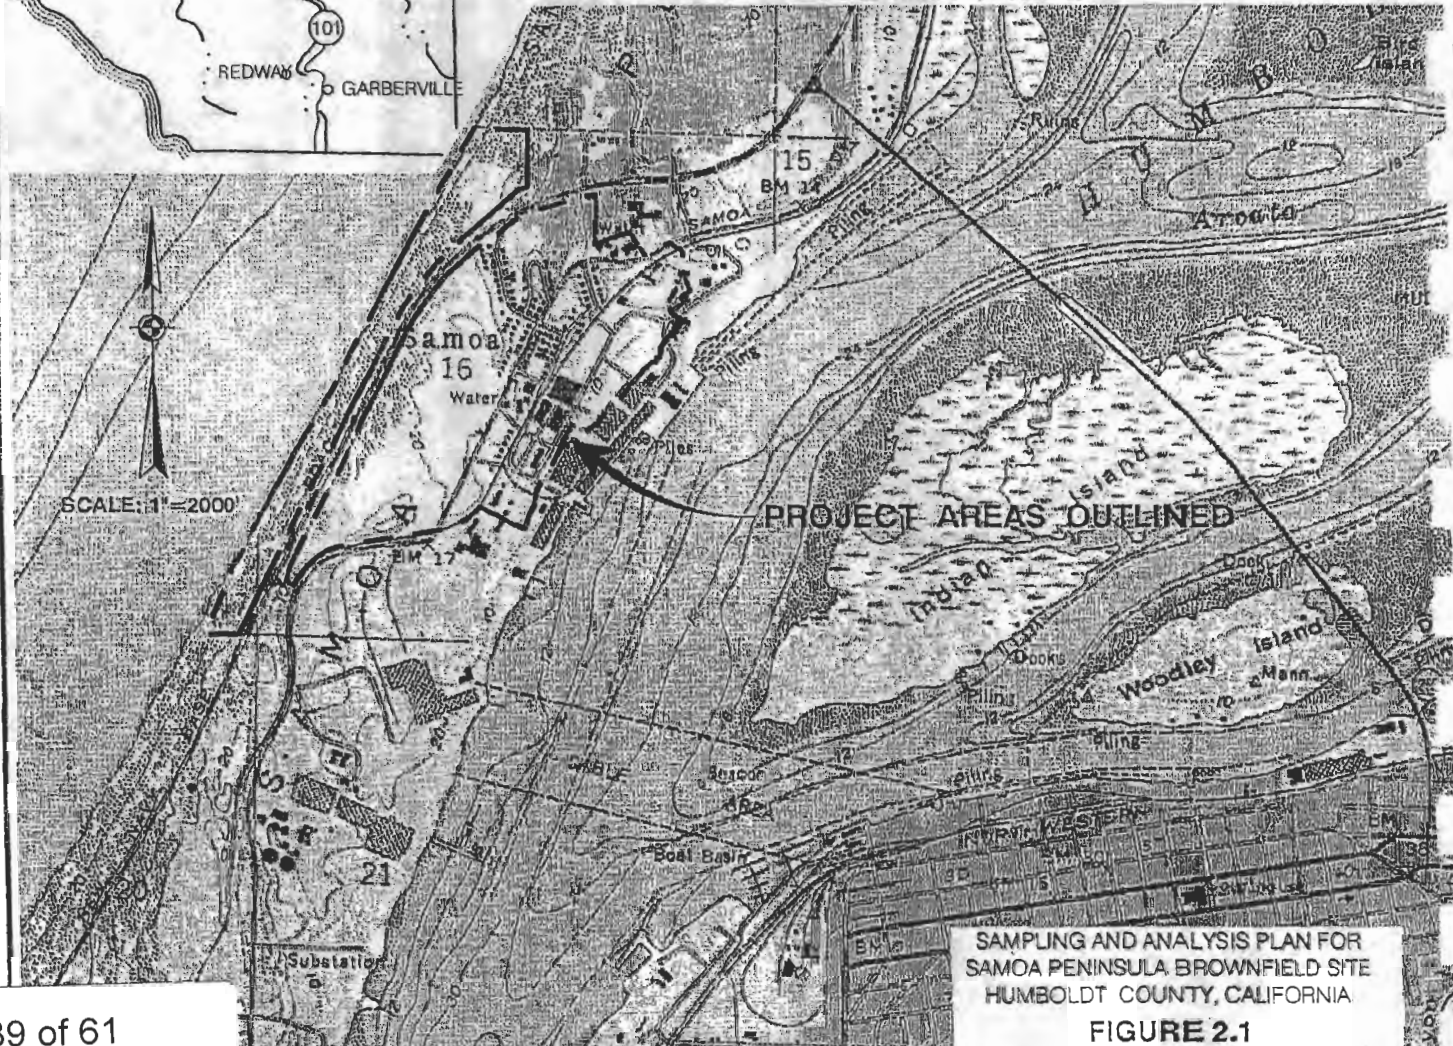
FIGURE 2.1

Surface water samples were collected at all buildings analyzed for lead based paint impacts as part of this investigation during a single rain storm event on February 7, 2007 (See Figure 2.1 Appendix B for site location). Pressurized polyethylene bailers were used to collect surface water runoff. Due to the rapid infiltration rate of water in the sandy soil at these locations, surface water was collected where runoff stayed at the surface for more the five minutes. Samples from the bailers were transferred to the appropriate sample container, which were labeled, placed in Ziploc baggies and then placed on ice while awaiting transfer to the analytical laboratory. Samples were filtered and preserved immediately upon receipt at the Laboratory. Surface water samples were collected and submitted for analysis of lead (dissolved).

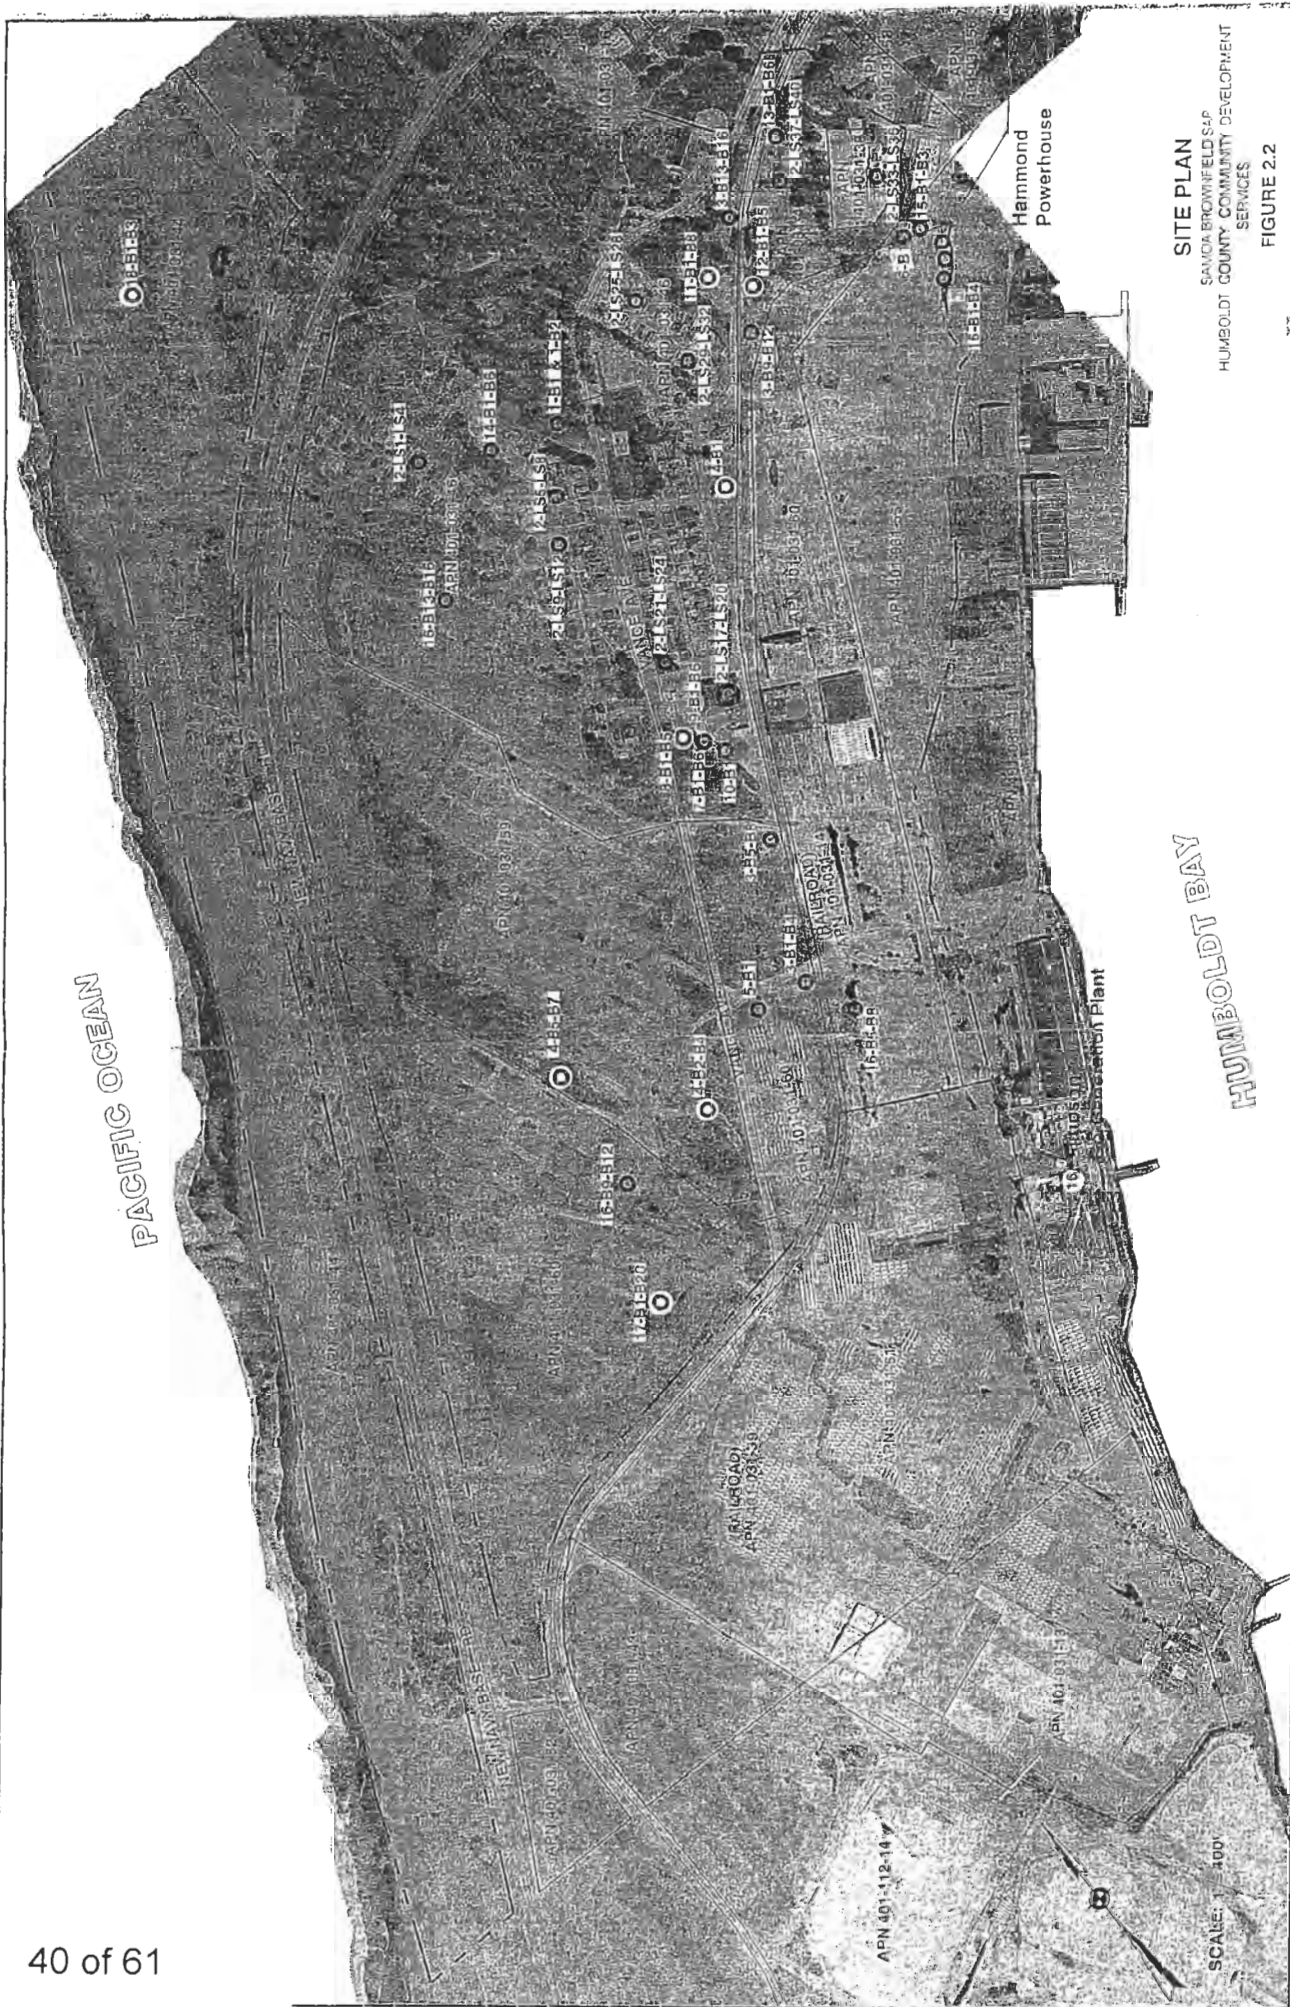
SITE PLAN
 SANDA BROWNFIELD SAP
 HUMBOLDT COUNTY COMMUNITY DEVELOPMENT SERVICES
FIGURE 2.2

During the previous Phase II investigation, very minor levels of TPH-D (up to 5.4 ppm) and TPH-MO (up to 21 ppm) were reported in the soil at two sites along the Railroad (the area of borings 3-B5 to B8 and the area of borings 3-B9 to B12). To address Regional Board concerns that low concentrations of TPH-D/ MO at these sites may be impacting groundwater, a total of two borings were installed (3-B17 and 3-B18). Boring 3-B17 is located within the previous Phase II ESA area "3-B5 to B8" and boring 3-B18 is located with the Phase II ESA area "3-B9 to 3-B12" (Figures 2.2 and 2.3, respectively, Appendix B).

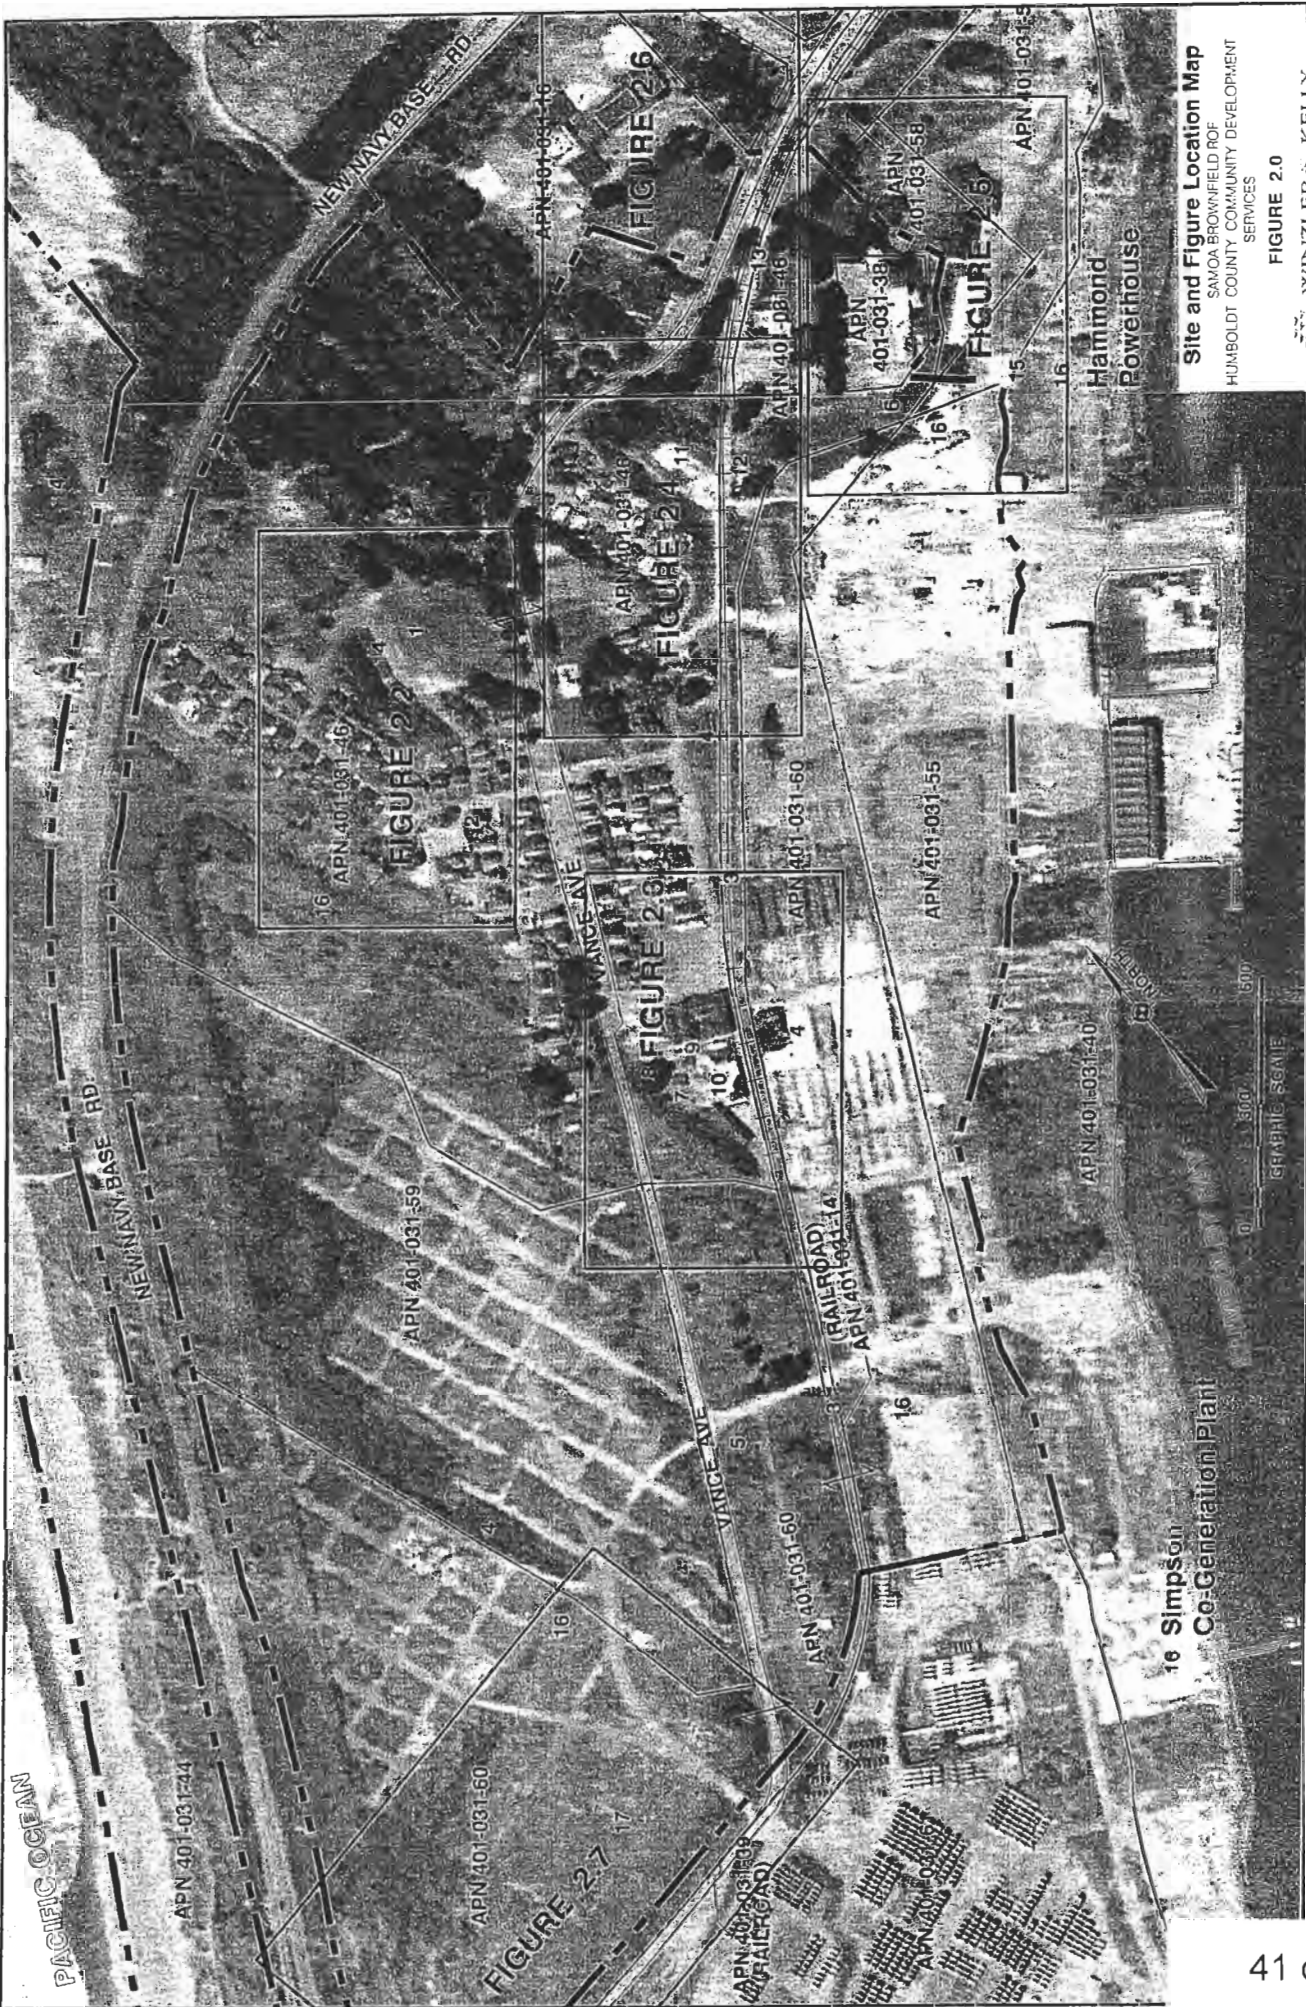
FIGURE 2.0

Groundwater samples were collected at five sites 3, 6, 13, 17, and 18 (See Figure 2.0 Appendix B for site locations). Groundwater samples were collected from hydropunch borings by placing screened well points throughout the depths of the borings. Disposable Polyethylene bailers with ball check valves were then used to collect groundwater from the well points after 1.5 gallons of water was purged. Well points were decontaminated between borings and all disposable equipment was discarded between borings. Groundwater samples were collected and submitted

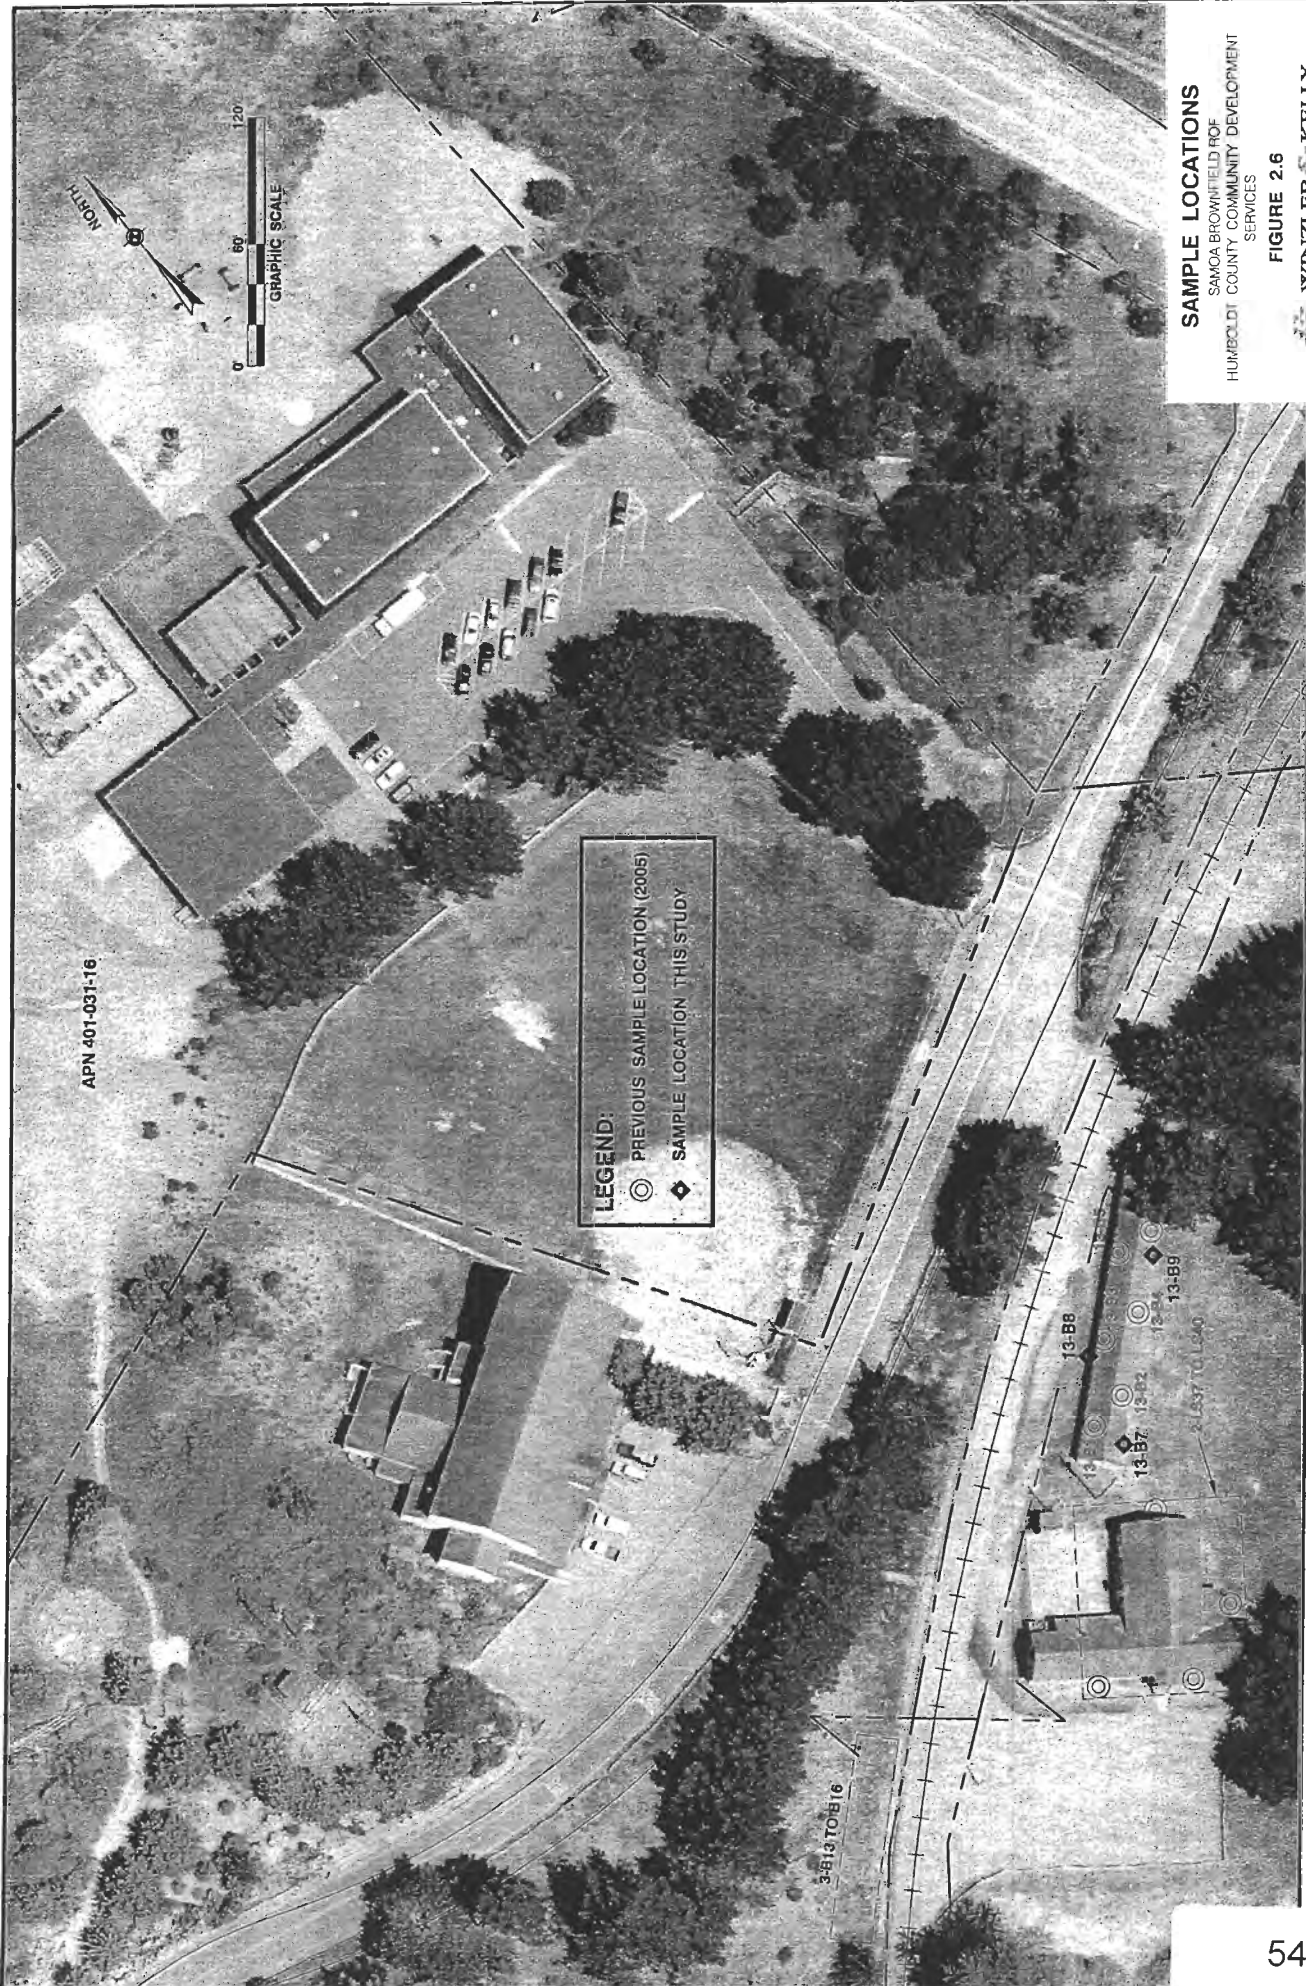
FIGURE 2.6
 WINZLER & KELLY

surface. Nothing was reported in the deeper samples collected at 18- and 36-inches below ground surface. No groundwater samples were collected. Additional sampling was performed to confirm the presence and extent of the TPH-D/MO impacts in the soil and groundwater. Per the Regional Board's comments, the levels of arsenic in groundwater in this area were also assessed. A total of three borings (13-B7, 13-B8, and 13-B9) were installed for assessment of arsenic and TPH-D/MO. Surface soil and groundwater samples at each of the three borings were analyzed for TPH-D/MO with silica gel cleanup. The groundwater sample collected from boring 13-B8 was also analyzed for dissolved arsenic. See Figure 2.6, Appendix B, for sampling locations.
