CALIFORNIA COASTAL COMMISSION

COASTAL DEVELOPMENT PERMIT APPLICATION

Application number3-04-030, Pebble Beach Golf Links, 5th Tee and 5th Green Seawalls

Project location.....Pebble Beach Golf Links 5th Hole, Pebble Beach (Monterey County).

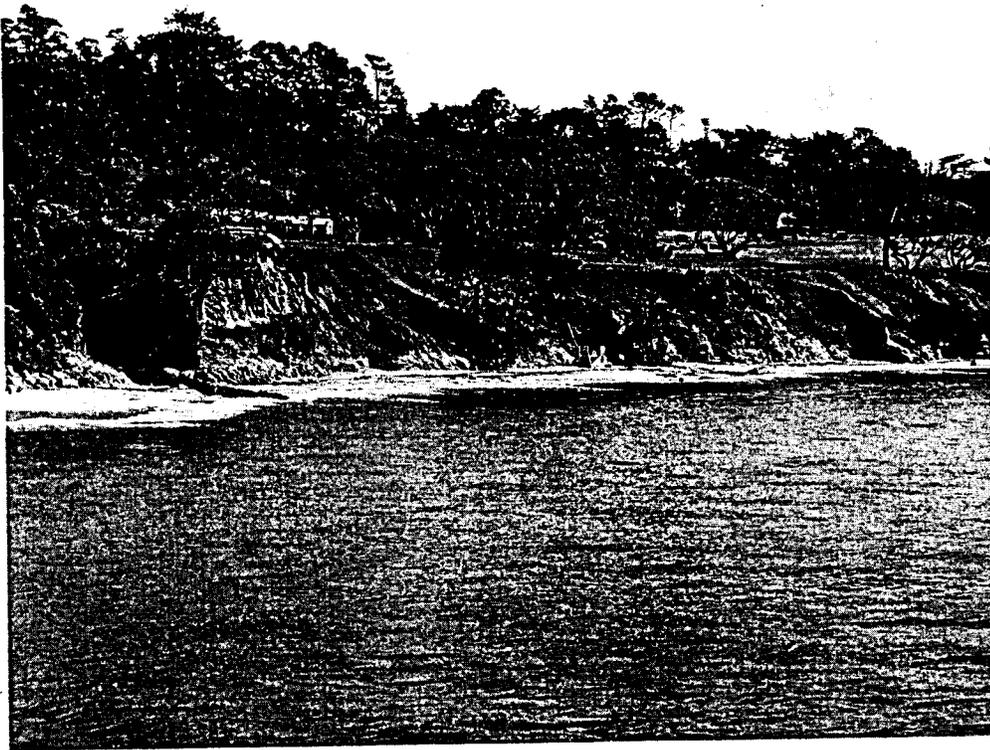
Photo 1.
Staff photo of 5th
Tee and fairway -
ravine, main tee
and upper tee on
left of photo.

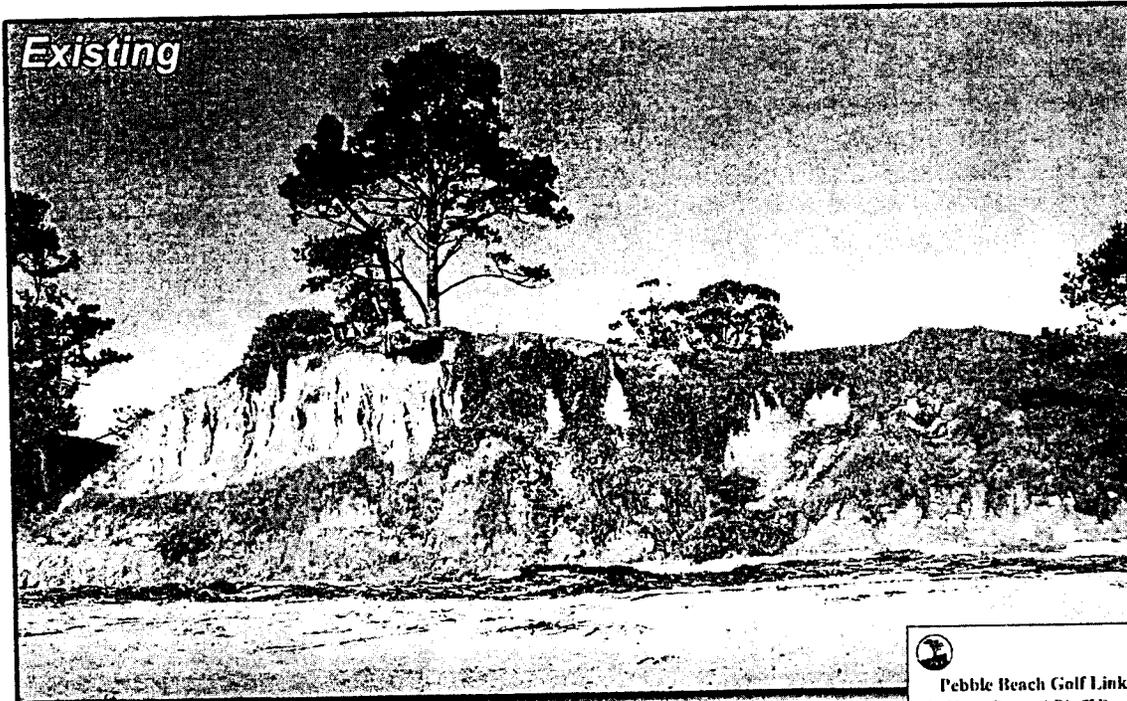
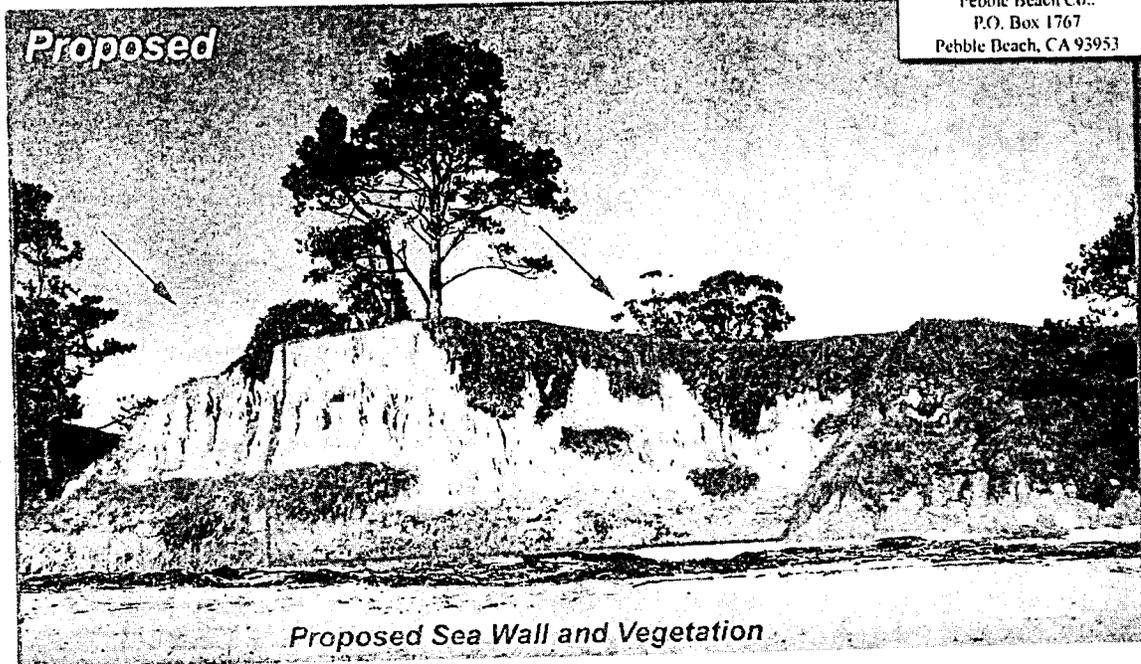
*Existing / Proposed View as seen
from Beach looking Northwest (Fifth Tee)*

Exhibit H - pg 1 of 2
Visual Simulation of Coastal Bluff - Before and After Proposed Seawalls -
5th Tee

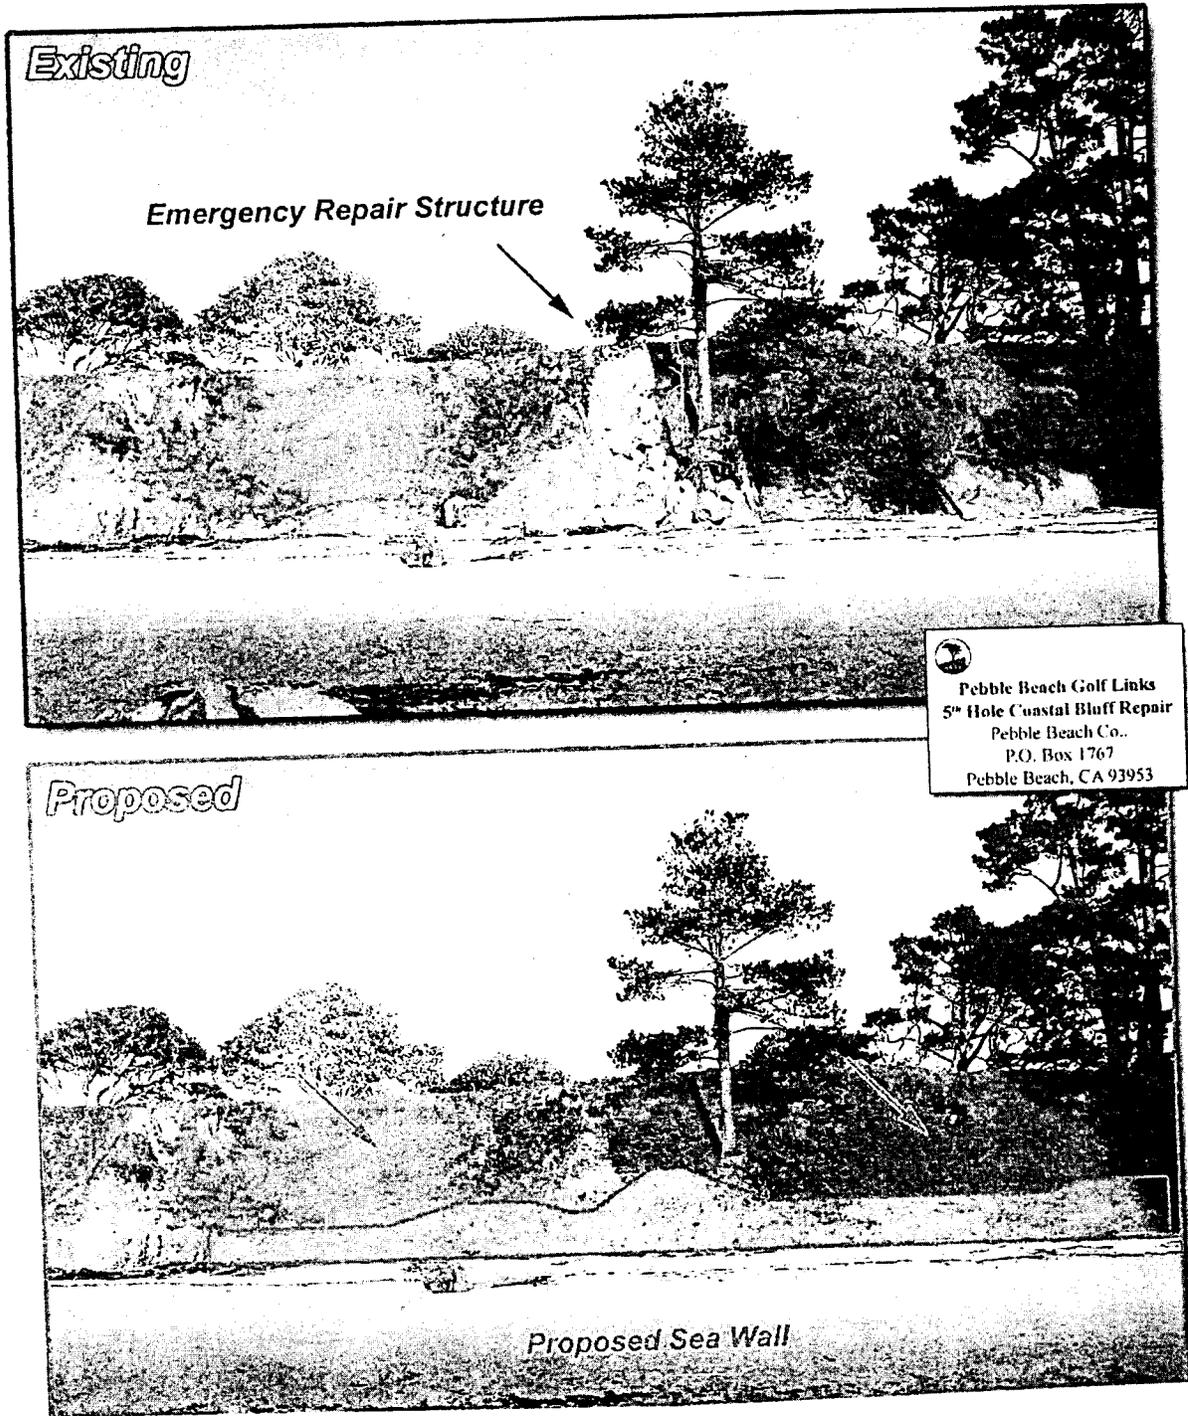
Existing / Proposed View as seen from Beach looking North (Fifth Green)

Exhibit H - pg 2 of 2
Visual Simulation of Coastal Bluff - Before and After Proposed Seawalls –
5th Green

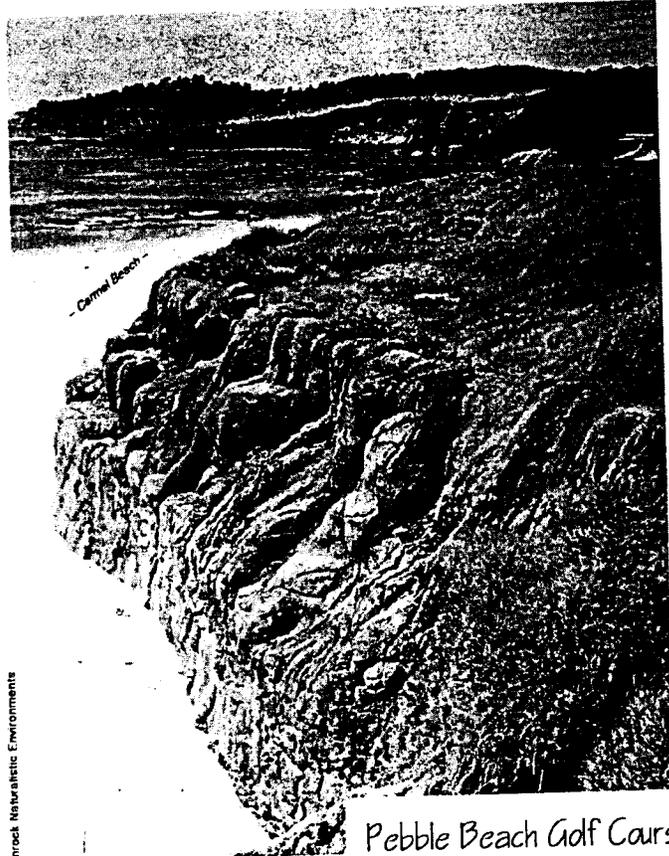
Photo 1.
Applicant's photo
of 9th Hole seawall
- dated Summer,
1998.

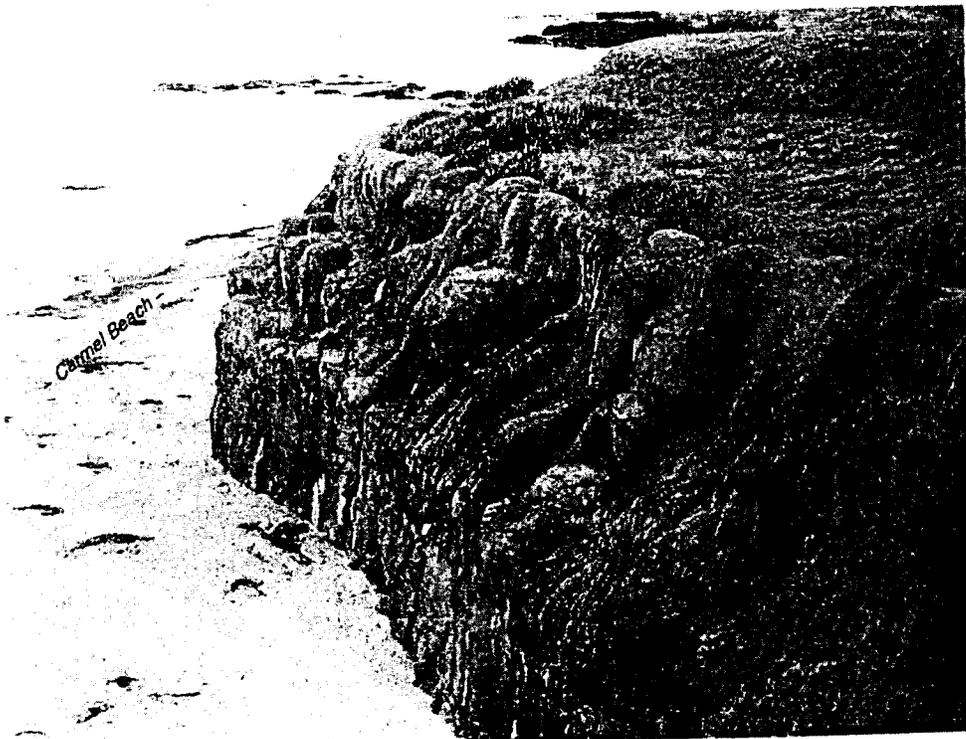
Photo 2.
Applicant's photo
of 9th Hole seawall
- dated 6/24/04.

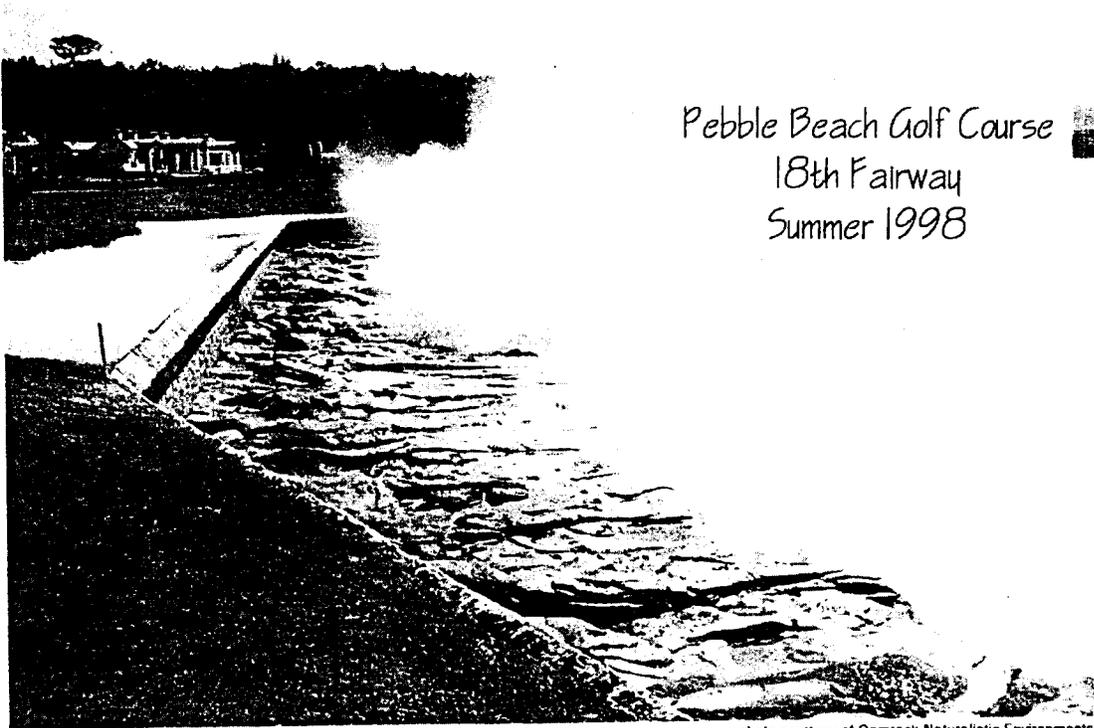
Pebble Beach Golf Course
18th Fairway
Summer 1998

Photo 3.
Applicant's photo of seawall at 18th fairway - dated Summer, 1998.

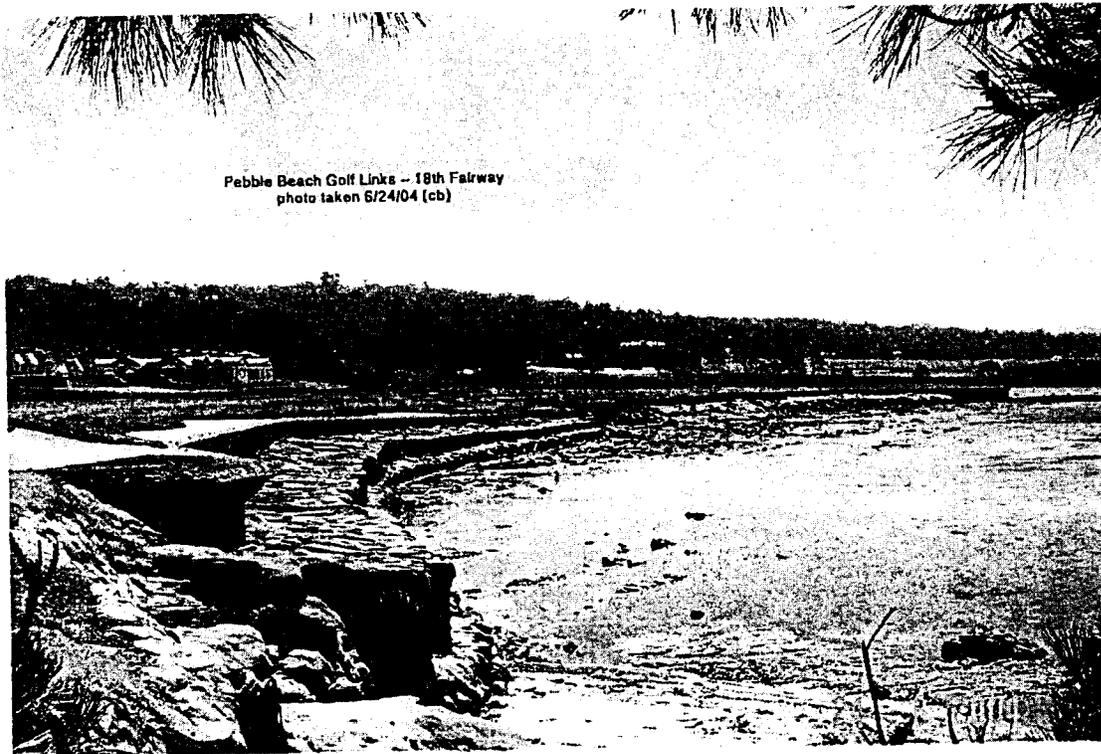
Pebble Beach Golf Links - 18th Fairway
photo taken 6/24/04 (cb)

Photo 4.
Applicant's photo of seawalls along 18th green (in foreground), fairway, and tee (on right side of photo) - dated 6/25/04.

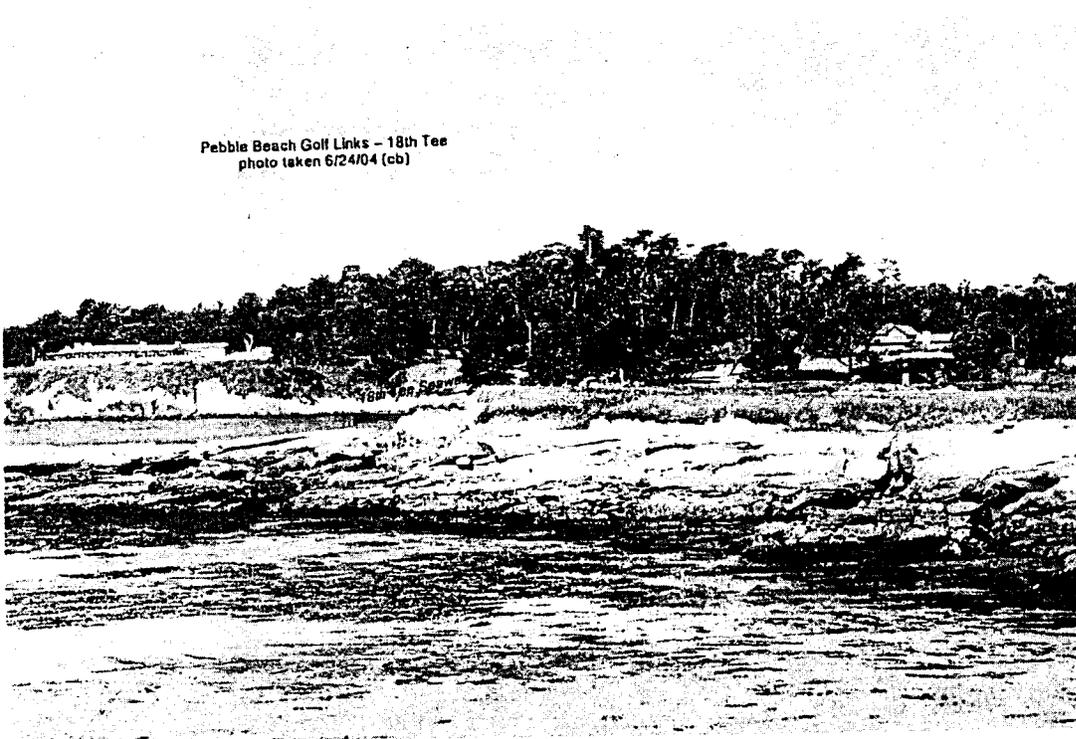
Pebble Beach Golf Links - 18th Tee
photo taken 6/24/04 (cb)

Photo 6.
Applicant's photo
of seawall at 18th
Tee - dated
6/24/04.
