**ADDITIONAL PHASE II
ENVIRONMENTAL SITE ASSESSMENT
FOR ASSESSOR'S PARCEL NUMBERS
401-031-038, -044, -046, -055, -059, AND -060
SAMOA PENINSULA BROWNFIELD SITE
SAMOA, HUMBOLDT COUNTY, CALIFORNIA**

Project No. 016670-5001-11110

April 2007

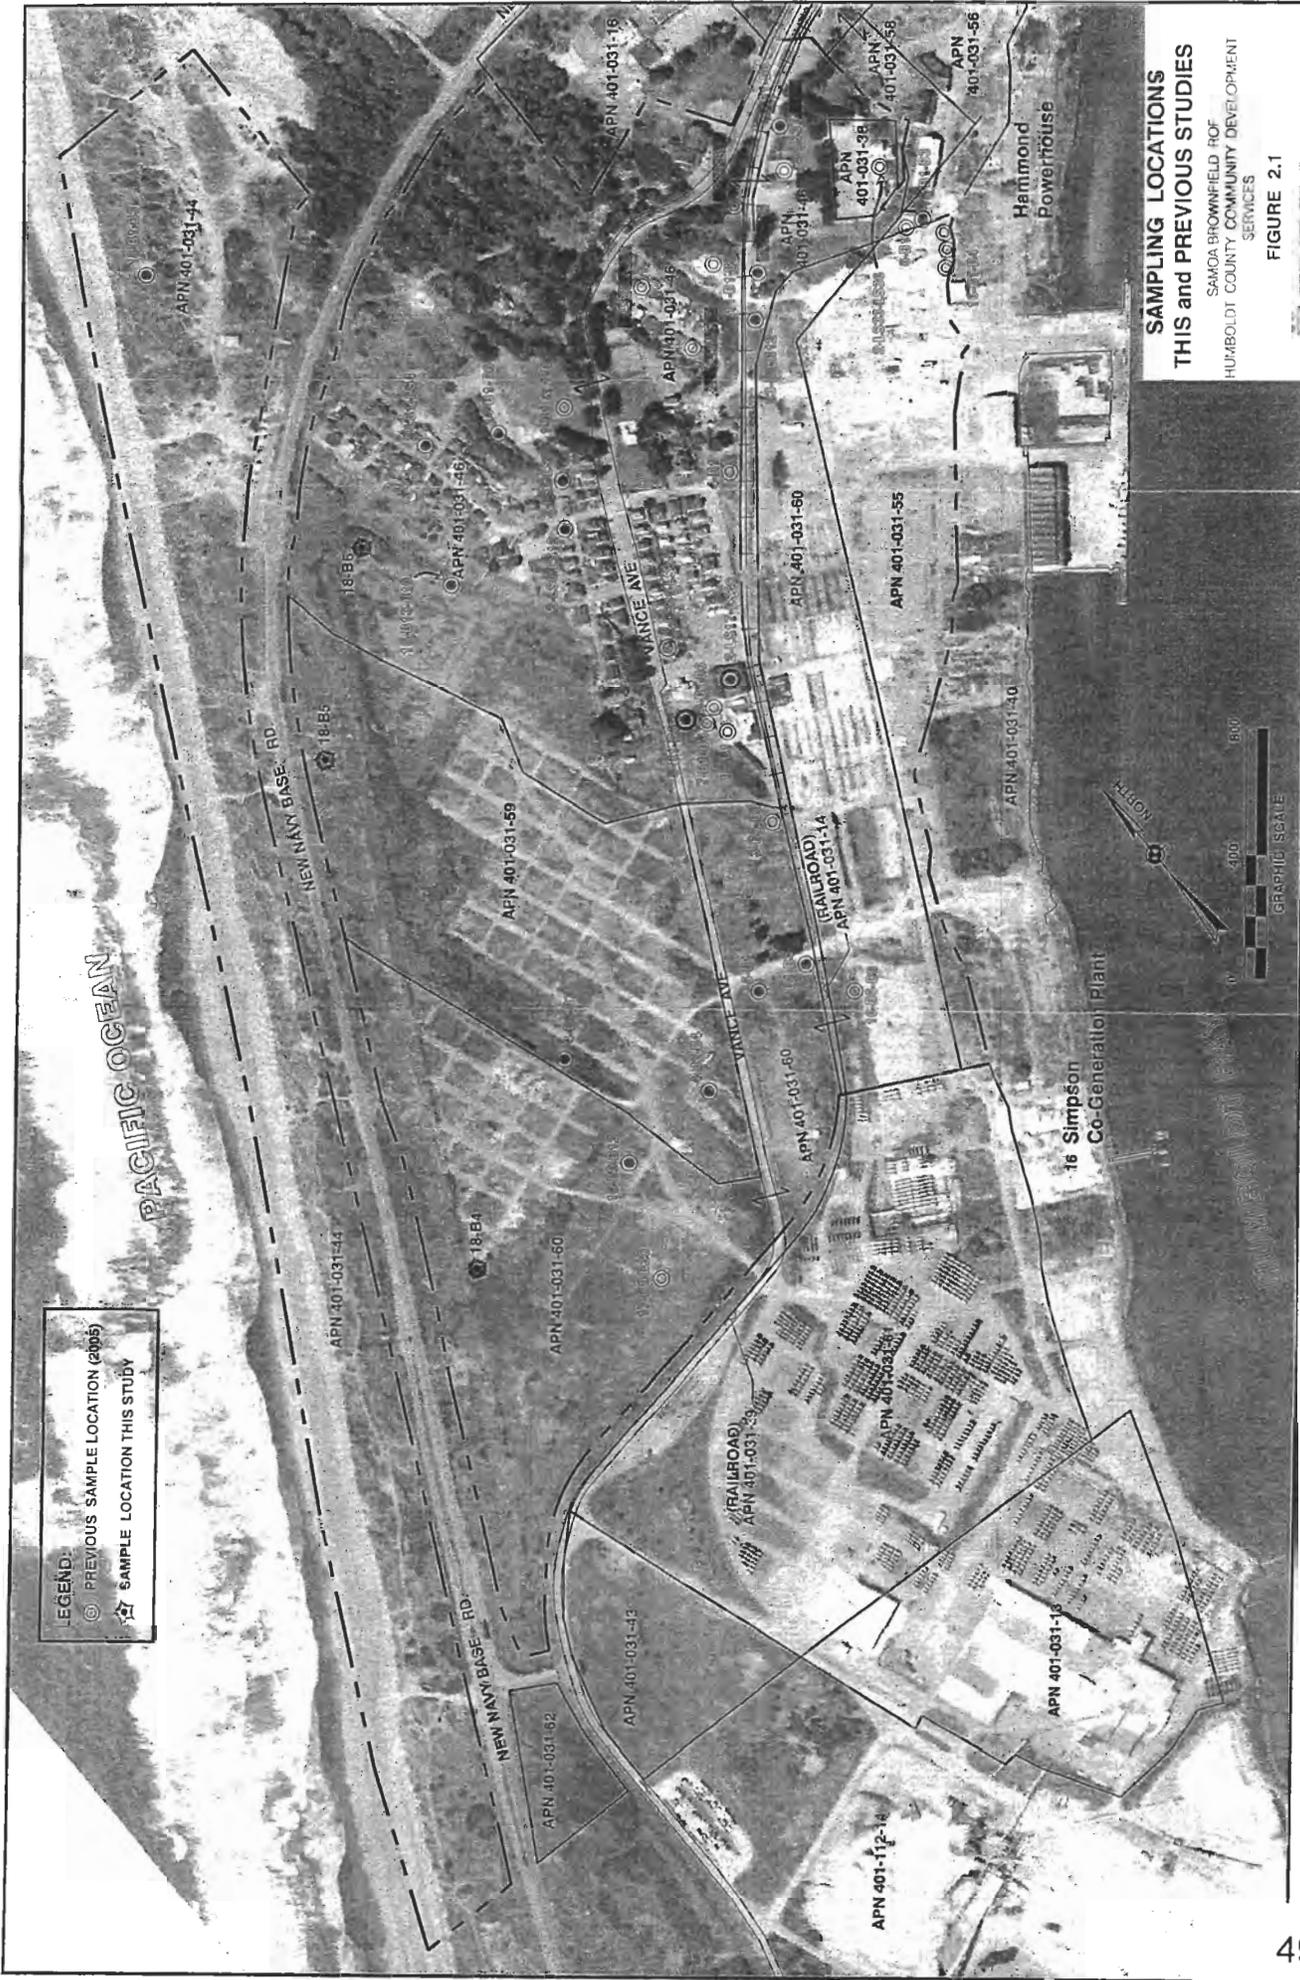
FIGURE 2.1

Background samples were collected for the analysis of arsenic in soils and groundwater. Three separate borings were installed (see Figure 2.1 for boring locations). Boring 18-B4 reported arsenic at 2.741 ppm in the surface soil sample and below the detection limit of 2.0 ppb in the groundwater sample. Boring 18-B5 reported arsenic at 3.147 ppm in the soil sample and below the detection limit in the groundwater sample. Boring 18-B6 reported arsenic at 2.84 ppm in the soil sample and below the detection limit in the groundwater sample. So it appears that the background soil arsenic level is approximately 3 ppm. This is consistent with other soil samples collected across the site except for the soil samples collected at 2-LS17 to 20 (arsenic levels from 13.66 to 15.15 ppm).

Surface water samples were collected at all buildings analyzed for lead based paint impacts as part of this investigation during a single rain storm event on February 7, 2007 (See Figure 2.1 Appendix B for site location). Pressurized polyethylene bailers were used to collect surface water runoff. Due to the rapid infiltration rate of water in the sandy soil at these locations, surface water was collected where runoff stayed at the surface for more the five minutes. Samples from the bailers were transferred to the appropriate sample container, which were labeled, placed in Ziploc baggies and then placed on ice while awaiting transfer to the analytical laboratory. Samples were filtered and preserved immediately upon receipt at the Laboratory. Surface water samples were collected and submitted for analysis of lead (dissolved).
