3-17-0335 (PACIFIC GROVE SEAWALL REPAIRS)

TITLE SHEET
 PACIFIC GROVE COASTAL BLUFF PROTECTION REPAIR
 OVERLOOK ALONG RECREATIONAL TRAIL
 SEAWARD OF 701 OCEAN VIEW BLVD.
 3-6-2017

Reference: Pacific Grove Coastal Bluff Protection Repair
Coastal Overlook Along Recreational Trail
Seaward of 701 Ocean View Boulevard
Pacific Grove, CA

Subject: Emergency Coastal Bluff Protection

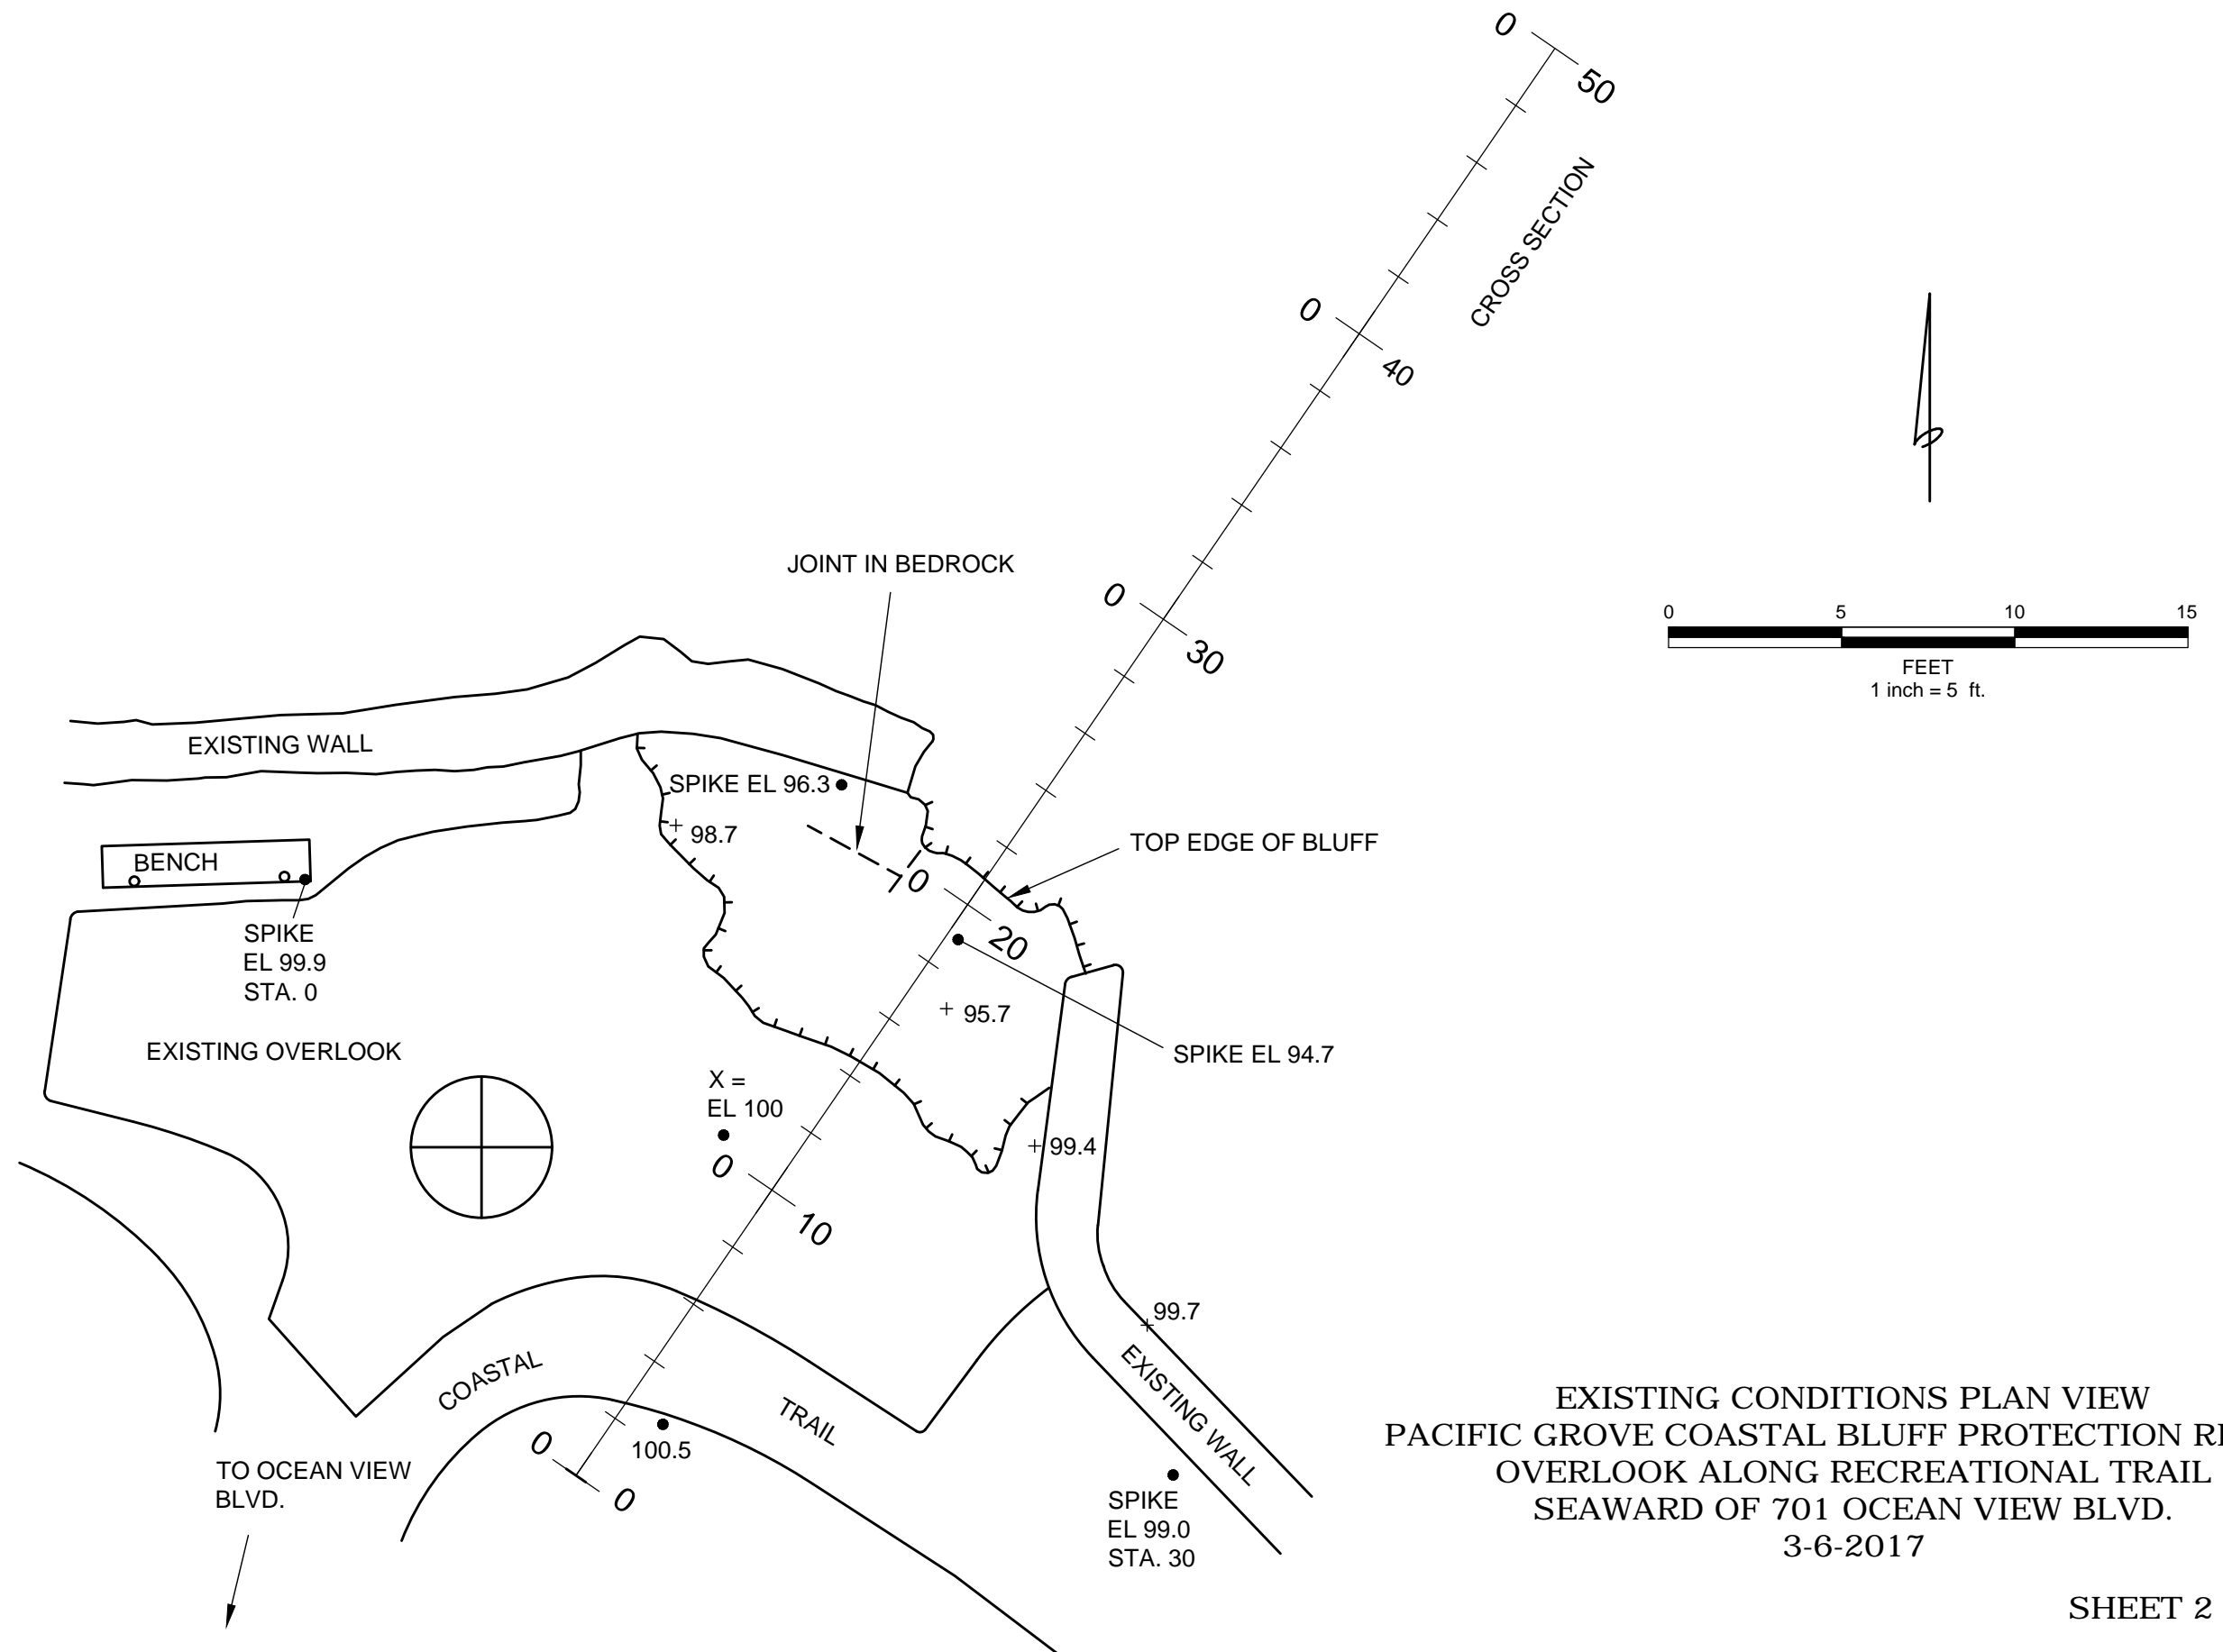
SHEET 2 of 5

EXISTING CONDITIONS PLAN VIEW
 PACIFIC GROVE COASTAL BLUFF PROTECTION REPAIR
 OVERLOOK ALONG RECREATIONAL TRAIL
 SEAWARD OF 701 OCEAN VIEW BLVD.
 3-6-2017

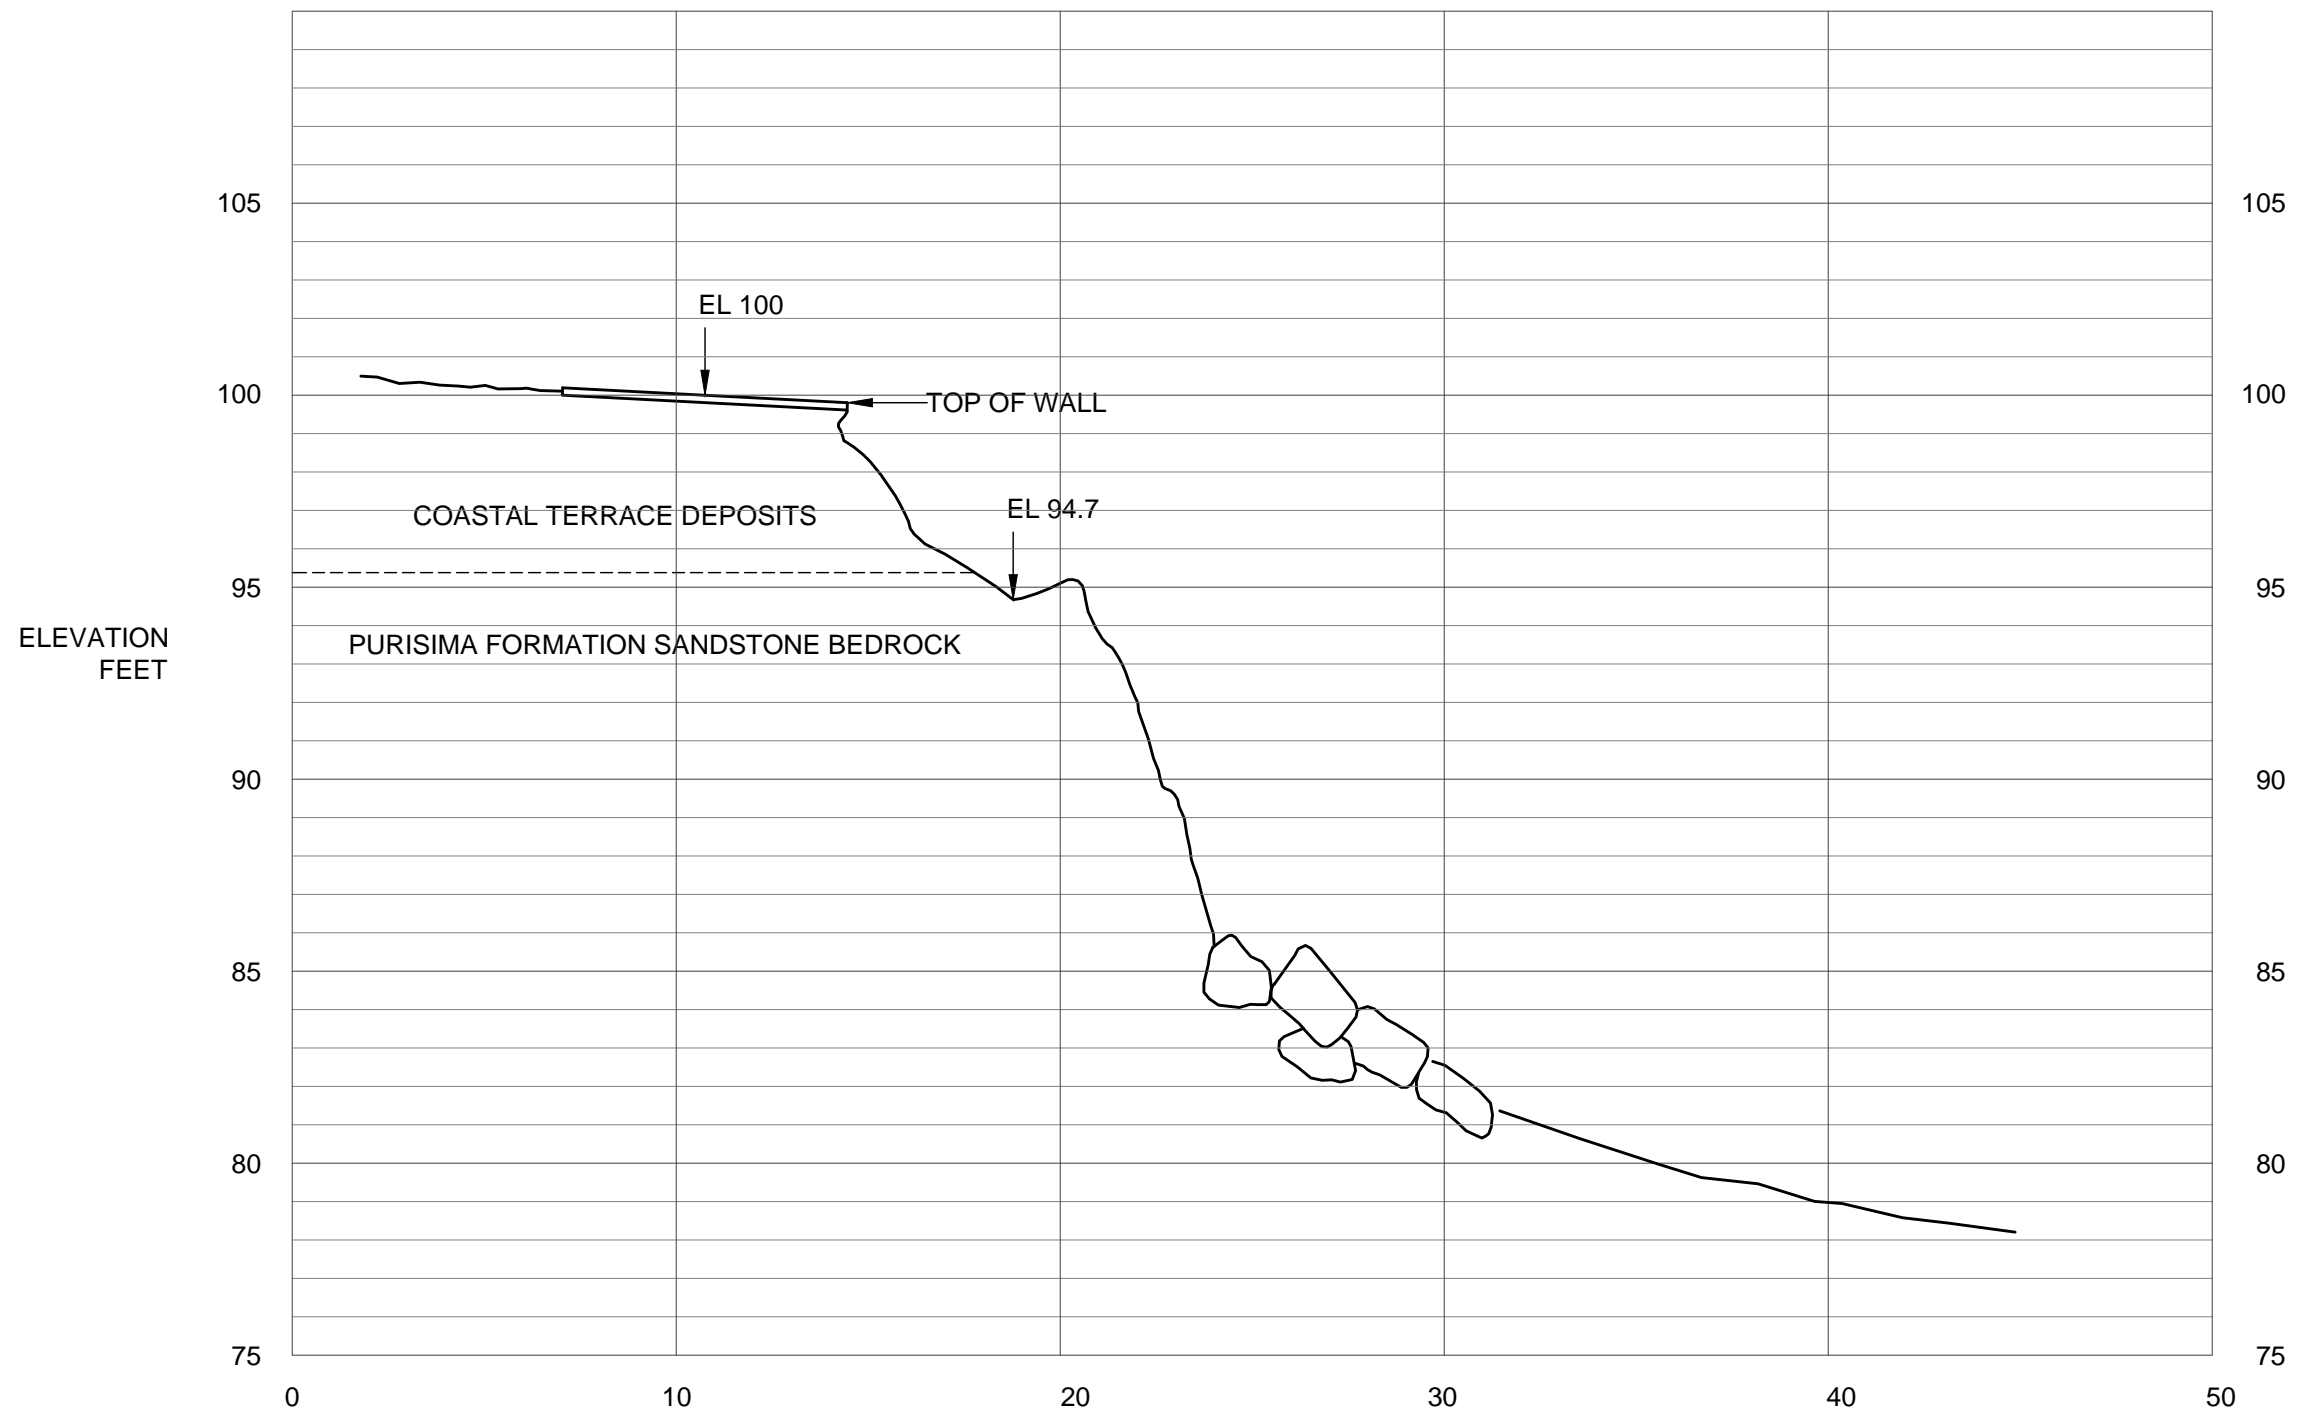
SHEET 3 of 5

EXISTING CONDITIONS CROSS SECTION
 PACIFIC GROVE COASTAL BLUFF PROTECTION REPAIR
 OVERLOOK ALONG RECREATIONAL TRAIL
 SEAWARD OF 701 OCEAN VIEW BLVD.
 3-6-2017

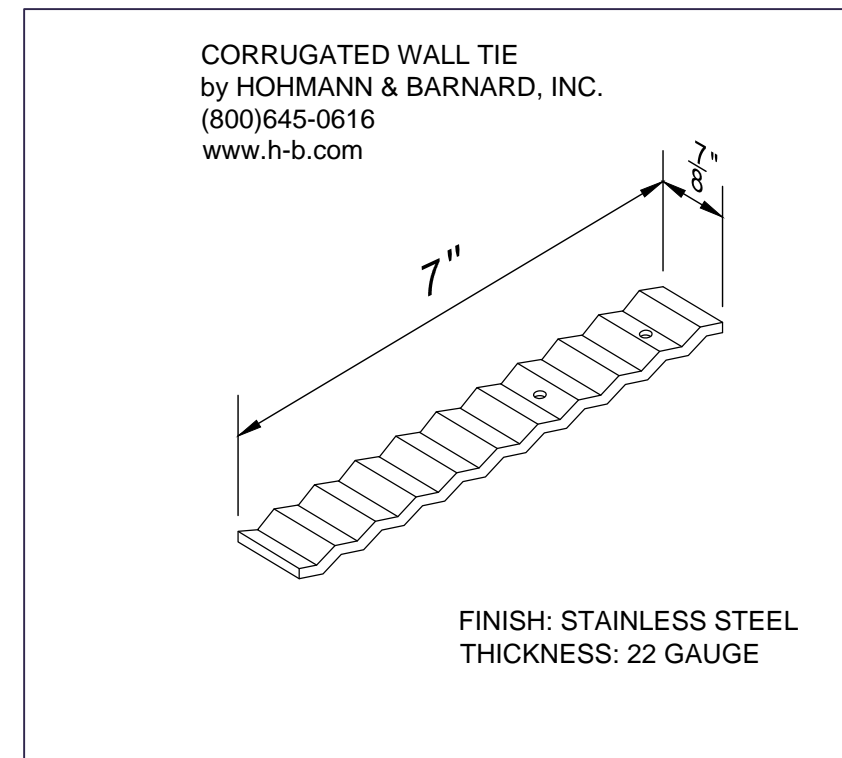
CORRUGATED WALL TIE DETAIL

**PROPOSED COASTAL OVERLOOK PROTECTION REPAIR
UTILIZING ARTIFICIAL ROCK SURFACE FASCIA**
