CALIFORNIA COASTAL COMMISSION

1-09-050

> Mad River Streambank Protection Project **Project Description**

Photograph Log Mad River Streambank Protection Project School Road McKinleyville, Humboldt County, California

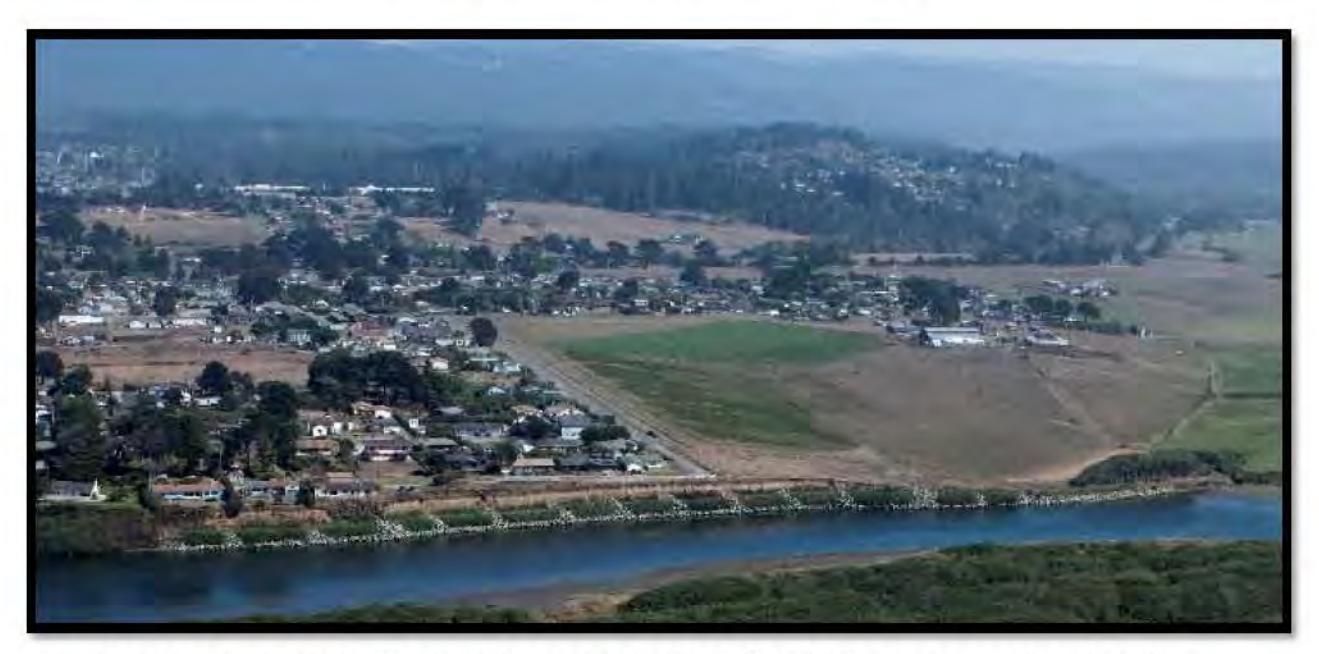
Photograph 1. Mad River Bluff Streambank Protection Project post-construction circa summer 2011. Image taken facing east.

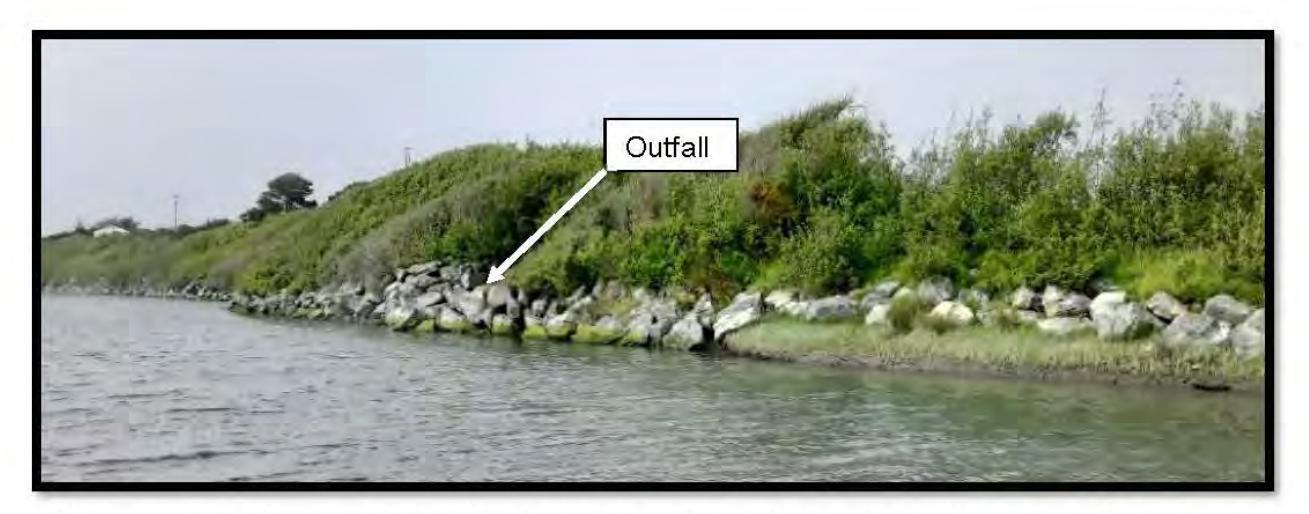
Photograph 5. View of stabilized bank at School Road stormwater outfall and upstream flank bay 15 in April 2020. Note that fencing present in Photographs 2, 3, and 4 was removed as part of the 2008 bluff stabilization project. Image taken facing north and downstream.

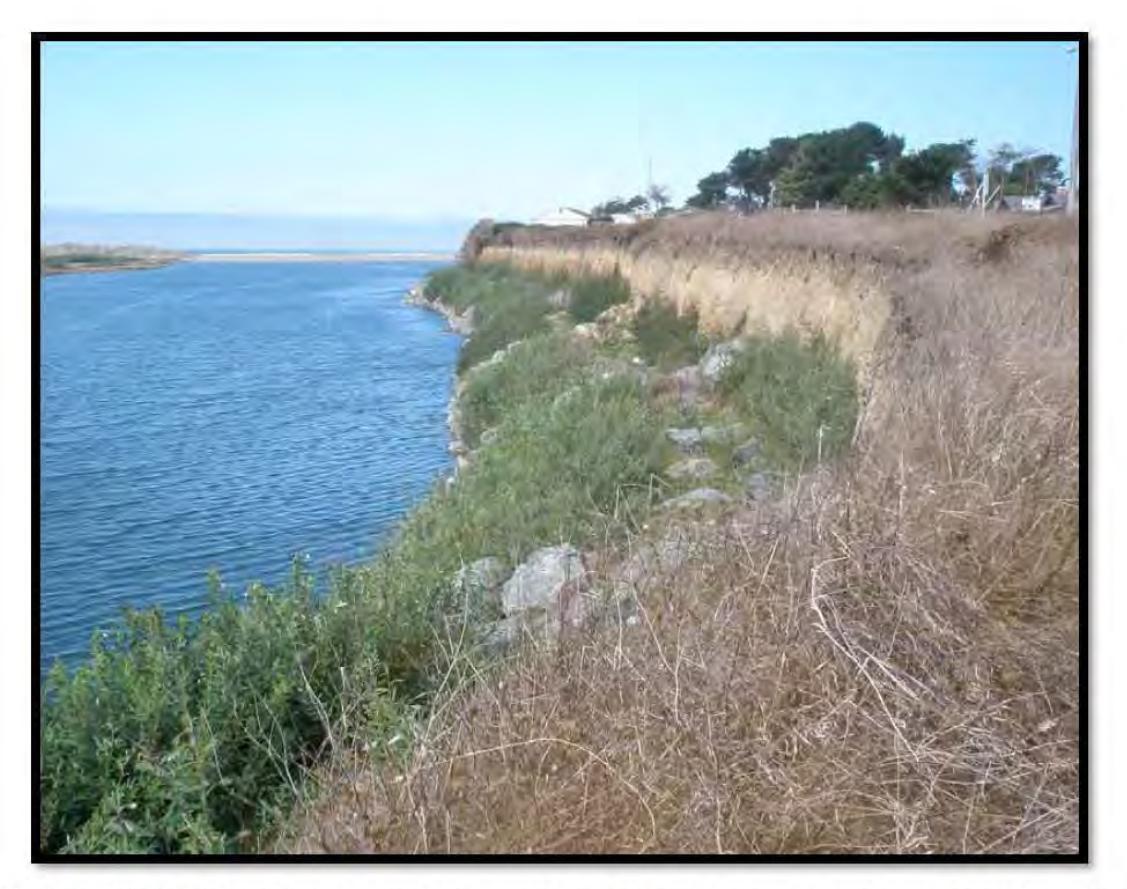
Photograph 6. Completed revetment segment north of School Road, and a portion of the revetment south of School Road as viewed from top of terrace in September 2009. Image taken facing north and downstream.

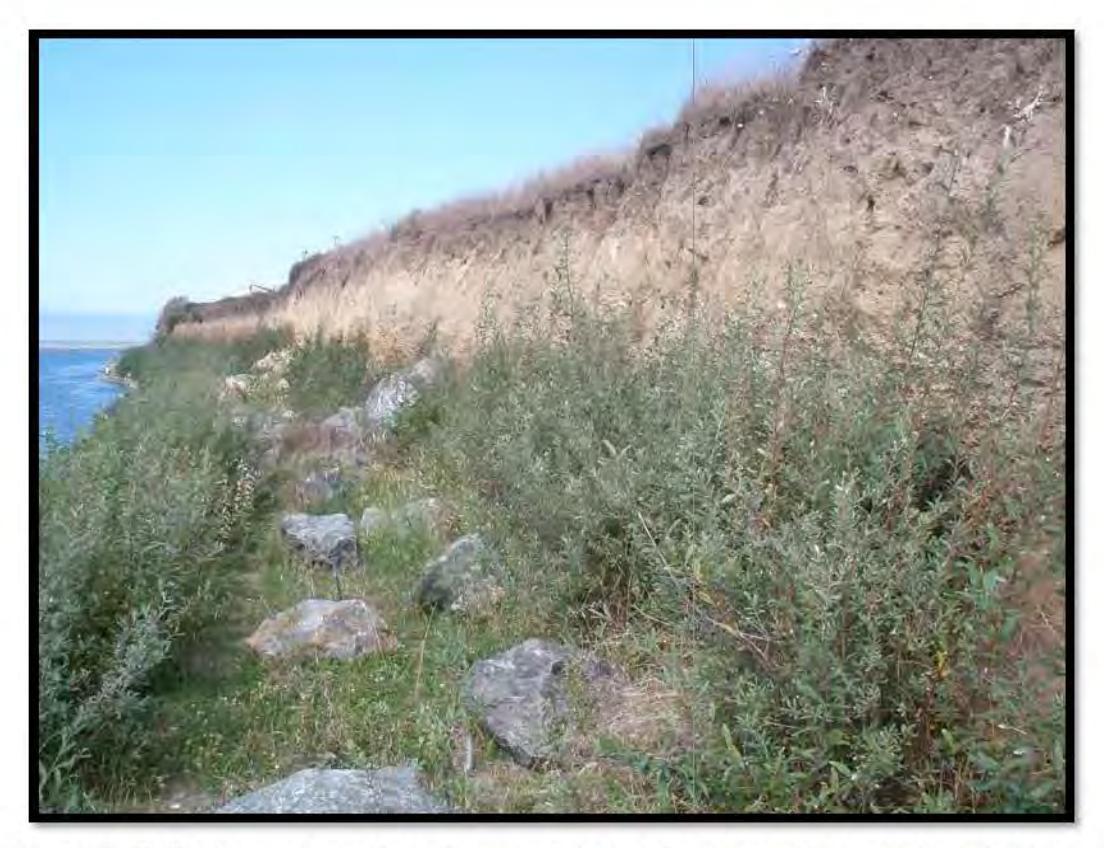
Photograph 7. Groins and vegetated bays as viewed from top of the revetment structure in September 2009. Image taken facing north and downstream.

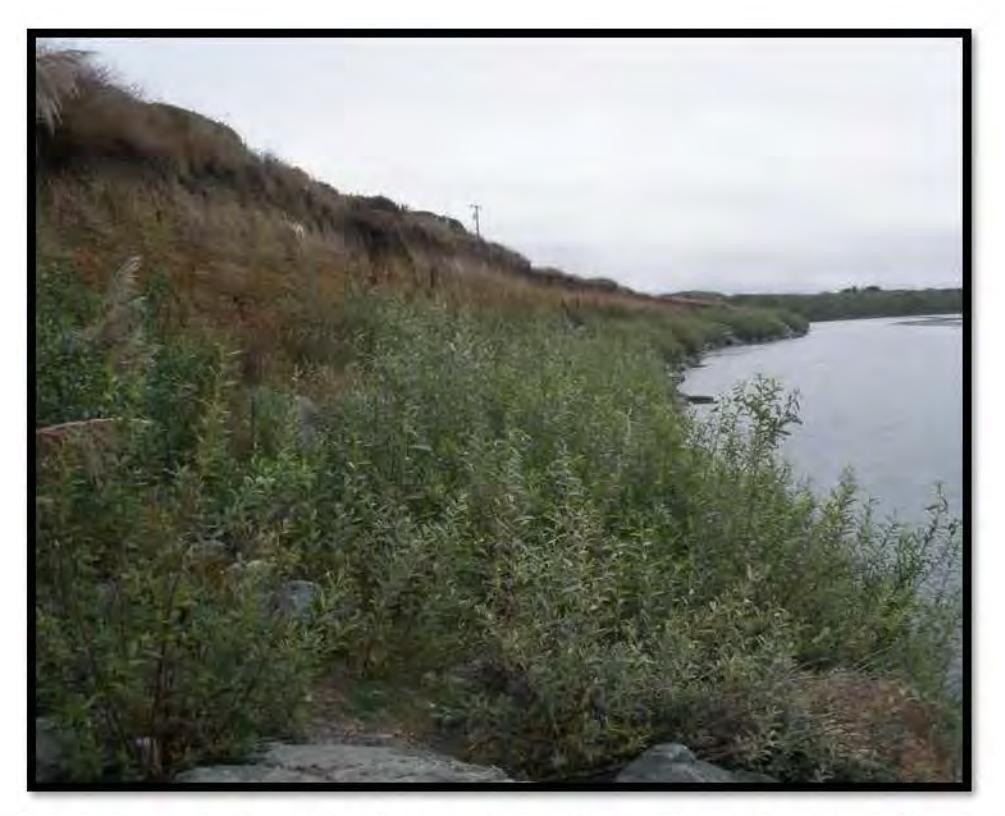
Photograph 8. Groins and vegetated bays as viewed from top of the structure in September 2009. Image taken facing south and upstream.

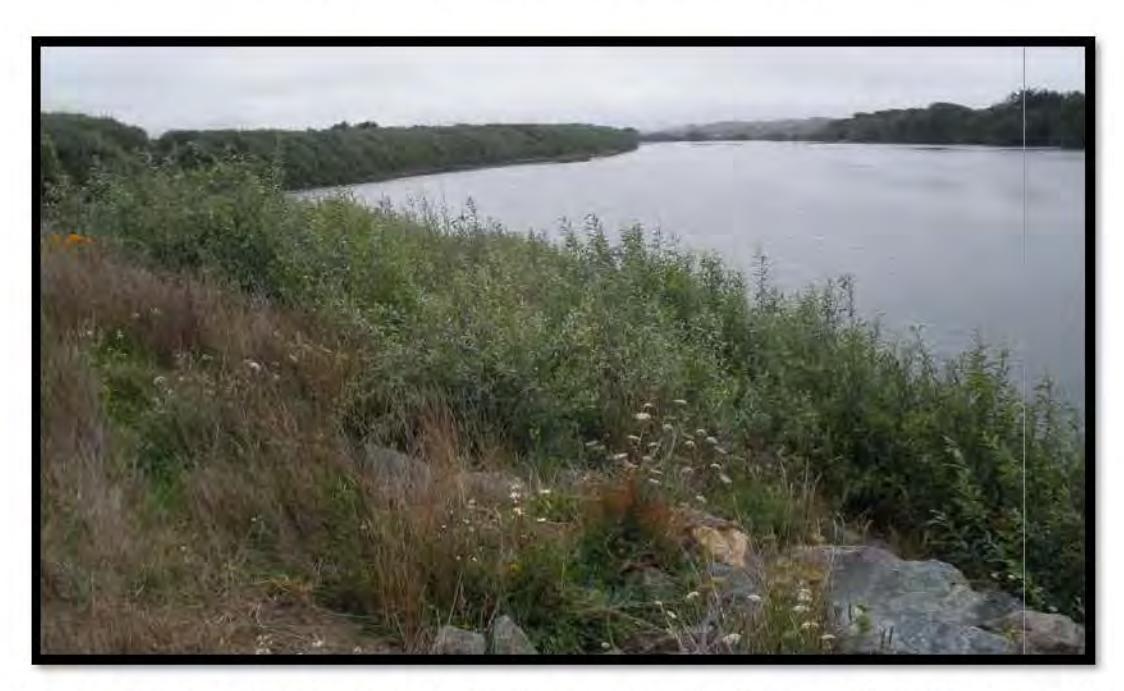
Photograph 9. Completed revetment bays 13 and 14 south of School Road as viewed from top of the bluff terrace in September 2009. Image taken facing south and upstream.

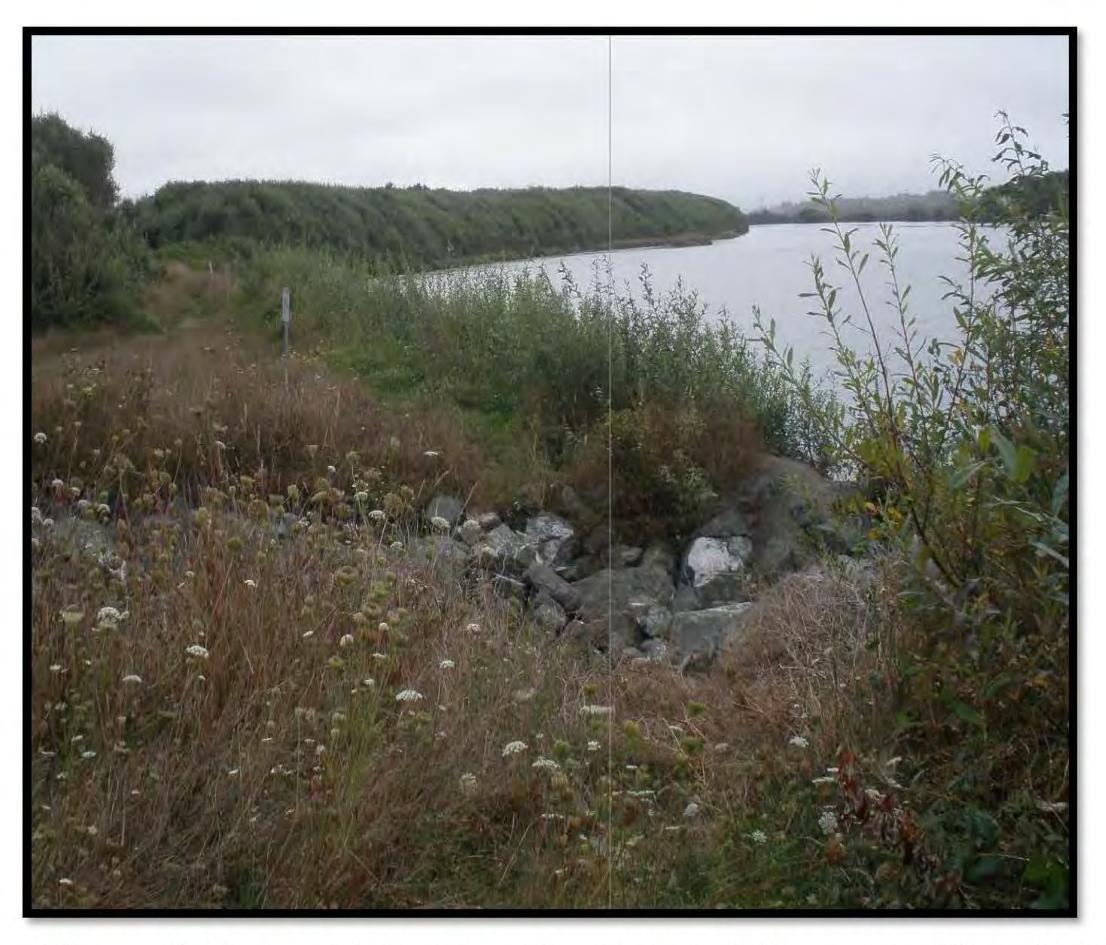
Photograph 10. Completed revetment bay 15 as viewed from north of the School Road stormwater outfall in September 2009. Image taken facing south and upstream.

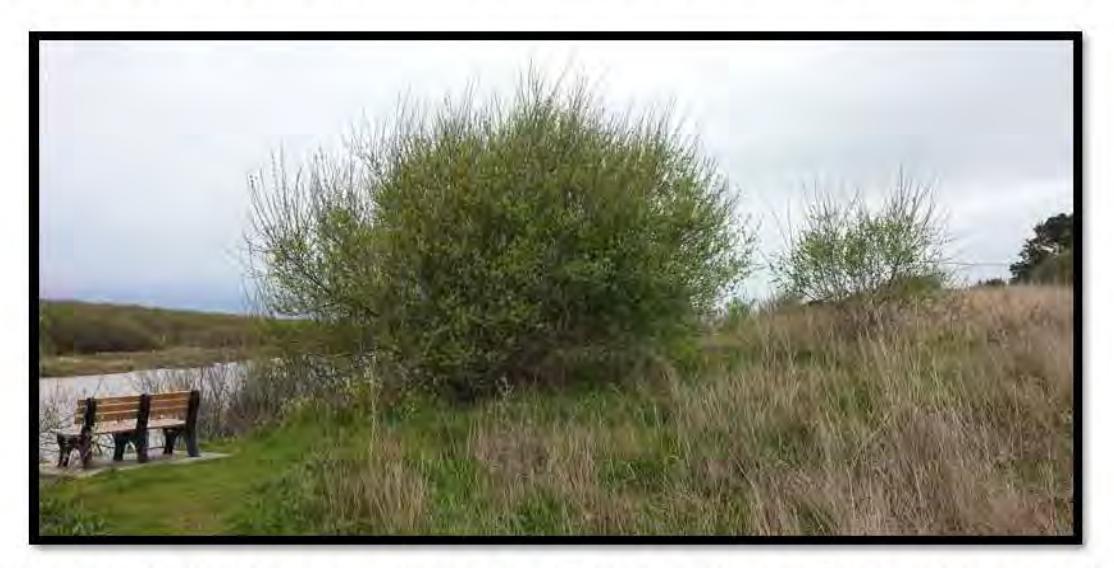
Photograph 15. Public access overlook and vegetative growth on the bluff terrace south of School Road circa April 2018. Image taken facing northwesterly.

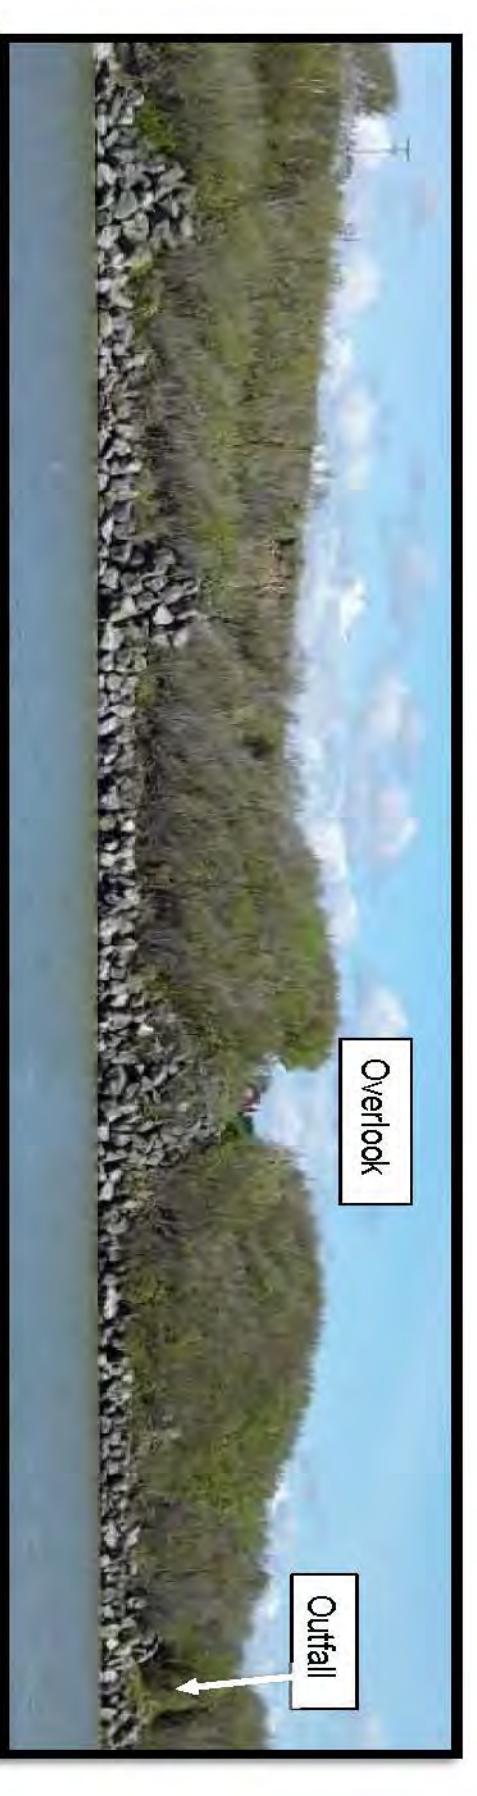
Photograph 17. Bluff protecting revetment north of School Road as viewed from the western bank of the Mad River in April 2020. Image taken facing southeasterly.

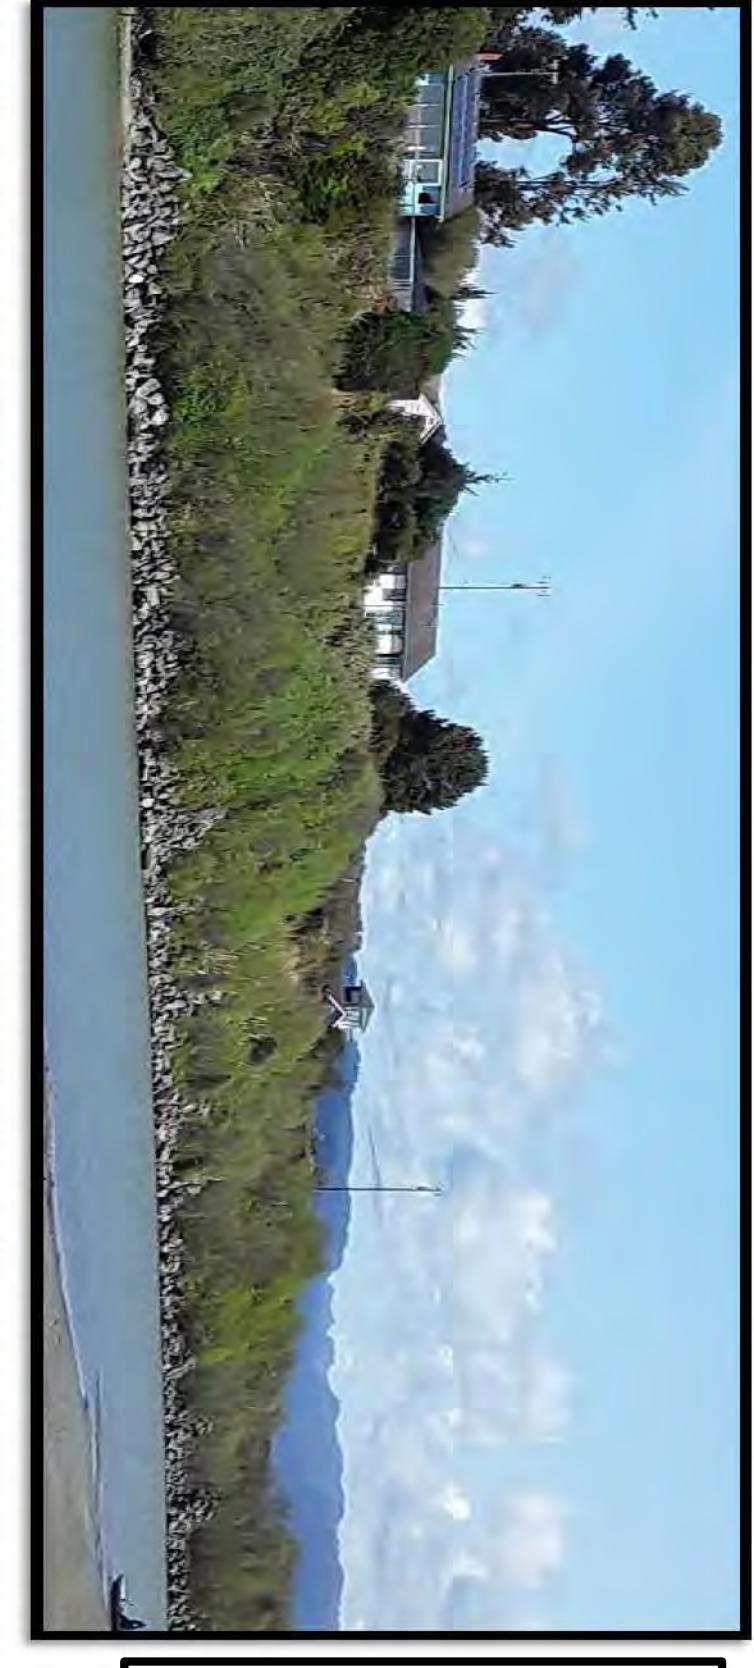
Overlook in Photograph 17 is visible in gap in trees; stormwater outfall is located on the right-hand side of the image. Image taken Photograph 18. Bluff protecting revetment south of School Road as viewed from the western bank of the Mad River in April 2020.

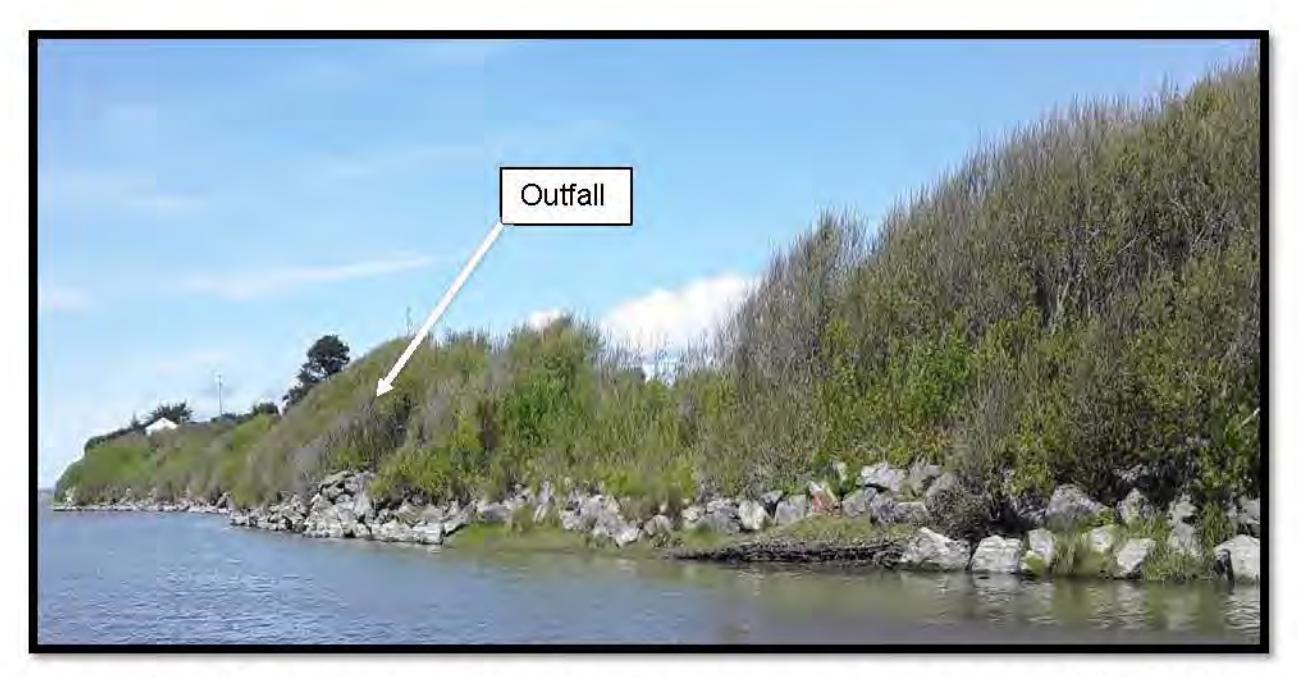
Photograph 20. Revetment as viewed from an upstream Mad River gravel bar in April 2020. Image taken facing north and downstream.

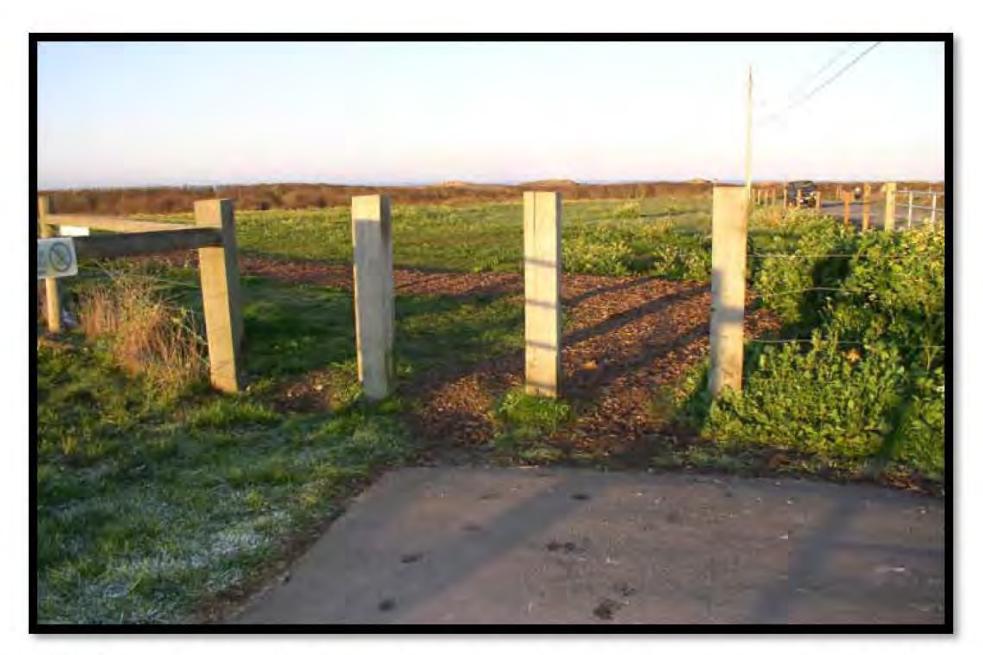
Photograph 22. School Road public access to the Project area, overlook, and river access trail in 2005. Image taken facing southwesterly.

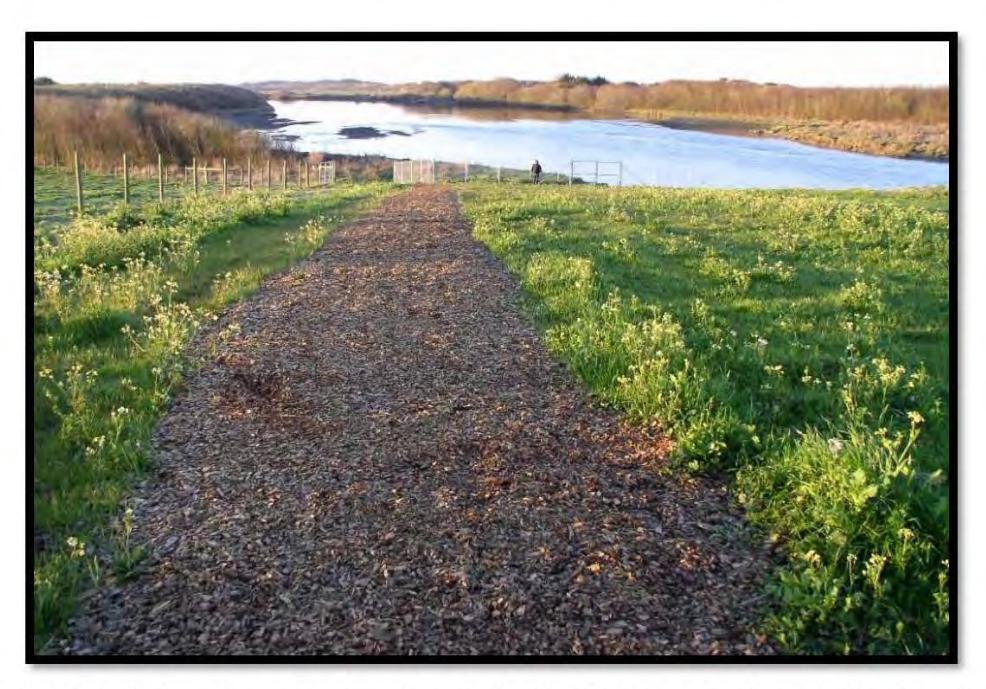
Photograph 23. Public path accessing the overlook, Mad River and other riparian area trails in 2005. Image taken facing south.

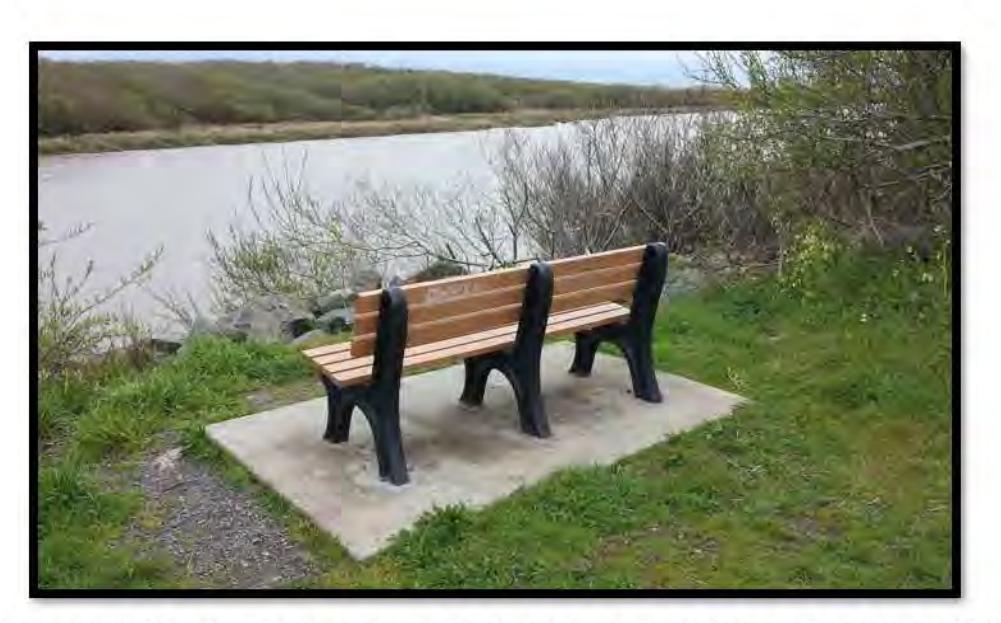
Photograph 24. Mad River overlook on terrace south of School Road circa 2018. Image taken facing northwesterly.

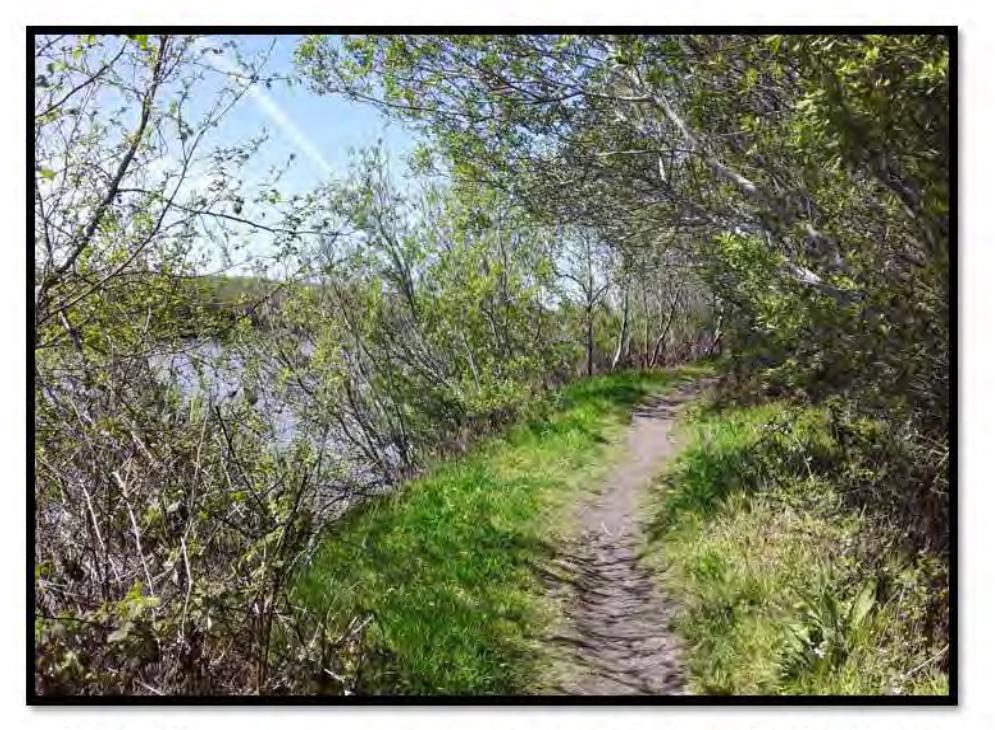
Photograph 25. Mad River access path south of School Road April 2020. Mad River is visible through willows on the left-hand side. Image taken facing northwesterly.

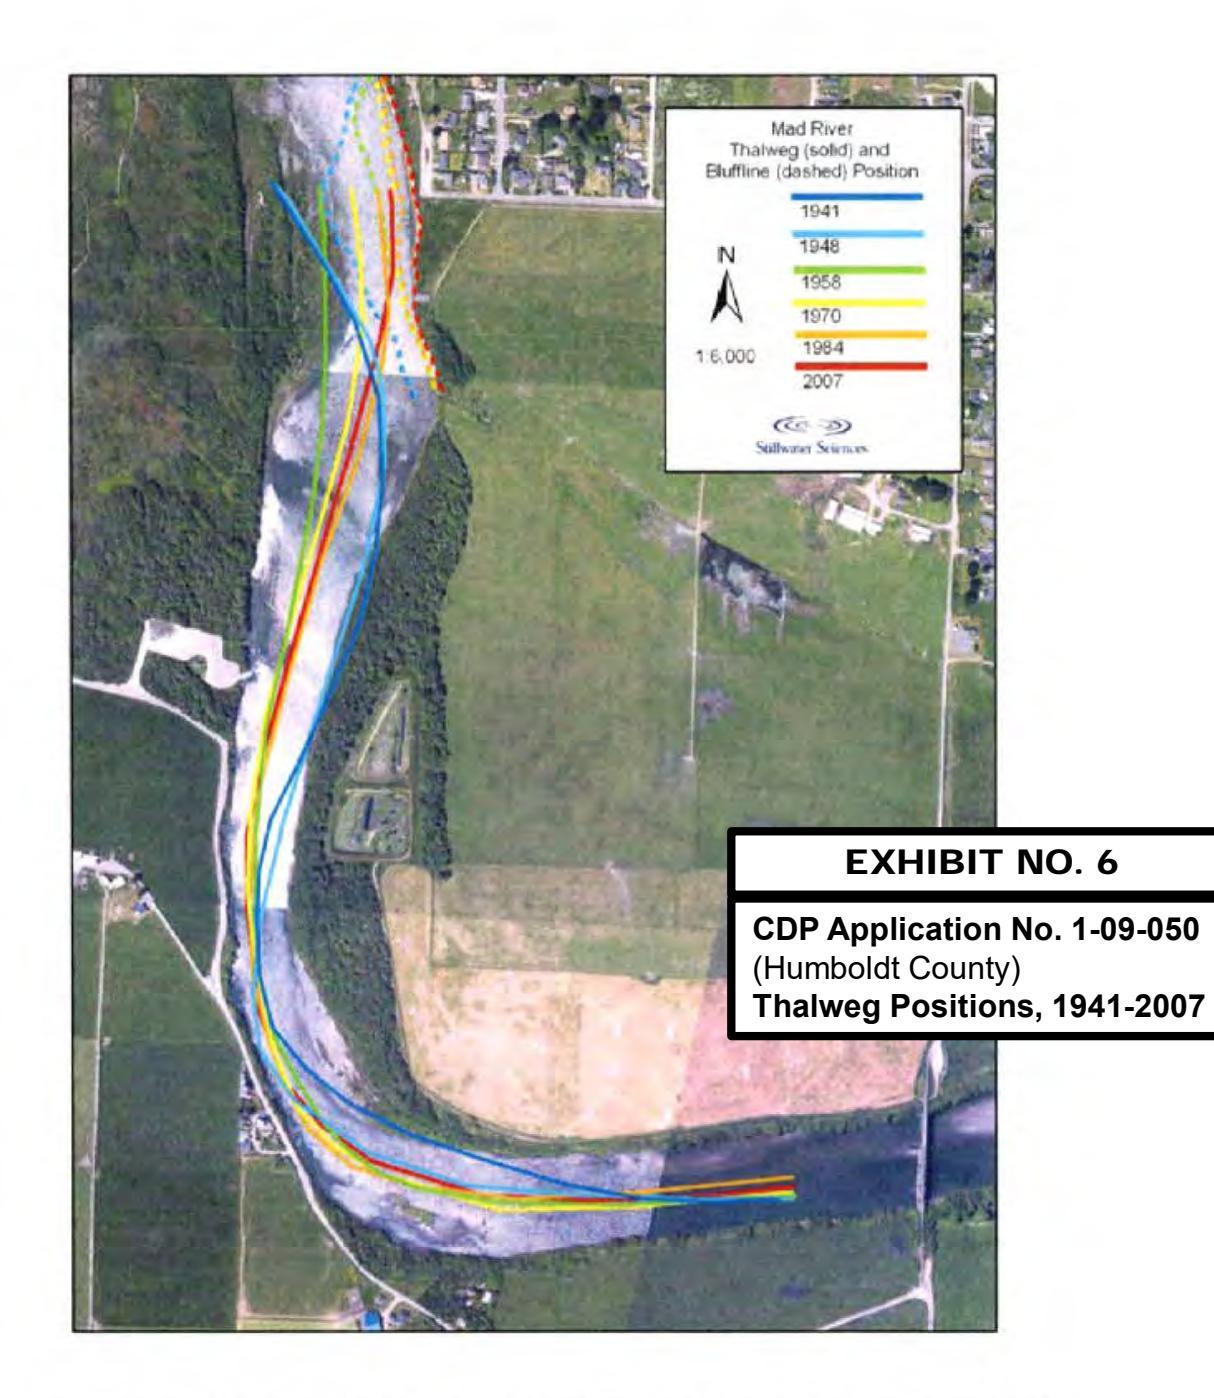
Figure 7. A comparison of sequential thalweg and bluff position for select years from 1941 to 2007 in the lower Mad River. Bluff positions were determined by LACO (2008).

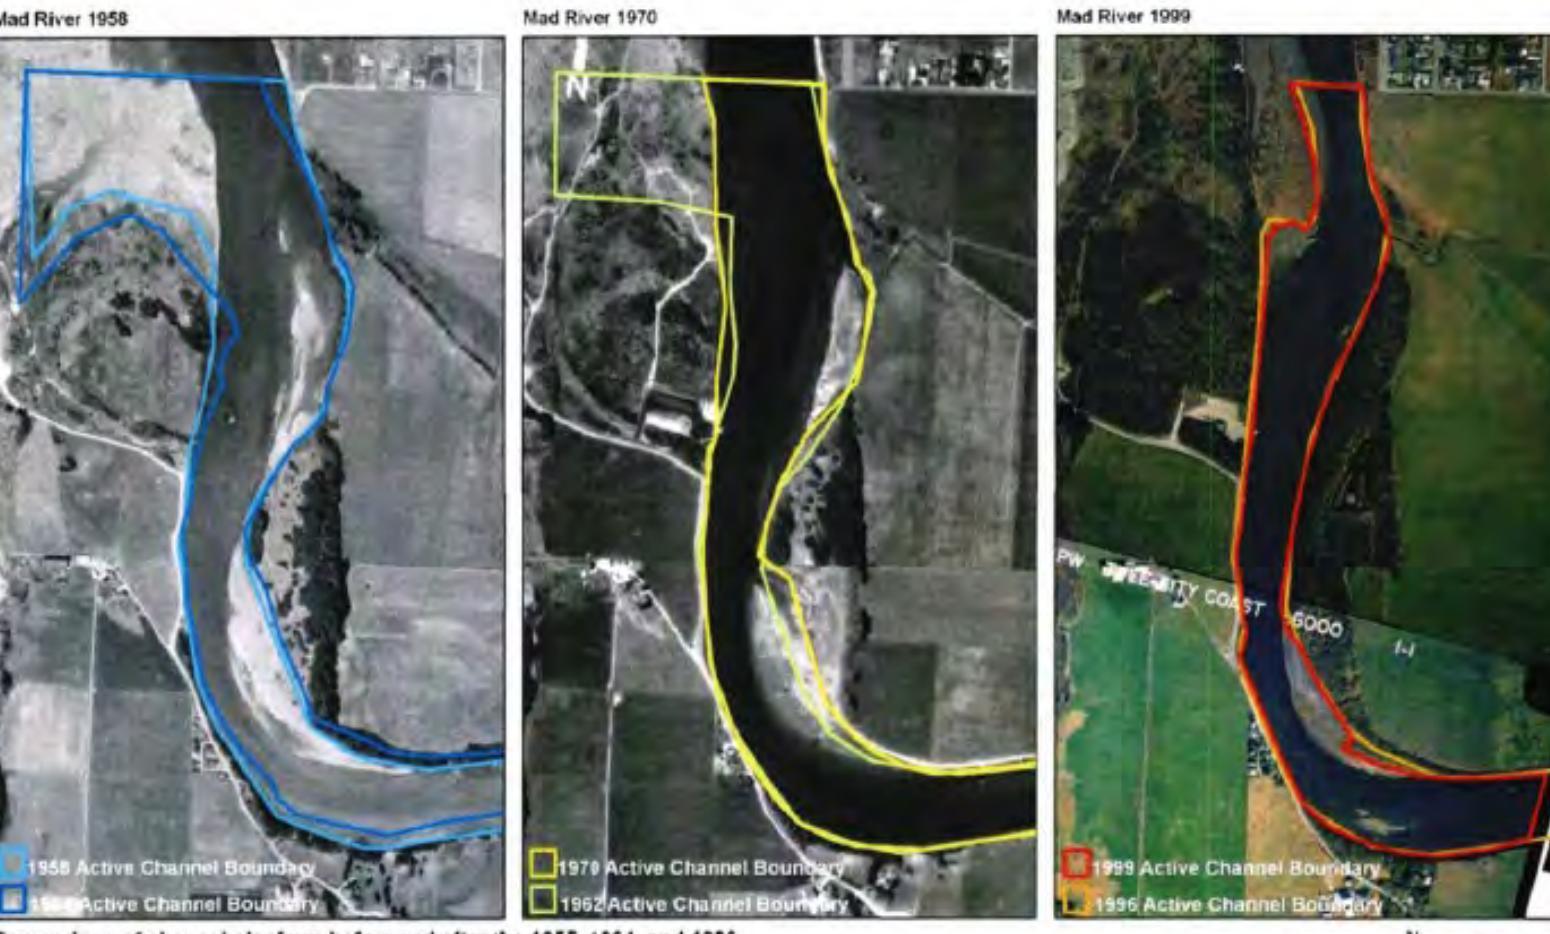
Figure 8. Comparison of the Mad River planform in the vicinity of the School Road erosion site before and after the 1955, 1964, and 1996 floods.

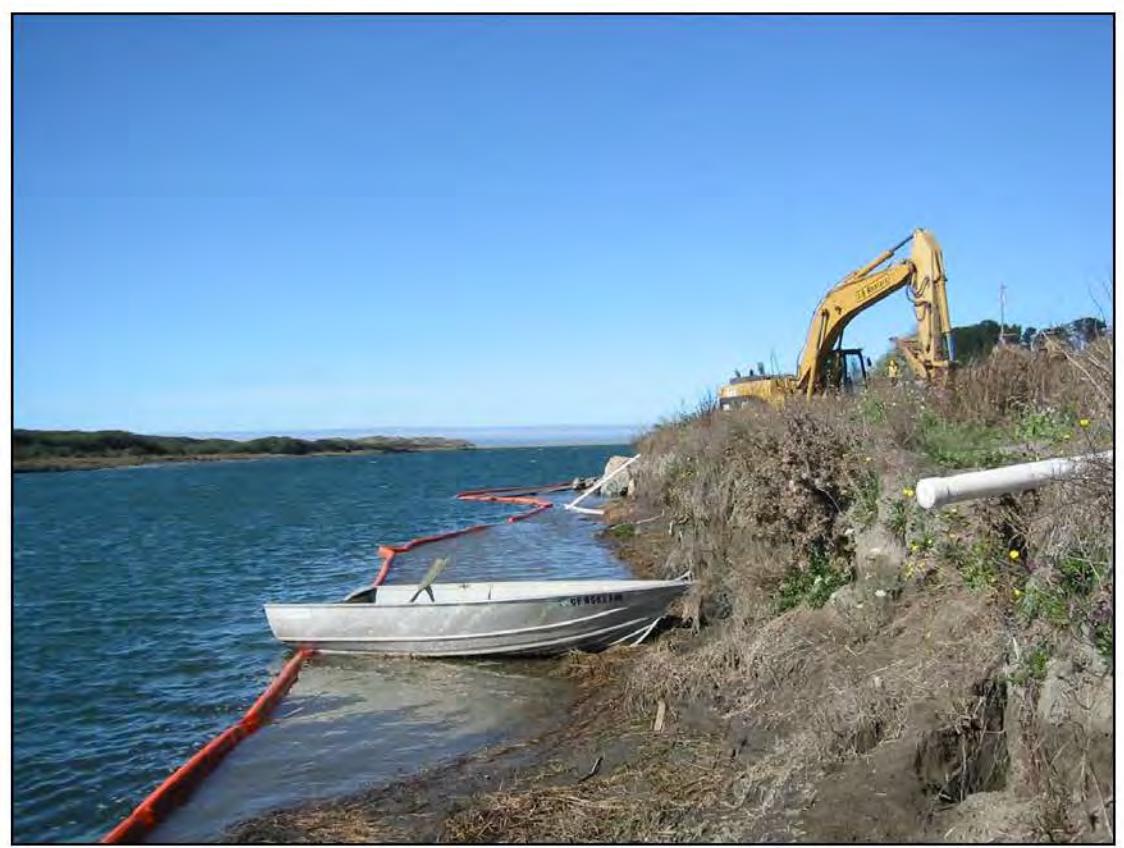
Figure 2: Salt Marsh Preconstruction

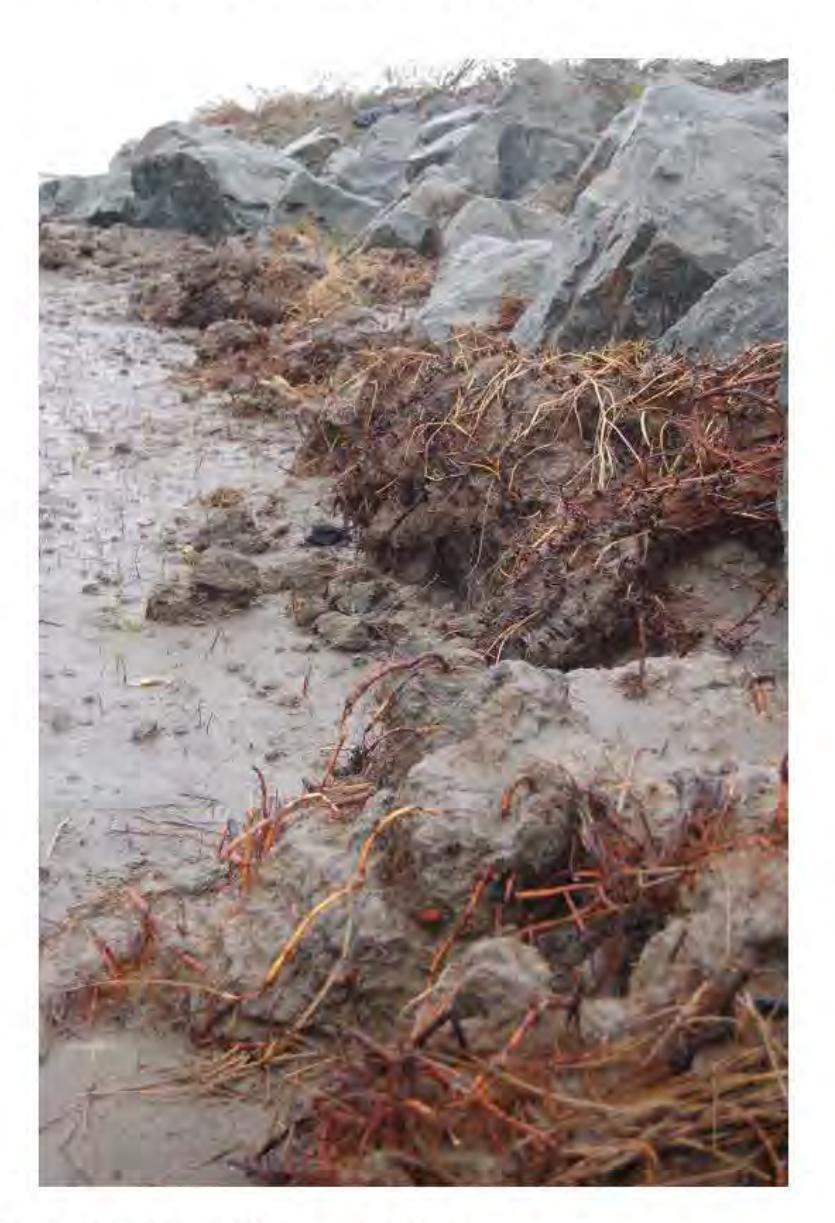
Figure 4: Salvaged Rhizomes of Scirpus americanus

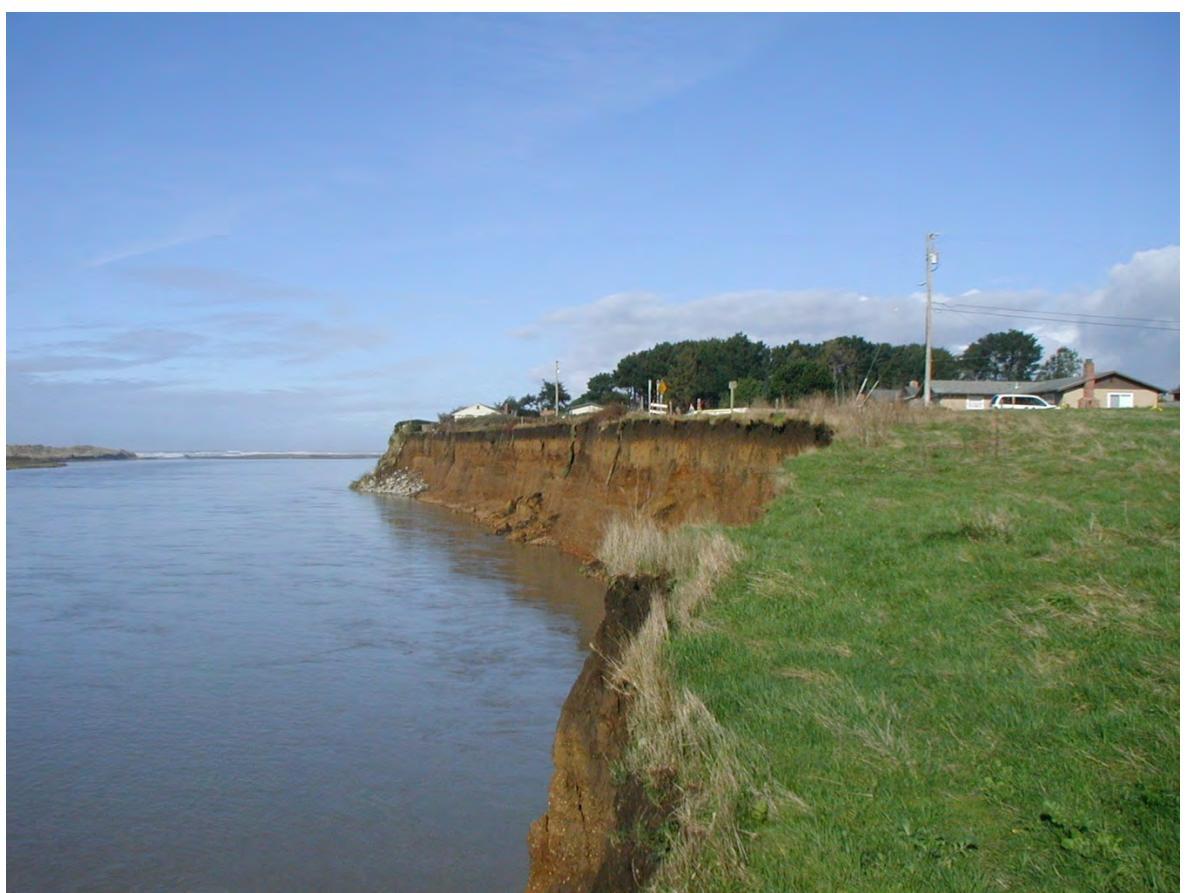
Photo 2: View facing north (January 19, 2006).

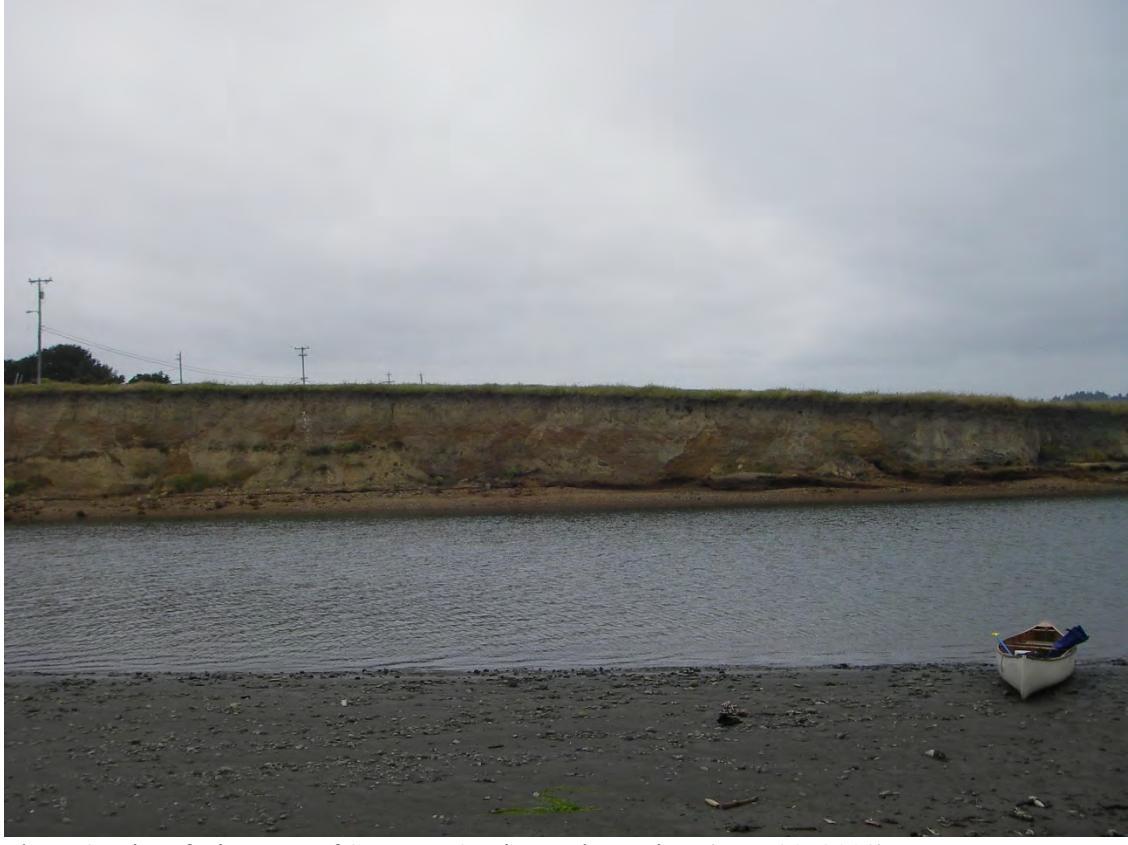
Photo 4: View facing east of Segment 2 prior to the project (May 30, 2008).

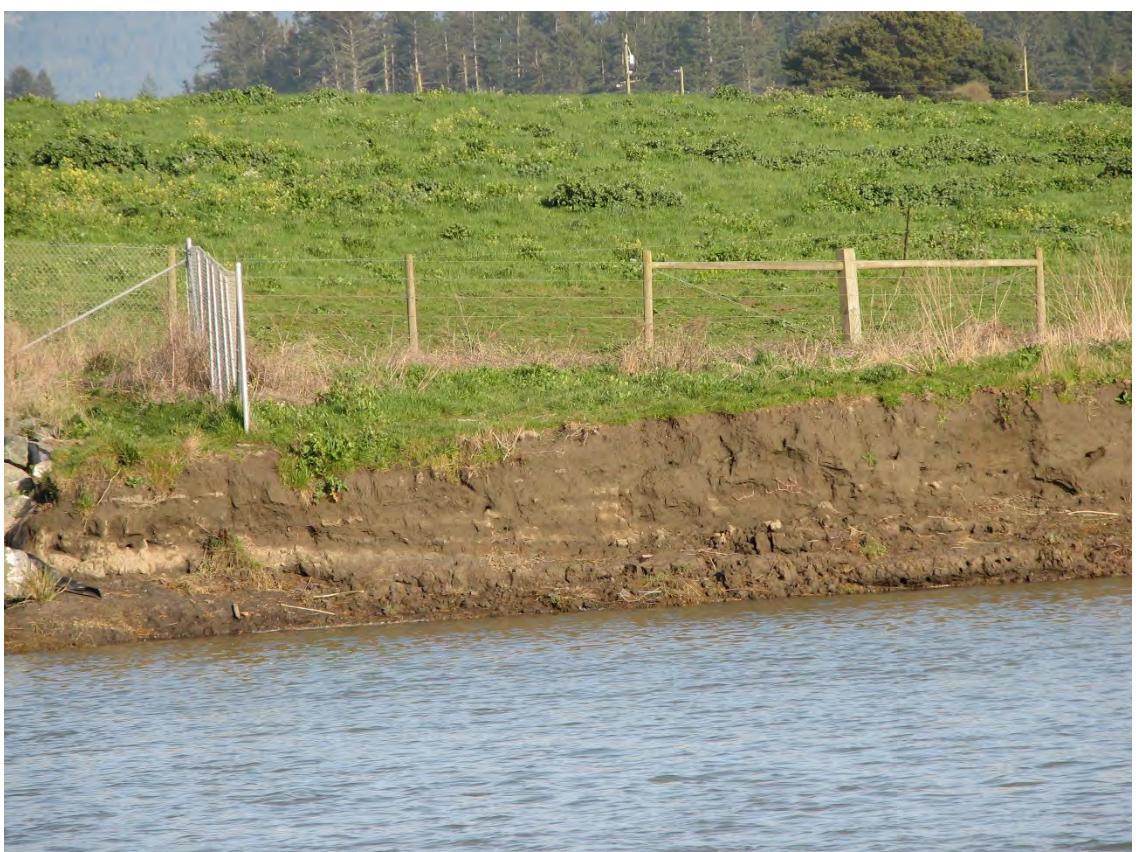
Bay 15 is the upstream portion of the Project, south of the existing stormwater outfall with an approximate length of 210 feet, composed of four- to six-ton rock boulders placed on the exposed river bank and intermixed with smaller rock, soil, and willow sprigs. This segment tapers into the streambank in an effort to mimic natural grade (Photographs 5, 19, 20, and 21). The top of the RSP was designed to

Photo 5: Representative photo of Segment 3 prior to the project (March 20, 2006). Exhibit No. 12 CDP Application No. 1-09-050 (Humboldt County) 12/12/20 Design Technical Memo

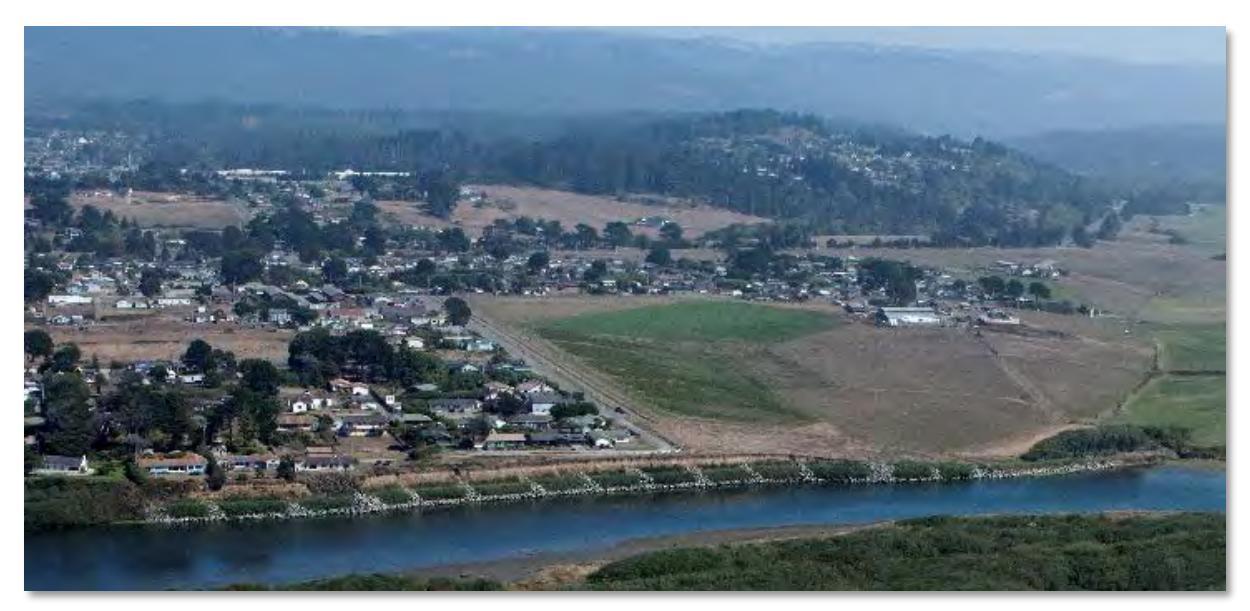
Stabilization of the right bank of the Mad River at School Road was visibly apparent shortly following Project completion. Willow growth was beginning to dominate the rock and fill, both along the water line and within the upper bench surface (Photographs 6 through 10). On the upper terrace surface, grass and flower growth improved aesthetic qualities and provided erosion protection. Photograph 11 from April 2010 includes the furthest upstream protection component after Project completion. A flooding event in late December 2010 resulted in discharges in excess of 30,000 cfs; Photographs 12 through 14 present conditions at the Project site during that event. In Photographs 12 and 13, turbulent flow along the base of the right bank is visible, and in Photograph 14 water is shallowly flooding the Mad River access path.

Photo 6: View facing east of post-construction conditions (summer 2011).
