CALIFORNIA COASTAL COMMISSION

1-09-050

> Mad River Streambank Protection Project **Project Description**

Photograph Log Mad River Streambank Protection Project School Road McKinleyville, Humboldt County, California

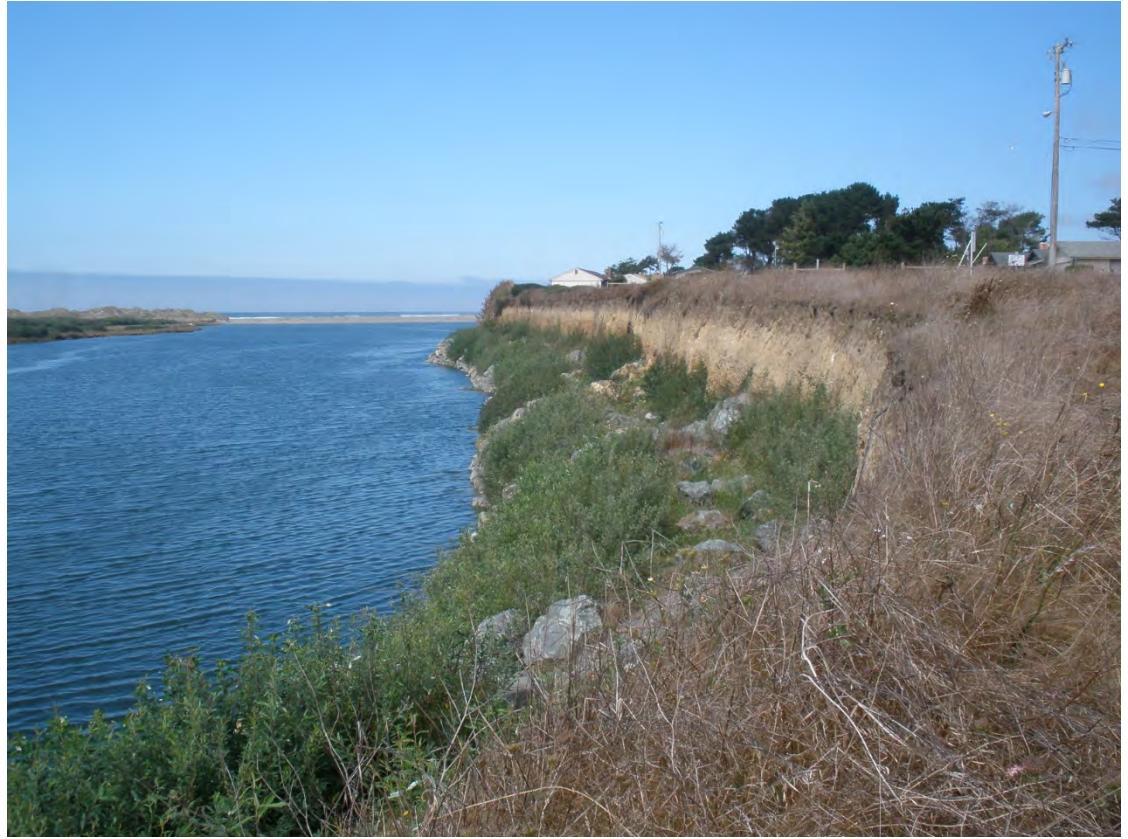
Stabilization of the right bank of the Mad River at School Road was visibly apparent shortly following Project completion. Willow growth was beginning to dominate the rock and fill, both along the water line and within the upper bench surface (Photographs 6 through 10). On the upper terrace surface, grass and flower growth improved aesthetic qualities and provided erosion protection. Photograph 11 from April 2010 includes the furthest upstream protection component after Project completion. A flooding event in late December 2010 resulted in discharges in excess of 30,000 cfs; Photographs 12 through 14 present conditions at the Project site during that event. In Photographs 12 and 13, turbulent flow along the base of the right bank is visible, and in Photograph 14 water is shallowly flooding the Mad River access path.

Photo 7: View facing north of Segment 1 and portions of Segment 2 (September 23, 2009).

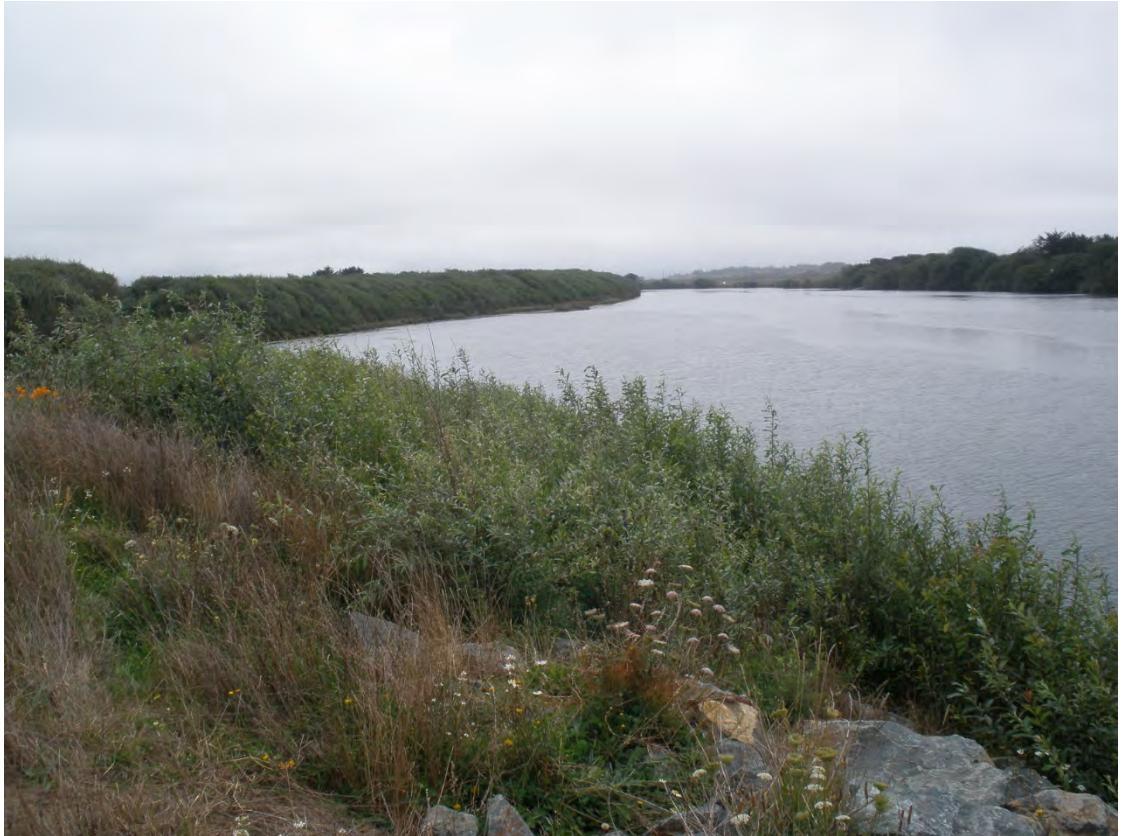
Photo 8: View facing south of Segment 3 (September 23, 2009).

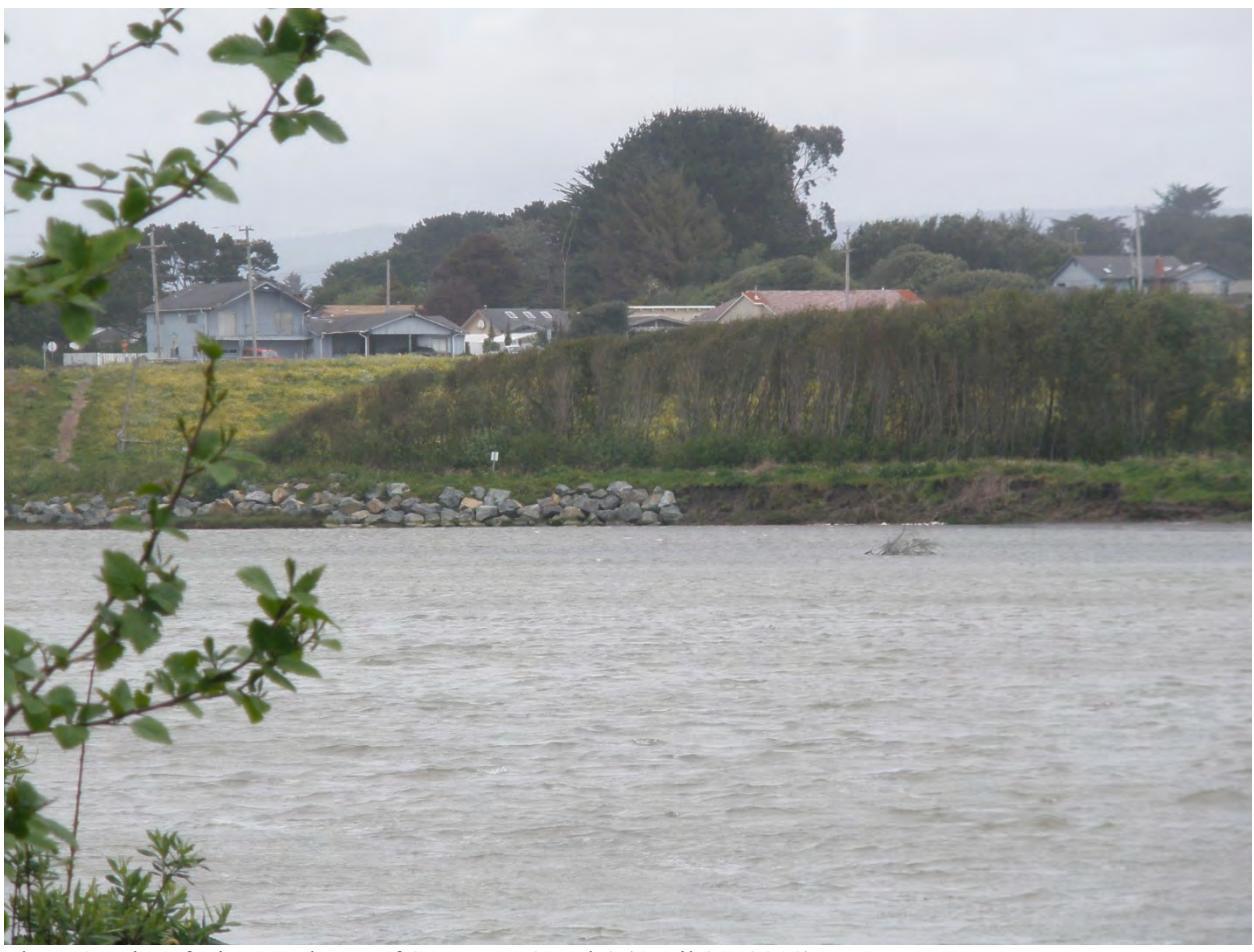
Photo 9: View facing northeast of Segments 3 and 4 (April 21, 2010).

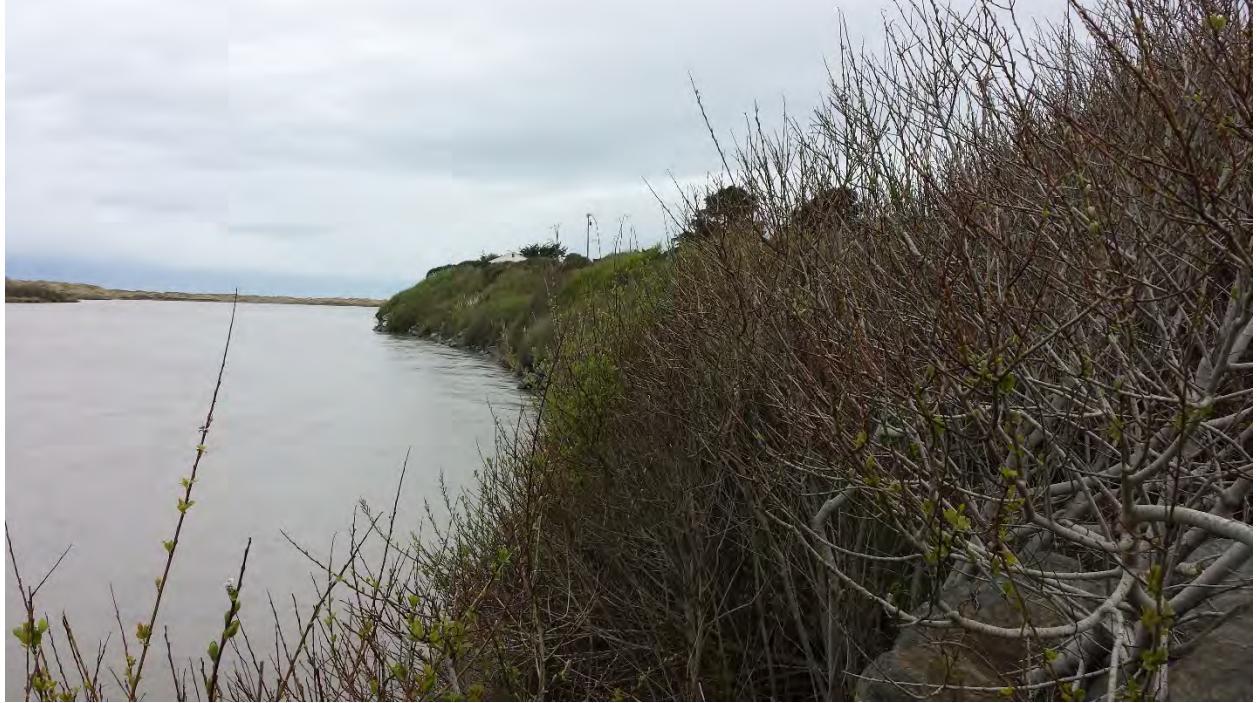
Photo 10: View facing north of Segments 2 and 3 (March 24, 2018).

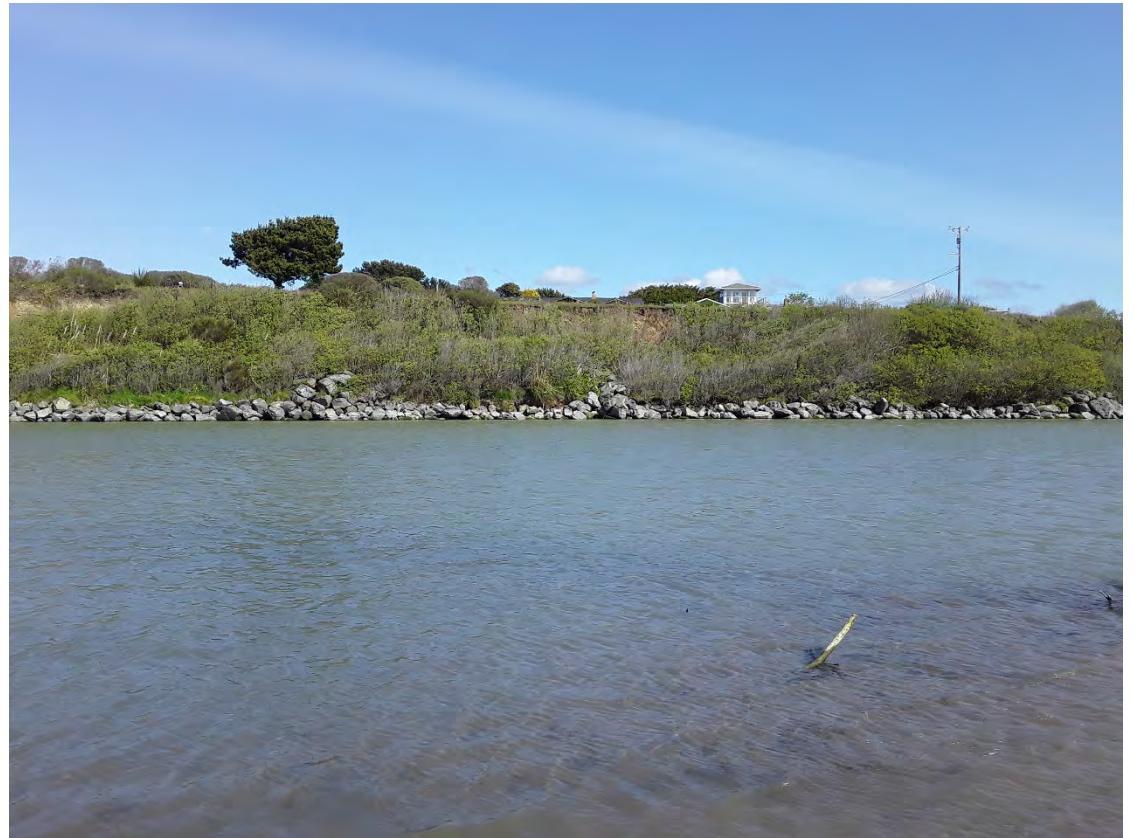
Photo 11: View facing east of Segment 1 (April 3, 2020).

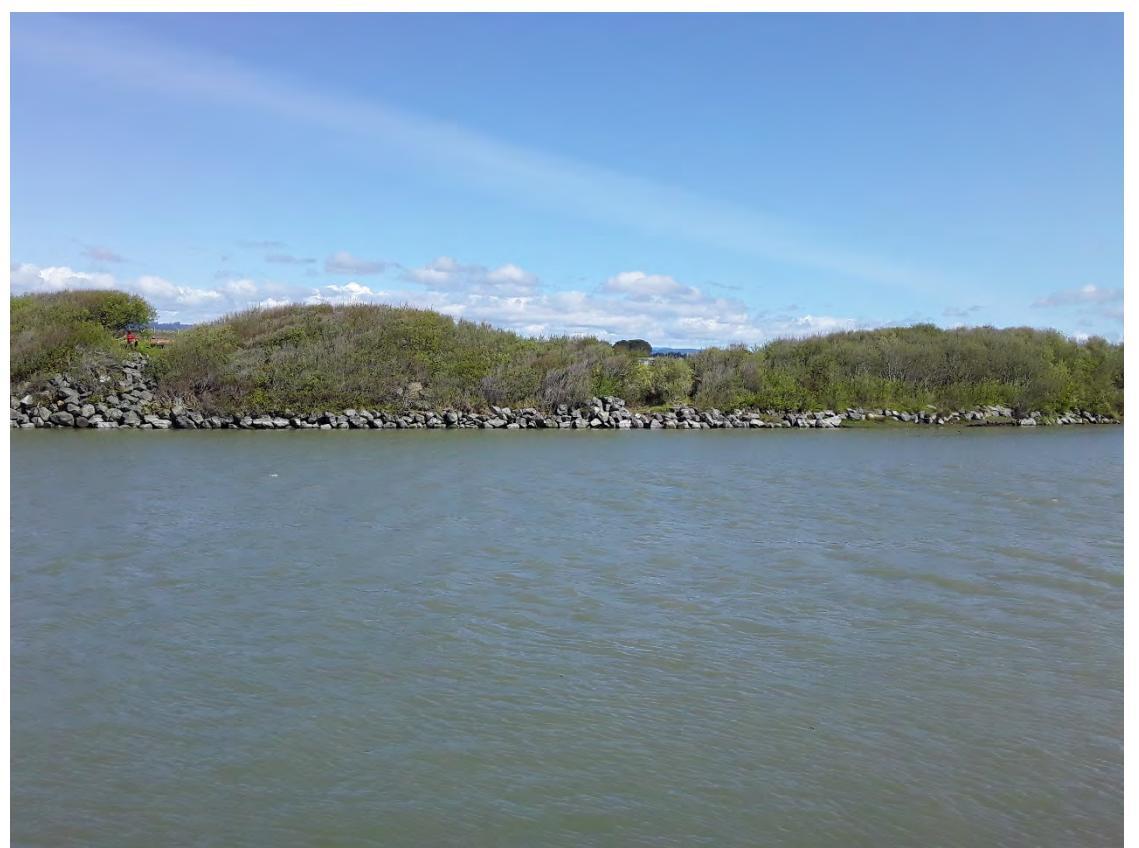
Photo 12: View facing east of Segment 3 (April 3, 2020).

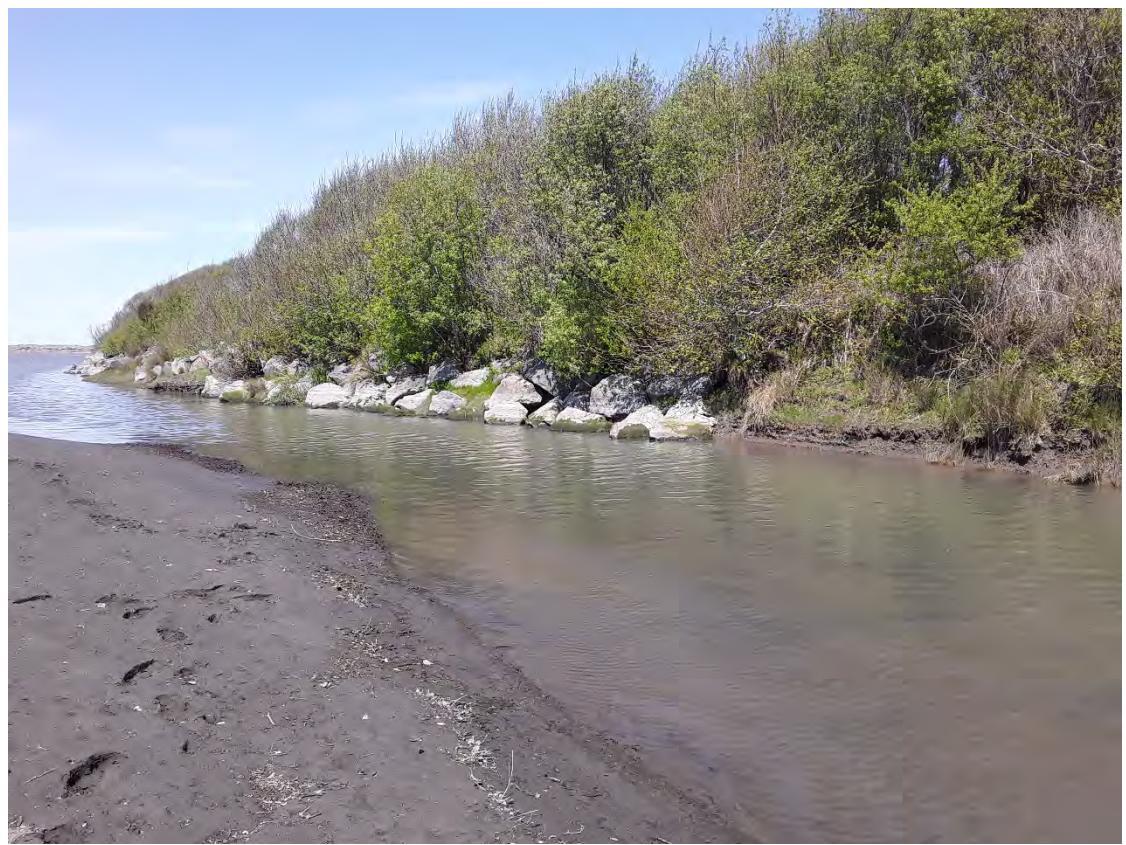
Photo 13: View facing northeast of Segment 3 and a portion of Segment 4 (April 3, 2020).
