# CDP 3-18-1081 (SANTA CRUZ WHARF REPAIR AND MAINTENANCE PROGRAM) SEPTEMBER 9, 2021 HEARING EXHIBITS

# Santa Cruz Wharf

# **Maintenance Plan**

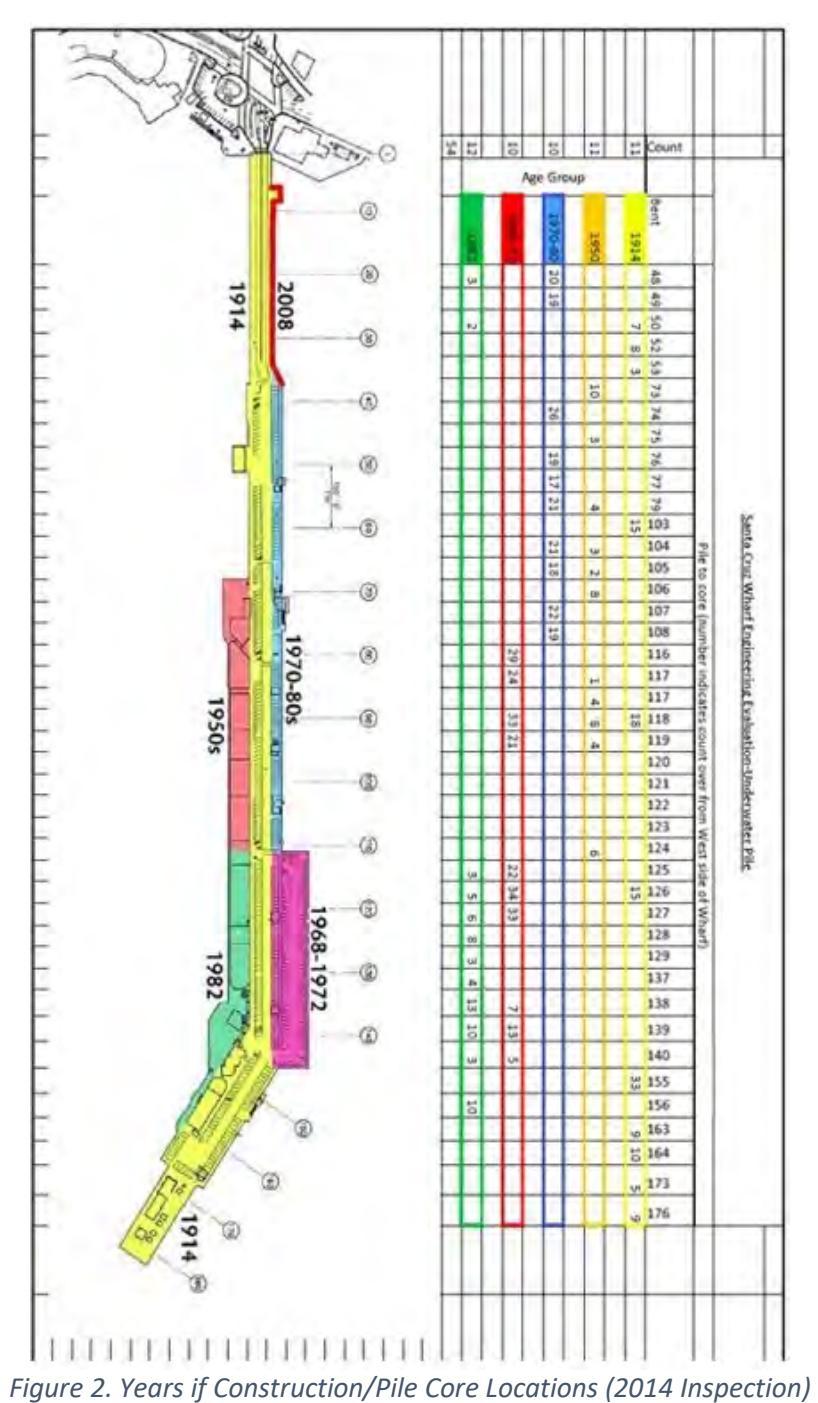
The historic Santa Cruz Wharf is approximately 2,700 feet long. The Wharf varies in width (55 feet to 250 feet) along its length as it was widened in different construction periods, see Figure 2. There are approximately 4,450 piles supporting the Wharf. There are 4 public landings. The Wharf is the longest timber pier (extending perpendicular to the shore) on the coast of the United States, and in continued use for the longest period of time.

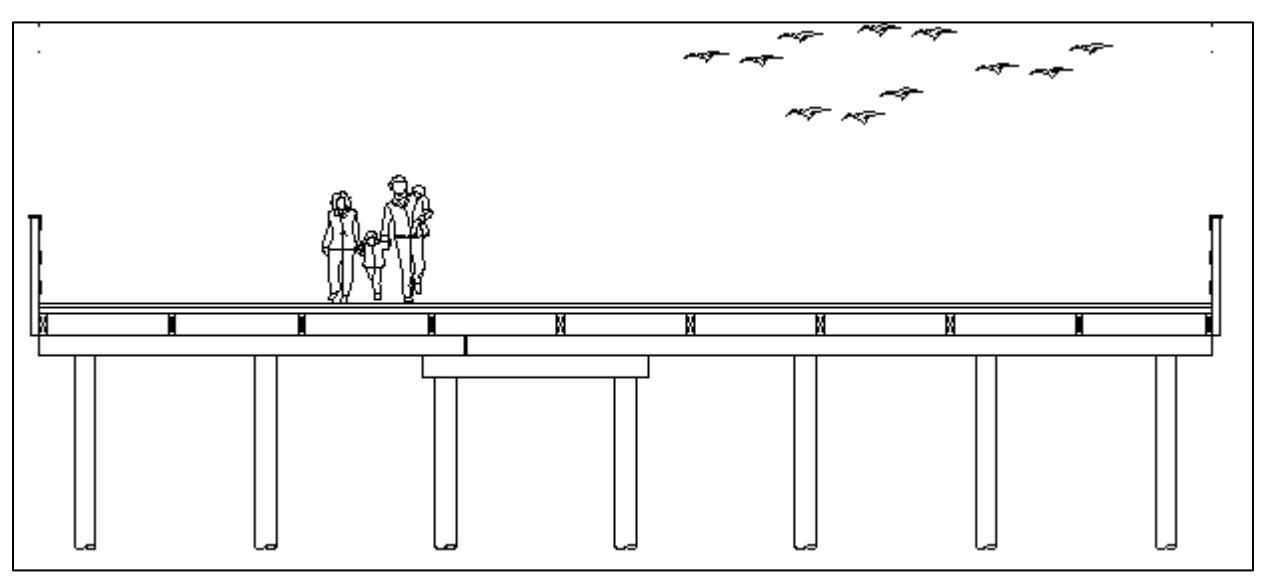
Figure 3. Typical Wharf Framing

The structural members are all timber comprised of rows of piles (bents), supporting caps, stringers, and decking. The decking is topped with a 2-inch, nominal, layer of asphalt concrete pavement. The arrangement of the structural members is regular with some variation along the joints of different

construction periods. The structure can be separated into 3 functional areas: foundation (piles and cap), deck (stringers, decking, and paving), and the superstructure (buildings on top).

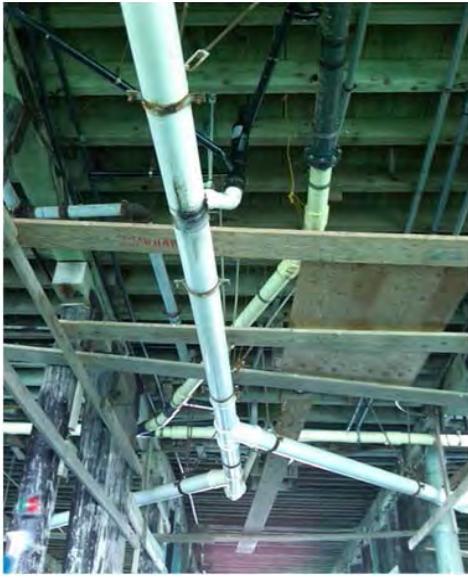
Figure 5. Under Deck Utilities

Sewage from the Wharf buildings is collected and transported by gravity pipes to two large pump stations on the Wharf. These stations pump sewage to the municipal collection system on shore. The existing pipes are constructed of corrosion resistant PVC and ABS material and are in good condition. Due to the proximity of the Wharf to public beaches it is paramount that there are no leaks in the sanitary piping. In a few locations there are older cast-iron pipes and utility lines (PVC and steel water lines, PVC electric conduit, etc.) that have been left in place and abandoned. Figure 5 shows utility lines located below the deck of the Wharf.

Remove abandoned piping beneath the Wharf and replace mild steel hangers with galvanized or stainless steel. Perform inspections monthly and after large wave events to check for leaks in sewage system. Conduct minor utility repairs on an as needed basis. Perform pressure tests on all new laterals installed on the Wharf.

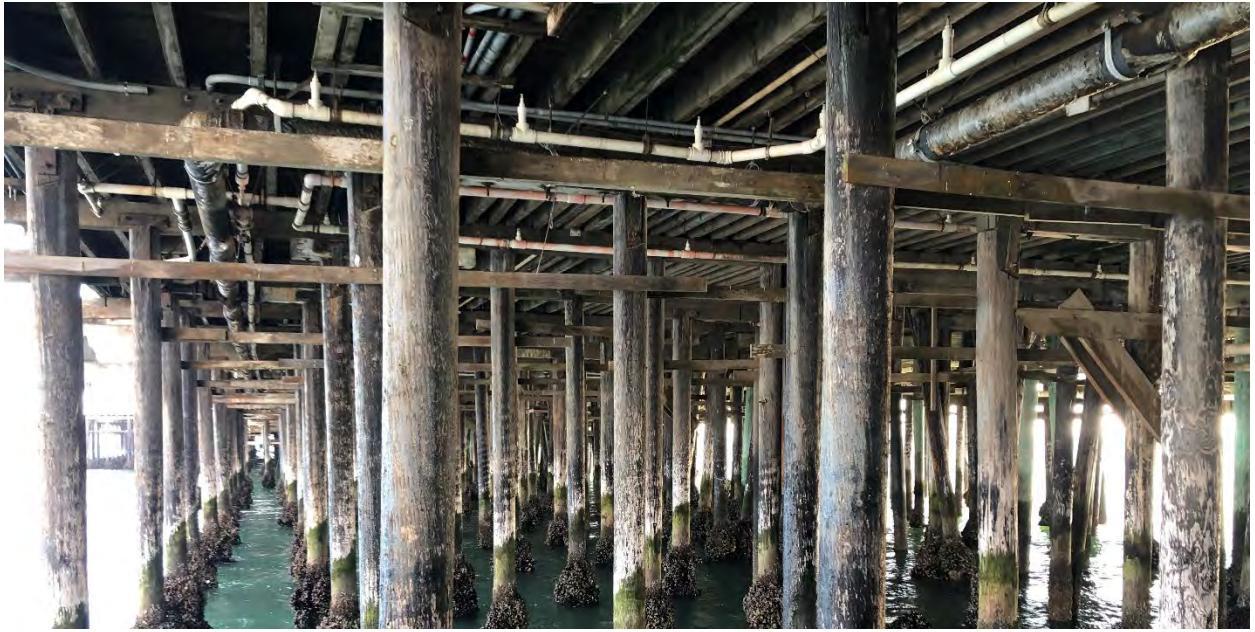
Figure 6. Fire Suppression Sprinklers Below Deck

The Wharf is classified as combustible construction under the fire code because it is constructed with timber. In the past 35 years, fire warning and suppression systems have been added to the Wharf as codes and standards were developed and the use of the Wharf by the public increased. Currently the Wharf is protected by a fire suppression system along the full length of the Wharf. This system includes hydrants, sprinklers, access hatches to substructure fire truck access and a zoned fire alarm system.
