## **CALIFORNIA COASTAL COMMISSION**

**3-83-172-A9 (Viewpointe Armoring)  
November 18, 2022**

**SUBJECT:** Response to California Coastal Commission (CCC) Staff Questions in an August 18, 2022 Email Regarding Shore Protection Maintenance at 1300 Palmetto Avenue, Cottages at Seaside, Pacifica, California.

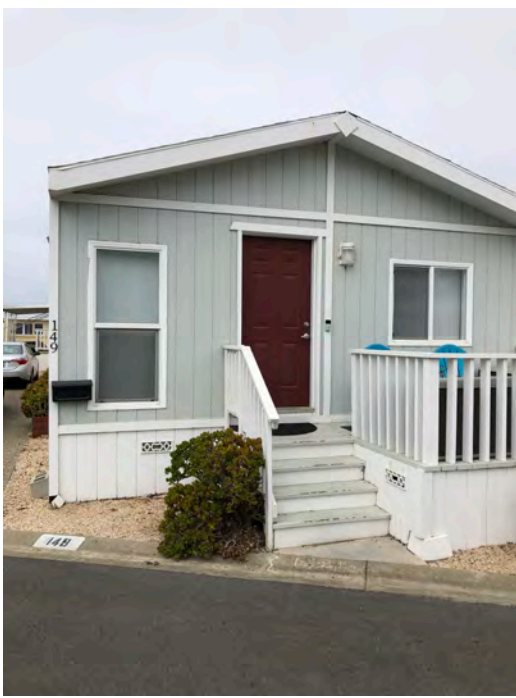
**149 First Ave - Front elevation. Gable roof, no overhang, typical of original construction. T1-11 siding typical of original construction. No indication of modification to structural roof or wall elements.**

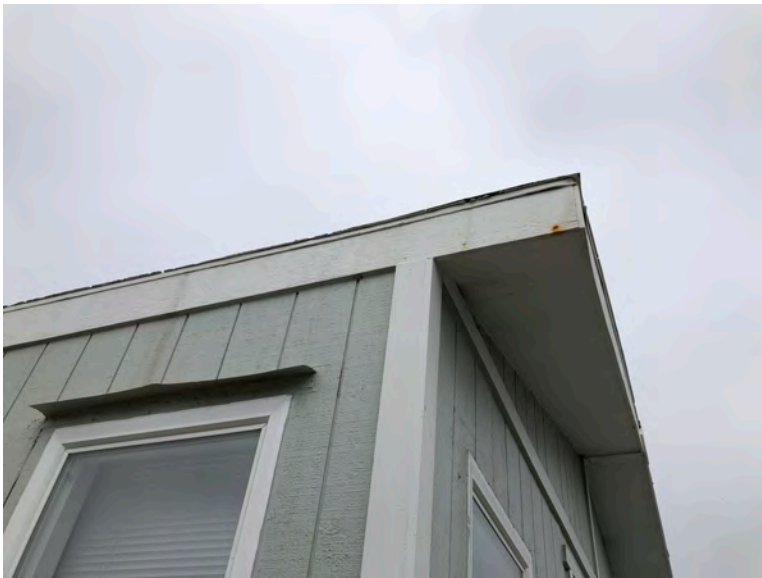
**149 First Ave - Left side. No overhang. Evidence of prior window replacement without modification of structural wall elements. T1-11 siding typical of original wall covering.**

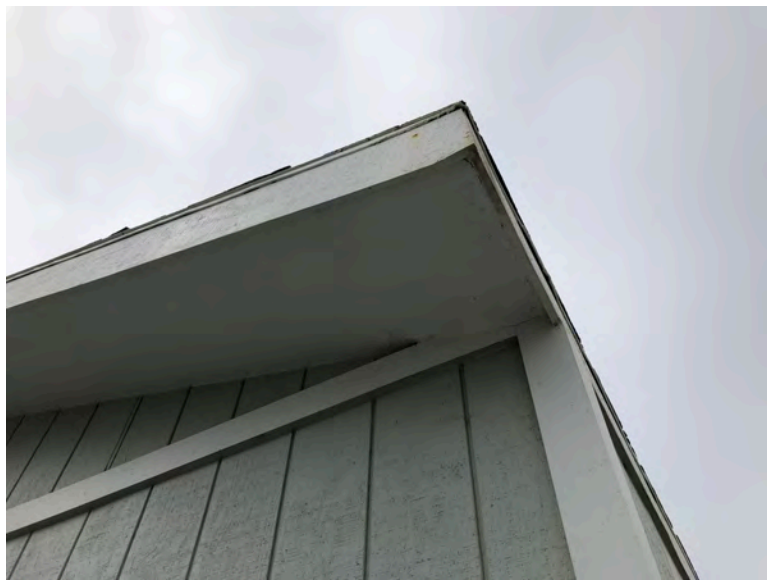
**149 First Ave - Overhang at front elevation. Boxed soffit typical of original construction. No evidence of structural modifications to wall or roof systems.**

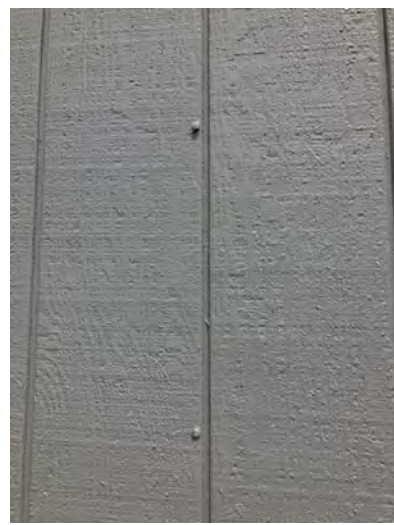
**149 First Ave - Exterior. T1-11 siding wall covering. Evidence of maintenance of T1-11 covering. No indication that removal or replacement of structural wall framing has occurred. Modification of wall elements also would have had significant impact on roof framing.**

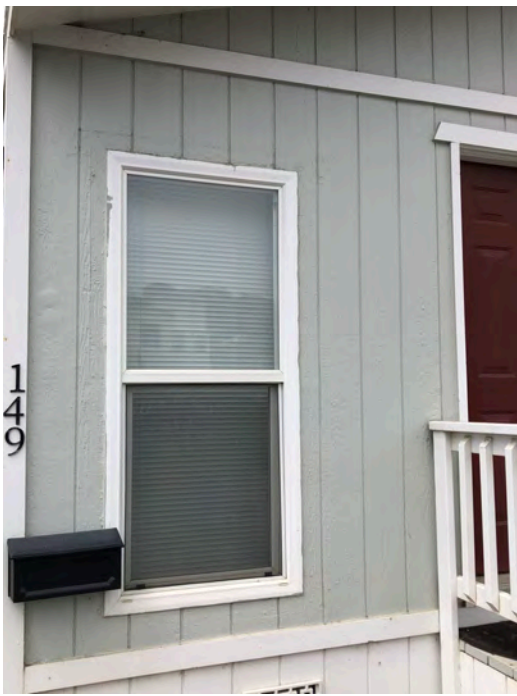
**149 First Ave - Front elevation. Evidence of prior window replacement without modification of structural wall elements.**

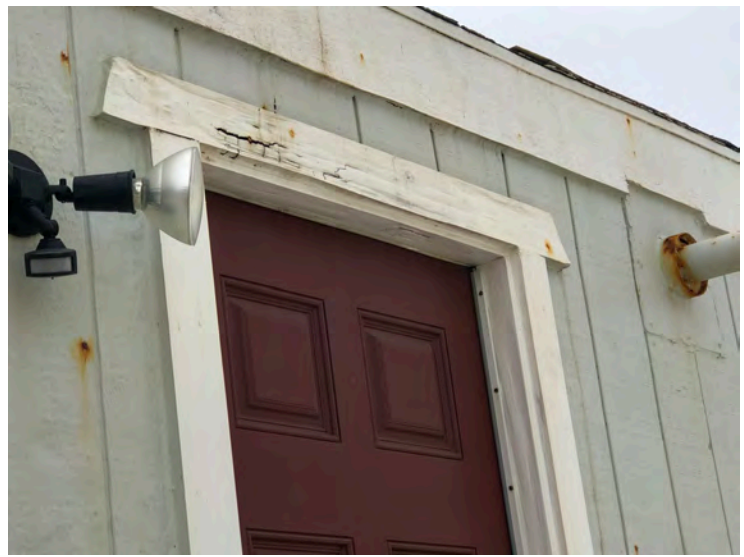
**149 First Ave - Moulding over entry. Gable end roof with no overhang typical of original construction. Some wood rot over moulding. No evidence of modification to roof framing. If structural roof elements had been replaced, an overhang likely would have been included to further protect siding elements.**

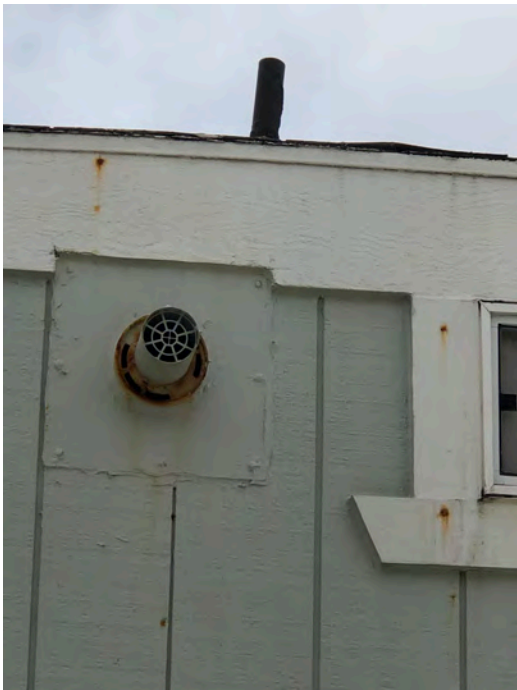
**149 First Ave - Original heater vent installed in existing wall, indicative of original construction.**

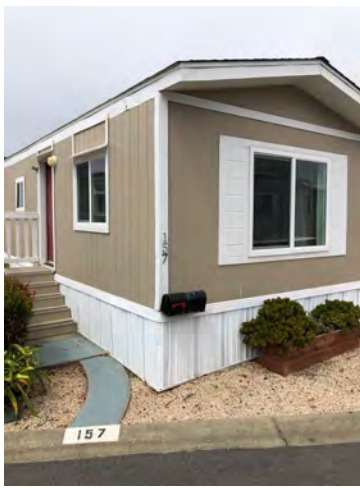
**157 First Ave - Front Elevation with side entrance ("shotgun installation"). Gable roof with no overhang typical of original unit. No evidence of any modifications to structural roof elements. Roof replacement would have had significant impact on wall framing and interiors and likely would have included a roof overhang.**

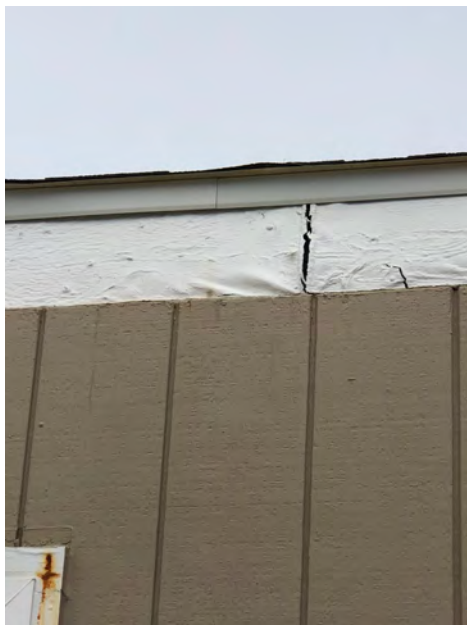
**157 First Ave - Fascia typical of original construction. Evidence of fascia wear and indications of maintenance, including caulking and re-painting. No evidence of any modifications to structural roof or wall elements. Roof replacement likely would have included overhang.**

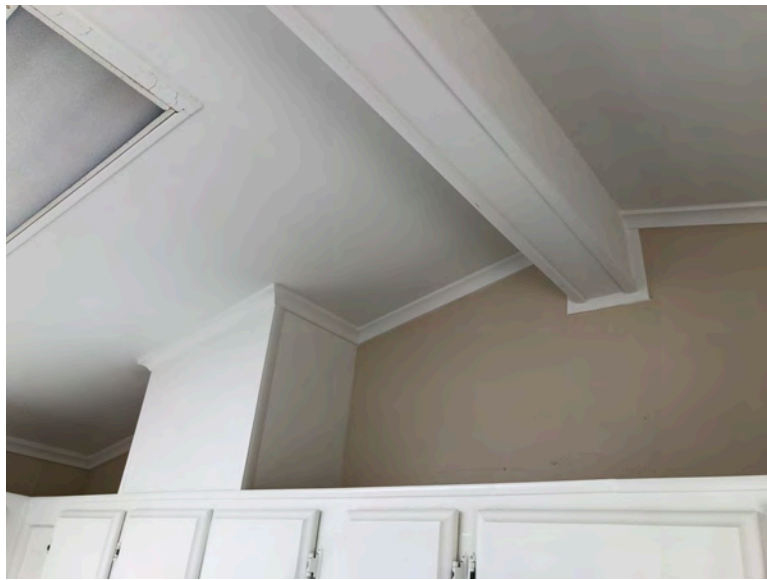
**157 First Ave - Interior elevation of vaulted ceiling (from gable construction) over kitchen. No evidence of any structural modifications. Cabinets and trim are integral to the original construction.**

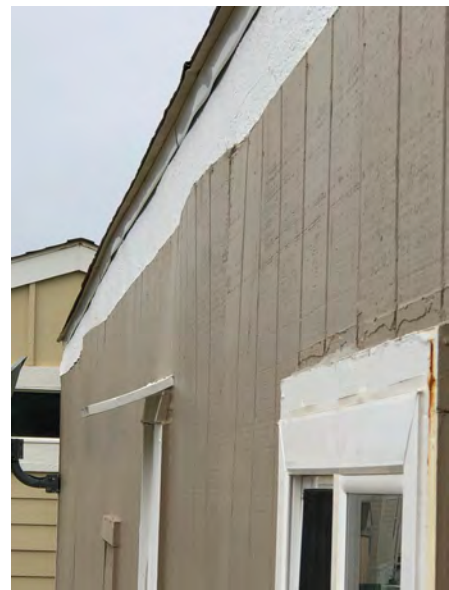
**157 First Ave - Side elevation. Evidence of prior window replacement without modification of structural wall elements. Evidence of non-structural repair and maintenance (e.g., caulking, sealing) of T1-11 wall covering. T1-11 siding typical of original construction. No indication that any removal or replacement of structural wall framing has occurred.**

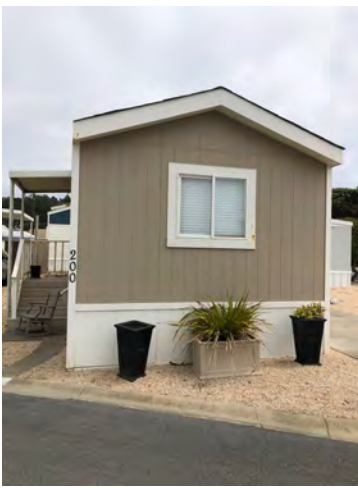
**200 Second Ave - Front elevation with side entrance ("shotgun installation"). Materials and gable roof with little or no overhang typical of original construction. No indication that any removal or replacement of structural roof framing has occurred. Replacement would have had significant impact on wall framing and interiors and likely would have been constructed with an overhang.**

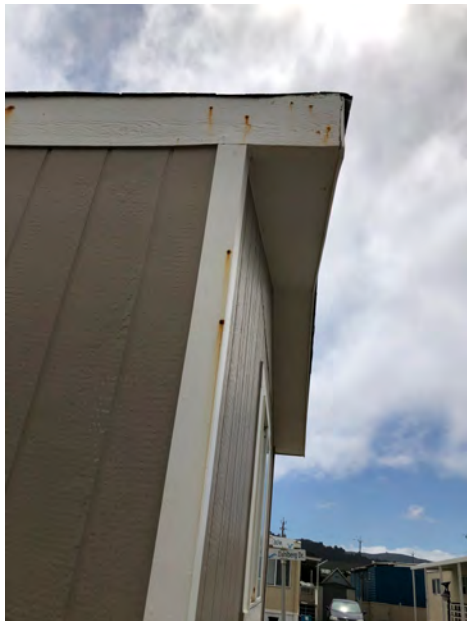
**200 Second Ave - Fascia detail at roof. Fascia typical of original construction. Evidence of fascia wear and indications of maintenance, including re-painting. No evidence of any modifications to structural roof or wall elements. Roof replacement likely would have included overhang**

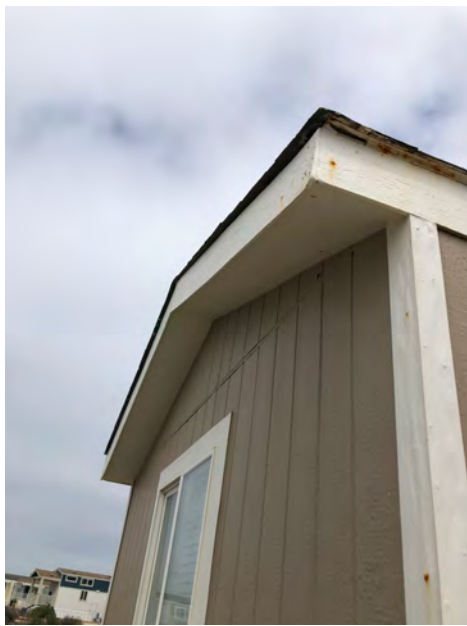
**200 Second Ave - Fascia detail at roof. Fascia typical of original construction. If roof structural framing had been replaced, boxed eave and fascia would not show similar wear. Replacement of roof elements likely would have included overhang.**

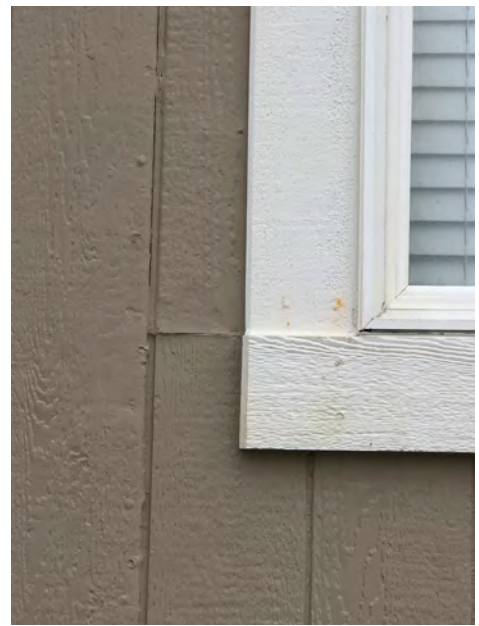
**200 Second Ave - Evidence of repair and maintenance (e.g., caulking, sealing) of T1-11 wall covering. No indication that removal or replacement of structural wall framing has occurred.**

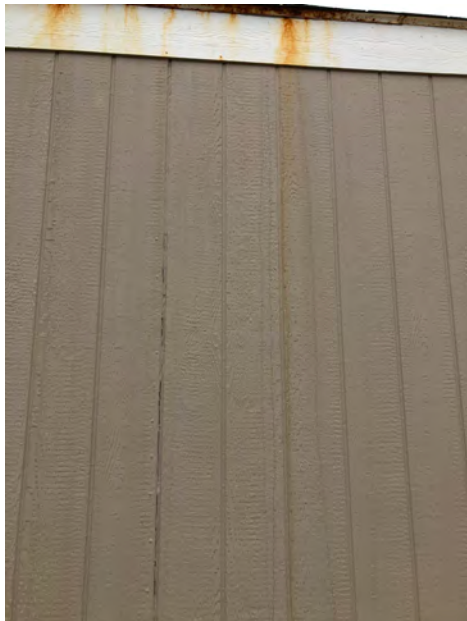
**200 Second Ave - Existing T1-11 siding reflecting non-structural repair and maintenance.**

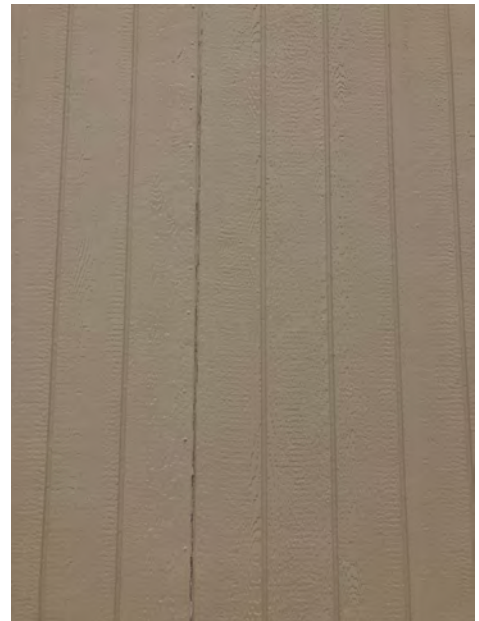
**200 Second Ave - Existing T1-11 siding reflecting non-structural repair and maintenance.**

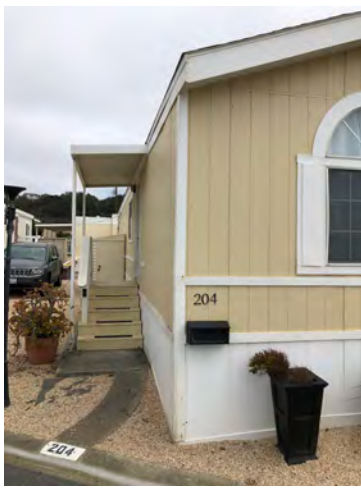
**204 Second Ave - Front elevation with side entrance ("shotgun installation"). Materials and gable roof with little or no overhang typical of original construction. No indication that removal or replacement of structural roof framing has occurred. Replacement would have had significant impact on wall framing and interiors and likely would have been constructed with an overhang.**

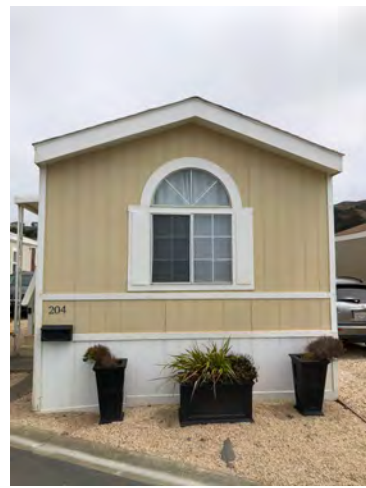
**204 Second Ave - Front elevation with side entrance ("shotgun installation") Materials and gable roof with little or no overhang typical of original construction. No indication that any removal or replacement of structural roof framing has occurred. Replacement would have had significant impact on wall framing and interiors and likely would have been constructed with an overhang.**

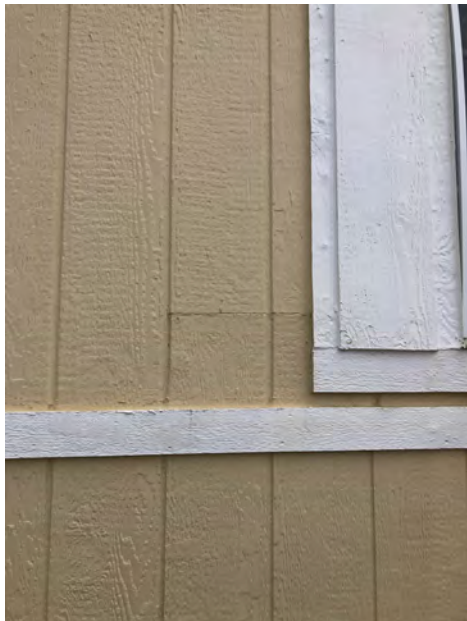
**204 Second Ave - 200 Second Ave - Evidence of non-structural repair and maintenance (e.g., caulking, sealing) of T1-11 wall covering. T1-11 siding typical of original construction. No indication that any removal or replacement of structural wall framing has occurred.**

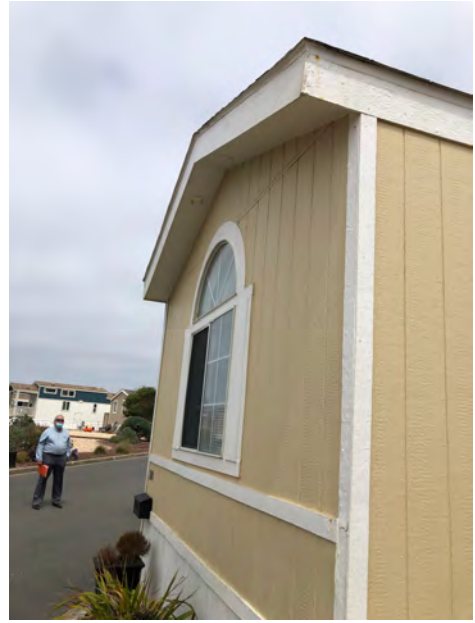
**204 Second Ave - Fascia detail at roof. If roof structural framing had been replaced, boxed eave and fascia would not show similar wear. Replacement of roof elements likely would have included overhang.**

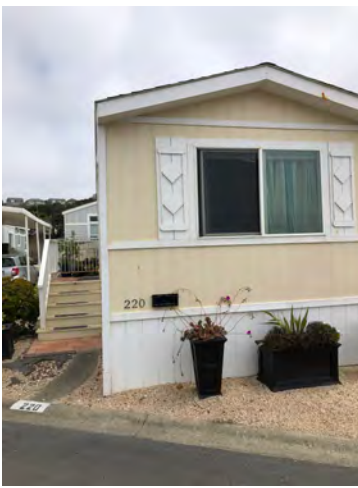
**220 Second Ave - Front Elevation with side entrance ("shotgun installation"). Materials and gable roof with little or no overhang typical of original construction. No indication that removal or replacement of structural roof framing has occurred. Replacement would have had significant impact on wall framing and interiors and likely would have been constructed with an overhang.**

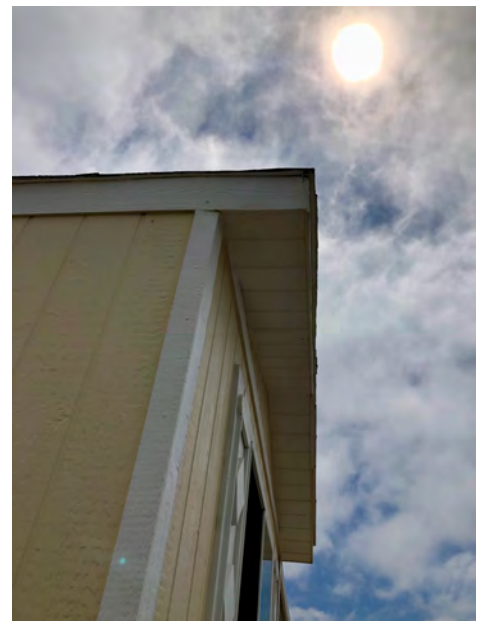
**220 Second Ave - Fascia detail at roof. If roof structural framing had been replaced, boxed eave and fascia would not show similar wear. Replacement of roof elements likely would have included overhang.**

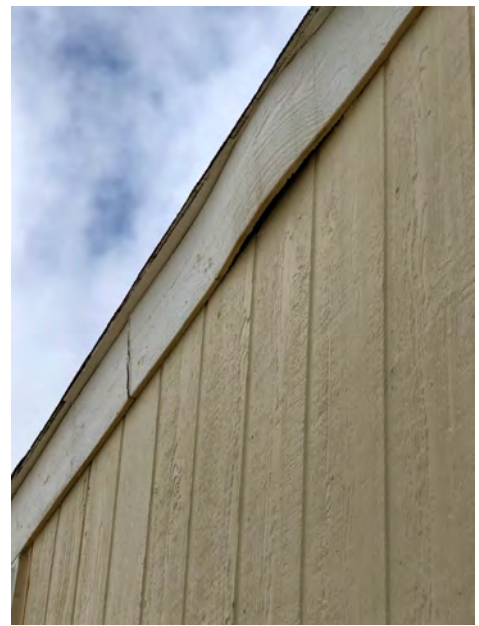
**220 Second Ave - Fascia detail at roof. Fascia typical of original construction. Evidence of fascia wear and indications of maintenance, including re-painting. No evidence of any modifications to structural roof or wall elements. If roof structural framing had been replaced, boxed eave and fascia would not show similar wear. Replacement of roof elements likely would have included overhang.**

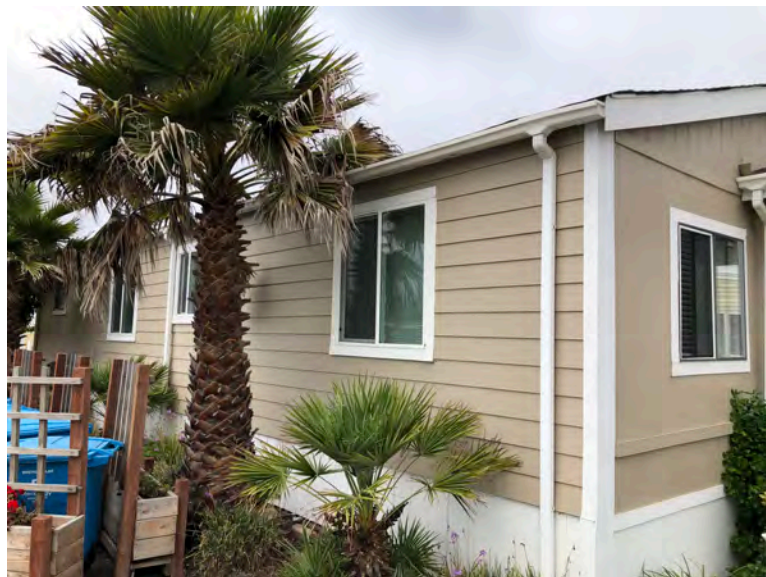
**229 Second Ave - Front view, gable construction with small overhang at eaves. No indication that removal or replacement of structural wall framing or siding elements has occurred.**

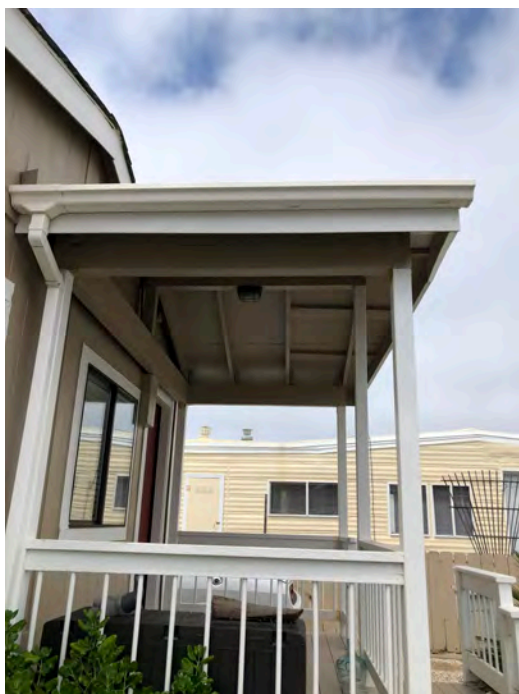
**229 Second Ave - Side view with lapped siding. No indication that removal or replacement of structural wall framing or siding elements has occurred.**

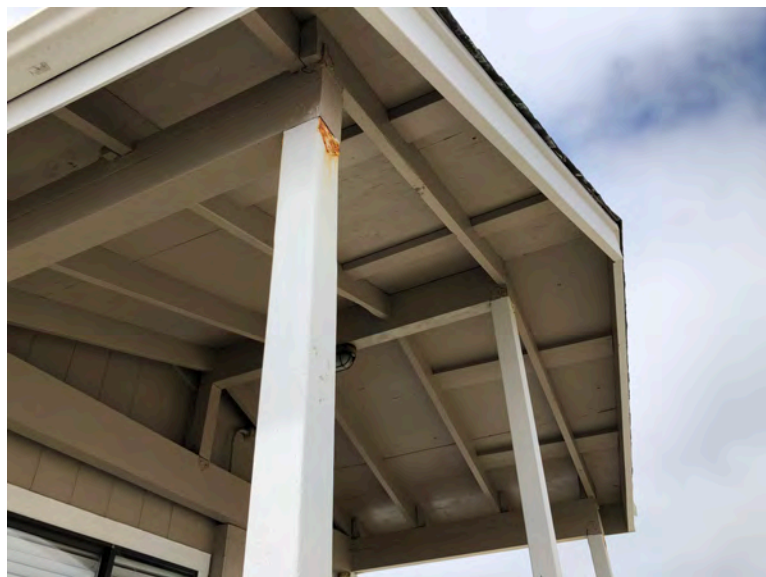
**229 Second Ave - Side view with posts and beams at porch.**

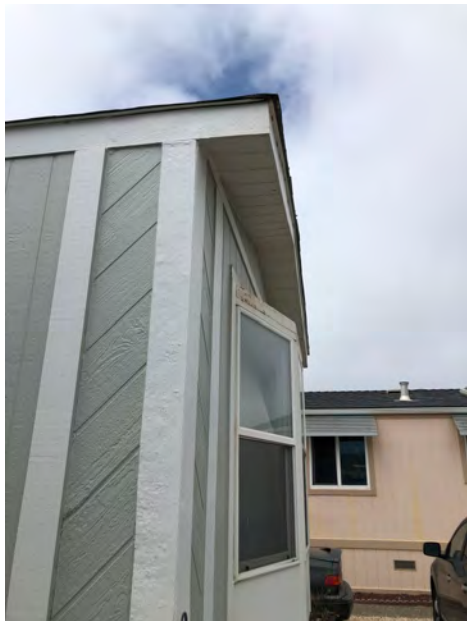
**245 Second Ave - Side view with T1-11 siding. Evidence of non-structural repair and maintenance (e.g. caulking, sealing) of T1-11 wall covering. T1-11 siding typical of original construction. No indication that any removal or replacement of structural wall framing has occurred.**

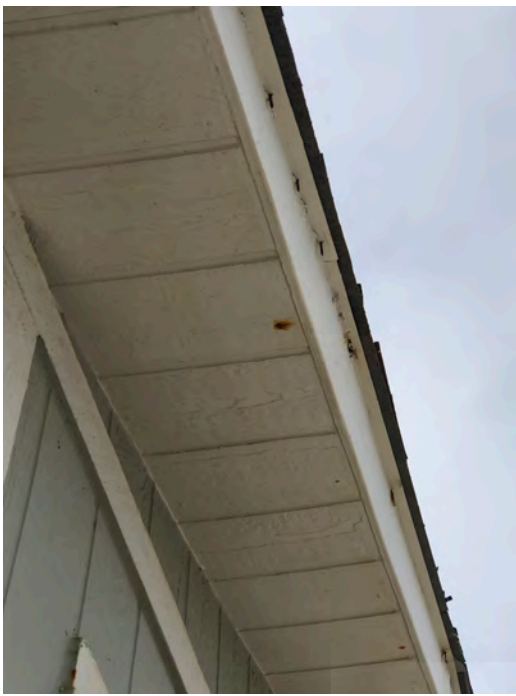
**245 Second Ave - Side View with T1-11 siding. Evidence of non-structural repair and maintenance (e.g. caulking, sealing) of T1-11 covering. No indication that any removal or replacement of structural wall framing has occurred.**

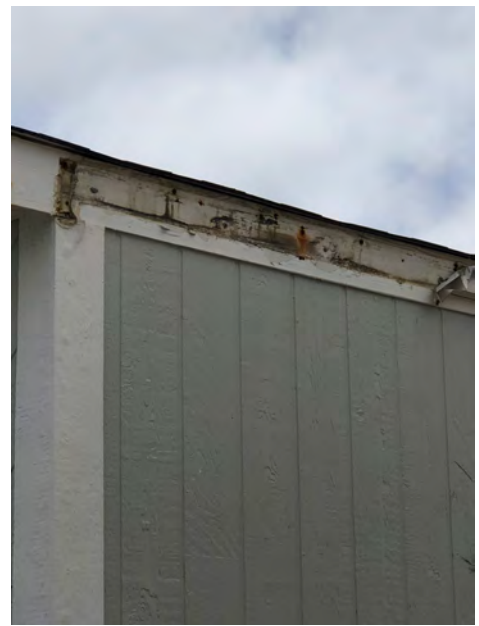
**245 Second Ave - Boxed eaves at front elevation. Typical of older construction.**

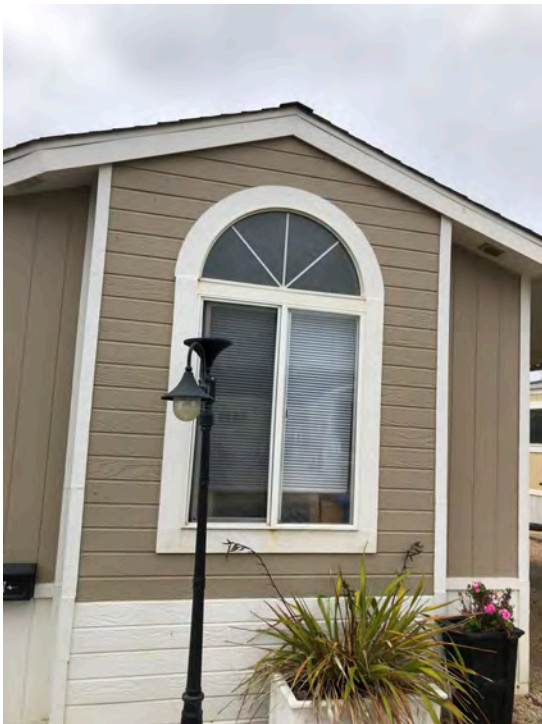
**317 Third Ave - Side view with T1-11 siding. Evidence of non-structural repair and maintenance (e.g., caulking, sealing) of T1-11 wall covering. T1-11 siding typical of original construction. No indication that removal or replacement of structural wall framing has occurred.**

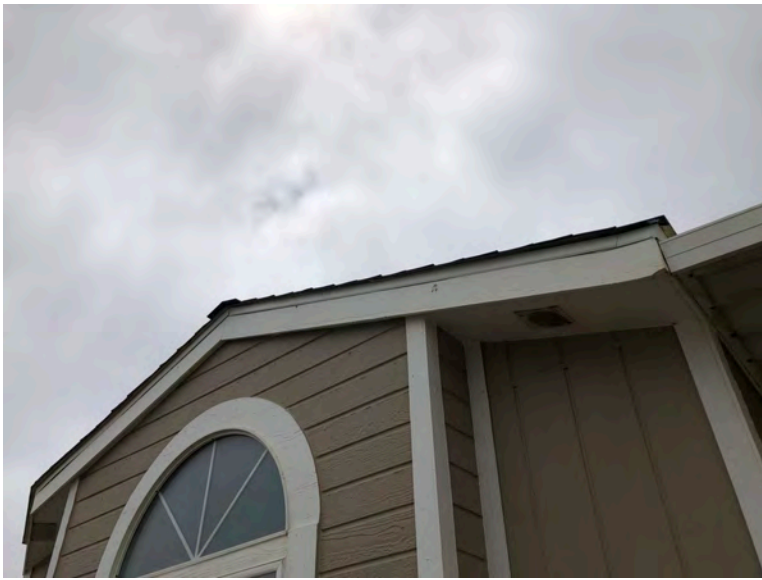
**317 Third Ave - Side view with T1-11 siding. Evidence of non-structural repair and maintenance (e.g., caulking, sealing) of T1-11 wall covering. No indication that any removal or replacement of structural wall framing has occurred.**

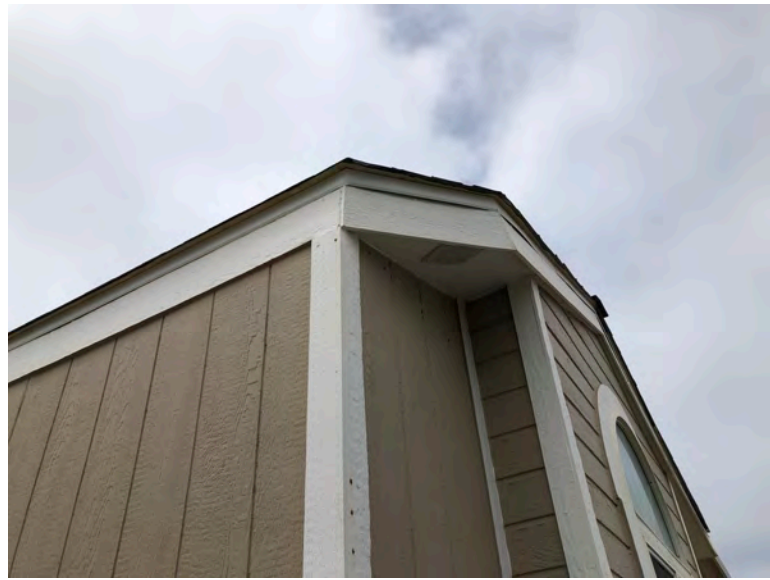
**317 Third Ave - Fascia detail at roof with boxed eave, no overhang. Fascia typical of original construction. Note old style vent at boxed eave, typical of original construction.**

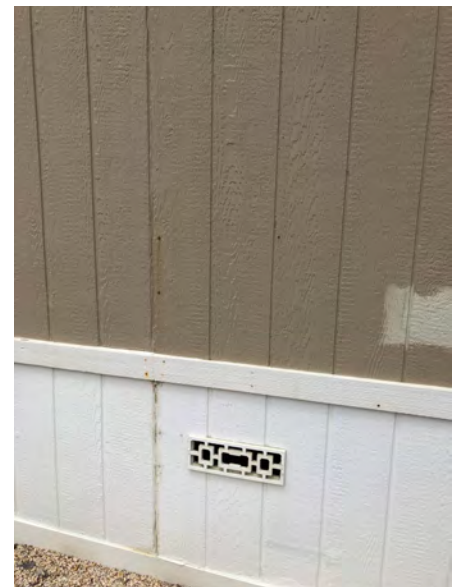
**317 Third Ave - Side view with T1-11 siding. Evidence of non-structural repair and maintenance (e.g., caulking, sealing) of T1-11 wall covering. No indication that any removal or replacement of structural wall framing has occurred. Note old style wall vent, typical of original construction.**

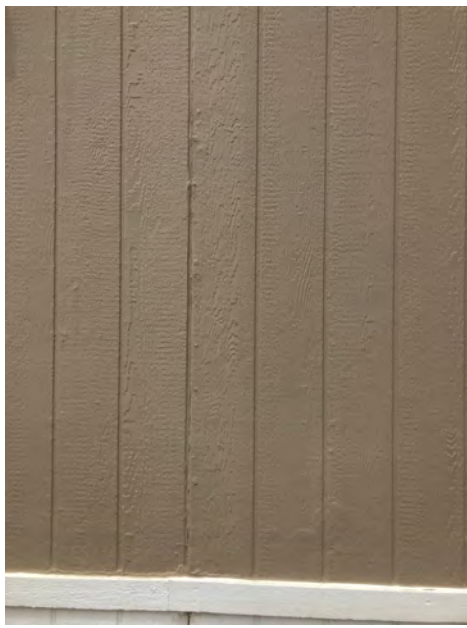
**317 Third Ave - Side view with T1-11 siding. Evidence of non-structural repair and maintenance (e.g., caulking, sealing) of T1-11 wall covering. No indication that any removal or replacement of structural wall framing has occurred. Note old style wall vent, typical of original construction.**

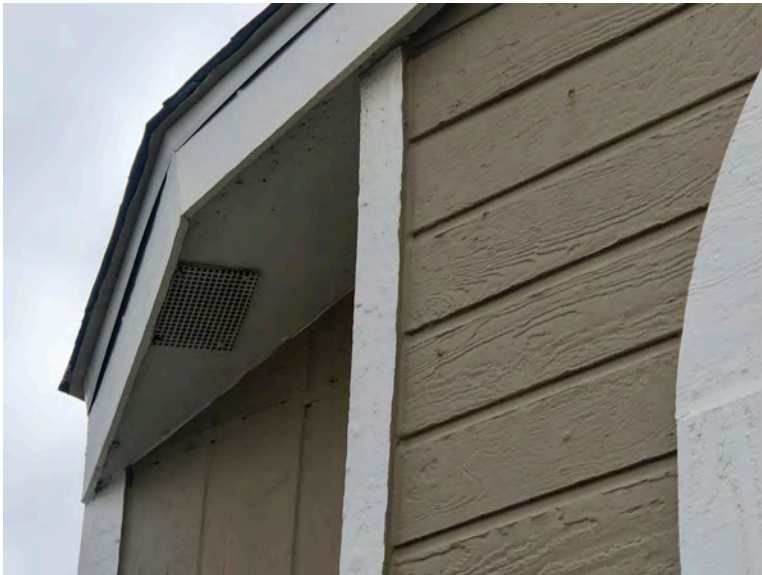
**317 Third Ave - Fascia detail at roof with boxed eave, no overhang. Note old style vent at boxed eave, typical of original construction.**

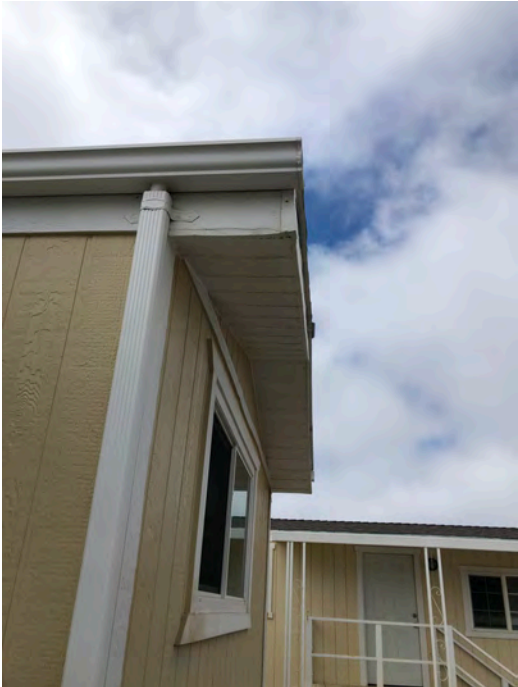
**321 Third Ave - Front elevation. Gable roof with no overhang, typical of original construction. Replacement would have had significant impact on framing and interiors and likely would have been constructed with an overhang.**

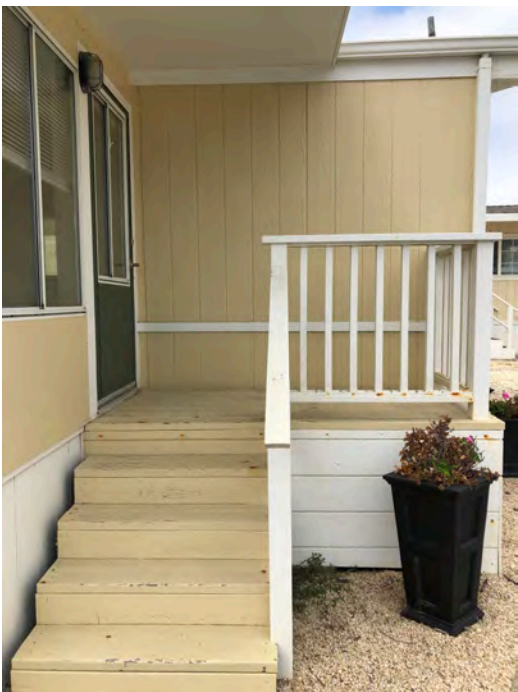
**321 Third Ave - Side view with T1-11 siding. Evidence of non-structural repair and maintenance (e.g., caulking, sealing) of T1-11 wall covering. T1-11 siding typical of original construction. No indication that any removal or replacement of structural wall framing has occurred.**

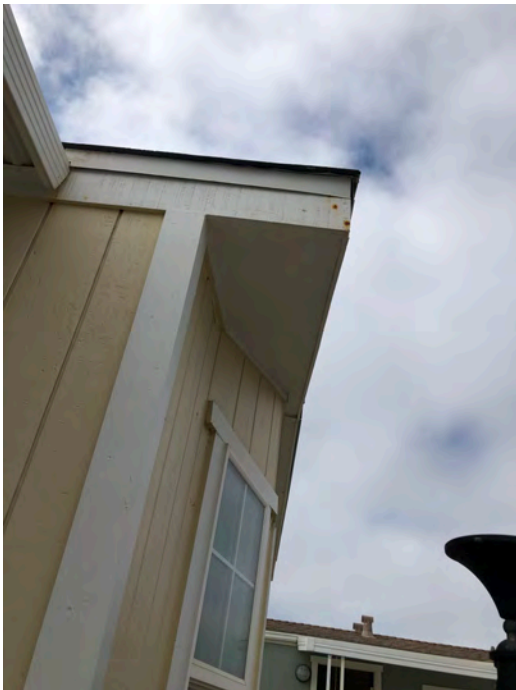
**325 Third Ave - Entrance at side elevation. No roof overhang, typical of original construction. No indication that any removal or replacement of structural roof framing has occurred. Replacement would have had significant impact on wall framing and interiors.**

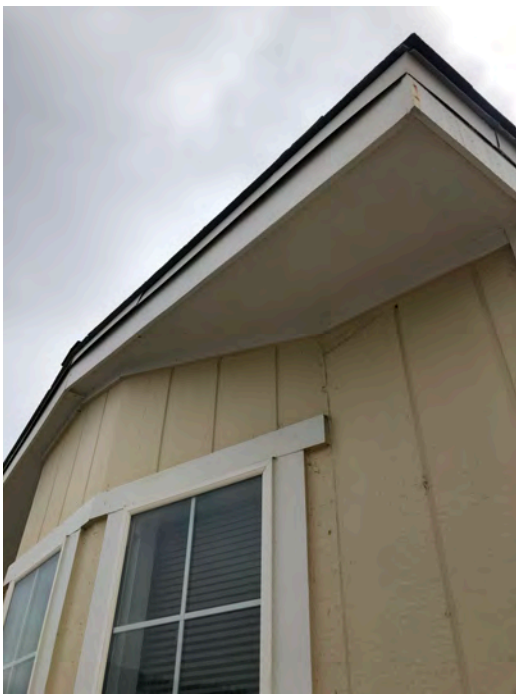
**325 Third Ave - Side view with T1-11 siding. Evidence of non-structural repair and maintenance (e.g., caulking, sealing) of T1-11 wall covering. T1-11 siding typical of original construction. No indication that any removal or replacement of structural wall framing has occurred.**

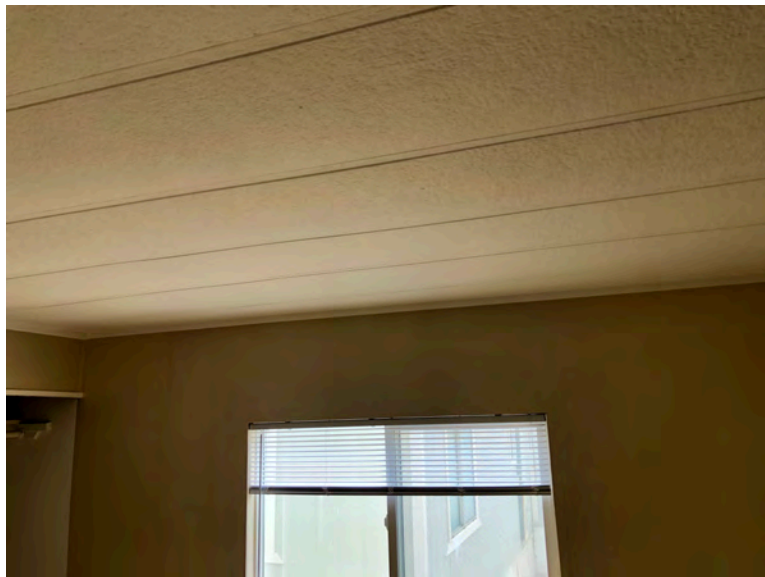
**325 Third Ave - Interior elevation of open ceiling with boxed beam, indicative of original gable construction. Interior finish materials at ceiling consistent with type used in older models of this genre.**

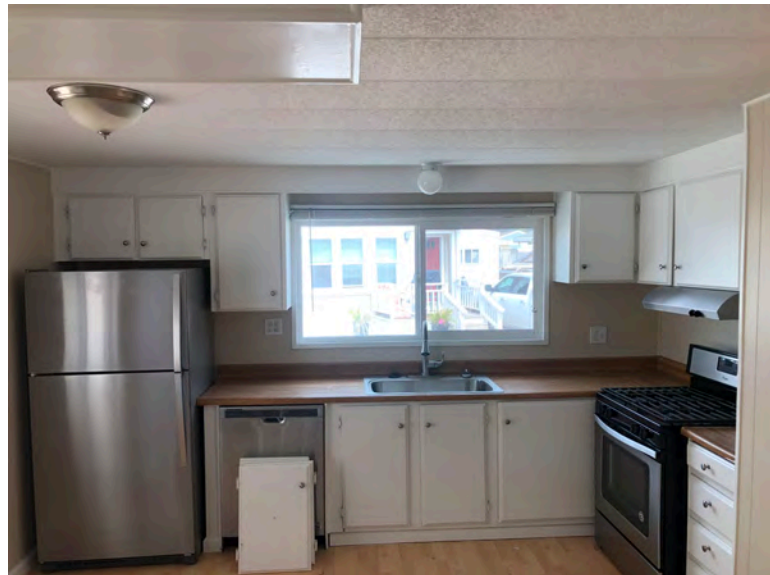
**325 Third Ave - Interior finish materials at ceiling consistent with type used in older models of this genre.**

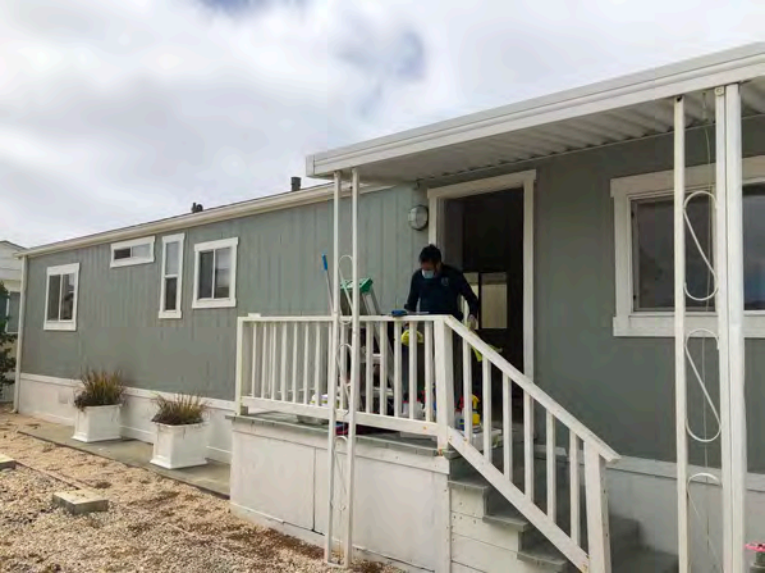
**329 Third Ave - Front elevation. Gable roof construction with no overhang, typical of original construction. No indication that removal or replacement of structural roof framing has occurred. Replacement would have had significant impact on wall framing and interiors and likely would have been constructed with an overhang.**

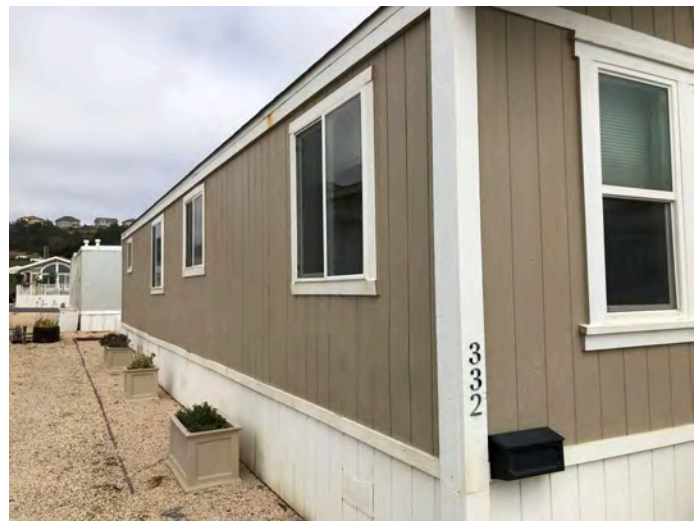
**332 Third Ave - Front Elevation. Gable roof with no overhang, typical of original construction. If roof framing had been replaced, likely would have been constructed with an overhang.**

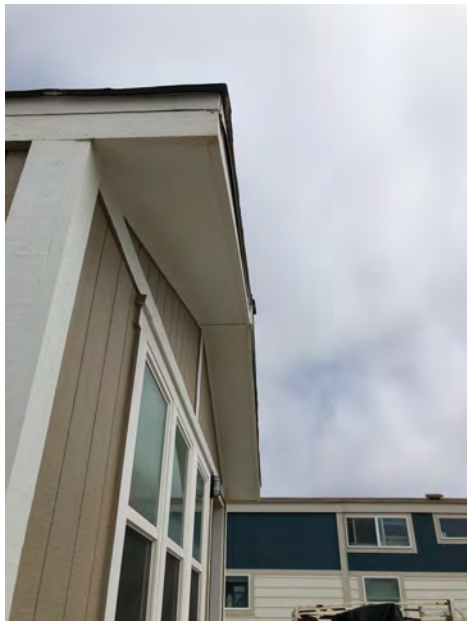
**332 Third Ave - Side view with T1-11 siding. Evidence of non-structural repair and maintenance (e.g., caulking, sealing) of T1-11 wall covering. T1-11 siding typical of original construction. No indication that removal or replacement of structural wall framing has occurred.**

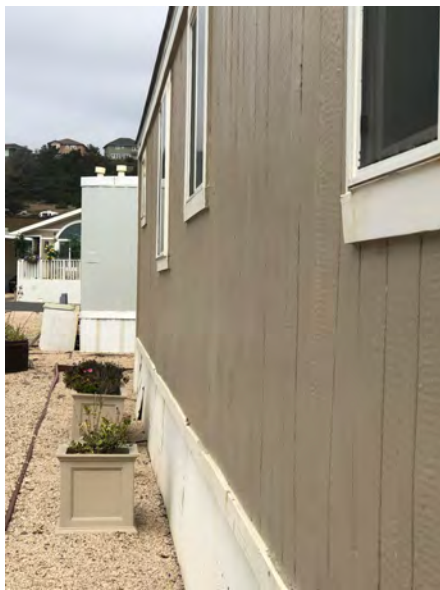
**332 Third Ave - Side elevation. T1-11 siding material typical of original construction.**

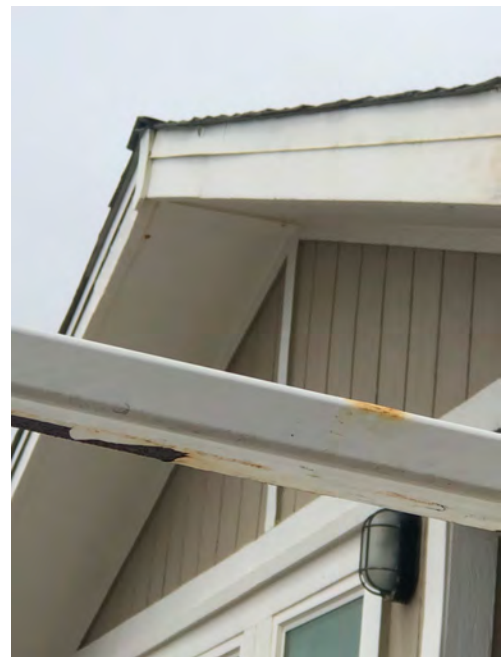
**332 Third Ave - Side elevation. T1-11 siding material typical of original construction.**

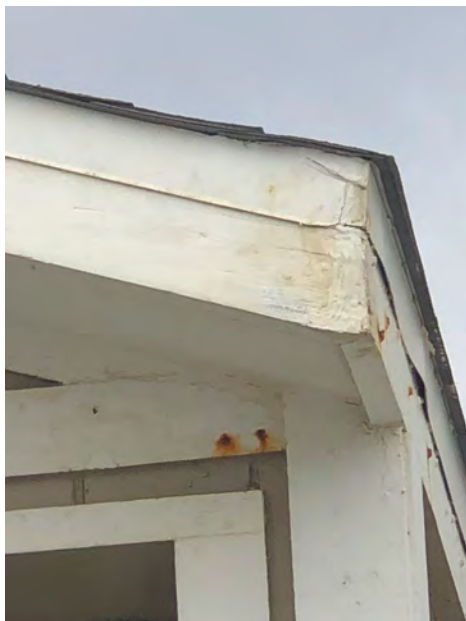
**332 Third Ave - Overhang at front elevation. Boxed soffit typical of original construction. No indication of structural modifications to wall or roof systems.**

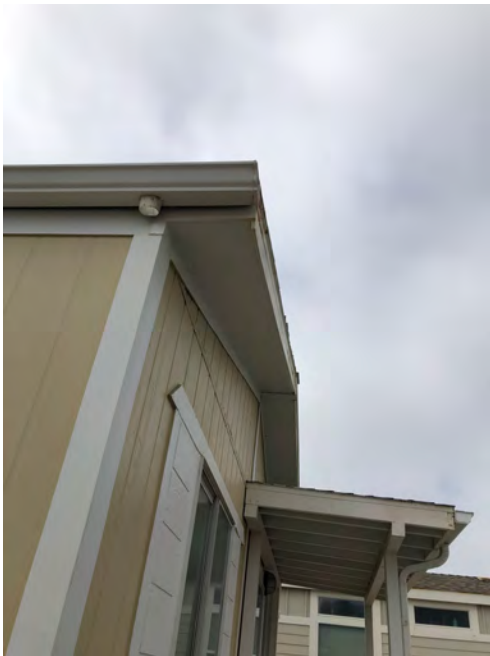
**333 Third Ave - Side view, no overhang. Side view with T1-11 siding. Evidence of non-structural repair and maintenance (e.g., caulking, sealing) of T1-11 wall covering. T1-11 siding typical of original construction. No indication that removal or replacement of structural wall framing has occurred.**

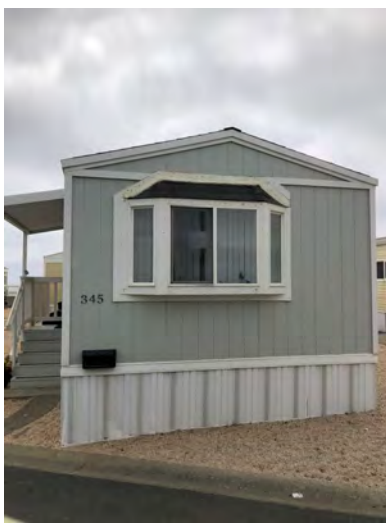
**345 Third Ave - Front elevation. Gable roof construction with boxed eave and pop out window, typical of original construction. No indication that removal or replacement of structural roof framing has occurred. Replacement would have had significant impact on wall framing and interiors and likely would have been constructed with an overhang.**

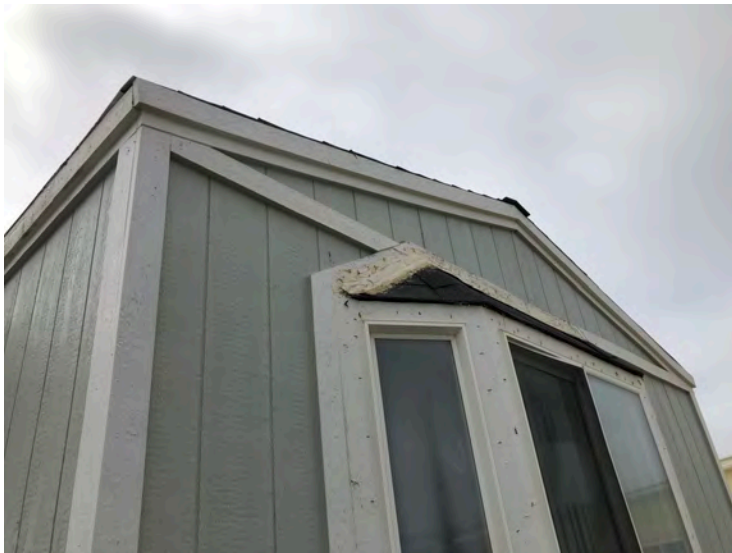
**345 Third Ave - Gable roof, no overhang. T1-11 siding typical of original construction. Fascia detail at roof reflecting non-structural repair and maintenance, including re-painting. If roof structural framing had been replaced, boxed eave and fascia would not show similar wear. Replacement of roof elements likely would have included overhang.**

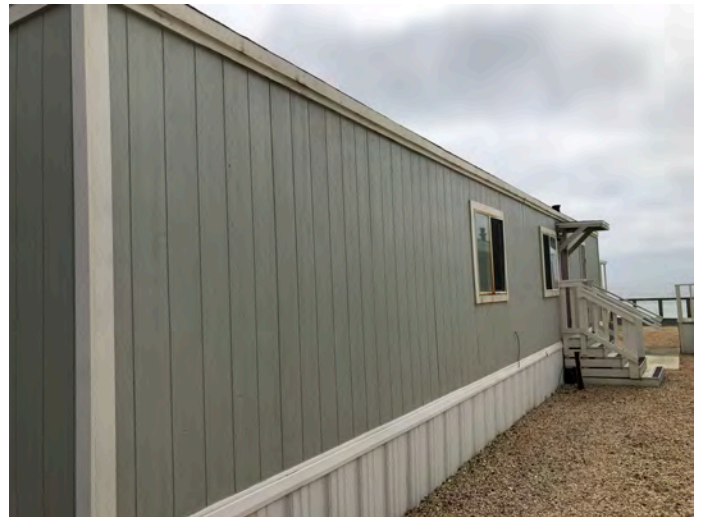
**345 Third Ave - Exterior T1-11 siding wall covering. Evidence of non-structural repair and maintenance (e.g., caulking, sealing) of T1-11 wall covering. T1-11 siding typical of original construction. No indication that removal or replacement of structural wall framing has occurred.**

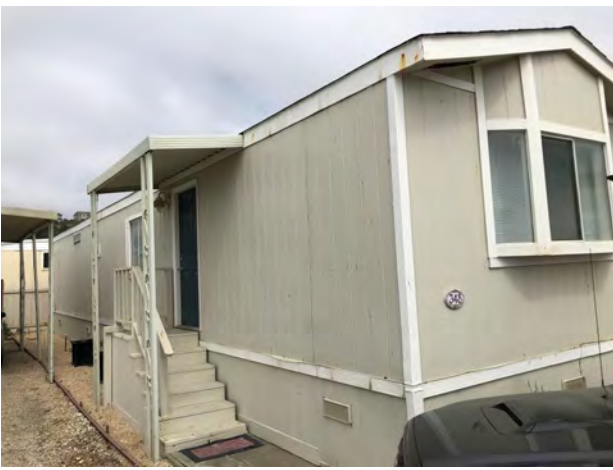
**348 Third Ave - Side view, entry steps. Materials, pop out window, and gable roof with little or no overhang typical of original construction. No indication that removal or replacement of structural roof framing has occurred. Replacement would have had significant impact on wall framing and interiors and likely would have been constructed with an overhang.**

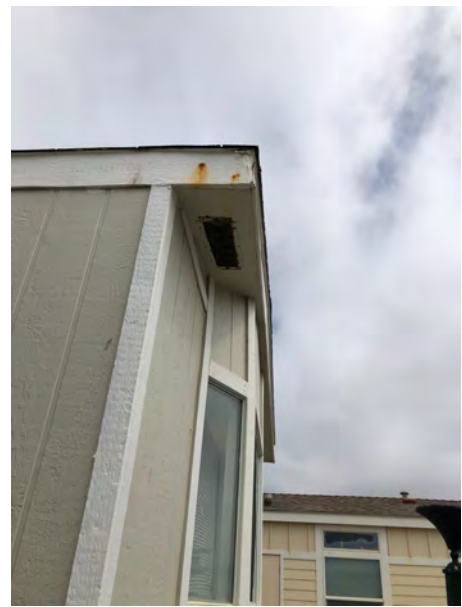
**348 Third Ave - Front elevation with boxed eave and pop out window indicative of original construction. No indication that removal or replacement of structural roofing has occurred. Note old style vent at boxed eave.**

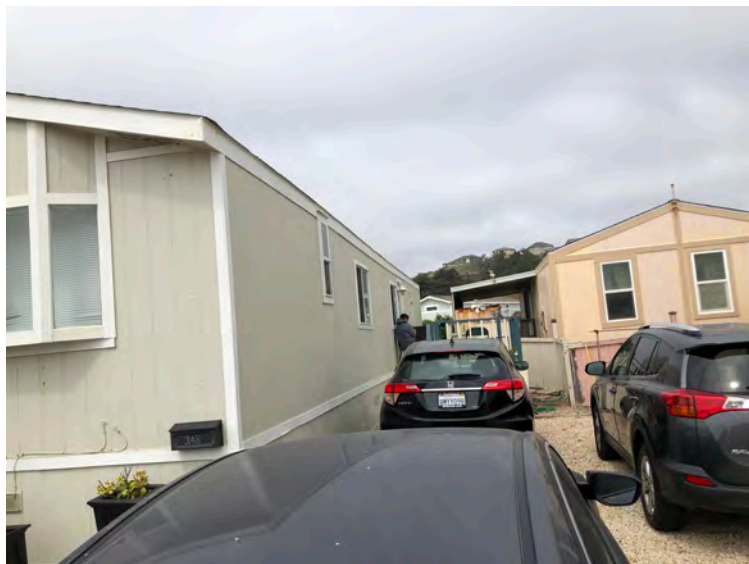
**348 Third Ave - Side view. Gable roof, no overhang. T1-11 siding typical of original construction. No indication that removal or replacement of structural wall framing has occurred.**

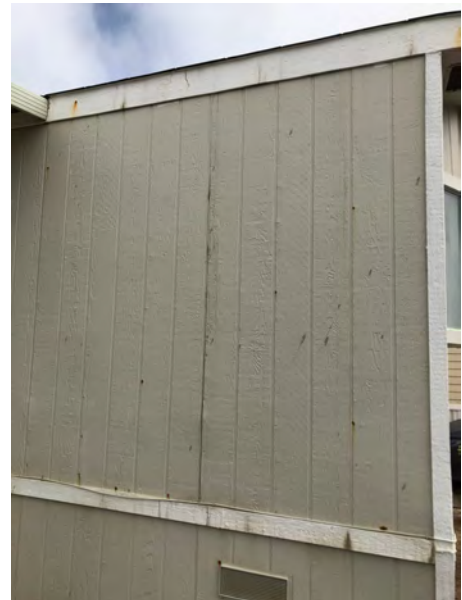
**348 Third Ave - Exterior T1-11 siding wall covering. Evidence of non-structural repair and maintenance (e.g., caulking, sealing) of T1-11 wall covering. T1-11 siding typical of original construction. No indication that removal or replacement of structural wall framing has occurred.**

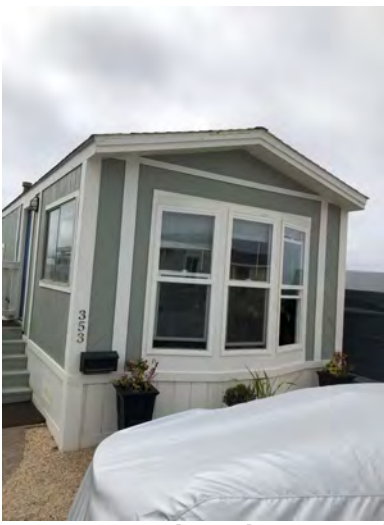
**353 Third Ave - Front elevation, side entry. Gable roof construction with pop out window, no overhang, typical of original construction. No indication that removal or replacement of structural roof framing has occurred. Replacement would have had significant impact on wall framing and interiors and likely would have been constructed with an overhang.**

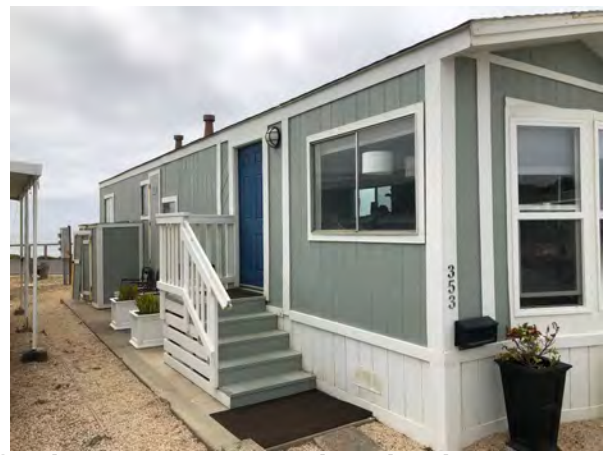
**353 Third Ave - Front elevation with side entrance. Materials and gable roof with little or no overhang typical of original construction. No indication that removal or replacement of structural roofing has occurred. Replacement would have had significant impact on wall framing and interiors and likely would have been constructed with an overhang.**
