## **CALIFORNIA COASTAL COMMISSION**

**3-83-172-A9 (Viewpointe Armoring)  
November 18, 2022**

**SUBJECT:** Response to California Coastal Commission (CCC) Staff Questions in an August 18, 2022 Email Regarding Shore Protection Maintenance at 1300 Palmetto Avenue, Cottages at Seaside, Pacifica, California.

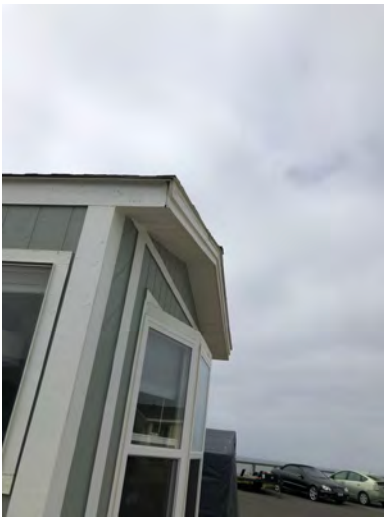
**353 Third Ave - Front elevation with pop out window, typical of original construction. No indication that removal or replacement of structural roof framing has occurred. Replacement would have had significant impact on wall framing and interiors and likely would have been built with an overhang.**

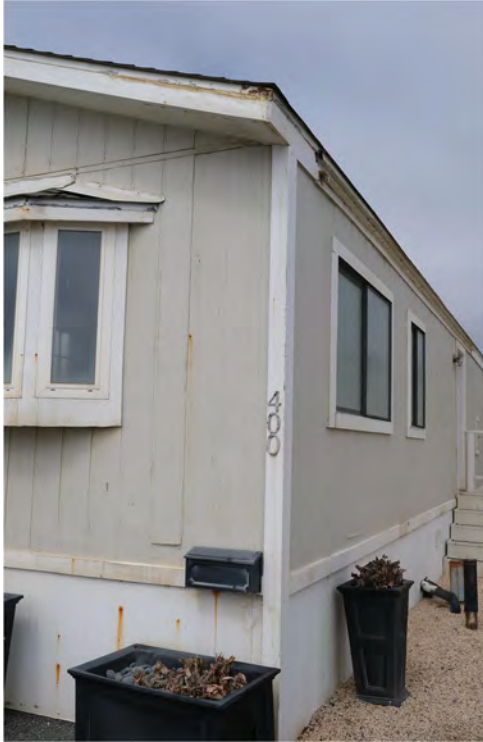
**400 Fourth Ave - Front elevation. Gable roof with no overhang, pop out window, typical of original construction. If roof framing had been replaced, likely would have been built with an overhang.**

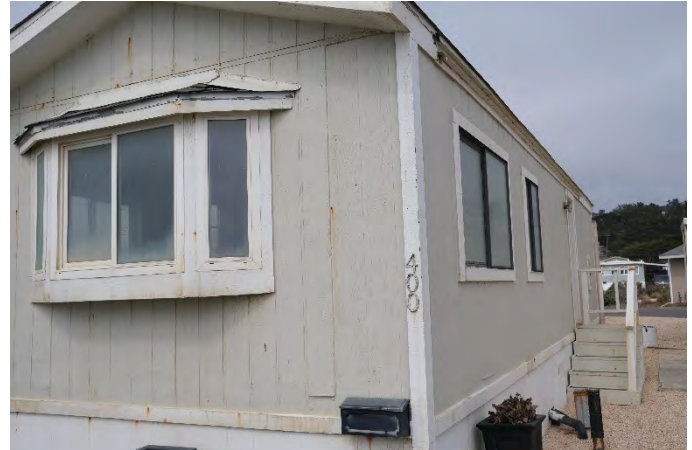
**400 Fourth Ave - Side view, entry steps. Materials and gable roof with little or no overhang typical of original construction. No indication that removal or replacement of structural roofing has occurred. Replacement would have had significant impact on wall framing and interiors and likely would have been built with an overhang.**

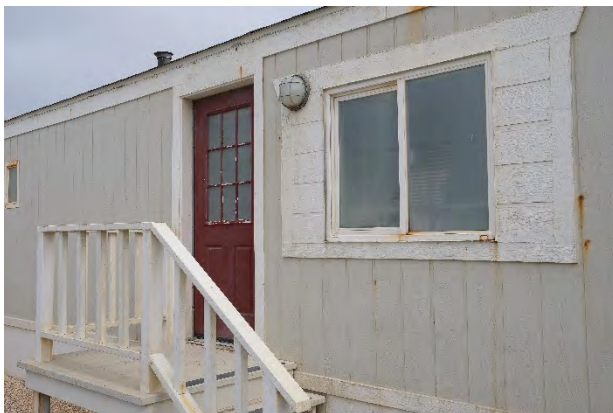
**400 Fourth Ave - Gable roof, no overhang. T1-11 siding typical of original construction. Fascia typical of original construction. Fascia wear at roof. If roof structural framing had been replaced, boxed eave and fascia would not show similar wear. Replacement of roof elements likely would have included overhang.**

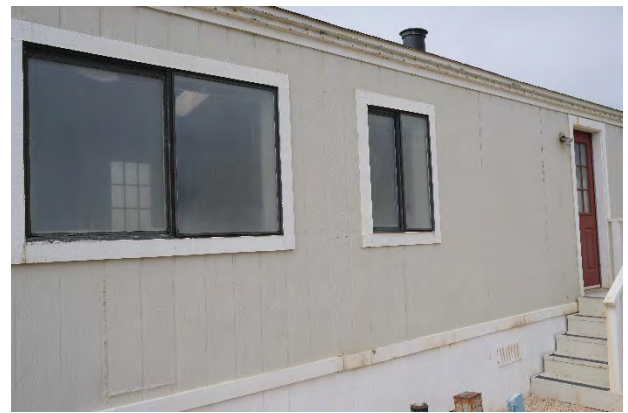
**400 Fourth Ave - Side view, entry steps. Gable roof, no overhang. T1-11 siding typical of original construction. No indication that removal or replacement of structural wall framing has occurred.**

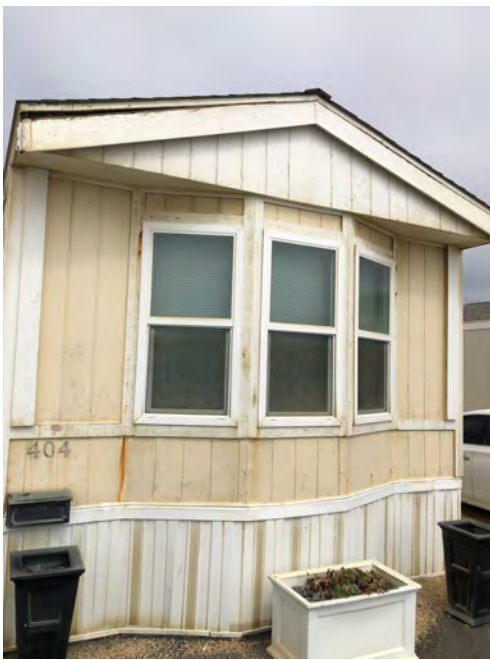
**404 Fourth Ave - Front elevation. Gable roof with no overhang, pop out window, typical of original construction. If roof framing had been replaced, likely would have been built with an overhang.**

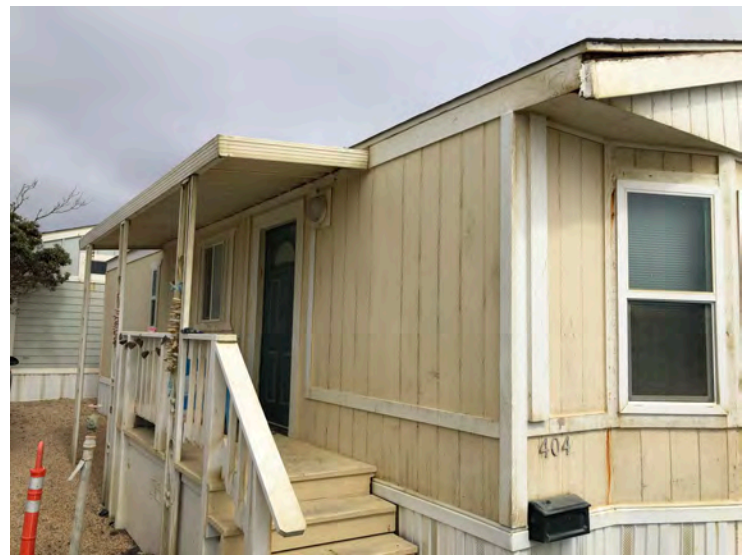
**404 Fourth Ave - Side view, entry steps. Materials and gable roof with little or no overhang typical of original construction. No indication that removal or replacement of structural roofing has occurred. Replacement would have had significant impact on wall framing and interiors and likely would have been built with an overhang.**

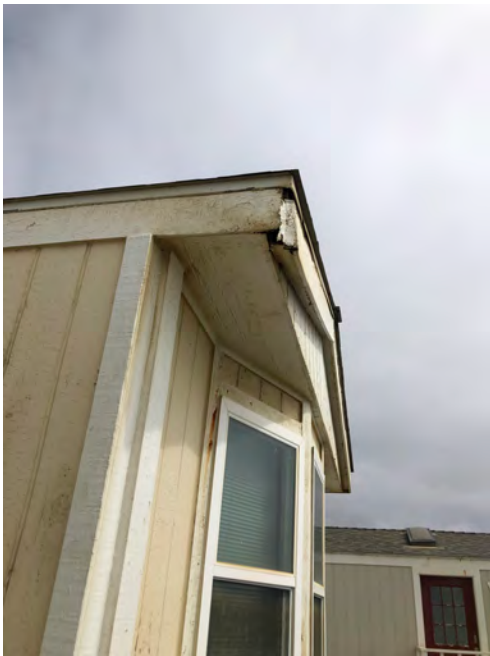
**404 Fourth Ave - Gable roof, no overhang. T1-11 siding typical of original construction. Fascia typical of original construction. Fascia wear at roof and indications of repair and maintenance. If roof structural framing had been replaced, boxed eave and fascia would not show similar wear. Replacement of roof elements likely would have included overhang.**

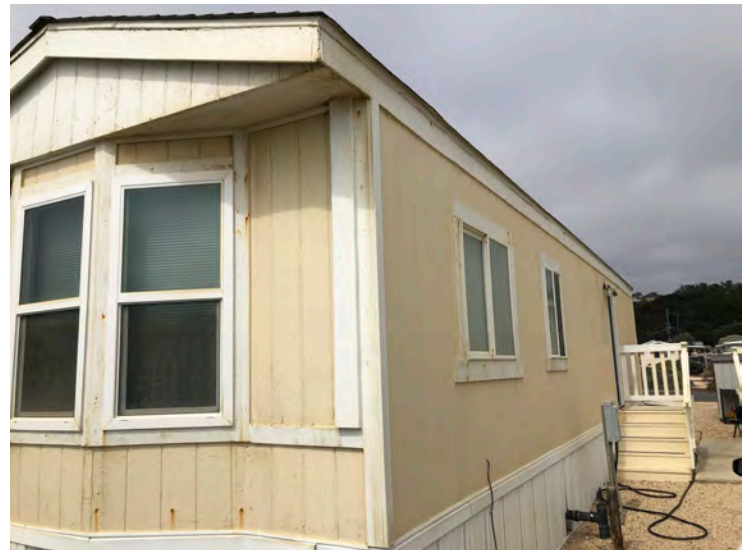
**404 Fourth Ave - Side view, entry steps. Gable roof, no overhang. T1-11 siding typical of original construction. Evidence of patch and repair work of existing T1-11 wall covering. No indication that removal or replacement of structural wall framing has occurred.**

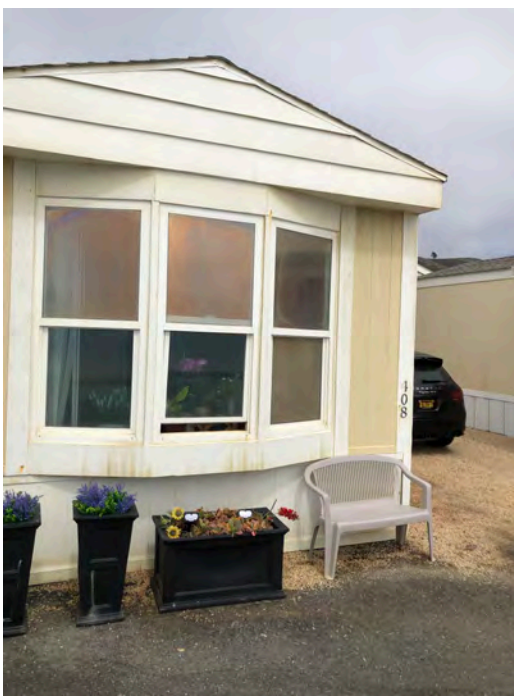
**408 Fourth Ave - Front elevation. Gable roof with no overhang, pop out window, typical of original construction. If roof framing had been replaced, likely would have been built with an overhang.**

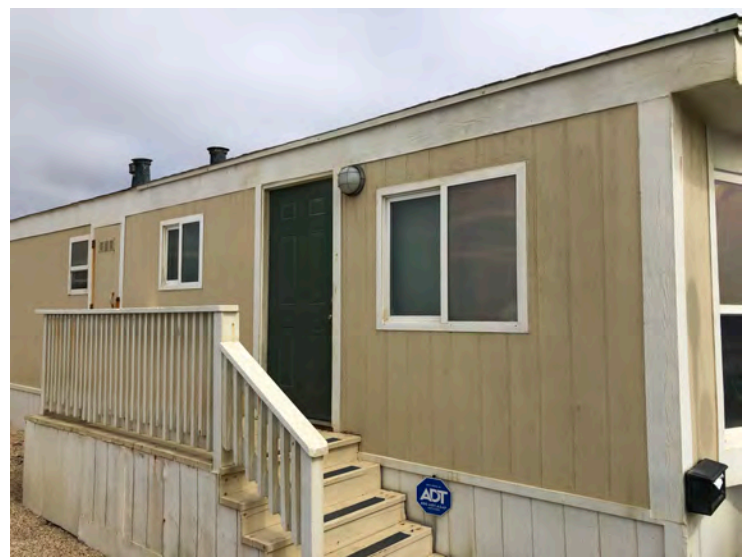
**408 Fourth Ave - Side view, entry steps. Materials and gable roof with little or no overhang typical of original construction. No indication that removal or replacement of structural roofing has occurred. Replacement would have had significant impact on wall framing and interiors and likely would have been built with an overhang.**

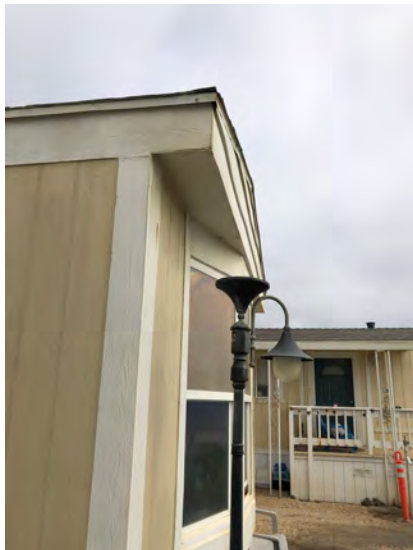
**408 Fourth Ave - Gable roof, no overhang. T1-11 siding typical of original construction. Fascia wear at roof. If roof structural framing had been replaced, boxed eave and fascia would not show similar wear. Replacement of roof elements likely would have included overhang.**

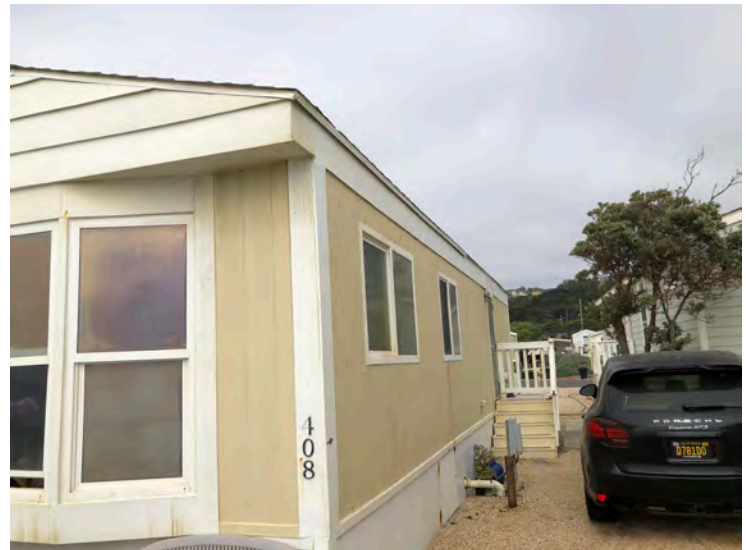
**408 Fourth Ave - Side view, entry steps. Gable roof, no overhang. T1-11 siding typical of original construction. Evidence of patch and repair of existing T1-11 wall covering. No indication that removal or replacement of structural wall framing has occurred.**

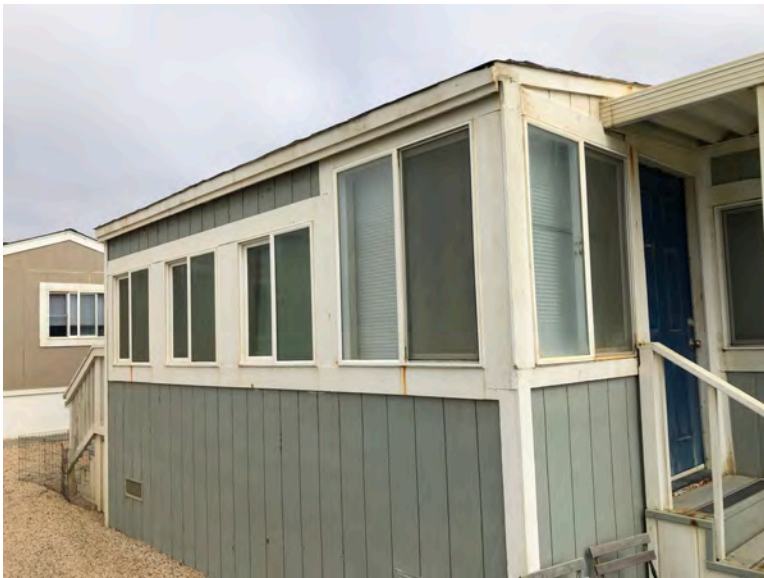
**412 Fourth Ave - Gable roof, no overhang. T1-11 siding and fascia typical of original construction. Fascia wear at roof and indications of maintenance. No evidence of any modifications to structural roof or wall elements. If roof structural framing had been replaced, fascia would not show similar wear. Replacement of roof elements likely would have included overhang.**

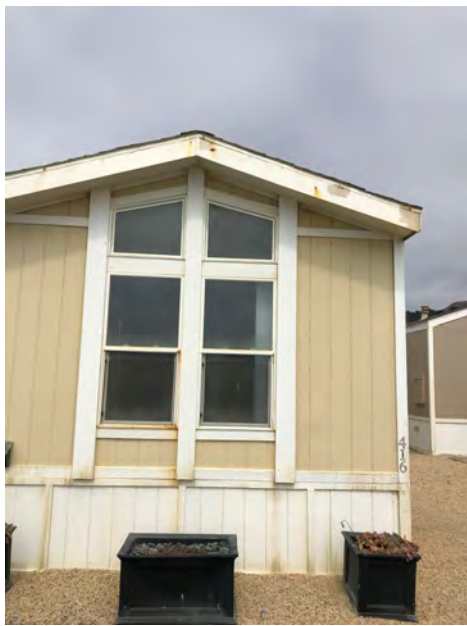
**416 Fourth Ave - Front elevation. Materials and gable roof with little or no overhang typical of original construction. No indication that removal or replacement of structural roofing has occurred. Replacement would have had significant impact on wall framing and interiors and likely would have been built with an overhang.**

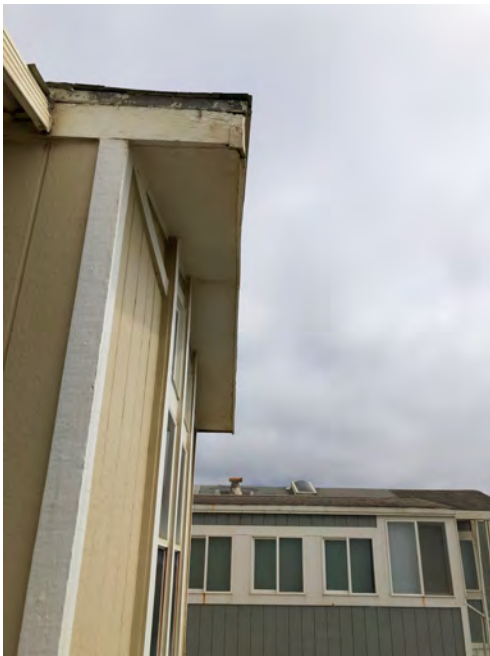
**416 Fourth Ave - Gable roof, no overhang. T1-11 siding typical of original construction. Fascia wear at roof and indications of repair and maintenance. If roof structural framing had been replaced, fascia would not show similar wear. Replacement of roof elements likely would have included overhang.**

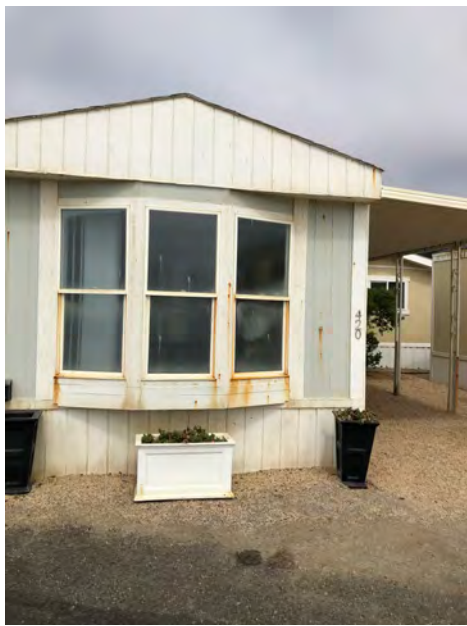
**420 Fourth Ave - Materials, pop out window, and gable roof with little or no overhang typical of original construction. No indication that removal or replacement of structural roofing has occurred. Replacement would have had significant impact on wall framing and interiors and likely would have been built with an overhang.**

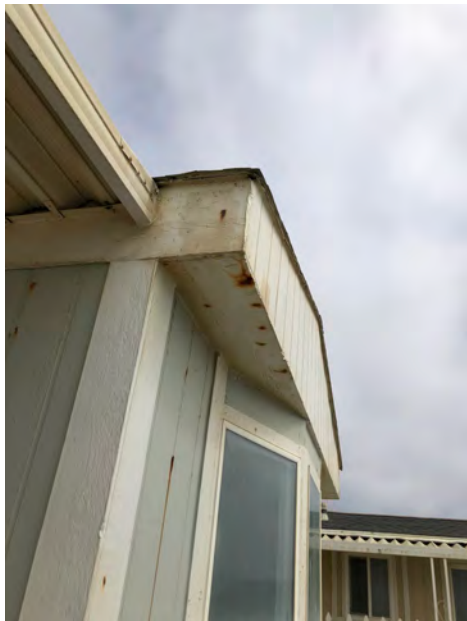
**420 Fourth Ave - Gable roof, no overhang. T1-11 siding and fascia typical of original construction. Fascia wear at roof and indications of repair and maintenance. If roof structural framing had been replaced, fascia would not show similar wear. Replacement of roof elements likely would have included overhang.**

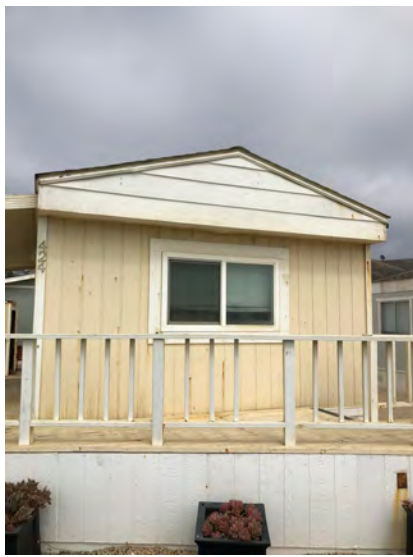
**424 Fourth Ave - Front elevation with side entrance ("shotgun installation"). Gable roof with no overhang typical of original unit. No evidence of any modifications to structural roof elements. Roof replacement would have had significant impact on wall framing and interiors and likely would have included a roof overhang.**

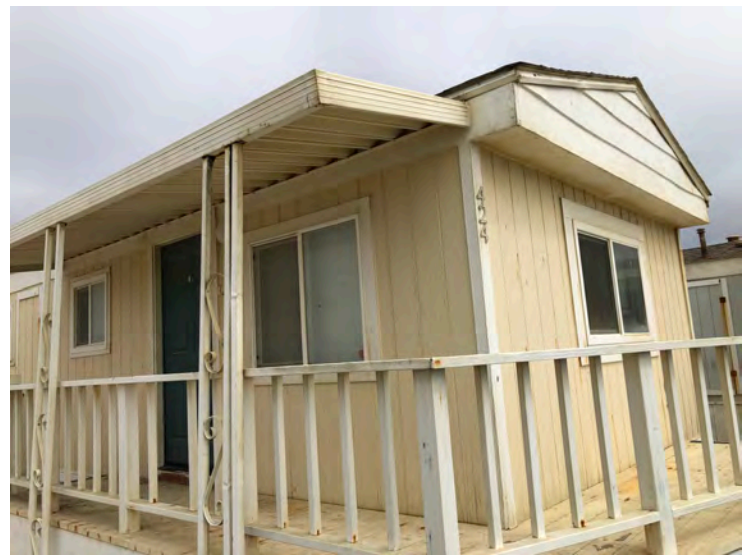
**424 Fourth Ave - Materials and gable roof with little or no overhang typical of original construction. No indication that removal or replacement of structural roofing has occurred. Replacement would have had significant impact on wall framing and interiors and likely would have been built with an overhang.**

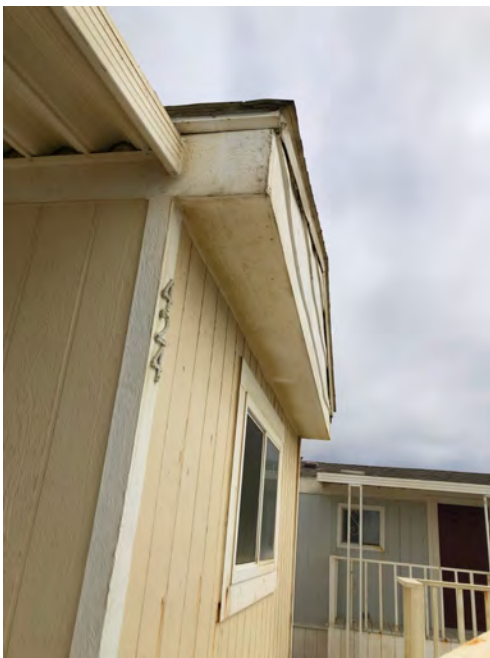
**424 Fourth Ave - Gable roof, no overhang. T1-11 siding and fascia typical of original construction. Fascia wear at roof and indications of repair and maintenance. If roof structural framing had been replaced, fascia would not show similar wear. Replacement of roof elements likely would have included overhang.**

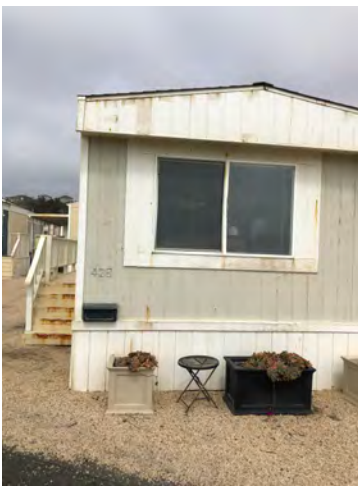
**428 Fourth Ave - Front elevation with side entrance ("shotgun installation"). Gable roof with no overhang typical of original unit. No evidence of any modifications to structural roof elements. Roof replacement would have had significant impact on wall framing and interiors and likely would have included a roof overhang.**

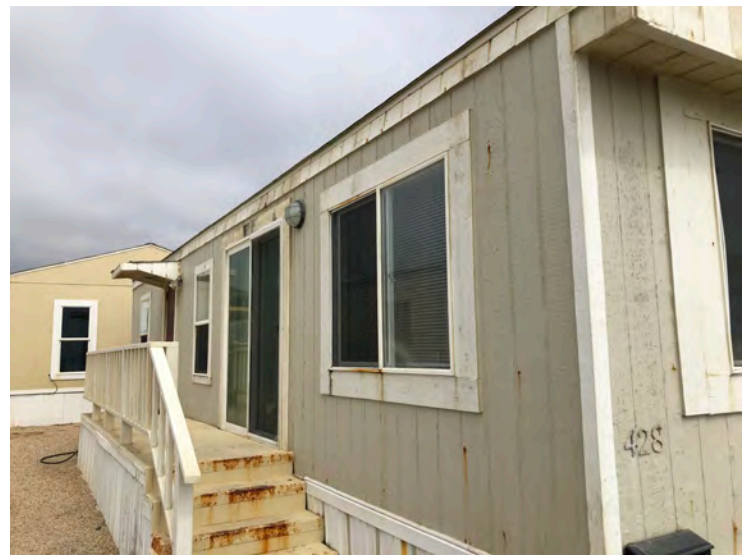
**428 Fourth Ave - Side entrance. Materials and gable roof with little or no overhang typical of original construction. No indication that removal or replacement of structural roofing has occurred. Replacement would have had significant impact on wall framing and interiors and likely would have been built with an overhang.**

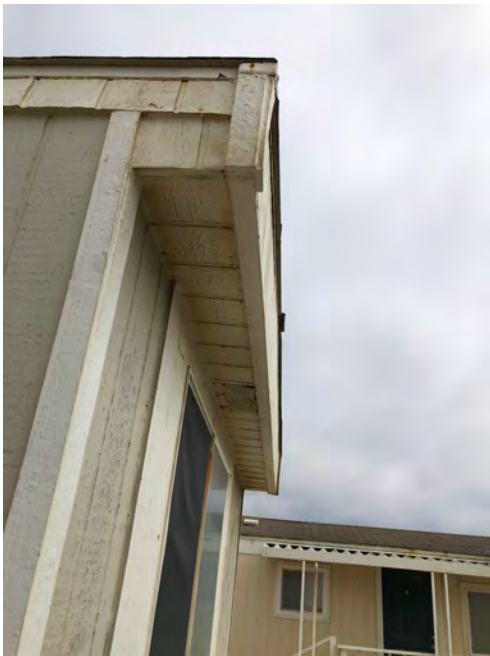
**428 Fourth Ave - Gable roof, no overhang. T1-11 siding and fascia typical of original construction. Fascia wear at roof. If roof structural framing had been replaced, fascia would not show similar wear. Replacement of roof elements likely would have included overhang.**

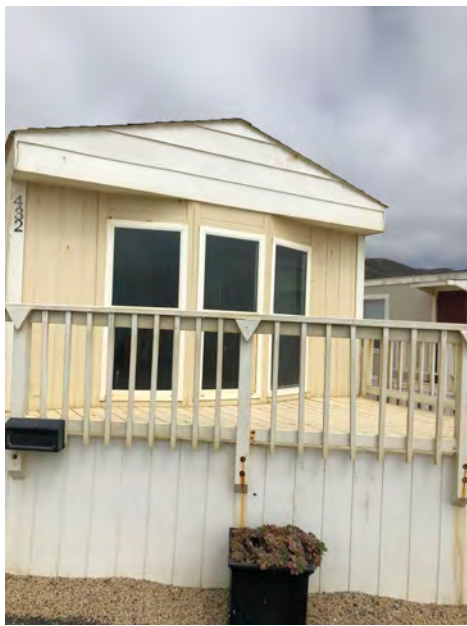
**432 Fourth Ave - Materials and gable roof with little or no overhang typical of original construction. No indication that removal or replacement of structural roofing has occurred. Replacement would have had significant impact on framing and likely would have been built with an overhang.**

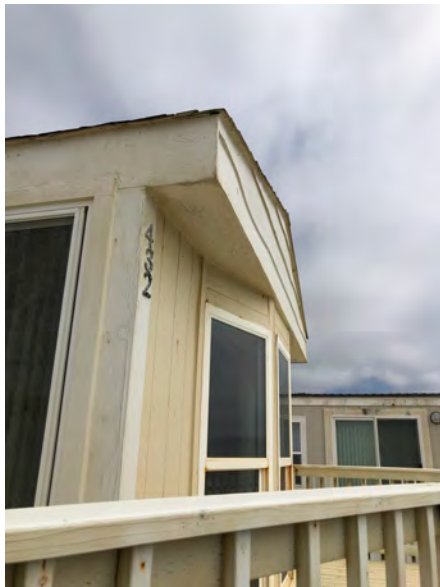
**432 Fourth Ave - Side view. Materials and gable roof with little or no overhang typical of original construction. No indication that removal or replacement of structural roofing has occurred. Replacement would have had significant impact on wall framing and interiors and likely would have been built with an overhang.**

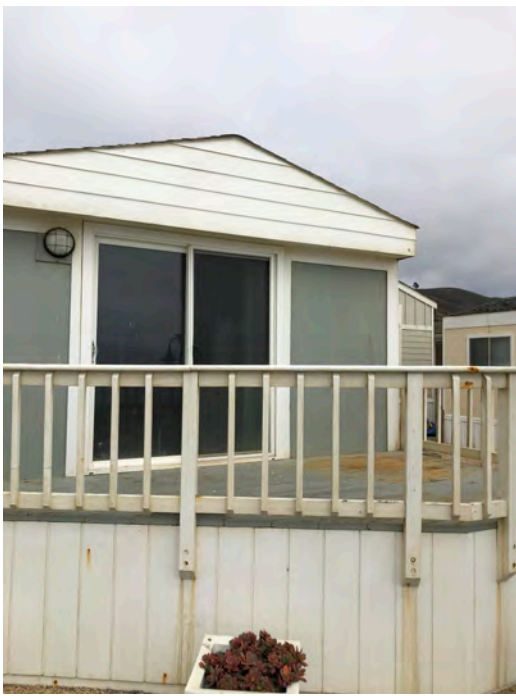
**432 Fourth Ave - Side elevation. Gable roof, no overhang. T1-11 siding typical of original construction. No indication that removal or replacement of structural wall framing has occurred.**

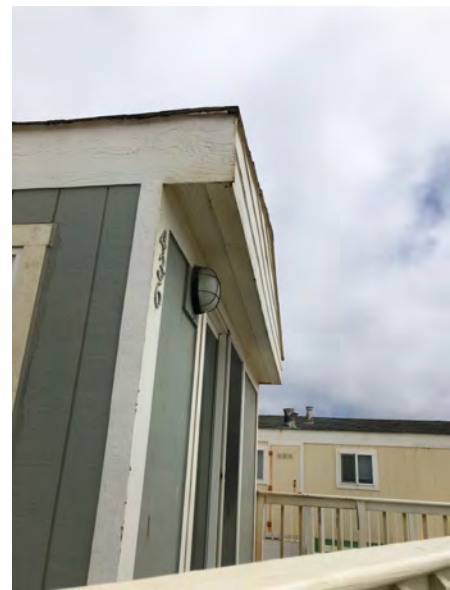
**436 Fourth Ave - Front elevation. Gable roof with no overhang, pop out window, typical of original construction. If roof framing had been replaced, likely would have been built with an overhang.**

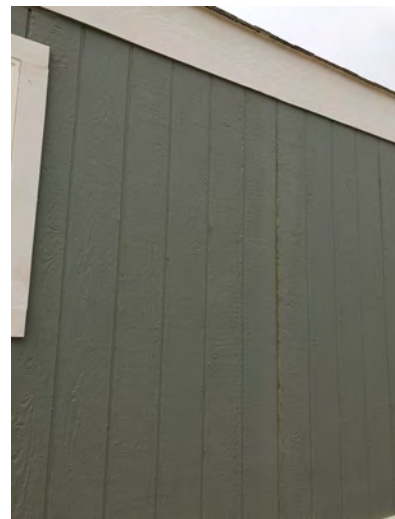
**436 Fourth Ave - Side elevation. T1-11 siding typical of original construction. Fascia wear at roof reflecting original construction. If roof structural framing had been replaced, fascia would not show similar wear. Replacement of roof elements likely would have included overhang.**

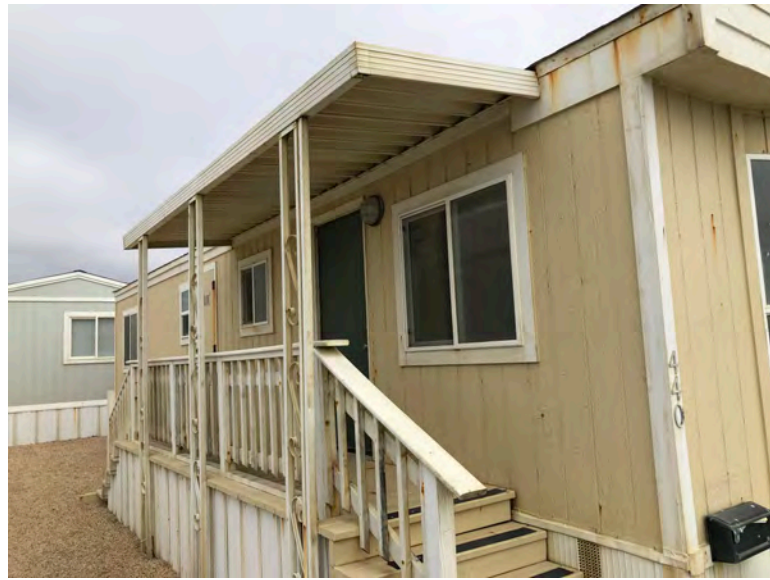
**440 Fourth Ave - Front elevation with side entrance ("shotgun installation"). Gable roof with no overhang typical of original unit. No evidence of any modifications to structural roof elements. Roof replacement would have had significant impact on wall framing and interiors and likely would have included a roof overhang.**

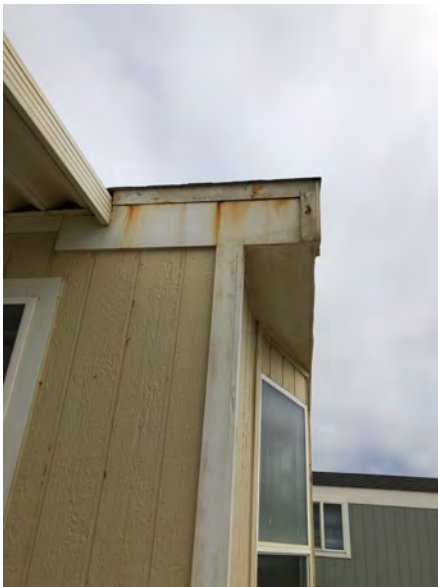
**440 Fourth Ave - Side view, entry steps. T1-11 siding and fascia typical of original construction. Fascia wear at roof. If roof structural framing had been replaced, fascia would not show similar wear. Replacement of roof elements likely would have included overhang.**

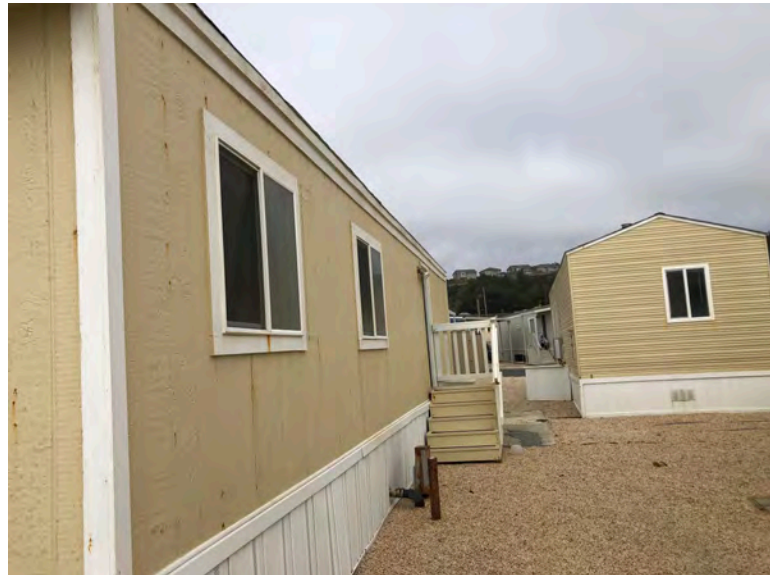
**440 Fourth Ave - Gable roof, no overhang. T1-11 siding typical of original construction. Fascia wear at roof. If roof structural framing had been replaced, fascia would not show similar wear. Replacement of roof elements likely would have included overhang.**

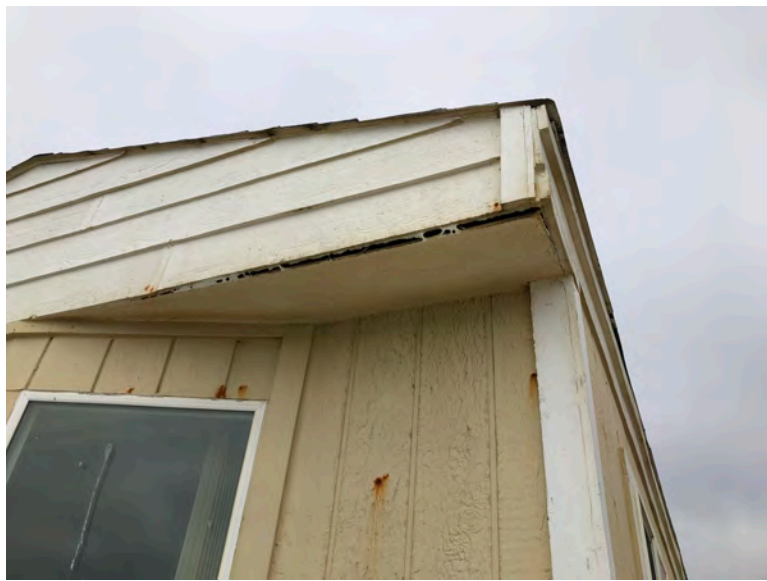
**440 Fourth Ave - Side elevation. T1-11 siding typical of original construction. Evidence of patch and repair of wall surface without modification of structural elements. Fascia wear at roof. If roof structural framing had been replaced, fascia would not show similar wear. Replacement of roof elements likely would have included overhang.**

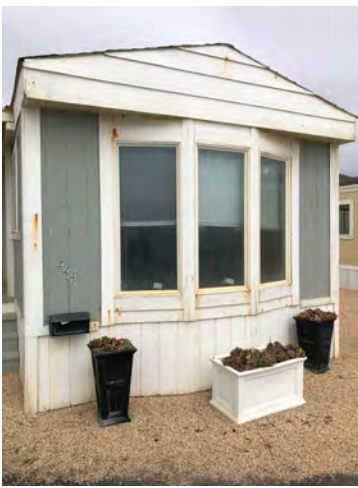
**440 Fourth Ave - Gable roof, no overhang. T1-11 siding typical of original construction. Fascia detail at roof reflecting repair and maintenance. If roof structural framing had been replaced, fascia would not show similar wear. Replacement of roof elements likely would have included overhang.**

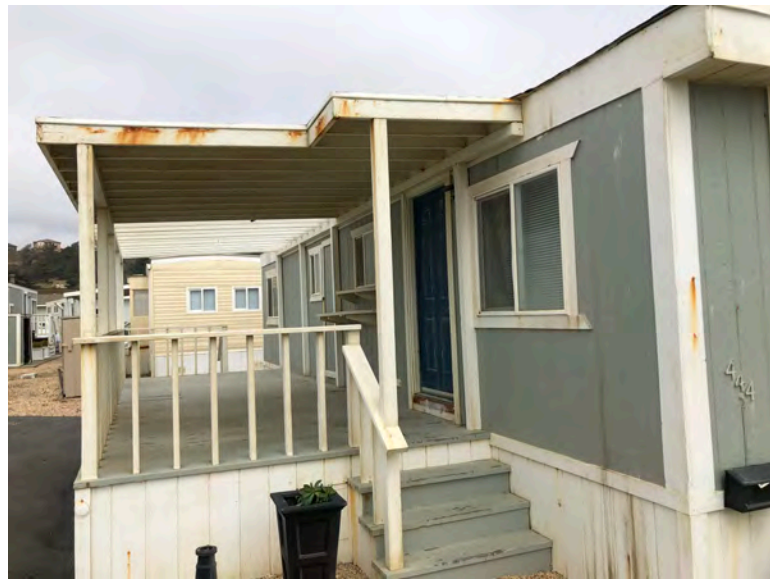
**444 Fourth Ave - Front elevation with side entrance ("shotgun installation"). Gable roof with no overhang typical of original unit. No evidence of any modifications to structural roof elements. Roof replacement would have had significant impact on wall framing and interiors and likely would have included a roof overhang.**

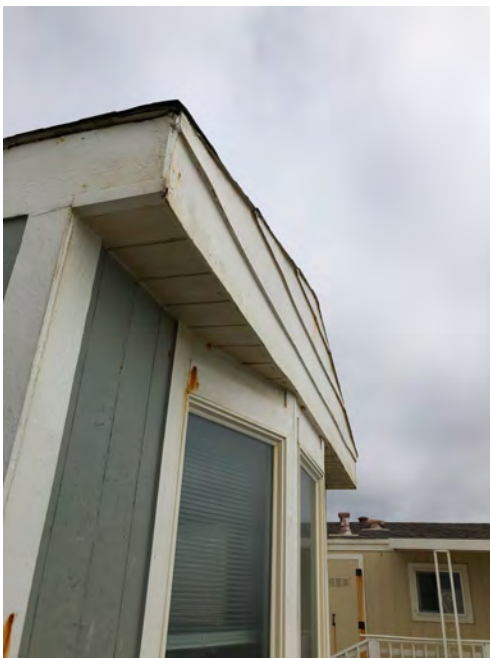
**444 Fourth Ave - Side view, entry steps. T1-11 siding and fascia typical of original construction. Fascia wear at roof. If roof structural framing had been replaced, fascia would not show similar wear. Replacement of roof elements likely would have included overhang.**

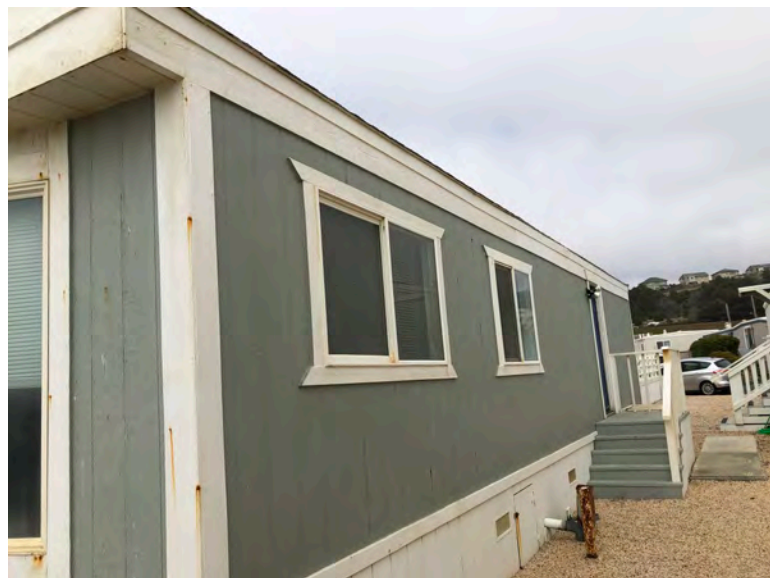
**444 Fourth Ave - Front elevation with boxed eave, pop out window, typical of original construction.**

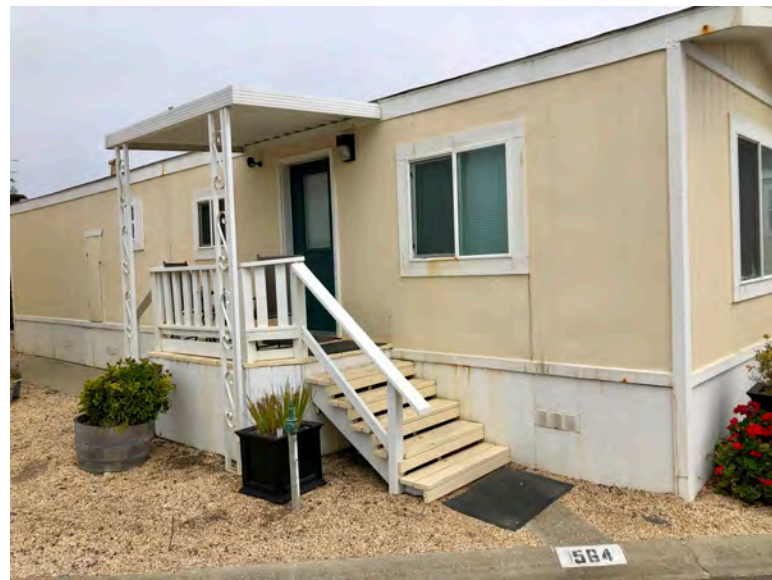
**564 Fifth Ave - Front elevation. Gable roof with no overhang, typical of original construction. If roof framing had been replaced, likely would have been built with an overhang.**

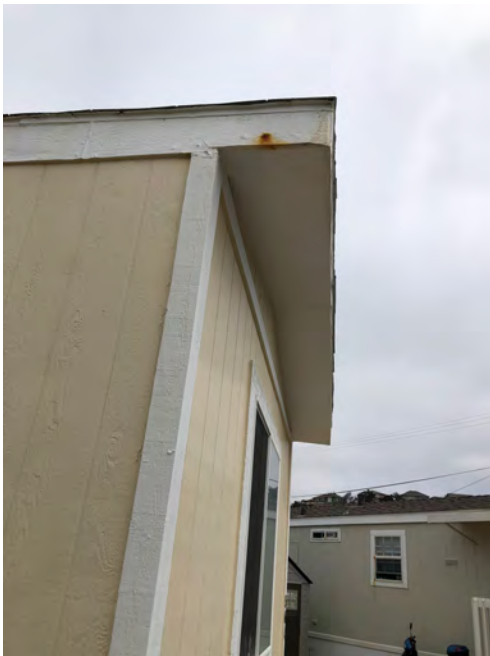
**564 Fifth Ave - Materials and gable roof with little or no overhang typical of original construction. No indication that removal or replacement of structural roofing has occurred. Replacement would have had significant impact on wall framing and interiors and likely would have been built with an overhang.**

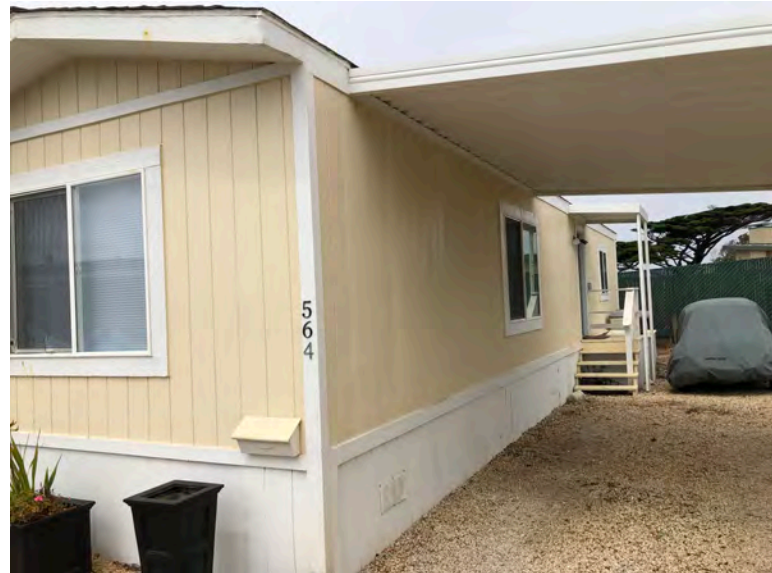
**564 Fifth Ave - Gable roof, no overhang. T1-11 siding and fascia typical of original construction. Fascia wear at roof. If roof structural framing had been replaced, fascia would not show similar wear. Replacement of roof elements likely would have included overhang.**

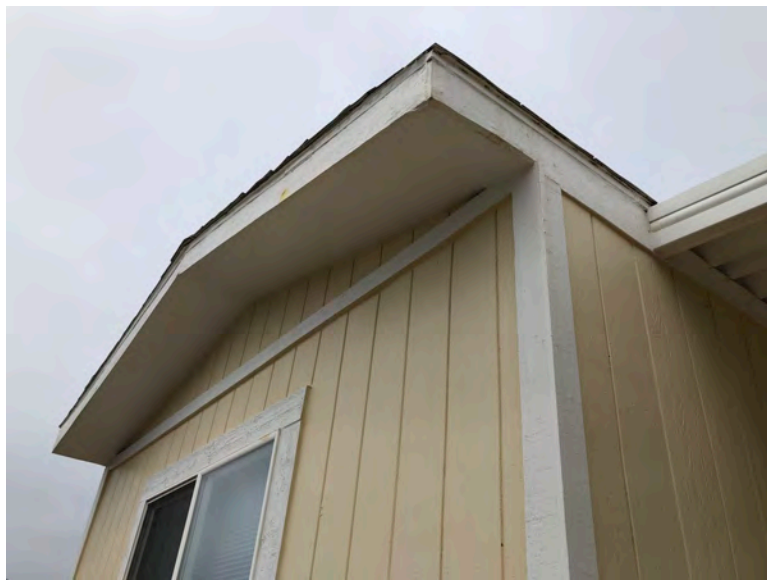
**564 Fifth Ave - Side elevation. Gable roof, no overhang. T1-11 siding typical of original construction. No indication that removal or replacement of structural wall framing has occurred.**

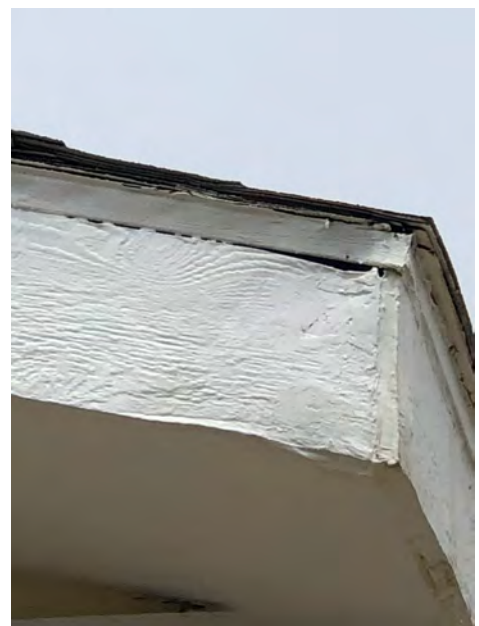
**564 Fifth Ave - Side view of front elevation, gable roof construction with no eaves at side and boxed eave at front. Typical of older model original construction**

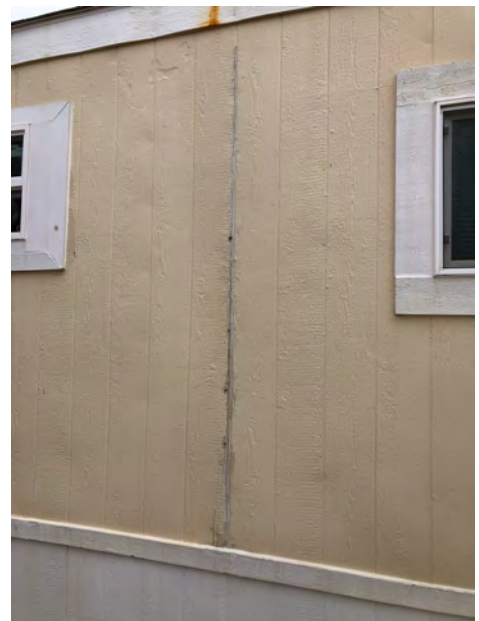
**564 Fifth Ave - T1-11 siding typical of original construction. Evidence of non-structural repair and maintenance (e.g., caulking, sealing) of T1-11 wall covering. No indication that removal or replacement of structural wall framing has occurred.**

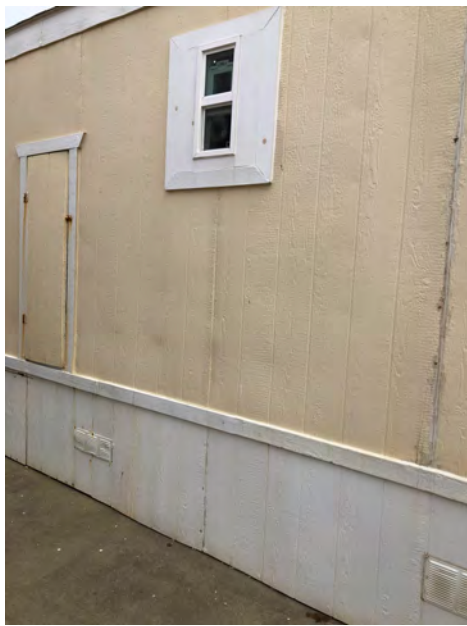
**564 Fifth Ave - Existing T1-11 siding reflecting wear and non-structural repair and maintenance. If structural wall framing had been replaced, siding would not show similar wear.**

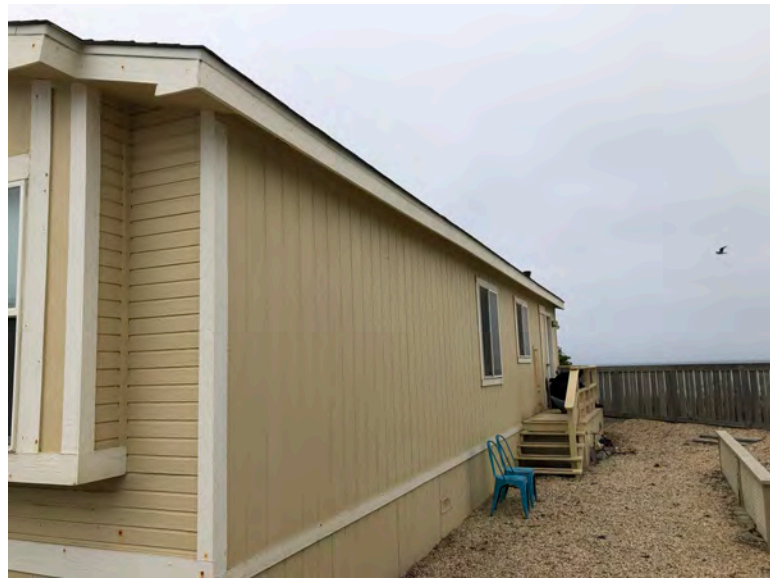
**580 Fifth Ave - Front elevation. Gable roof construction with slight overhang at eaves.**

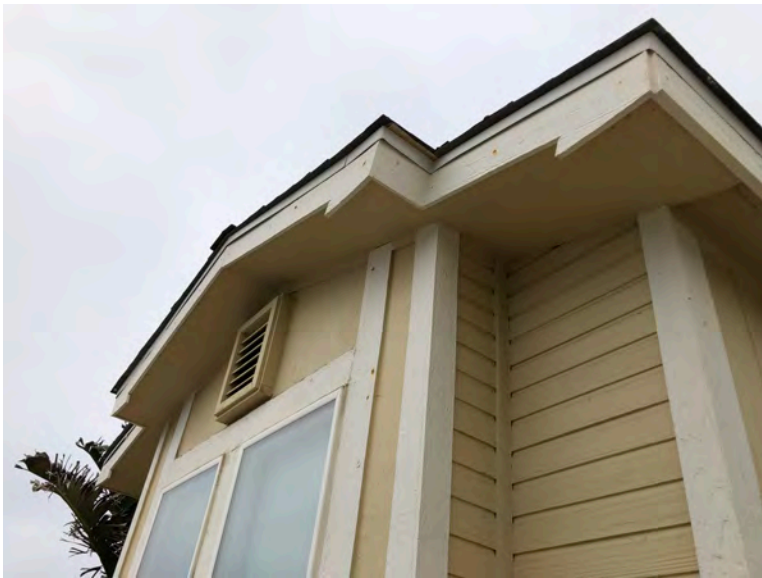
**580 Fifth Ave - Side view. T1-11 siding typical of original construction. Evidence of non-structural repair and maintenance (e.g., caulking, sealing) of T1-11 wall covering. No indication that removal or replacement of structural wall framing has occurred.**

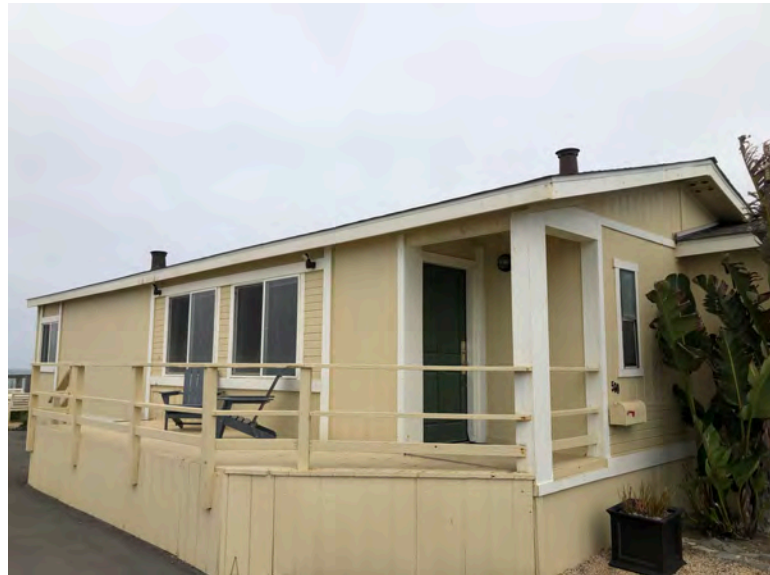
**580 Fifth Ave - Front elevation with boxed eave and pop out window bay typical of original construction. No indication of modifications to structural roof elements.**

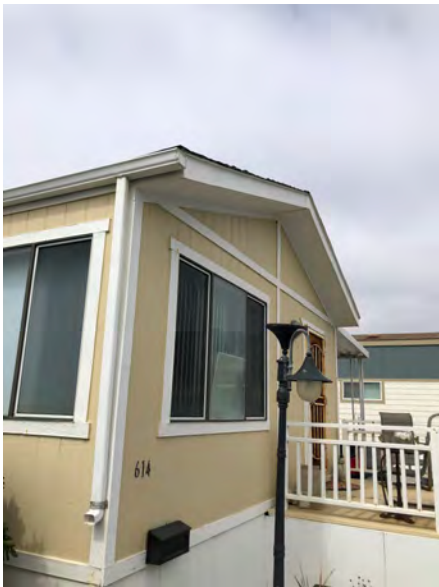
**614 Sixth Ave - Front elevation. Gable roof with no overhang, typical of original construction. If roof framing had been replaced, likely would have been built with an overhang.**

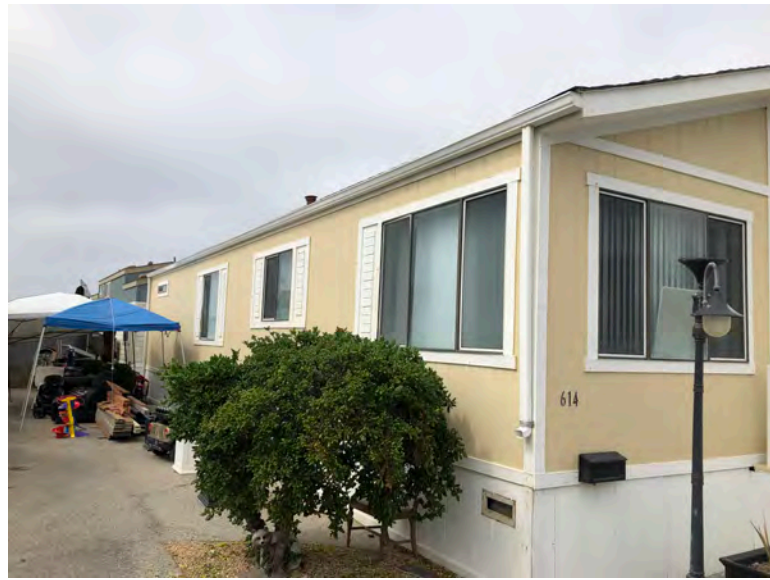
**614 Sixth Ave - Gable roof with no overhang. Gable roof construction with no eaves at side and boxed eave at front. Typical of older model original construction. No indication that removal or replacement of structural roofing has occurred.**

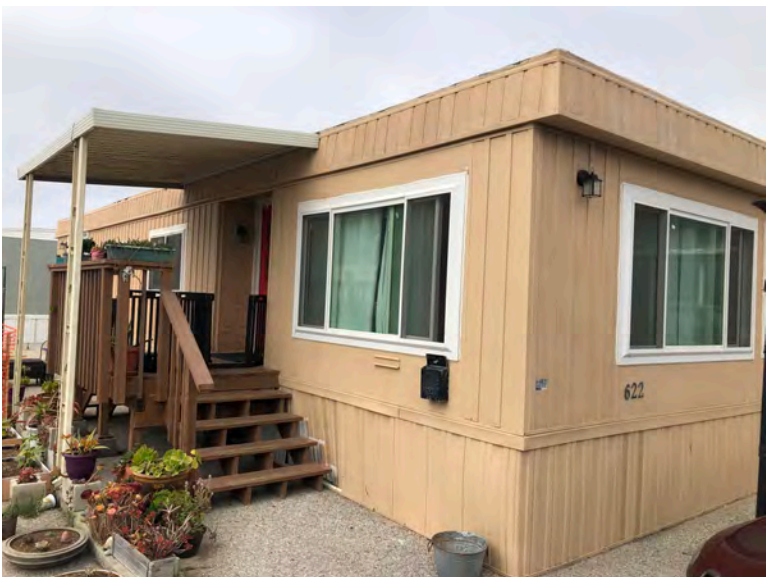
**622 Sixth Ave - Mansard roof with flat roof at center. Original framing materials at walls and parapet indicating original construction. No indication that removal or replacement of structural roof or wall framing elements has occurred.**

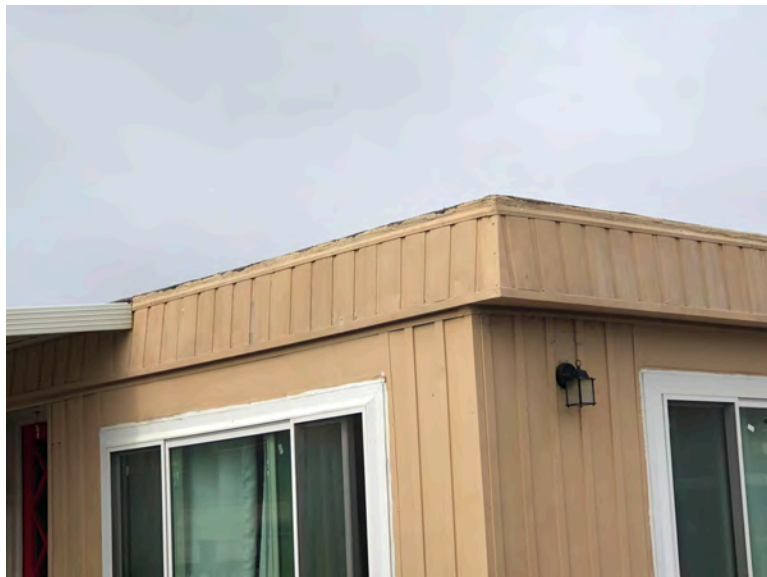
**622 Sixth Ave - Side view with mansard roof (flat section in center), entry stairs. Original metal siding.**

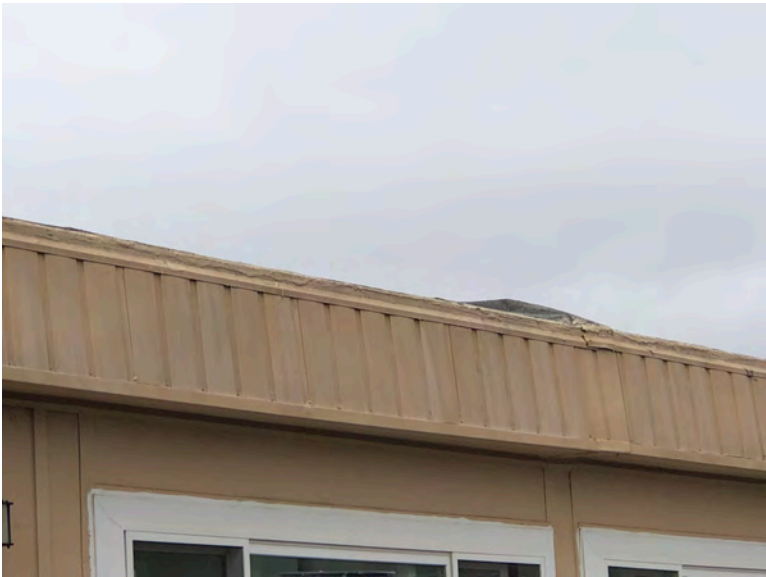
**622 Sixth Ave - Original metal wall covering at roof parapet.**
