COASTAL DEVELOPMENT PERMIT APPLICATION

Application number3-04-030, Pebble Beach Golf Links, 5th Tee and 5th Green Seawalls

Project descriptionTwo seawalls at base of the coastal bluff to protect the 5th Tee and 5th Green, using concrete reinforced with steel tiebacks and artificial stone fascia. 5th Tee seawall: 83 feet long, with 24 feet of buried wing walls, and height varying from 43 to 46 feet; sloping from base to top of bluff; and 5th green seawall: 160 feet long with 22 feet of buried wing walls, and height from 14 to 22 feet; vertical seawall to maximum height of 22 feet, with unprotected upper bluff backfilled and vegetated to recreate 2:1 slope.

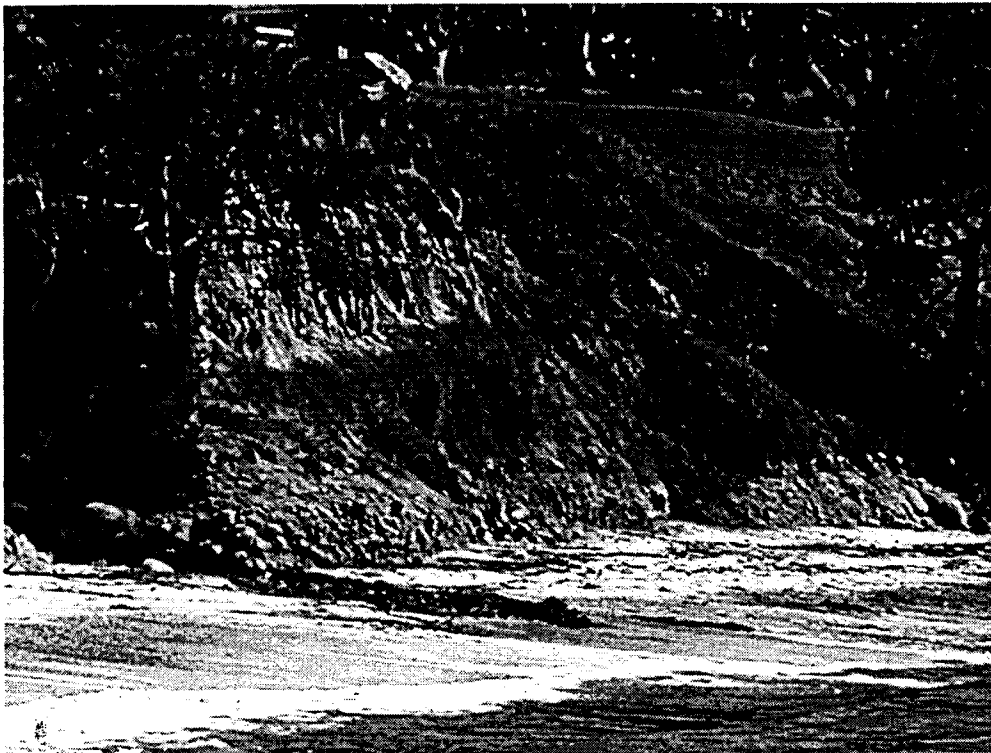
Photo 2.
Staff photo bluff
below 5th tee.

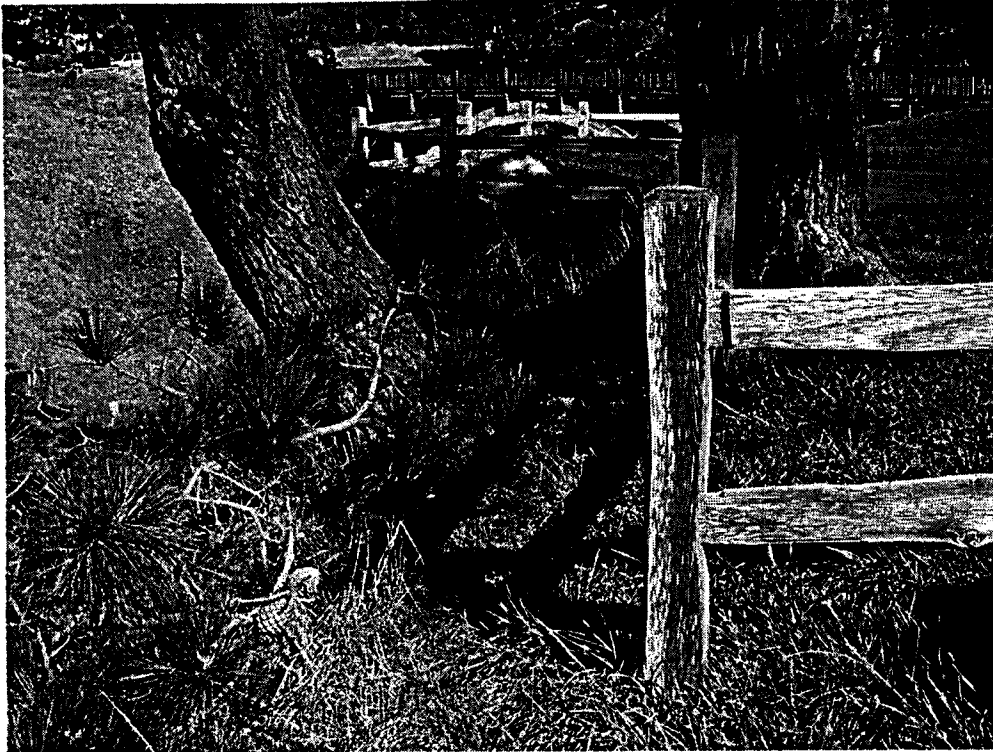
Photo 3.
Staff photo of 5th
Tee – showing tee
box retaining wall
along ravine and
edge of bluff at
undercut tree near
upper tee.

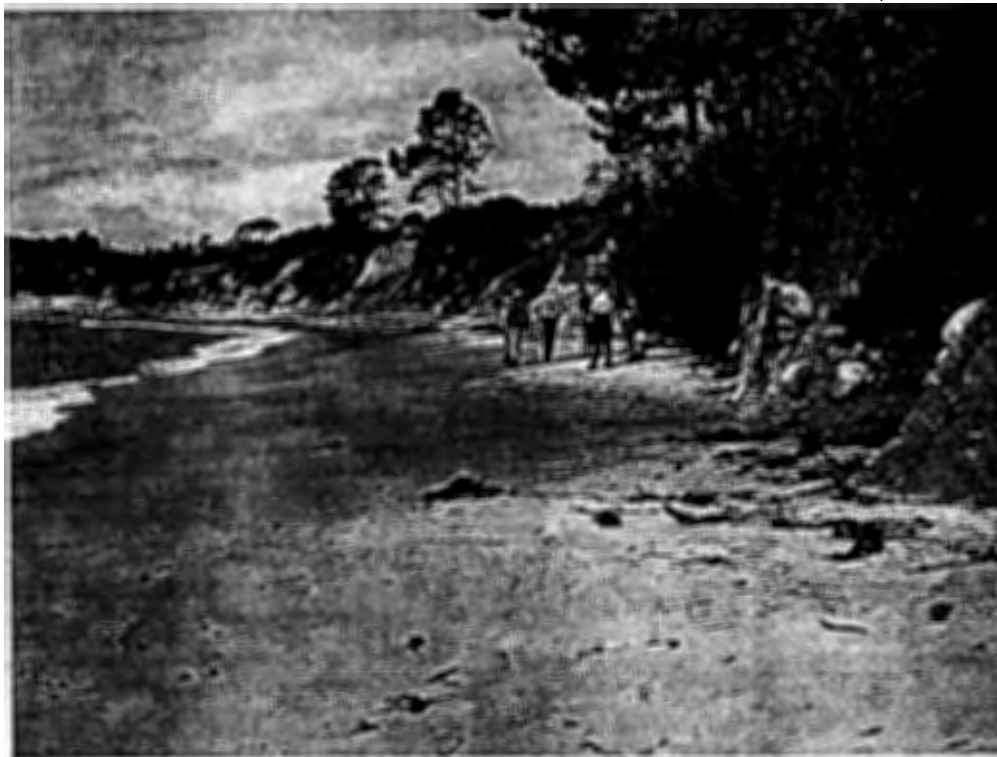
Photo 4.
Staff photo of bluff
below 5th hole -
showing undercut
area near 5th tee.

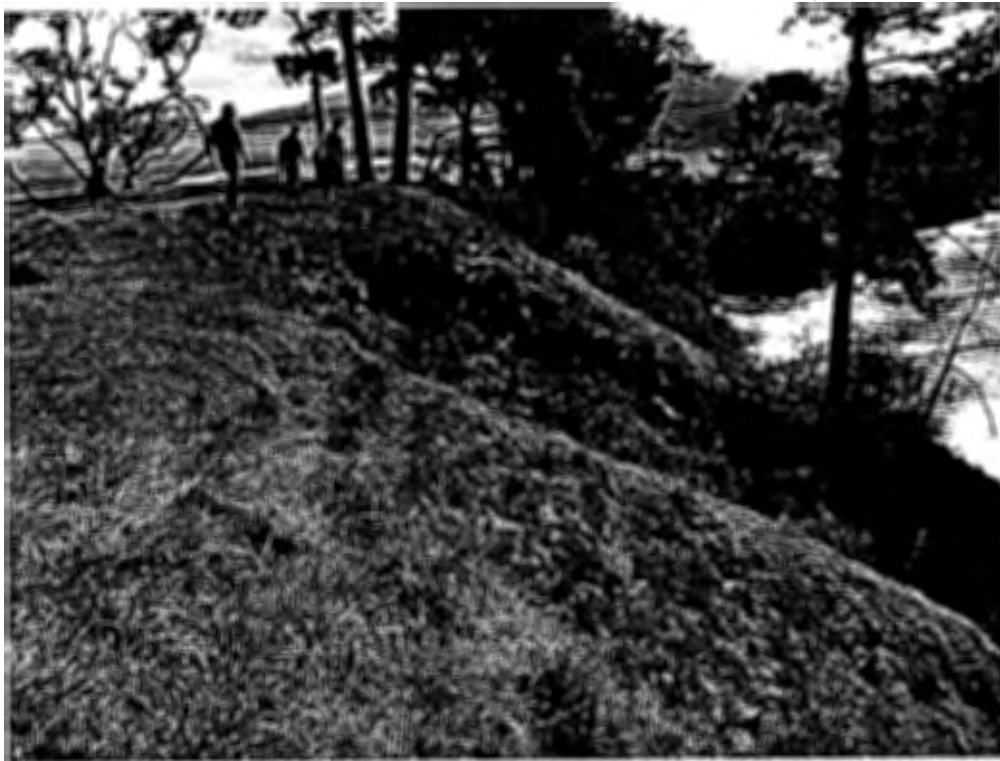
Photo 5.
Staff photo of
landslide scarp
and erosional gully
near 5th green –
bunker to left.

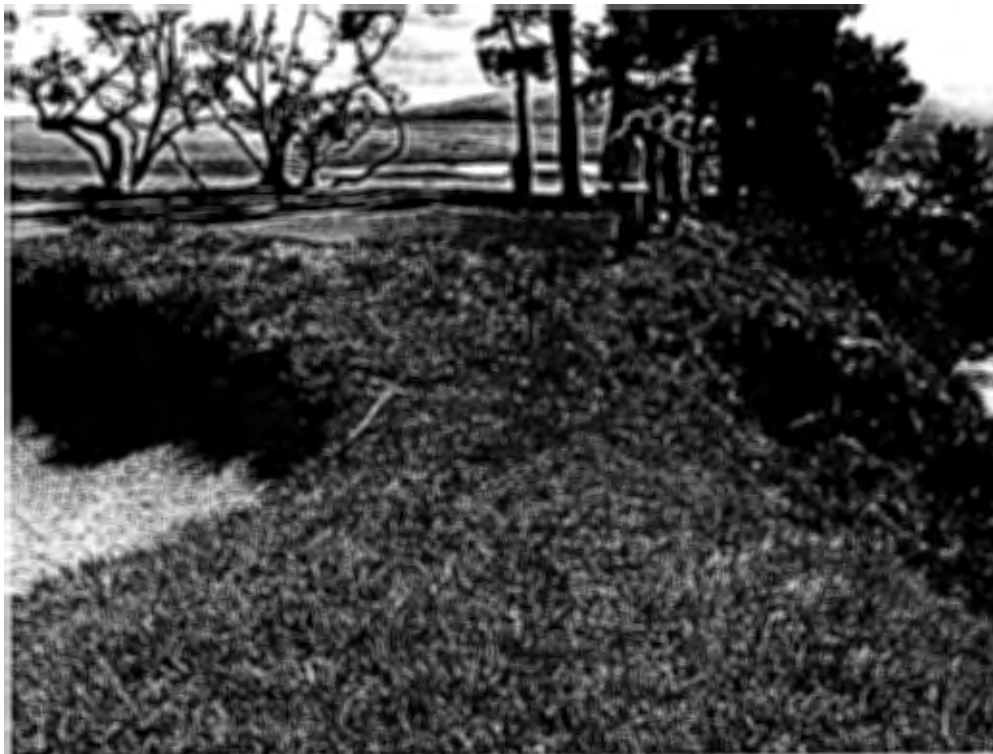
Photo 6.
Staff photo of
proximity of
sandtrap and 5th
green 5th to top of
landslide scarp

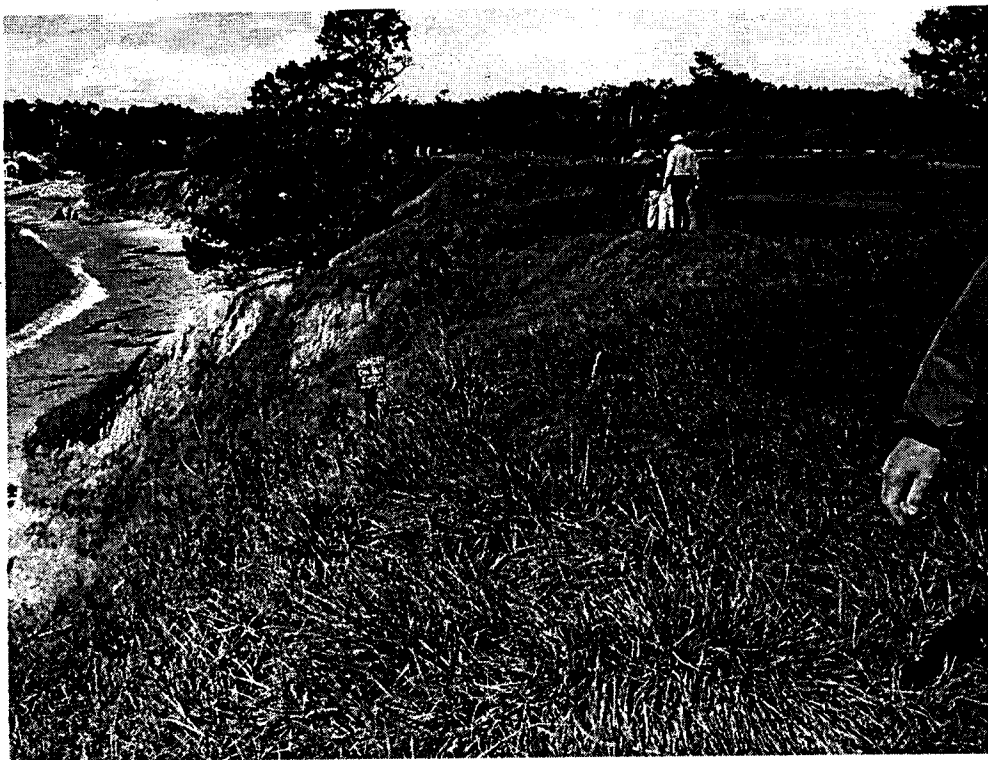
Photo 7.
Staff photo looking
north from 5th
green showing
proximity of hole
to top of bluff.

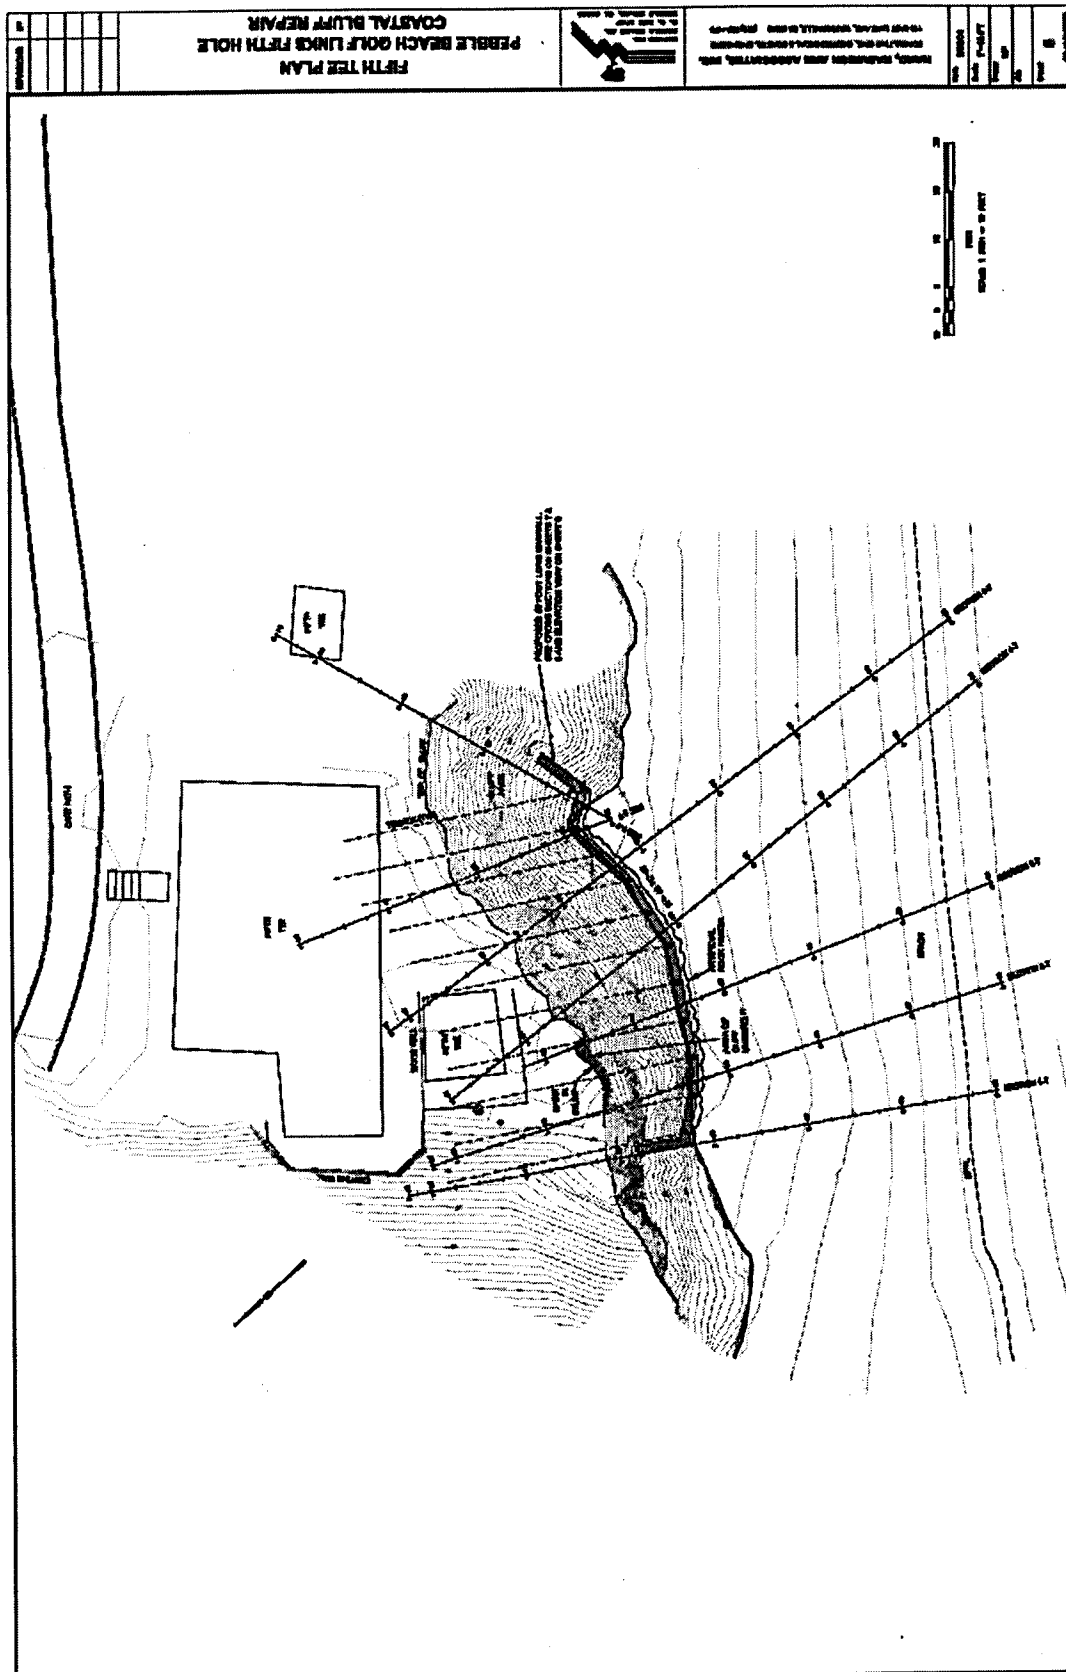
Exhibit G – pg 1 of 4
 Proposed Site Plans and Elevations

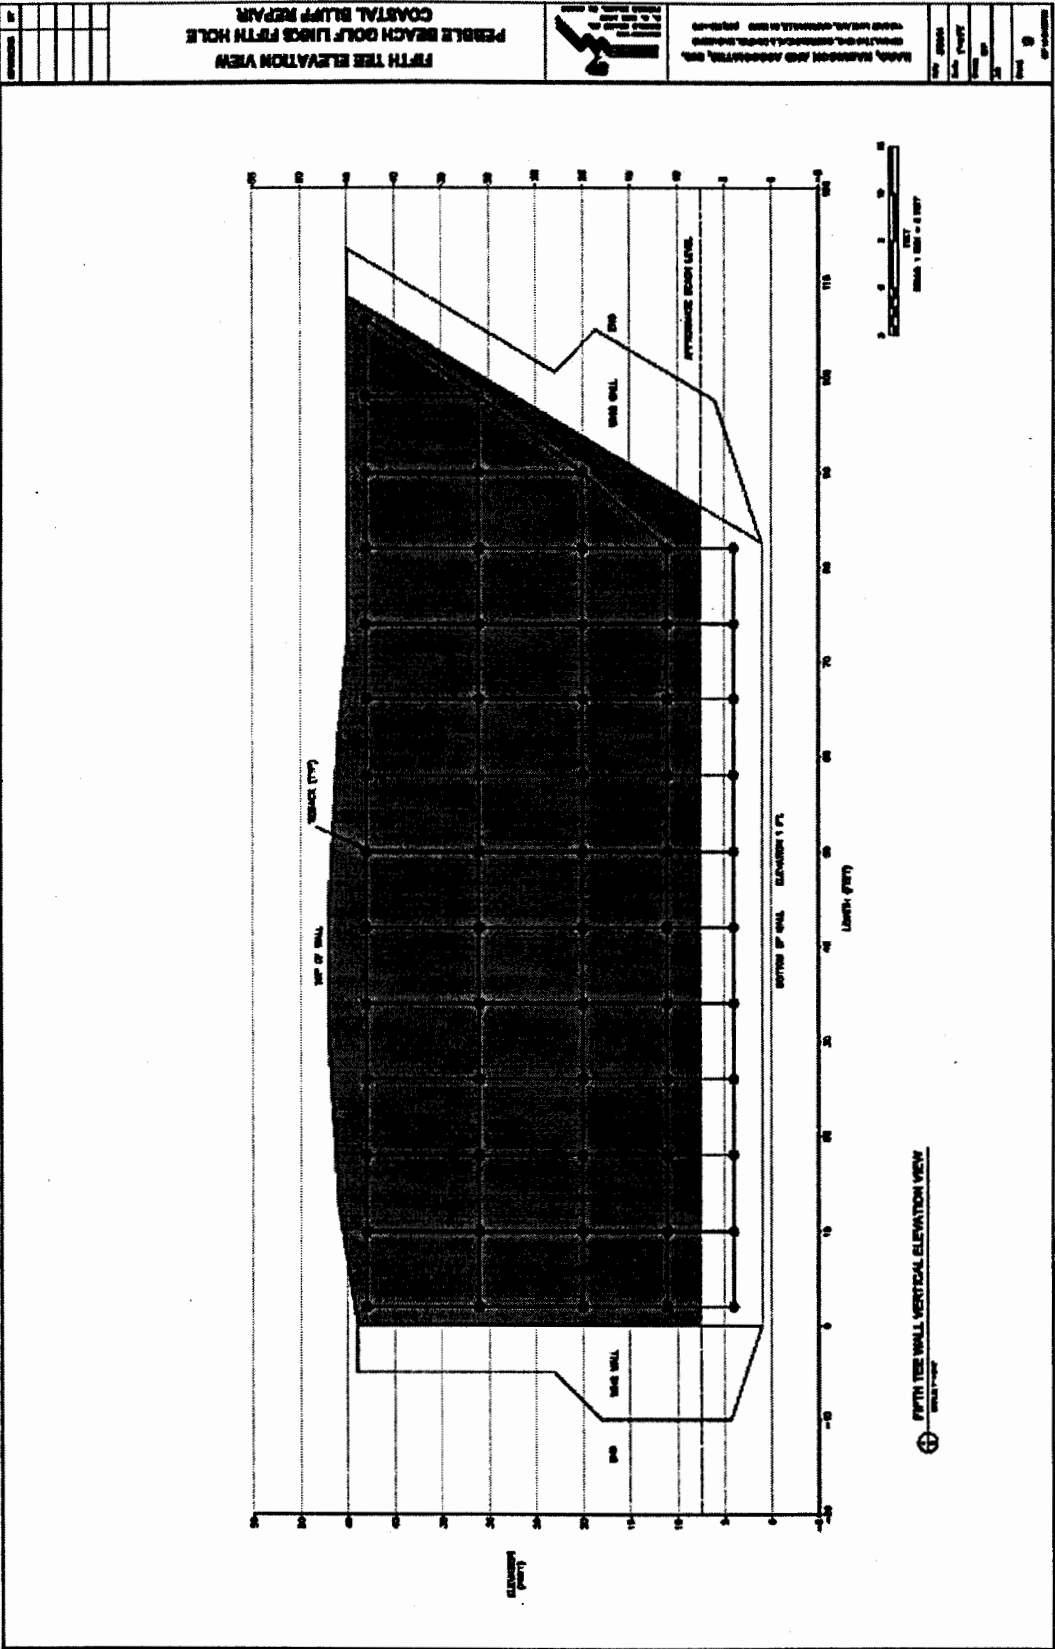
Exhibit G – pg 2 of 4
Proposed Site Plans and Elevations

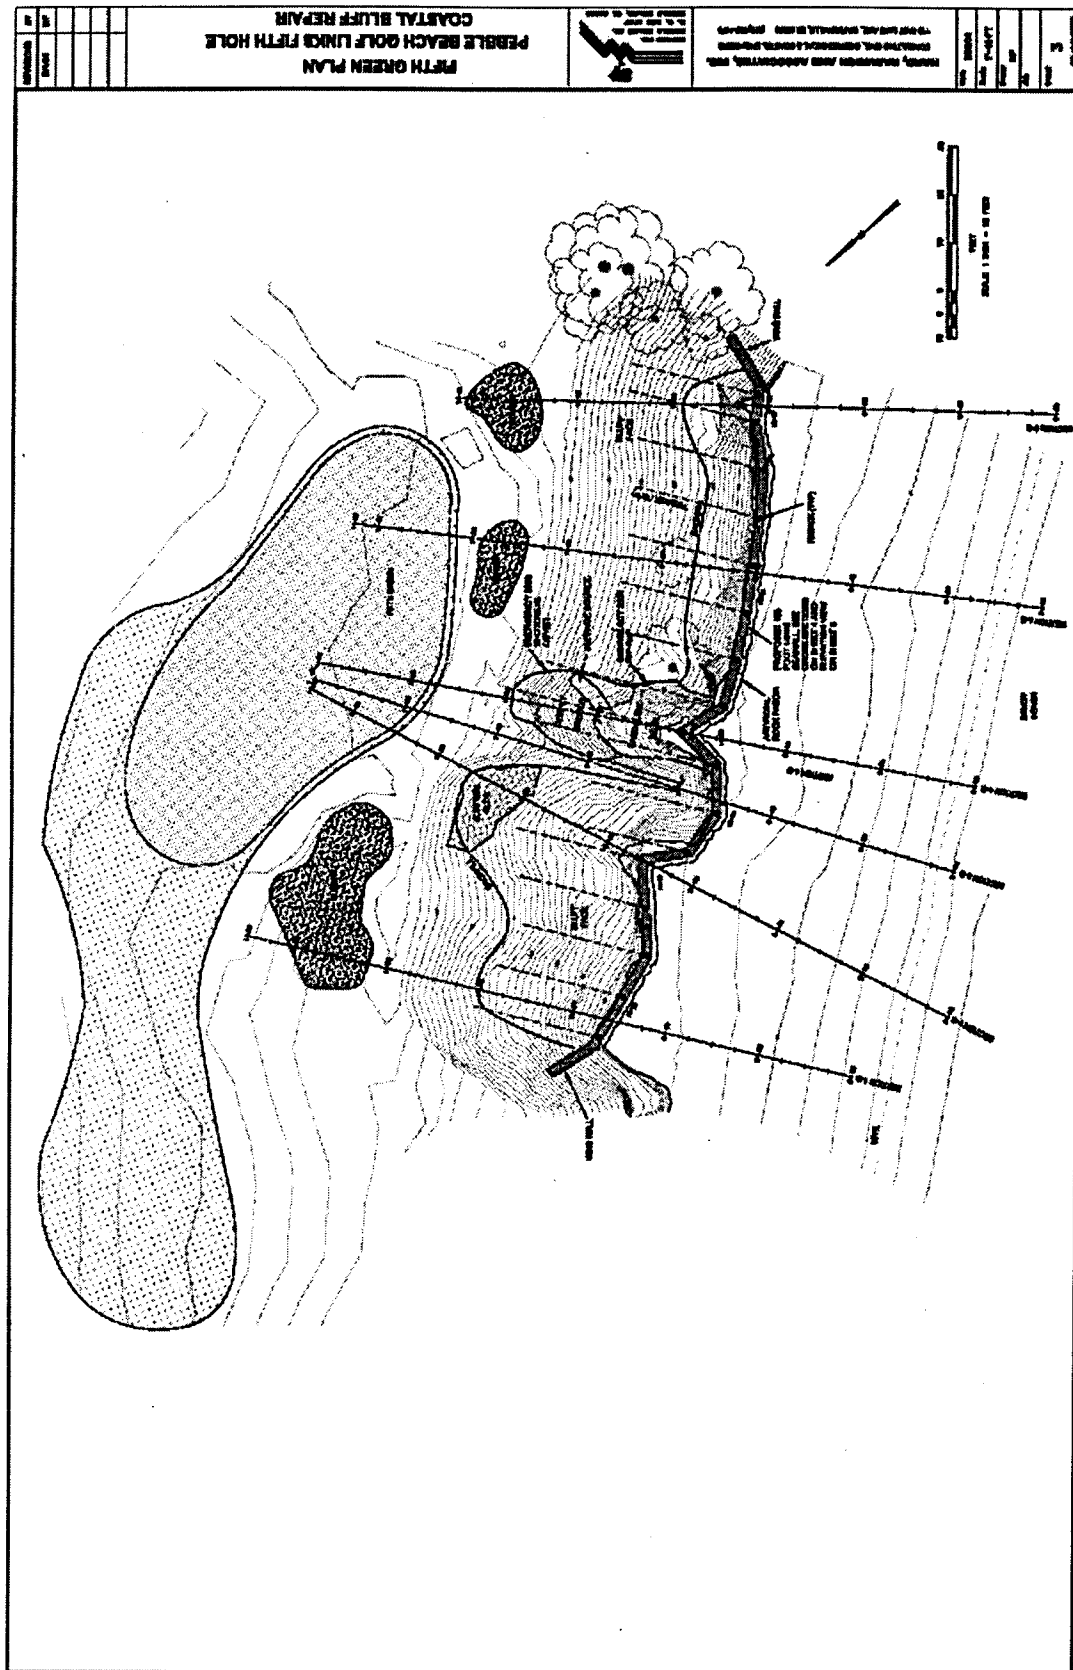
Exhibit G – pg 3 of 4
 Proposed Site Plans and Elevations

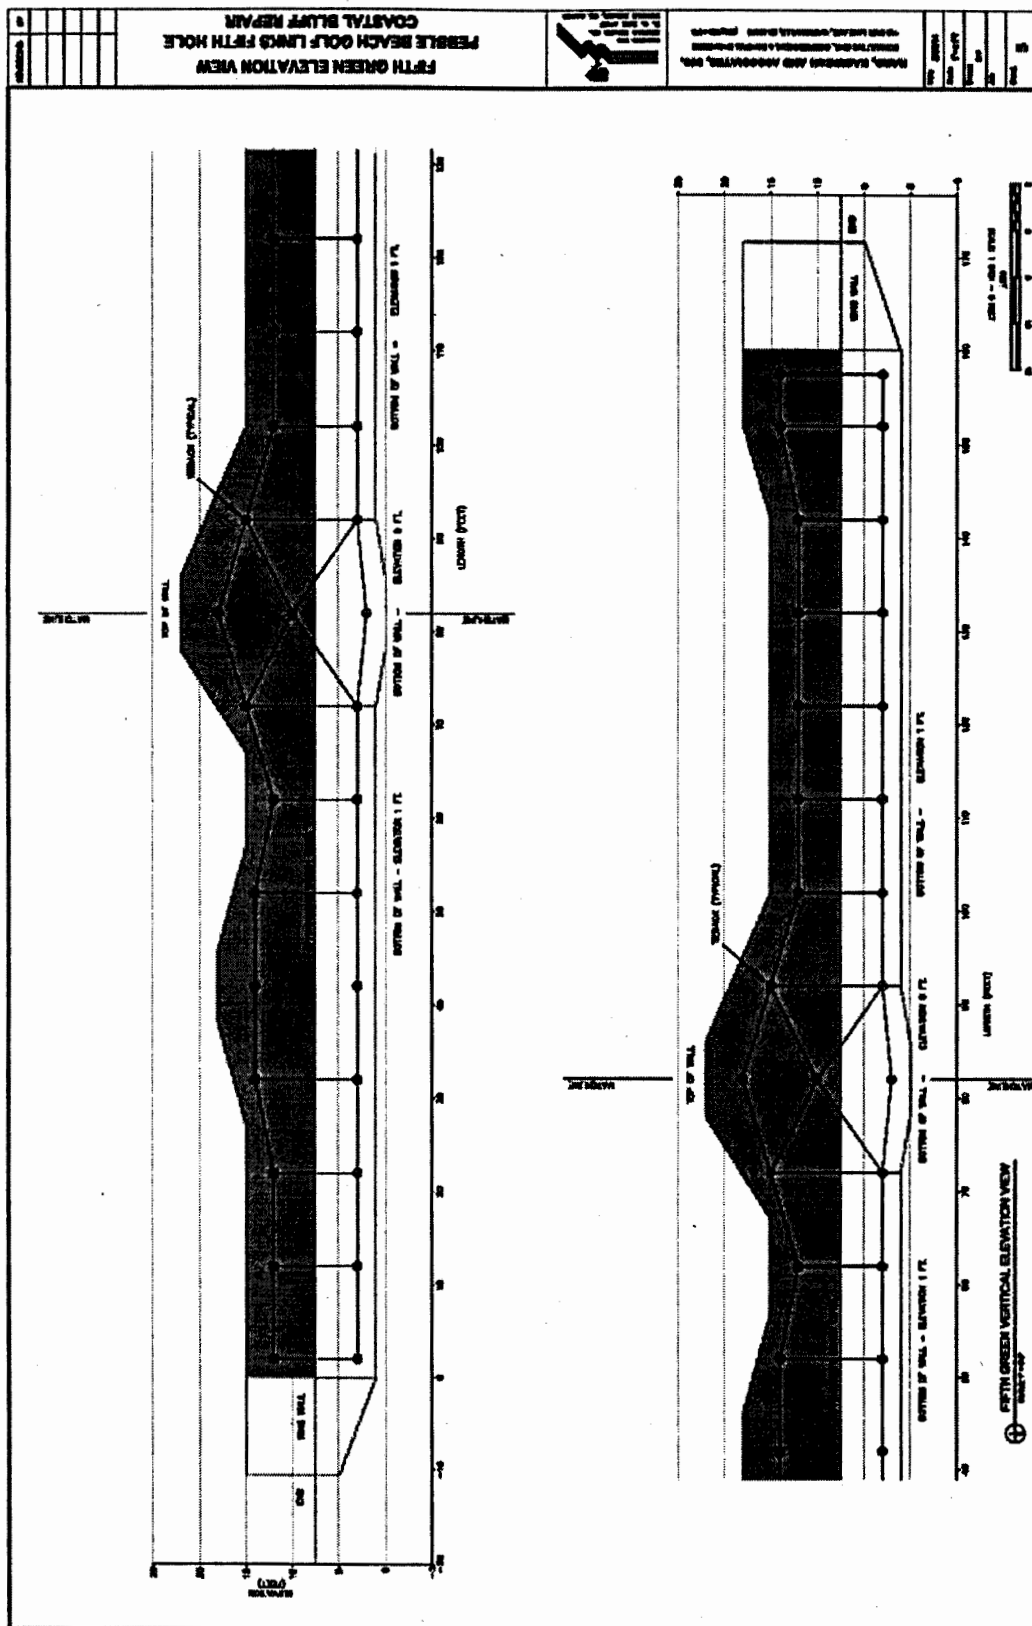
Exhibit G – pg 4 of 4
Proposed Site Plans and Elevations

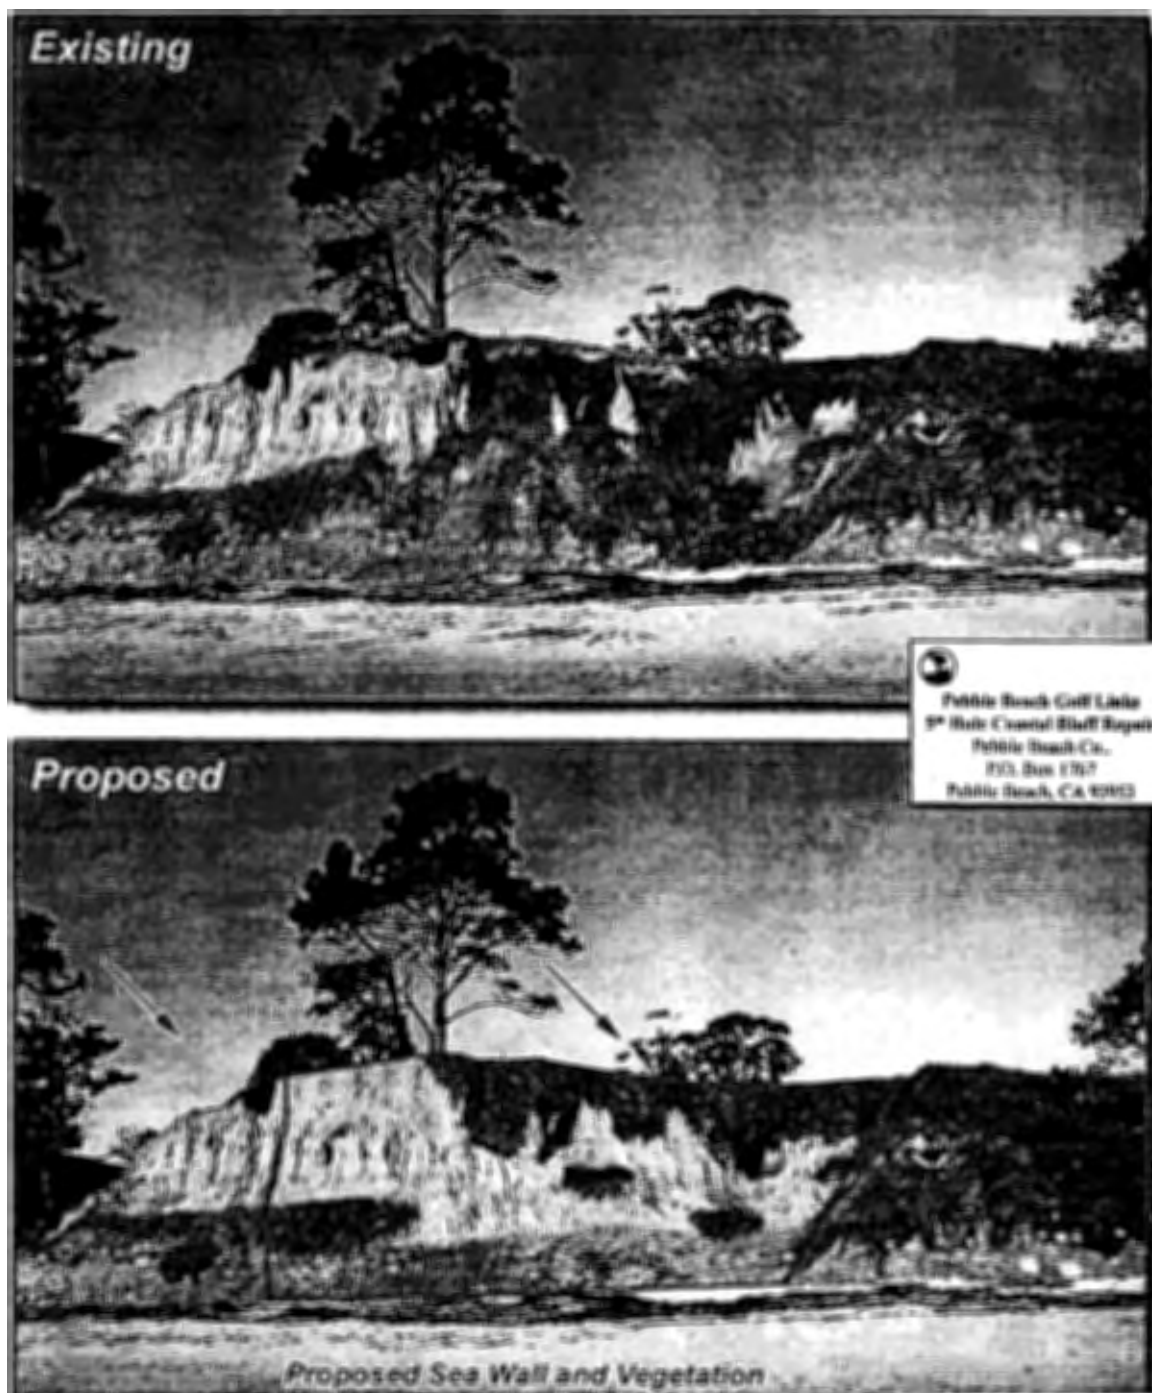
***Existing / Proposed View as seen
from Beach looking Northwest (Fifth Tee)***

Exhibit H - pg 1 of 2
Visual Simulation of Coastal Bluff - Before and After Proposed Seawalls -
5th Tee

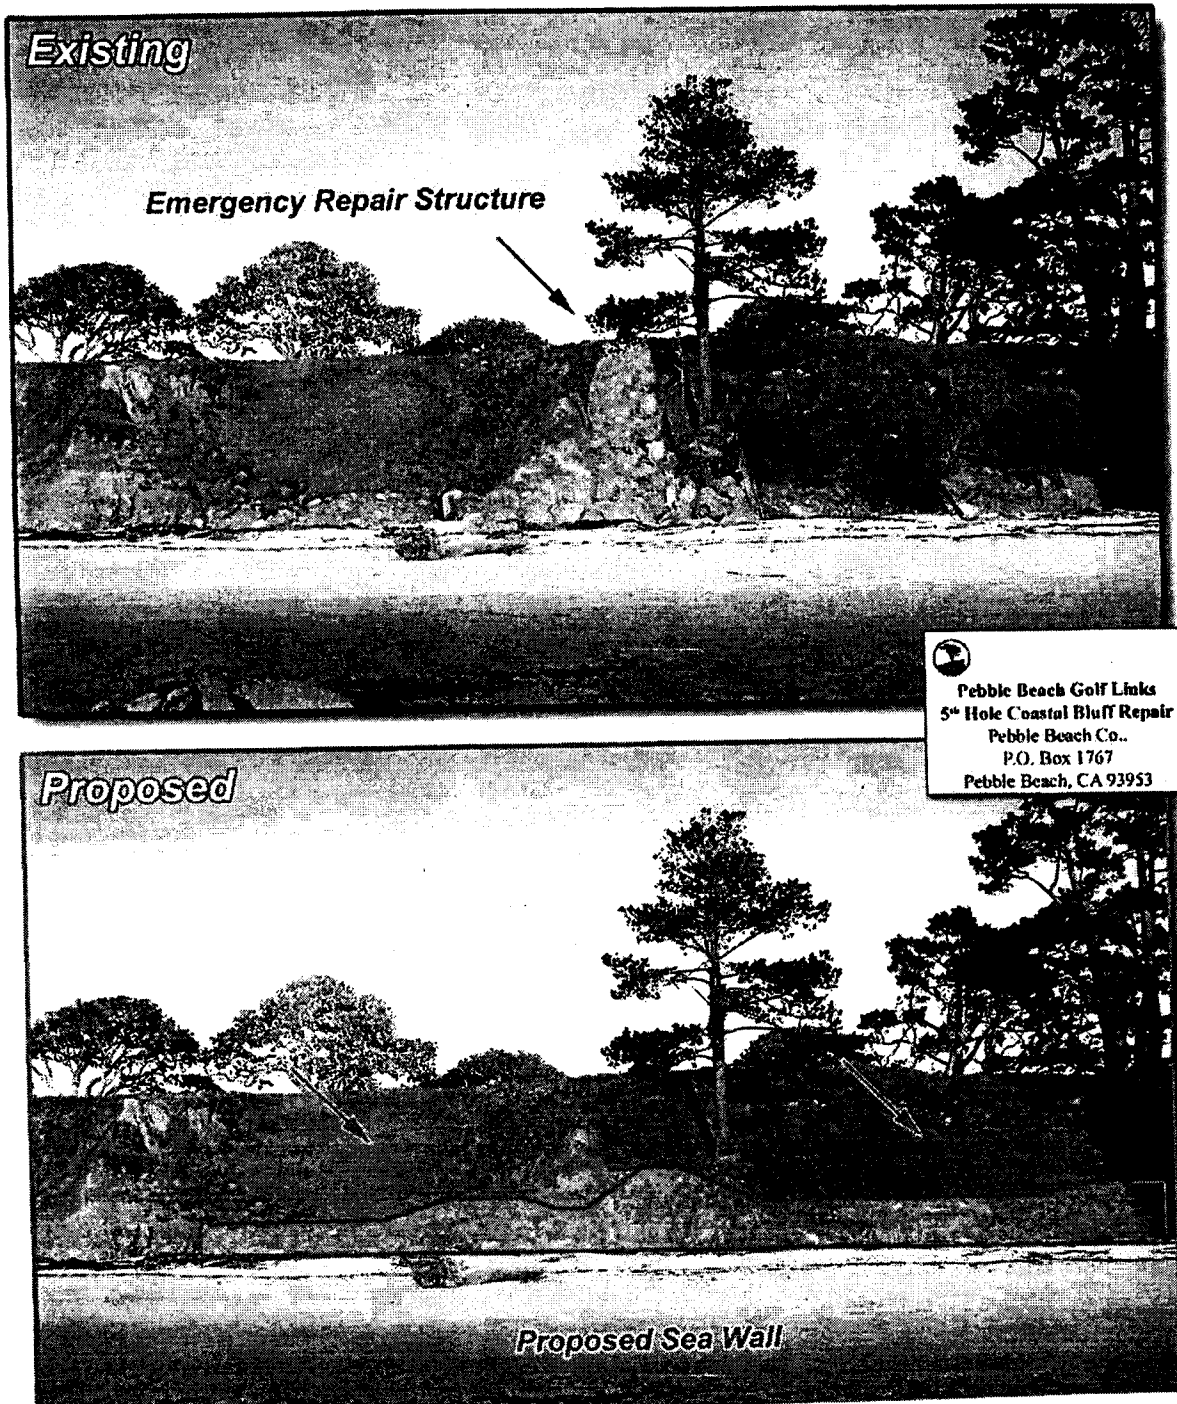
***Existing / Proposed View as seen
from Beach looking North (Fifth Green)***

Exhibit H - pg 2 of 2
Visual Simulation of Coastal Bluff - Before and After Proposed Seawalls –
5th Green

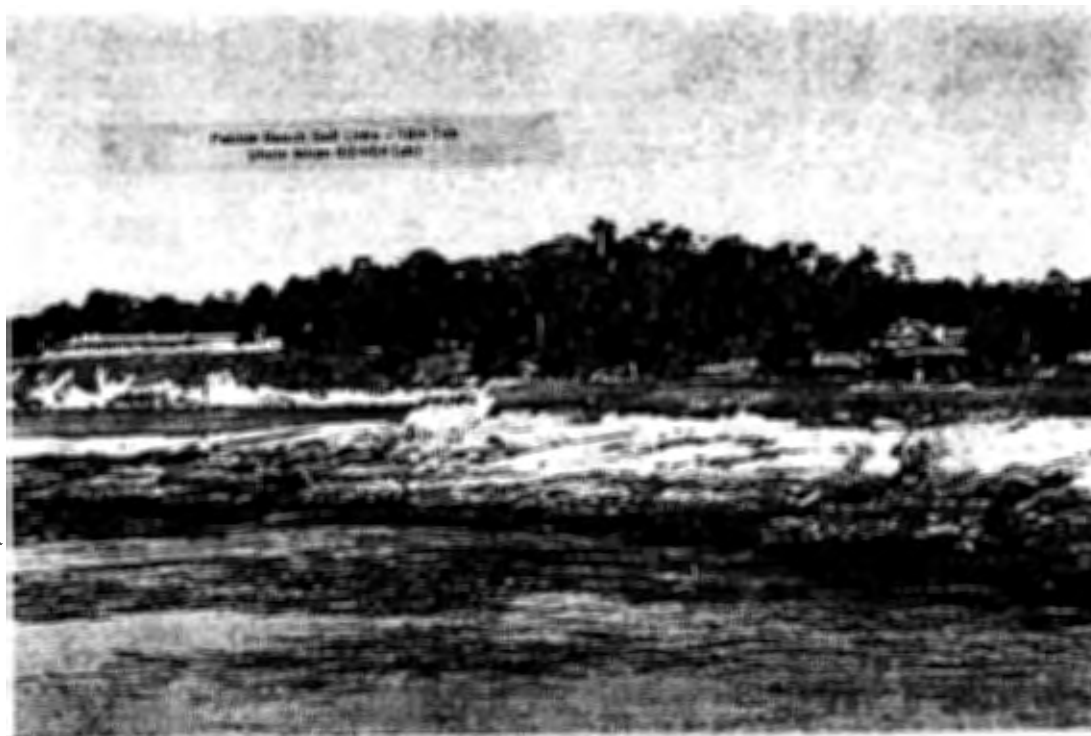
Photo 6.
Applicant's photo
of seawall at 18th
Tee - dated
6/24/04.

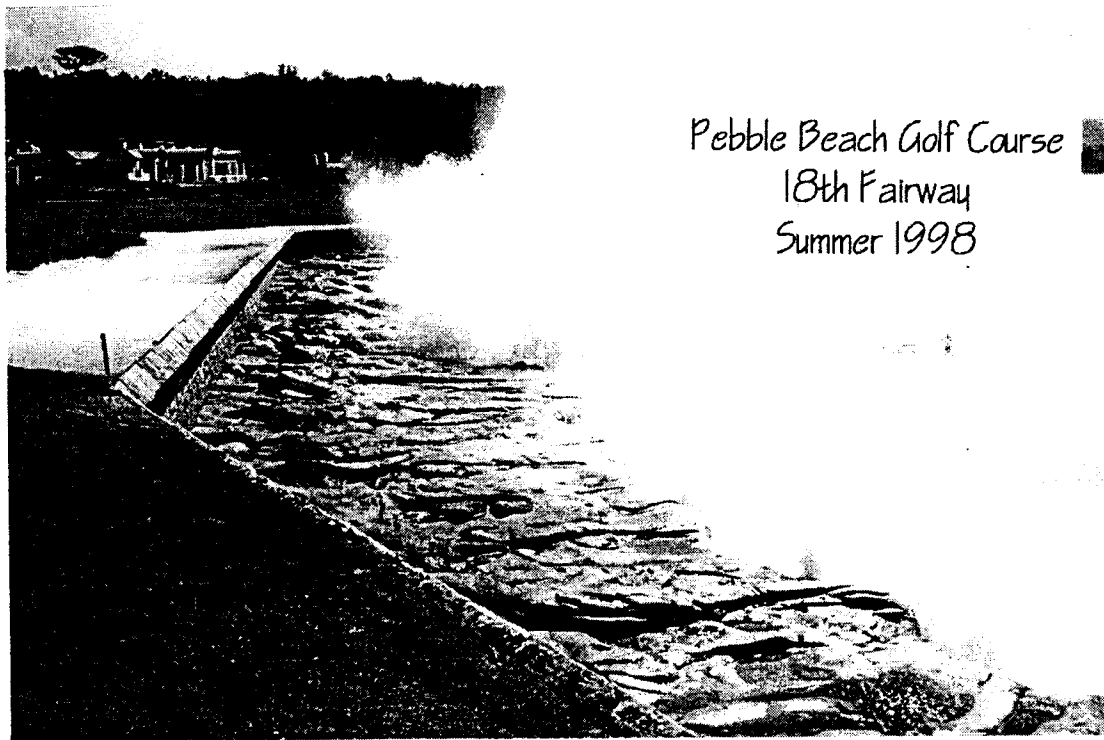
Photo 3.
Applicant's photo
of seawall at 18th
fairway - dated
Summer, 1998.

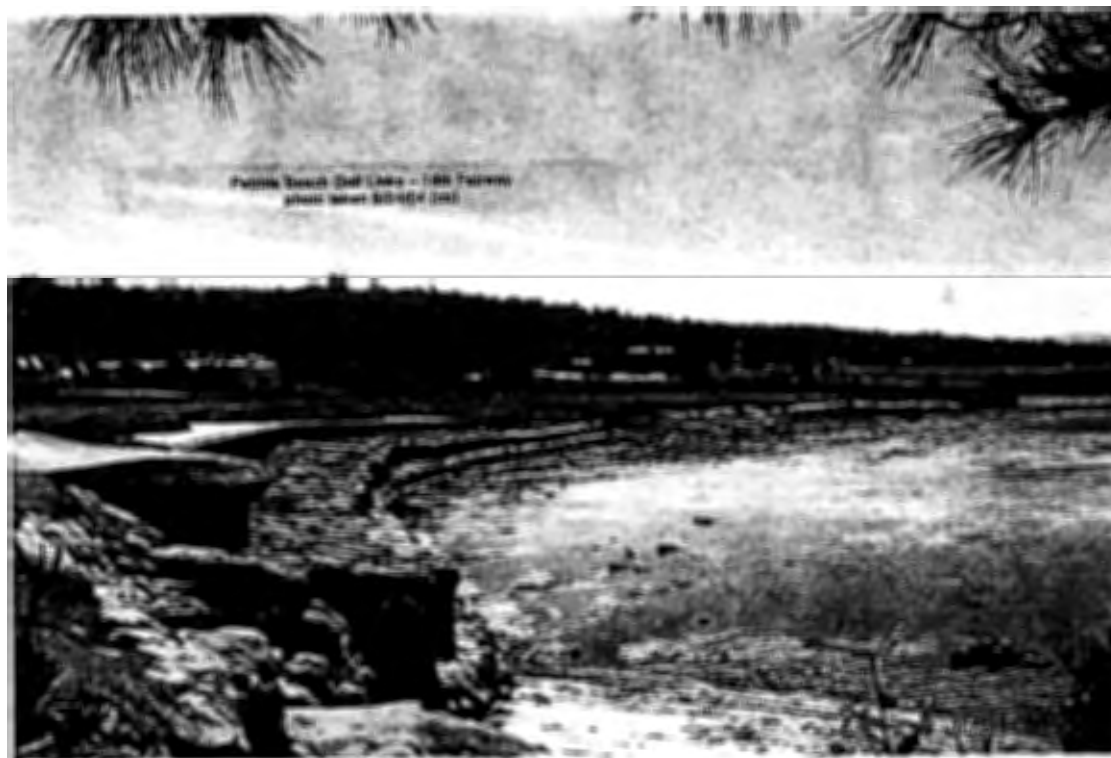
Photo 4.
Applicant's photo
of seawalls along
18th green (in
foreground),
fairway, and tee
(on right side of
photo) - dated.
6/25/04.

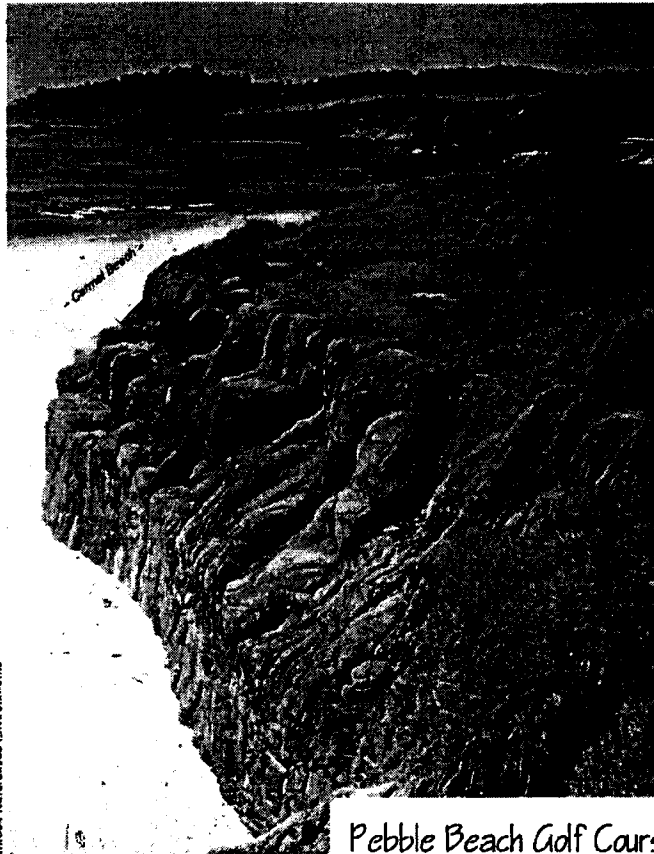
Photo 1.
Applicant's photo
of 9th Hole seawall
– dated Summer,
1998.

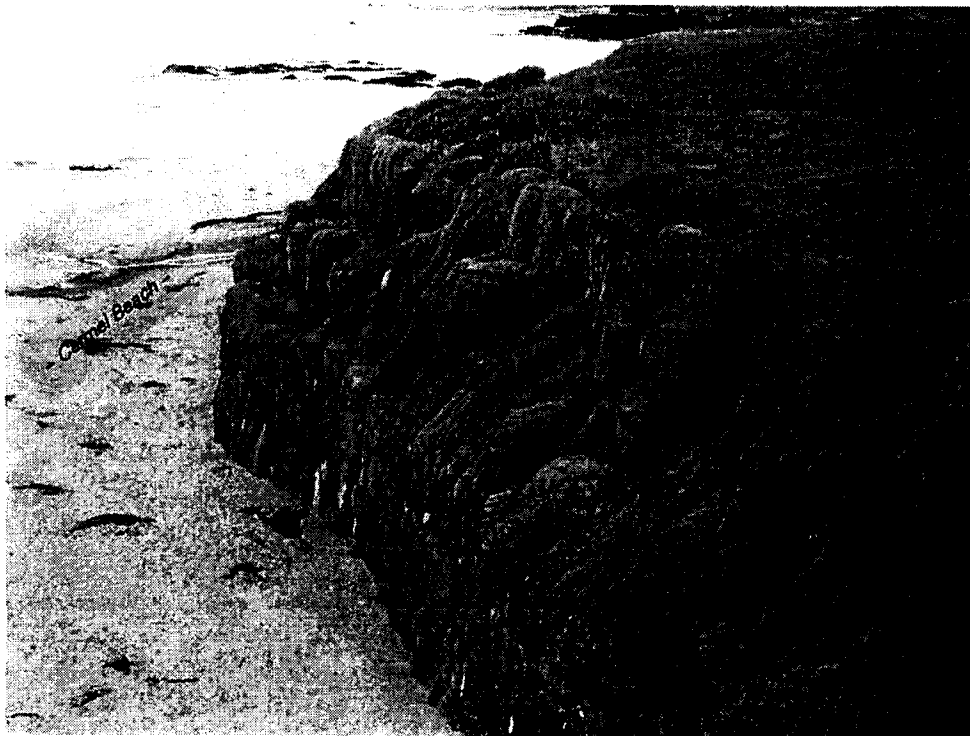
Photo 2.
Applicant's photo
of 9th Hole seawall
- dated 6/24/04.

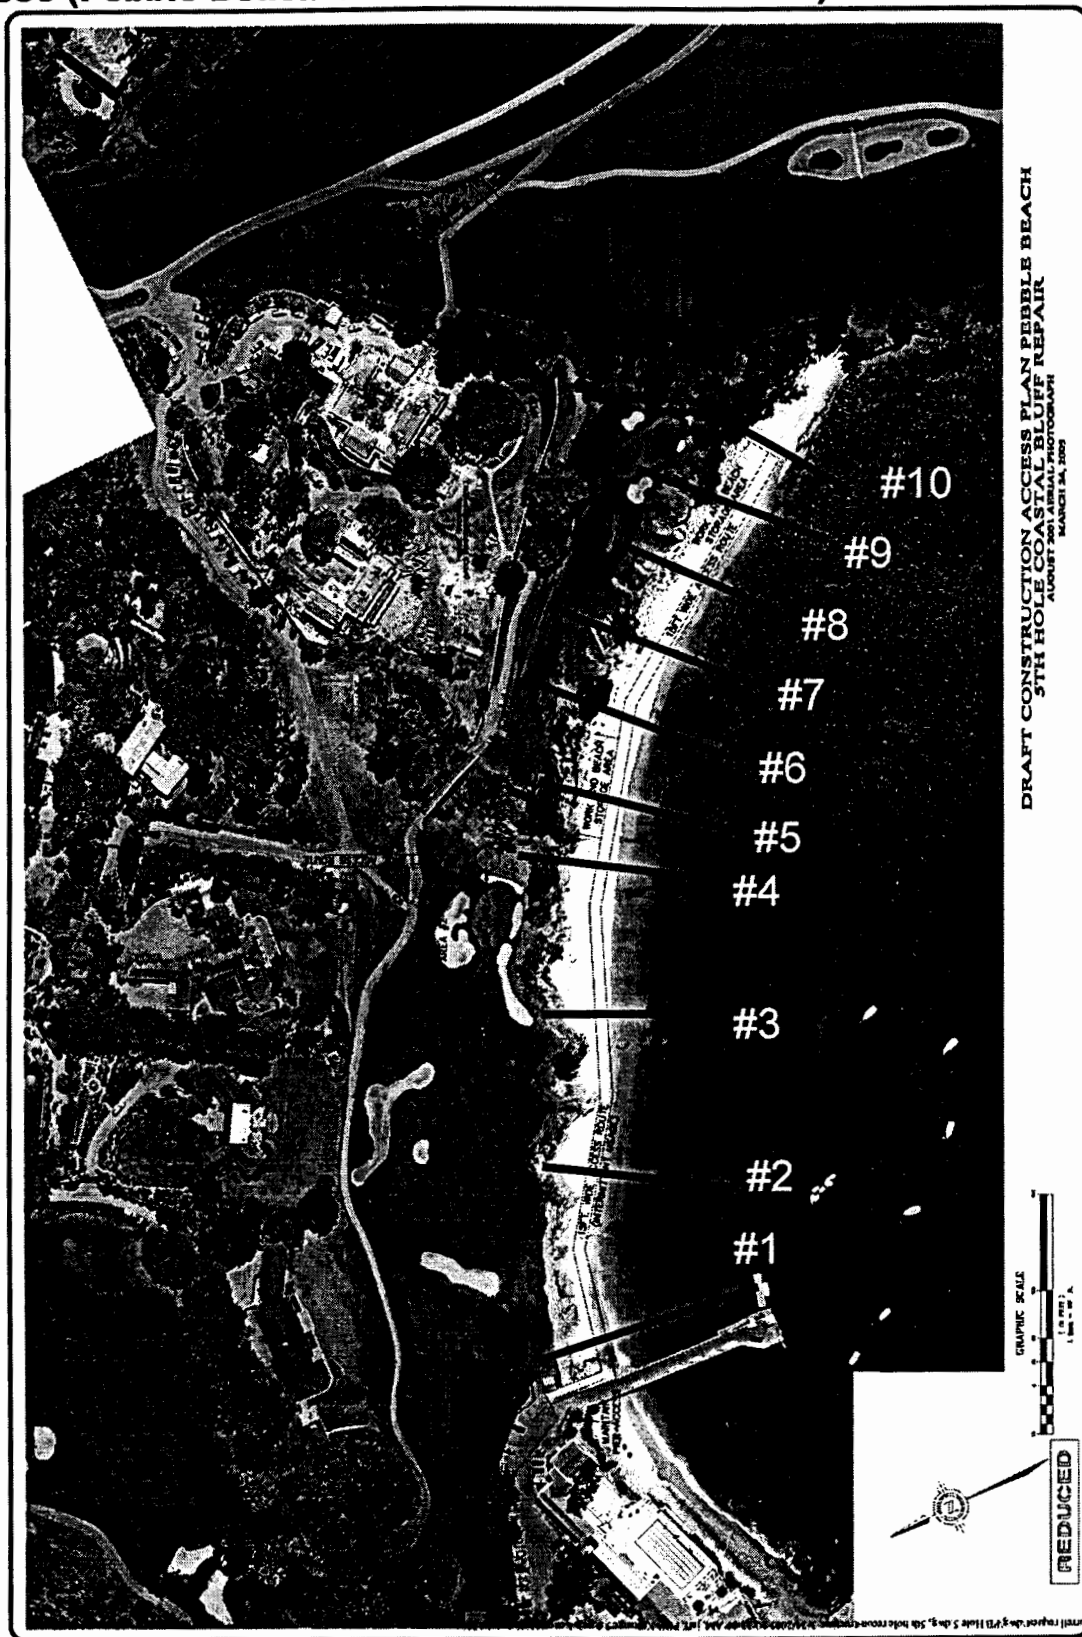
Exhibit I2
2001 Aerial Photo of Site Showing Required Beach and Bluff Profiles -
Approximate Locations

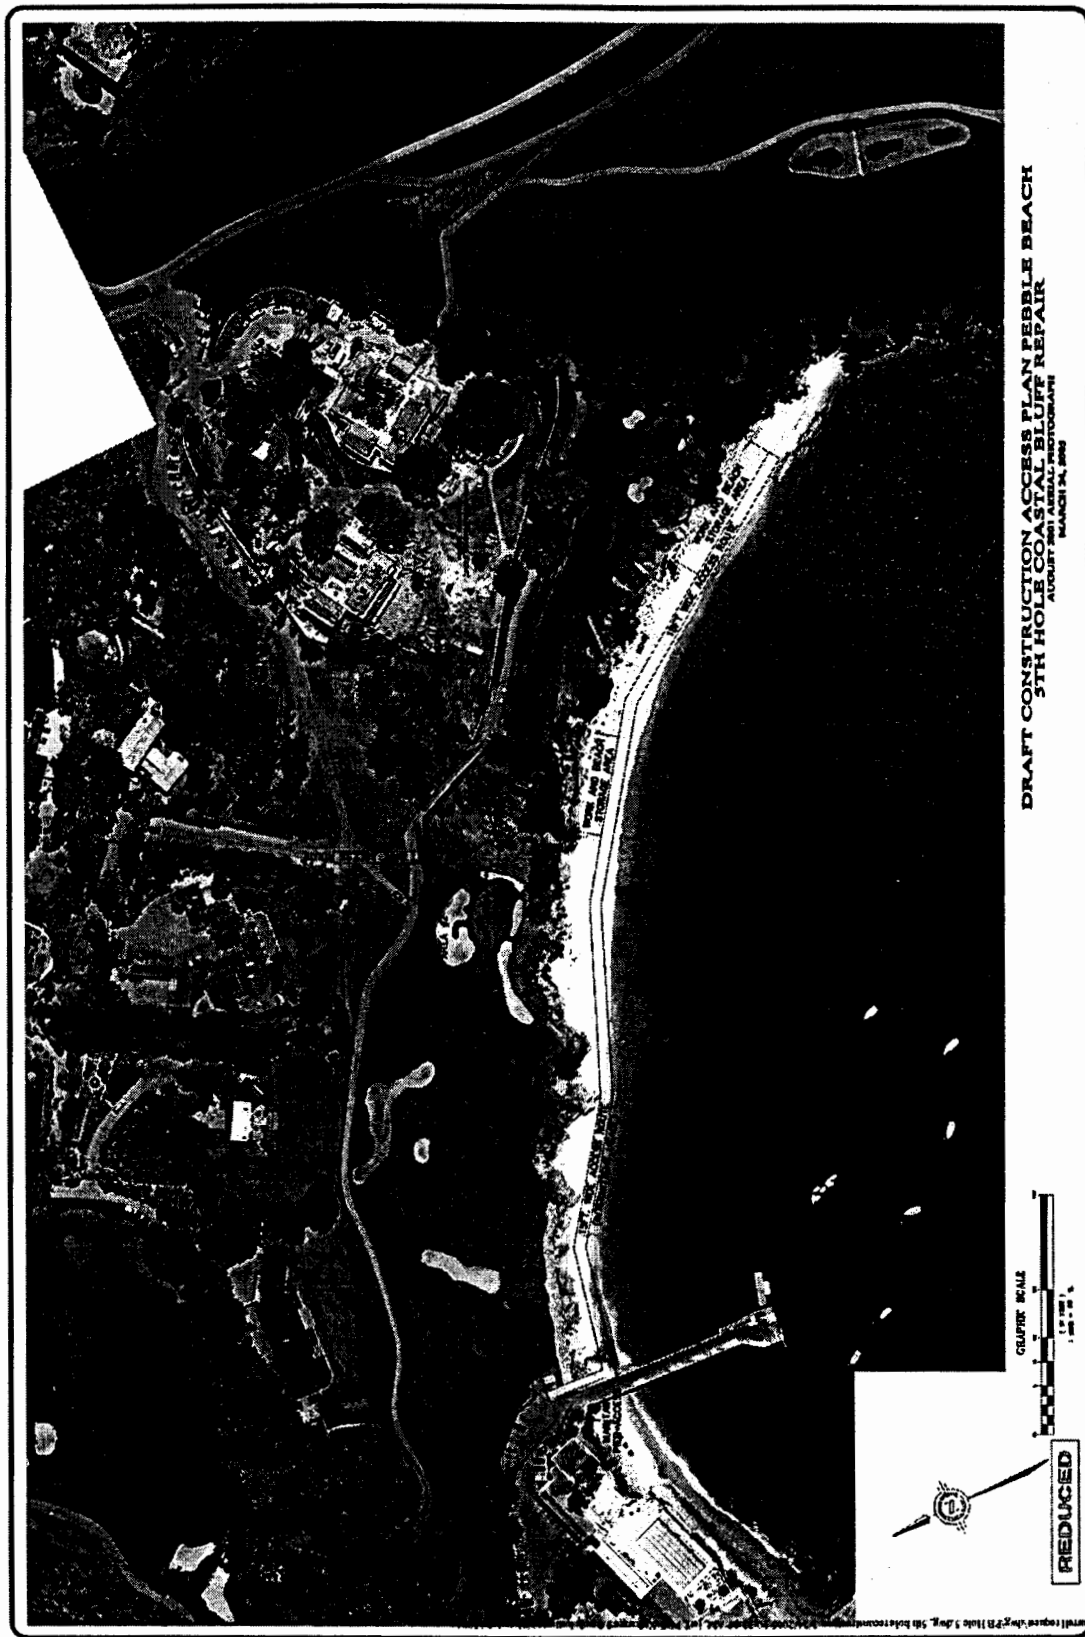
Exhibit I
2001 Aerial Photo of Site Showing Proposed Construction Route
