CALIFORNIA COASTAL COMMISSION

**STAFF REPORT: REGULAR CALENDAR**

APPLICATION NO.: 4-08-026

PROJECT DESCRIPTION: Remediate active slope failure and repair/reconfigure 250 linear ft. segment of Hume and Briarbluff Roads involving 135,630 cu. yds. of grading (43,500 cu. yds. of cut, 130 cu. yds. of fill, and 92,000 cu. yds. of removal and recompaction), install drainage system, a temporary irrigation system, and revegetate site with native plants along a former 475 linear ft. segment of Hume Road (and descending slopes) between Castlewood and Briarbluff Road intersections in follow-up to three separate emergency permits previously issued for slope remediation and road repair.

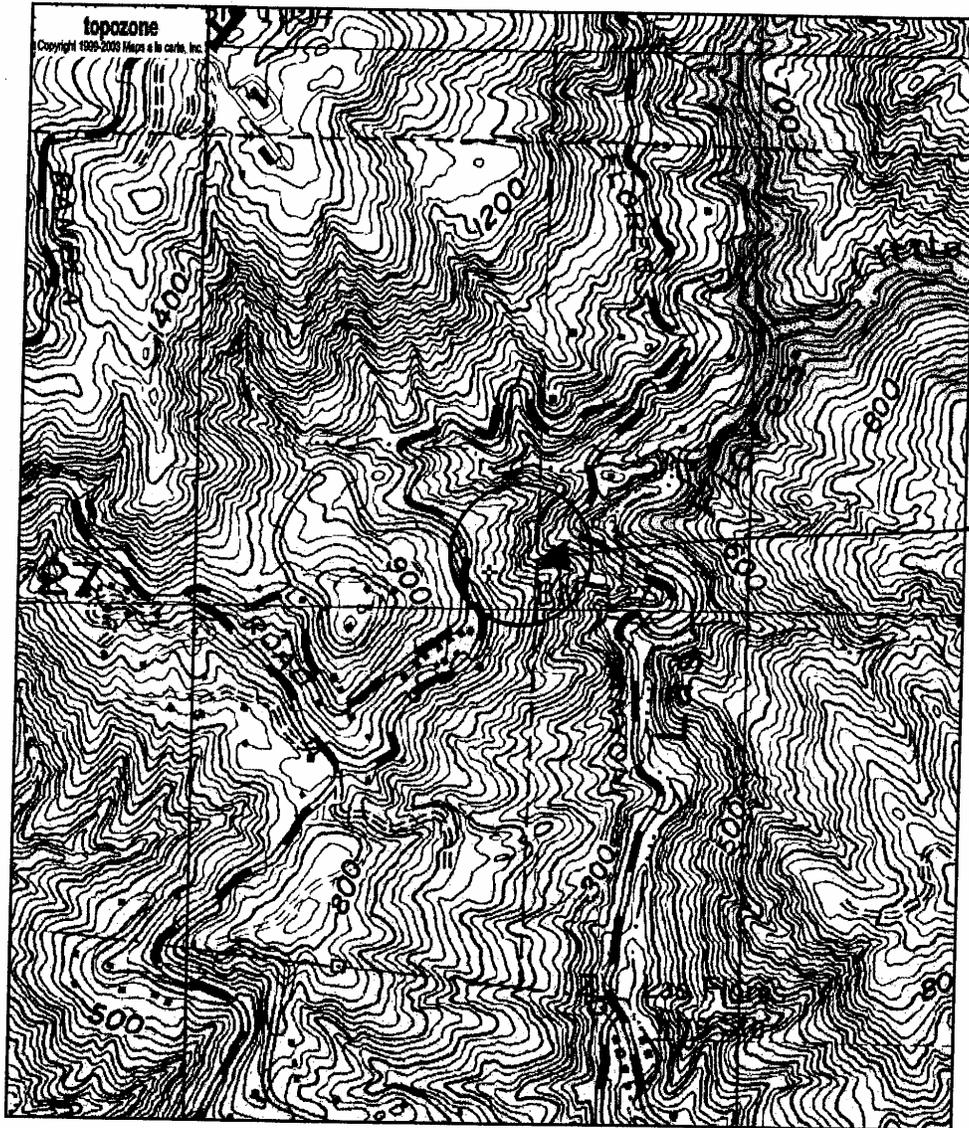
Exhibit 2
Appl No. 4-08-026
LA Co DPW
Topo Map

UTM 11 348532E 3769073N (NAD27)
USGS Malibu Beach (CA) Quadrangle
Projection is UTM Zone 11 NAD83 Datum

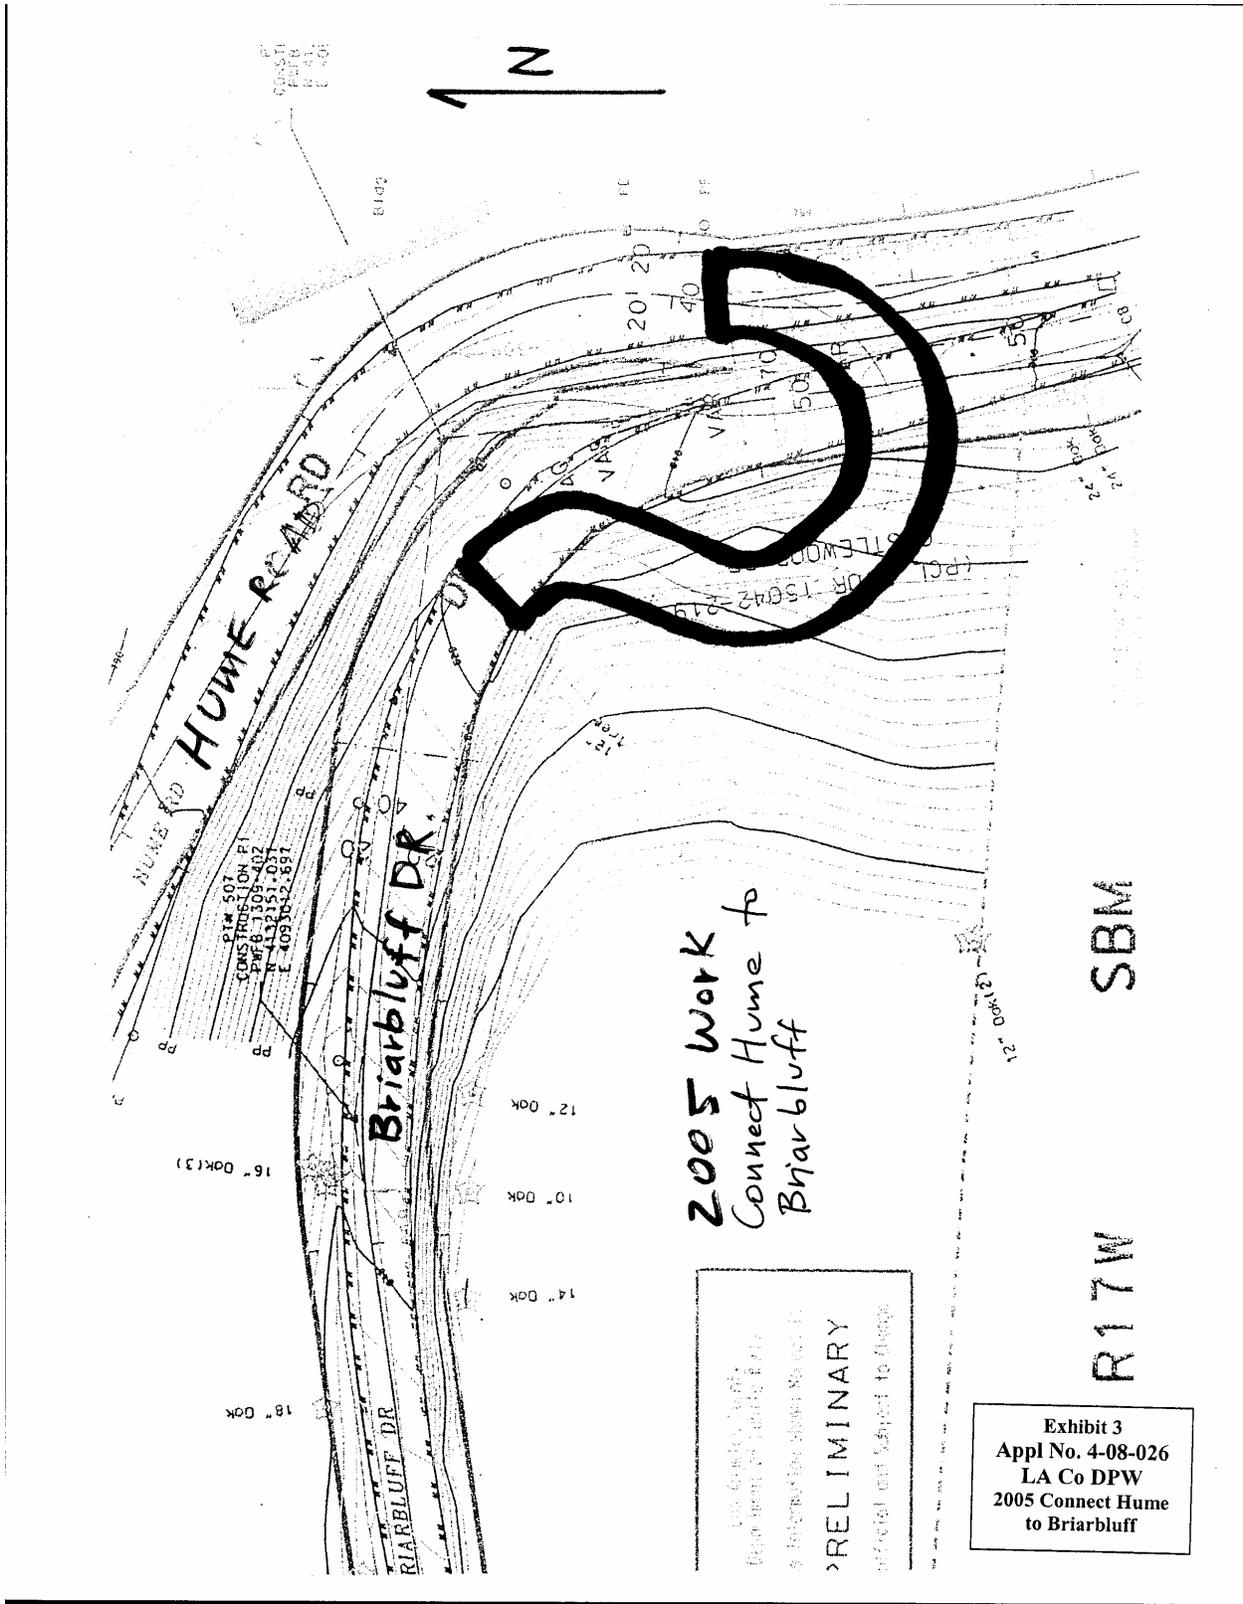
Exhibit 3
Appl No. 4-08-026
LA Co DPW
2005 Connect Hume
to Briarbluff

2005 Work
Connect Hume to
Briarbluff

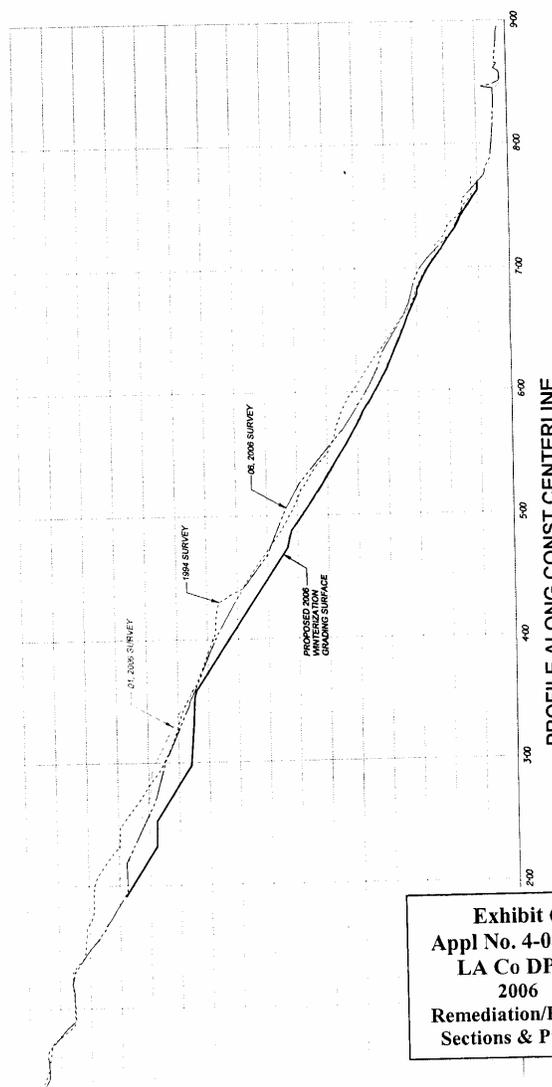
Exhibit 6
Appl No. 4-08-026
LA Co DPW
2006
Remediation/Repair
Sections & Profile

2006 Remediation/Repair

HUME ROAD - 2006 WINTERIZATION GRADING
