Exhibit 4  
CDP 4-10-040 through 4-10-045  
Site Geology/Landslide Areas

**COTTON, SHIRES AND ASSOCIATES, INC.**  
CONSULTING ENGINEERS AND GEOLOGISTS

**PEER REVIEW ENGINEERING GEOLOGIC MAP**  
Sweetwater Mesa Development Project  
Malibu, California

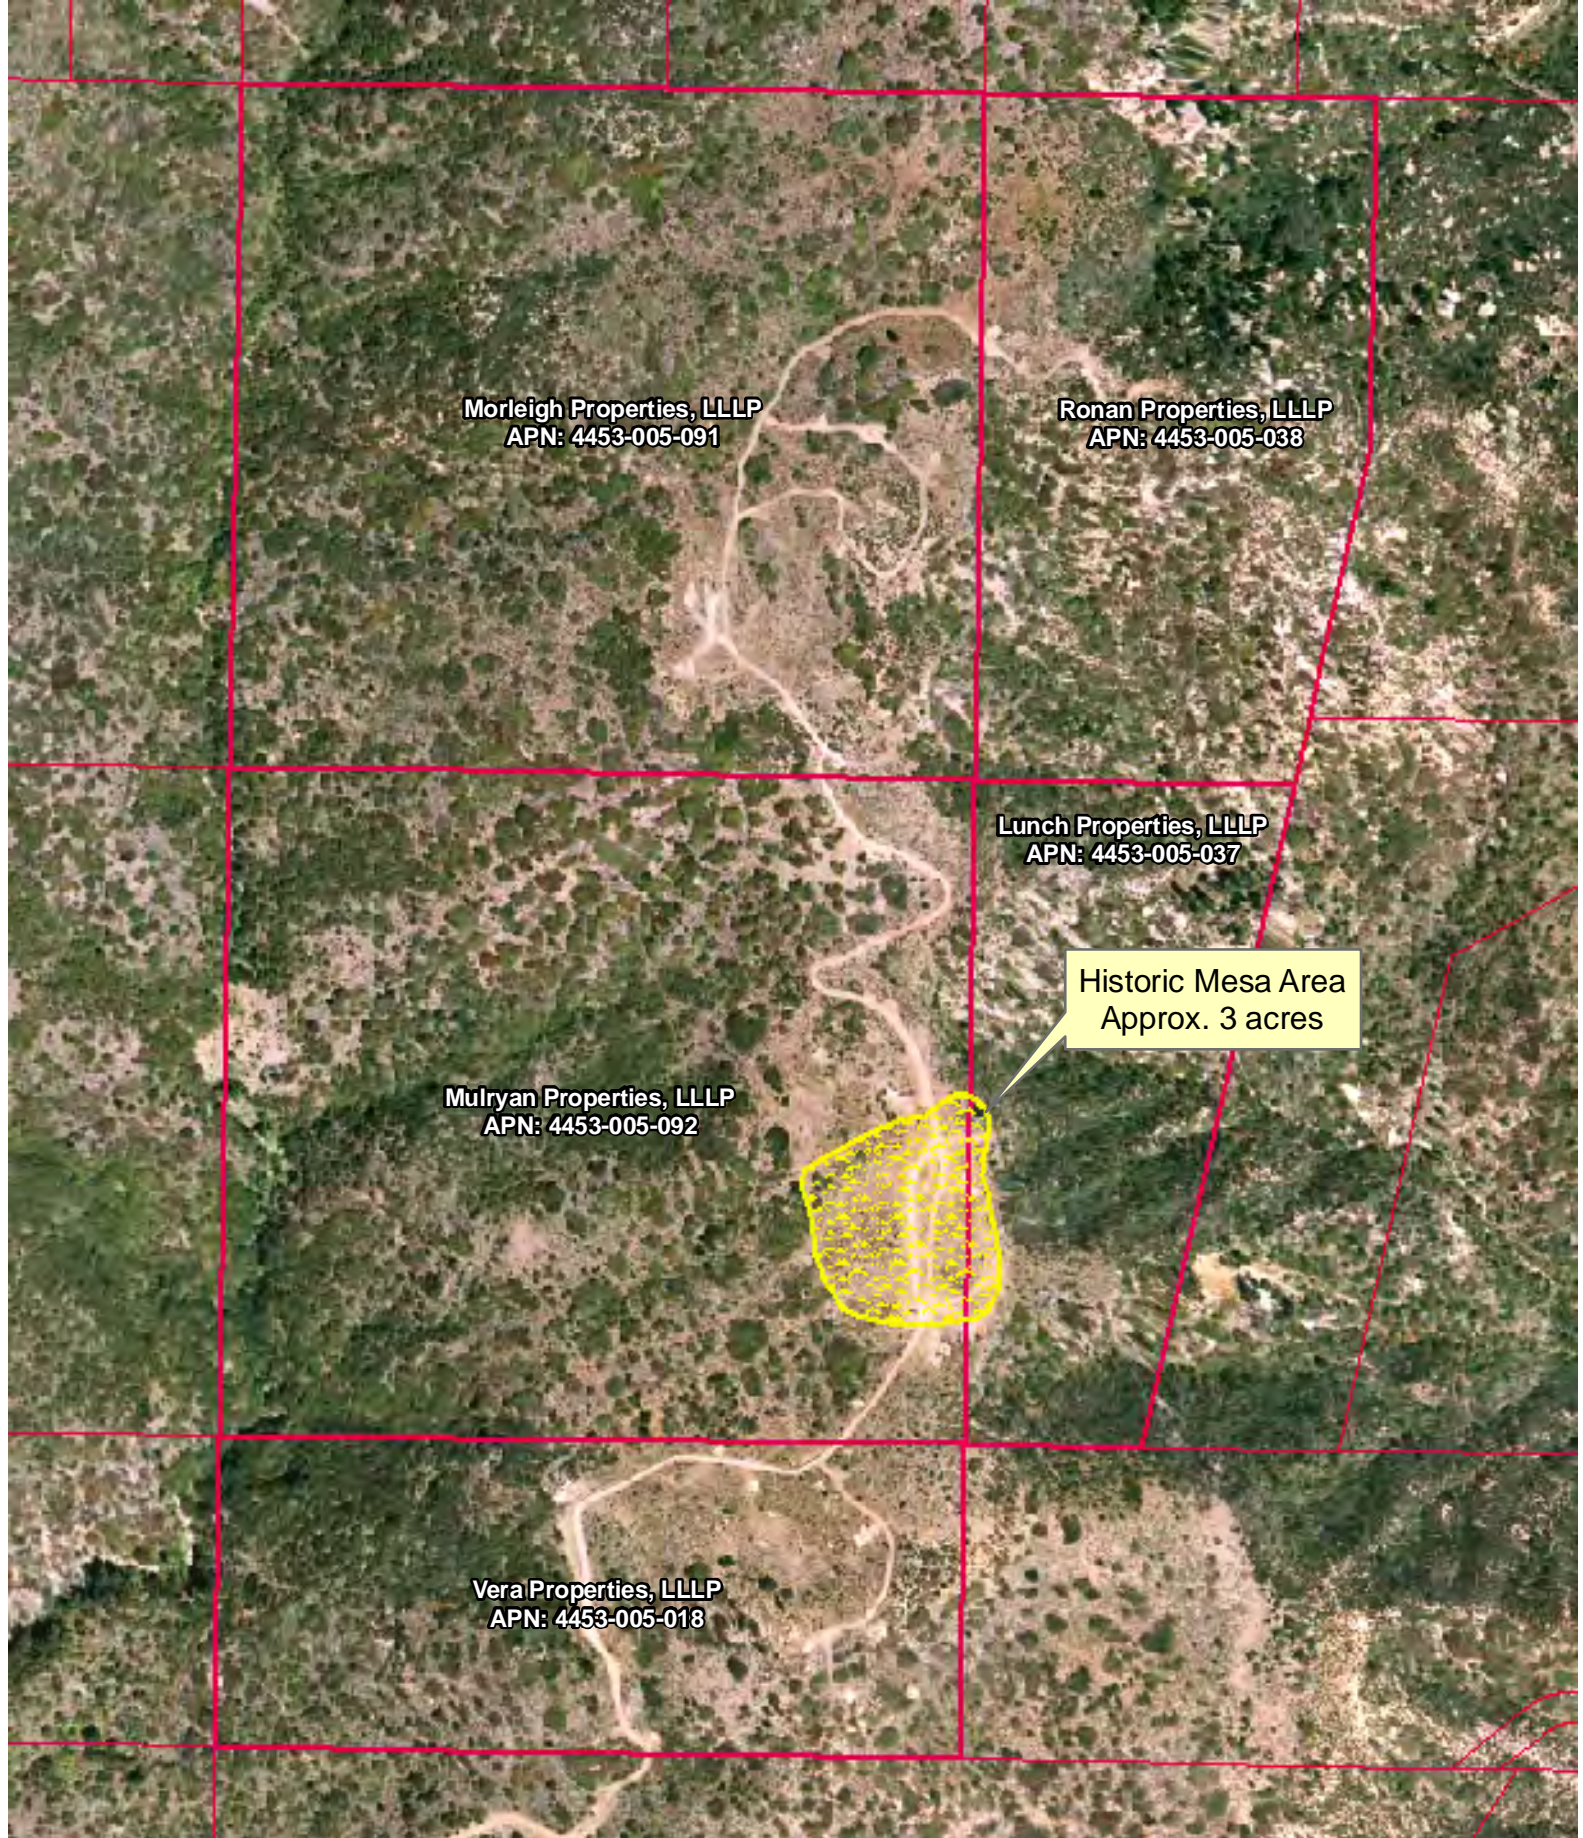
Historic Mesa Area  
Approx. 3 acres

Proposed Water Main Alignment
