**STAFF REPORT: PERMIT AMENDMENT**

APPLICATION NO.: A-5-RPV-93-005-A14
APPLICANT: Ocean Trails LP
AGENT: Kenneth A. Zuckerman, CEO

SUMMARY OF AMENDMENT 14:

The applicant seeks permission to install 150-200 subterranean shear pins (21 foot long, three foot-diameter concrete and steel caissons) in the translational slide block of landslide C to stabilize it for safety. The shear pins would be installed in the slide failure plane, which is 90 feet below the ground surface. Stabilizing the main block will allow the applicant to proceed with approved efforts to divert storm water from the slide plane ("winterization"). The applicant further requests amendments to conditions 1, 8, and 28, to allow grading and removal of vegetation for purposes of erosion control and installation of the shear pins (also known as underground caissons) from a larger area than was permitted in the conditions imposed on amendment 13. Amendment 13, allowed activities

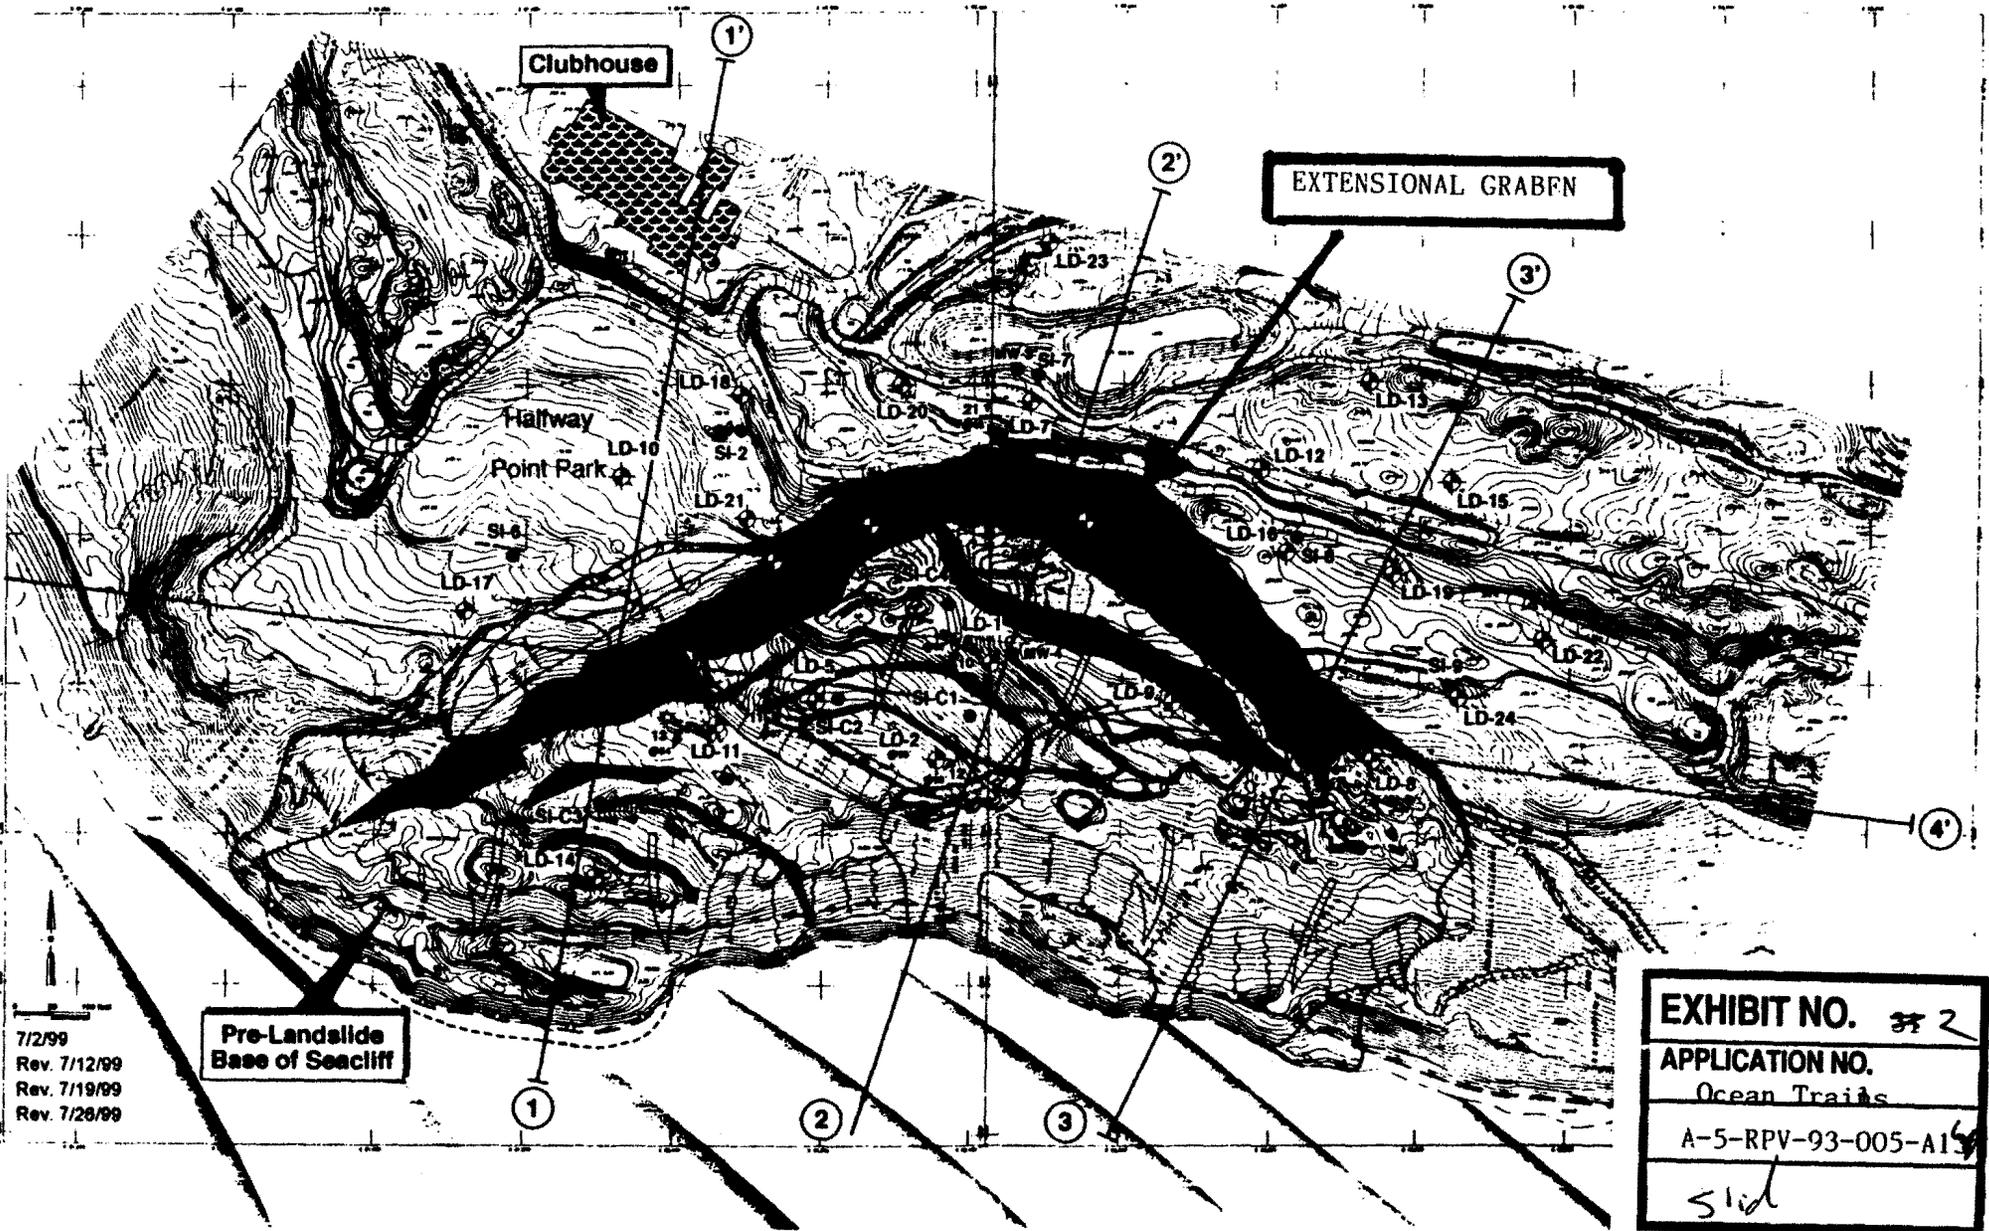
PRELIMINARY LANDSLIDE MAP SLIDE C - OCEAN TRAILS

Pre-Landslide
Base of Seacliff

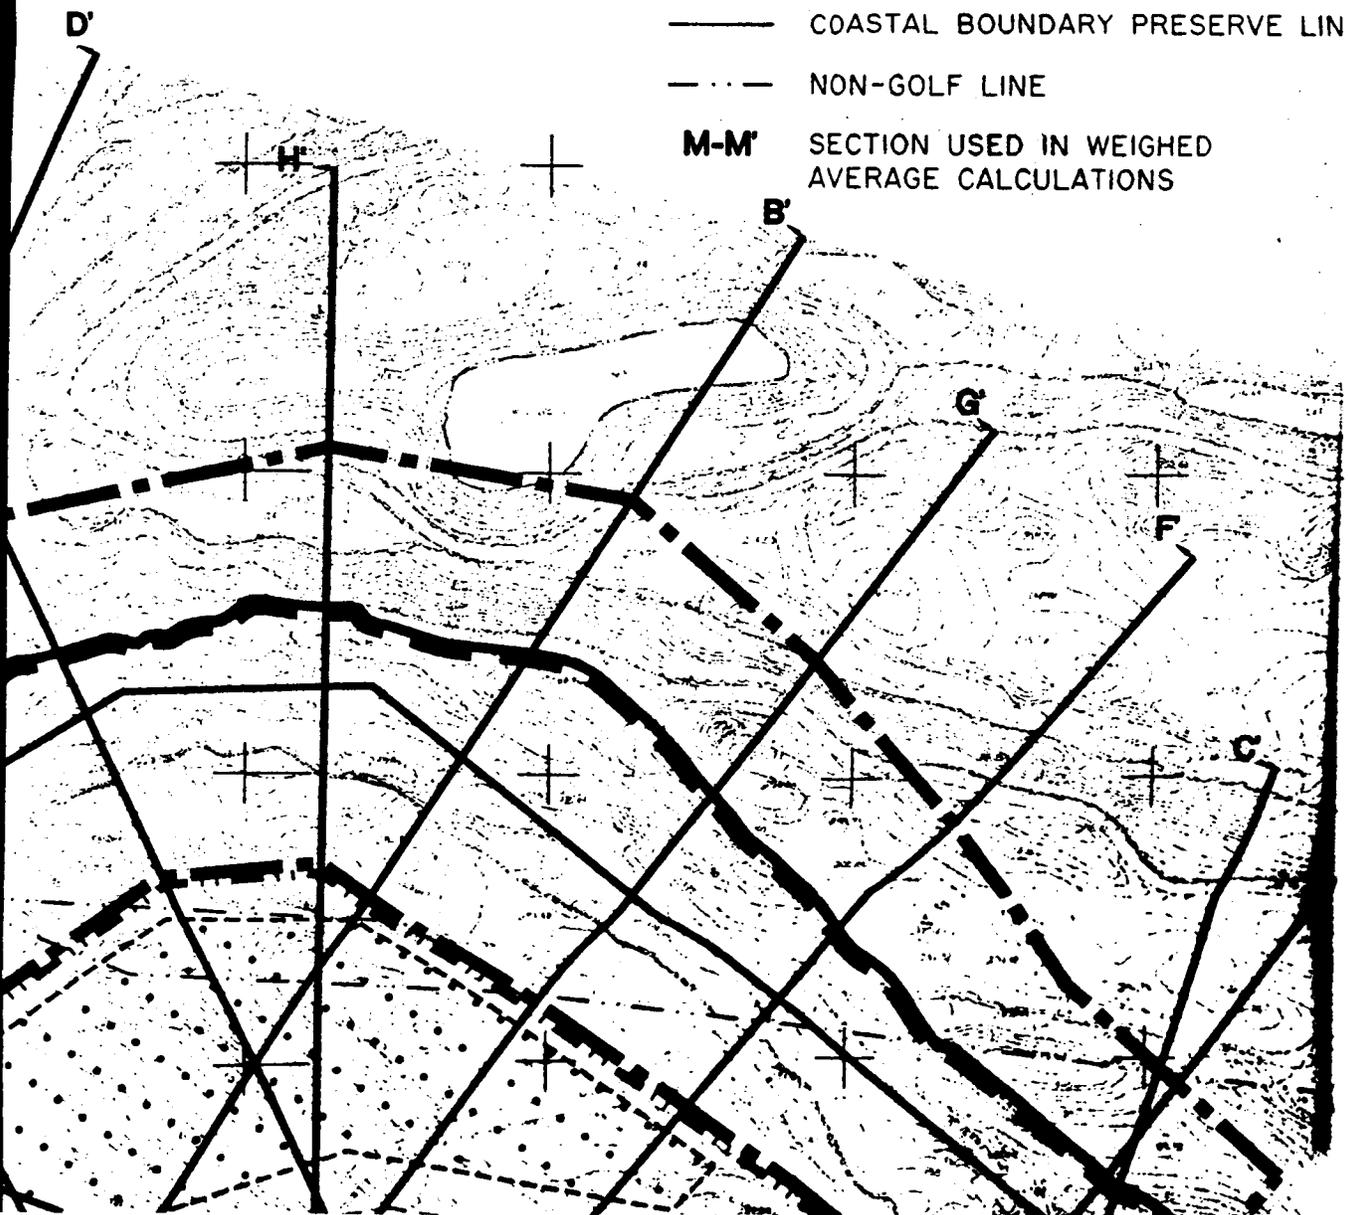
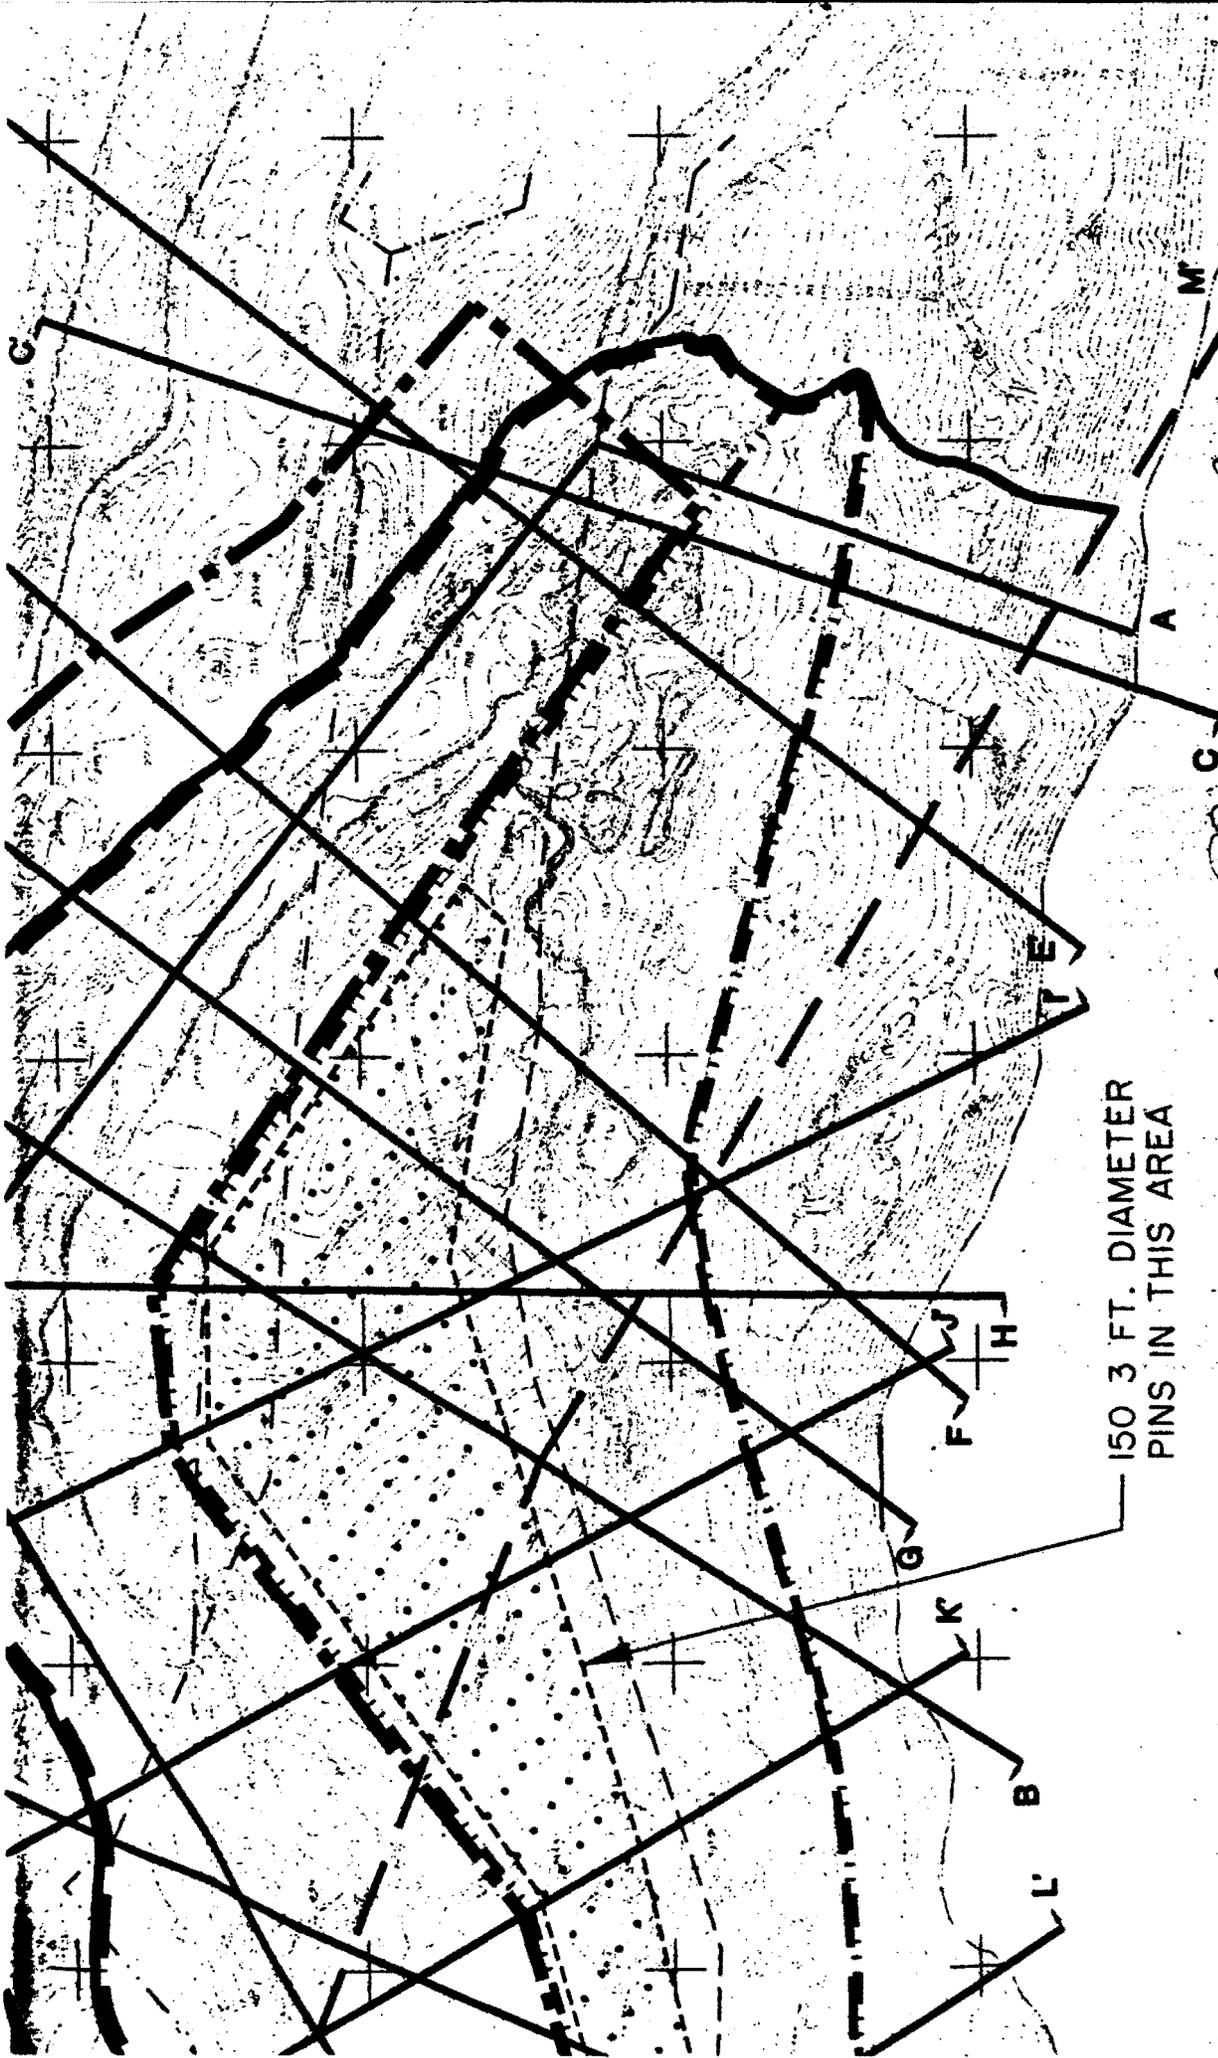
AS RRU 93 005 A14
Exhibit 15 P.13

- APPROXIMATE LIMITS OF SLIDE
- - -** APPROXIMATE LIMITS OF PIN AREA
- · — ·** APPROXIMATE LIMITS OF REPAIR EX
- COASTAL BOUNDARY PRESERVE LIN
- · - · -** NON-GOLF LINE
- M-M'** SECTION USED IN WEIGHED AVERAGE CALCULATIONS

150 3 FT. DIAMETER
PINS IN THIS AREA

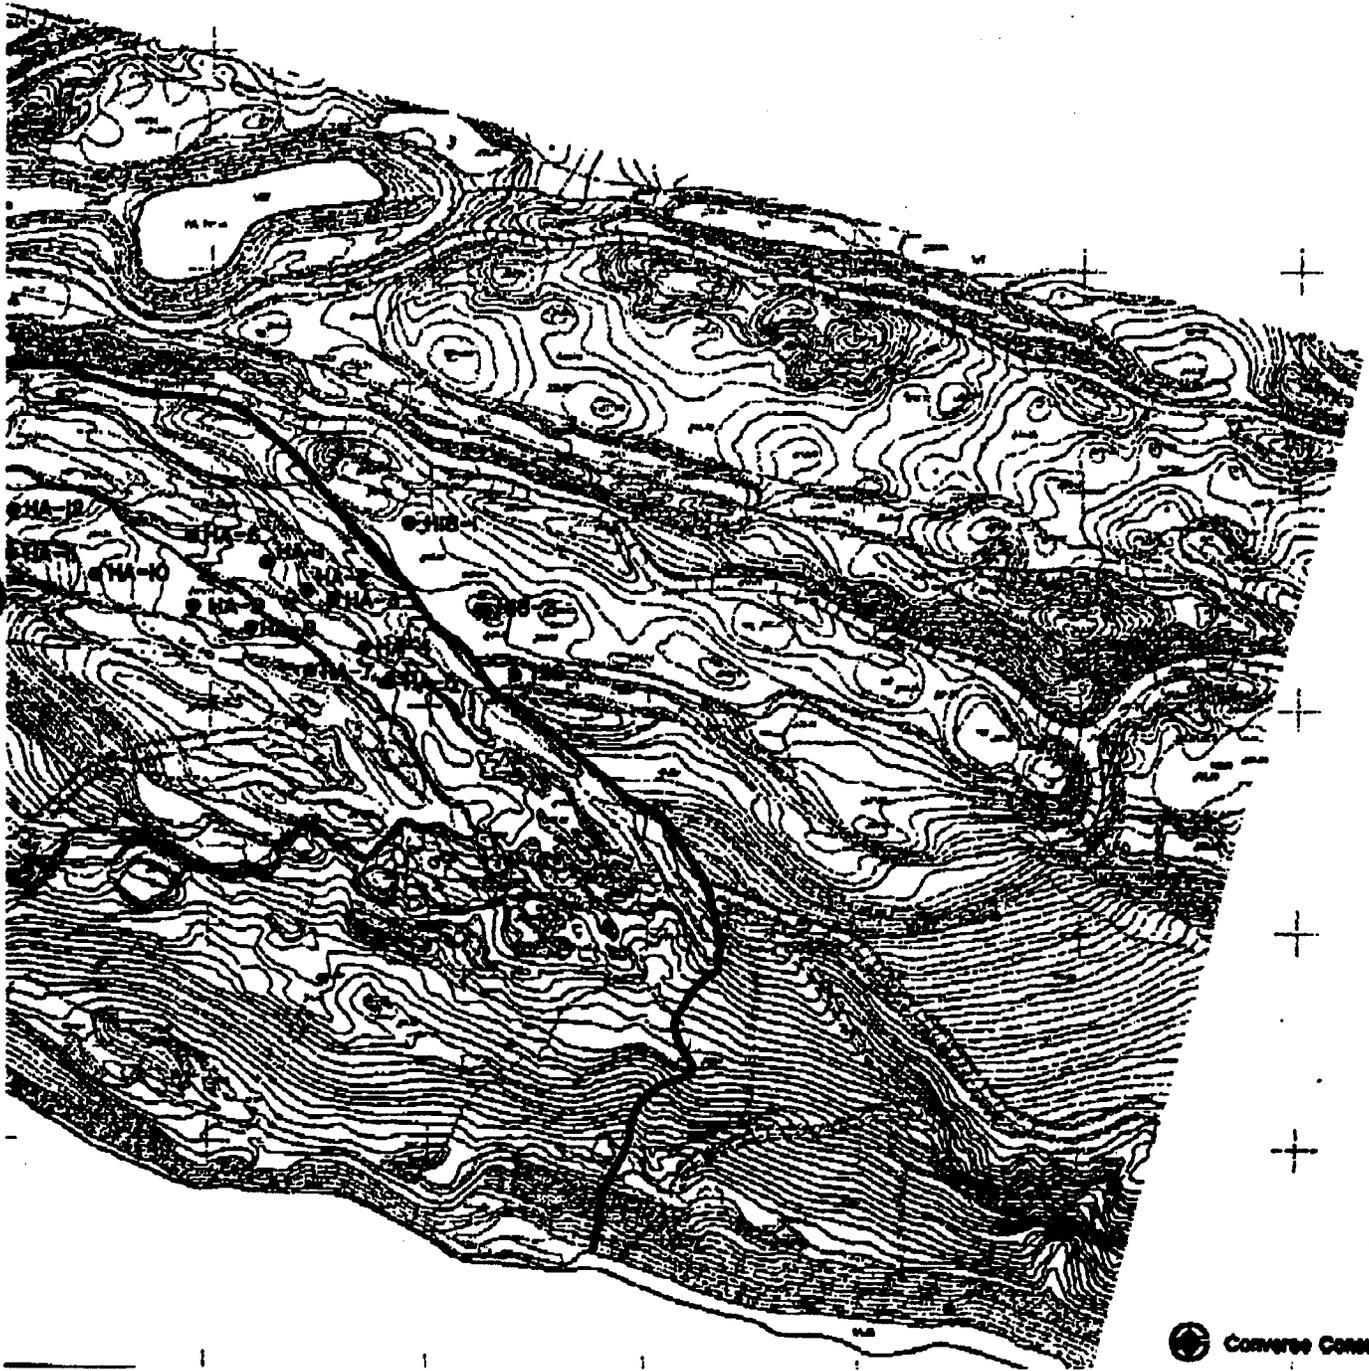
AS RPV 93 005 A14
Exhibit 18 p5

180-3 ● APPROXIMATE LOCATION OF
HAND ALGER TEST BORING

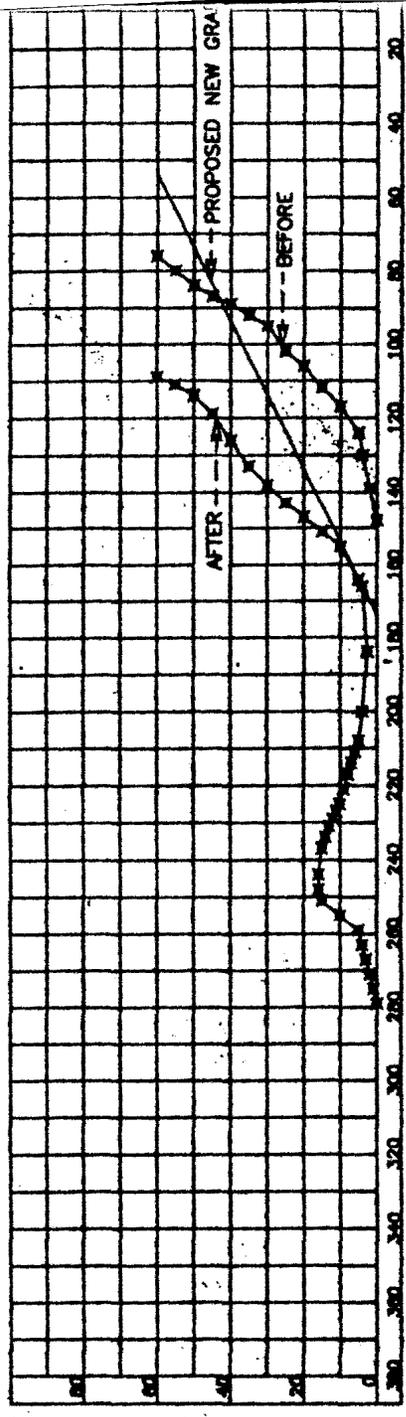
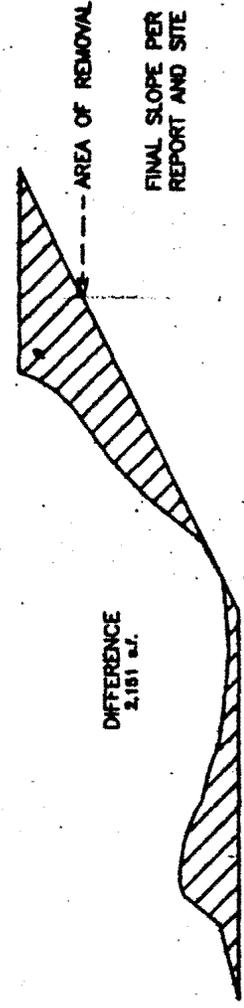
SECTION 2
SCALE: 1"=40'

FINAL SLOPE PER GEO TECHNICAL
REPORT AND SITE CONDITIONS

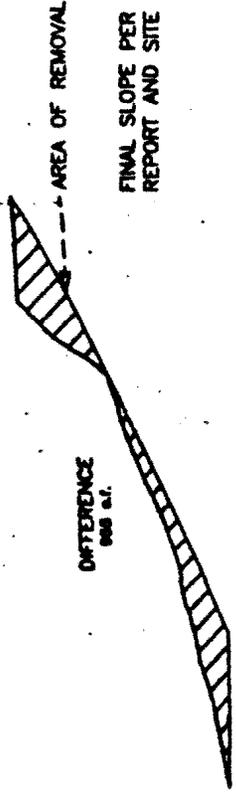
SECTION 3
SCALE: 1"=40'

FINAL SLOPE PER GEO TECHNICAL
REPORT AND SITE CONDITIONS

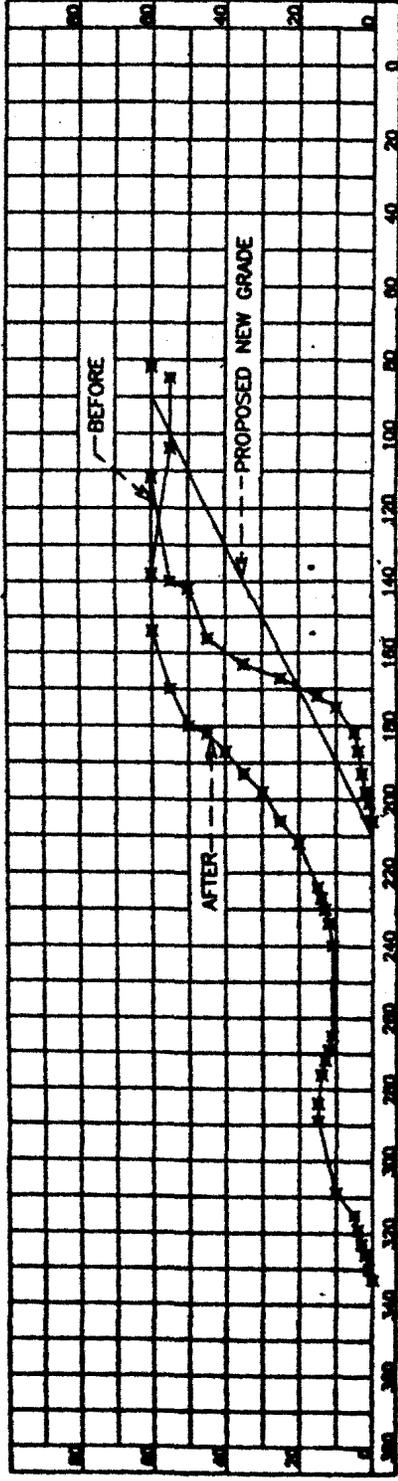
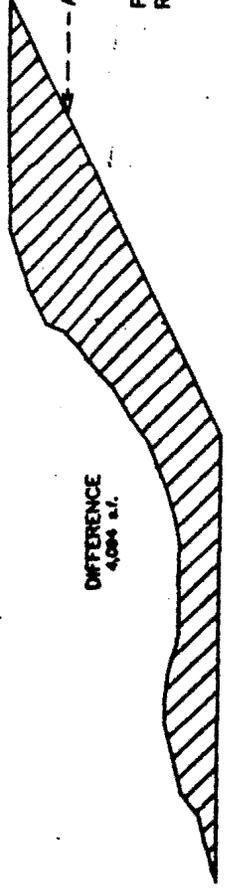
SECTION 1
SCALE: 1"=40'

FINAL SLOPE PER GEO TECHNICAL
REPORT AND SITE CONDITIONS
