STAFF REPORT AND RECOMMENDATION ON APPEAL

APPEAL NO.: A-6-LJS-98-169

PROJECT DESCRIPTION: Interior and exterior renovation to an existing non-conforming 10,006 sq.ft., two-story over basement single family residence with attached garage resulting in a reduction in size to 9,801 sq.ft. on a .23 acre blufftop lot. Also proposed is the demolition and rebuilding of a south side yard wall, removal of an encroachment into the Mira Monte Place public right-of-way, removal and replacement of a wall along the eastern portion of the home, landscape improvements and after-the-fact approval (and repair) of an existing 96-foot long, concrete vertical seawall which attains a height of +11.7 ft. MSL to +18 ft. MSL.

PROJECT LOCATION: 6102 Camino de la Costa, La Jolla, San Diego, San Diego County. APN 357-141-04

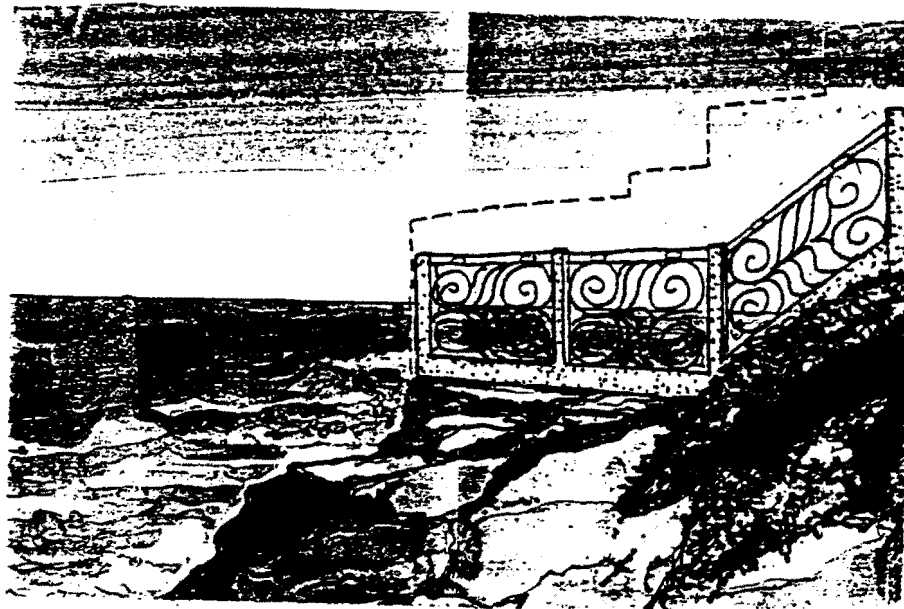
VIEW AS PROPOSED FROM MIRA MONTE PLACE THROUGH
NEW REDUCED HEIGHT OPEN PROTECTIVE FENCING

"after"

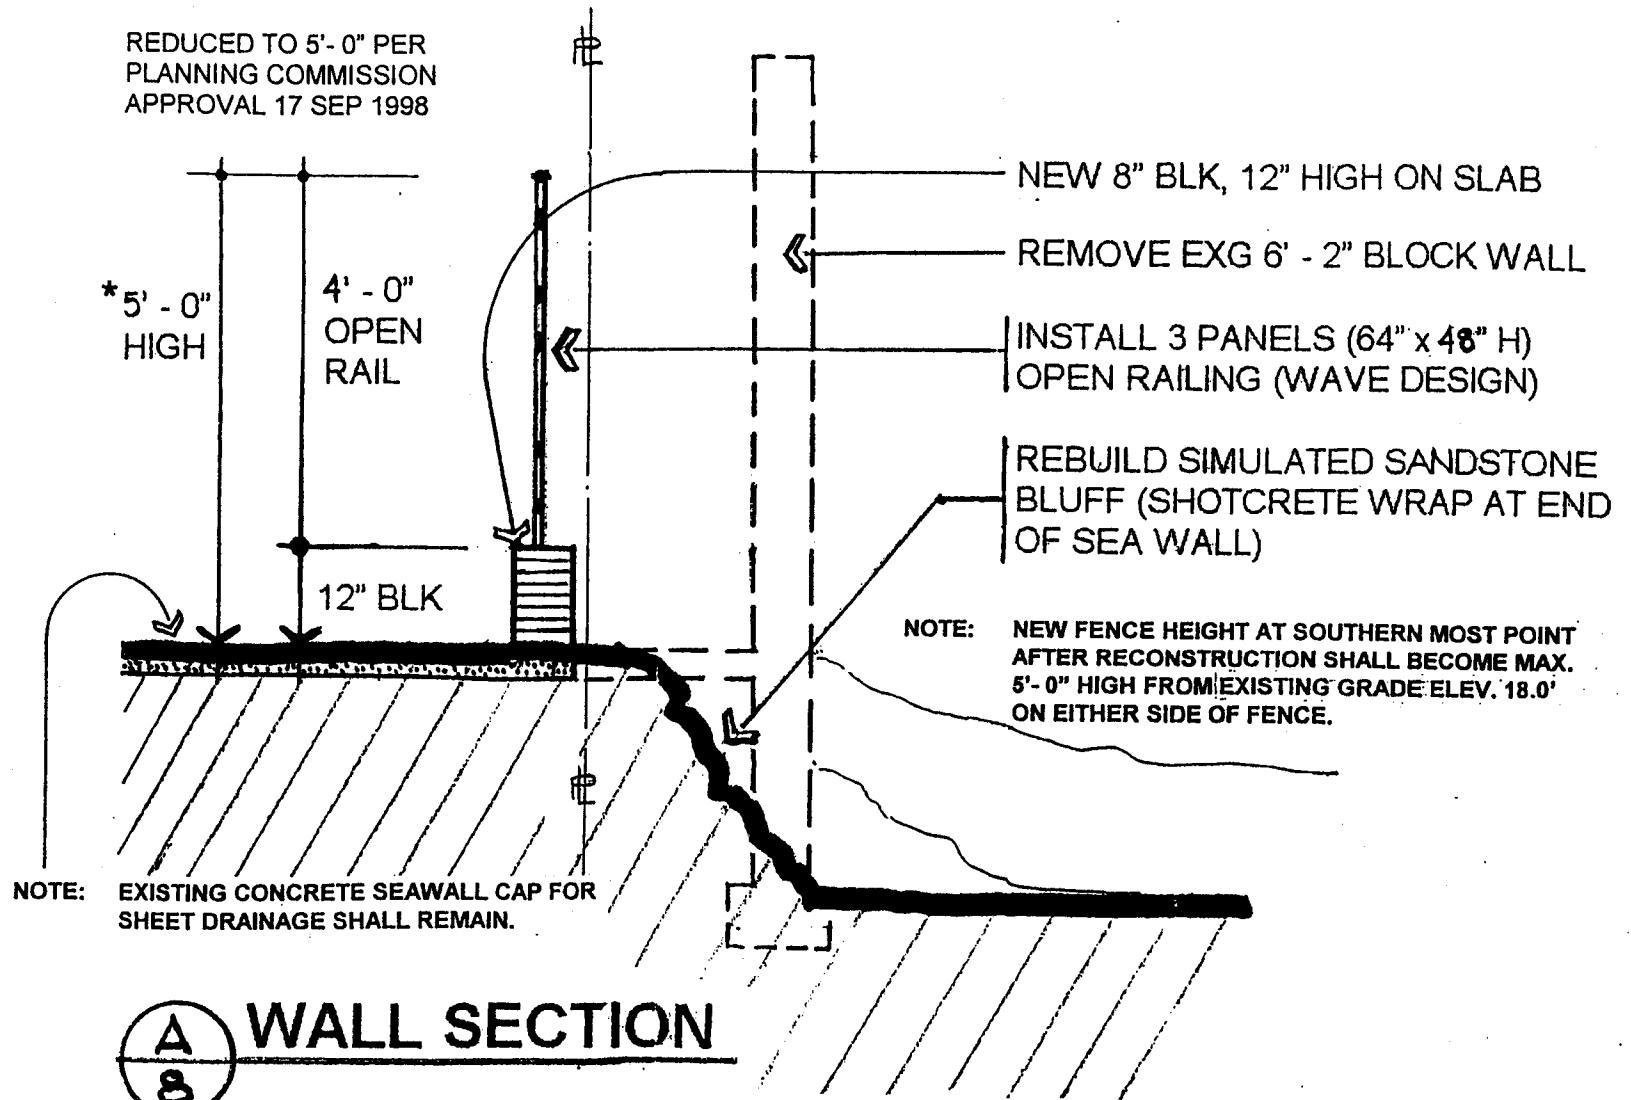
REDUCED TO 5'-0" PER
PLANNING COMMISSION
APPROVAL 17 SEP 1998

EXHIBIT NO. 5
APPLICATION NO.
A-6-LJS-98-169
Cross-Section of Proposed
South Side-Yard Wall
California Coastal Commission
