REGULAR CALENDAR
STAFF REPORT AND PRELIMINARY RECOMMENDATION

Application No.: 6-01-159

Description: Construction of an approximately 40 ft.-long, 13 ft.-high and 27 in.-thick tiedback concrete seawall incorporating two rows of approximately 30 ft.-long rock anchors.

Site: On the public beach below 308/310 Neptune Avenue, Encinitas, San Diego County. APN: 256-352-04

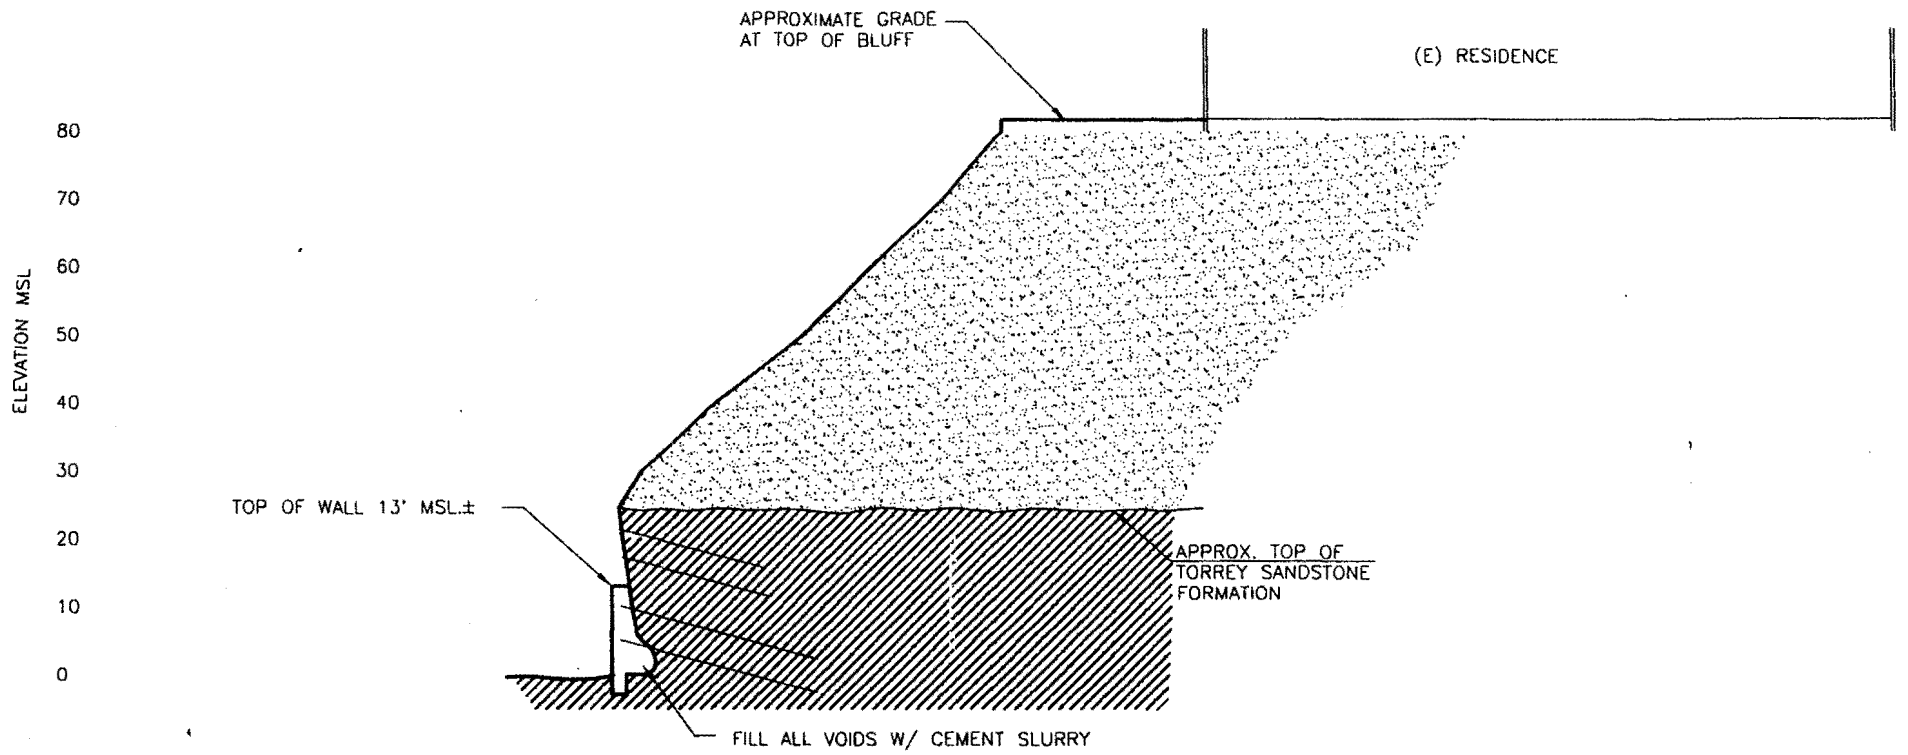
PROFILE SECTION A/2

SCALE: 1"=20'

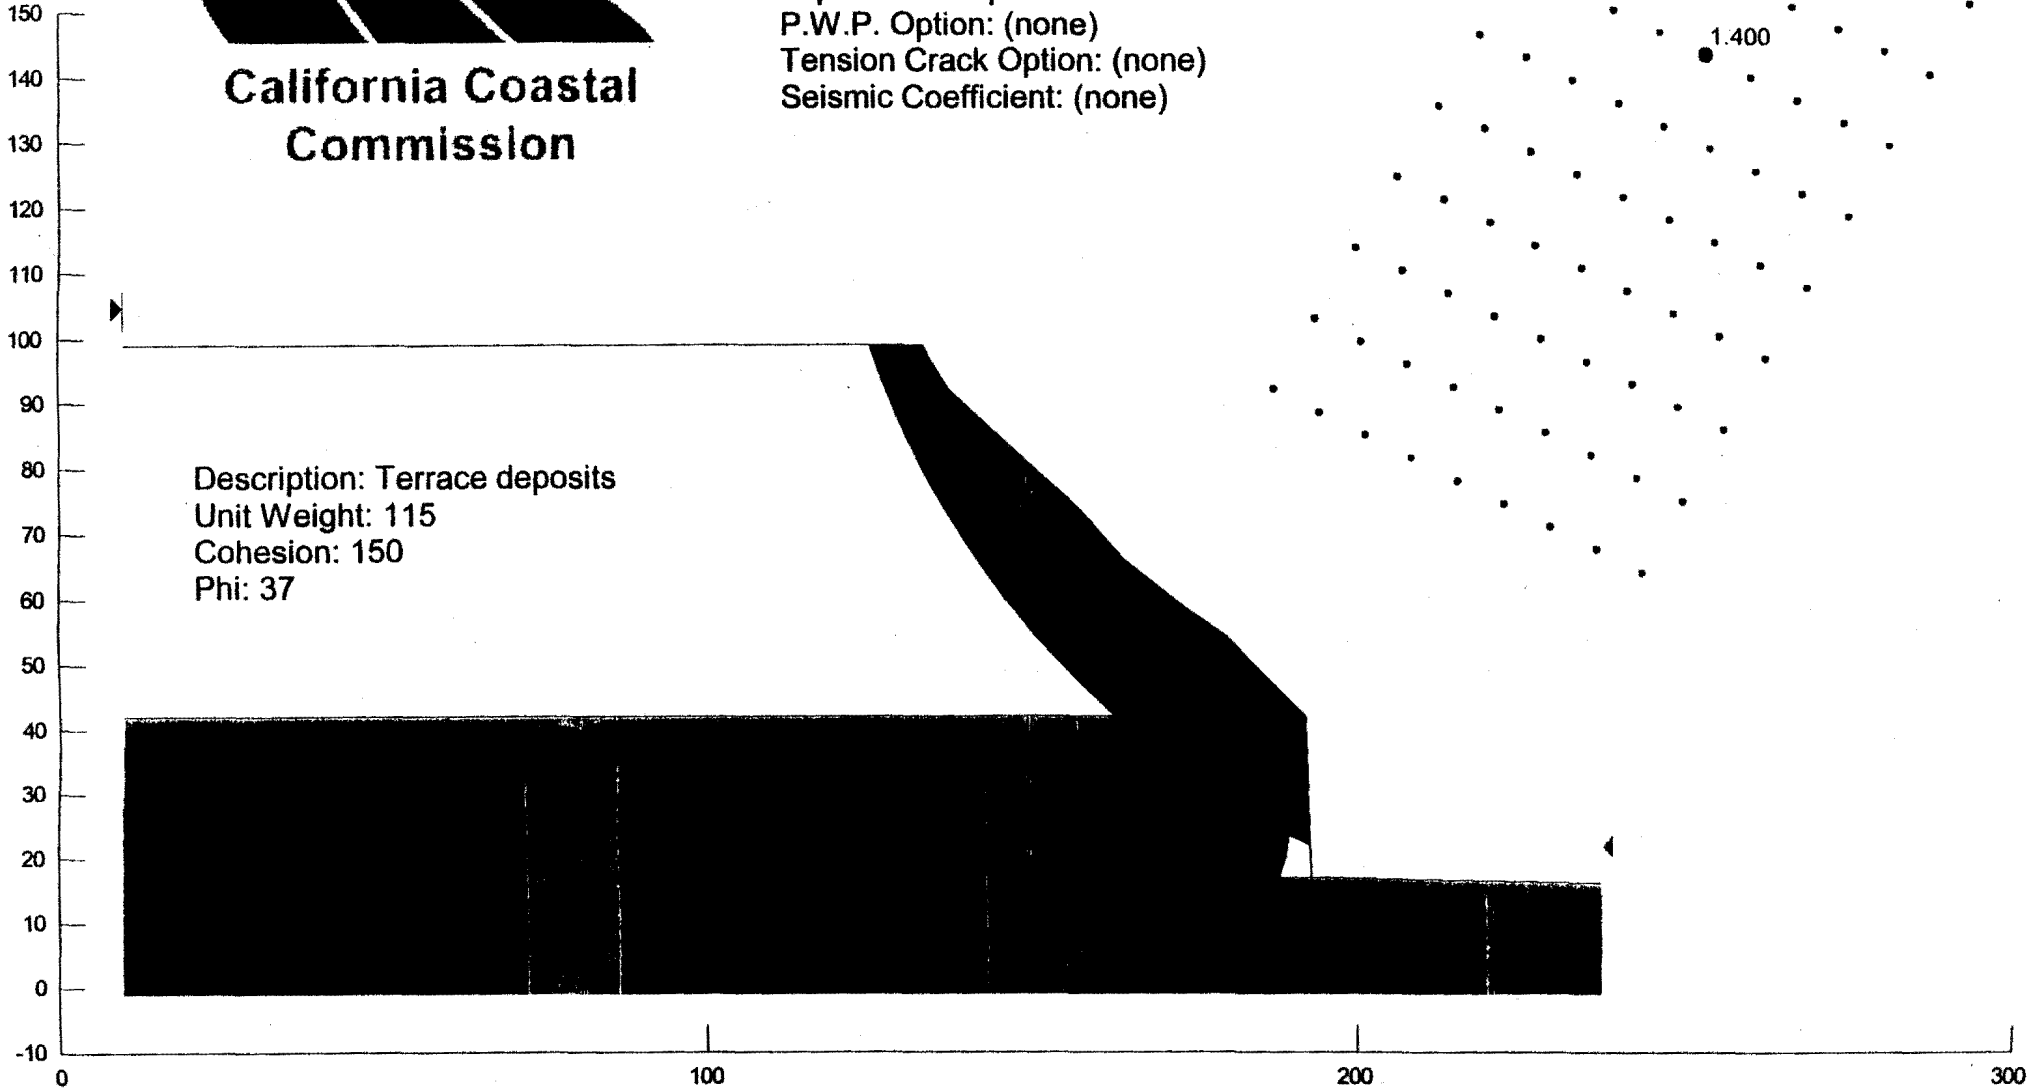
Encinitas Bluff stability:
CDP Application 6-01-053:
Analysis Method: Bishop
Slip Surface Option: Grid and Radius
P.W.P. Option: (none)
Tension Crack Option: (none)
Seismic Coefficient: (none)

angle) and similar analysis methods as in the 17 March 2000 and 7 April 2000 Soil Engineering Construction reports, I was unable to reproduce the reported low factors of safety for the overall stability of bluff. My analysis showed a static factor of safety of 1.400 using the Bishop method, and 1.398 using the mathematically more rigorous Morgenstern-Price method (see attached figures). Although these figures are below the figure of 1.5 generally required for new construction, they do show that the bluff is not in imminent danger of failure through a mechanism involving collapse of the entire bluff along a failure plane extending uninterrupted through the Torrey sandstone and the overlying terrace deposits.
