REGULAR CALENDAR
STAFF REPORT AND PRELIMINARY RECOMMENDATION

Application No.: 6-01-160

Description: Construction of an approximately 80 ft.-long, 13 ft.-high and 27 in.-thick tiedback concrete seawall incorporating two rows of approximately 30 ft.-long rock anchors.

Site: On the public beach below 252 and 258 Neptune Avenue, Encinitas, San Diego County. APNs: 256-352-13 and 256-352-12

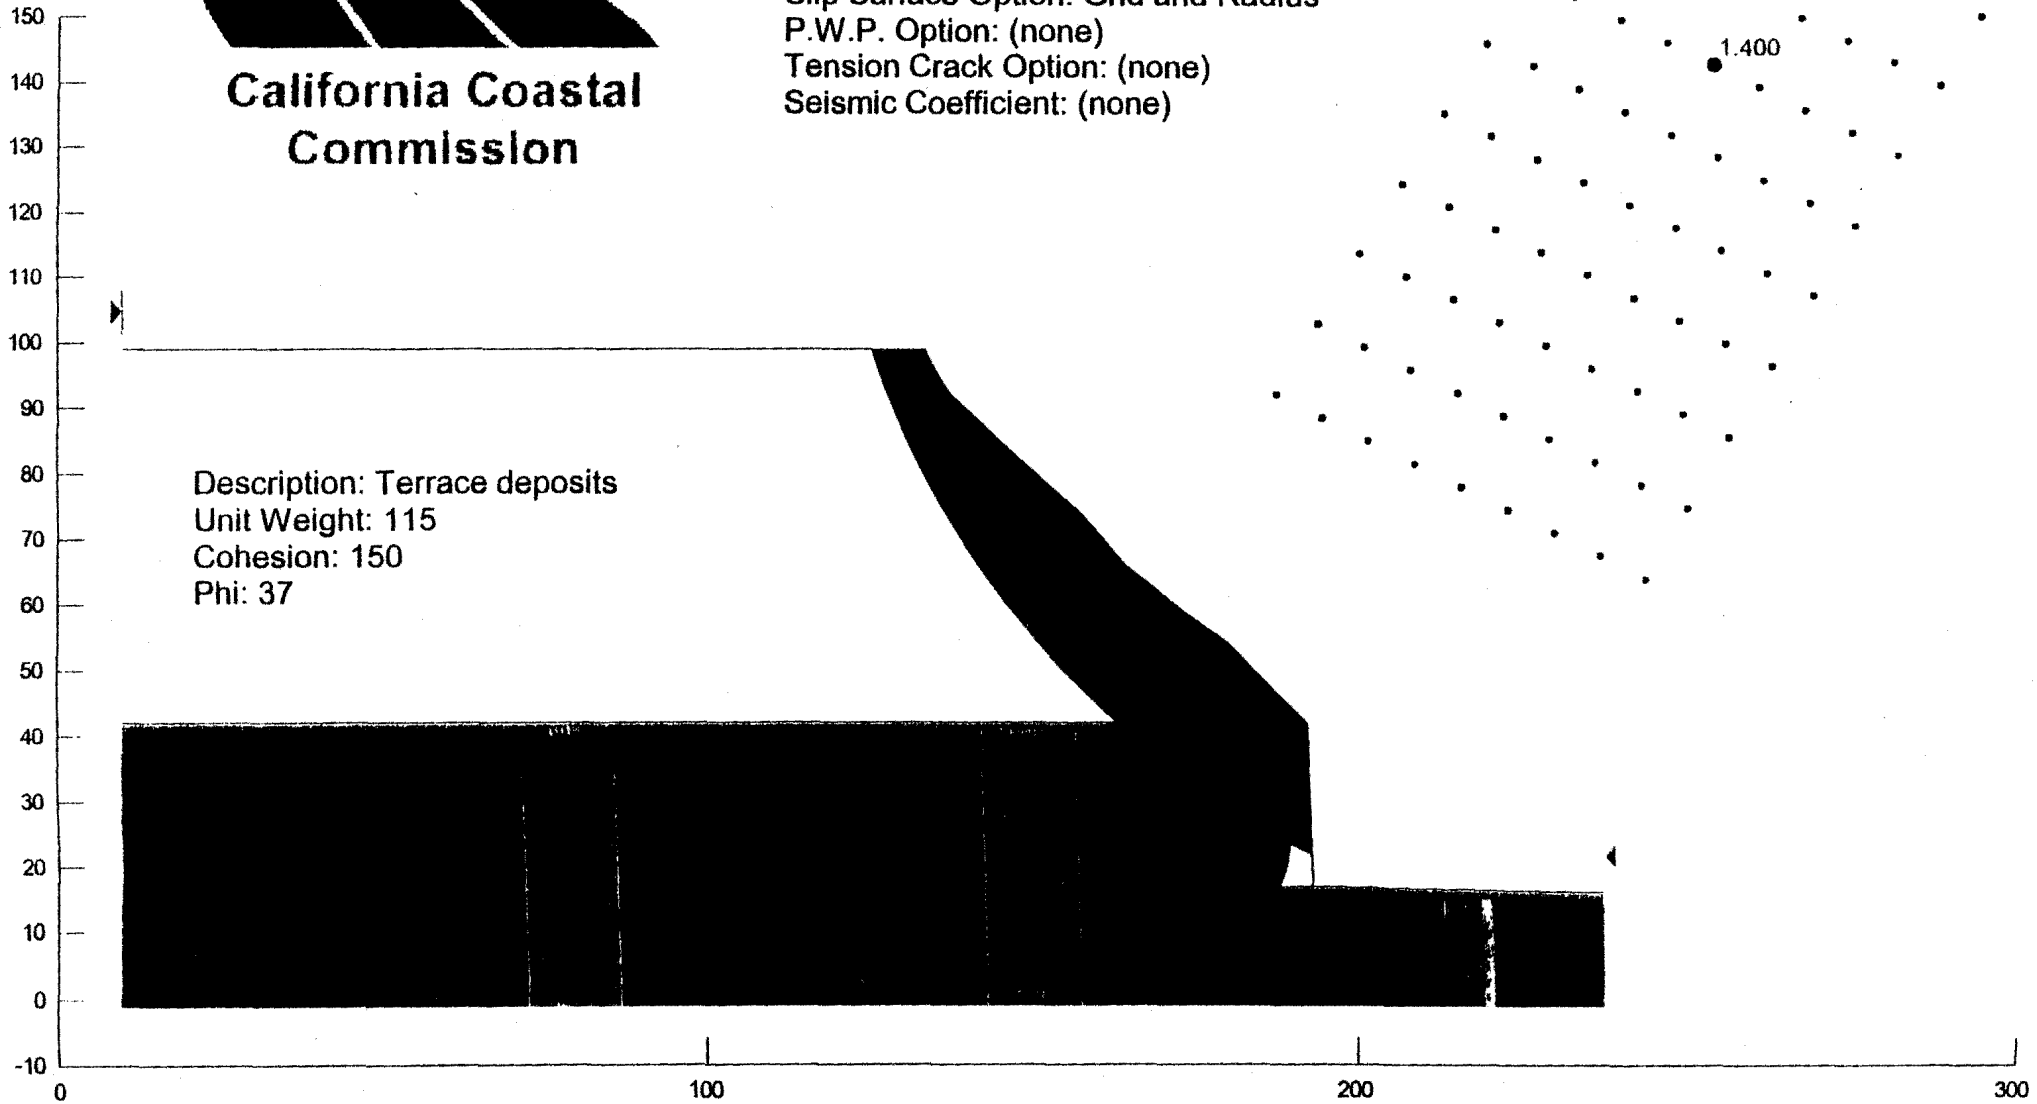
Encinitas Bluff stability:
CDP Application 6-01-053:
Analysis Method: Bishop
Slip Surface Option: Grid and Radius
P.W.P. Option: (none)
Tension Crack Option: (none)
Seismic Coefficient: (none)

angle) and similar analysis methods as in the 17 March 2000 and 7 April 2000 Soil Engineering Construction reports, I was unable to reproduce the reported low factors of safety for the overall stability of bluff. My analysis showed a static factor of safety of 1.400 using the Bishop method, and 1.398 using the mathematically more rigorous Morgenstern-Price method (see attached figures). Although these figures are below the figure of 1.5 generally required for new construction, they do show that the bluff is not in imminent danger of failure through a mechanism involving collapse of the entire bluff along a failure plane extending uninterrupted through the Torrey sandstone and the overlying terrace deposits.

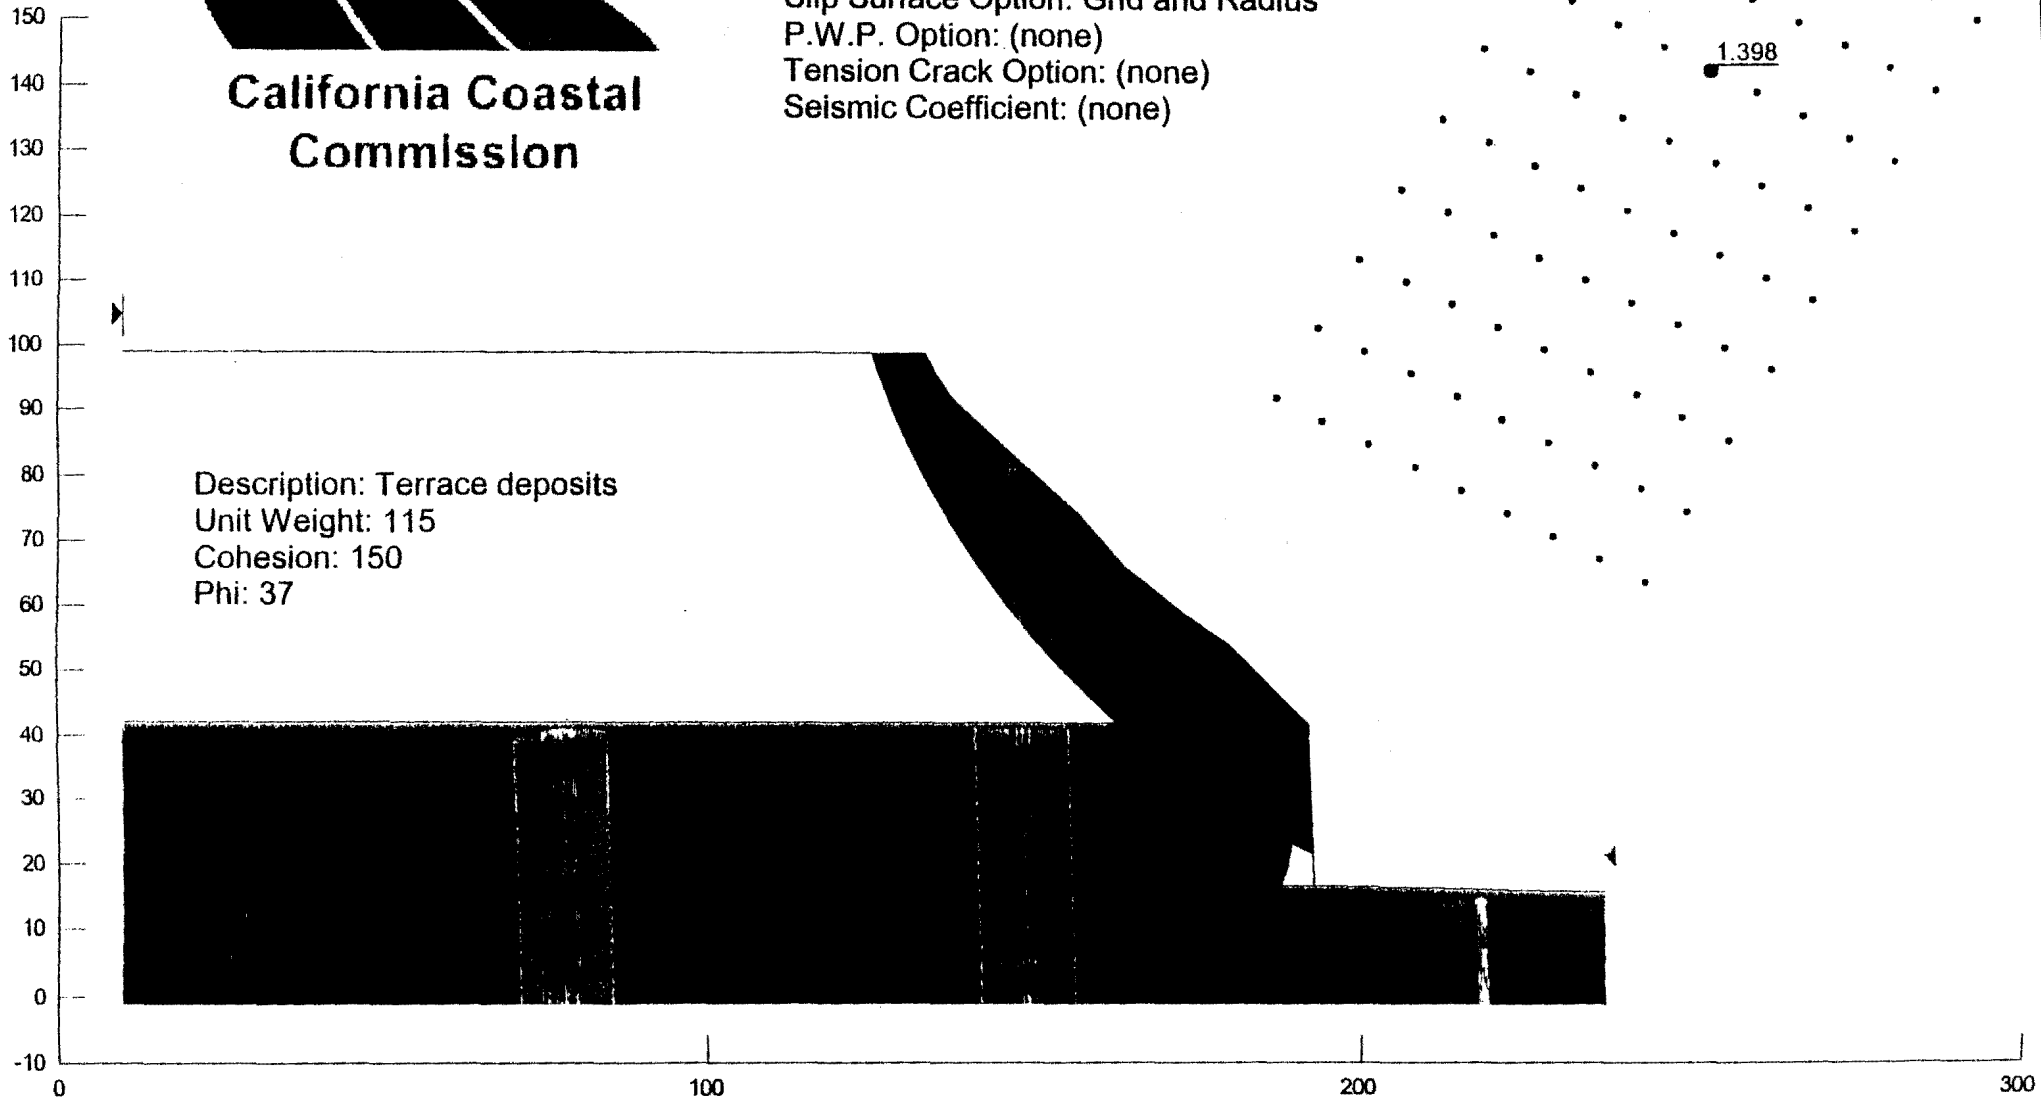
Encinitas Bluff stability:
CDP Application 6-01-053:
Analysis Method: Morgenstern-Price
Slip Surface Option: Grid and Radius
P.W.P. Option: (none)
Tension Crack Option: (none)
Seismic Coefficient: (none)
