CALIFORNIA COASTAL COMMISSION

STAFF REPORT: REGULAR CALENDAR

APPLICATION NO.: 4-01-180

PROJECT DESCRIPTION: Construction of a one-story, 18 foot high, 2,321 sq. ft. single family residence, with attached two-car garage, septic system, swimming pool, entry gate, widened driveway, and 79 cu. yds. of grading (55 cu. yds. cut, 24 cu. yds. fill).

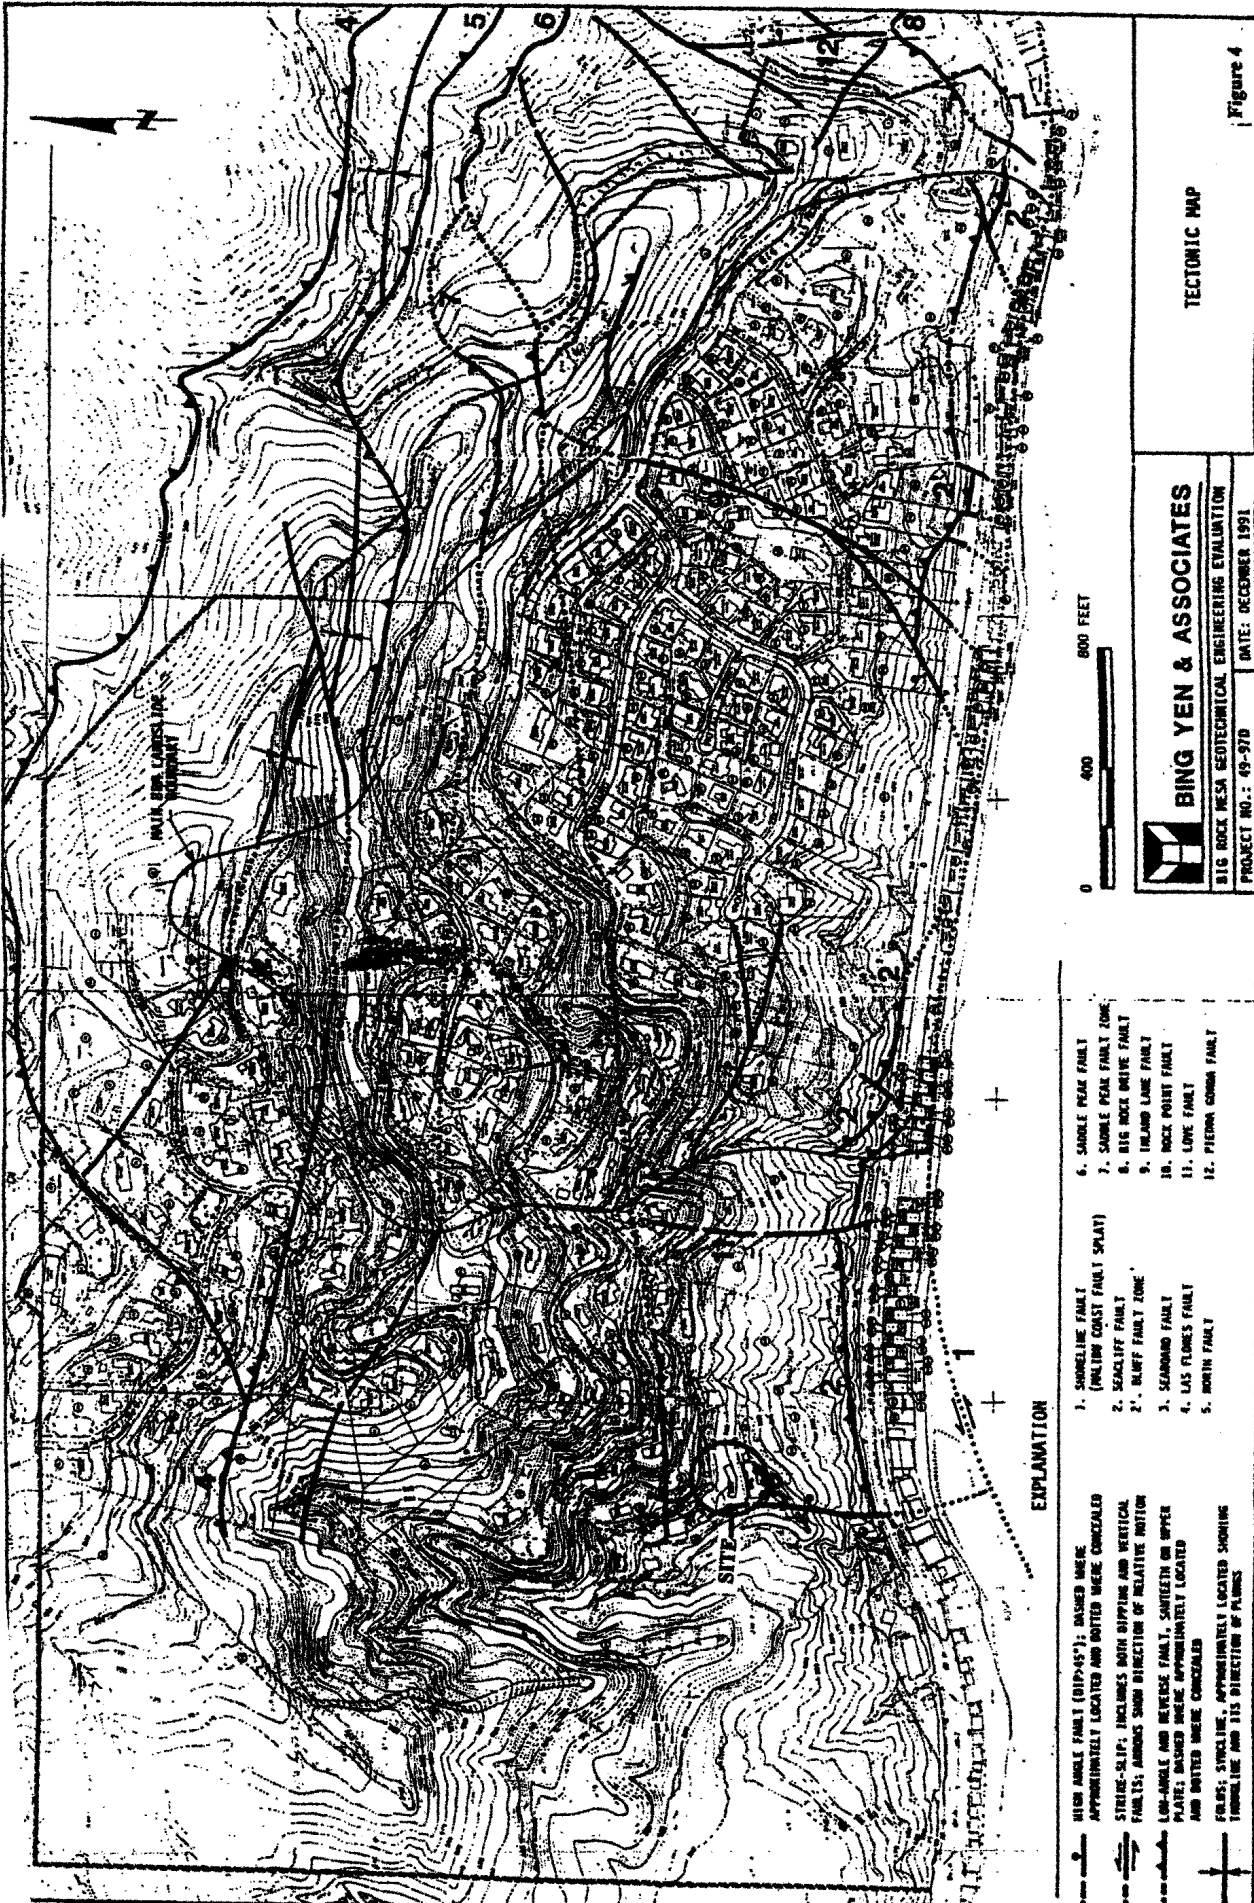
Figure 4

TECTONIC MAP

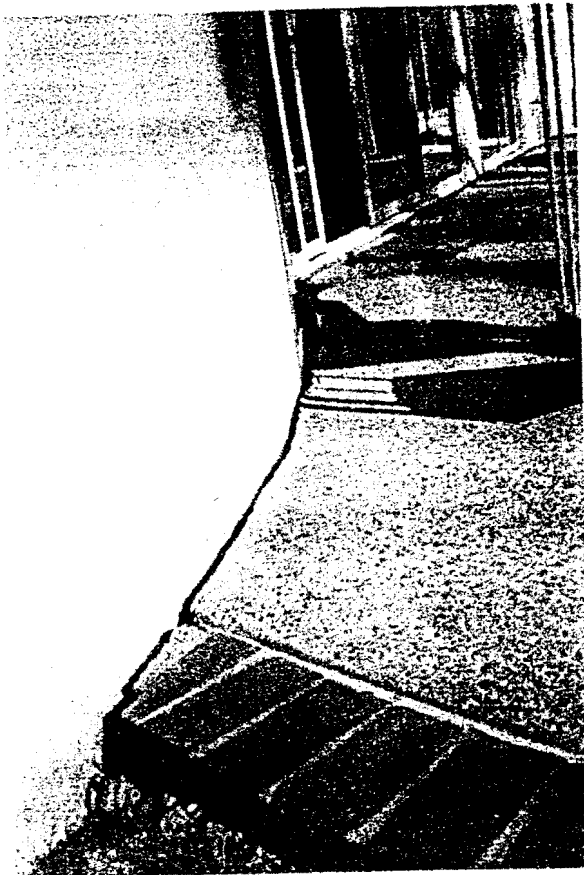
Retaining Wall Supporting
the Downslope from the
Applicants' Property

Property Damage Caused
by 1998-2000 Landslide Activity

As noted in the 2002 Kowalewsky Report and the Ehlert Report, the 1998 water main break caused landslide movement that resulted in substantial damage to the neighboring properties. Among other things, major cracks appeared in retaining walls supporting the slope of the Property, the concrete decking around the 20790 residence, and the swimming pool. The Applicants visited the residence, observed and discussed the damage and its cause with the owners. Photographs of damage caused by the water main break and resulting ground movement are attached.

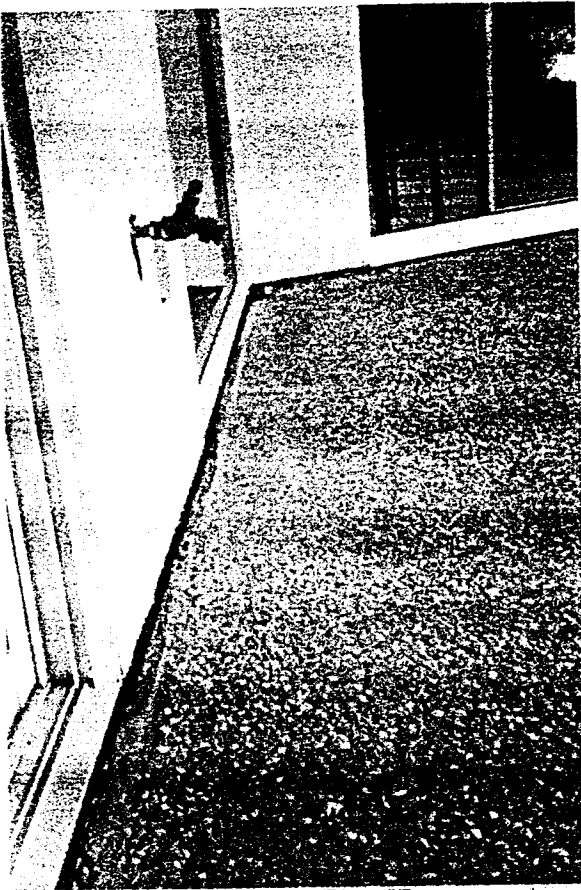
Property Damage Caused
by 1998-2000 Landslide Activity

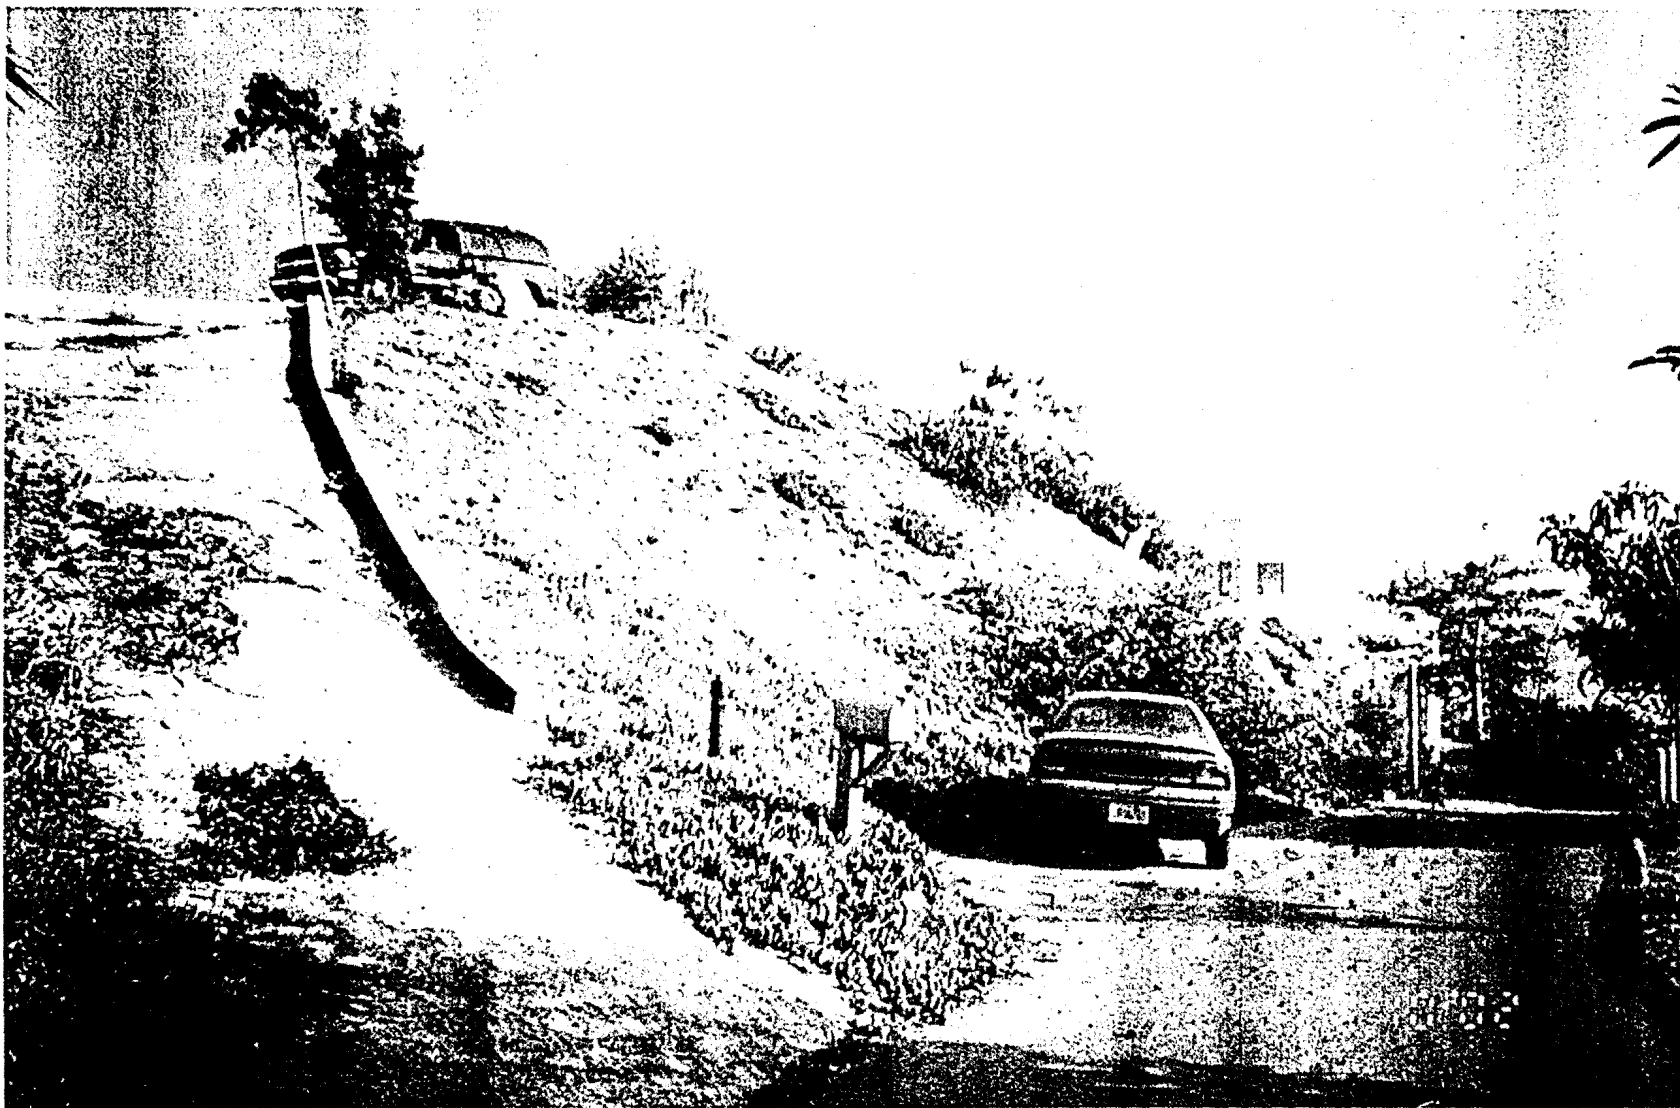
Photo 4: Rockpoint Road (right) and existing driveway. Canyon slope is to the right of photo. 20790 Rockpoint Way is in background. View is to the south.
