STAFF RECOMMENDATION**ON CONSISTENCY DETERMINATION**

Consistency Determination No. CD-009-06
Staff: Diane Livia-SF
File Date 2/6/2006
60th Day: 4/7/2006
75th Day: 4/22/2006
Commission Meeting: 4/11/2006

Pillar Point Harbor, Half Moon Bay, San Mateo County
(**Exhibits 1&2**)

East Breakwater Repair and Maintenance

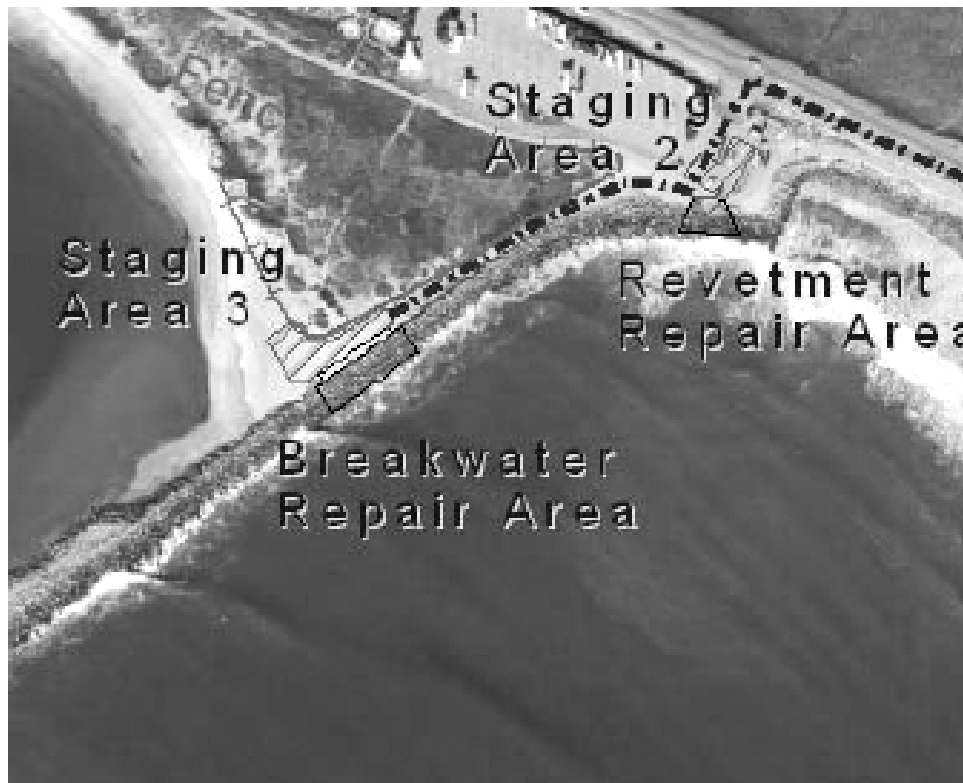
EXHIBIT NO. 4
APPLICATION NO.
CD-009-06
USACE

Location of revetment and breakwater repair sections

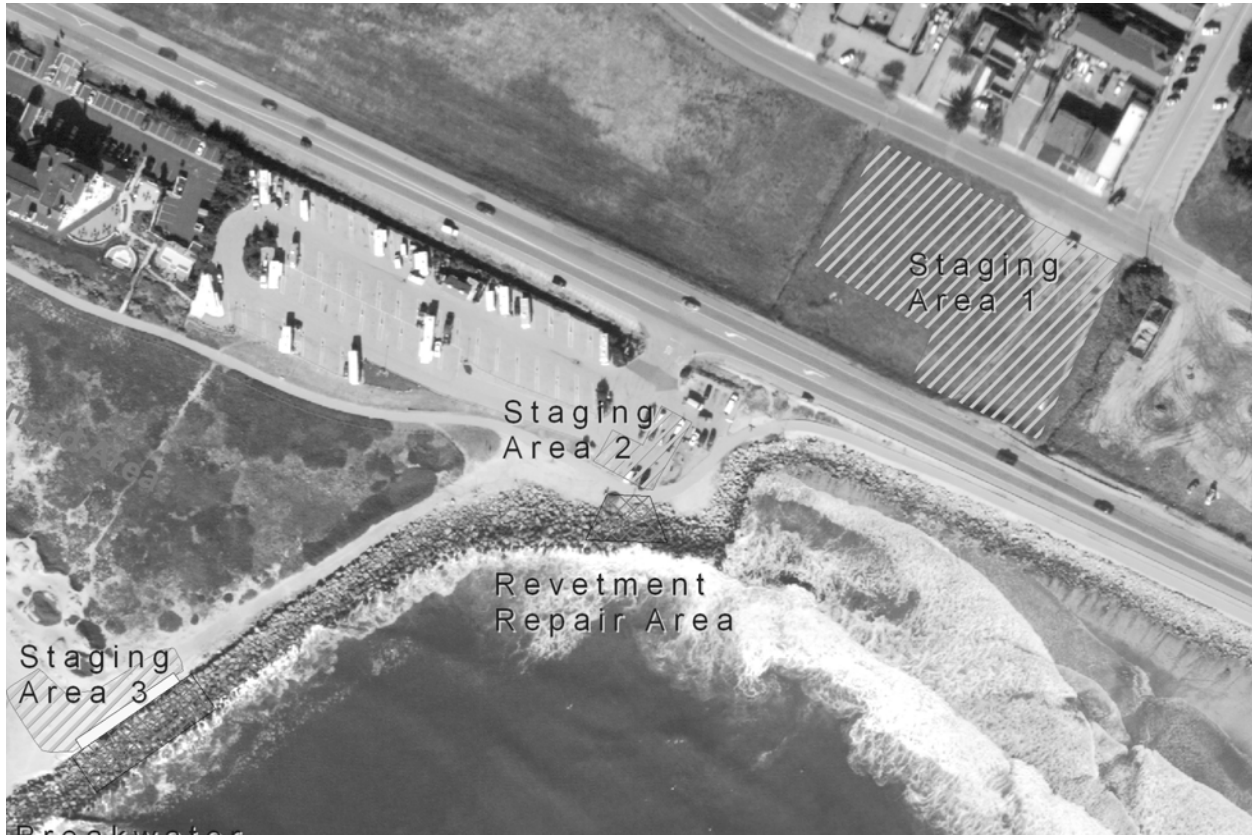
EXHIBIT NO. 6
APPLICATION NO.
CD-009-06
USACE

Staging Areas 1, 2, and 3

Ingress and Egress. The Corps would transport rocks between the breakwater repair section and staging area 1, by truck, through an open path in the sand next to the breakwater. The Corps would also use the open path in the sand to bring the crane in and out of staging area 3. The Corps would move rocks between the repair area and staging area 1, as well as the crane, through the public parking lot via public roads. At the request of the Commission staff, the Corps has agreed to minimize truck impact on Highway 1 traffic during peak traffic hours. The travel distance between staging areas 1 and 2 ranges from approximately one half mile to a mile and a half, depending on the route used. Typical rock trucks carry 18 – 20 tons per load. Trucks could carry two to three loads per hour, and could operate during summer daylight hours up to 10 hours per day.

For truck and crane movement, the Corps will use approximately seven of the 23 spaces in the public parking lot adjacent to the revetment repair section. The Corps has agreed to change the original location of staging area 1, leaving the overflow parking lot on the landward side of Highway 1 available to the public, thereby minimizing the impact on public parking. The beaches up coast and down coast of the east breakwater will remain open. In addition, the sections of the breakwater not undergoing repair will not be blocked to public access in any way. This impact on direct access would be minimal, and temporary. However, the project could also cause indirect access impacts through increased traffic congestion during the busy summer months.

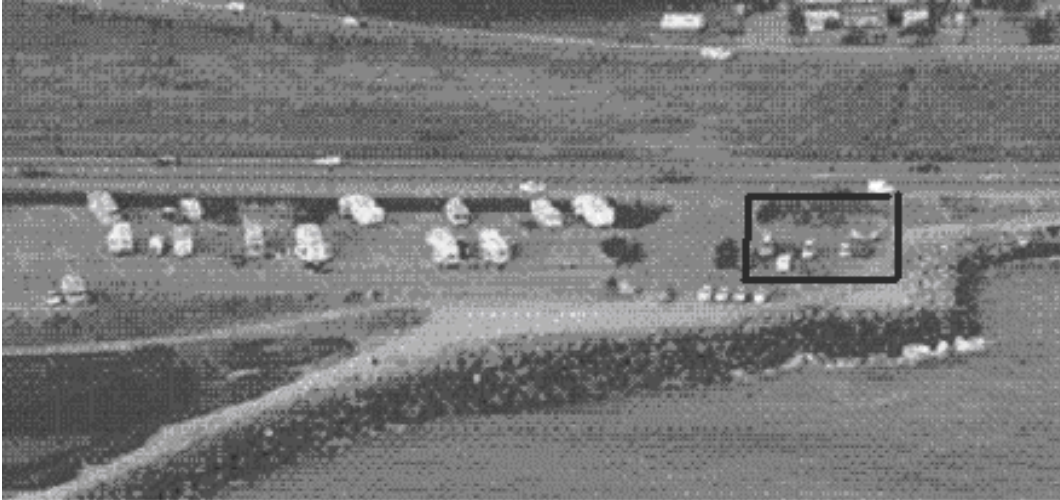
EXHIBIT NO. 7
APPLICATION NO.
CD-009-06
USACE

Public Parking Lot
