# ADDENDUM

SUBJECT: ADDENDUM TO **ITEM Th10b**, COASTAL COMMISSION PERMIT APPLICATION **#5-12-065** FOR THE COMMISSION MEETING OF **August 2012**.

**Project Description:** Bulkhead repair by placement of geotextile filter fabric and rock to restore protection to the toe of bulkhead at 19 properties on various sites throughout Huntington Harbor, Huntington Beach (Orange County).

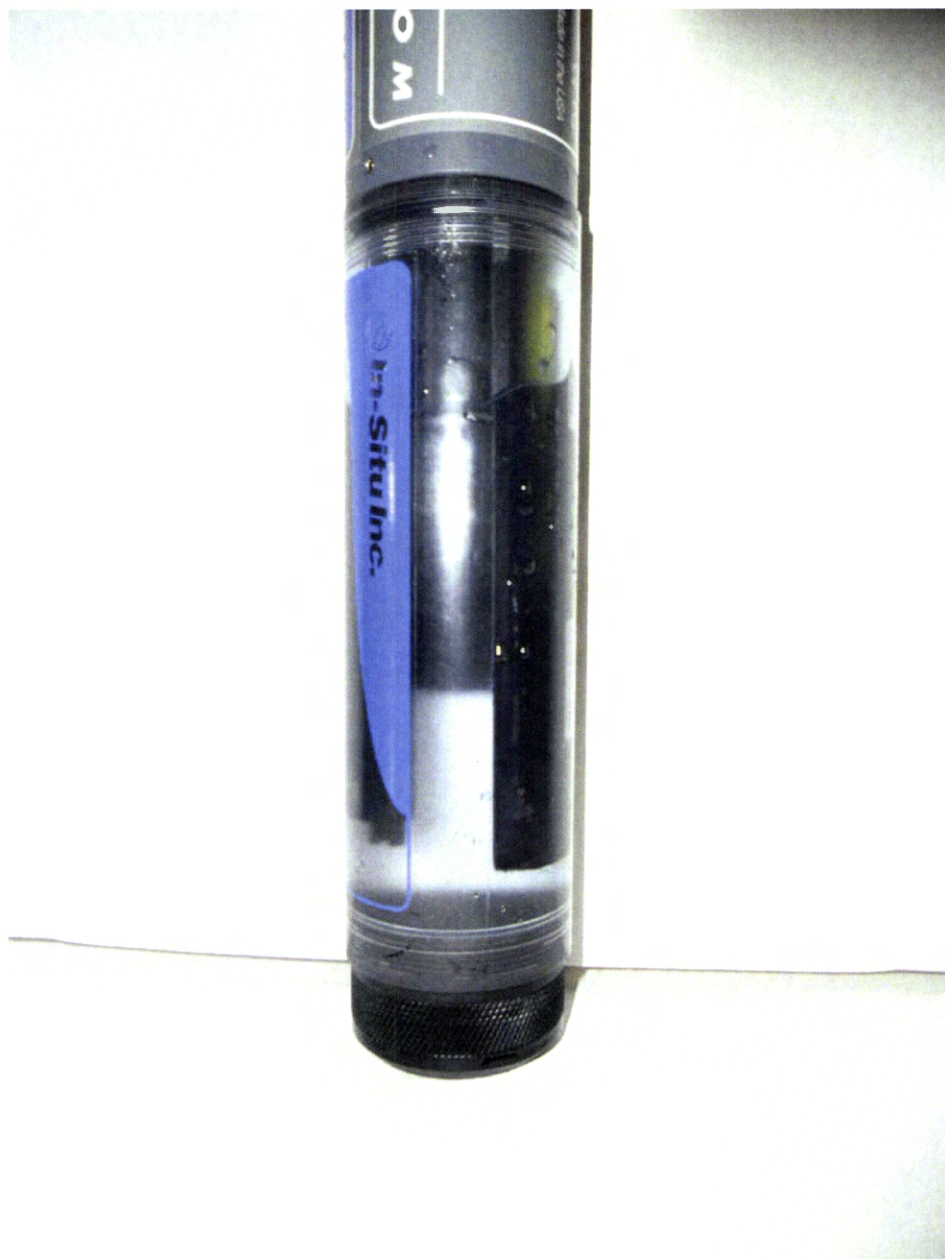
Photo 1: Turbidity of 9.1 FNU that is not noticeable within instrument when held at arms length.

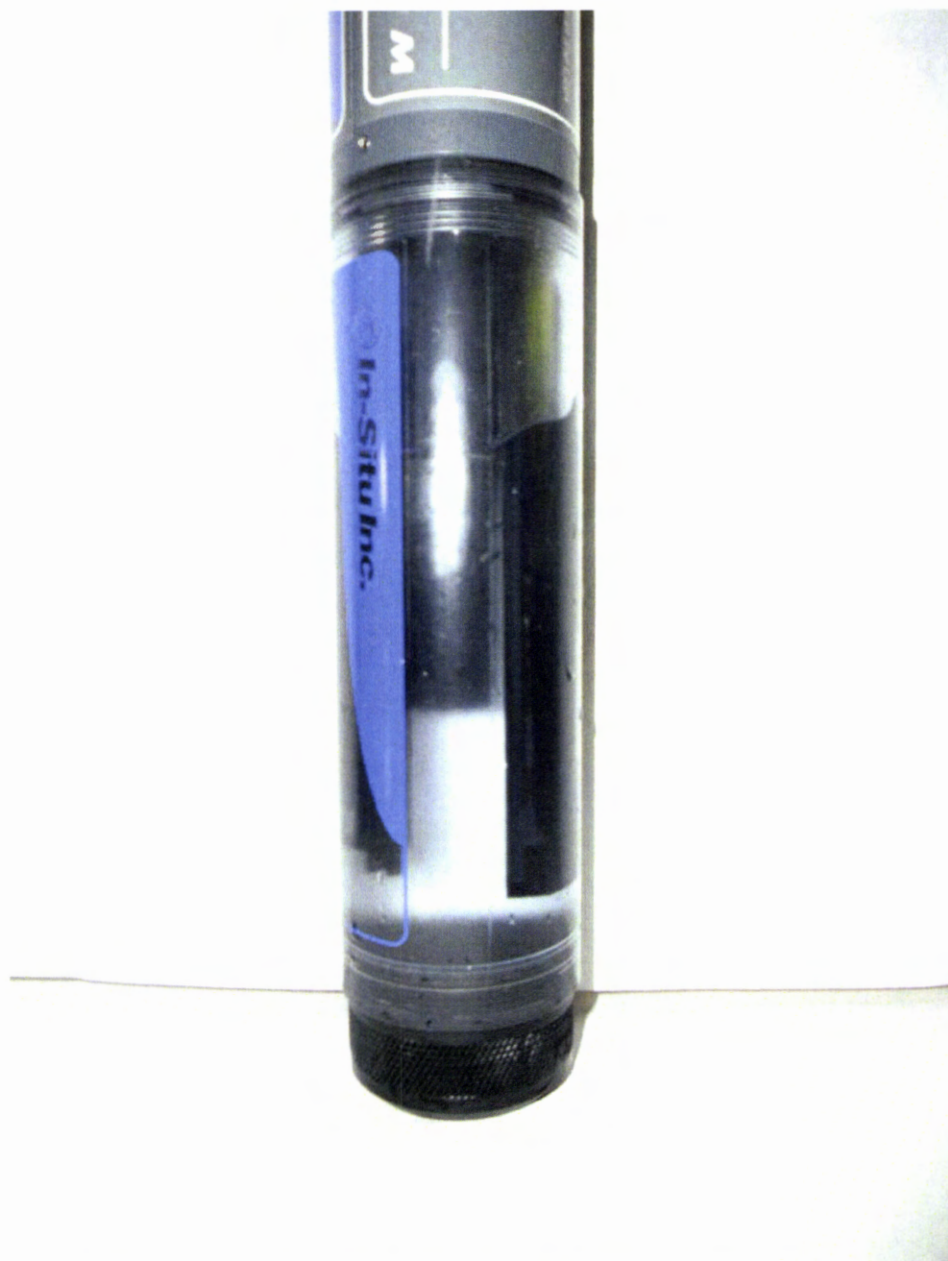
Photo 2: Turbidity of 14.4 FNU that is not noticeable within instrument when held at arms length.

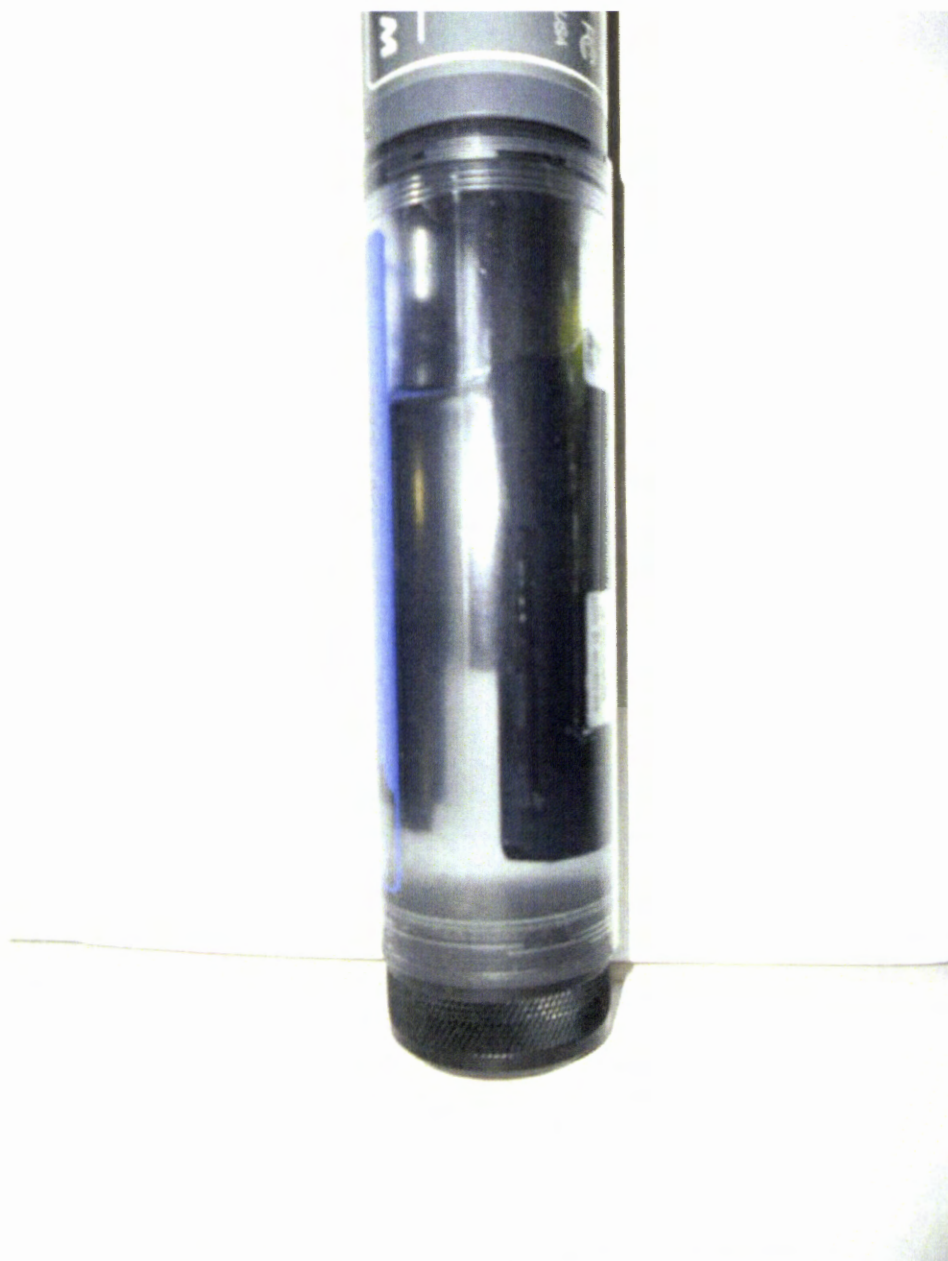
Photo 4: Turbidity of 77.9 FNU that is just noticeable within instrument when held at arms length.

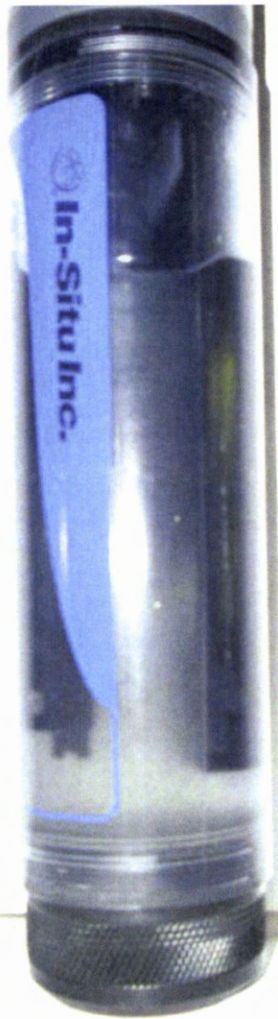
Photo 5: Turbidity of 339.0 FNU that is clearly noticeable within the instrument.
