RE: Monterey Bay Shores ("MBS")

Appeal No. A-3-SNC-114 (Security National Guaranty ("SNG")

Hearing Pursuant to Settlement Agreement
W10a-Th6a-F6a

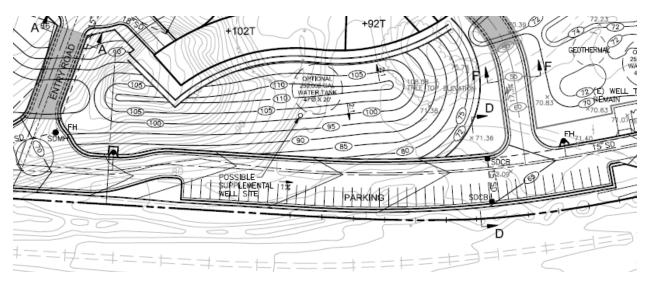
On the other alternative suggested by staff on March 6th, moving the public parking area south to the roundabout is also a bad design and idea and "crams" and "bottlenecks" the access to the north and from the tunnel. Similar issues identified above would be created. For example, consider a section of TM-2 of the VTM showing the area in question.

North of the tunnel there is less traffic. The road here is used for trucks, service, employees, public parking, residents, pedestrians, bikers, occasional emergency vehicles and access to the parcel in the north. However, similar issues exist. By moving the parking south, no view shed benefits are gained, the dune would have to be cut further and significantly near the tunnel and a large retaining wall of at least 25' would need to be built in the southern portion to make up for the grade differential. The situation would worsen if another 5' separation is required per staff suggestion. Circulation close to the roundabout would be impacted with cars from this

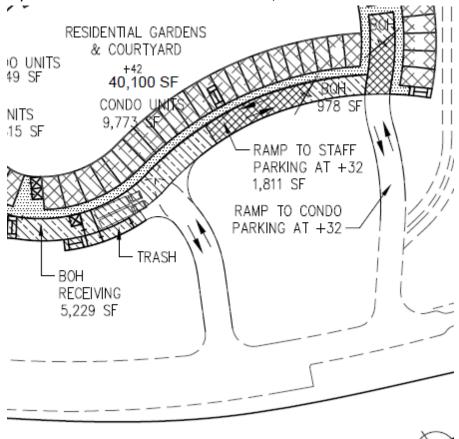
The first access is the Hotel and Back of House deliveries and service access which also doubles as the Employee parking access. It is best shown when looked at in the MBS Plan, Level 42' previously submitted to the Coastal Commission, a section of which is shown below.

This section shows two 40' trailer trucks, typically around 14' high, that are parked against the loading docks which are provided inside the building so as to hide away from the view corridor. Servicing the hotel with loading docks is an operational requirement. Because we are entering at level 42', the floor plate is 20' high[takes 2 floors], to level 62'. Aside from being below the view corridor, a portion of the driveway is covered making the driveway section near the building a tunnel sufficient in height to accommodate trucks of 15' height and completely hide any vehicles or trucks. The top of this tunnel (which also applies to the Condominium access to the north) appears as a restored dune and integrates seamlessly with the green living roof on top of the building and the surrounding area, providing an undulating dune view from Hwy 1 when travelling either south or north for that less than 2 seconds of view. This is another way in which the MBS provides additional habitat restoration area. Inside the building, a portion that is about 110' in length, allows trucks to turn around and maneuver in and out from the receiving docks at 42' out of sight, inside the building. This access and docking facilities are a standard requirement of any hotel operation and circulation. Because the resort provides only underground parking for guests and residents, there is no other location that can accommodate this required service area. This access also serves as entry driveway for employee parking which takes them to the level below at 32'. That is their only access. This area also serves for Trash to be collected and picked up by the refuse company and is also hidden from view. None of these
