**3-18-0814 (CAPITOLA JETTY REHABILITATION)**

## **EXHIBITS**

**Subject:** Capitola Beach Jetty Rehabilitation – Project Description, Revision 1

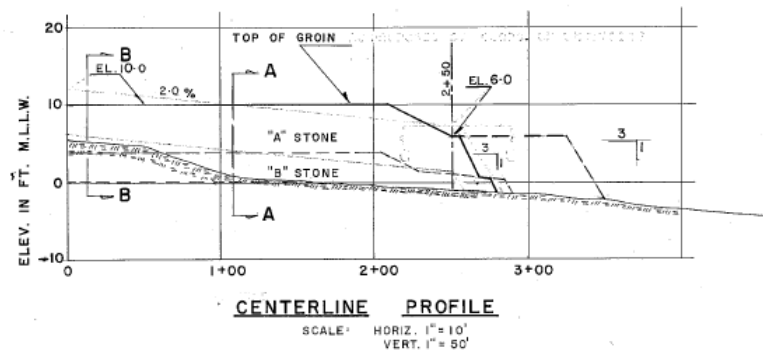
Figure 1: Elevation View of Jetty (Original Design)

The Jetty was originally constructed in 1969 (Figures 1 – 3) to help stabilize the beach and the outlet of Soquel Creek. The construction of the jetties at the Santa Cruz Yacht Harbor in the early 1960's resulted in a disturbance to longshore sediment transport. Capitola Beach was no longer receiving the same quantity of sand, resulting in loss of beach width and presenting a flooding hazard to the City due to waves breaking closer to the shore. The original Jetty was designed by the USACE and constructed as an emergency project to restore the original function of the beach.

Based on the sections shown in the As-Built Drawings, it is anticipated that approximately 3,300 CY of rock was used to construct the jetty. It is estimated that approximately 380 CY (12%) will be needed to restore the jetty to its original configuration (note the initial estimate of 900 CY to reconfigure the jetty has decreased to 380 CY after final design). Of that 380 CY, some of the material will be rocks that have been displaced from the jetty and some of the rock will be new, imported rock. Approximately 240 CY (7%) of rock will either be placed or replaced below the USACE delineated Jurisdictional High Tide Line (HTL) and 170 CY (5%) of rock will be placed or replaced below the USACE delineated Jurisdictional Mean High Water Line (MHW). The remaining quantity of rock (140 CY – 4%) to be placed or replaced is located outside of the intertidal zone.

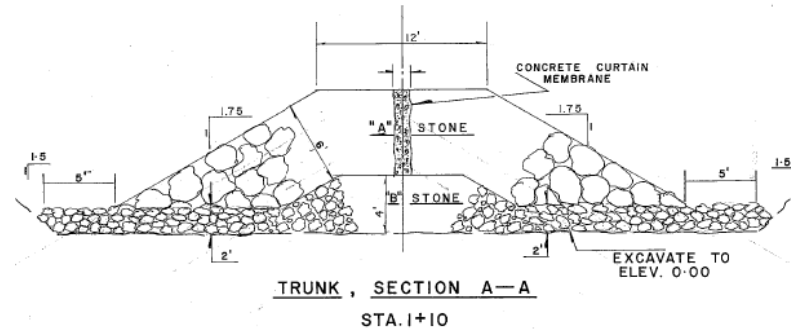
Figure 2: Section View at Seaward End (Original Design)

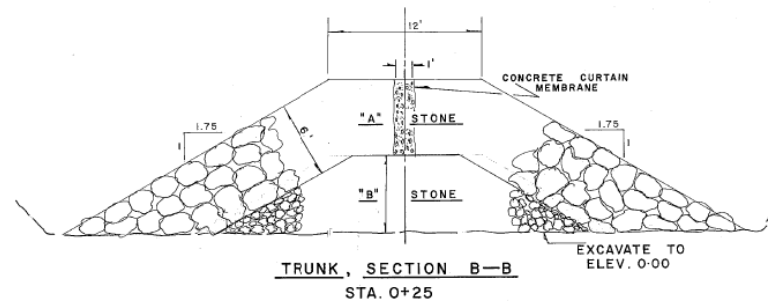
Figure 3: Section View at Landward End (Original Design)

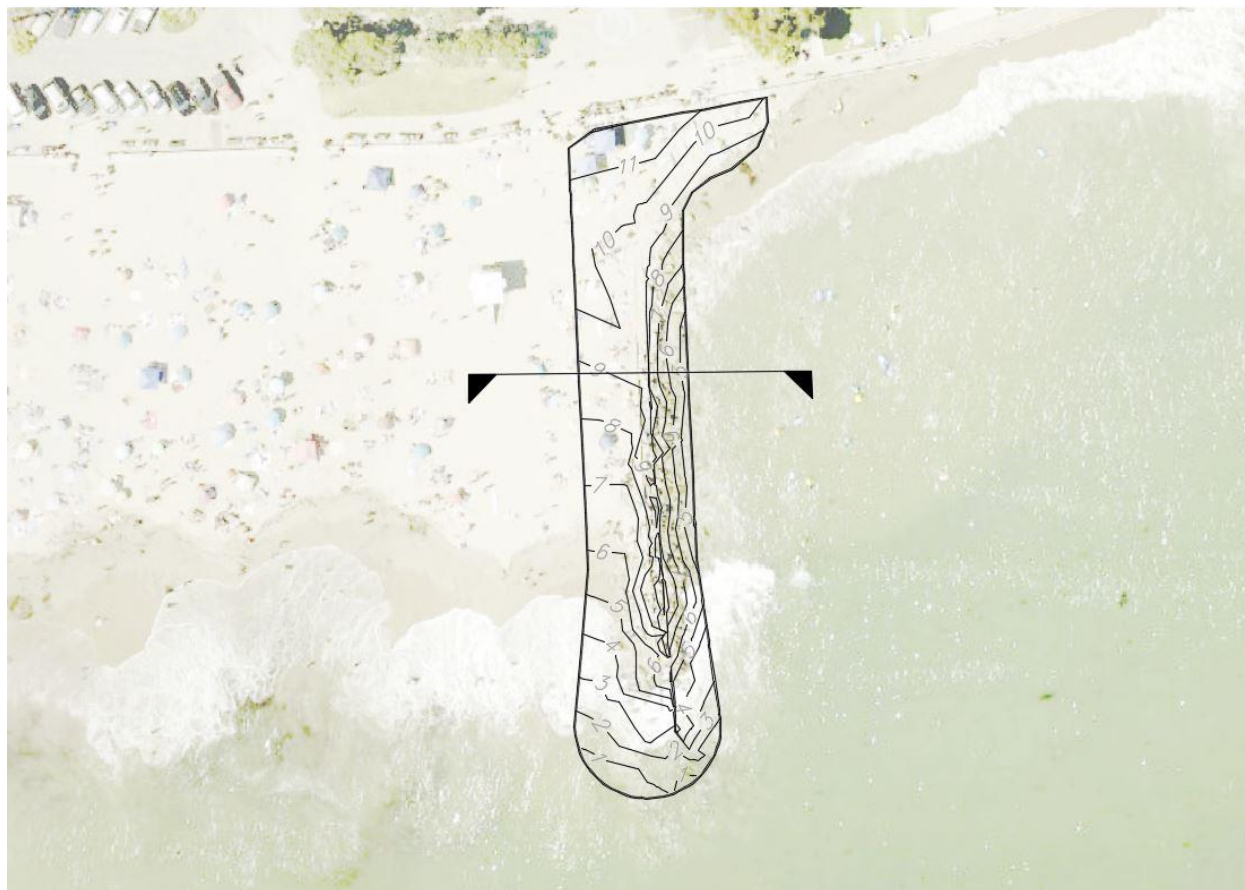
Figure 4: Existing Elevations (feet MLLW) from topographic Survey in May 2018

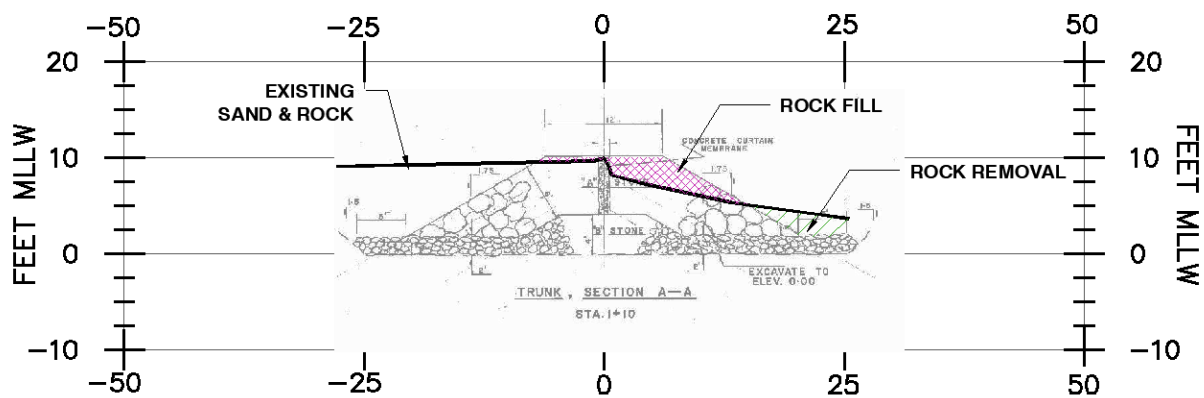
Figure 5: Typical Jetty Section

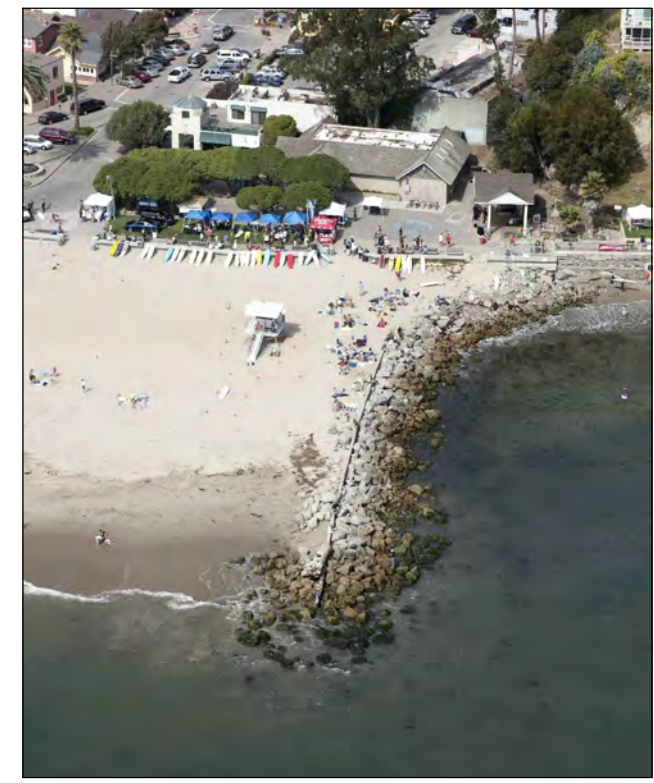
PHOTO 1—JETTY PRE—PROJECT (EXISTING)  
SCALE: NTS

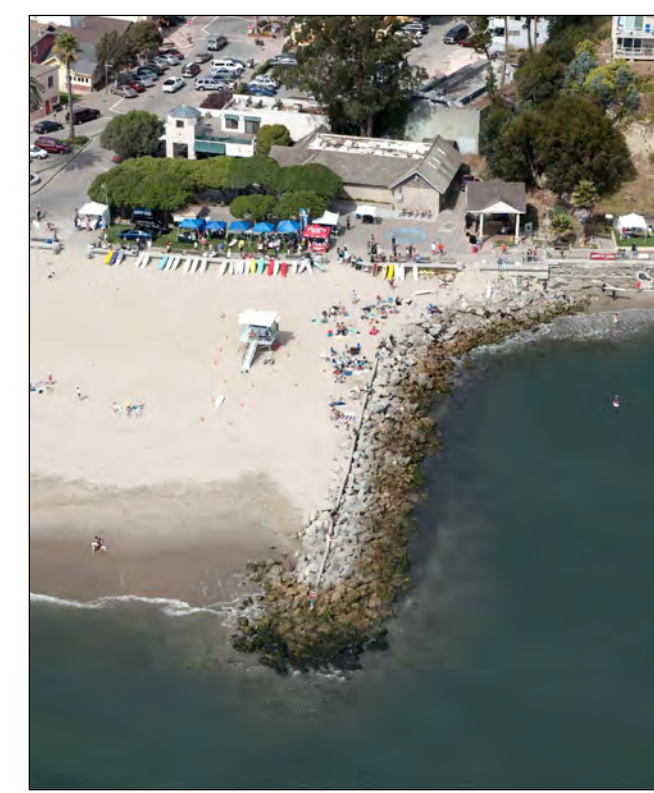
PHOTO 2—JETTY POST— PROJECT (PHOTO RENDITION)  
SCALE: NTS

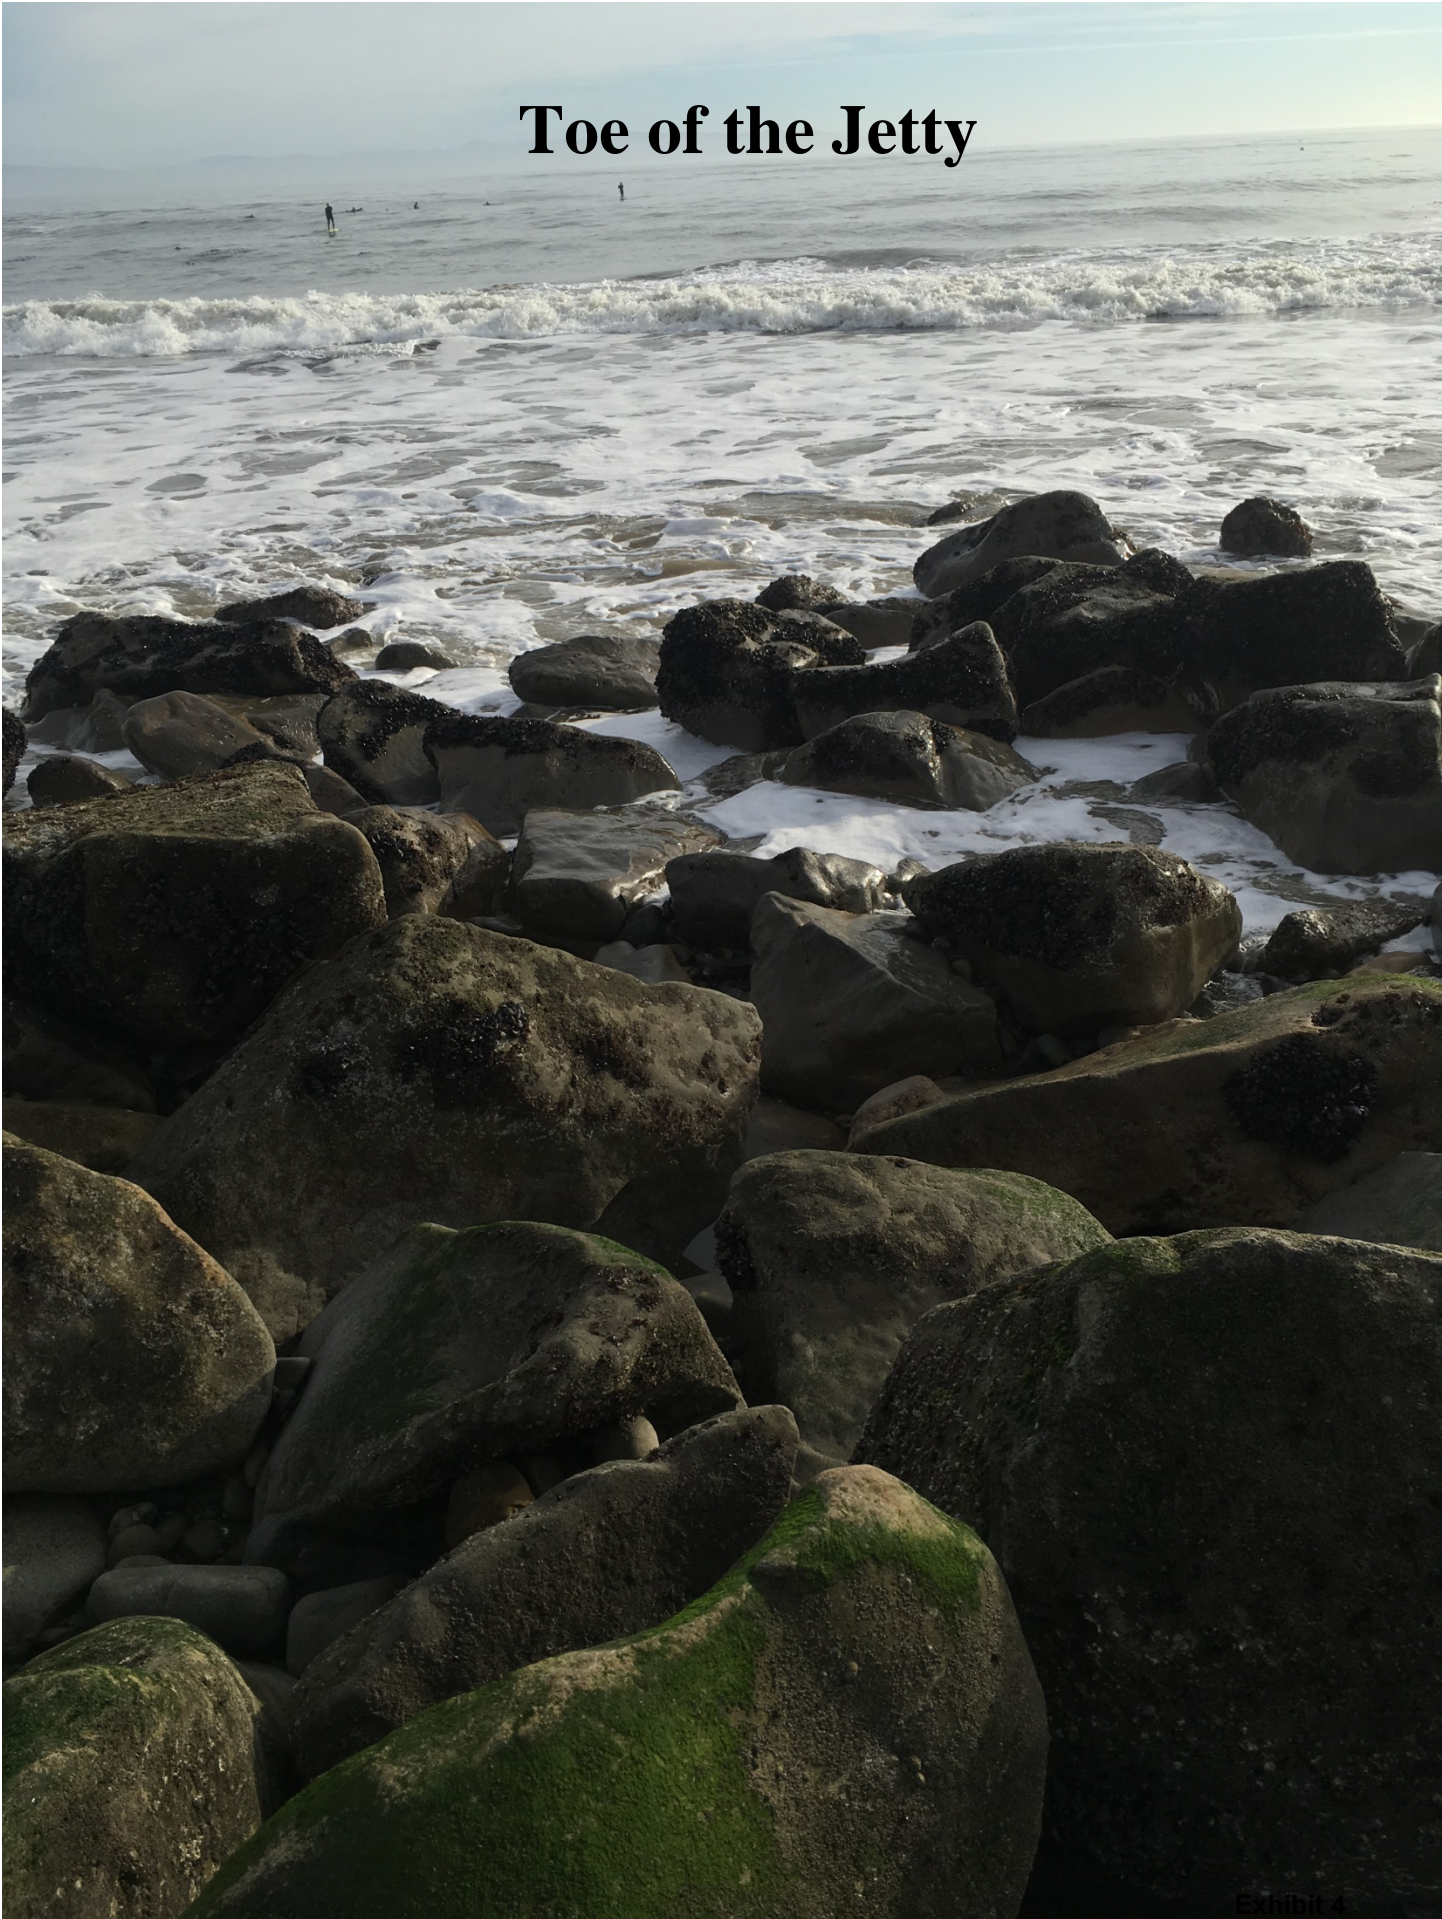
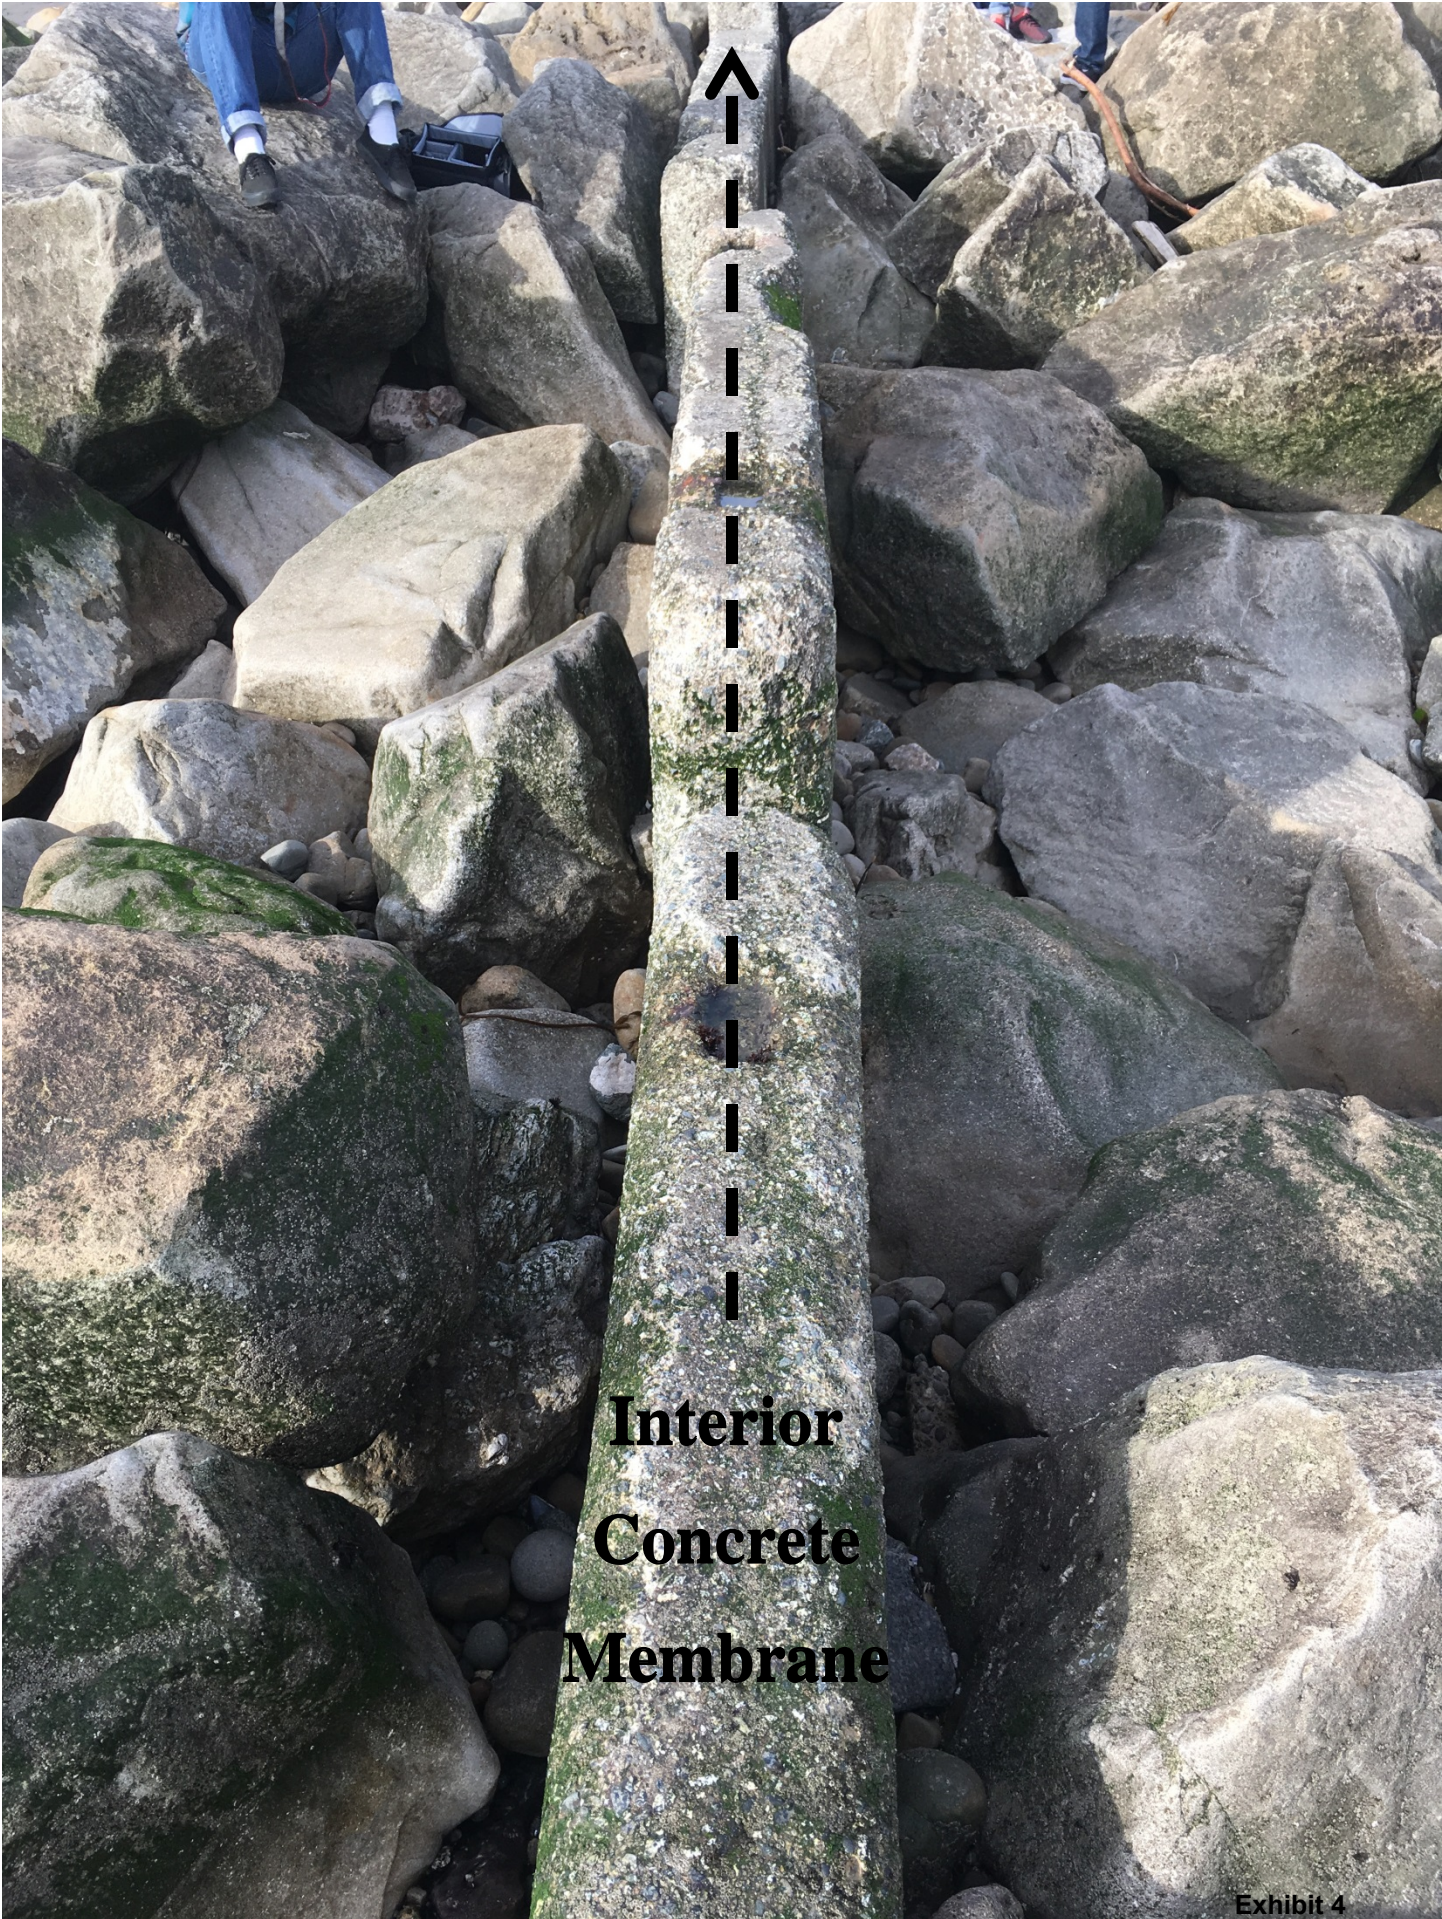
# Toe of the Jetty

**Interior  
Concrete  
Membrane**

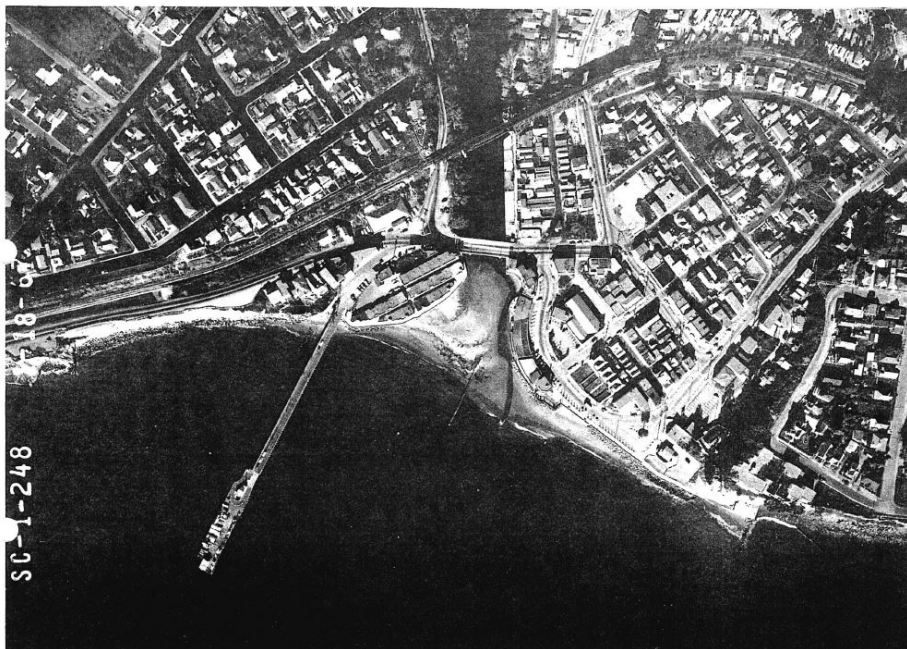
*Figure 2: Aerial of Capitola Beach in 1967 after construction of Jetties at Santa Cruz and Prior to Construction of Capitola Jetty (source: USACE 1971)*

With the construction of the jetties at the Santa Cruz Harbor in 1963, the disruption in longshore sediment transport from west to east resulted in less sand being deposited on the beach at Capitola. This disruption delayed the closure of Soquel Creek and resulted in a narrower beach, restricting public access significantly. The lack of beach at Capitola also presented a major flooding threat from storm surge, waves and swell. Figure 2 shows the narrow beach that enabled wave runup to reach buildings along Soquel Creek.

of the jetties at the Santa Cruz Harbor, respectively. Both Figure 1 and Figure 2 are before the construction of the Capitola Jetty.

If the Jetty wall is allowed to fail and no repairs performed on the Jetty, essentially allowing the Jetty to stop capturing sand and stabilizing the mouth of Soquel Creek, the beach will likely reach a footprint similar to the 1967 footprint shown in Figure 2. A smaller beach width will result in decreased public access, increased frequency of flooding, and loss of habitat if there is not sufficient sand to close Soquel Creek. These impacts will become more hazardous with future SLR conditions.

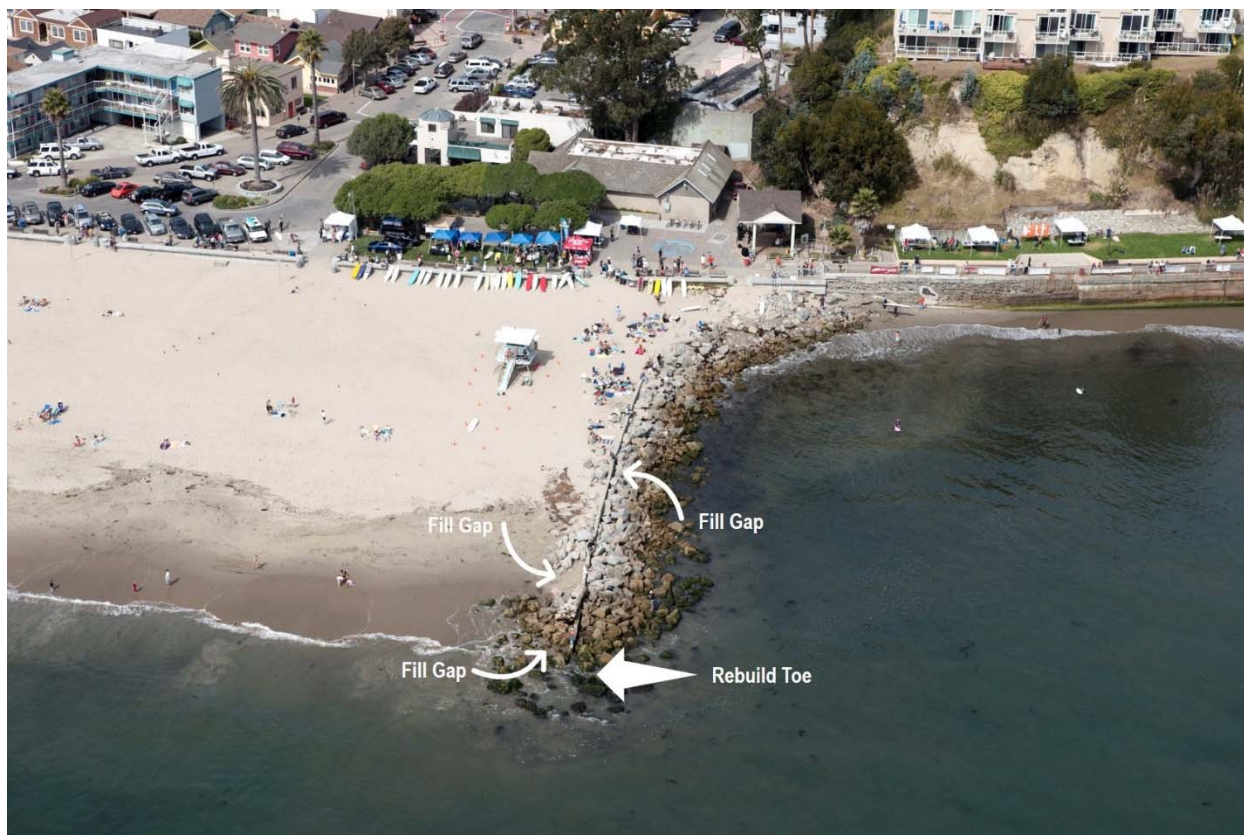
*Figure 3: Proposed Repairs to Jetty*

Additionally, rock scattered on the beach is posing a hazard to visitors to the beach. It also decreases the amount of available area for public access. The project intends to retrieve the rock on the beach and place it back onto the Jetty so as to protect the wall from wave exposure. Additionally, rocks at the toe of the structure have scattered along the beach. This toe will be rebuilt using rocks in close proximity to the Jetty that have not yet been buried as well as importing new rock. The rocks below the water level that are buried will be left where they are to minimize disturbance of the natural habitat. For areas where the armor rock has been displaced and the underlying layer of rock has been washed out, new underlying rock will be placed before the armor stones are returned to the Jetty. Figure 3 shows areas of repair on the Jetty.

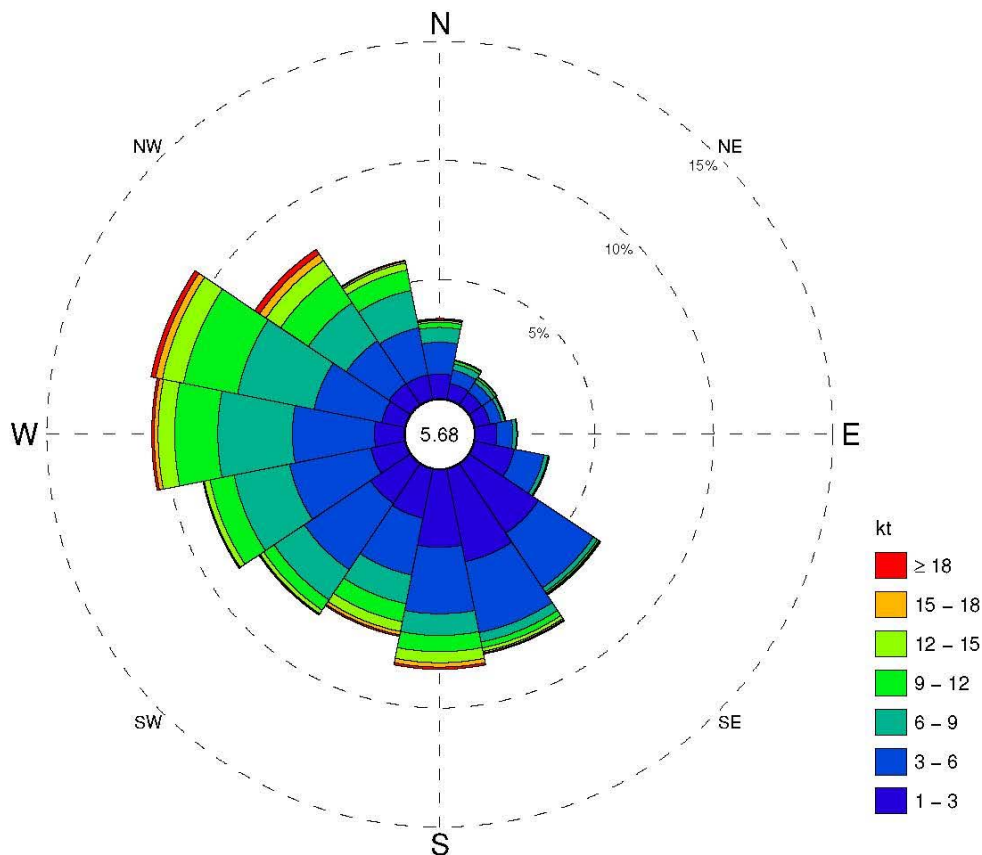
Wind Speed (Annual)  
Station 9413450 – Monterey, CA  
Period 10–Nov–2009 to 27–Apr–2018

Direction FROM is shown  
Center value indicates calms below 1 kt  
Total observations 635822, calms 36144

Figure 5: Wind Rose and Percent Occurrence Table for Wind Speed and Direction at Monterey Harbor

Data from the NOAA operated meteorological station 9413450 was analyzed to define the wave climate at Capitola. As with the water levels at Monterey Harbor, there is no significant variation in wind conditions for neighboring sites as long as the topography of the region is similar. Therefore, wind conditions at Capitola can be reasonably estimated using the wind measurements at Monterey Harbor. Wind speed and direction was measured at this station in six-minute intervals beginning in 2009. The wind rose is presented in Figure 5.

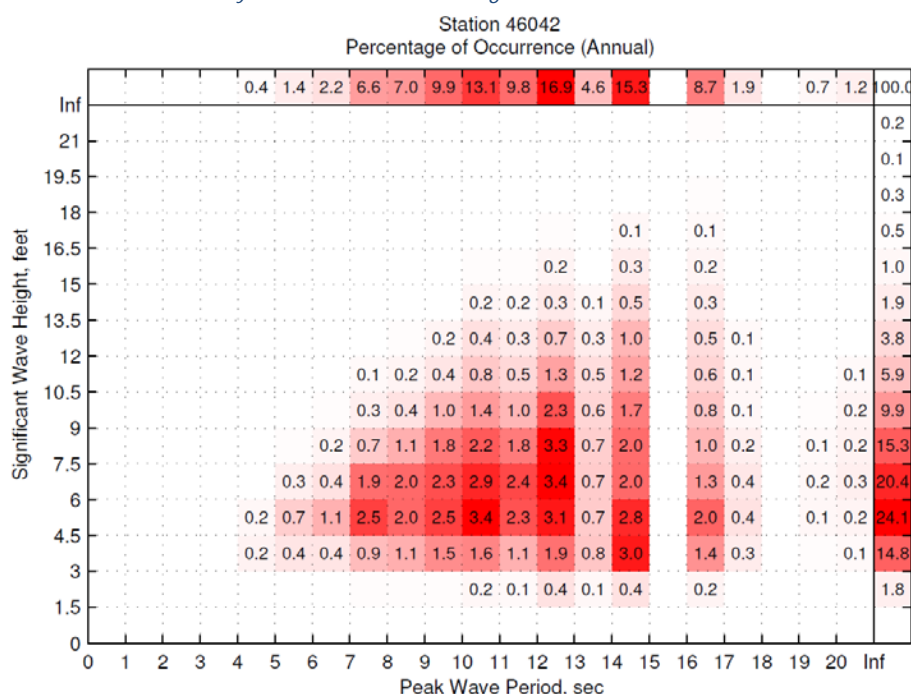
Table 3: Joint Probability Distribution of Wave Height and Wave Period at NDBC Station 46042

Offshore wave measurements are available at the National Data Buoy Center Station 46042, located approximately 27 miles west of the Monterey Bay coastline. Wave measurements are composed of both swell and wind-wave components superimposed on each other. Longer period waves are generally representative of swell conditions and shorter period waves represent wind-waves. Table 3 gives the joint probability of wave height and wave period at Station 46042.

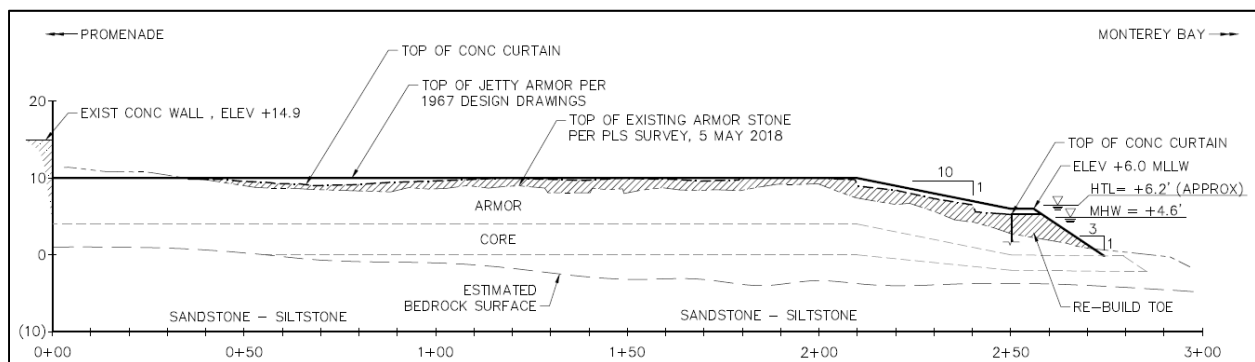
Figure 2. Jetty Profile

The jetties constructed for the Santa Cruz Harbor in 1963 initially trapped large volumes of sand that would otherwise have nourished the shoreline downcoast to Capitola. The sand deficiency led to accelerated cliff erosion, depleted Capitola Beach, and waves eventually undercut building foundations along the waterfront and exposed a storm sewer outfall. The jetty was constructed in 1969 to retain sand and replenish the beach. The current Jetty Profile including existing concrete membrane wall, and the proposed region of restoration are shown in Figure 2.

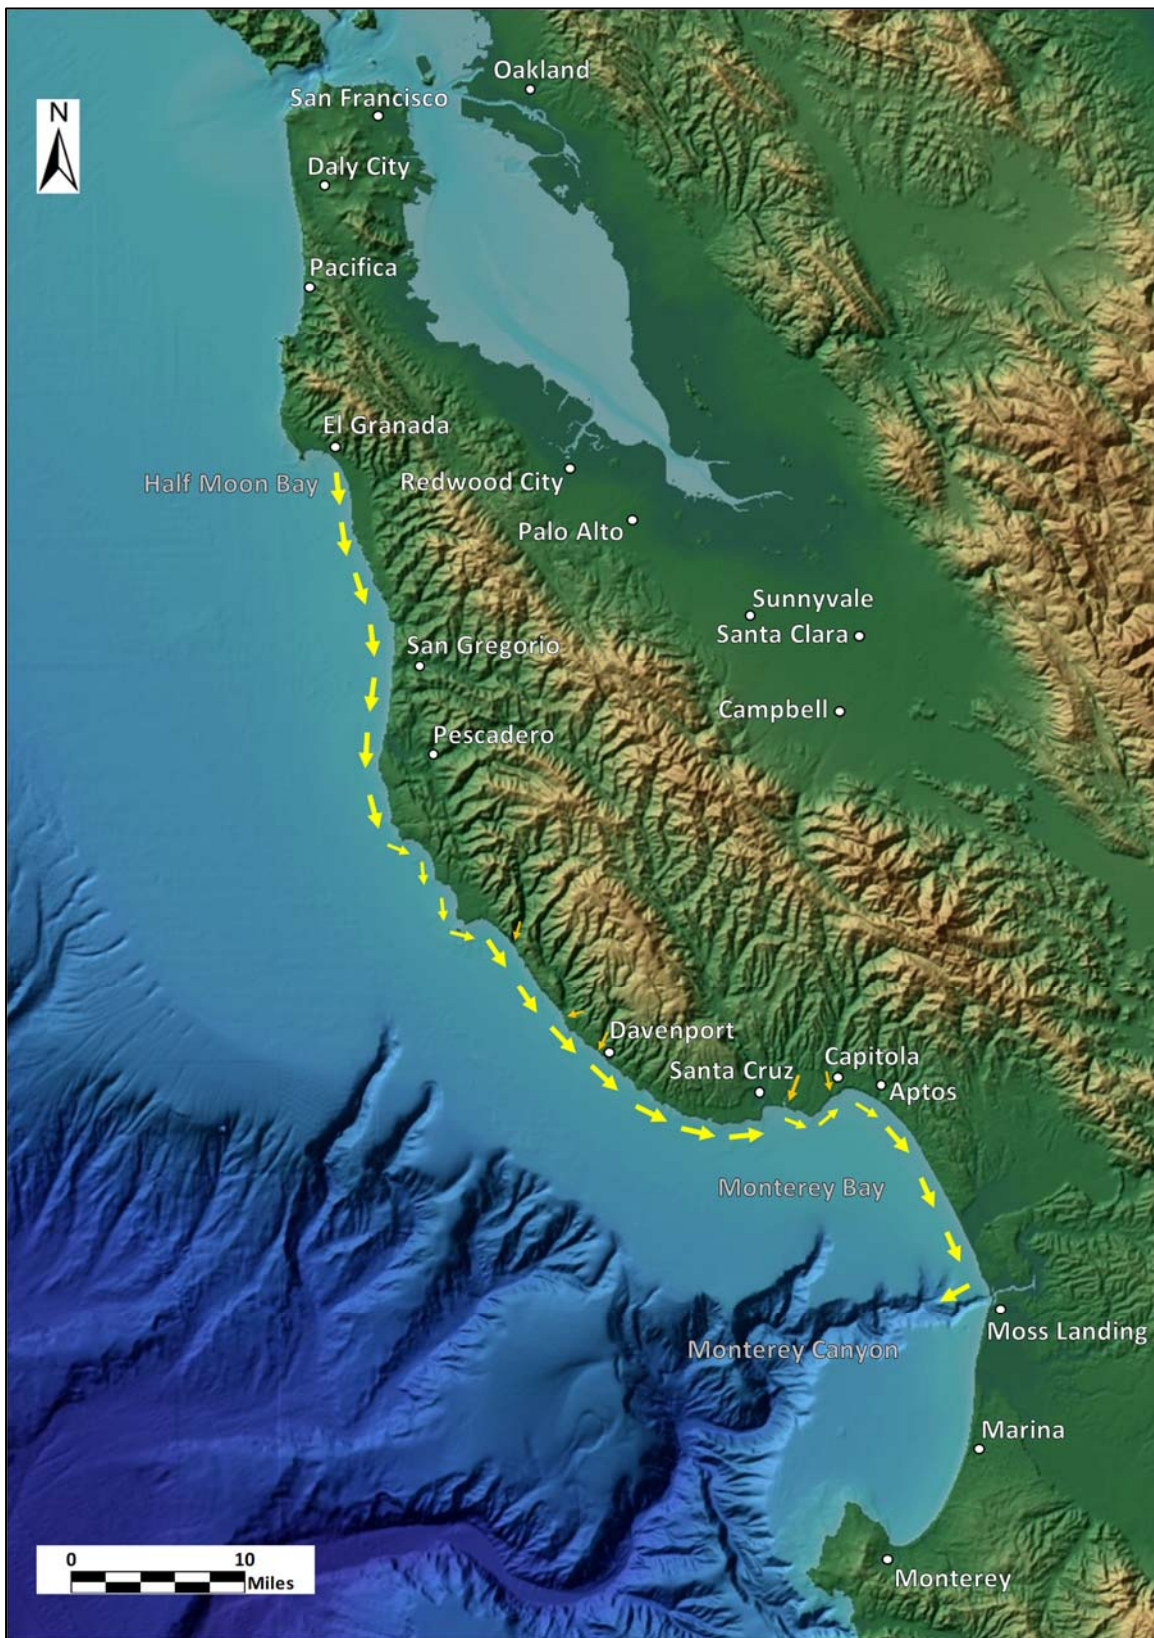
Figure 3: Santa Cruz Littoral Cell.

Sand transport at Capitola is governed by the regional setting of Monterey Bay on the Pacific Coast (Figure 3). Capitola is located within the Santa Cruz Littoral Cell, which represents a self-contained system of sediment movement. Sediment movement is driven by wave action which produces a longshore coastal current.

The Littoral cell begins at Pillar Point in Half Moon Bay and ends at the Monterey Submarine Canyon offshore of Moss Landing. On the Pacific Coast the net longshore littoral transport is southward (downcoast), turning eastward into Monterey Bay. The net sand transport direction is indicated with yellow arrows in Figure 3. Sources of sediment originating from major streams are indicated by orange arrows.

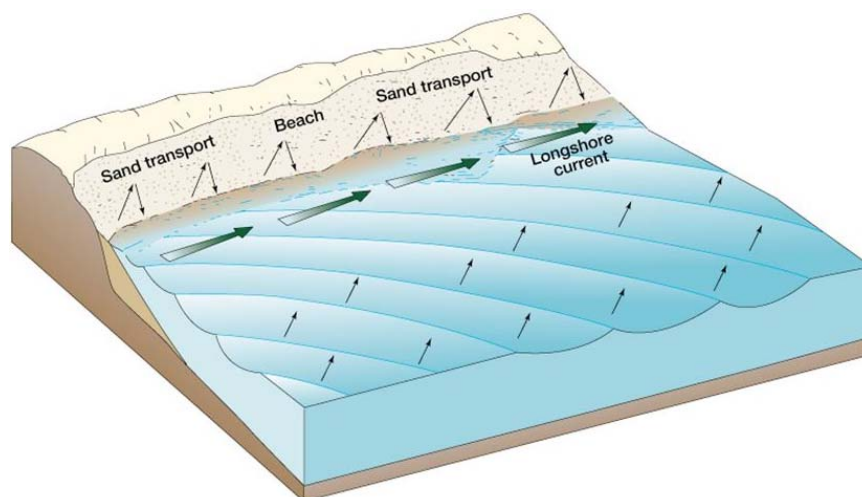
Figure 6: Wave-induced longshore littoral transport.

Longshore transport of sand occurs when waves arrive at an angle to the shoreline. The steeper the angle, the larger the amount of material transported downcoast. Figure 6 illustrates the process of longshore sediment transport due to waves arriving at an angle to the beach. The runup and downrush of individual waves makes sand on the beach move in a sawtooth pattern. Wave-breaking produces a longshore current in the surf zone which transports sediments suspended in the water and along the bottom.

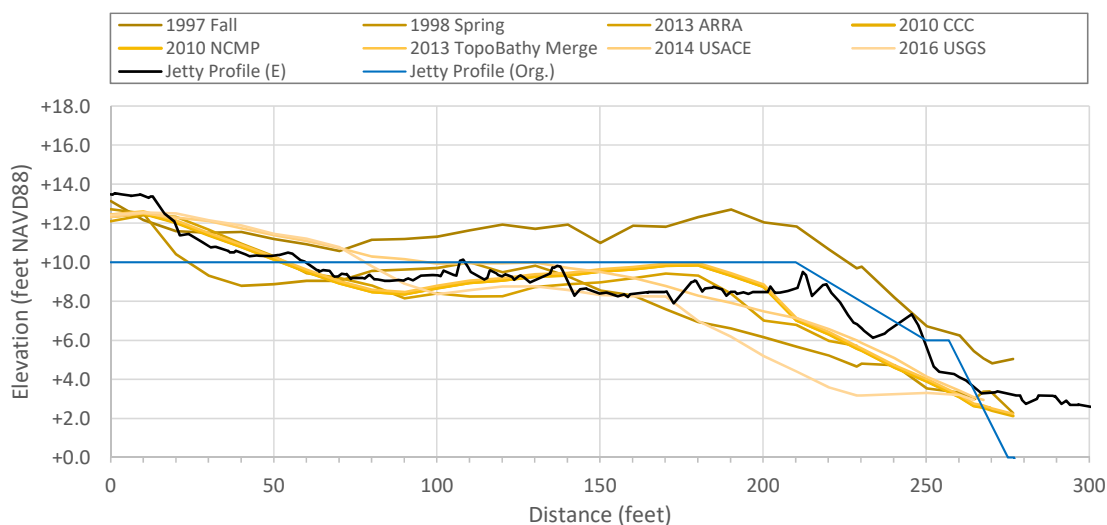
Figure 7: Comparison of beach profiles with jetty elevation.

Figure 7 shows beach profiles on the upcoast side of the jetty obtained from coastal LiDAR surveys conducted between 1997 and 2016. The figure also shows the crest elevation of the original jetty in blue and the crest elevation of rock along the existing jetty in black, which shows that the structure has deteriorated somewhat since its construction.

The figure shows that the jetty crest elevation at around +10 feet NAVD88 is generally in line with the beach elevations. The data shows that in some years, the beach profile can build up to elevations above the crest of the jetty (1997 Fall). However, the beach profiles are generally in line with the crest of the jetty. Bypassing of sand to the shoreline downcoast of the jetty takes place at the back beach (left in the figure, approximately from 0-50 feet). Sand transport in this area is wind-driven. Bypassing of sand also occurs around the offshore end of the jetty. This is indicated by the fact that the beach profiles extend beyond the toe of the jetty (to the right in the figure, around 280 feet). Sand transport in this area is wave and current driven. An example of this mode of sand bypassing can be seen in Figure 1, evidenced by the sediment plumes along the beach drifting around the end of the jetty. Figure 1 also shows the buildup of sand over the crest of the jetty at the back beach.

<sup>4)</sup> Ref. section on Jetty Performance, Figure 7. Cross-sectional area between higher and lower beach profiles and beach extent of 1,000 feet.
