CALIFORNIA COASTAL COMMISSION

(CDP 5-20-0006, Marquita LLC and City of San Clemente)

OCTOBER 7, 2020

REVISED EXHIBITS

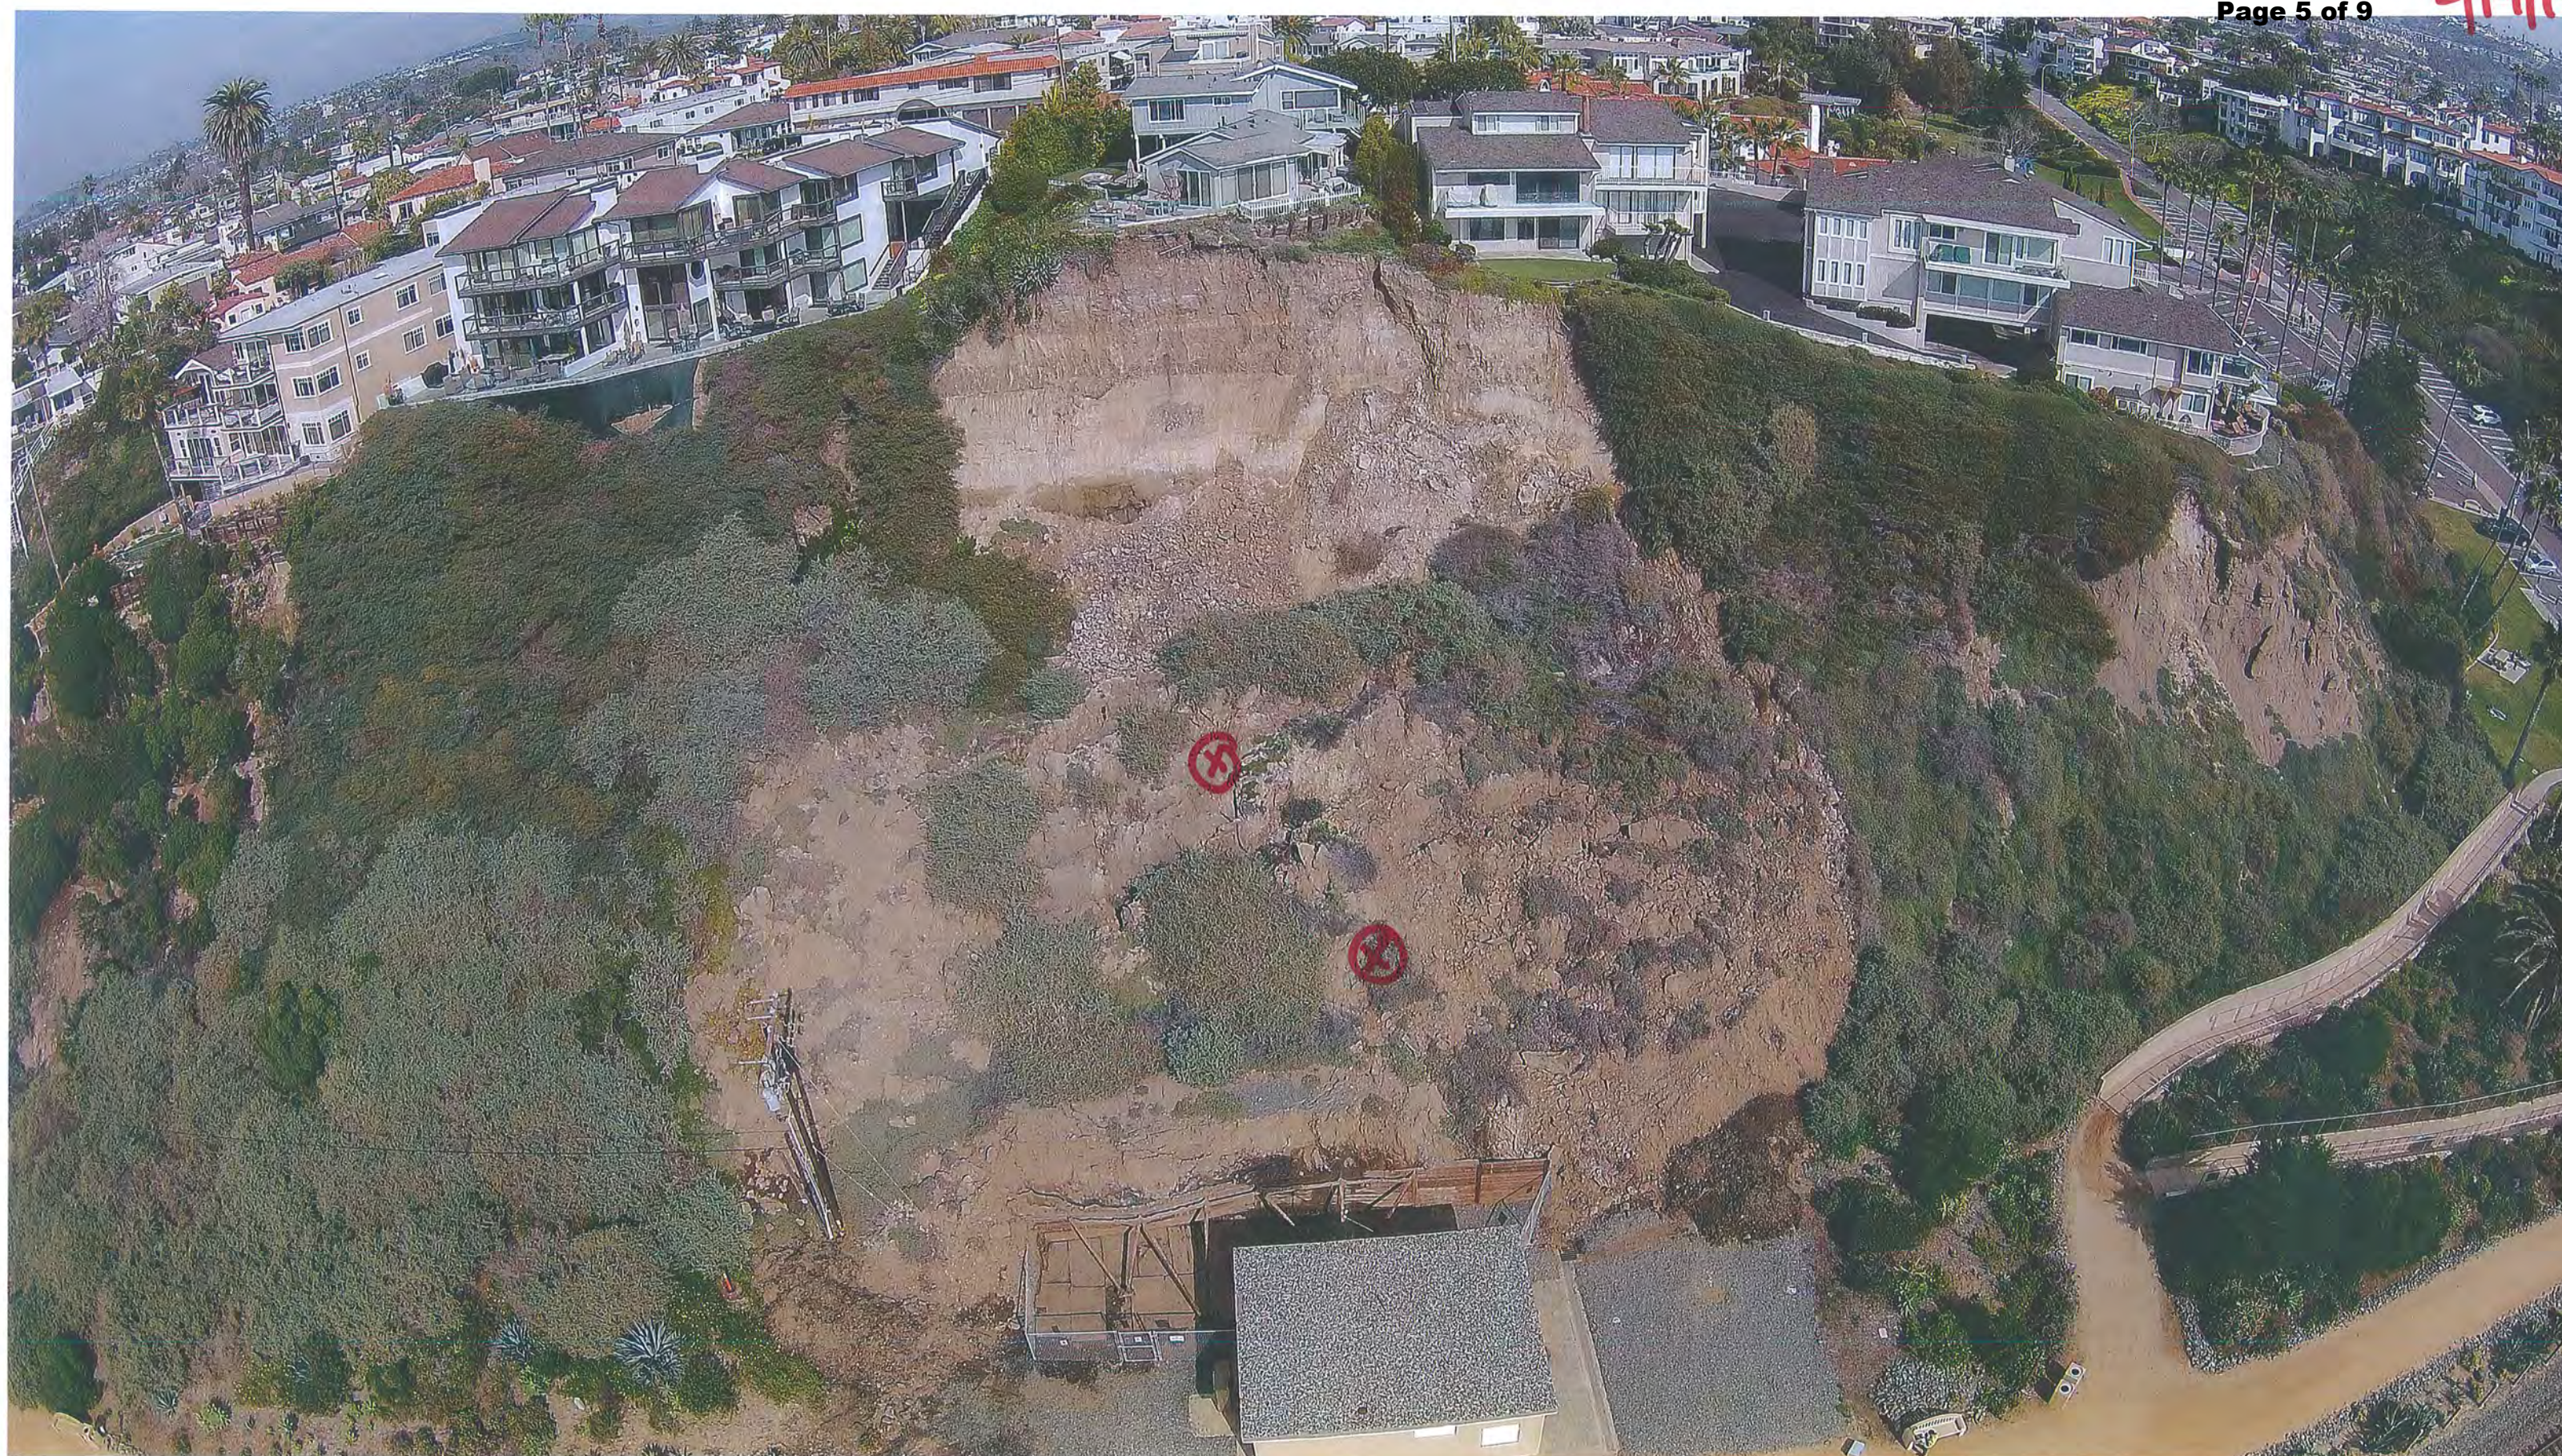
ⓧ Approx. Location of
Slope Inclinometer

City constructed
temporary wood lagging
wall beginning to be
overtopped

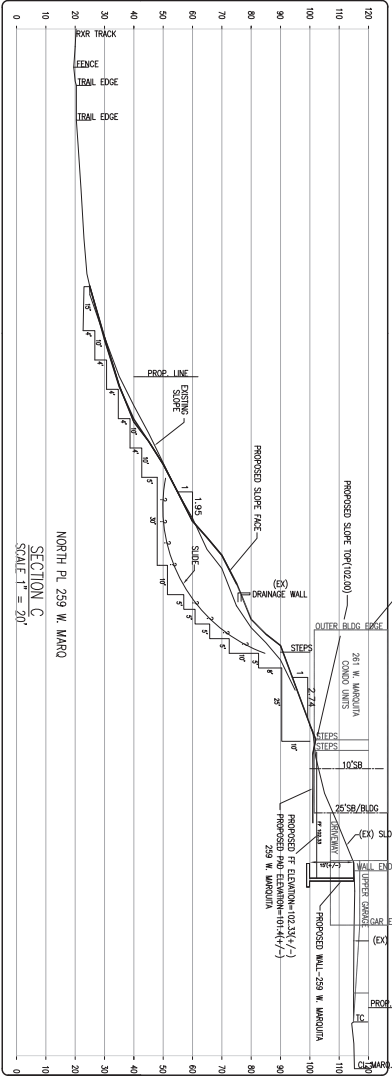
REGION	BY	DESCRIPTION	APPROVED	DATE	SCALE	DESIGNED	SCALE	ORIGIN	LEGAL DESCRIPTION	BENCHMARK	A.P. NUMBER	PETER and ASSOCIATES ENGINEERS	SECTIONS A,B,C
1	SP	RECORD BLUFF SLOPE TO PRE-SLOPE BLUFF SLOPE		3/15/18	N/A				LOT 23, BLOCK 17	CGSM 355-2-82 ELEVATION = 95.558 NAD 83/010M	692-095-07	1419 CALIF. ULS SAN CLEMENTE, CA 92073 Tel: (949) 469-3725 Fax: (949) 462-1891	259 WEST MARQUITA SAN CLEMENTE, CA 92072 PREPARED FOR: TIM RACCH SEA BLUFF HOA (261 WEST MARQUITA)

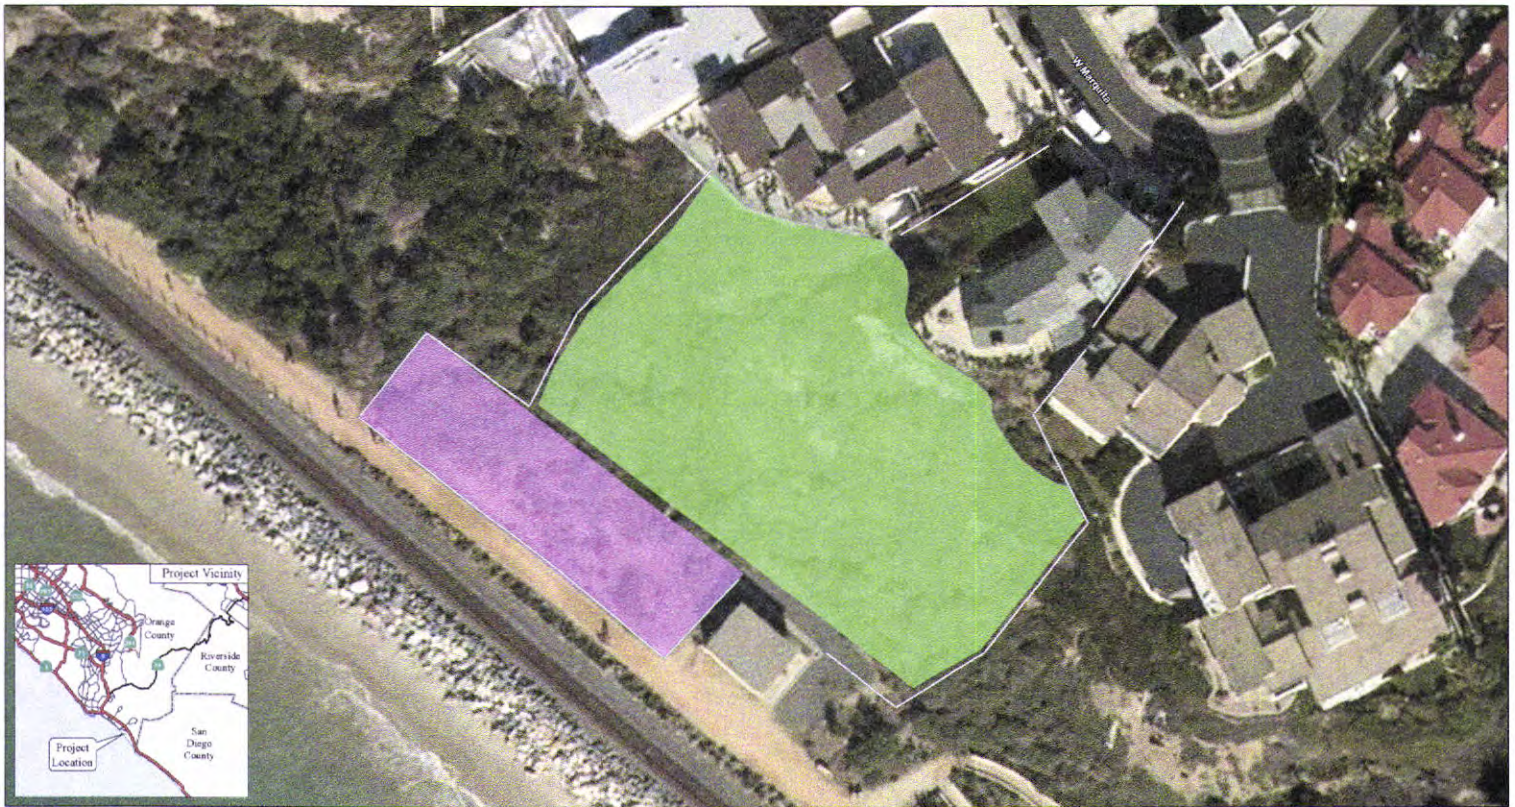
FIGURE 1

- Approximate Native Landscaping Limits (~0.61 ac)
- Approximate City-directed Landscaping Limits (~0.19 ac)
- Construction Fence

This Native Landscape Plan and Specifications (Specifications) for the slope repair project at 259 West Marquita, City of San Clemente (City), California (Figure 1) provides guidelines for the installation and maintenance of native landscaping following completion of construction activities. The purpose of this revegetation effort is to provide self-sustaining, native vegetation within the slope repair portion of the project area that would be disturbed during project activities. This revegetation effort will potentially provide habitat (coastal bluff scrub) for native wildlife species. In addition, the construction staging area will be revegetated following construction activities.

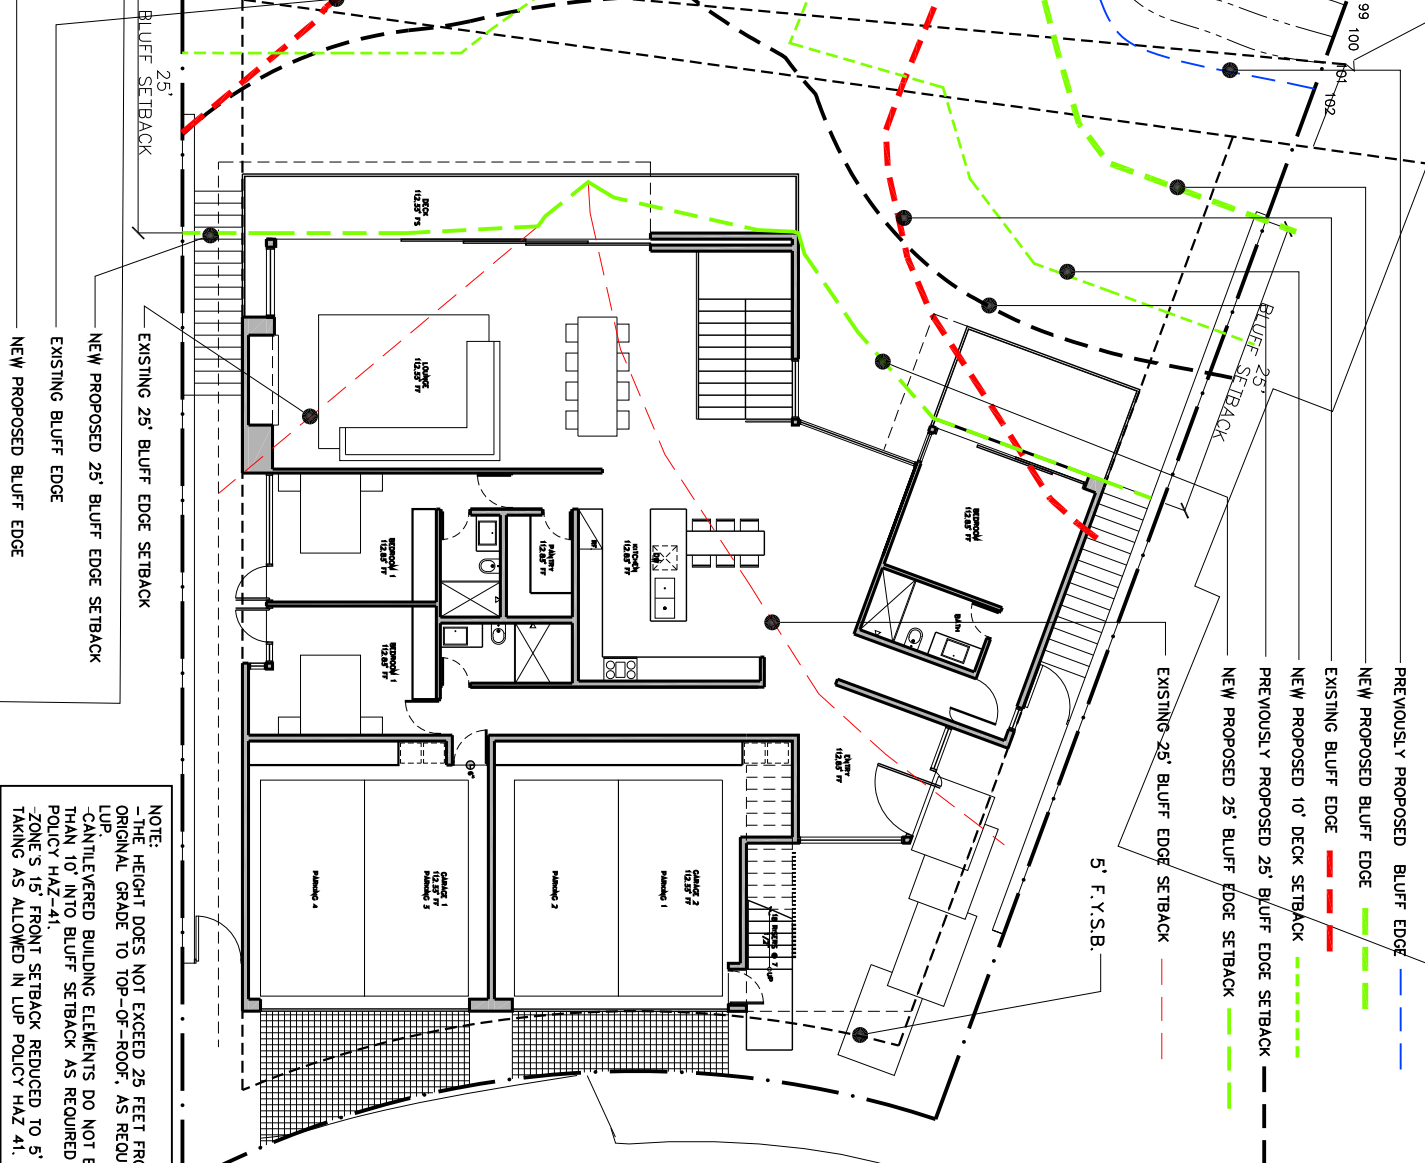
Exhibit 12
Page 3 of 6

NOTE: THE HEIGHT DOES NOT EXCEED 25 FEET FROM AVERAGE ORIGINAL GRADE TO TOP-OF-ROOF, AS REQUIRED IN THE LUP CANTILEVERED BUILDING ELEMENTS DO NOT EXTEND MORE THAN 10' INTO BLUFF SETBACK AS REQUIRED IN LUP POLICY HAZ-41.
ZONE 5 IS FRONT SETBACK REDUCED TO 5' TO AVOID A TAKING AS ALLOWED IN LUP POLICY HAZ 41.

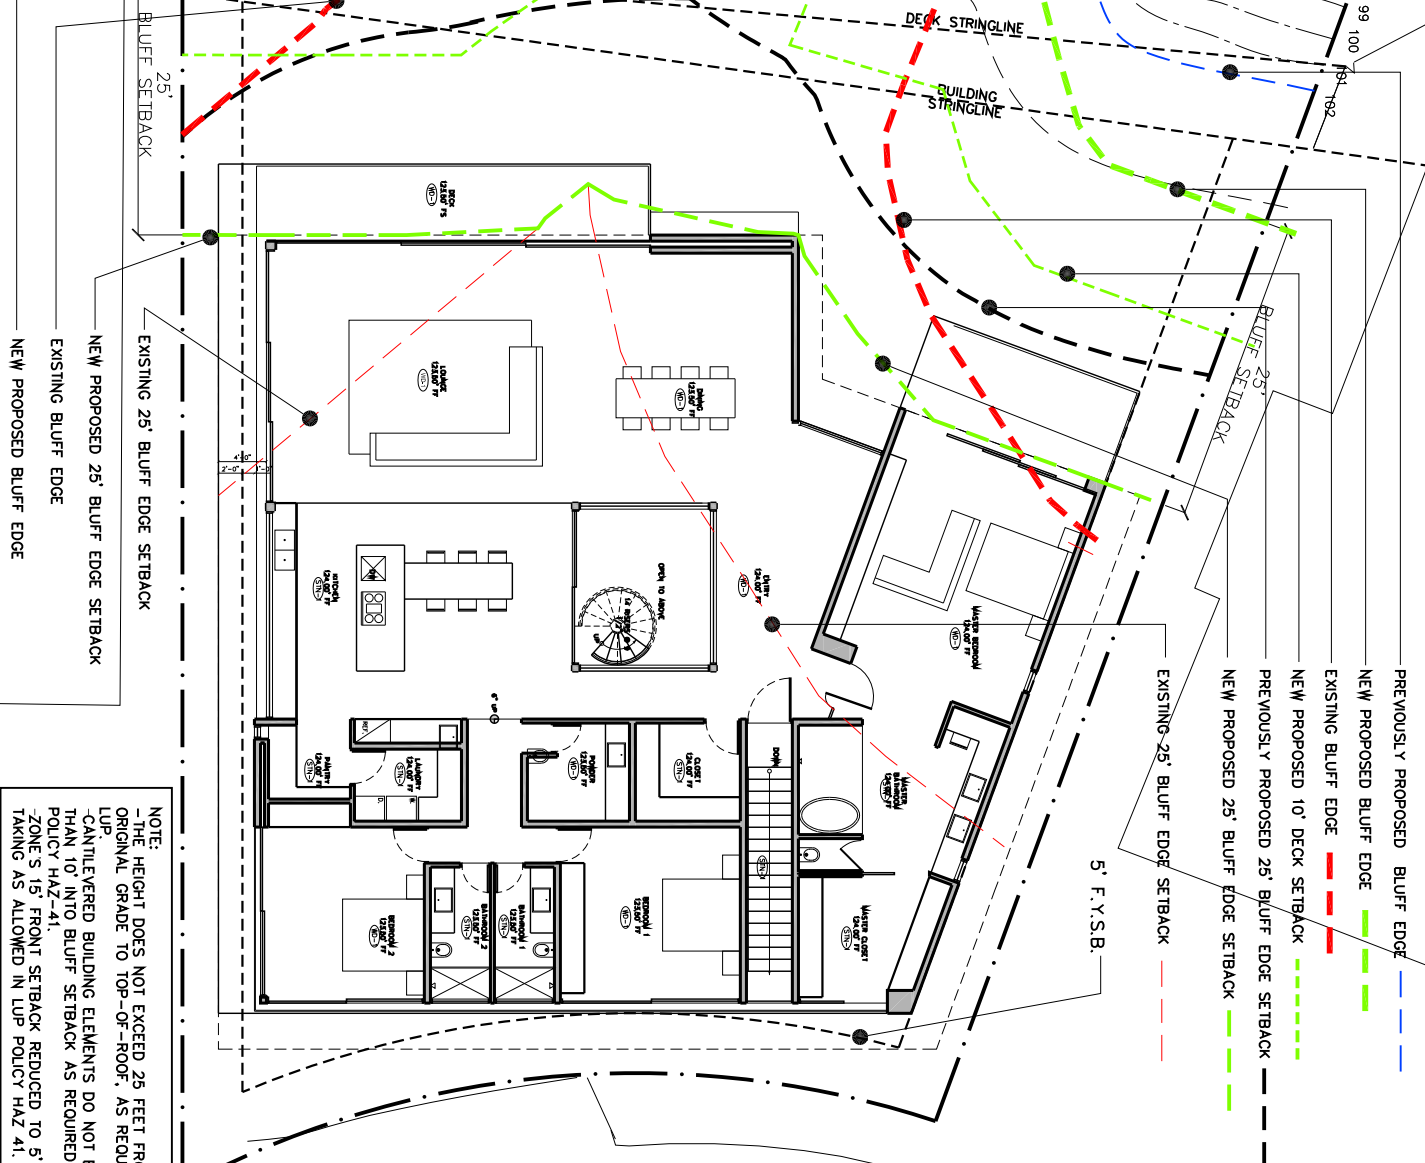
Exhibit 12
Page 4 of 6

NOTE: THE HEIGHT DOES NOT EXCEED 25 FEET FROM AVERAGE ORIGINAL GRADE TO TOP-OF-ROOF, AS REQUIRED IN THE LUP CANTILEVERED BUILDING ELEMENTS DO NOT EXTEND MORE THAN 10' INTO BLUFF SETBACK AS REQUIRED IN LUP POLICY HAZ-41.

ZONING S 15 FRONT SETBACK REDUCED TO 5' TO AVOID A TAKEAS AS ALLOWED IN LUP POLICY HAZ 41.
