CALIFORNIA COASTAL COMMISSION

1-20-0560

(HUMBOLDT COUNTY DPW)

Humboldt Bay Trail South Alignment Figures

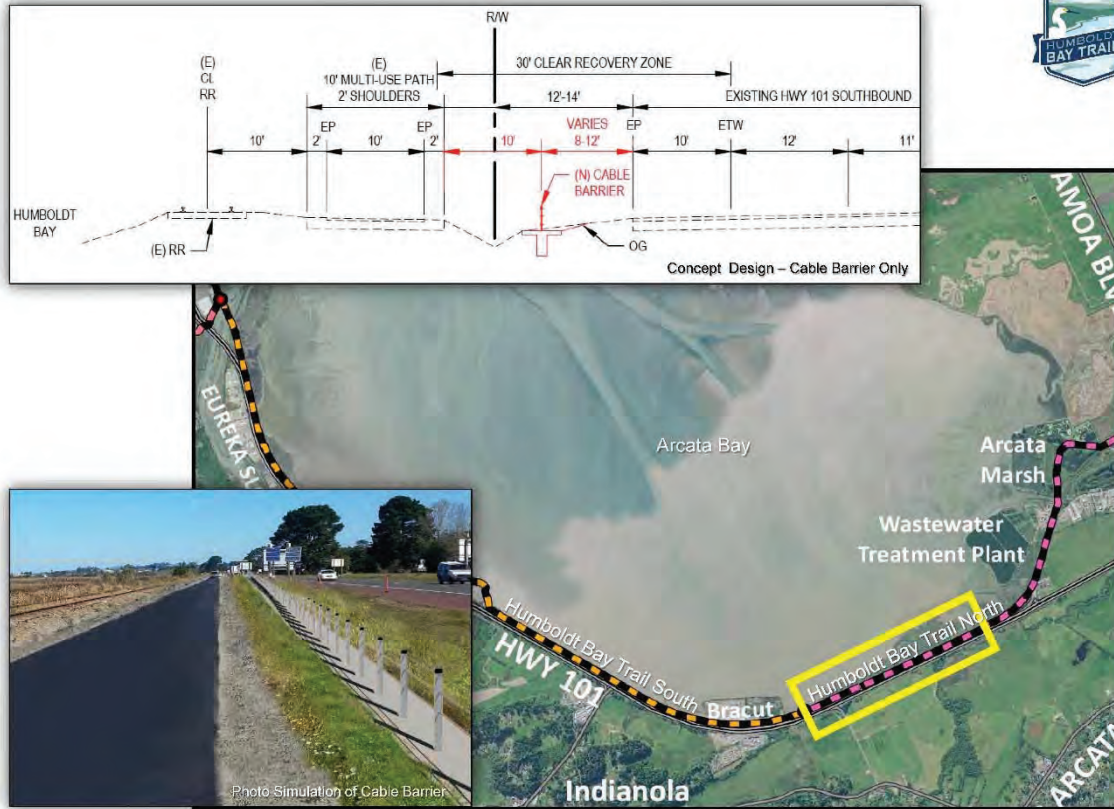
Humboldt Bay Trail North - HBTS

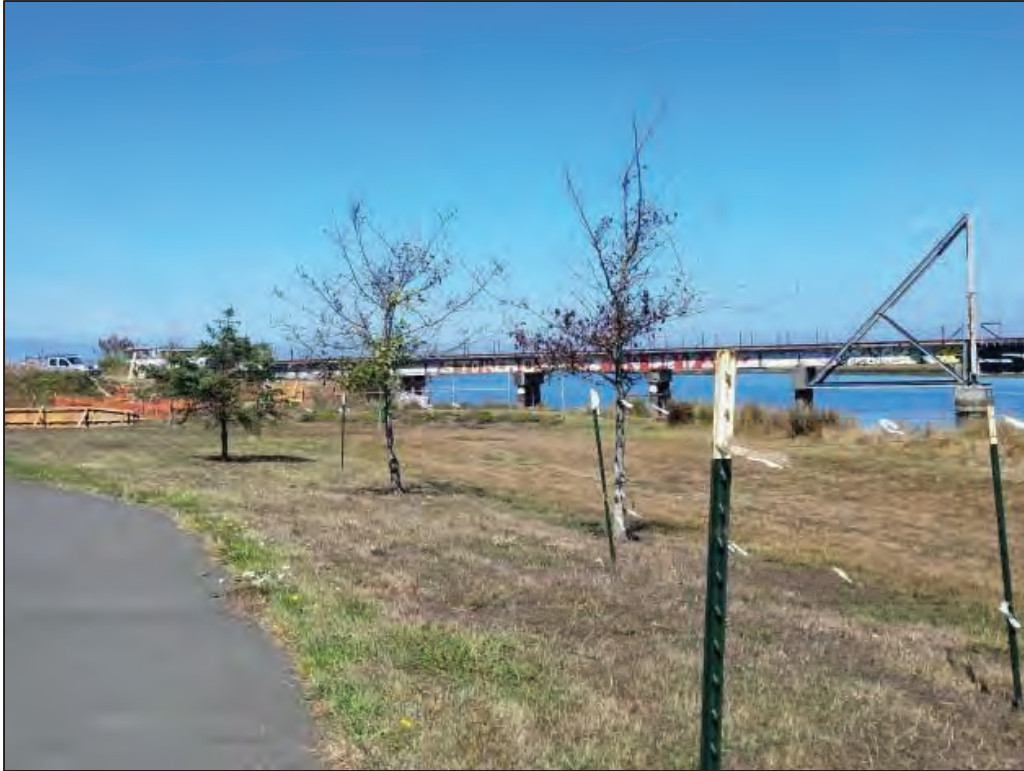
Image 1A (VAU 1, KOP 1). Existing view of the proposed trail alignment and NCRA Railroad bridge crossing over Eureka Slough. View looking north towards Humboldt Bay.

Because of its public accessibility, parking availability, and proximity to Eureka Slough, it is popular with recreationists, including fishermen, walkers, and kayakers. KOP 1 represents a recreationist's point of view. Image 1A illustrates the existing view from this KOP facing north toward the proposed project and the railroad bridge over Eureka Slough. Views of Eureka Slough are fairly expansive from this KOP; however, human-made visual intrusions, including ornamental trees and metal fencing in the fore- and middle-ground, and the railroad bridge in the background are somewhat visually intrusive and views of Humboldt Bay in the distance.

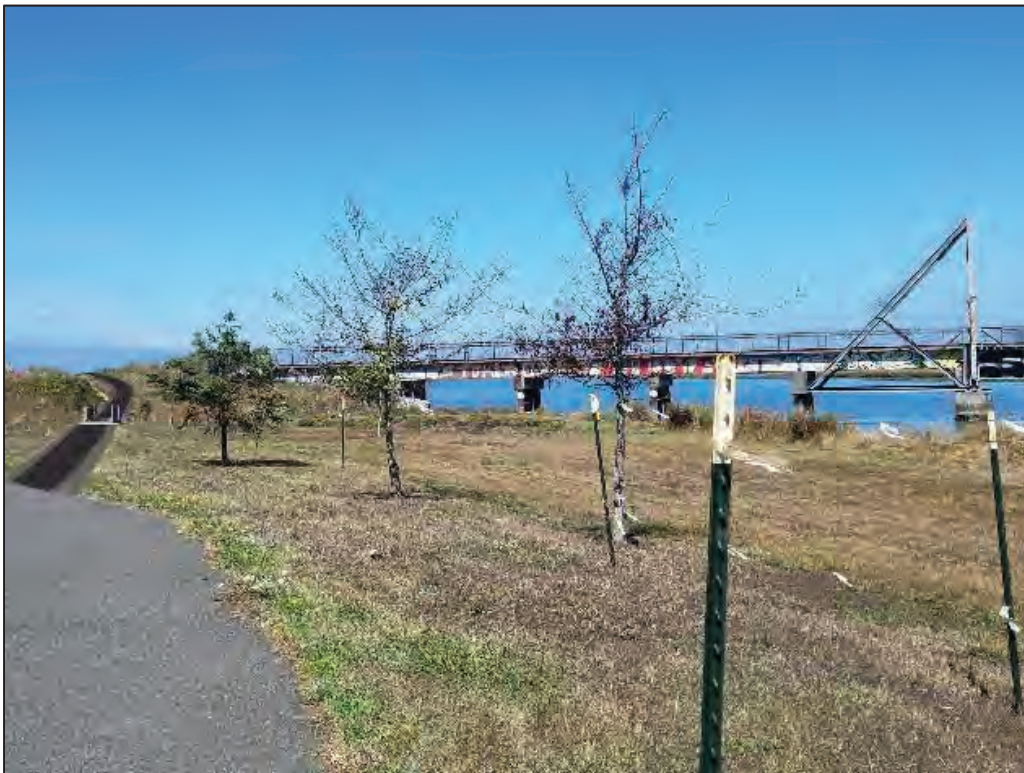
Image 1B (VAU 1, KOP 1). Visual simulation of post-project view of the trail alignment and NCRA Railroad bridge crossing over Eureka Slough. View looking north towards Humboldt Bay.

The proposed trail would follow the railroad alignment in the background. As shown in the post-project visual simulation (Image 1B), a section of the Eureka Waterfront Trail—visually simulated to illustrate its connection to the Humboldt Bay Trail that would begin where the former would intersect the railroad corridor immediately to the left of the railroad bridge—would be created to link the public parking area to the Humboldt Bay Trail. Specific to the proposed Humboldt Bay Trail, the visual simulation illustrates the new bridge railing, which would be consistent with the existing view. As seen from KOP 1, the existing landscape would be modified as a result of trail development actions associated with the extension of the Eureka Waterfront Trail, but as it ascends into the background toward the Humboldt Bay Trail, it creates an inviting view to explore the trail system. Modifications to the railroad bridge as a result of the addition of new railing and the intersection of the two trails at the left end of the bridge would not significantly change the existing pattern elements associated with the view. Scale and continuity of the existing visual features would not change. The pattern character observed from KOP 1 and VAU 1 is the result of scale and continuity of the

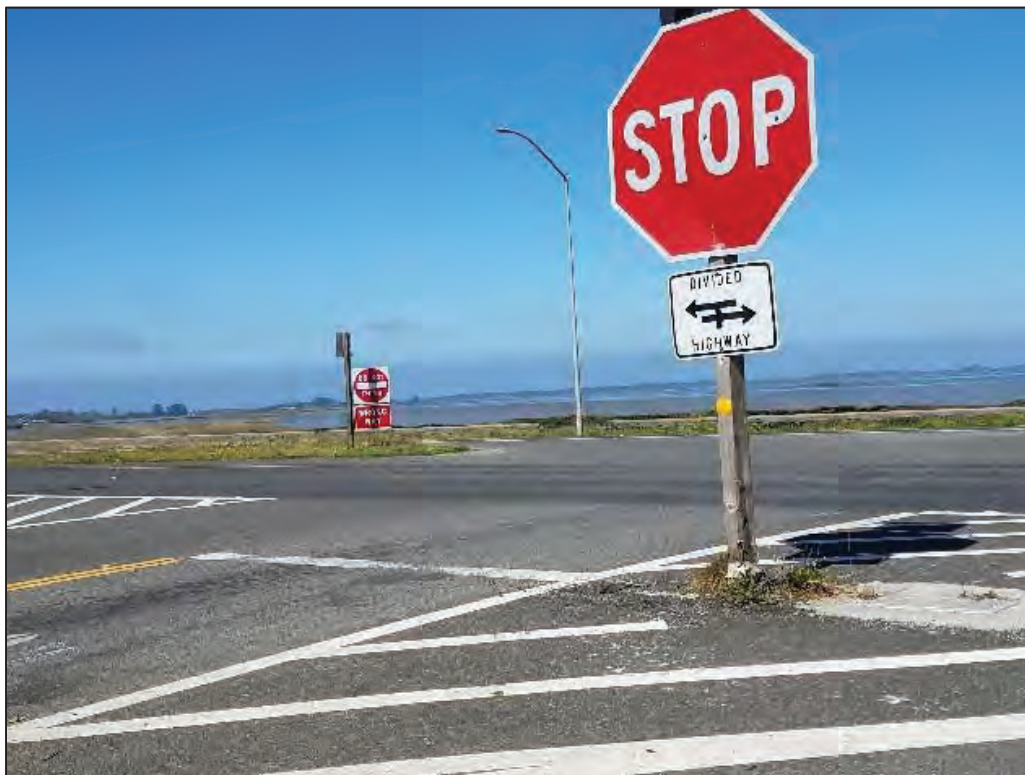
Image 4B (VAU 4, KOP 4). Visual simulation of the post-project view looking northwest from the intersection of Airport Road and Highway 101.

VAU 4 earns moderate ratings for intactness, unity, and vividness despite the obvious human-made intrusions on the landscape. Similar to the project effects on visual resources described for VAU 3, views such as those shown in Image 4A and in the post-project visual simulation, Image 4B, are aesthetically pleasing and pattern elements (form, line, color, and texture) are generally harmonious. Such views are relatively common over the extent of the proposed trail alignment through Segment 4 and are not individually remarkable. Changes to the view, including vegetation removal and exposure of the trail to neighbors on the south side of Highway 101, and installation of safety barriers such as cables to ensure separation of the trail from the highway to the east and the NWR to the west, would be an additional human-made intrusion on the landscape. However, any such project features would be low profile (elevation) and linear, consistent with the other linear features in the VAU. Removal of the taller vertical vegetation would enhance the vividness, intactness and unity of the view by returning it to a more natural coastal plain without the tall shrubs that are not commonly found in this habitat community. The continuity of the pattern character and use of low-chroma and non-glare construction materials would lessen the effects of the trail on the unity of the coastal plain. Construction activities would be a temporary visual impact and not unlike maintenance equipment used in the Highway 101 corridor. Project-related impacts on the visual environment as seen from KOP 4 would be less than significant and would result in a positive effect on the visual resource as summarized in Table 4.

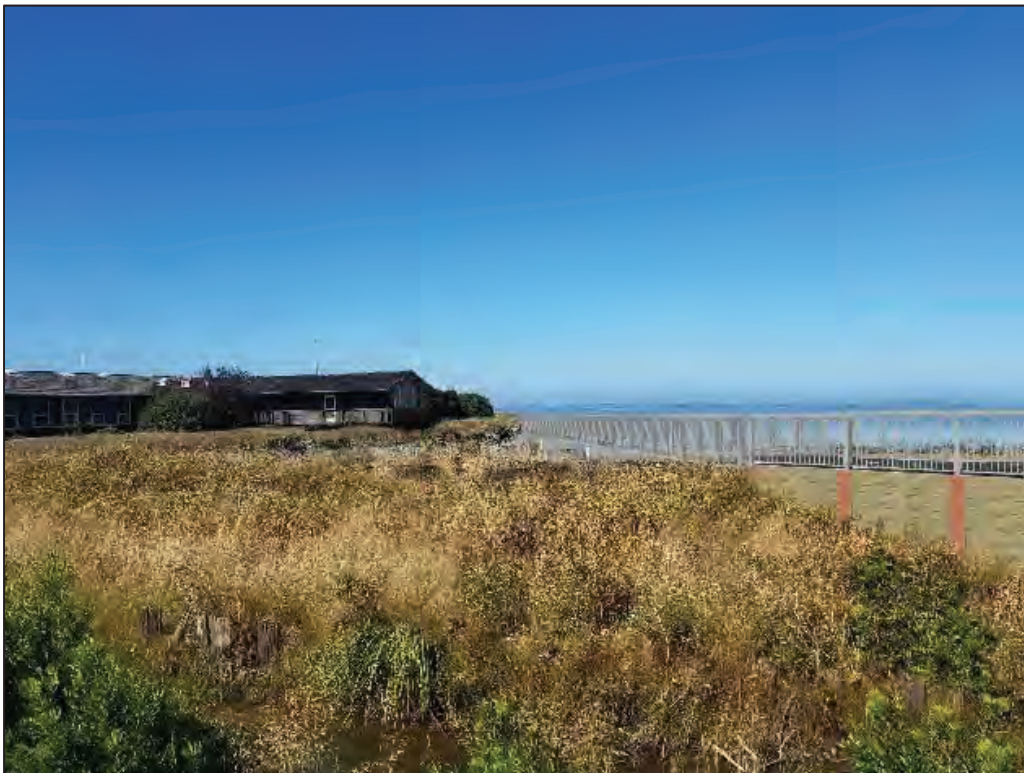
Image 6B (VAU 6, KOP 6). Visual simulation of proposed bridge connection to levee at north end of CRC parcel. View looking southwest toward levee.

The proposed bridge crossing would add a sense of connectivity between the bustling activity occurring on Highway 101 and the tranquility of Humboldt Bay. The color, line, and airy form of the proposed bridge would be inviting and encourage viewers to explore beyond what can be seen from KOP 6. Minor obstruction to views from the adjacent CRC office building could result from the proposed bridge alignment, but the openness of the structure over the water would minimize this potential effect. It is anticipated that the temporarily disturbed area would be restored to pre-project conditions.

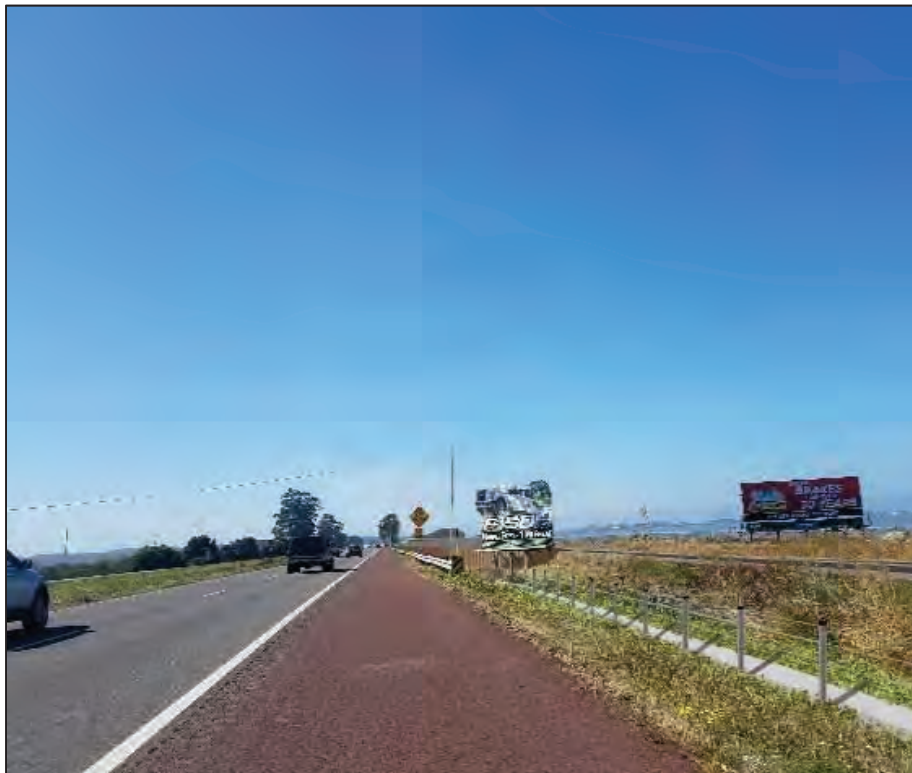
Image 8B (VAU 8-1, KOP 8). Visual simulation of the post-construction trail alignment along Highway 101 south, just south of Indianola Cutoff.

KOP 8 is used to illustrate the changes to visual resources and aesthetics that would occur as a result of removing the sizable eucalyptus that currently line Highway 101 south. As shown in Image 8A, the trees dominate the existing view, drawing the viewer's eye skyward. In contrast, post-construction visual simulation Image 8B draws the viewer's line of vision toward the background of the image. The northern end of this stand of eucalyptus trees along

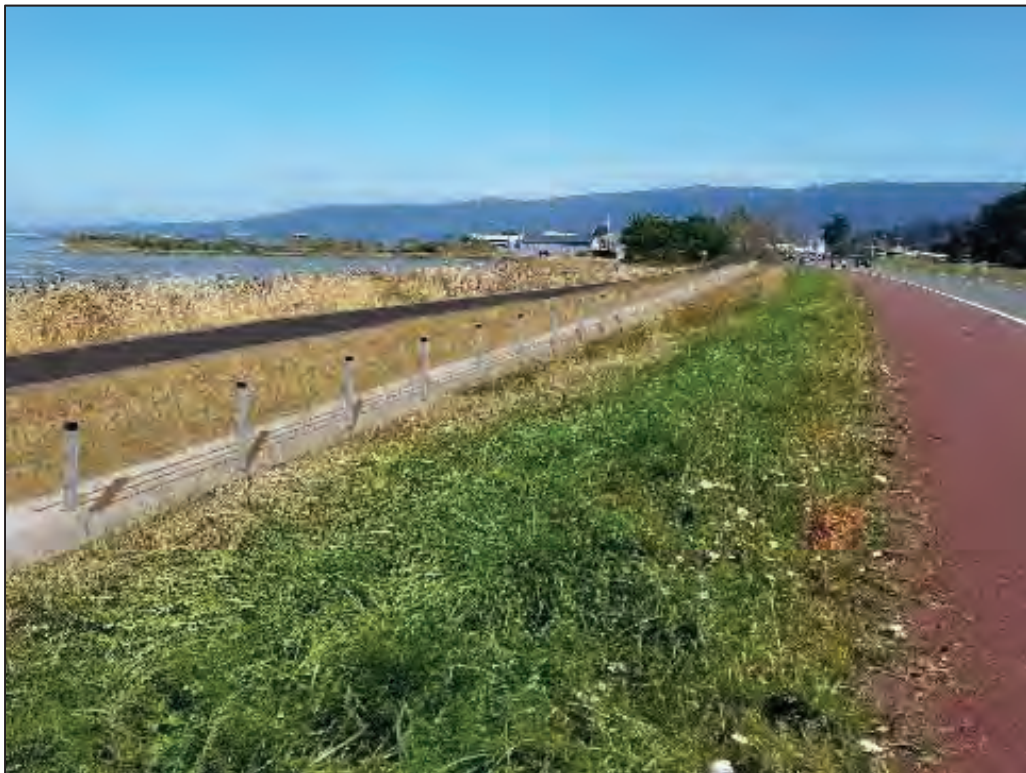
Image 9B. (VAU 8-2, KOP 9). Post-construction visual simulation of proposed trail south of Bracut. View facing north.

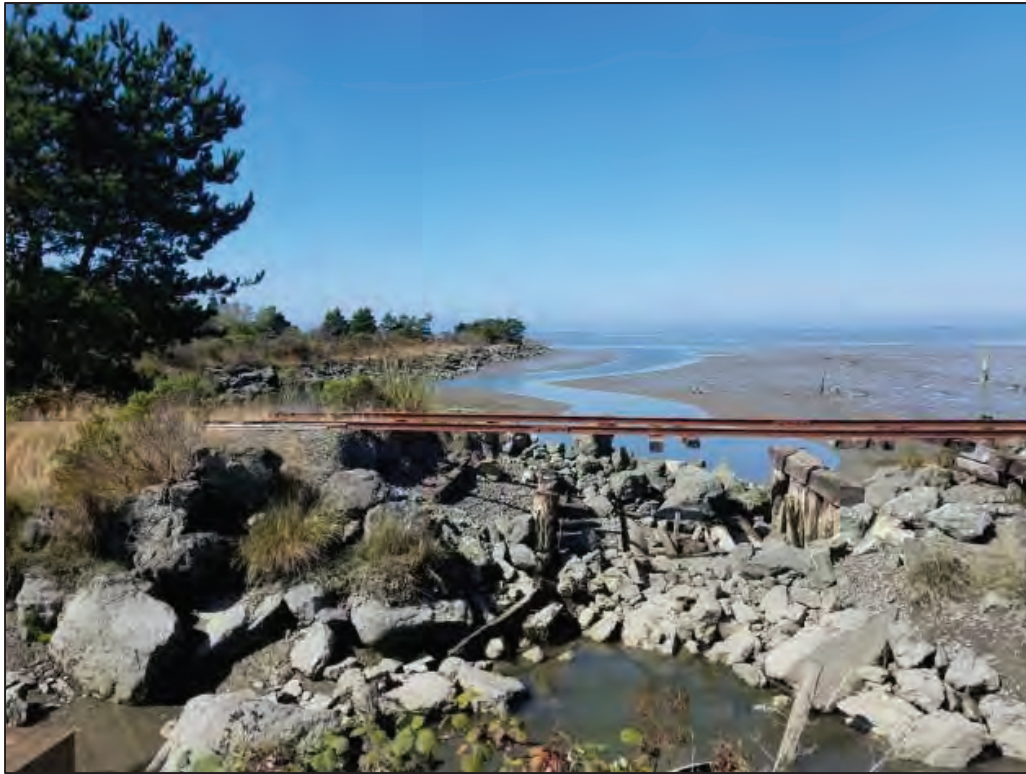
Image 10 (VAU 9, KOP 10). Existing Brainard Slough railroad crossing. View looking west.

The existing vividness, intactness, and unity of views from KOP 10 earn moderately high to high ratings. Views such as those shown in Images 10 and 11A are aesthetically pleasing due to the pattern elements (form, line, color, and texture) that are harmonious throughout the entirety of the views. Although the proposed bridge crossing, revetment, and trail alignment would be visual intrusions on the landscape, the retention of existing trees and landscape features (as shown in visual simulation Image 11B) would continue to draw the viewer's eye upward and towards the background of the image instead of along the horizontal trail. Use of rock and low-chroma colors that would be consistent with the surrounding environment would lessen the visual effect of the bridge on the landscape. The continuity of the pattern character would be maintained as a result of the linearity of the trail alignment; however, intactness and unity would be slightly diminished. The vividness (memorability) of the view from this KOP would remain high given the uniqueness of the bridge crossing. The proposed trail and its features would be apparent to travelers on Highway 101 and may distract from the scenic resources associated with the bay in the background. The presence of recreational trail uses so close to the highway could be a distraction to drivers. However, railings, fencing, and other barriers used throughout the trail alignment for safety may partially obstruct views of areas outside of the trail and conversely, views of the trail afforded motorists on Highway 101. During construction equipment and machines would be present which would provide a temporary increase in visual intrusions. Project-related impacts on the visual environment as seen from KOP 9 would be negative, but less than significant as summarized in Table 10.

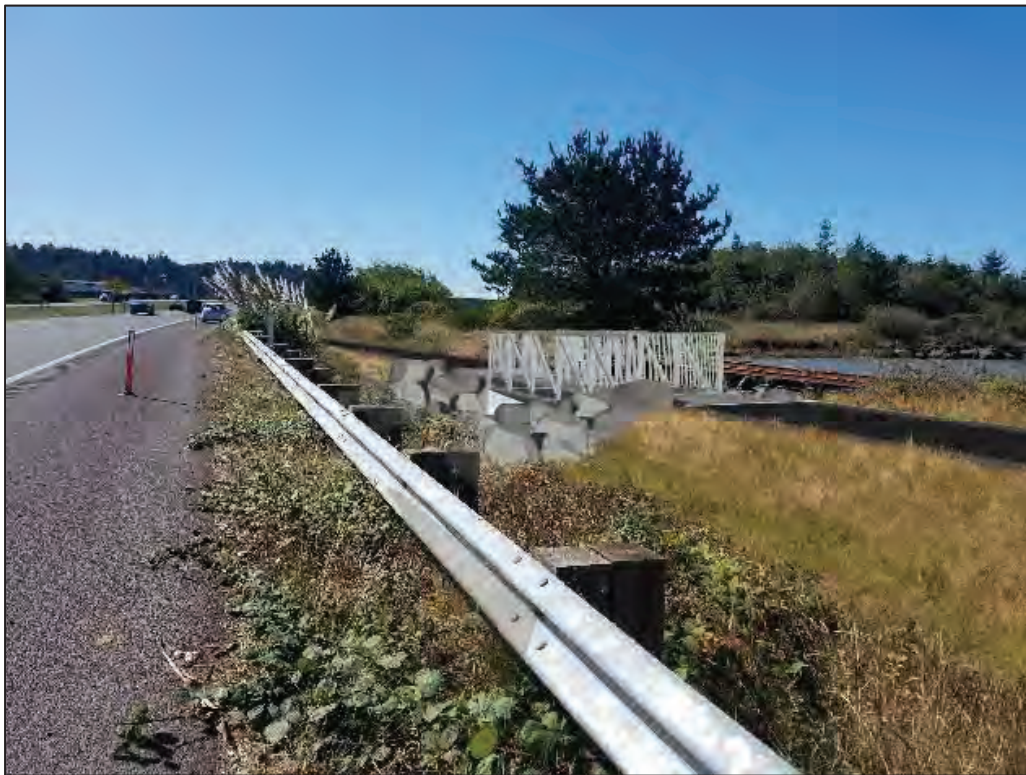
Image 11B (VAU 9, KOP 11). Post-construction visual simulation showing proposed Brainard Slough crossing from Highway 101 south. View looking southwest.

from Highway 101, views of the crossing would be fleeting, but nonetheless interesting. The unique quality of this view decreases slightly with the presence of the metal guardrail and highway corridor as shown in Image 11A, but it continues to retain a sense of the area's history. Installation of a pedestrian bridge crossing as a part of the proposed trail would change the character of the view by adding a modern, vertical, human-made feature to the visual resource. Table 10 summarizes the anticipated effect of the proposed project on visual resources as seen from VAU 9.

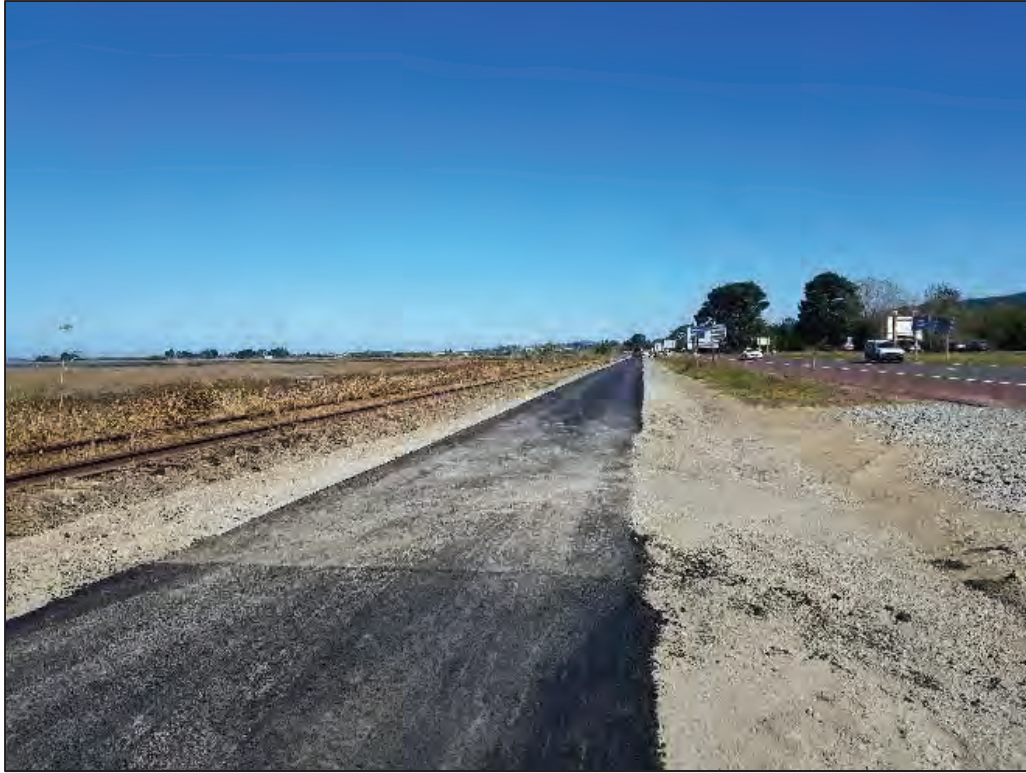
Image 12A. (VAU 10, KOP 12). Existing view of the Humboldt Bay Trail North, which is currently under construction. View facing north.

VAU 10 is comprised of the southernmost extent of the nearly completed Humboldt Bay Trail North (shown in Image 12A). The proposed cable barrier fencing would be extended north from Landscape Unit #9 into Landscape Unit #10 (as far as the Gannon Slough crossing). No other activities would occur in this VAU, since the Bay Trail North has already been implemented under a separate project. Visual simulation Image 12B illustrates the existing paved trail segment, including the cable barrier fencing. The low profile cable barrier would be set back from the edge of trail and approximately 8 to 12 feet from the edge of the Highway 101 shoulder. The cable barrier would consist of steel wire ropes (typically 4 strands) mounted on steel posts secured in concrete foundations. An approximately 2-foot wide concrete weed mat would be installed along the length of the cable barrier. Views such as those shown in Images 12A and 12B would be common throughout the entirety of the proposed trail system improvements along Humboldt Bay between Arcata and Eureka. Although the cable barrier fencing would be another human-made intrusion on the landscape, it would be consistent with existing conditions, which include the paved trail, the NCRA corridor, and Highway 101. Views in this area are expansive and generally unobstructed. Travelers of all types can appreciate the size of the bay and get a sense of the coastline as it extends into the distance. Table 11 summarizes the anticipated effect of the proposed project on visual resources as seen from VAU 10.

KOP 12 earns moderately high ratings for intactness, unity, and vividness. The pattern elements present are harmonious and open. While the addition of the cable barrier fencing, including its concrete foundation and metal fence posts, would be intrusive on the landscape, it would be consistent with the existing paved trail, adjacent Highway 101 corridor, and the railroad prism. The low profile and openness of the barrier would not obstruct views available to motorists or recreationists. While there may be an increased potential for glare as a result of the use of galvanized metal and concrete, it is anticipated that this potential impact would be avoided through the use of non-glare and low-chroma construction materials. Intactness and unity would increase with the installation of the barrier because of its linearity and consistency with the other human-made features visible from KOP 12. The proposed trail and its features would be apparent to travelers on Highway 101 and may slightly distract from the scenic resources associated with the bay, but the impact would be low. Recreationists would similarly find views of the trail to be visually common and would not be distracted from the panoramic views of the adjacent coastline. Railings, fencing, and other barriers used throughout the trail alignment for safety may partially obstruct views of areas outside of the trail and conversely, views of the trail afforded motorists on Highway 101. During construction equipment and machines would be present, which would provide a temporary increase in visual intrusions; however, because the pavement has already been installed in this VAU, the duration of construction would be shorter than along other segments of the Humboldt Bay Trail South. Project-related impacts on the visual environment as seen from KOP 10 would be less than significant and would result in a positive effect on the visual resource as summarized in Table 12.

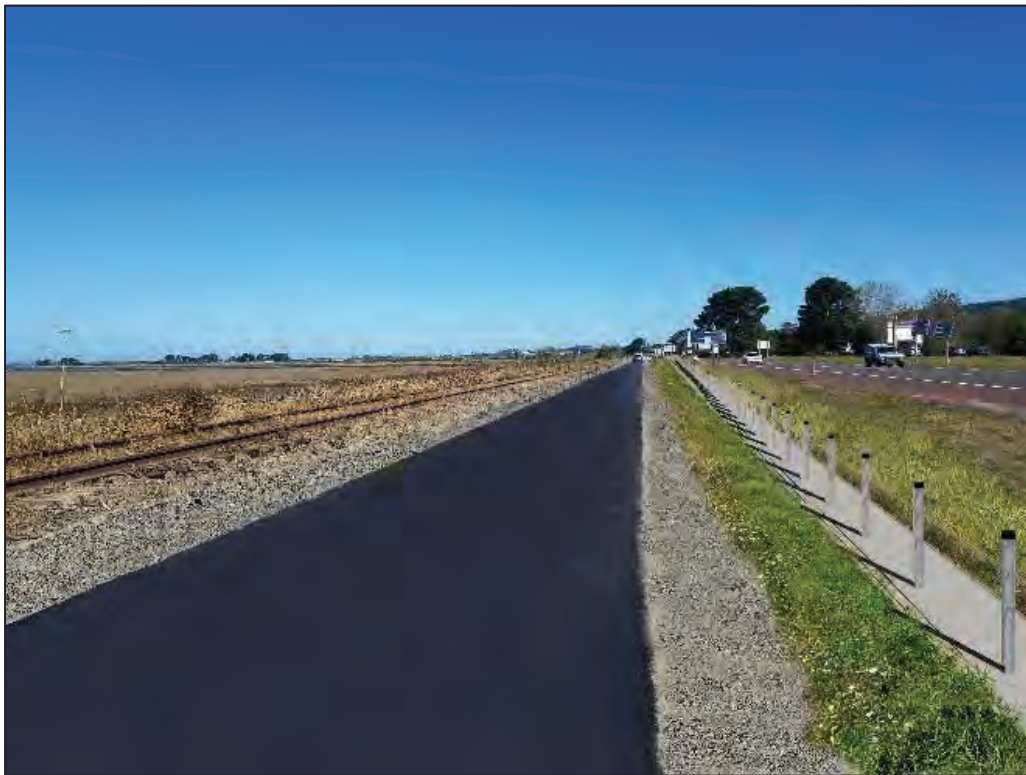
Image 12B. (VAU 10, KOP 12). Visual simulation of the completed Humboldt Bay Trail North, including the continuation of cable barrier fencing from VAU 9. View facing north.

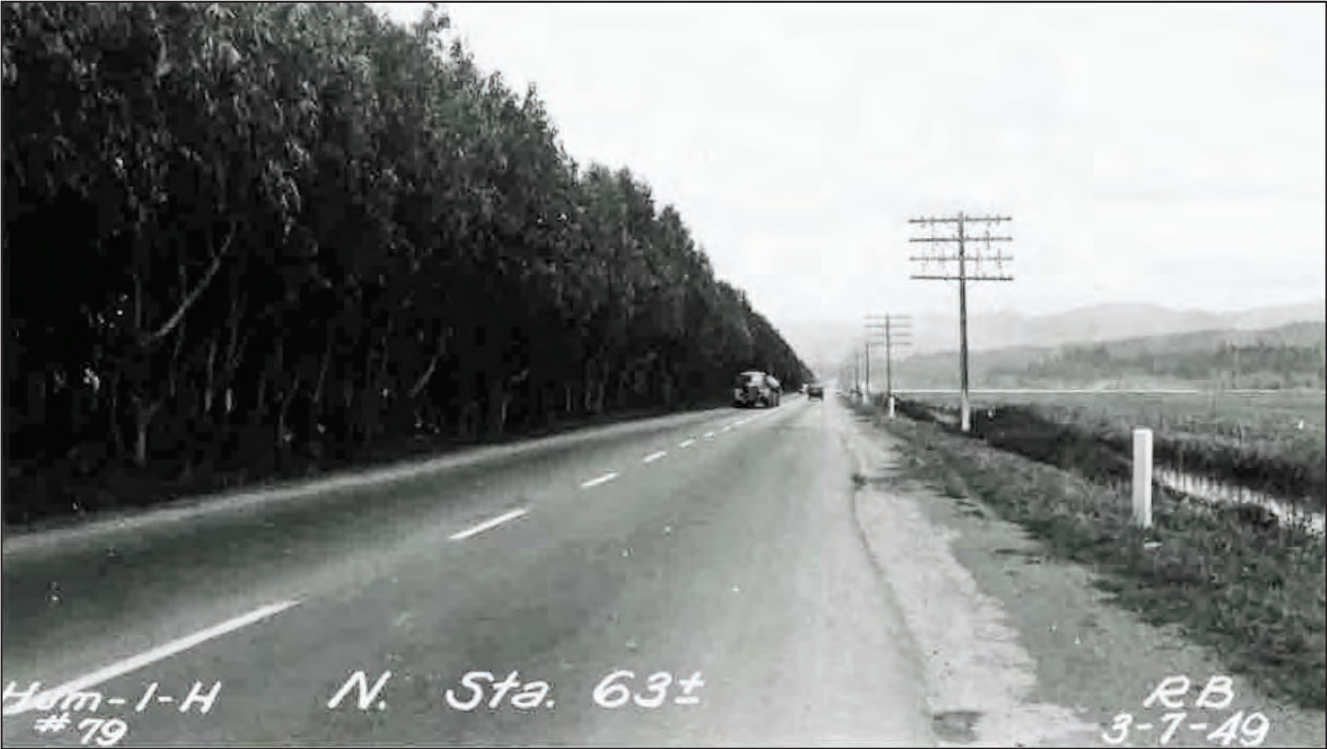
03/07/1949 (above): Historically , the stand was very dense with many more trees (Image excerpted from document 2.Maps and Photographs of Eucalyptus Trees along the future segment of the Humboldt Bay Trail, dated August 2, 2018.).
09/14/2018 (below): Similar view illustrating the current lack of density, increased height and top-heavy canopy, and trees devoid of lateral limbs and lower foliage.

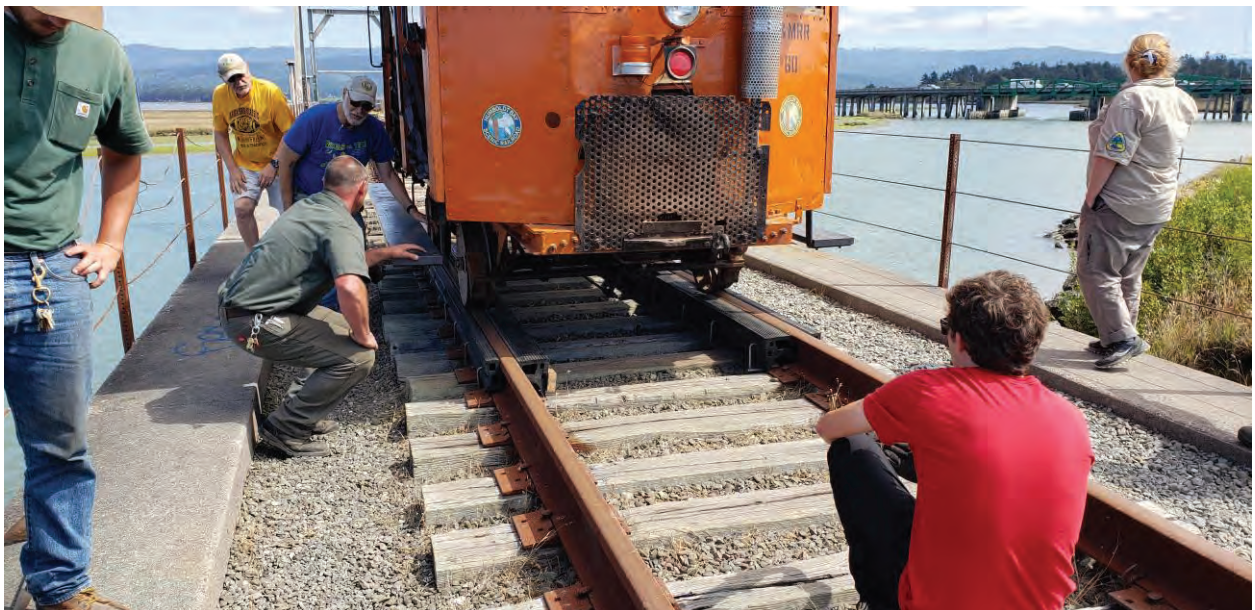
Photo 4 (September 6, 2019): Test of flangeway filler products on Eureka Slough Bridge (Segment 2).

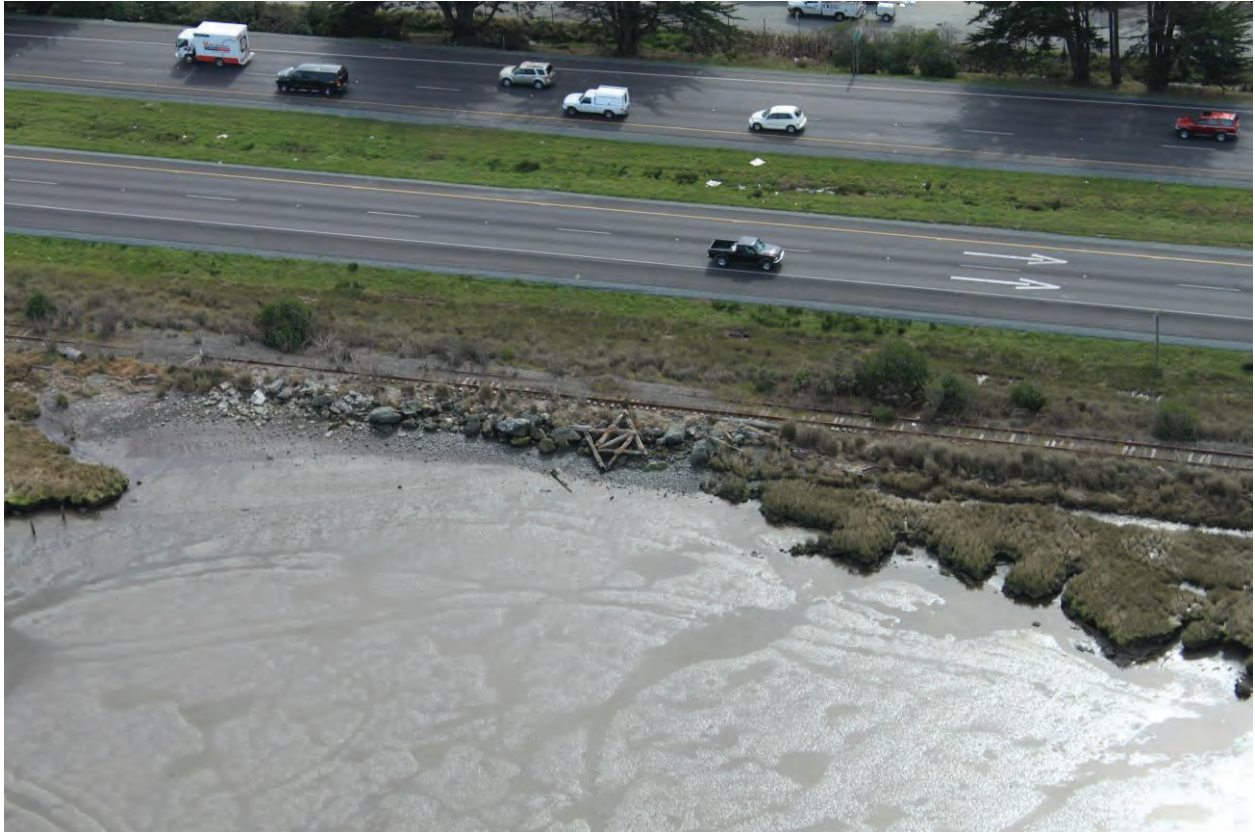
Photo 9 (February 25, 2014): View facing southeast of erosion along shoreline (Segment 4).

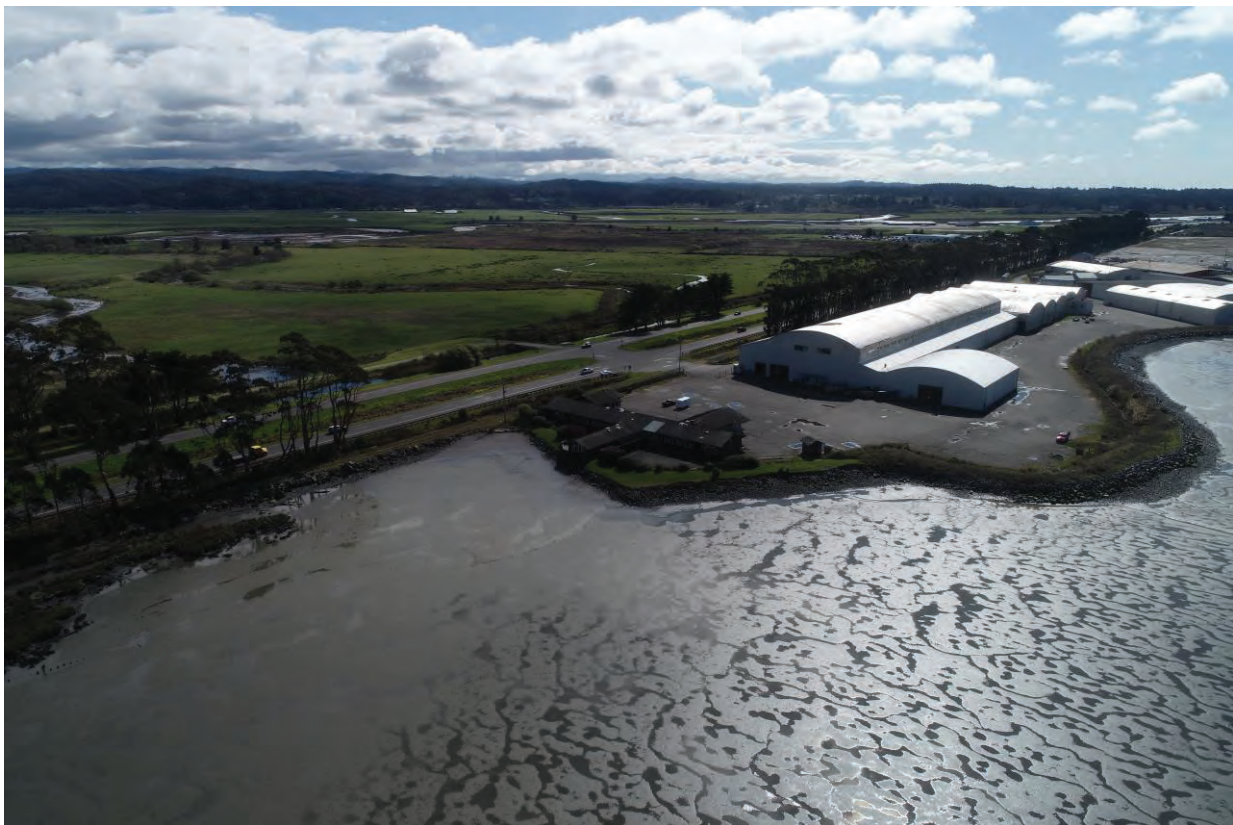
Photo 14 (March 18, 2020): View facing southwest of proposed bridge connection (Segment 6) between Brainard levee (Segment 5) and railroad prism (Segment 7).

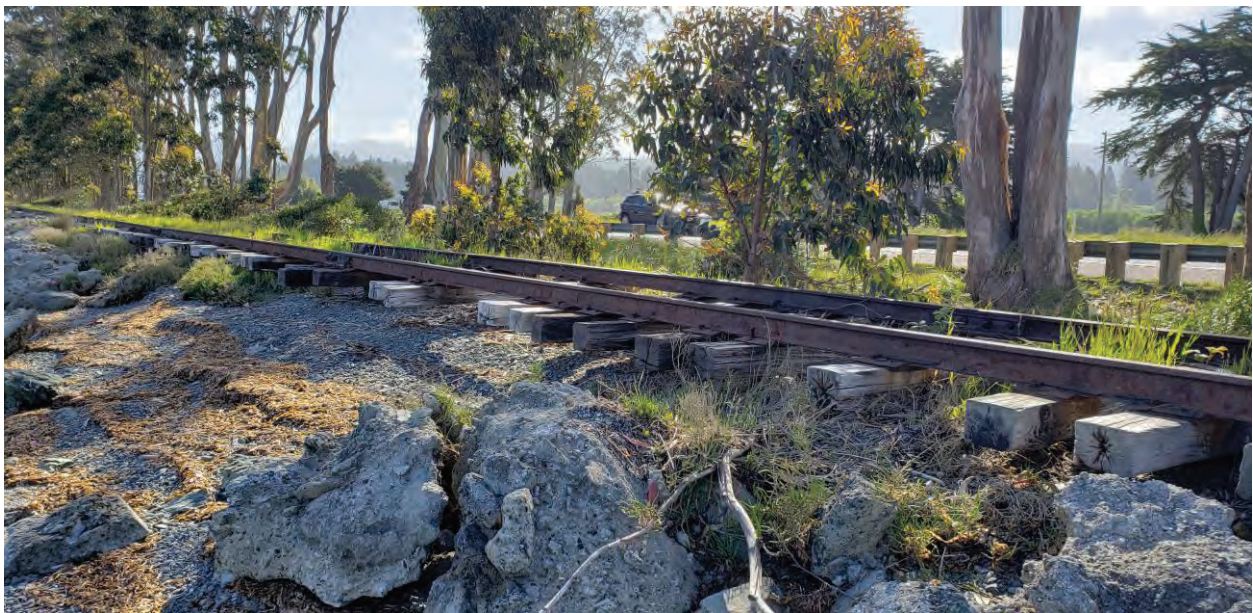
Photo 16 (May 2, 2019): View facing northeast of erosion of railroad prism (Segment 7).

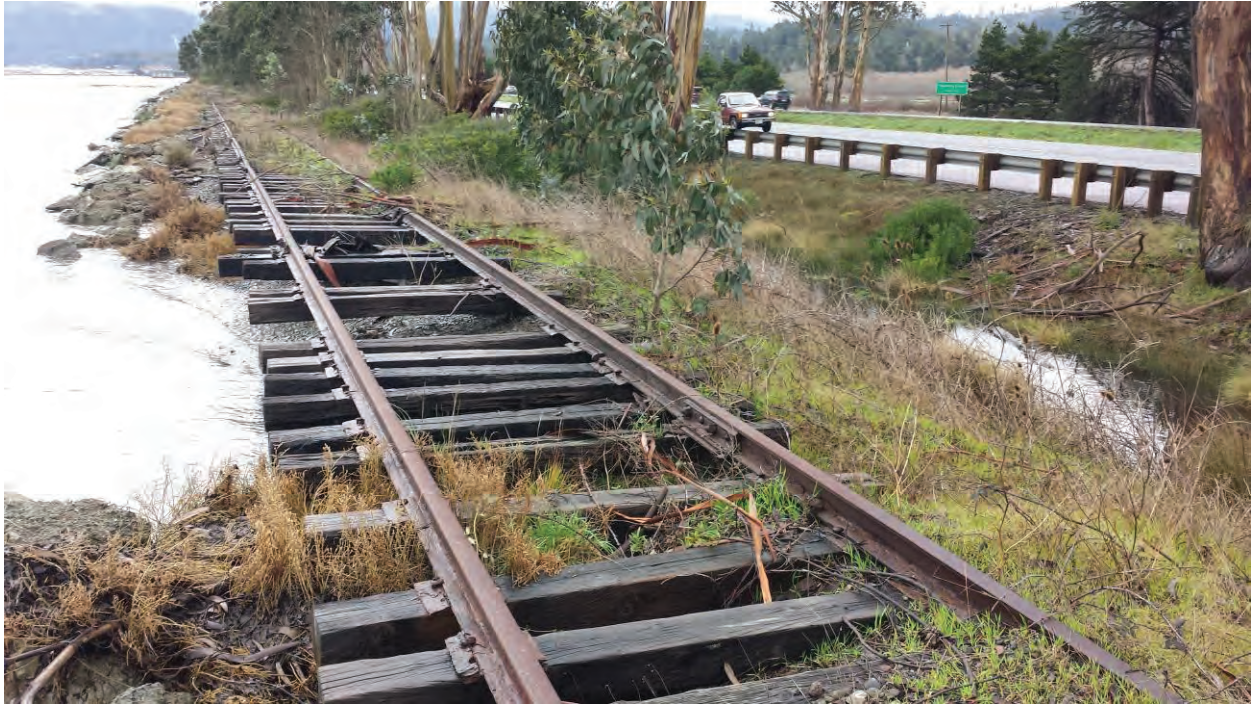
Photo 17 (February 9, 2017): View facing northeast of erosion of railroad prism (Segment 7).

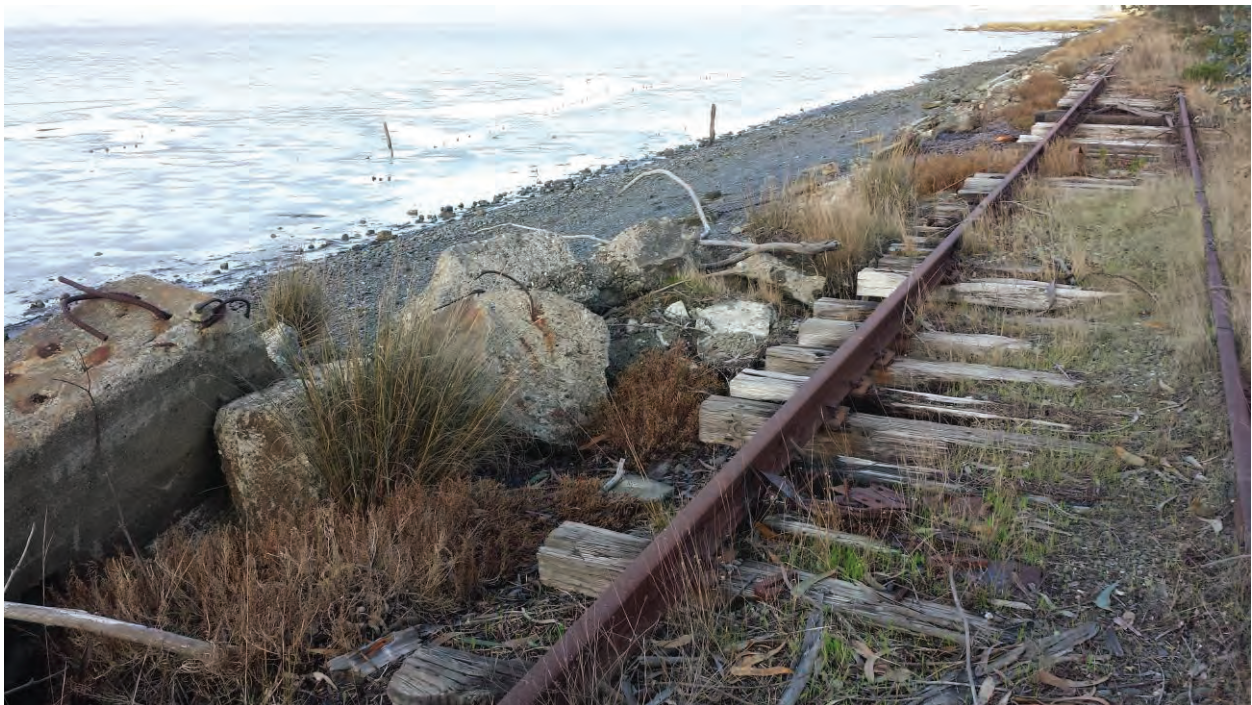
Photo 18 (December 1, 2017): View facing north of disarrayed rubble along shoreline and erosion of railroad prism (Segment 7).

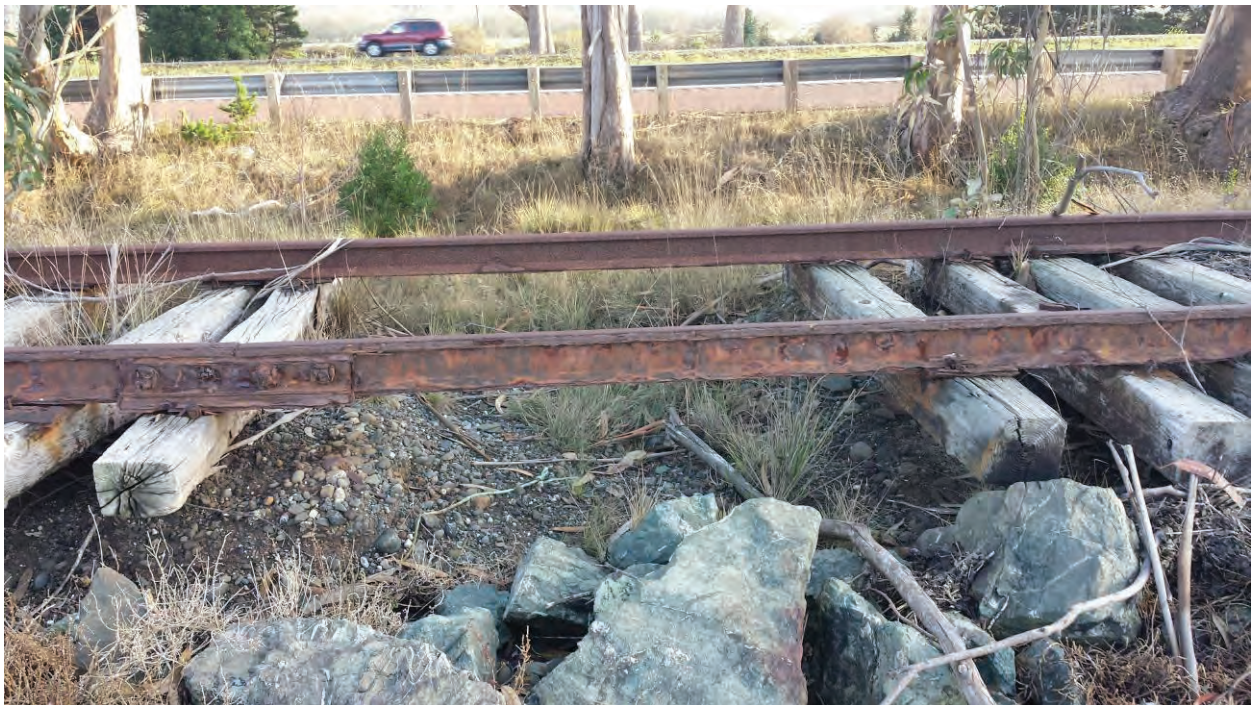
Photo 20 (December 1, 2017): View facing east of erosion of railroad prism (Segment 7).

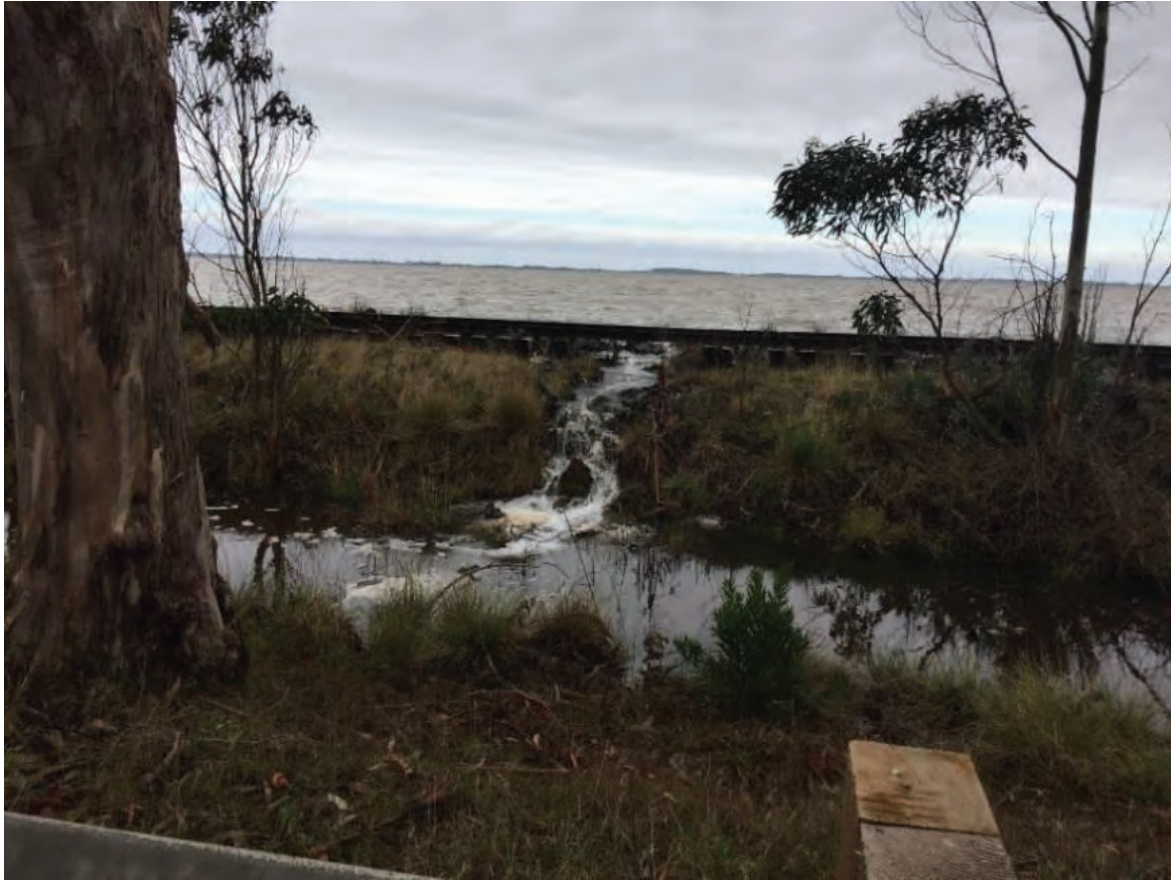
Photo 21 (approx. 2017): View facing west of flooding through damaged railroad prism (Segment 7).

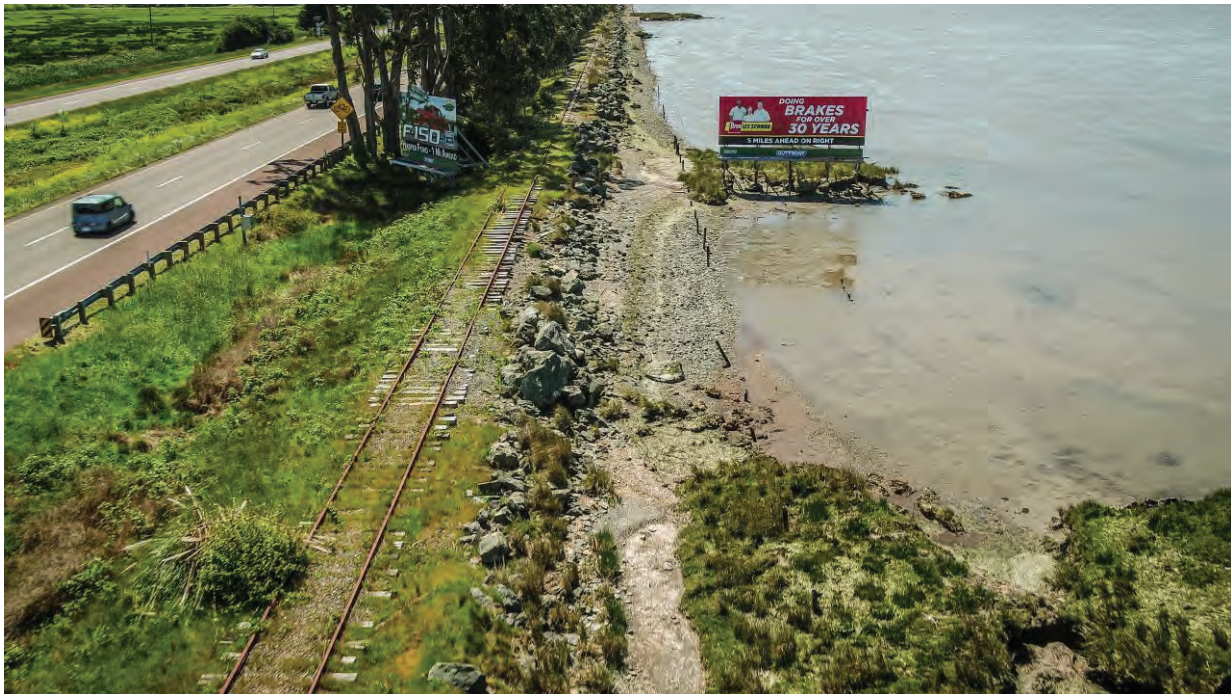
Photo 24 (April 30, 2019): View facing south of eucalyptus trees and billboards (Segment 7) and areas of erosion and disarrayed revetment (Segment 8).

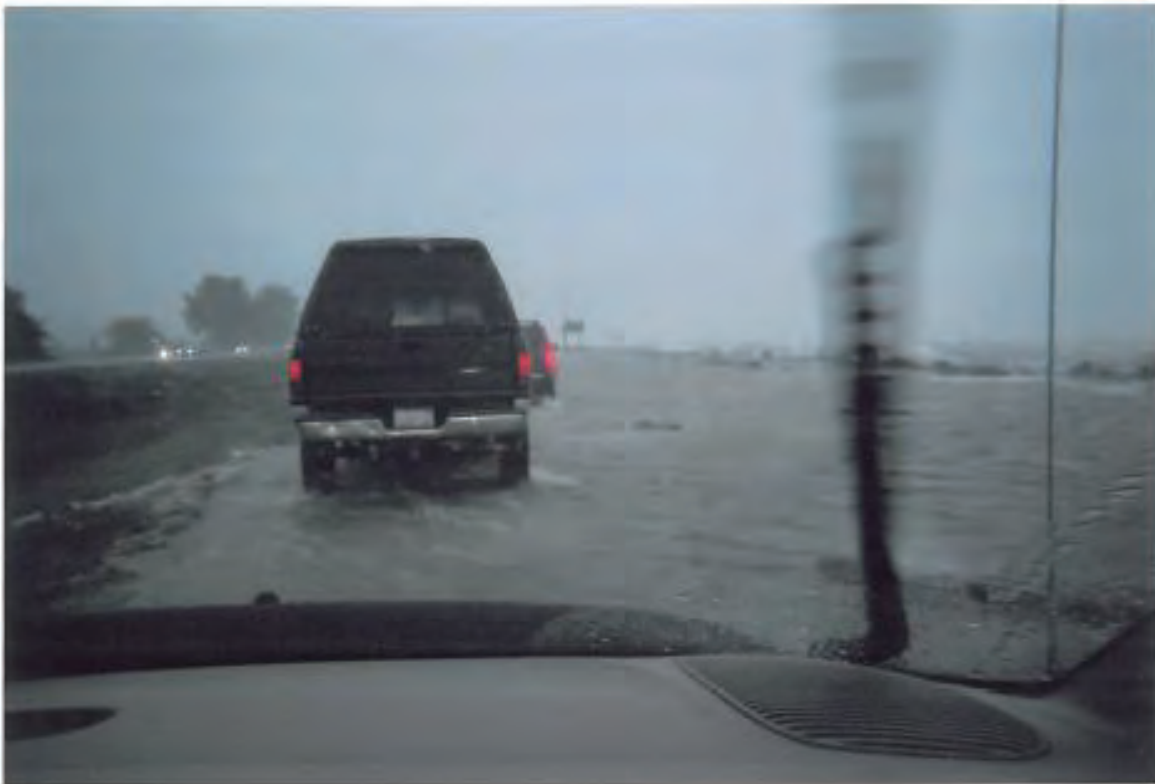
Photo 28 (December 31, 2005): View facing south of flooding on Highway 101 (near Segment 8).
