CALIFORNIA COASTAL COMMISSION

1-20-0560

(HUMBOLDT COUNTY DPW)

Humboldt Bay Trail South Alignment Figures

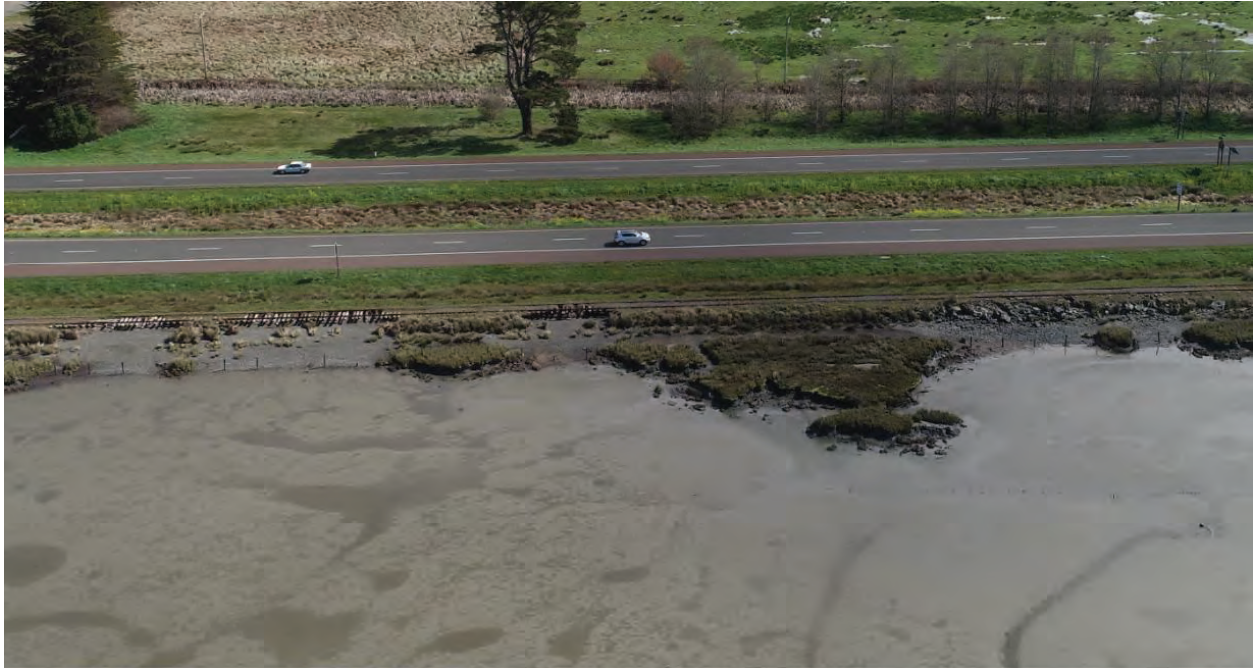
Photo 29 (March 18, 2020): View facing east of erosion on railroad prism (Segment 8).

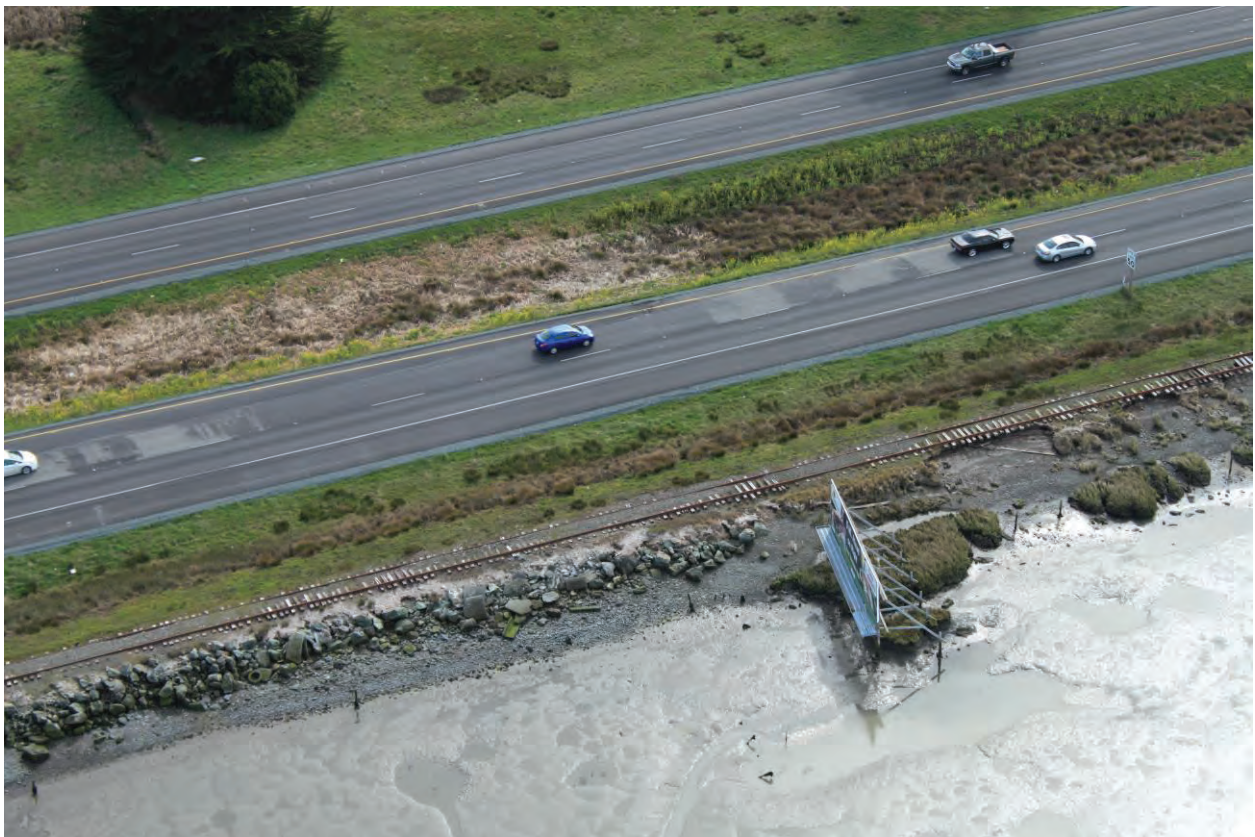
Photo 30 (February 25, 2014): View facing east of erosion of shoreline and railroad prism (Segment 8).

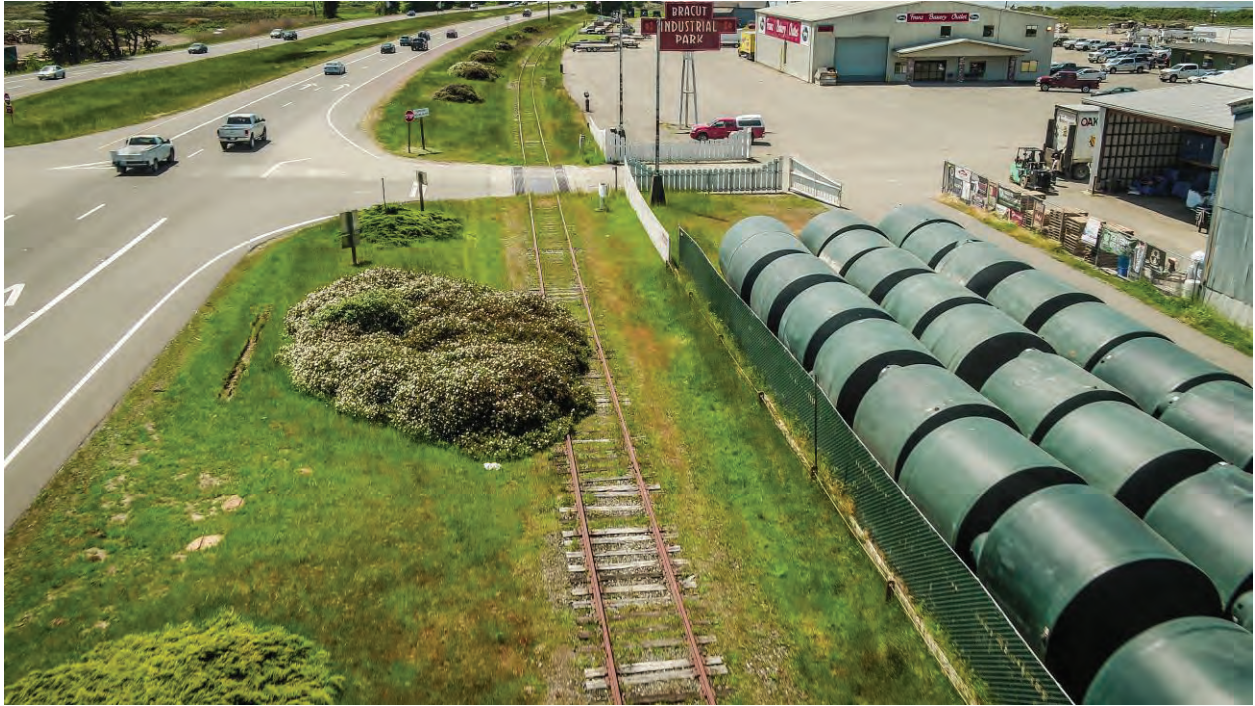
Photo 33 (April 30, 2019): View facing south of entrance to Bracut Industrial Park (Segment 9).

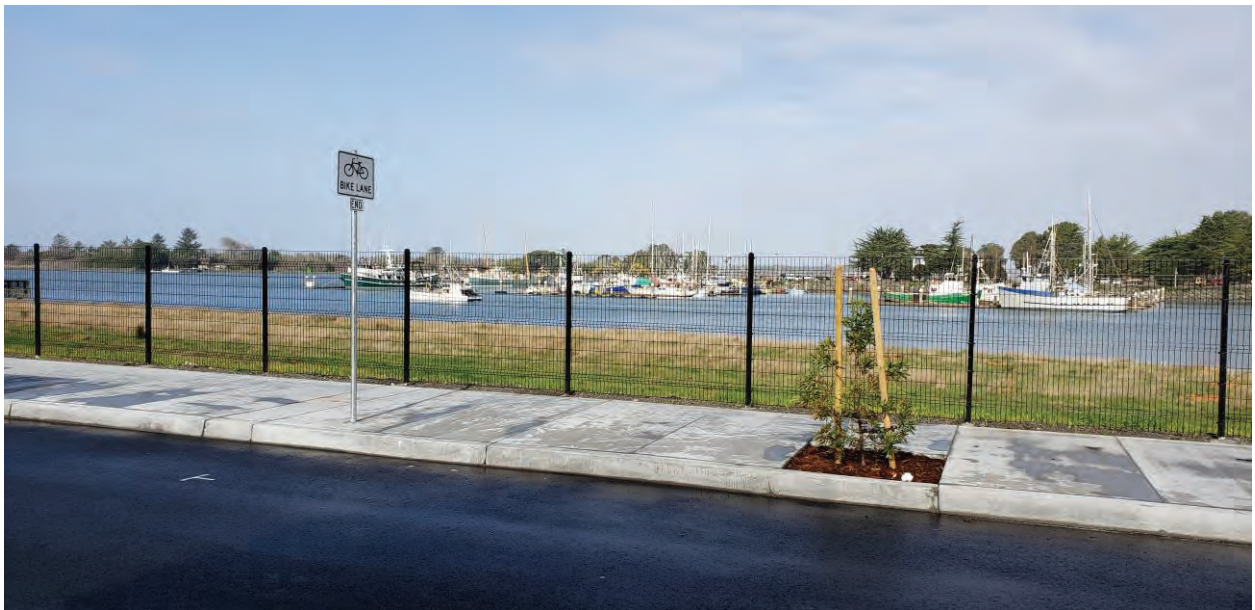
Photo 34: Example of fence type (welded wire) proposed along property line at Bracut Industrial Park.

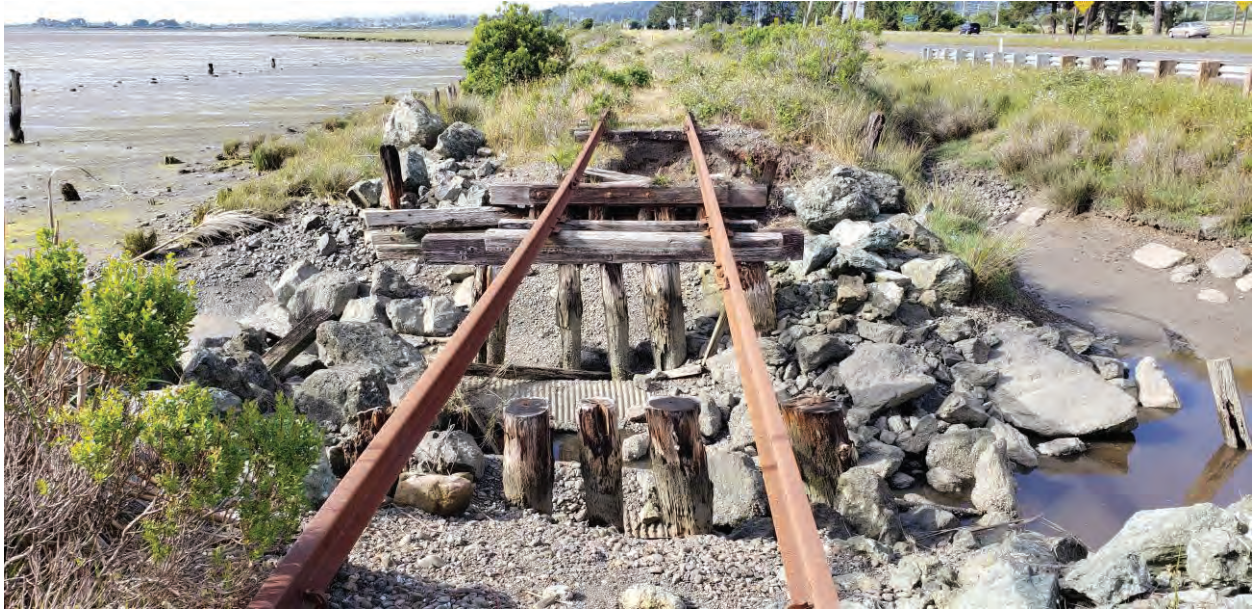
Photo 35 (May 31, 2020): View facing north of railroad crossing at Brainard Slough (Segment 9).

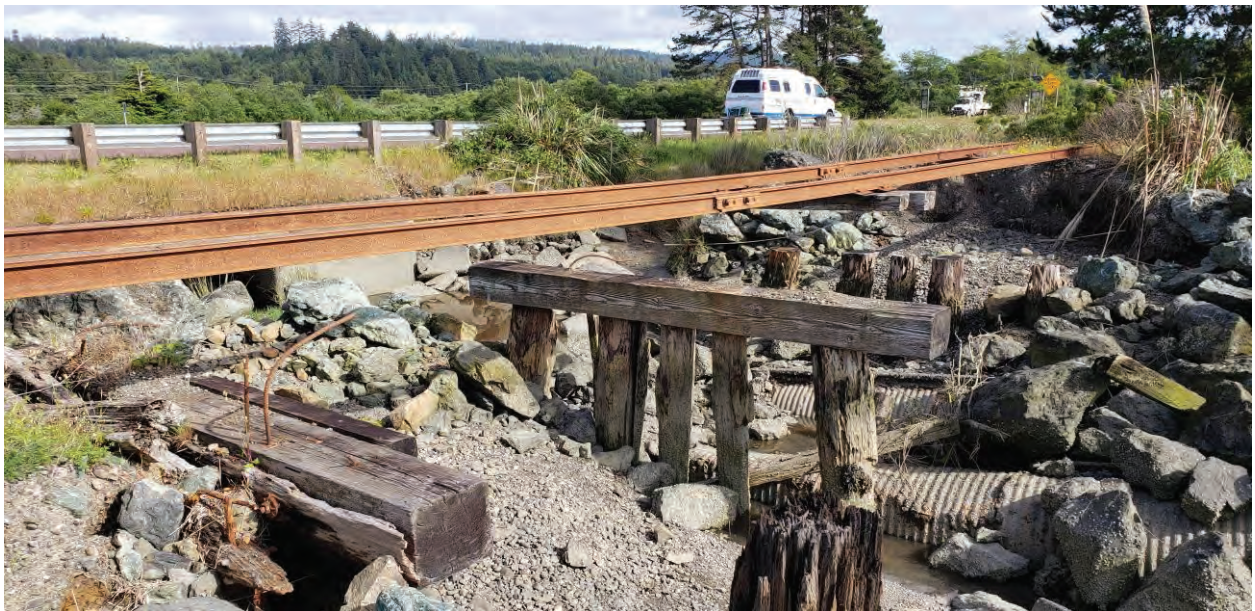
Photo 36 (May 31, 2020): View facing southeast of railroad crossing at Brainard Slough (Segment 9).

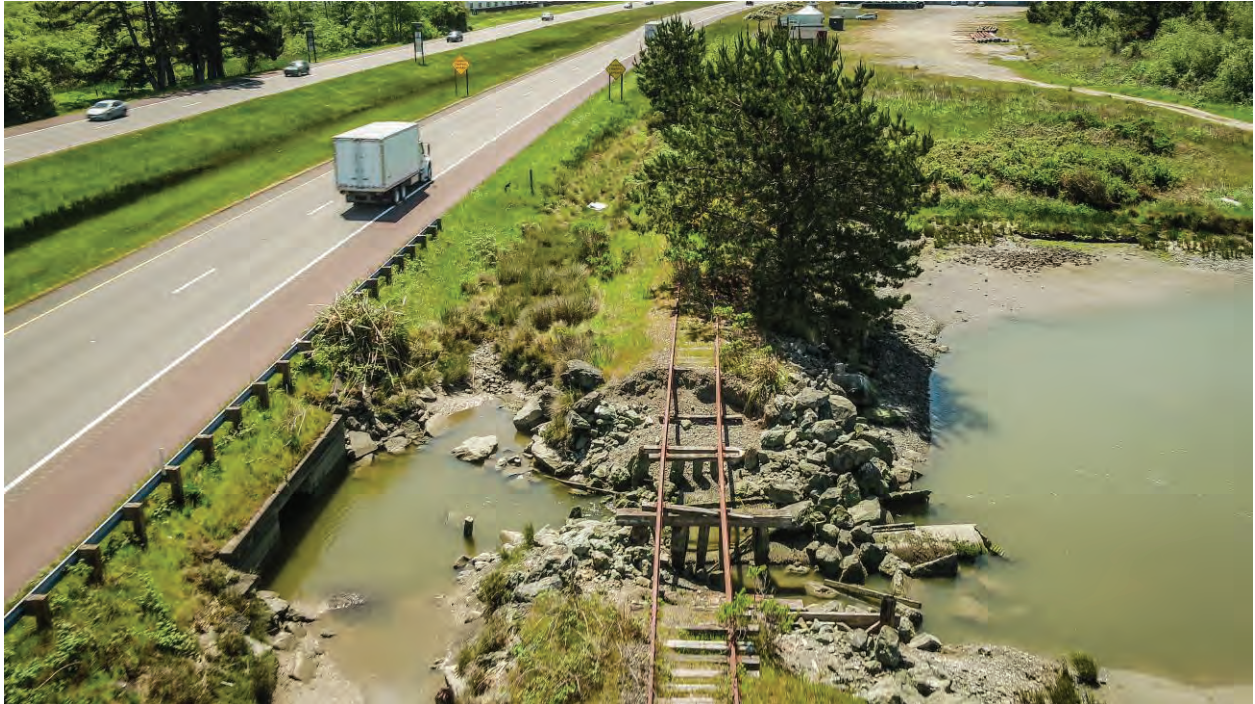
Photo 37 (April 30, 2019): View facing south of railroad crossing at Brainard Slough (Segment 9).

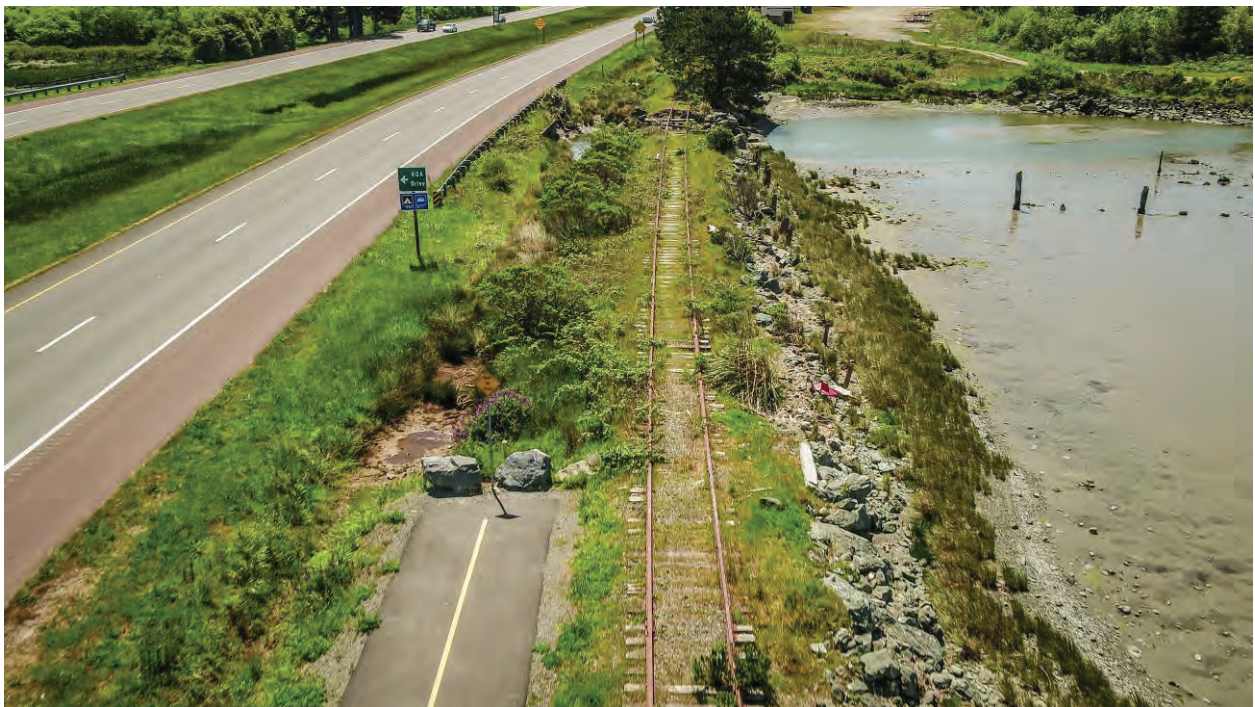
Photo 38 (April 30, 2019): View facing south of southern terminus of Humboldt Bay Trail North and Brainard Slough (Segment 9).
