A-2-MAR-25-0040 (SLADDEN-MCELROY SFD)

1) Name or description of project: Appeal No.A-2-Mar-25-0044 (Sladden-McElroy)

Two survey exhibits dated October 27, 2025, provide supporting data and visual documentation of bluff retreat and toe undermining conditions. Key findings include:

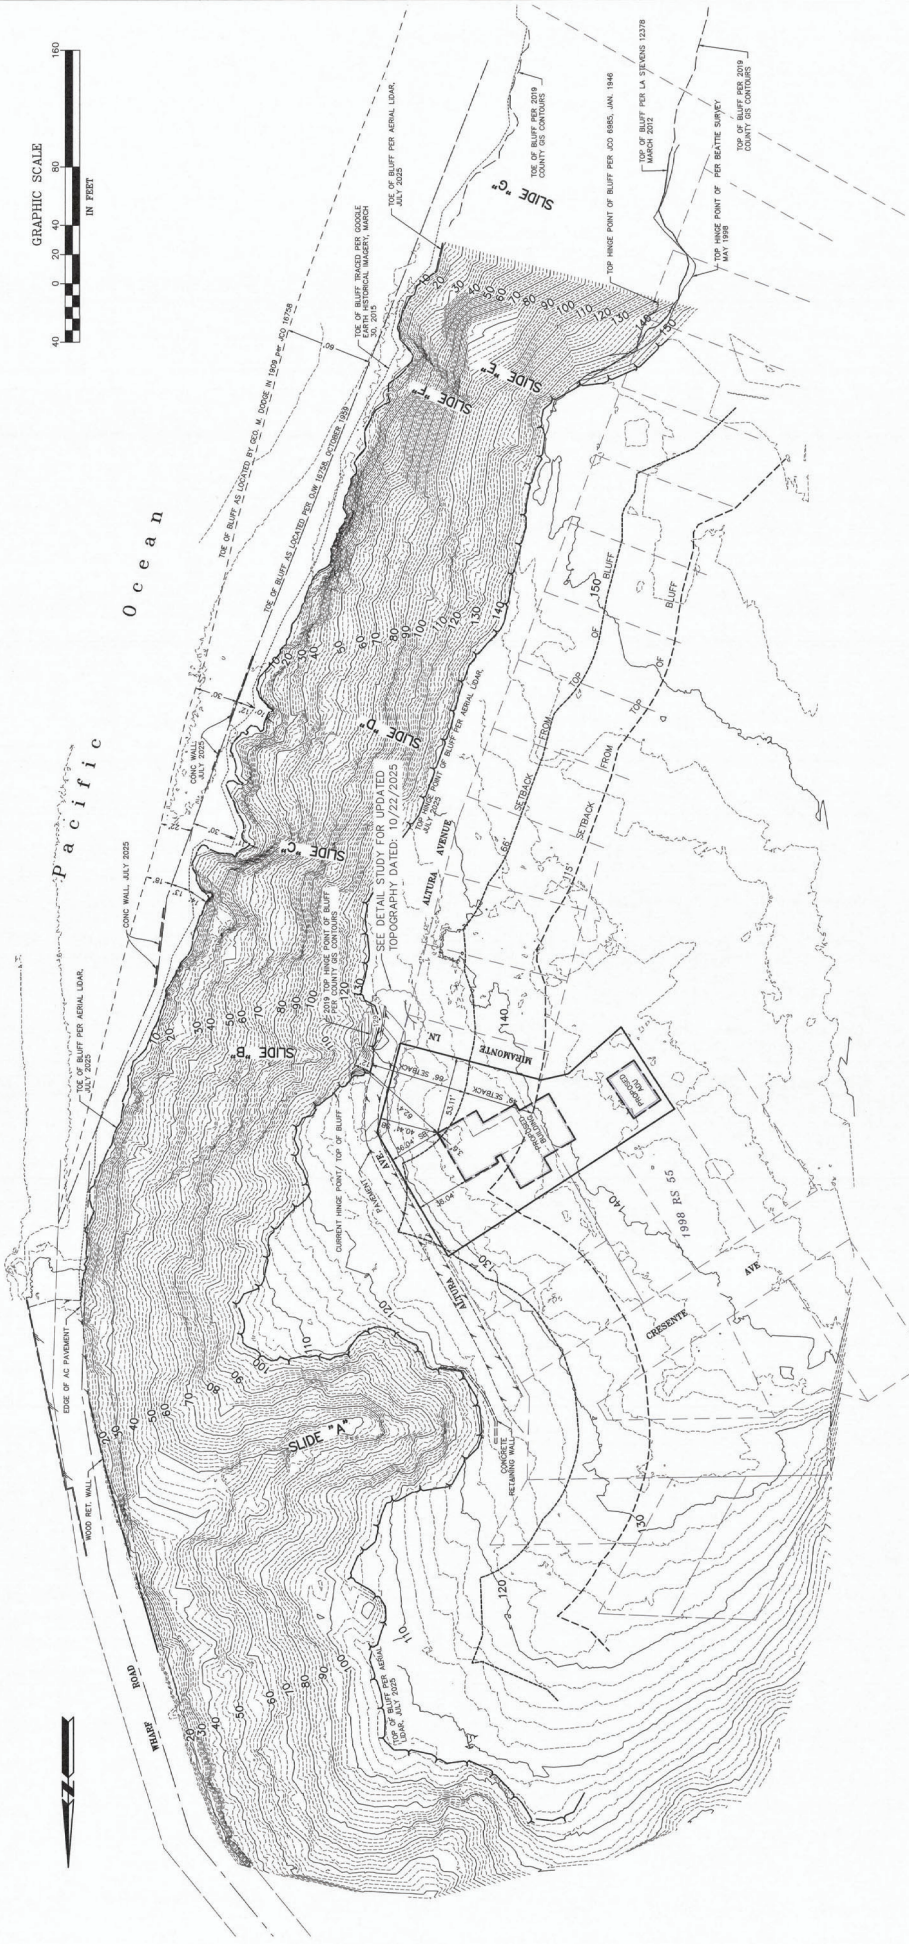
ALL DISTANCES ARE IN FEET AND DECIMALS THEREOF.

SURVEYOR'S NOTES:

1. CONTOUR INTERVAL: 2 FEET (1 FOOT INSIDE DETAIL STUDY)
2. CONTOUR DATA PER AERIAL LIDAR DRONE FLIGHT CONDUCTED BY BEAR FLAG ENGINEERS, JULY 2025.
3. VERTICAL DATUM: NORTH AMERICAN VERTICAL DATUM OF 1988 (NAV88) ELEVATION ESTABLISHED BY GPS RELATIVE POSITIONING FROM NATIONAL GEODETIC SURVEY (NAD83) CONTINUOUSLY OPERATING REFERENCE STATIONS (CORS). STATIONS USED WERE: 04N1, 161, 1484, 1724, 1858
4. THE LOCATION OF THE "HINGE POINT" AND "TOE" OF EACH "SLIDE" WILL BE DETERMINED IN THE FIELD AND NOTED ON THIS DRAWING AND THE LICENSEE RESPONSIBLE FOR THE WORK.
5. REVERSE LOCATION OF HINGE POINT AS NOTED BASED ON FIELD SURVEY DATA COLLECTED 10/22/2025.

1. SLIDE "A" PER THE OWNER OF 43 ALTAIR AVE. THE MOST RECENT SLIDES HAVE OCCURRED IN MAY OF 2024 AND DECEMBER OF 2024. HE HAS ALSO NOTED THERE HAVE BEEN SLIDES OVER THE YEARS IN THIS VICINITY.
2. SLIDE "B" SHOWN ACTIVE BETWEEN MARCH 2015 & JUNE 2017 AND AGAIN BETWEEN FEBRUARY 2021 & NOVEMBER 2022.
3. SLIDE "C" SHOWN ACTIVE SOME TIME JUST BEFORE JUNE 2004, THEN BETWEEN MARCH 2015, MARCH 2015 & JUNE 2017 AND AGAIN BETWEEN NOVEMBER 2022 & MAY 2023.
4. SLIDE "D" APPEARS BETWEEN APRIL 2013 & MARCH 2015, THEN ACTIVE AGAIN MARCH 2015, MARCH 2015 AND JUNE 2017, THEN AGAIN BETWEEN NOVEMBER 2022 AND MAY 2023.
5. SLIDES "E" & "F" ACTIVE BETWEEN MAY 2012 & APRIL 2013, MARCH 2015 & JUNE 2017, AND THEN AGAIN BETWEEN NOVEMBER 2022 & MAY 2023.
6. SLIDE "G" APPEARS BETWEEN MARCH 2015 & JUNE 2017, AND IS ACTIVE BETWEEN NOVEMBER 2022 & MAY 2023, THEN AGAIN BETWEEN MAY 2023 AND APRIL 2024.

- The Top of Bluff has migrated approximately 12 feet landward since 2019 based on comparison with Marin County GIS contours.
- The current toe of the bluff is being actively undermined due to failure of the historic seawall along the base.
- The measured 62.4-foot setback is less than the 66-foot LCP minimum.
- The seawall is deteriorated, allowing direct wave attack and accelerating erosion.
- No recent studies have been mentioned regarding the toe of bluff erosion which gives support to the hillside, the seawall failures at the prior toe of the hillside and sea level rise. The reports give mention that many of these slides occur because of the erosion at the bluff toe.

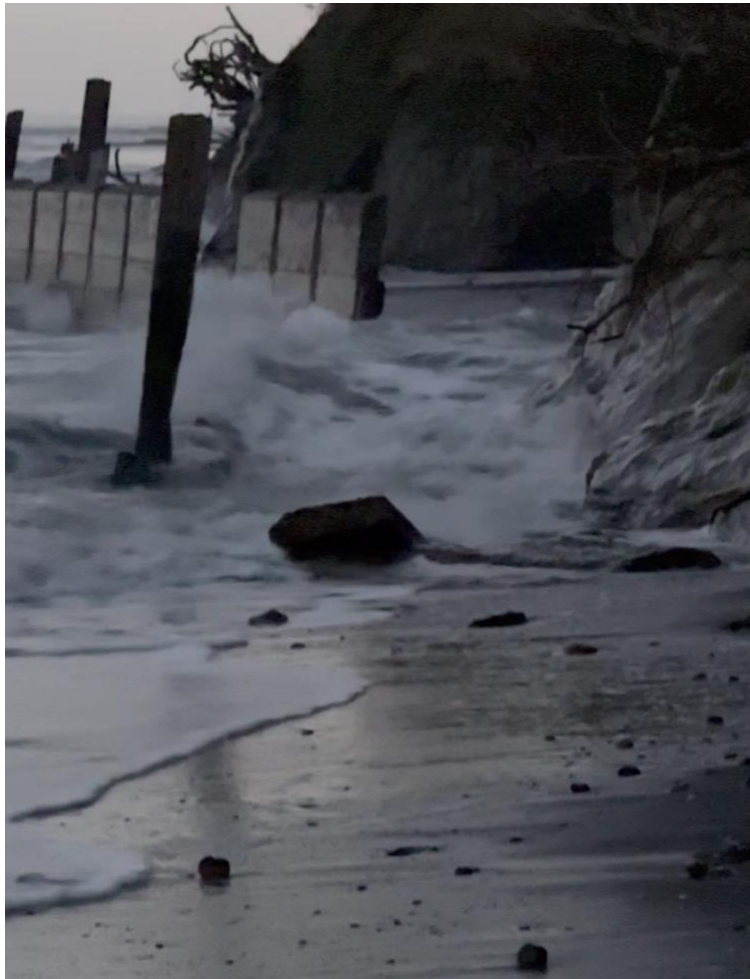
(Screenshot from video of waves past seawall.)

There is good reason to believe that the seawall at the base of the bluff will not last for the life of the applicant’s proposed structure. Videos taken by my client show that waves are already overtopping the seawall.

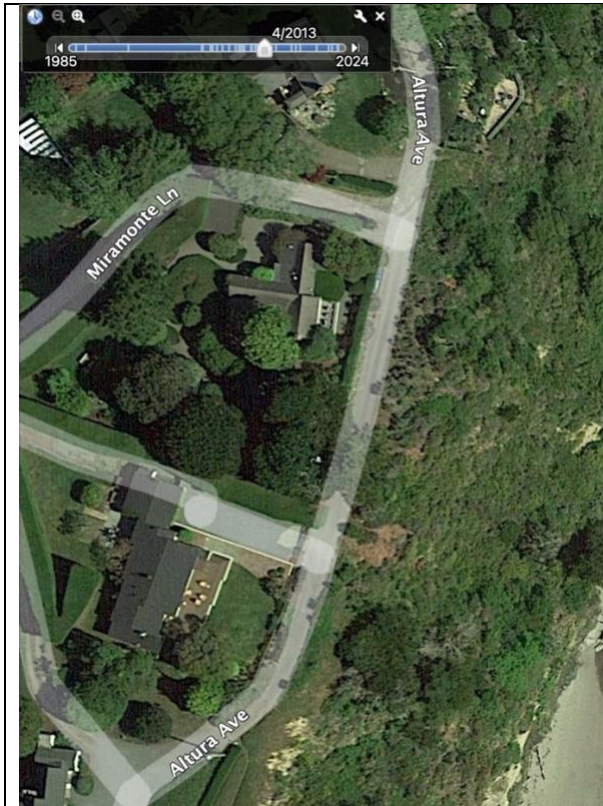
April 2013 baseline

The staff report also does not address that, in areas where “vigorous sliding” is taking place, the LCP requires an additional 15 meters of setback. (Zoning Code § 20.64.060.B(1).) In just the previous 13 years, vigorous and repeated slides are apparent in Google Earth imagery:

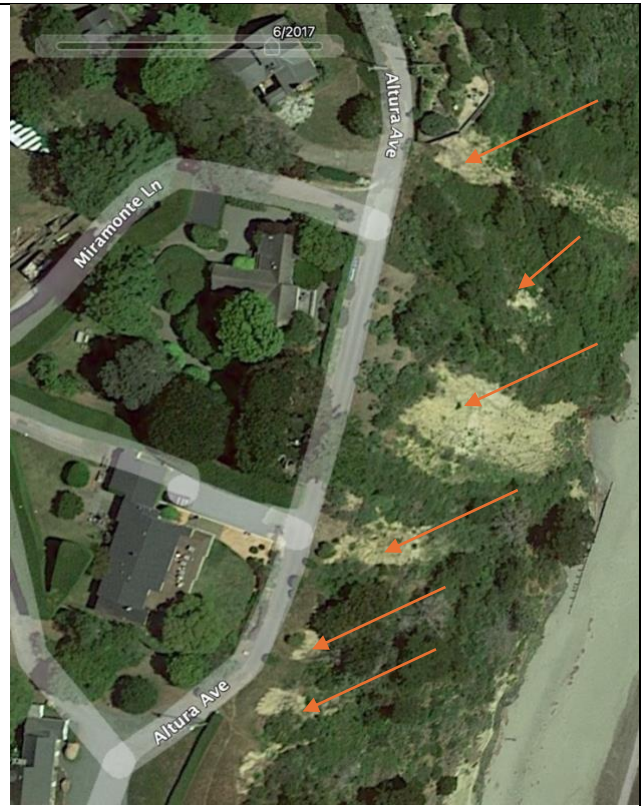
June 2017 additional slides

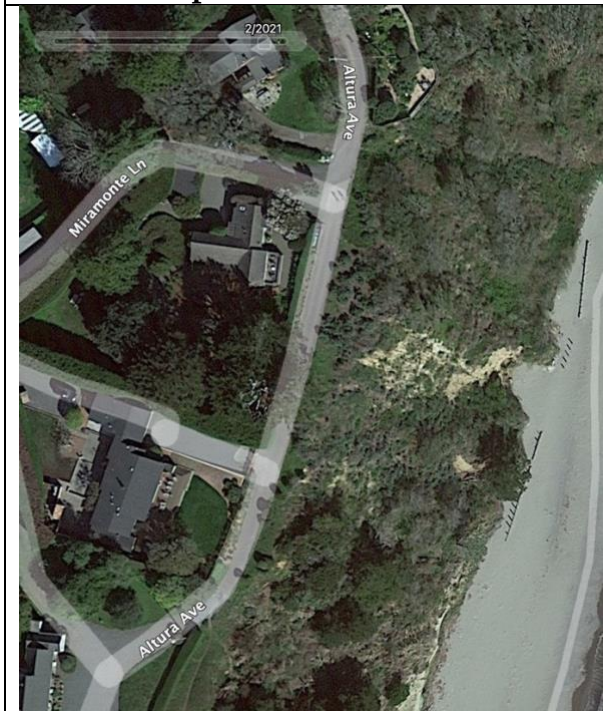
February 2021 regrowth

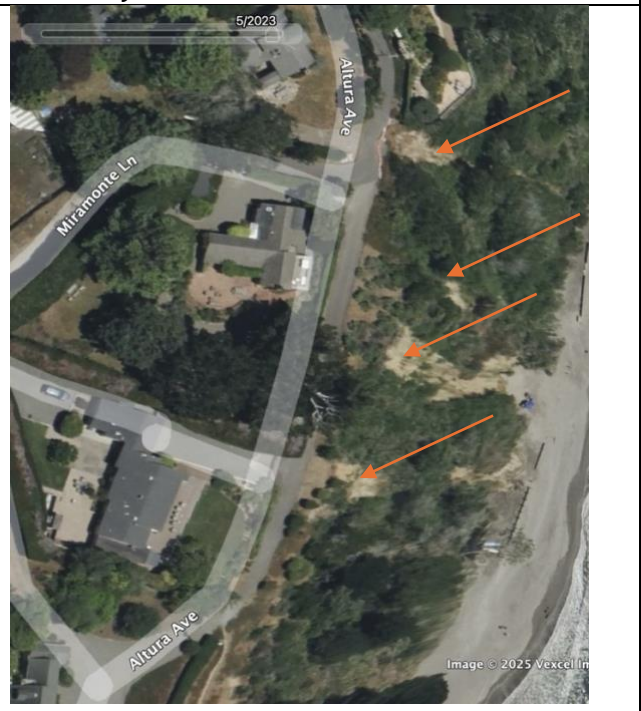
May 2023 additional slides

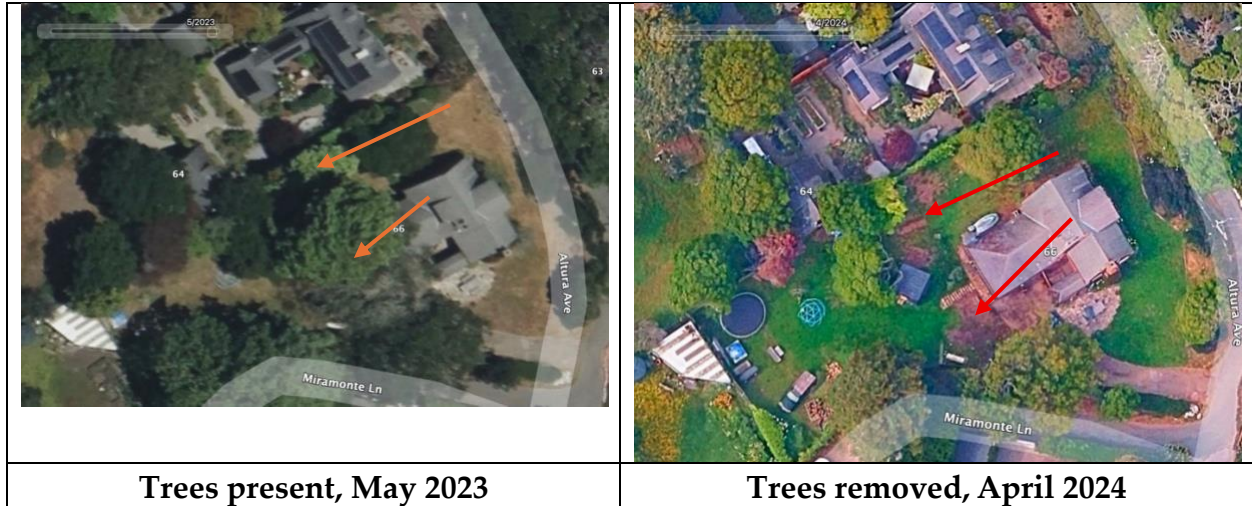
The tree removal is readily apparent from Google Earth imagery:

The staff report does not acknowledge a recent, and significant, apparent code and Coastal Act violation at the site of the proposed project that has only contributed to the landslide problem: the applicants recently removed huge protected redwood trees from their property, without permits, which could otherwise have helped to absorb some of the runoff from this property and project.

This tree removal is significant here because redwoods are well known to absorb significant amounts of water.¹ Here, water runoff contributes to the erosion problem that is the heart of the issue with this application. The redwoods that were removed could have helped mitigate the increased runoff from this project. Instead, their removal only exacerbates the problem.

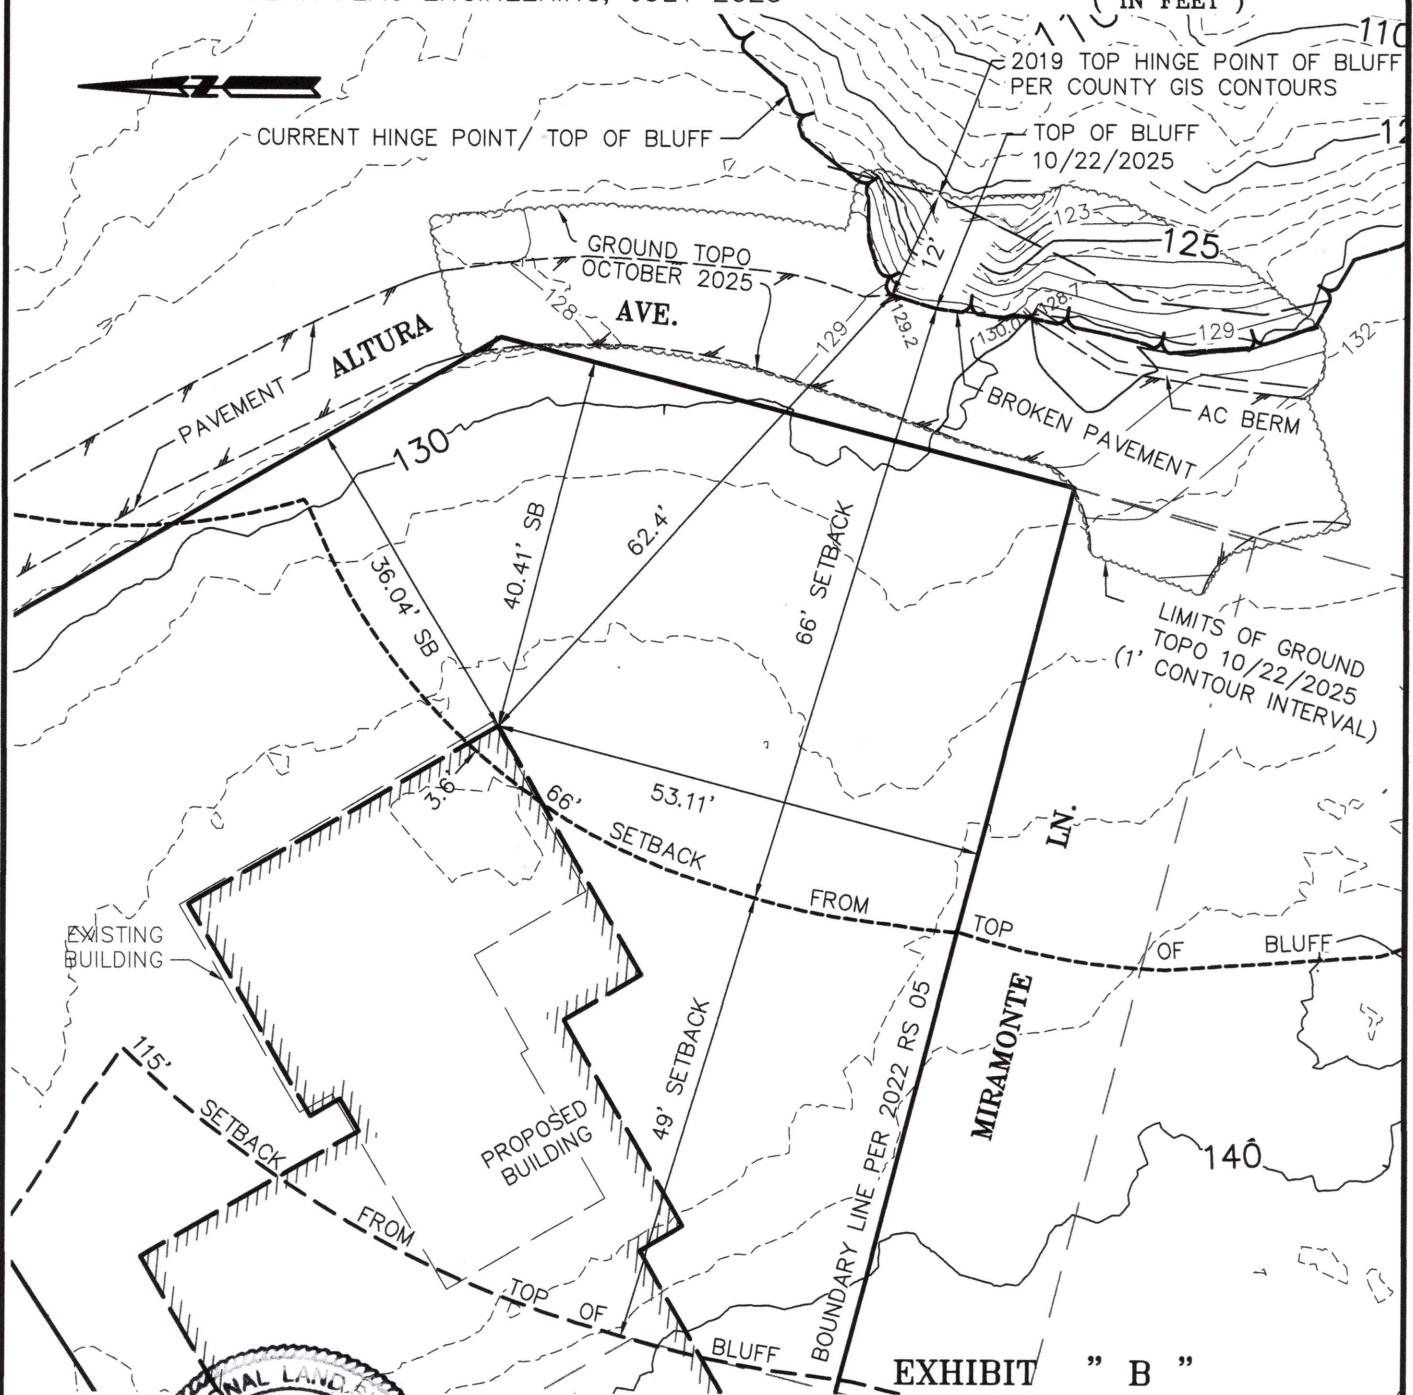
EXHIBIT " B "
DETAIL STUDY OF
"HINGE POINT" / TOP OF BLUFF
& PERTINENT SETBACKS

CONTOUR DATA OUTSIDE OF CLOUDED AREA PROVIDED BY BEAR FLAG ENGINEERING, JULY 2025

(IN FEET)
