CALIFORNIA COASTAL COMMISSION

STAFF REPORT: REVISED FINDINGS

APPLICATION NO.: 3-97-65

PROJECT DESCRIPTION: Shotcrete erosion control seawall, approximately 15 ft. high by 150 ft. long. See detailed description in Finding 1.

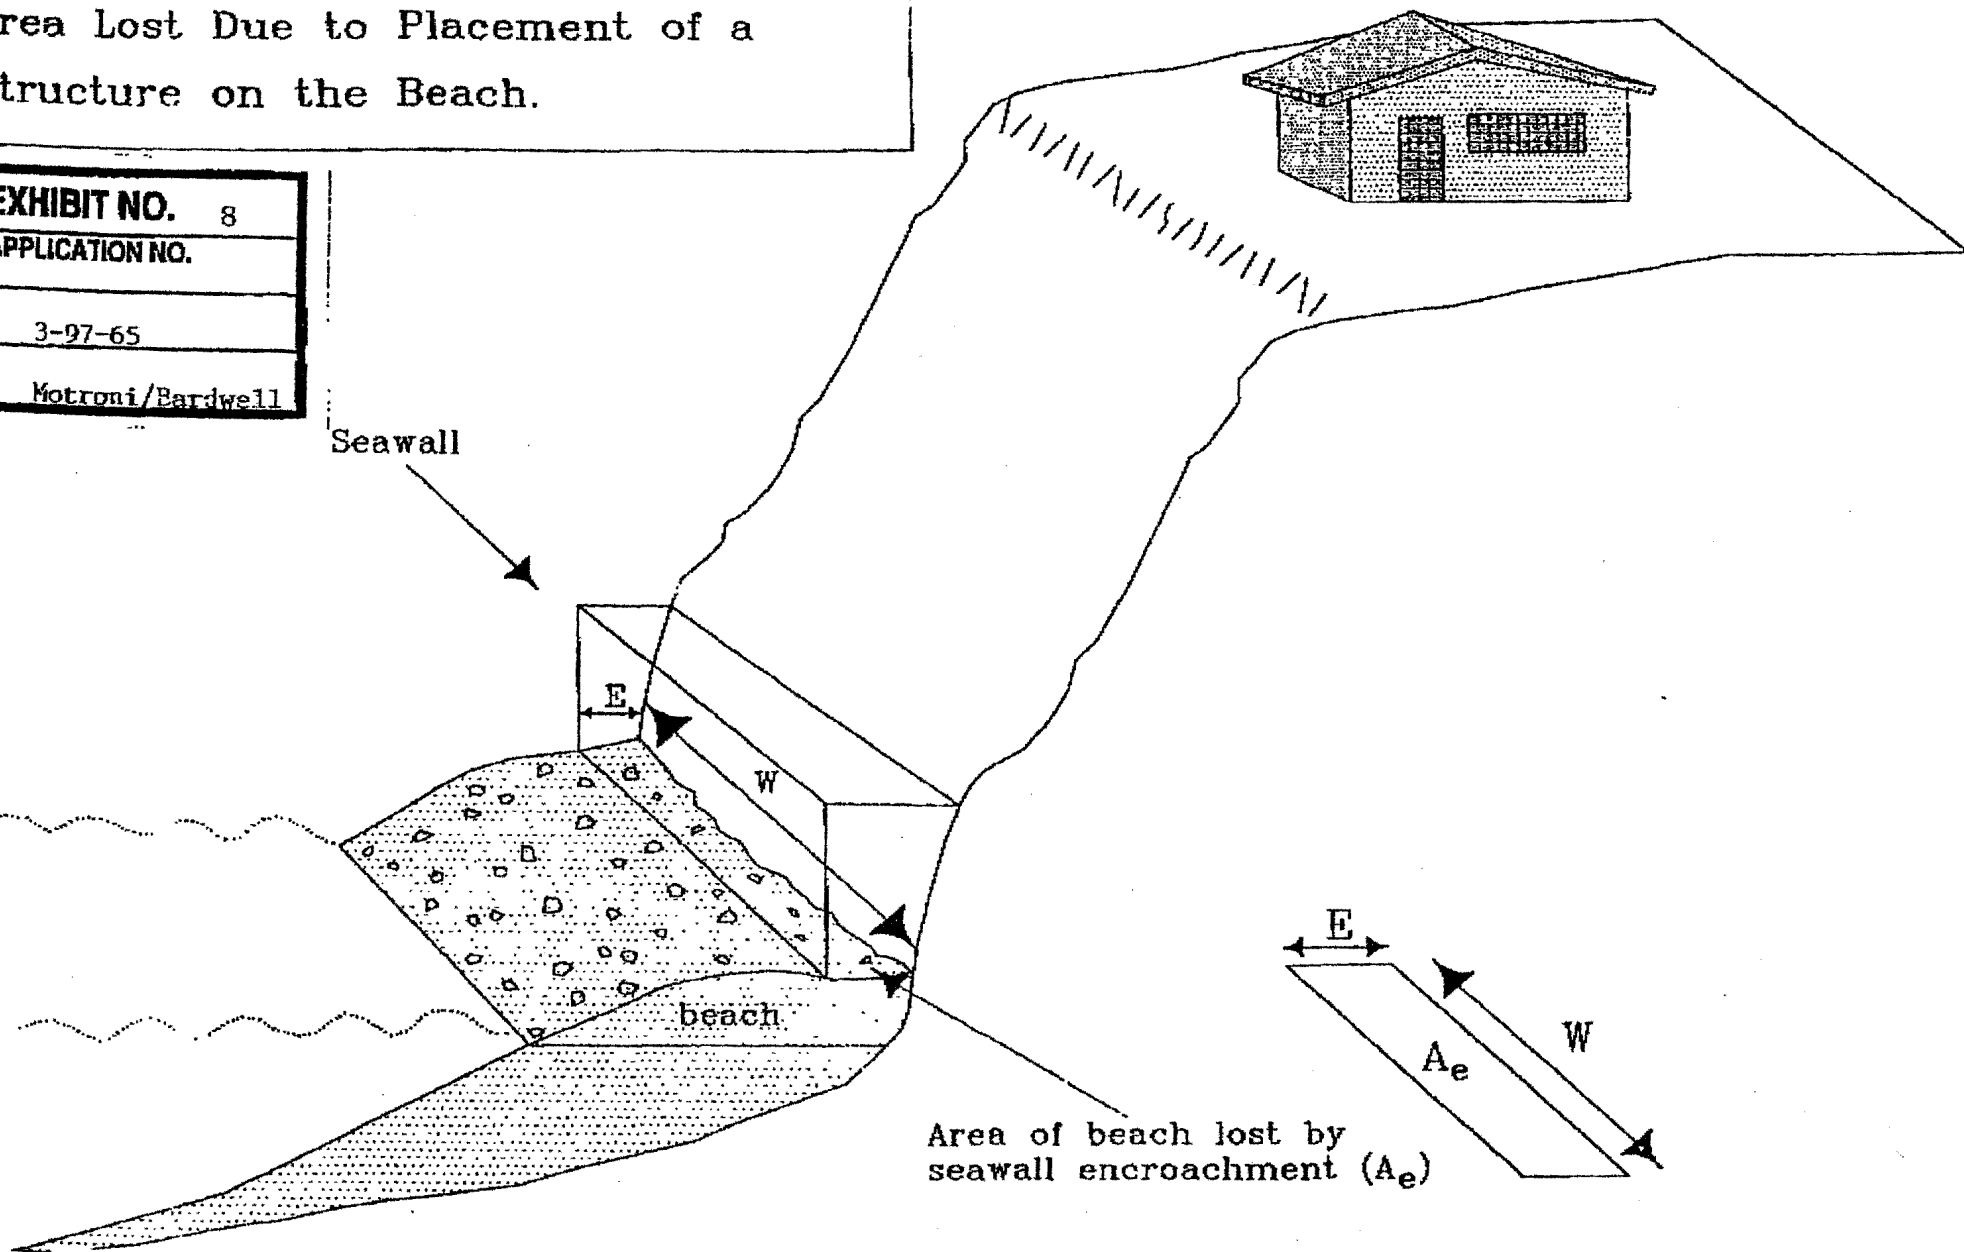
EXHIBIT NO.	8
APPLICATION NO.	
	3-97-65
	Motroni/Bardwell

Seawall
